Baseline Assessment – Stream Attributes

Reach S-VV13d (Temporary Access Road) Perennial Spread B Lewis County, West Virginia

Spread B Stream S-VV13d (Temporary Access Road) Lewis County

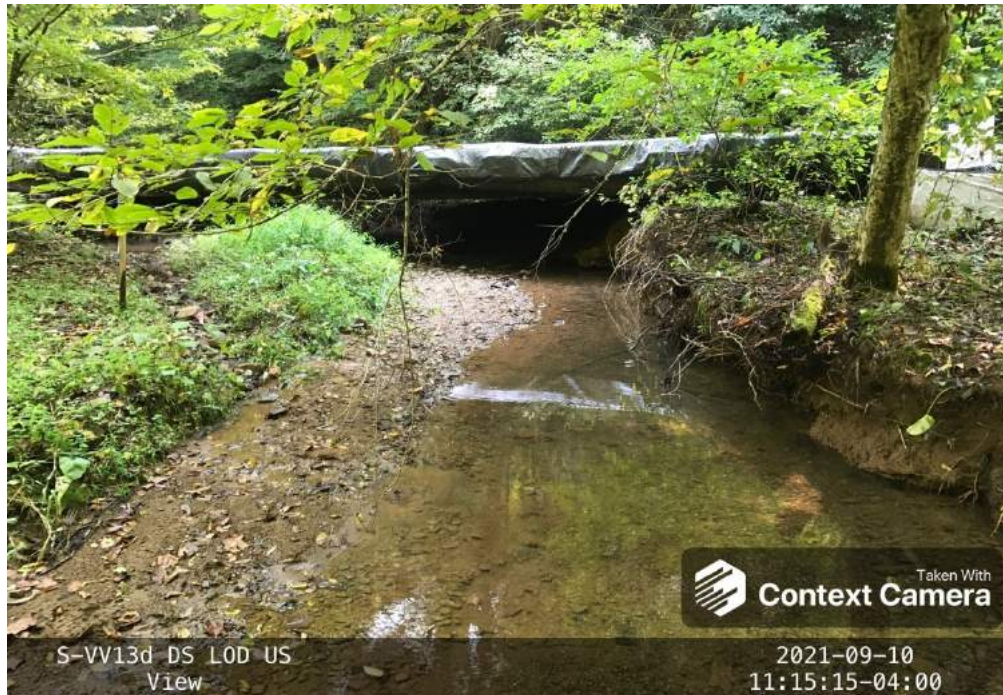
Photo Type: DS, US View

Location, Orientation, Photographer Initials: Downstream Edge of ROW, Upstream View, AJE/KAY
Lat: 38.902549 Long: -80.564778

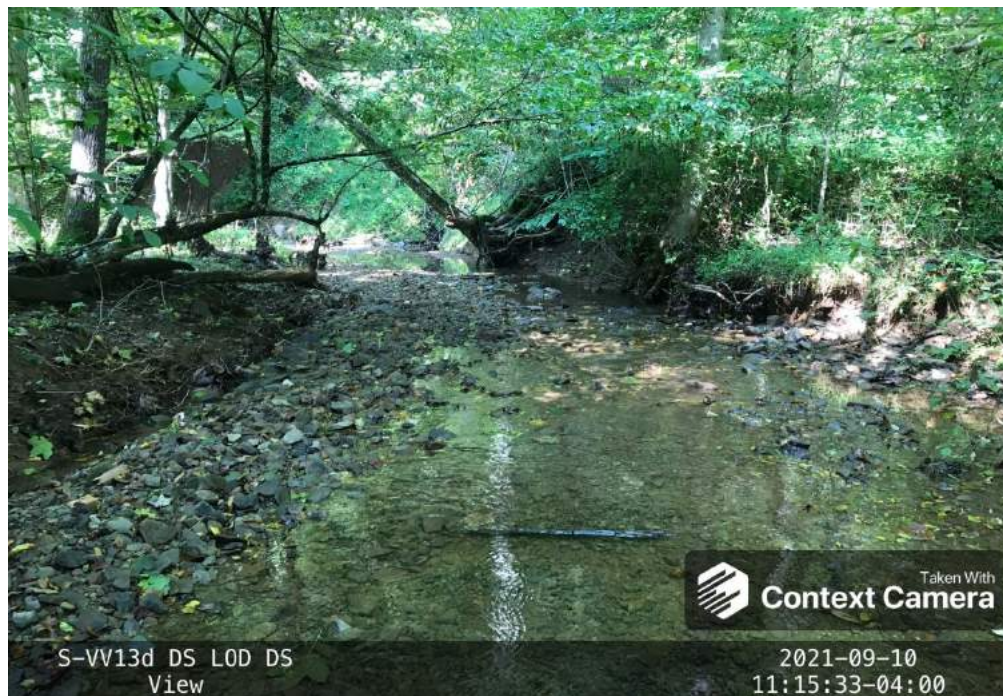
Photo Type: DS, DS View

Location, Orientation, Photographer Initials: Downstream Edge of ROW, Downstream View, AJE/KAY
Lat: 38.902549 Long: -80.564778

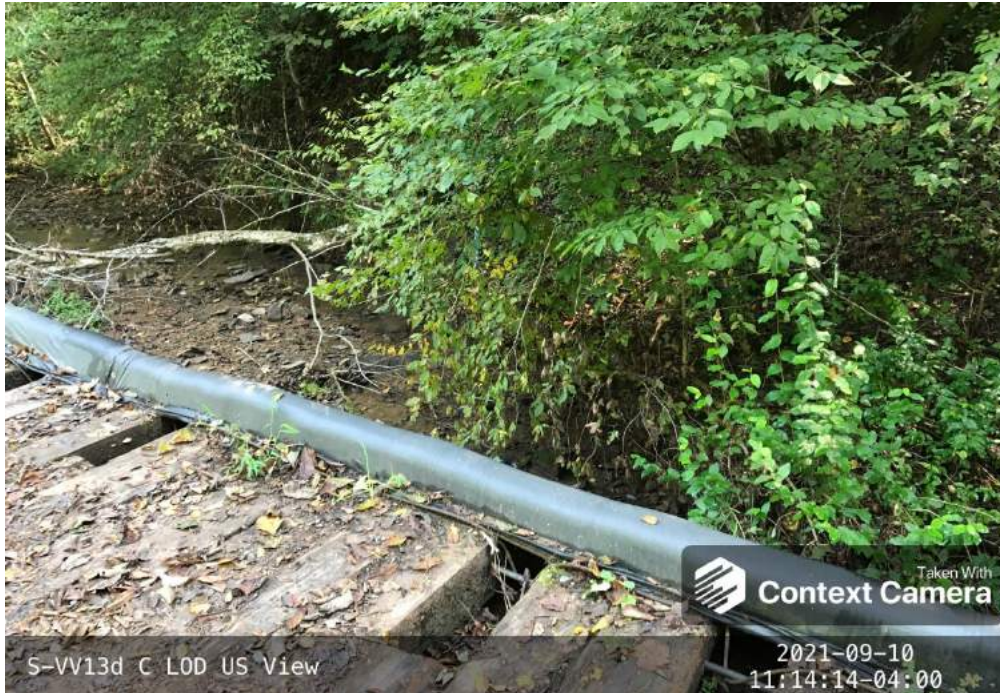
Photo Type: US View at Center
Location, Orientation, Photographer Initials: Center ROW, Upstream View, AJE/KAY
Lat: 38.902549 Long: -80.564778

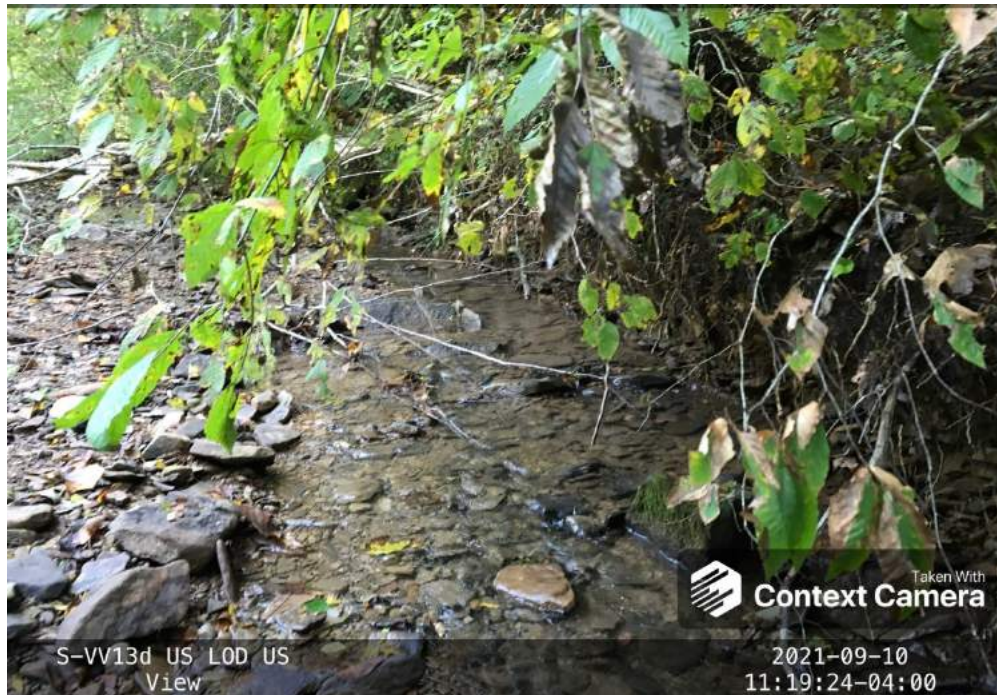
Photo Type: US, US View
Location, Orientation, Photographer Initials: Upstream Edge of ROW, Upstream View, AJE/KAY
Lat: 38.902549 Long: -80.564778

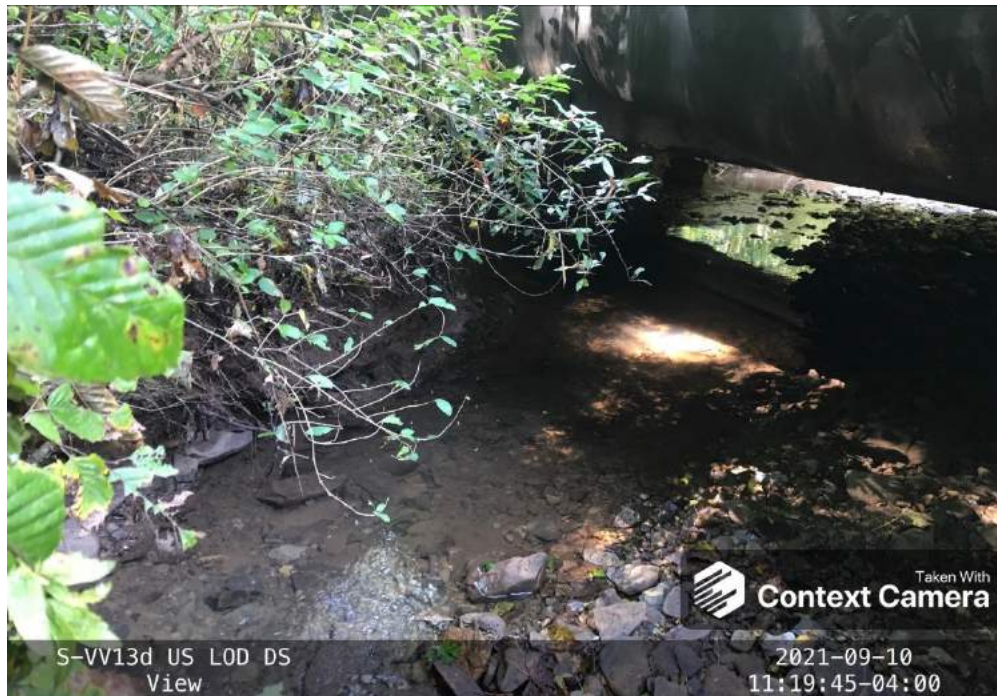
Photo Type: US, DS View
Location, Orientation, Photographer Initials: Upstream Edge of ROW, Downstream View, AJE/KAY
Lat: 38.902549 Long: -80.564778

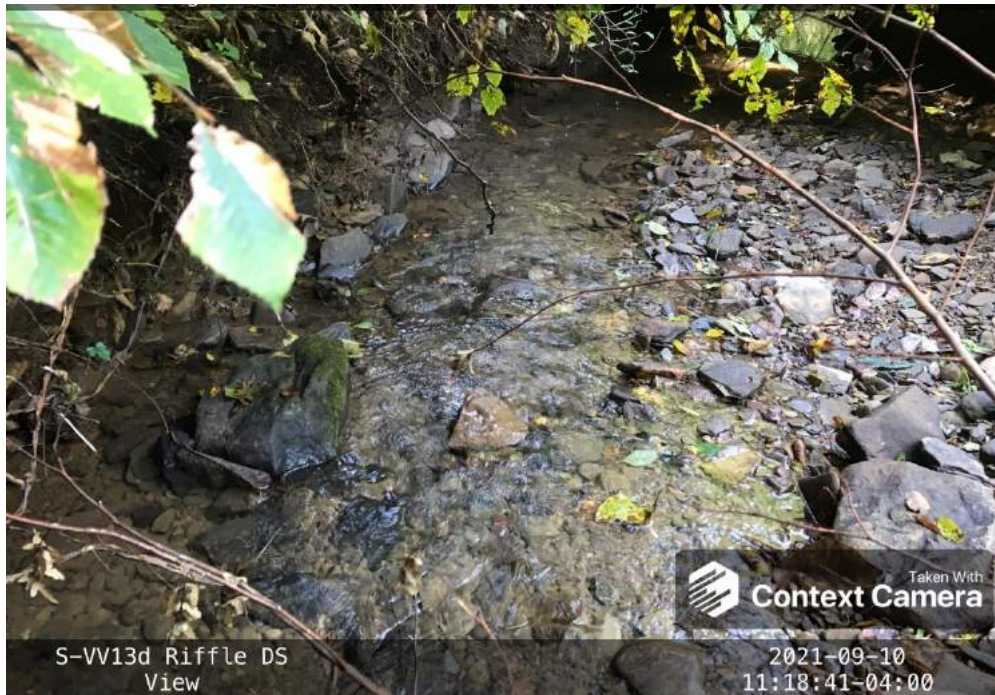
Photo Type: Riffle, DS View
Location, Orientation, Photographer Initials: Upstream of Riffle, Downstream View, AJE/KAY
Lat: 38.902549 Long: -80.564778

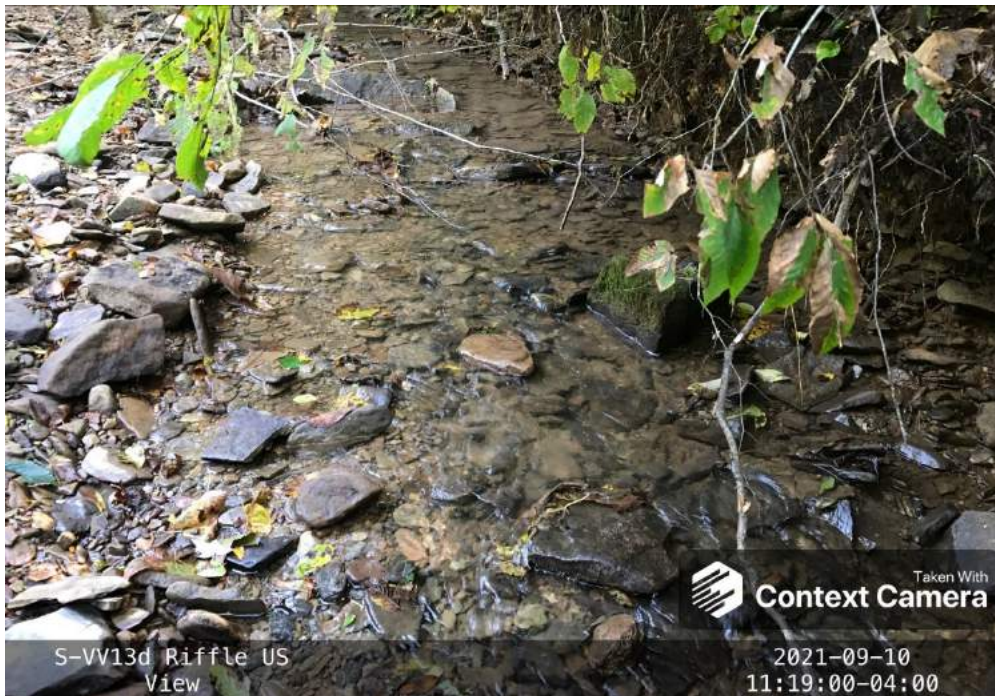
Photo Type: Riffle, US View
Location, Orientation, Photographer Initials: Downstream of Riffle, Upstream View, AJE/KAY
Lat: 38.902549 Long: -80.564778

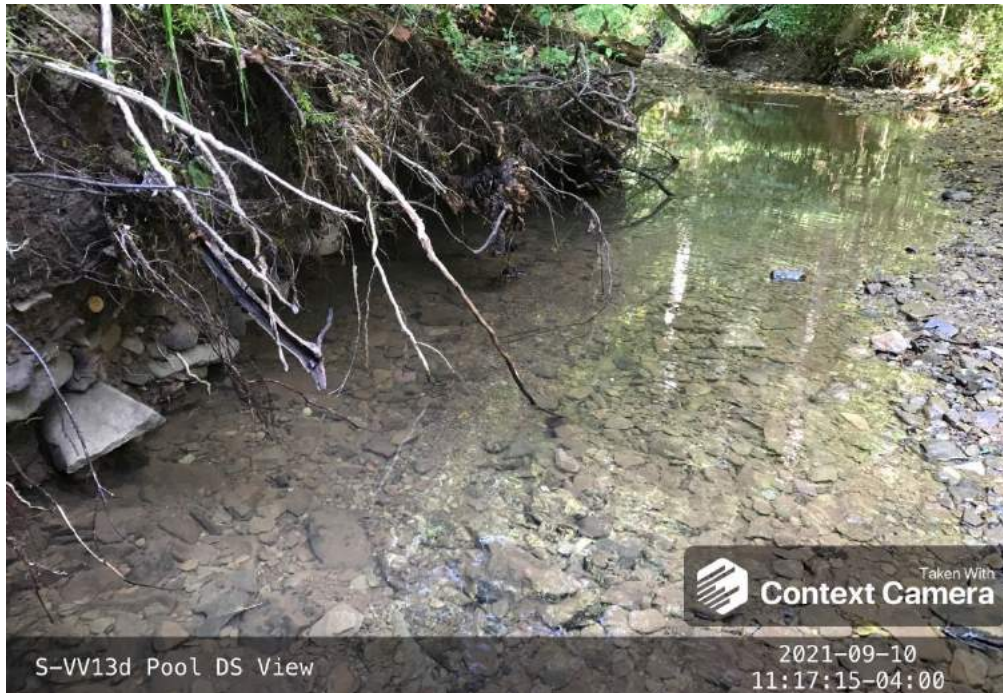
Photo Type: Pool, DS View
Location, Orientation, Photographer Initials: Upstream of Pool, Downstream View, AJE/KAY
Lat: 38.898431 Long: -80.56825

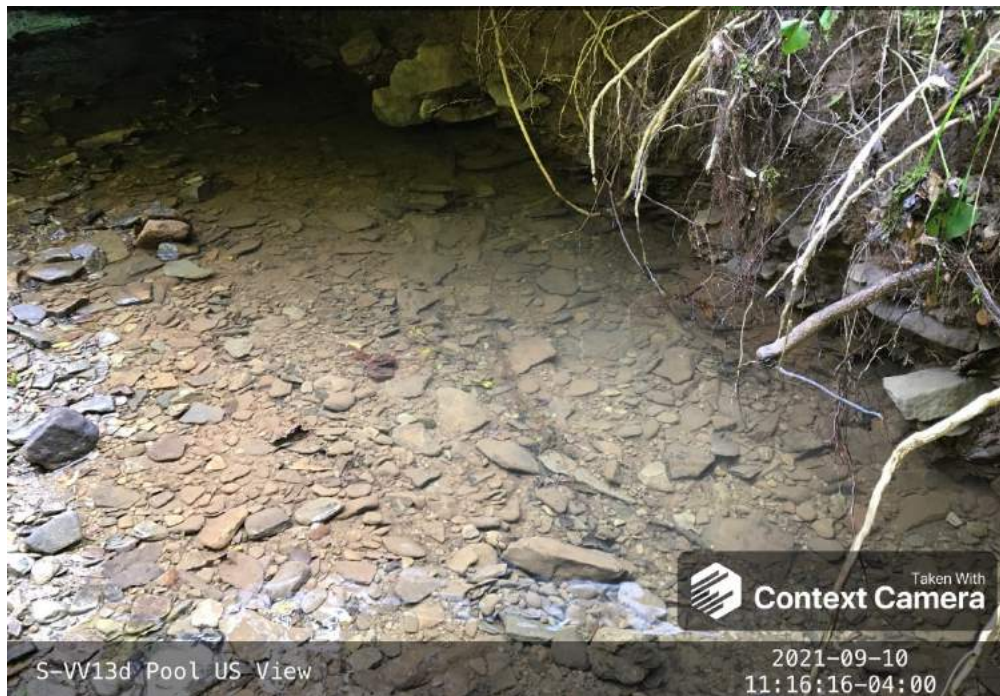
Photo Type: Pool, US View
Location, Orientation, Photographer Initials: Downstream of Pool, Upstream View, AJE/KAY
Lat: 38.902549 Long: -80.564778
