Baseline Assessment – Stream Attributes

Reach S-VV2 (Pipeline ROW)
Perennial
Spread B
Braxton County, West Virginia

<p> TITLE AND CROSS-SECTIONS BASELINE SURVEY S-W2 - UNT TO CLOVER FORK (MP 65.45) BRAXTON COUNTY, WV </p>	<p> Client MCM 222 </p>
--	--

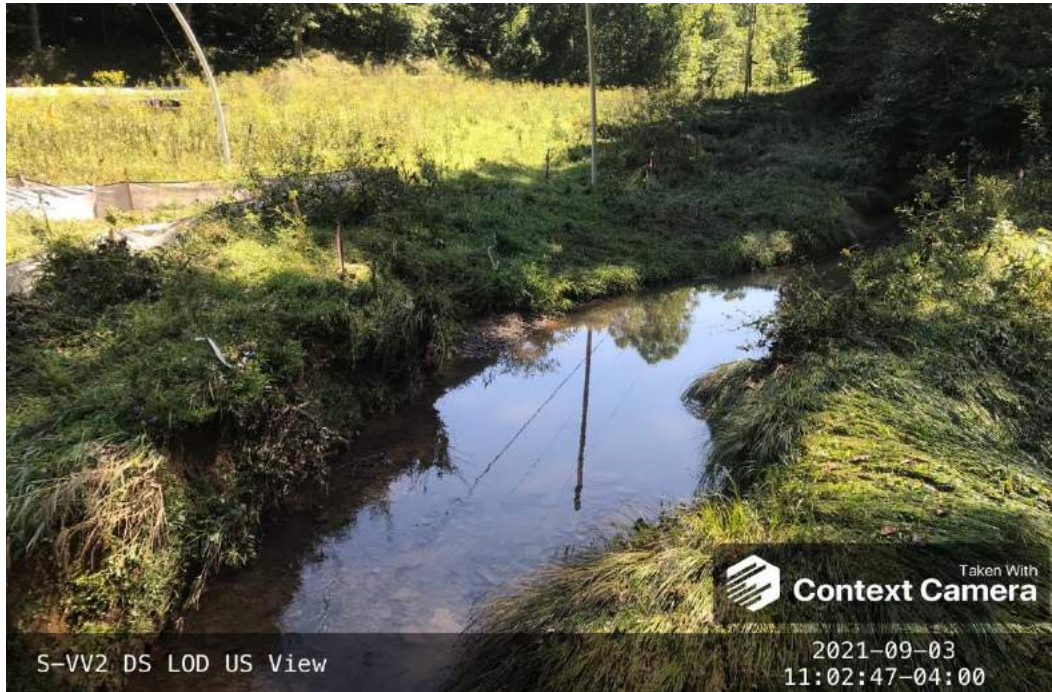
Photo Type: DS, US View

Location, Orientation, Photographer Initials: Downstream Edge of ROW, Upstream View, AJE/PEL
Lat: 38.86273025 Long: -80.52512835

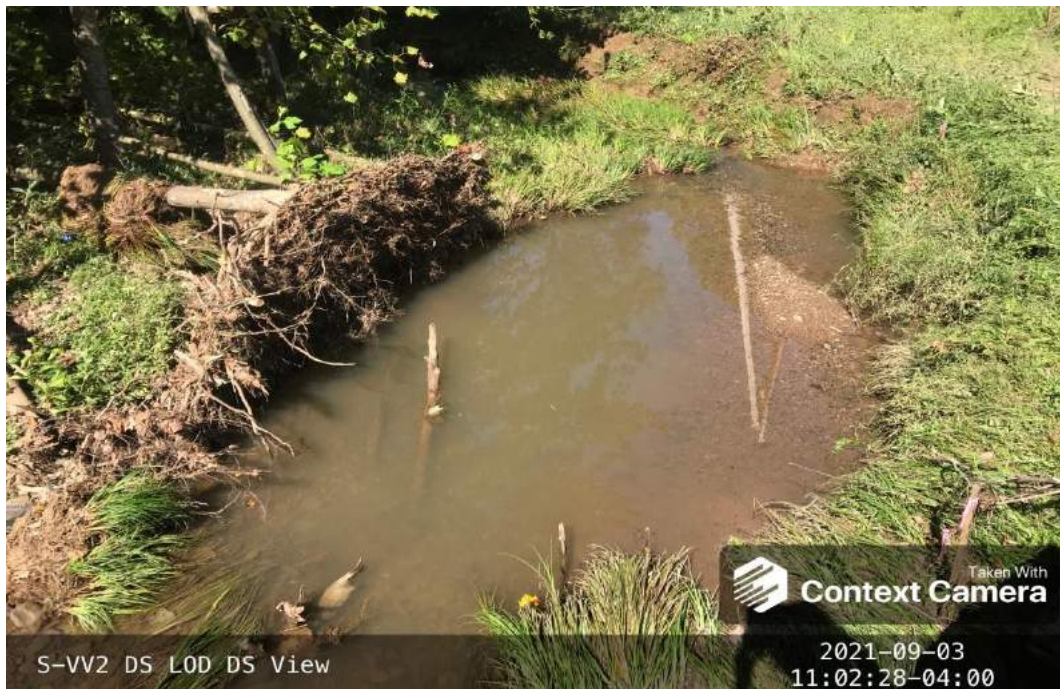
Photo Type: DS, DS View

Location, Orientation, Photographer Initials: Downstream Edge of ROW, Downstream View, AJE/PEL
Lat: 38.86273025 Long: -80.52512835

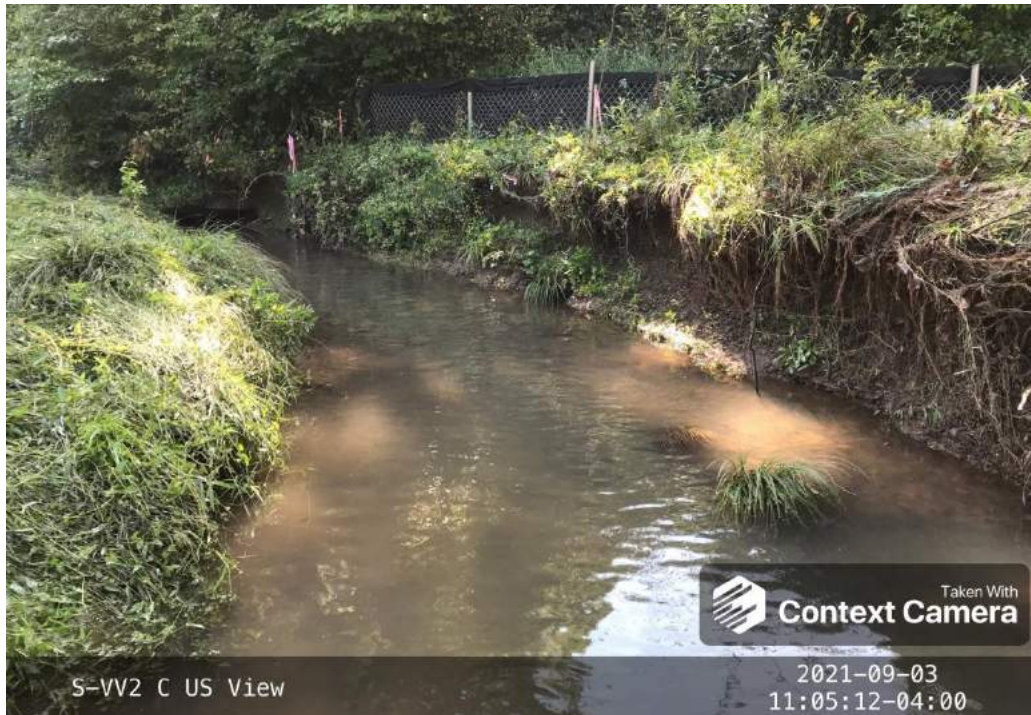
Photo Type: US View at Center
Location, Orientation, Photographer Initials: Center ROW, Upstream View, AJE/PEL
Lat: 38.86273025 Long: -80.52512835

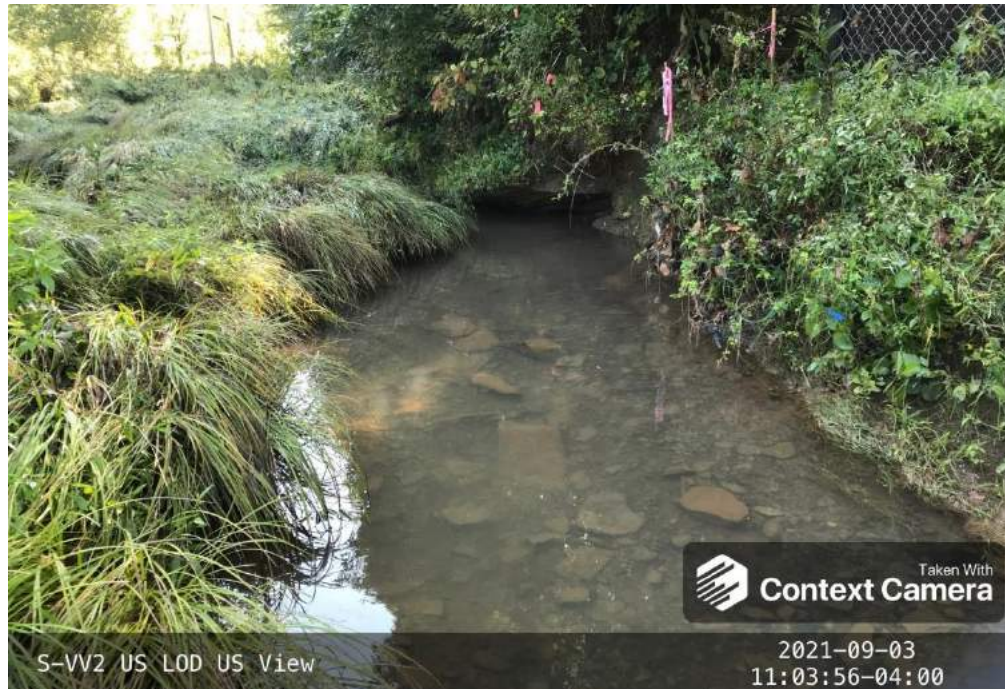
Photo Type: US, US View

Location, Orientation, Photographer Initials: Upstream Edge of ROW, Upstream View, AJE/PEL
Lat: 38.86273025 Long: -80.52512835

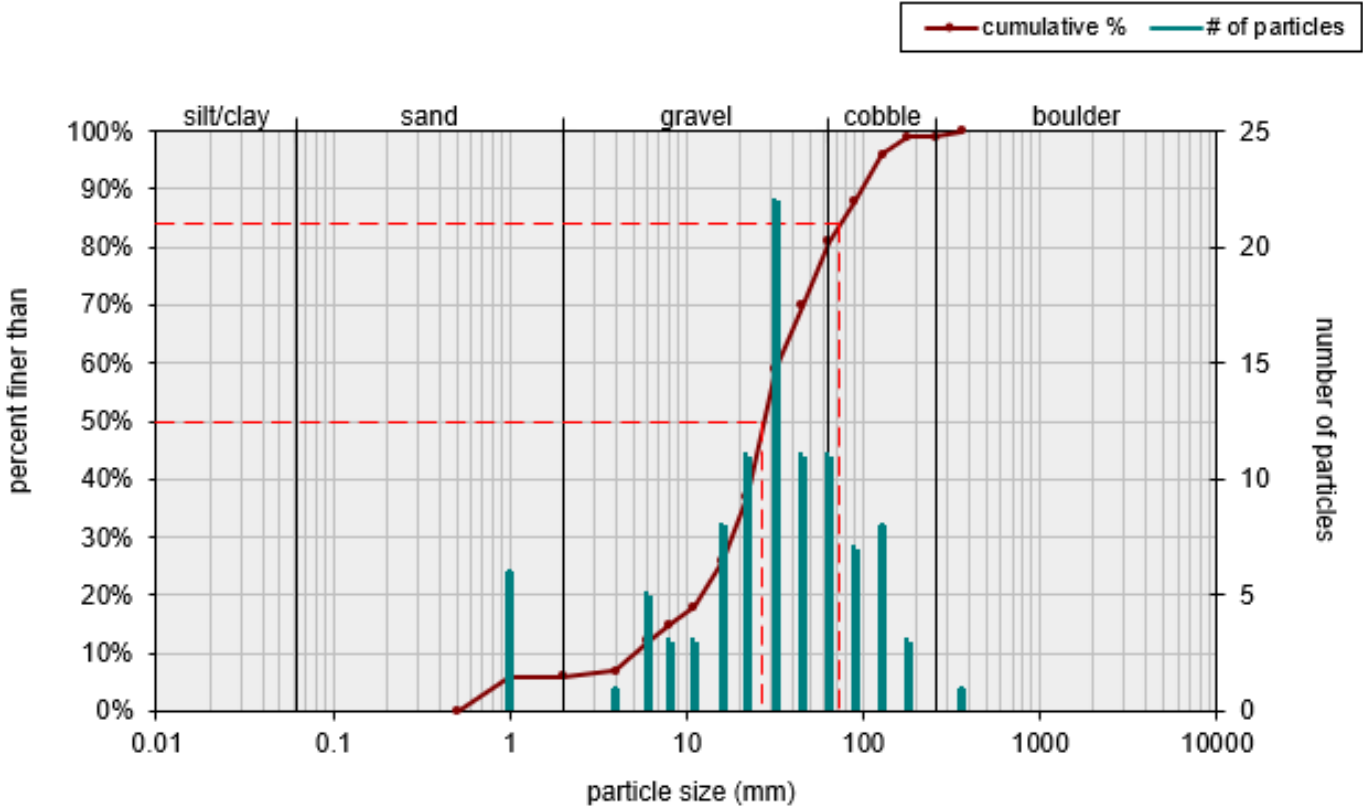
Riffle Surface Pebble Count, S-VVV2

Size (mm)		Size Distribution		Type	
D16	8.9	mean	25.7	silt/clay	0%
D35	21	dispersion	2.9	sand	6%
D50	27	skewness	-0.02	gravel	75%
D65	39			cobble	18%
D84	74			boulder	1%
D95	120

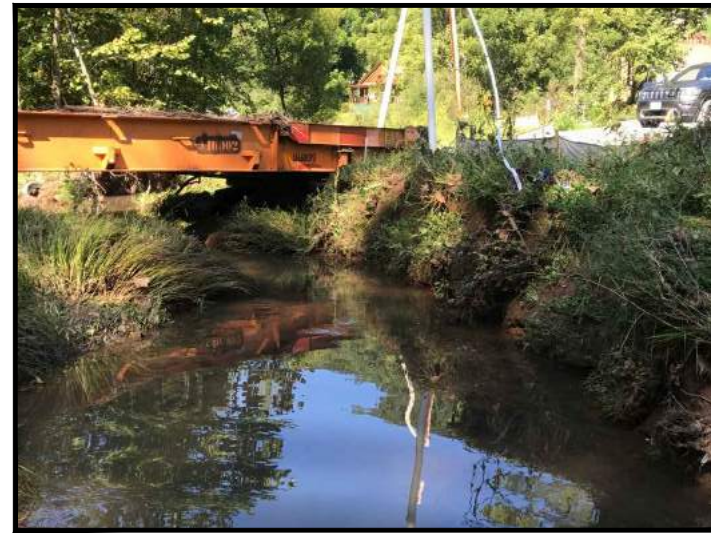
PHOTO TAKEN LOOKING DOWNSTREAM
FROM UPSTREAM IMPACT LIMITS
