## Baseline Assessment – Stream Attributes

**Reach S-A32 (Pipeline ROW)**

**Spread G**

**Giles County, Virginia**

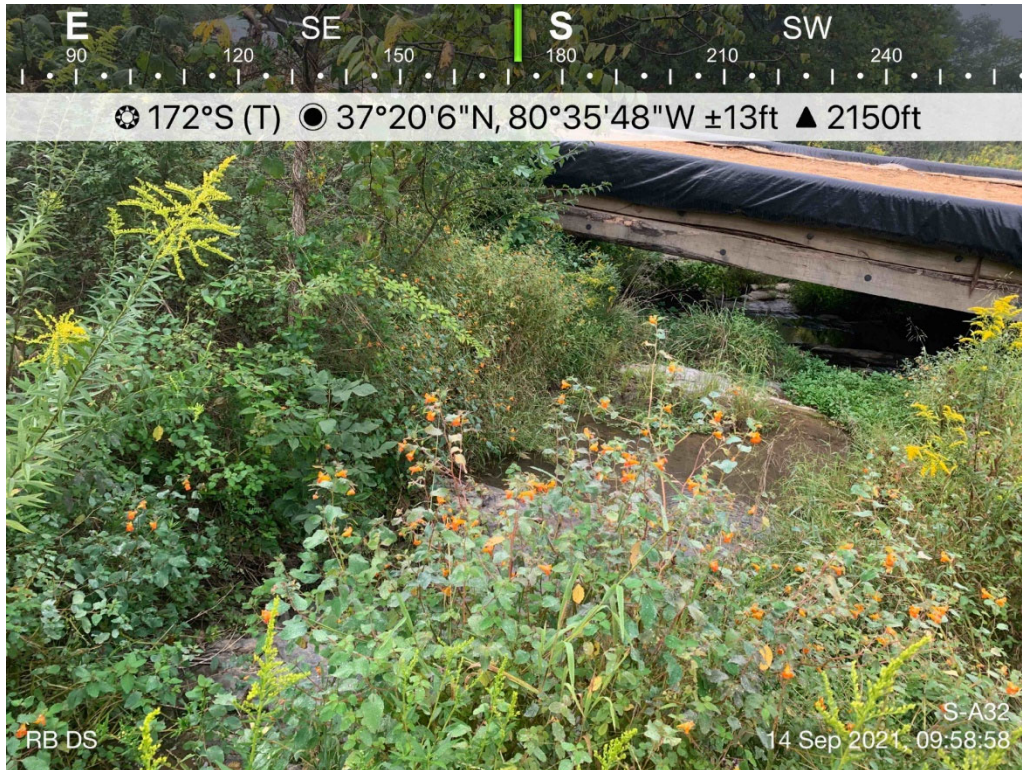
Photo Type: RB DS VIEW

Location, Orientation, Photographer Initials: Standing on RB looking downstream along the ROW looking S, TC

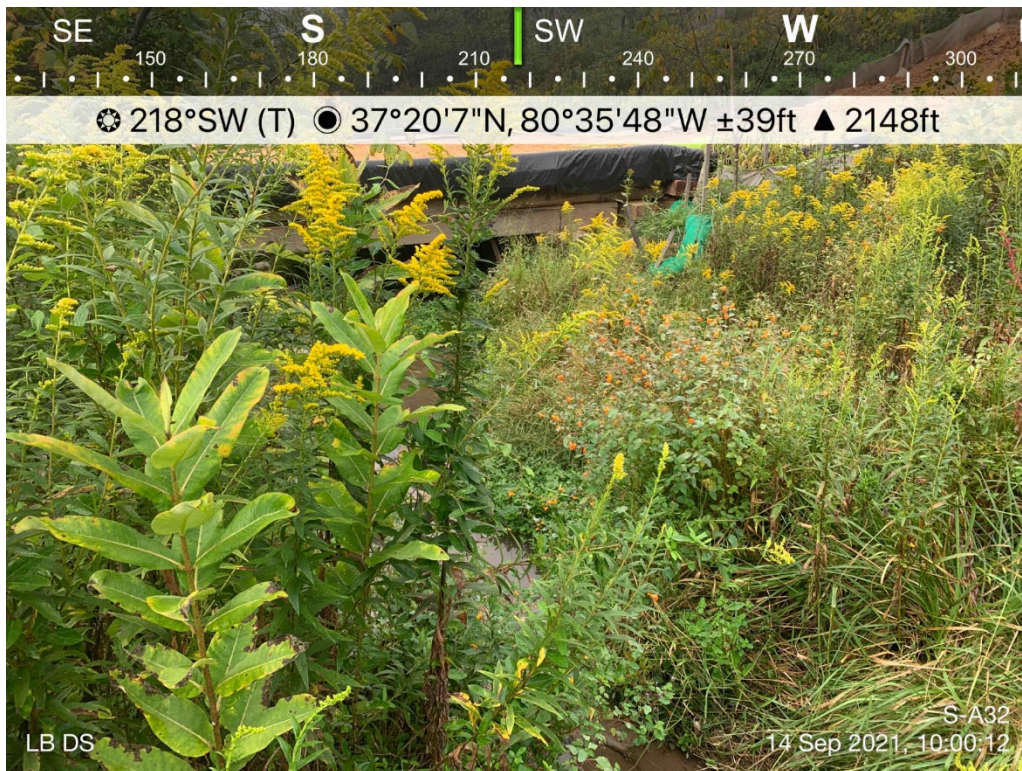
Photo Type: LB DS VIEW

Location, Orientation, Photographer Initials: Standing on LB looking downstream along the ROW looking SW, TC

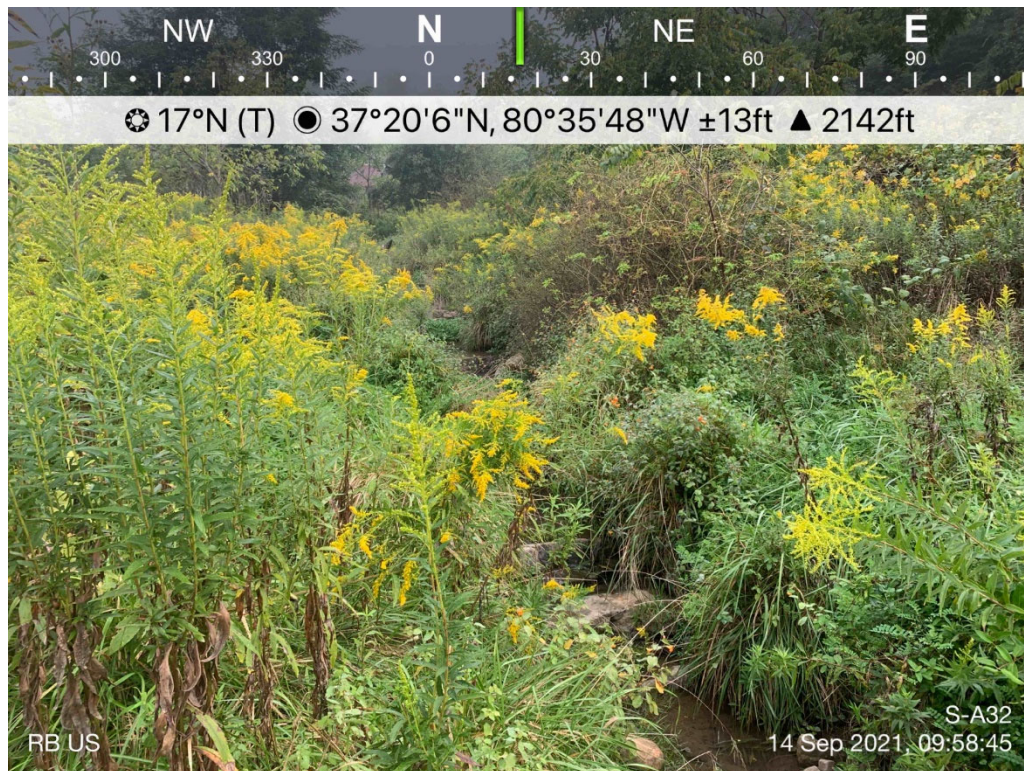
Photo Type: RB US VIEW

Location, Orientation, Photographer Initials: Standing on RB looking upstream along the ROW looking N, TC

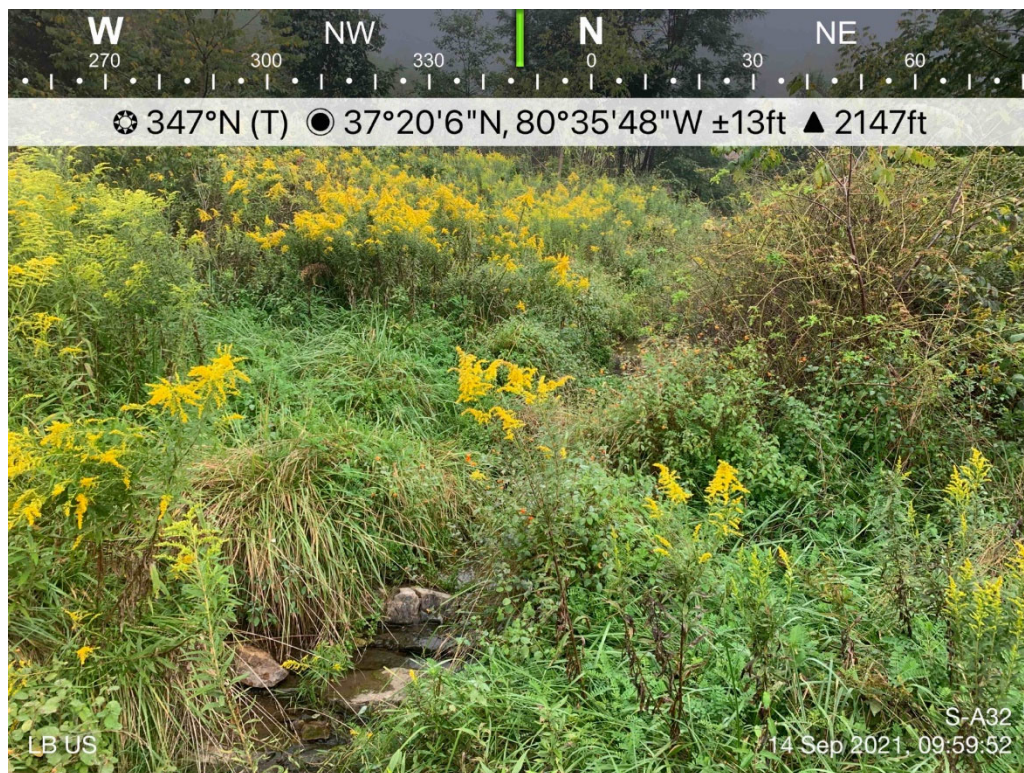
Photo Type: LB US VIEW

Location, Orientation, Photographer Initials: Standing on LB looking upstream along the ROW looking N, TC

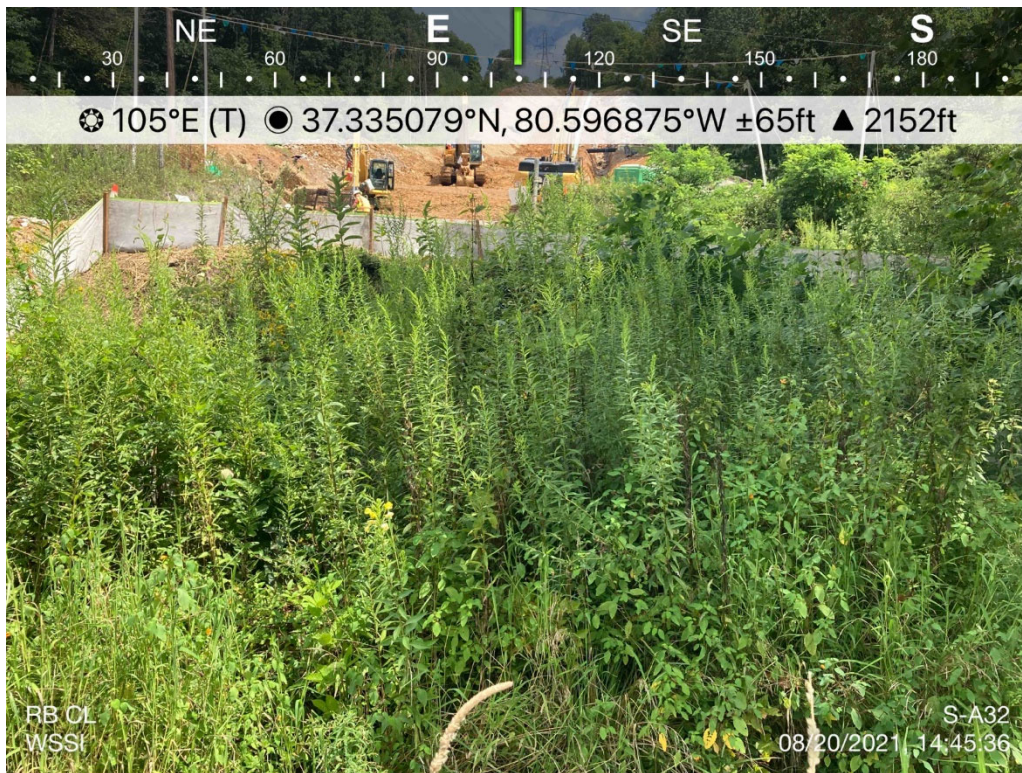
Photo Type: RB CL

Location, Orientation, Photographer Initials: Standing on RB looking at LB along pipe centerline looking E, ES

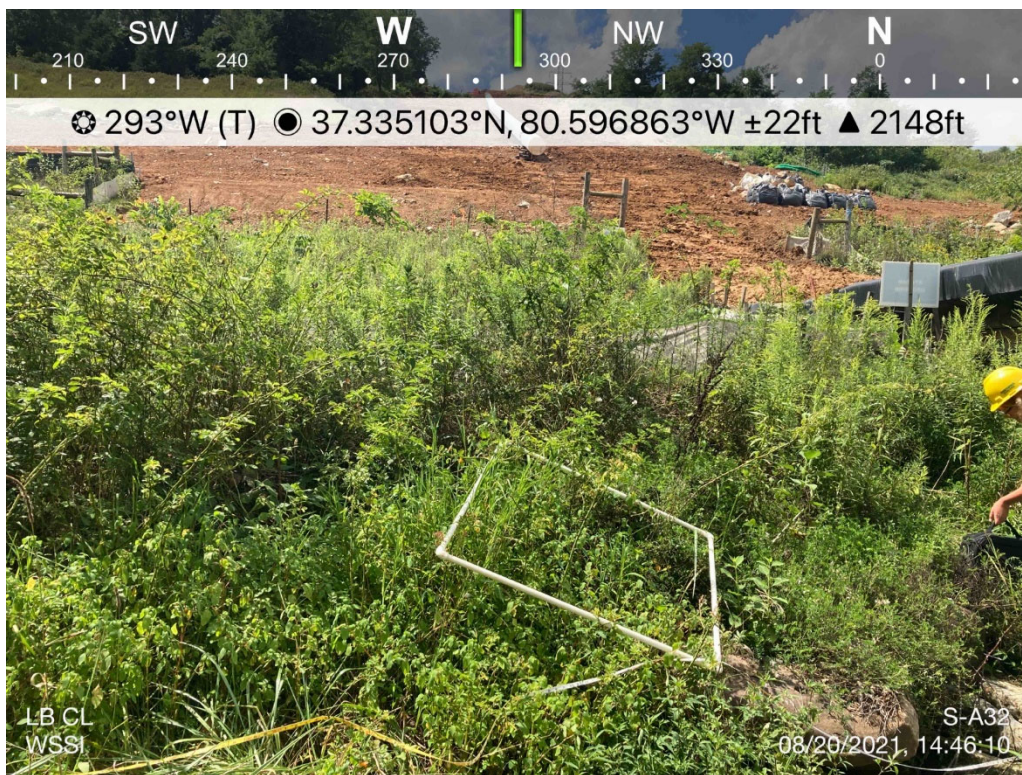
Photo Type: LB CL

Location, Orientation, Photographer Initials: Standing on LB looking at RB along pipe centerline looking W, ES

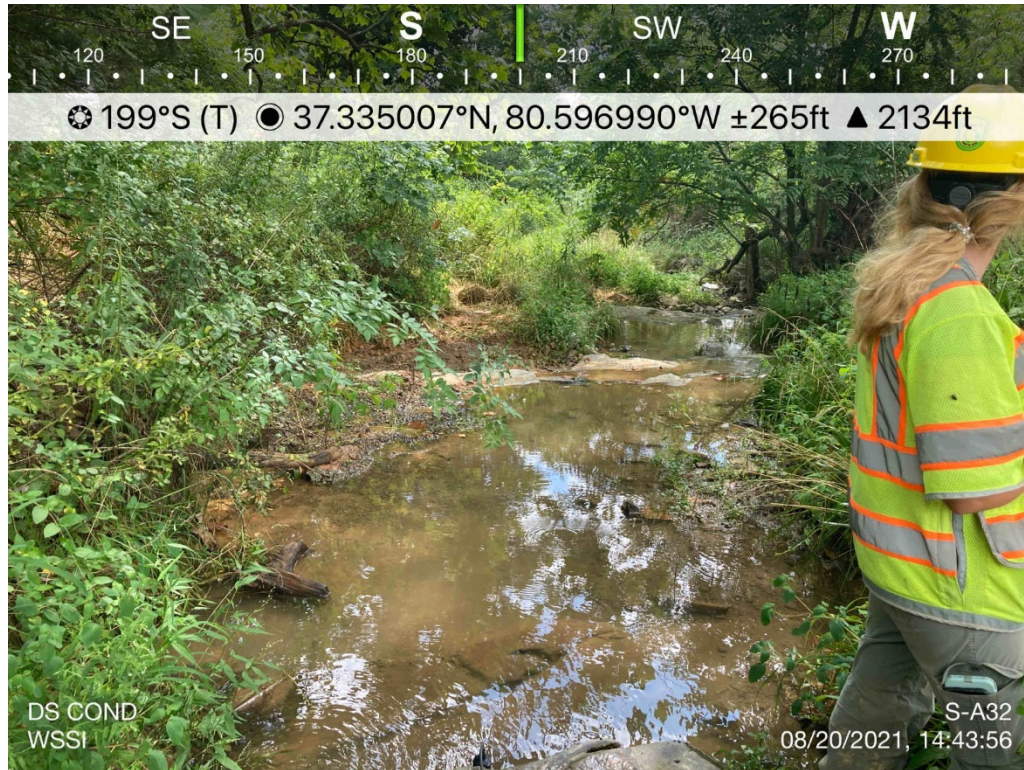
Photo Type: DS COND

Location, Orientation, Photographer Initials: Downstream conditions outside of ROW looking S, ES

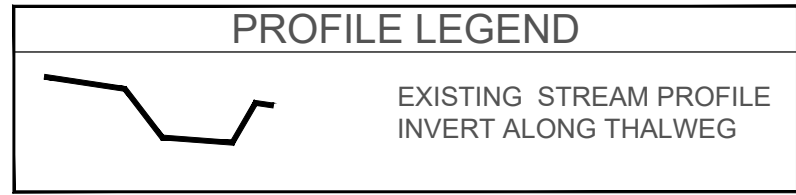
CL STAKEOUT POINTS: S-A32 CROSS SECTION B (PIPE CL)					
PRE-CROSSING			POST-CROSSING		
PT. LOC.	NORTHING	EASTING	ELEV	VERT. DIFF.	HORZ. DIFF.
TS-L	13556802.66	1757595.87	2139.20	----	----
BS-L	13556803.23	1757593.09	2137.52	----	----
THW	13556803.75	1757589.77	2136.90	----	----
BS-R	13556805.30	1757583.40	2137.91	----	----
TS-R	13556806.63	1757576.89	2142.07	----	----
