Baseline Assessment - Stream Attributes

Reach S-0013 (Pipeline ROW)

Giles County, Virginia

Profile and Cross-Sections Baseline Survey

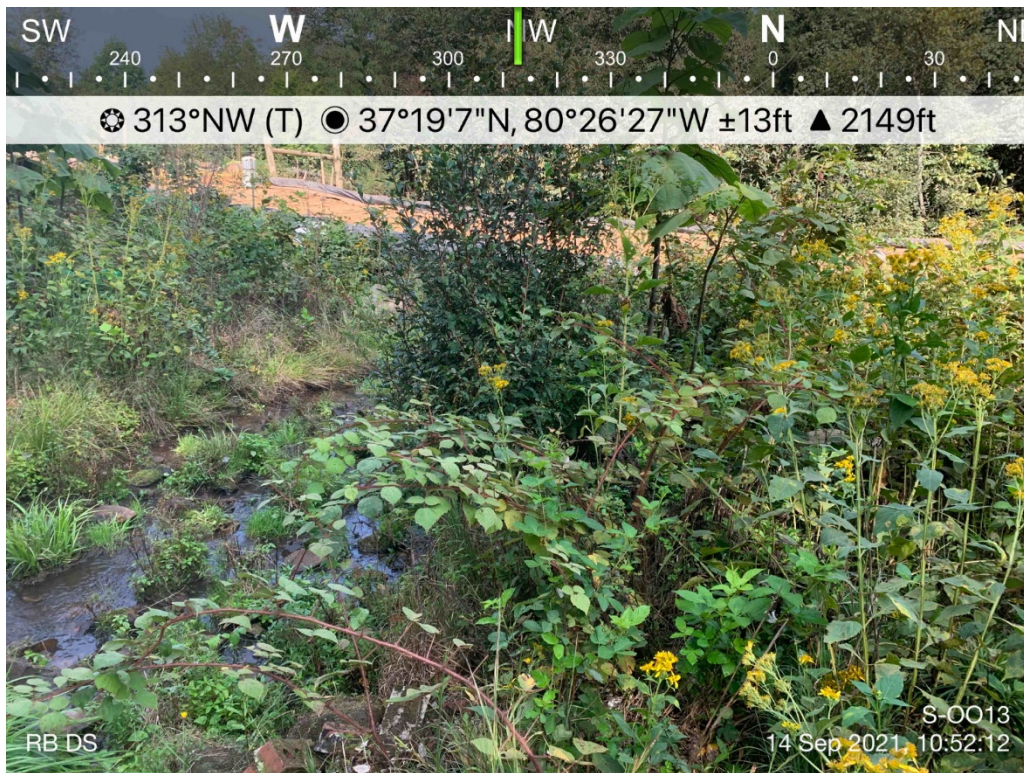
Photo Type: RB DS VIEW

Location, Orientation, Photographer Initials: Standing on RB looking downstream along the ROW looking NW, TC

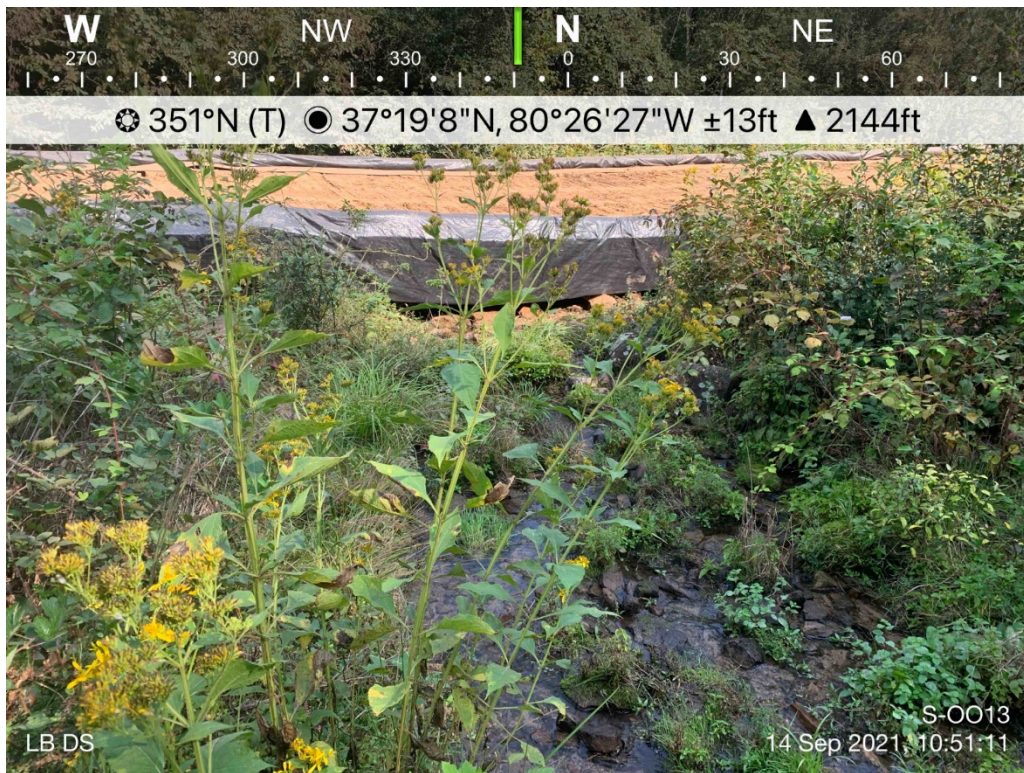
Photo Type: LB DS VIEW

Location, Orientation, Photographer Initials: Standing on LB looking downstream along the ROW looking N, TC

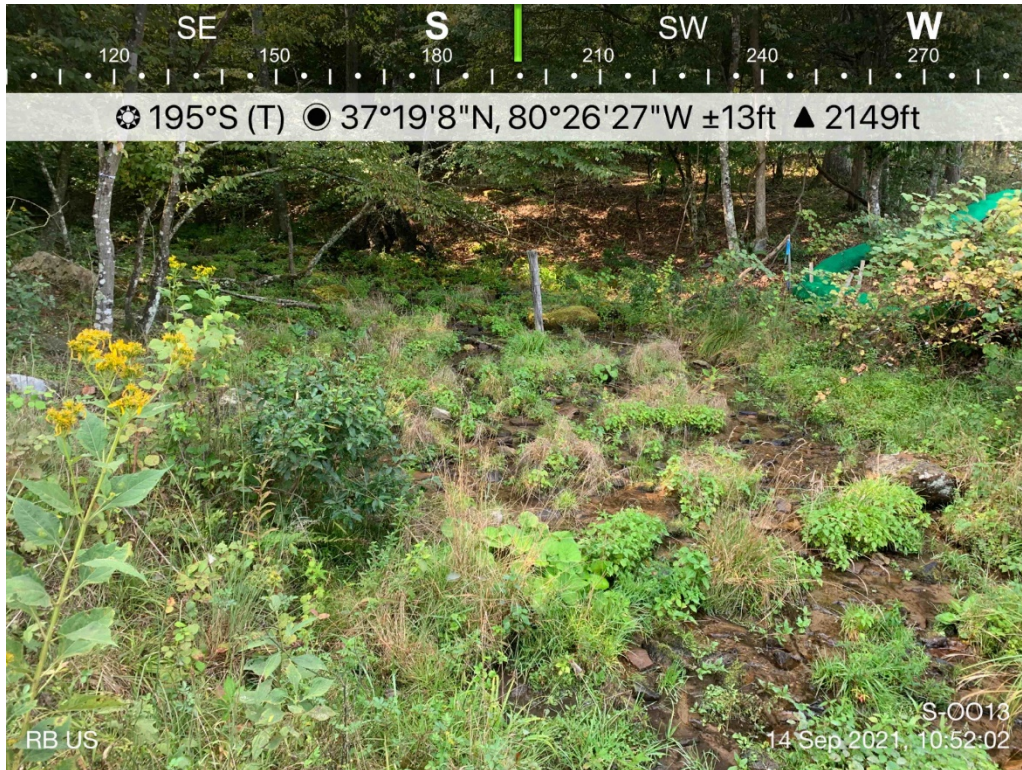
Photo Type: RB US VIEW

Location, Orientation, Photographer Initials: Standing on RB looking upstream along the ROW looking S, TC

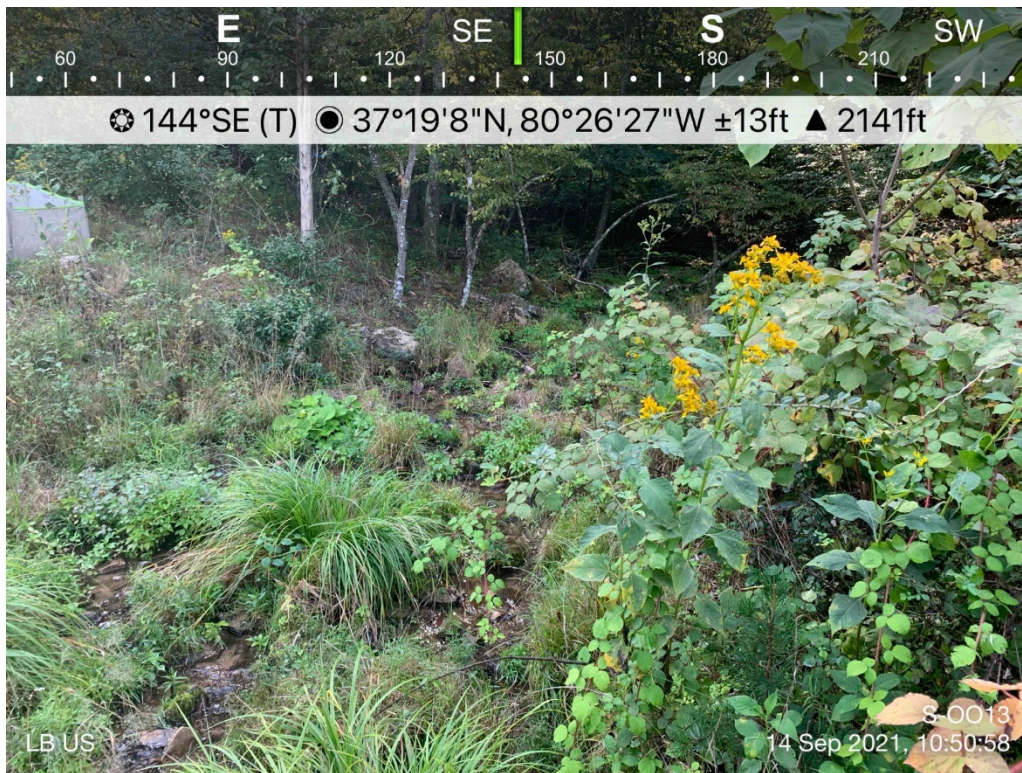
Photo Type: LB US VIEW

Location, Orientation, Photographer Initials: Standing on LB looking upstream along the ROW looking SE, TC

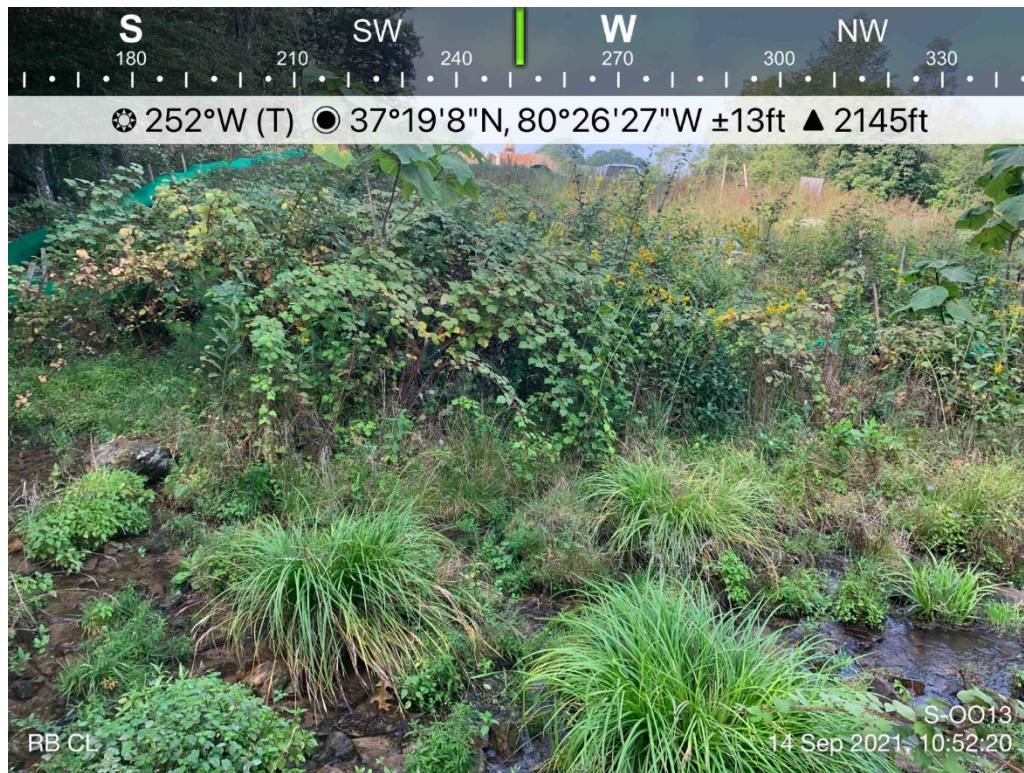
Photo Type: RB CL

Location, Orientation, Photographer Initials: Standing on RB looking at LB along pipe centerline looking W, TC

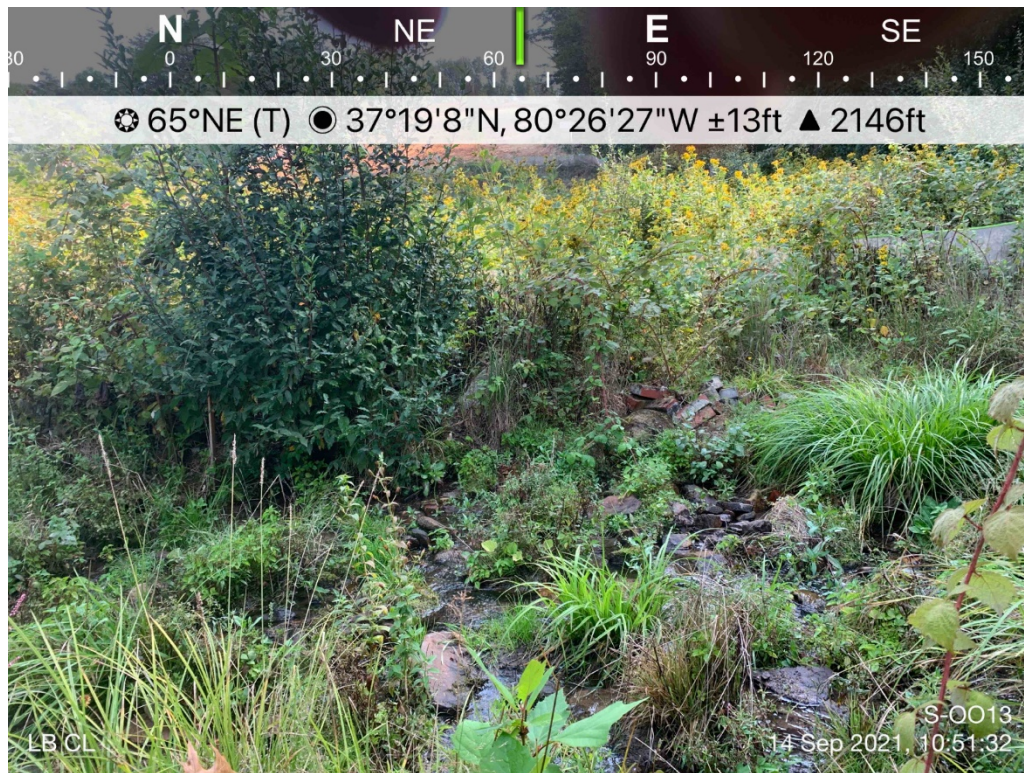
Photo Type: LB CL

Location, Orientation, Photographer Initials: Standing on LB looking at RB along pipe centerline looking NE, TC

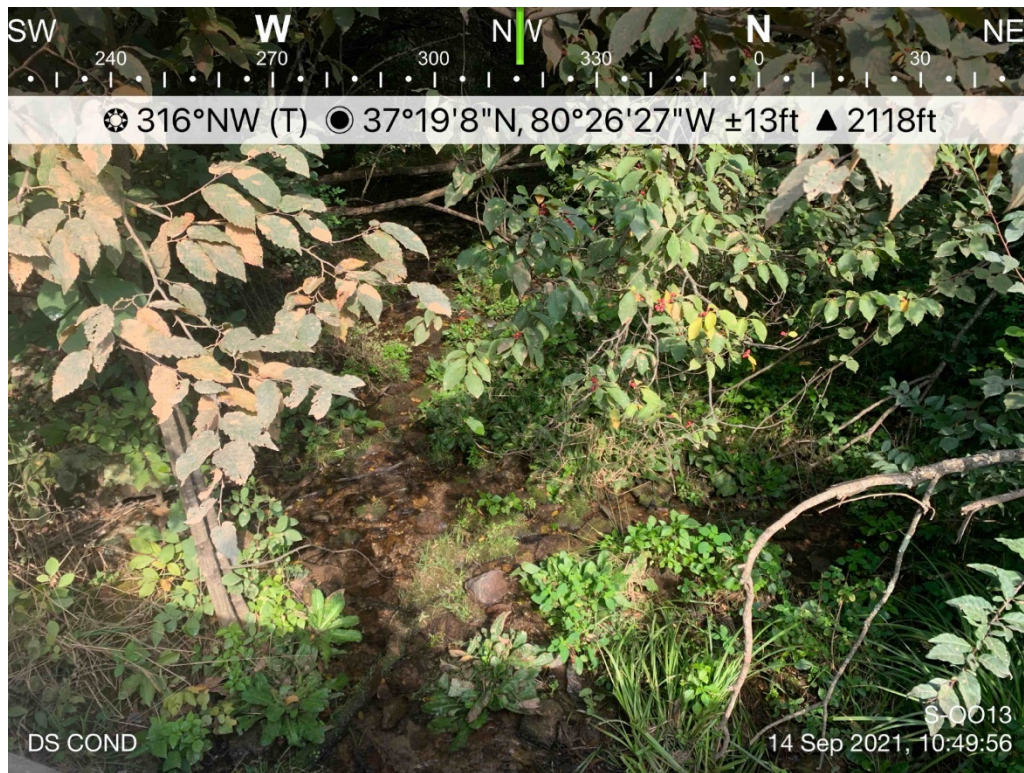
Photo Type: DS COND

Location, Orientation, Photographer Initials: Downstream conditions outside of ROW looking NW, TC

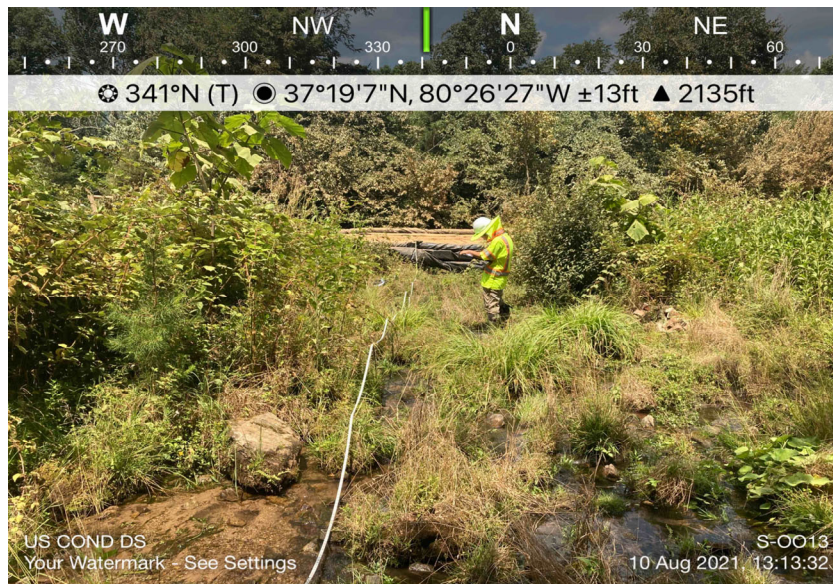
Looking downstream within the ROW. Assessment is limited to areas within the temporary ROW.
