Baseline Assessment - Stream Attributes

Reach S-B21 (Pipeline ROW)

Roanoke County, Virginia

PROFILE AND CROSS-SECTIONS
BASELINE SURVEY
CROSSING S-B21 - UNNAMED TRIB.
MILL CREEK (MP 245.89)
ROANOKE COUNTY VA

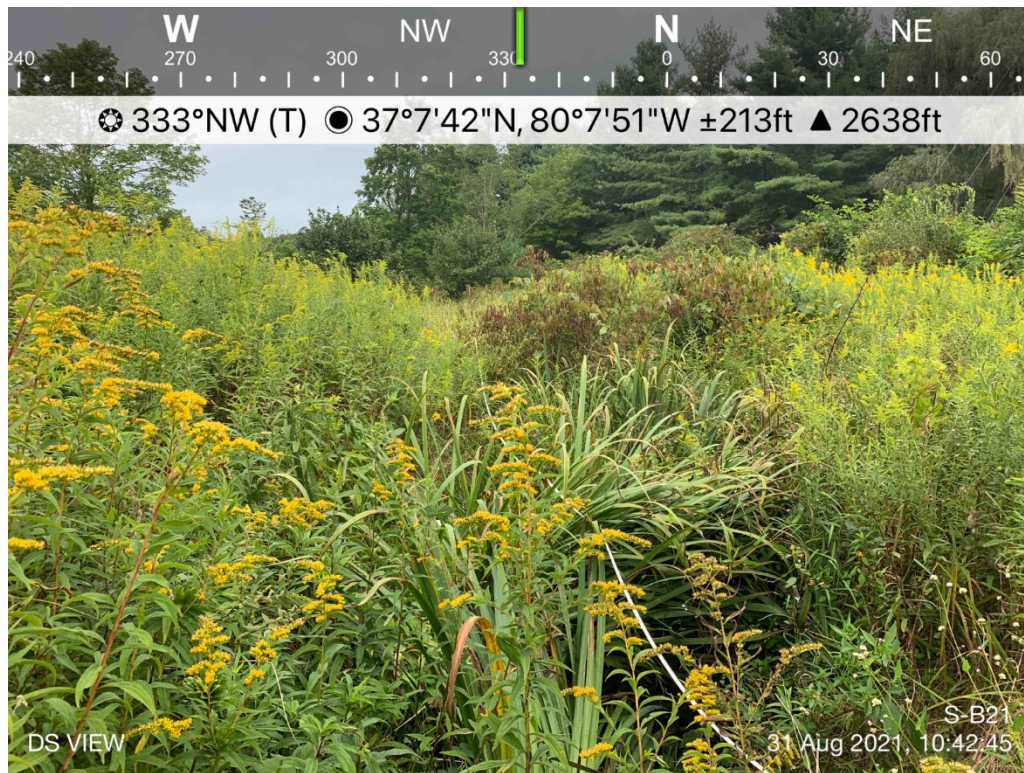
Photo Type: DS VIEW

Location, Orientation, Photographer Initials: Downstream view of ROW looking NW, TC

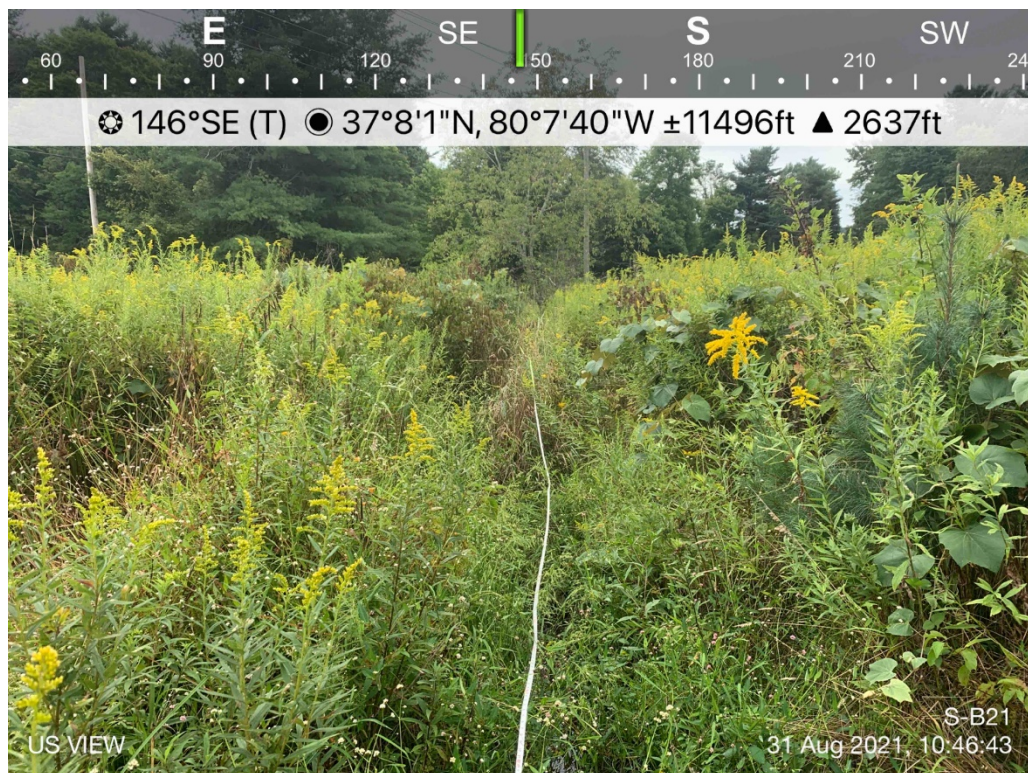
Photo Type: US VIEW

Location, Orientation, Photographer Initials: Upstream view of ROW looking SE, TC

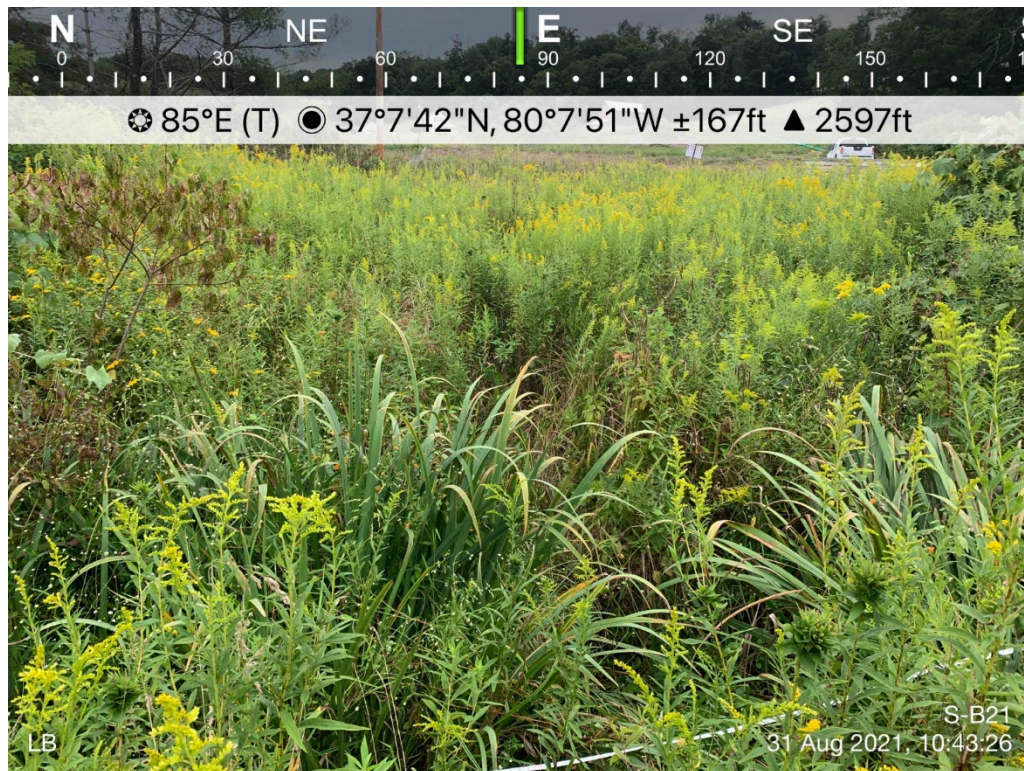
Photo Type: LB CL

Location, Orientation, Photographer Initials: Standing on LB looking at RB along pipe centerline looking E, TC

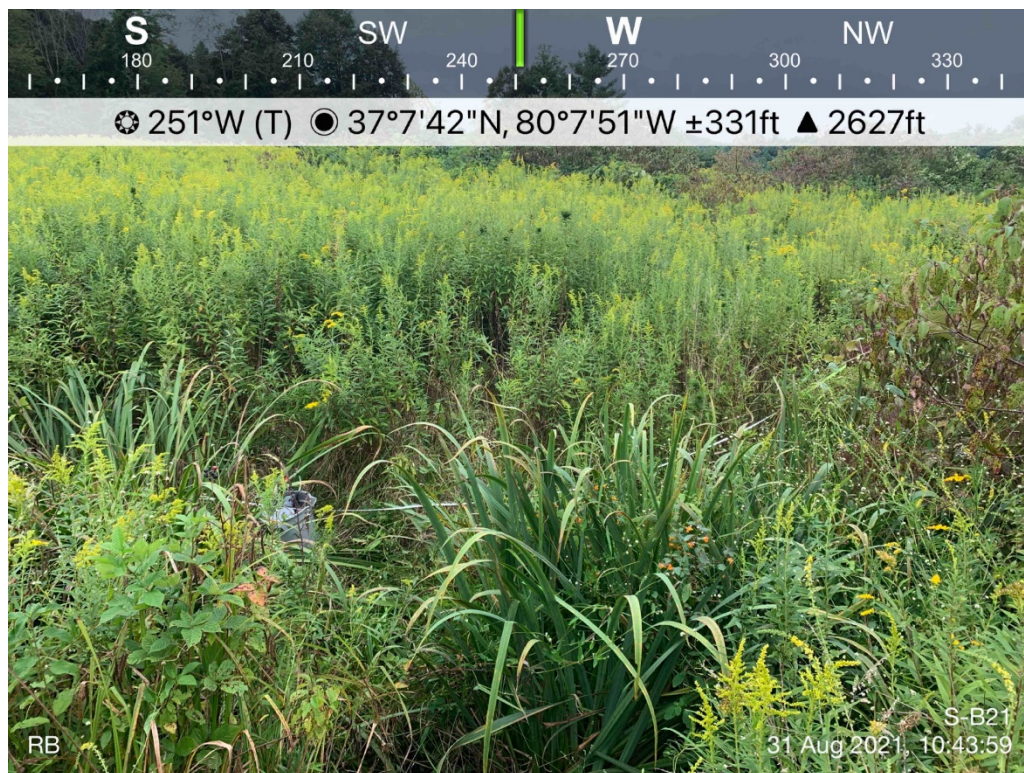
Photo Type: RB CL

Location, Orientation, Photographer Initials: Standing on RB looking at LB along pipe centerline looking W, TC

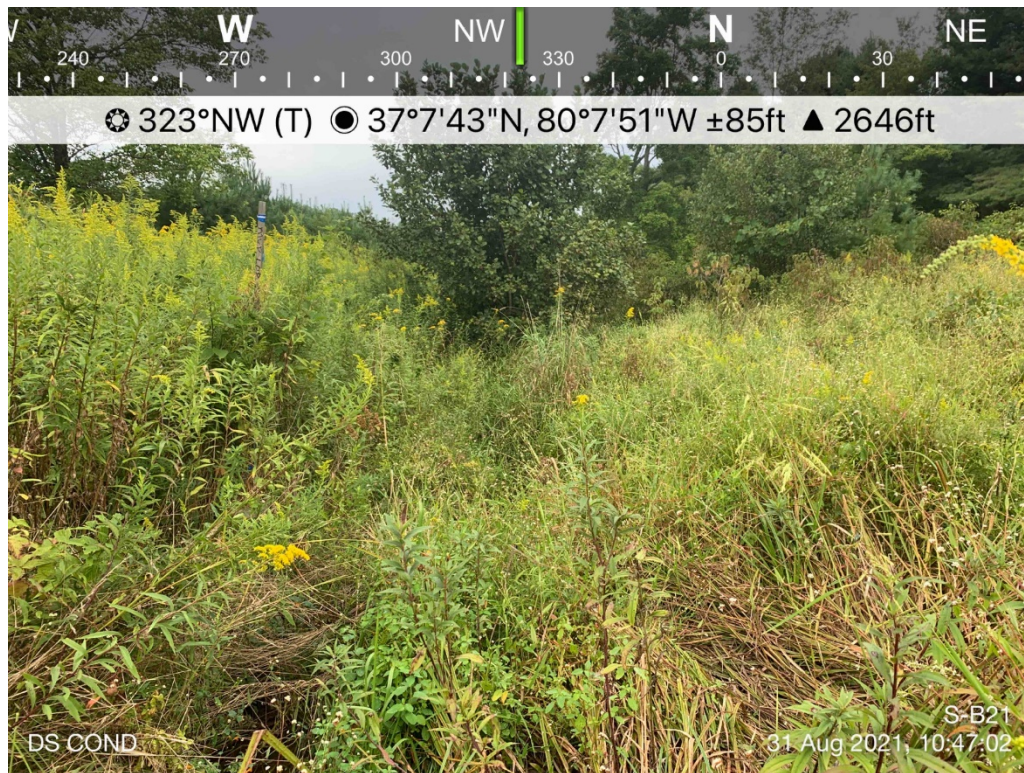
Photo Type: DS COND

Location, Orientation, Photographer Initials: Downstream conditions outside of ROW looking NW, TC

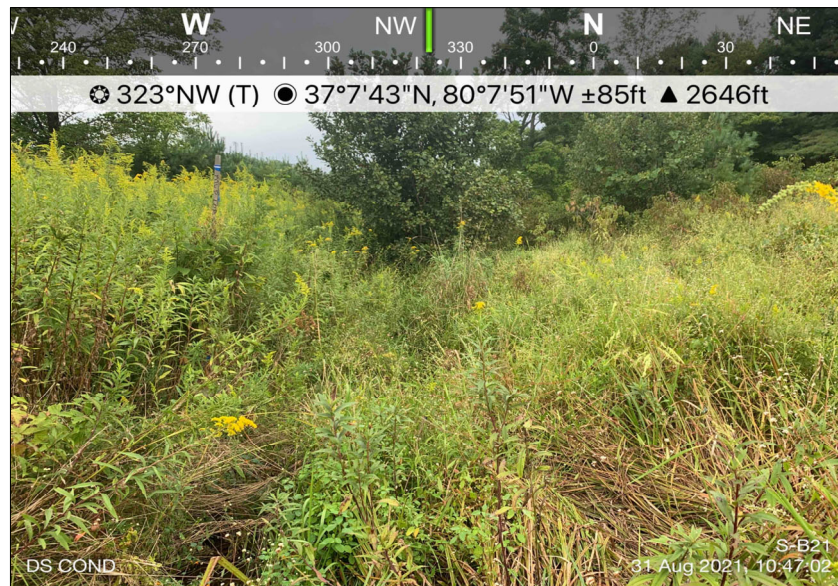
(WSSI Photo Location L:\22000s\22800\22865.06\Admin\05-ENVR\Field Data\Spread H\Field Forms\S-B21\Photos\DS COND.JPG)

Downstream view within the ROW. Assessment is limited to areas within temporary ROW.

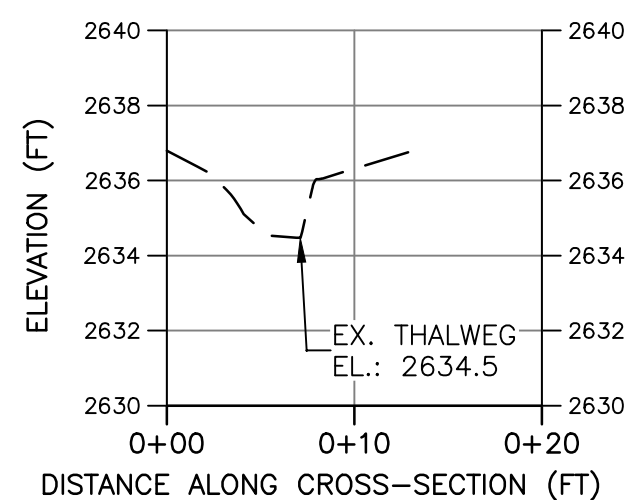
CL STAKEOUT POINTS: S-B21 CROSS SECTION A (PIPE CL)					
	PRE-CROSSING			POST-CROSSING	
PT. LOC.	NORTHING	EASTING	ELEV	VERT. DIFF.	HORIZ. DIFF.
TS-L	13482532.361	1893666.236	2637.09		
BS-L	13482532.649	1893672.071	2636.02		
THW	13482532.827	1893675.685	2634.94		
BS-R	13482533.055	1893680.245	2636.07		
TS-R	13482533.227	1893683.799	2636.95

SCALE: H: 1"=10'
V: 1"=5'

PHOTO TAKEN LOOKING DOWNSTREAM
FROM UPSTREAM IMPACT LIMITS ON 08/31/21

PHOTO TAKEN LOOKING UPSTREAM FROM
DOWNSTREAM IMPACT LIMITS ON 08/31/21
