Baseline Assessment – Stream Attributes

Reach S-A22 (Timber Mat Crossing) Intermittent Spread I Franklin County, Virginia

Stream S-A22 (ROW) Franklin County

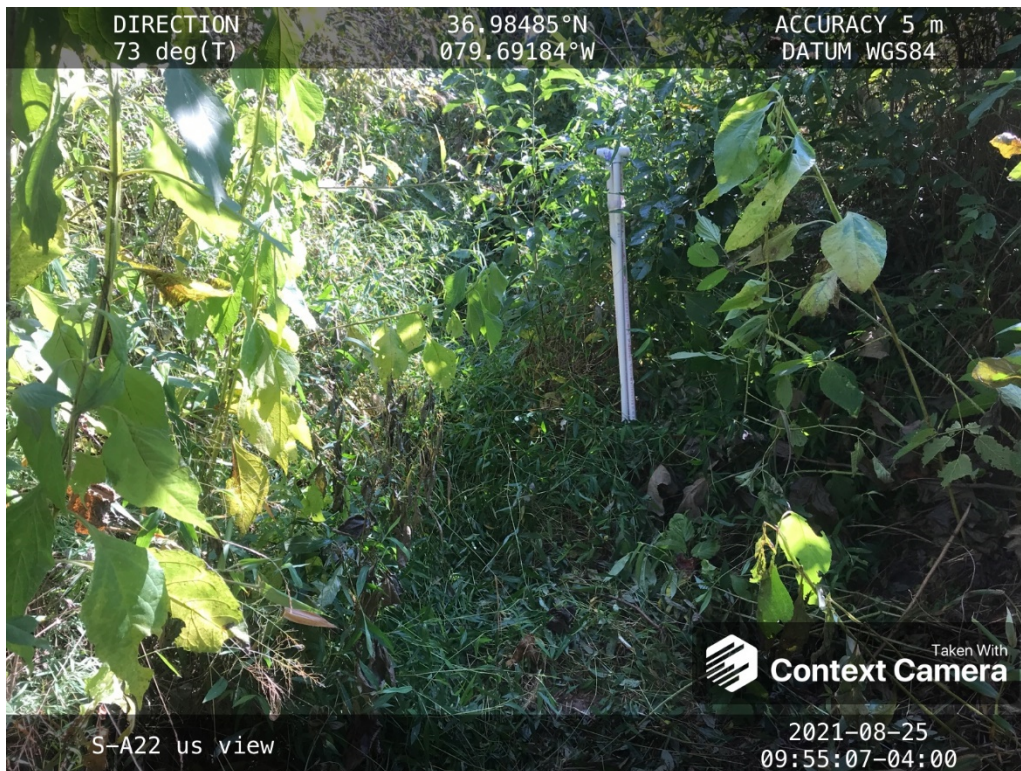
Photo Type: US VIEW

Location, Orientation, Photographer Initials: Downstream at LOC looking SE upstream, RAH

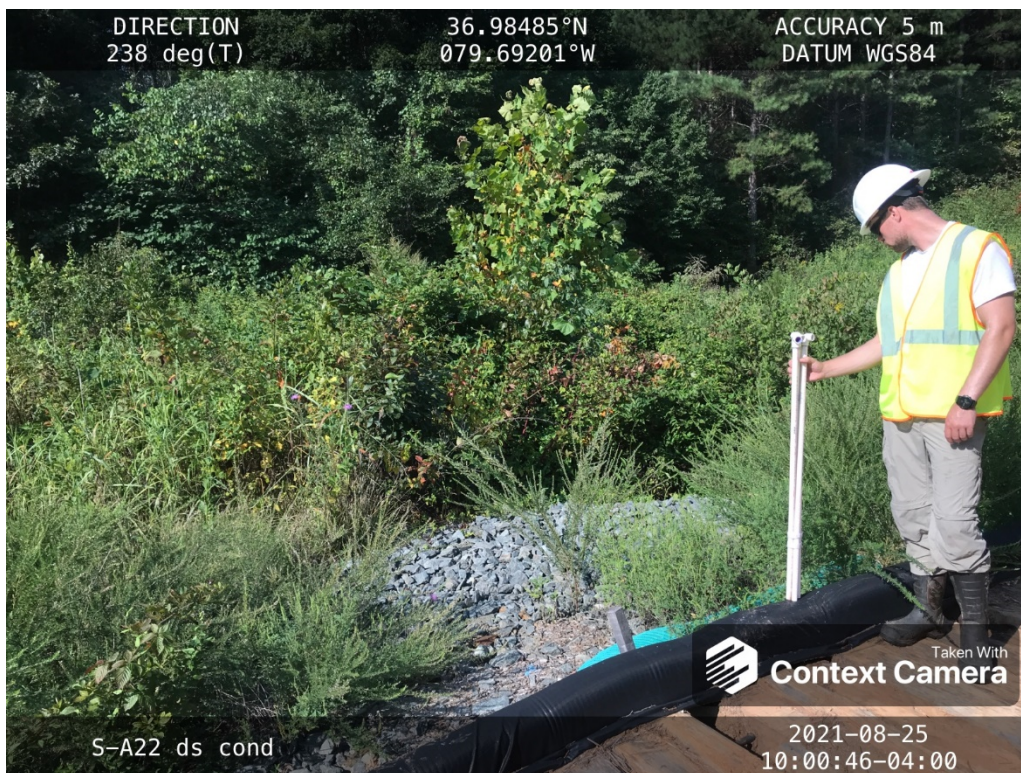
Photo Type: DS COND DS

Location, Orientation, Photographer Initials: Downstream at ROW looking SW downstream, RAH

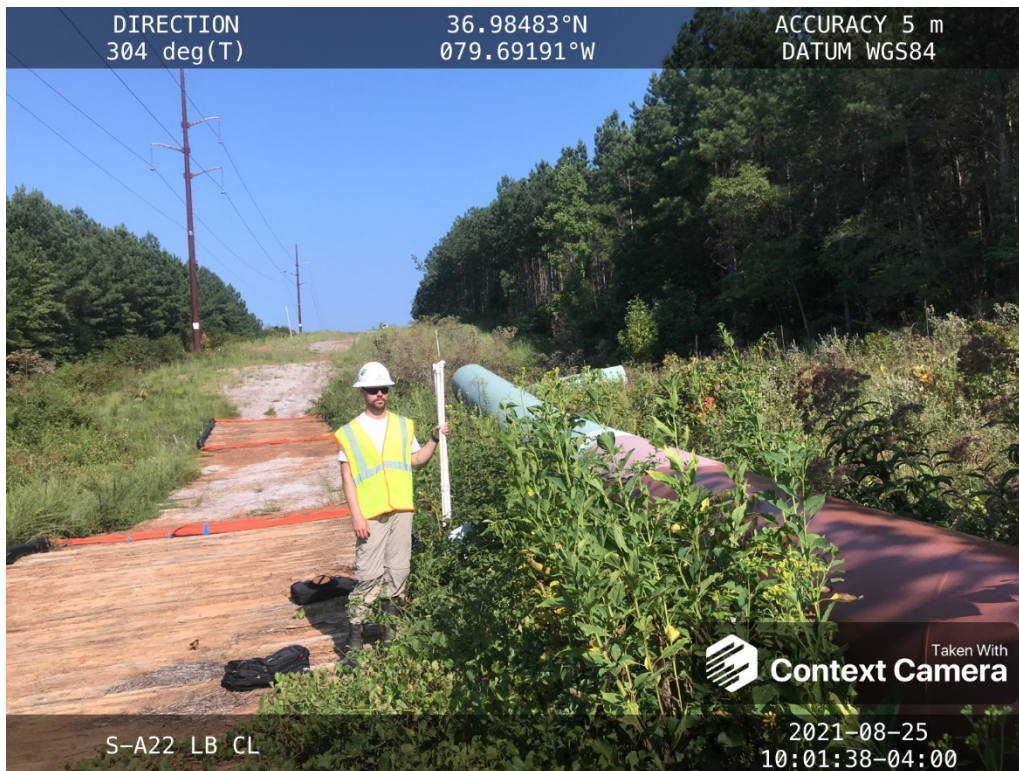
Photo Type: LB CL

Location, Orientation, Photographer Initials: On thalweg at pipe centerline looking NW at left streambank, RAH

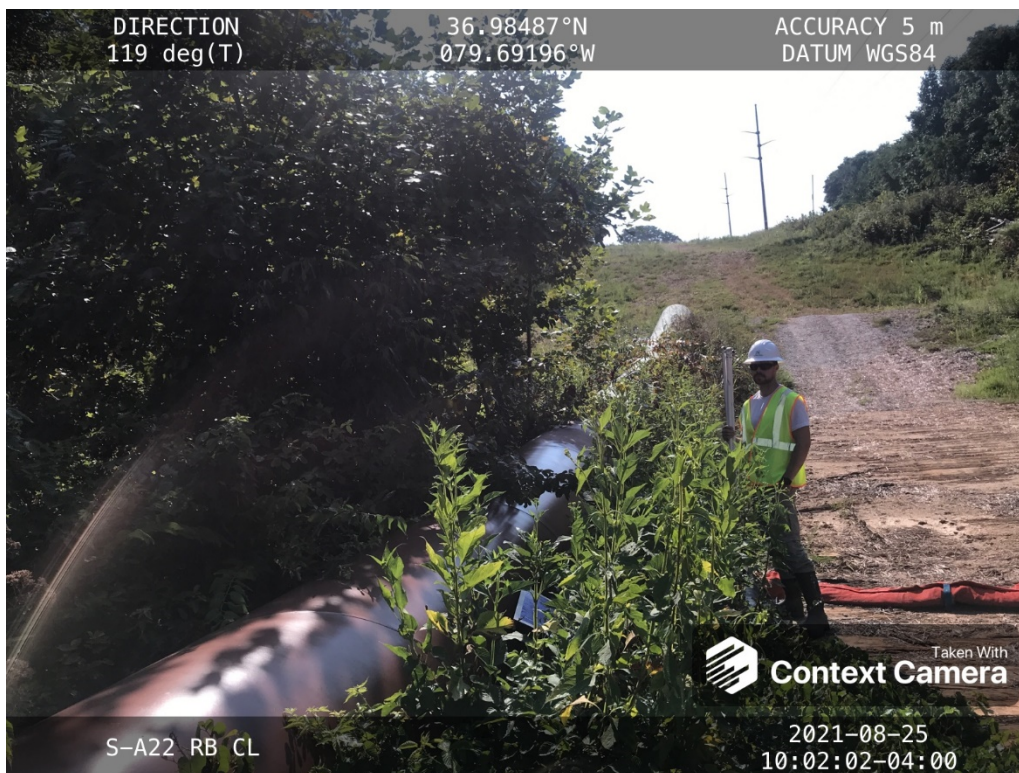
Photo Type: RB CL

Location, Orientation, Photographer Initials: On thalweg at pipe centerline looking SE at right streambank, RAH

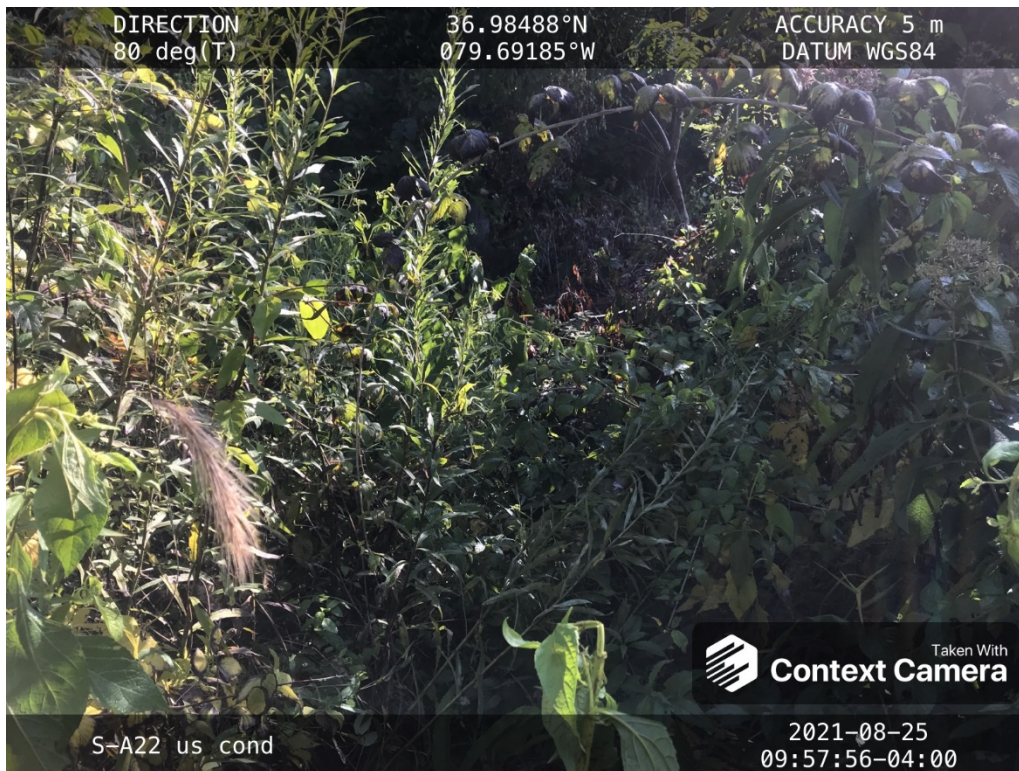
Photo Type: US COND

Location, Orientation, Photographer Initials: Upstream at LOC looking E upstream, RAH

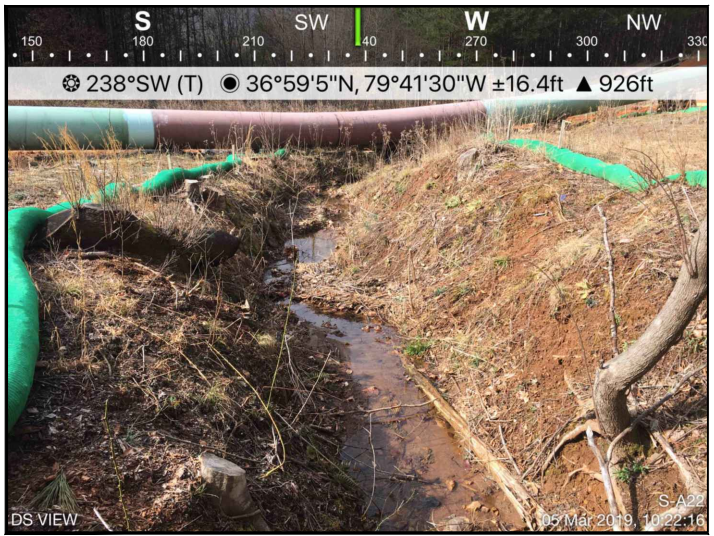
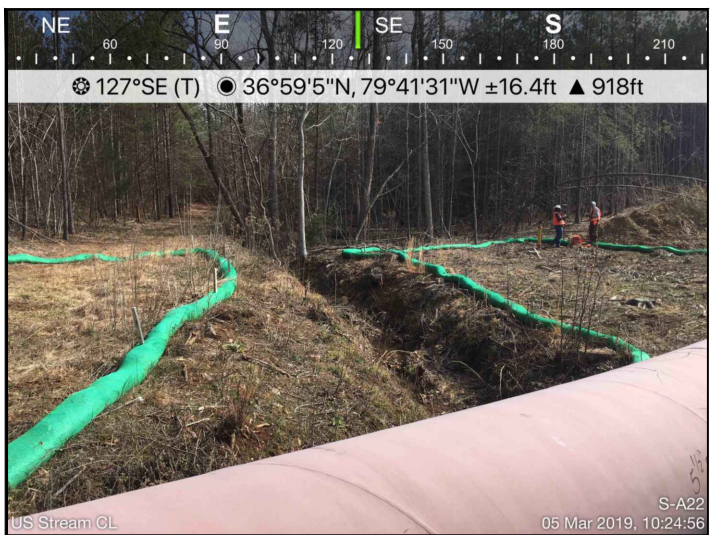
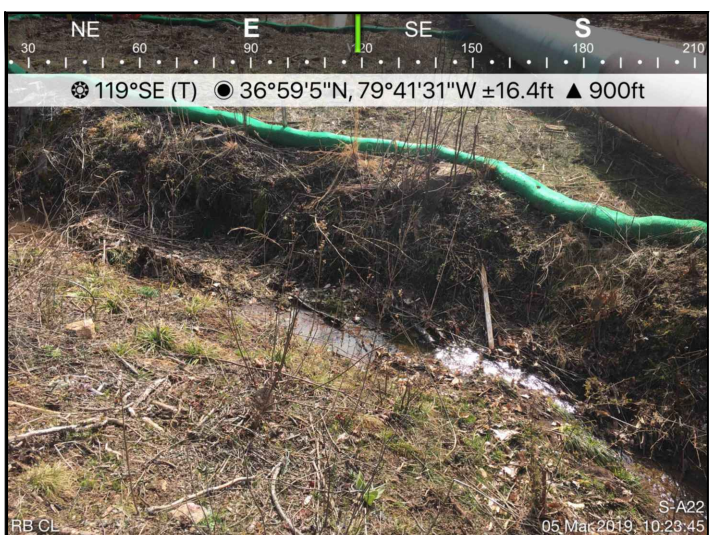
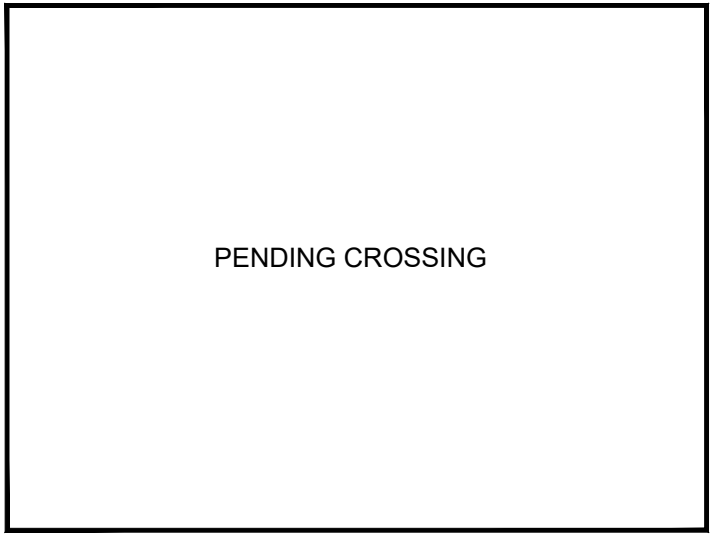
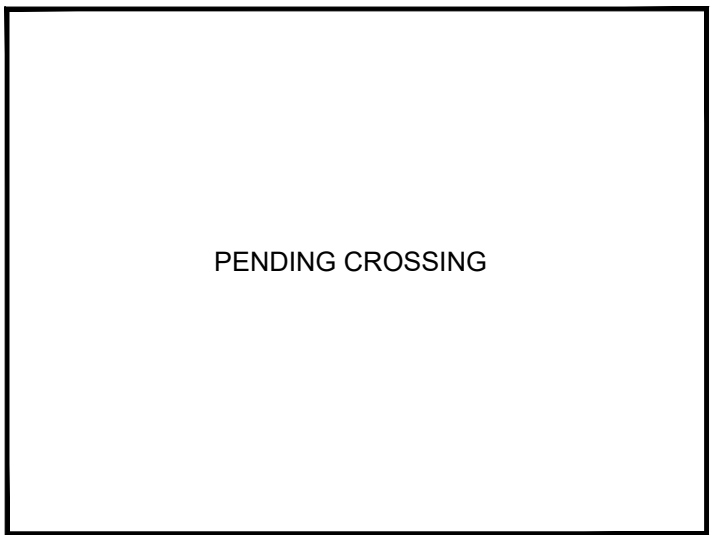
1. This map has been oriented to NAD 1983 UTM ZONE 17N, and vertically to The North American Vertical Datum of 1988 (NAVD 88), using a Real Time Network (RTN) GPS. Field locations were completed on March 5, 2019.

2. Monumentation, including traverse stations and fly points, shown on this drawing should be used to orient any future boundary, topographic, or location survey.
3. Easement lines shown on plan view were provided by Mountain Valley Pipeline (MVP).
4. WSSI Contour Interval = 2.0'. Contours within the channel were interpolated using stream channel breaklines (i.e. top of slopes, toe of slopes, thalweg) and cross-sectional points. Contours outside the channel were interpolated using cross-sectional spot shots.
5. All section views shown are left to right facing downstream.
6. Cross-section B shot at location of pipe centerline (based on best professional judgement).
