Baseline Assessment – Stream Attributes

Reach S-CD6 (Pipeline ROW)

Franklin County, Virginia

</div>		<div>Profile and Cross-Sections Baseline Survey</div> <div>Prepared For: MVP</div> <div>Crossing S-CD6 - Little Creek (MP 262.3)</div> <div>Franklin County, Virginia</div> <div>Copyright © 2021 Wetland Studies and Solutions, Inc.</div>																																			
<table><tr><th colspan="4">REVISIONS</th></tr><tr><th>No.</th><th>Date</th><th>Description</th><th>App. By</th></tr><tr><td> </td><td> </td><td> </td><td> </td></tr><tr><td> </td><td> </td><td> </td><td> </td></tr><tr><td> </td><td> </td><td> </td><td> </td></tr><tr><td> </td><td> </td><td> </td><td> </td></tr><tr><td> </td><td> </td><td> </td><td> </td></tr><tr><td> </td><td> </td><td> </td><td> </td></tr></table> <table><tr><td>DATE: September, 2021</td><td>SCALE: AS NOTED</td></tr></table>				REVISIONS				No.	Date	Description	App. By																									DATE: September, 2021	SCALE: AS NOTED

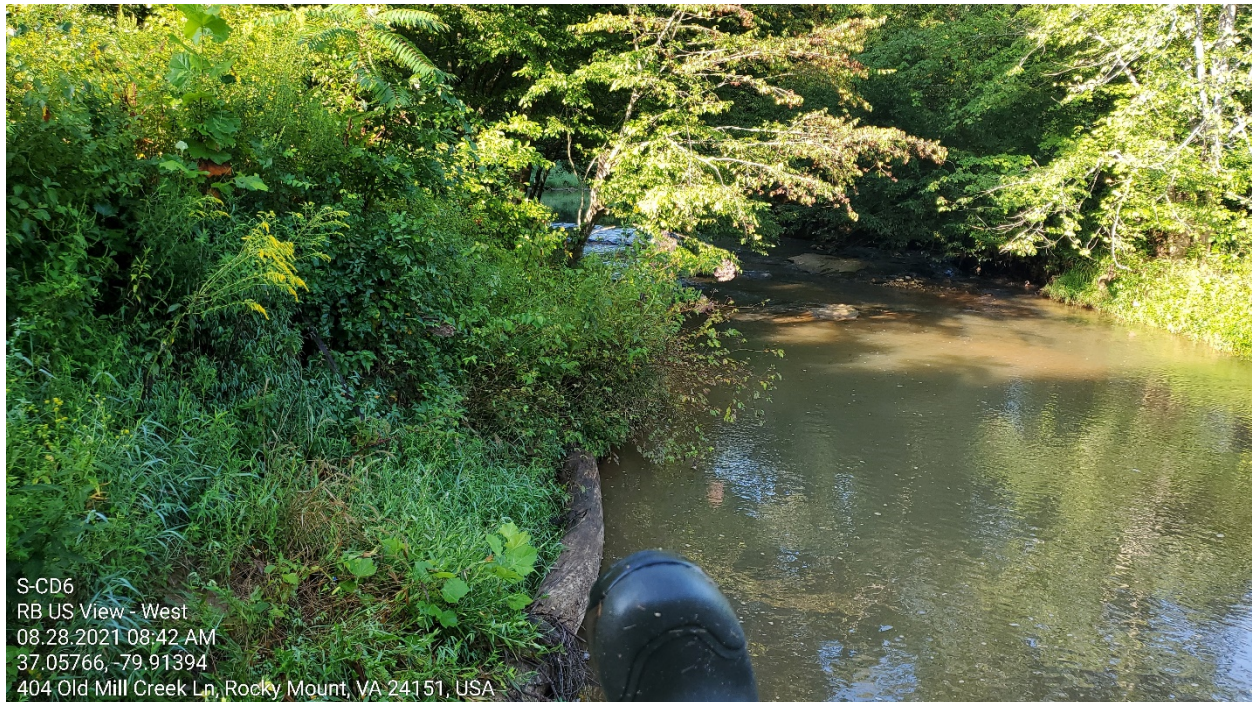
Photo Type: RB US VIEW

Location, Orientation, Photographer Initials: Downstream at ROW/LOD on right bank looking W upstream, DW

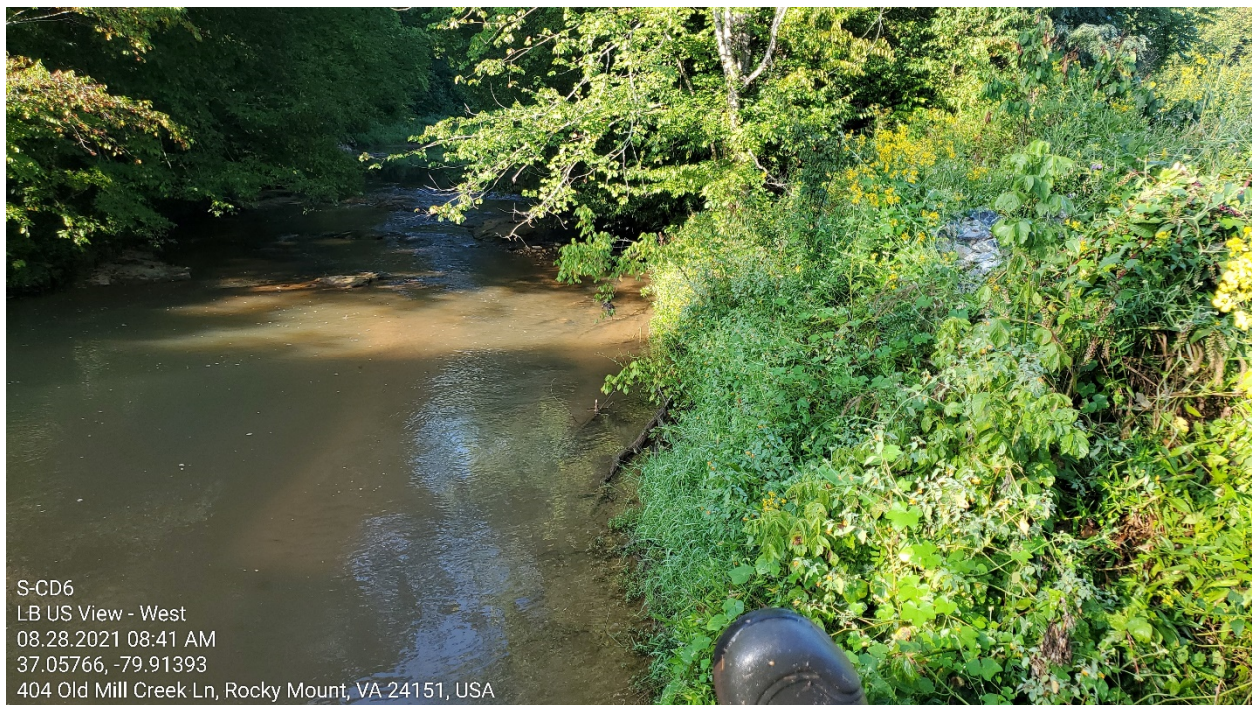
Photo Type: LB US VIEW

Location, Orientation, Photographer Initials: Downstream at ROW/LOD on left bank looking W upstream, DW

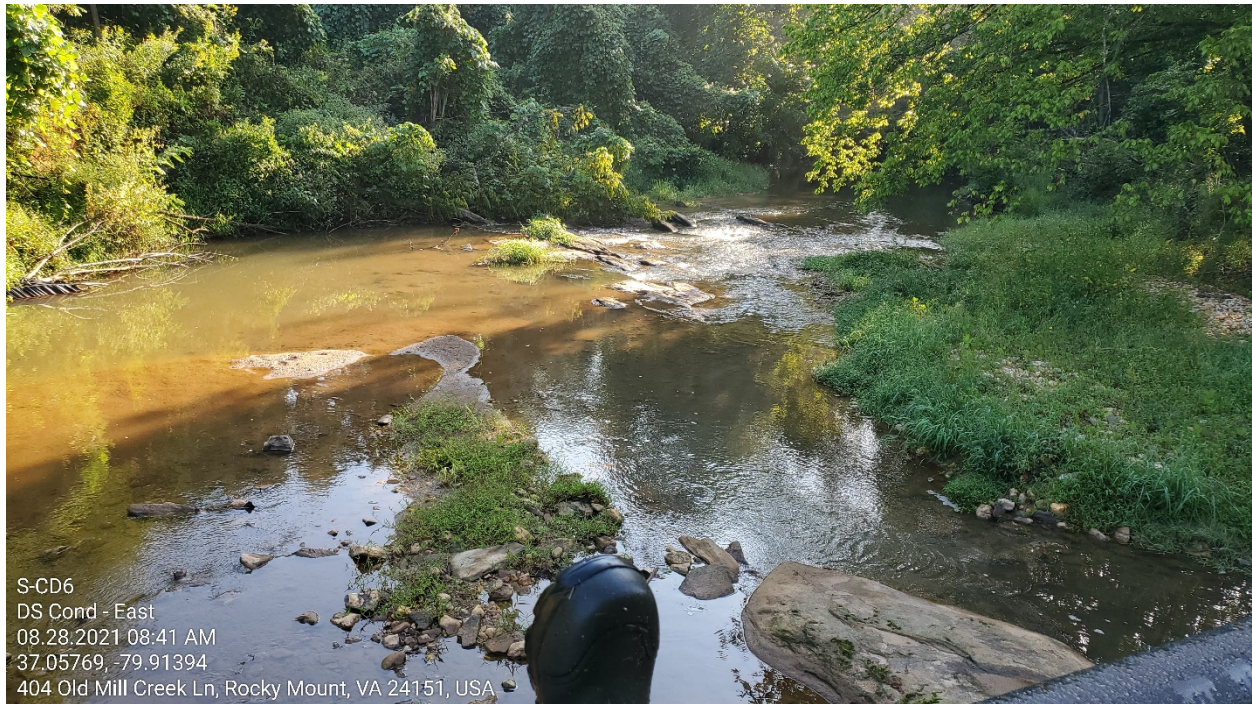
Photo Type: DS COND

S-CD6
DS Cond - East
08.28.2021 08:41 AM
37.05769, -79.91394
404 Old Mill Creek Ln, Rocky Mount, VA 24151, USA

Location, Orientation, Photographer Initials: Downstream at ROW/LOD looking E downstream, DW

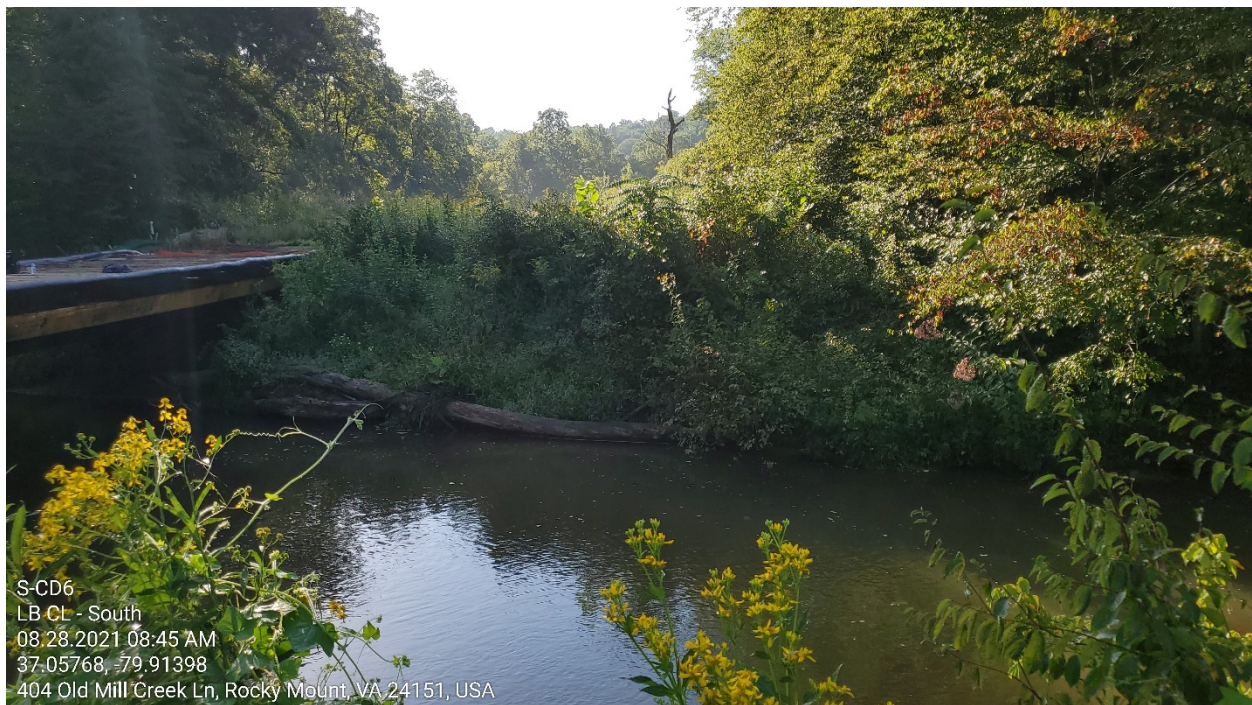
Photo Type: LB CL

S-CD6
LB CL - South
08.28.2021 08:45 AM
37.05768, -79.91398
404 Old Mill Creek Ln, Rocky Mount, VA 24151, USA

Location, Orientation, Photographer Initials: On thalweg at pipe centerline looking S at right streambank, DW

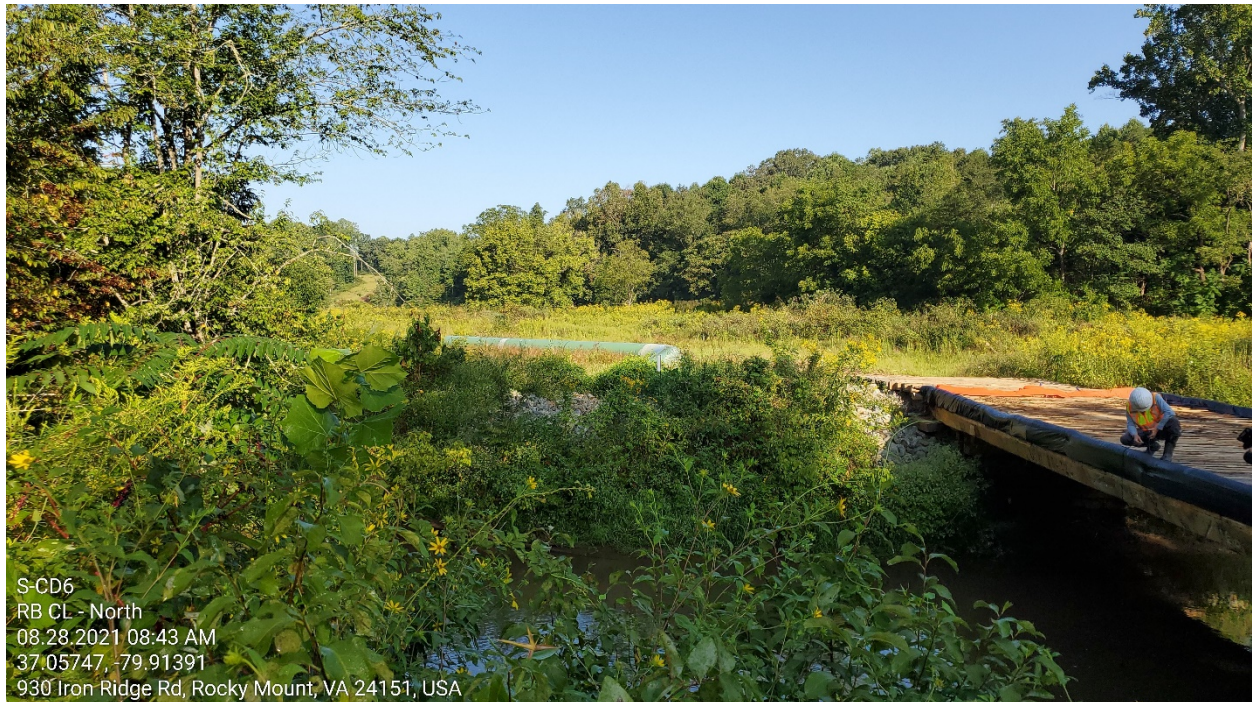
Photo Type: RB CL

S-CD6
RB CL - North
08.28.2021 08:43 AM
37.05747, -79.91391
930 Iron Ridge Rd, Rocky Mount, VA 24151, USA

Location, Orientation, Photographer Initials: On thalweg at pipe centerline looking N at left streambank, DW

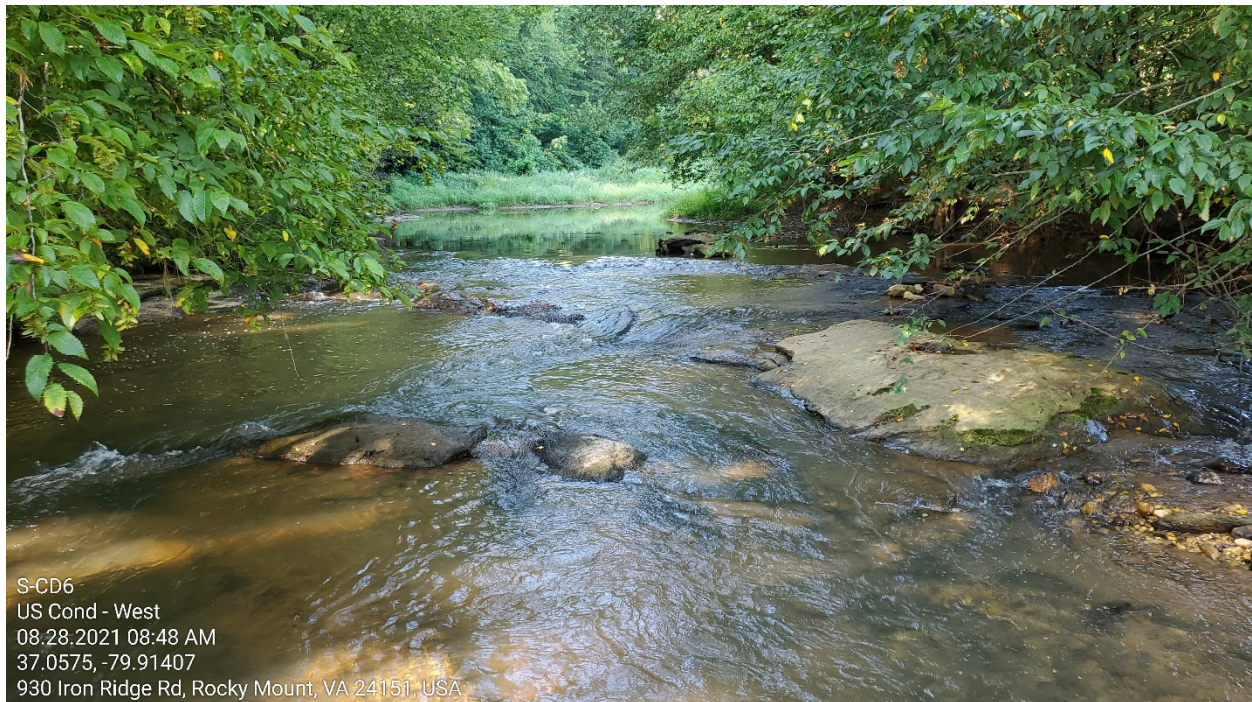
Photo Type: US COND

S-CD6
US Cond - West
08.28.2021 08:48 AM
37.0575, -79.91407
930 Iron Ridge Rd, Rocky Mount, VA 24151, USA

Location, Orientation, Photographer Initials: Upstream at ROW/LOD looking W upstream, DW

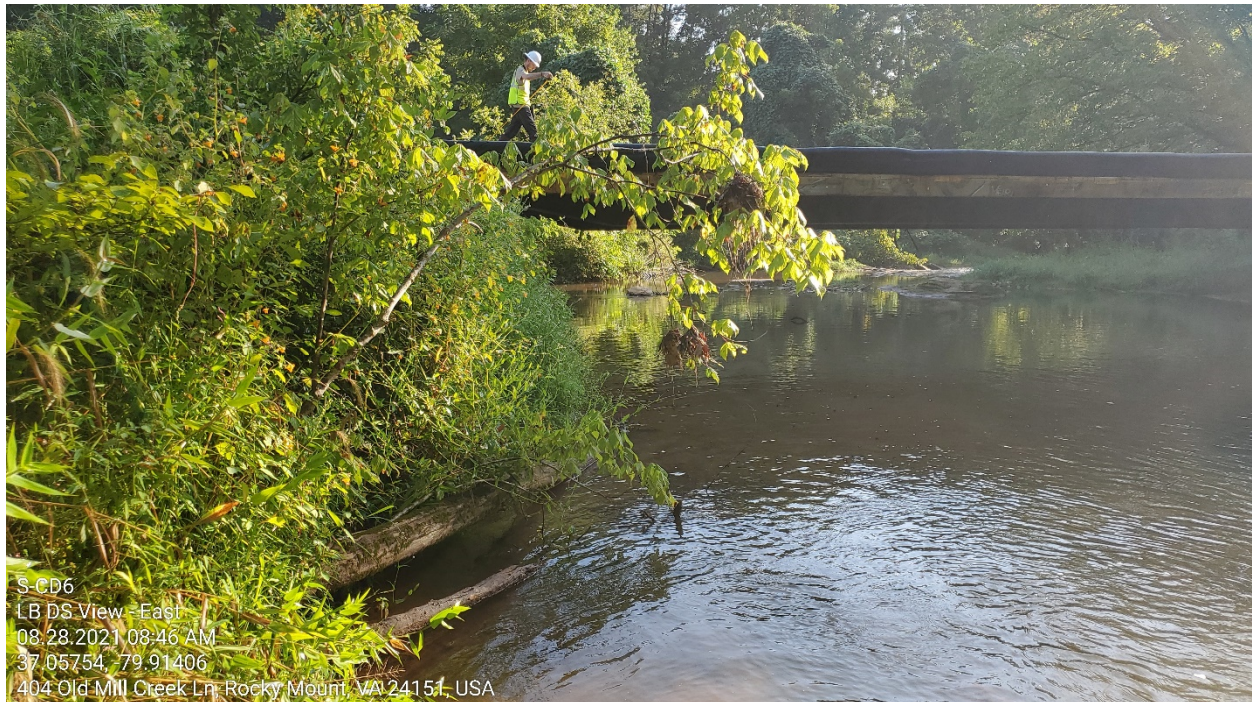
Photo Type: LB DS VIEW

Location, Orientation, Photographer Initials: Upstream at ROW/LOD on left bank looking E downstream, DW

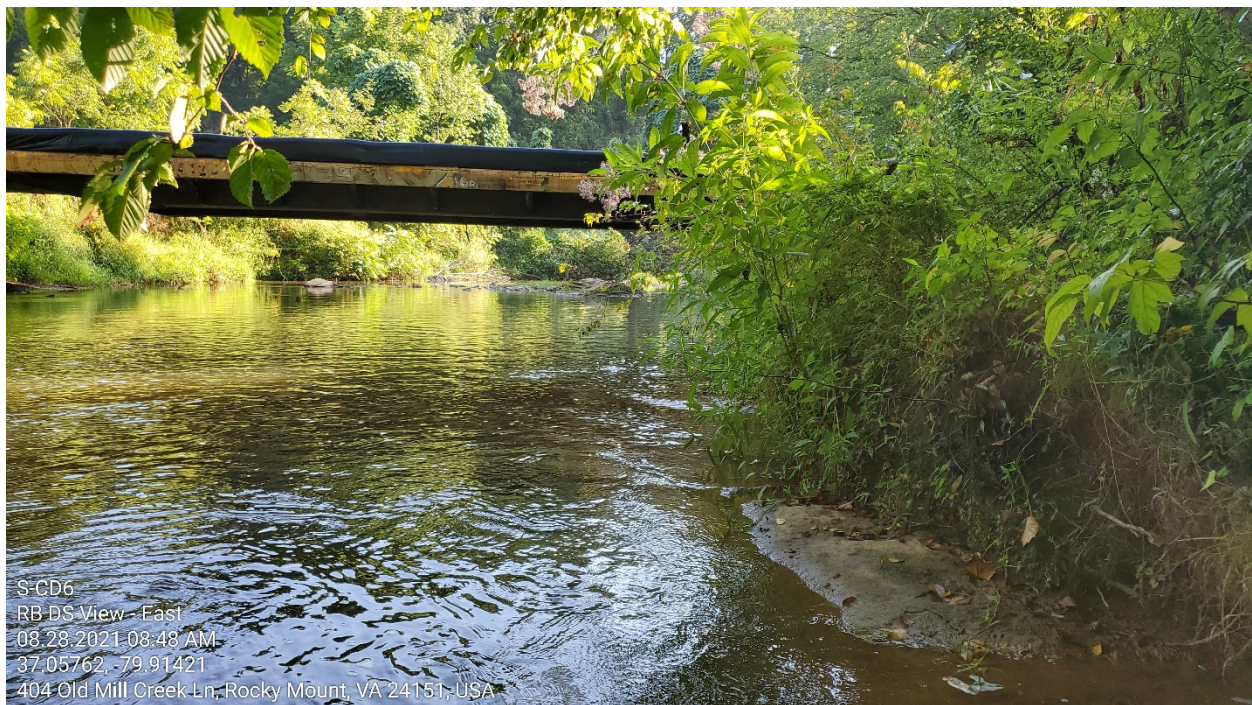
Photo Type: RB DS VIEW

Location, Orientation, Photographer Initials: Upstream at ROW/LOD on right bank looking E downstream, DW

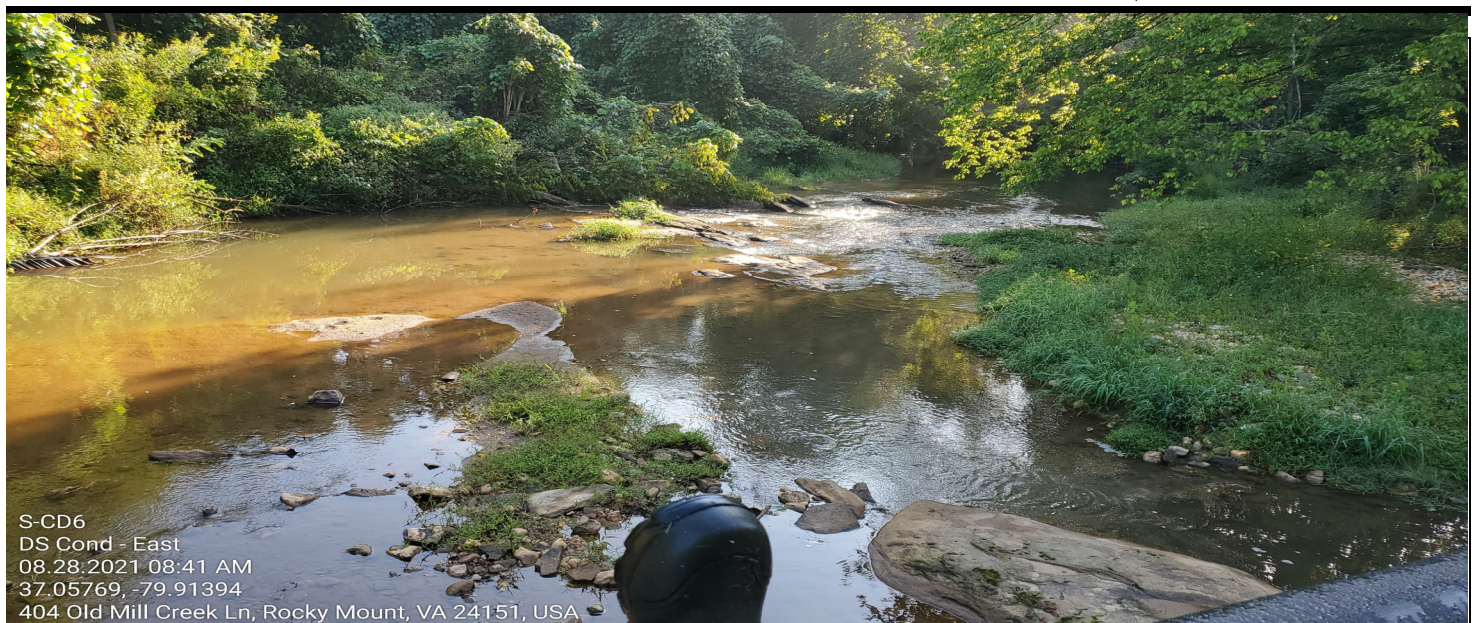
S-CD6
DS Cond - East
08.28.2021 08:41 AM
37.05769, -79.91394
404 Old Mill Creek Ln, Rocky Mount, VA 24151, USA

CAPTION. Assessment is limited to areas within the temporary ROW.
