Baseline Assessment – Stream Attributes

Reach S-D23 (Pipeline ROW)

Franklin County, Virginia

Crossing S-D23 - Teels Creek (MP 260.7)

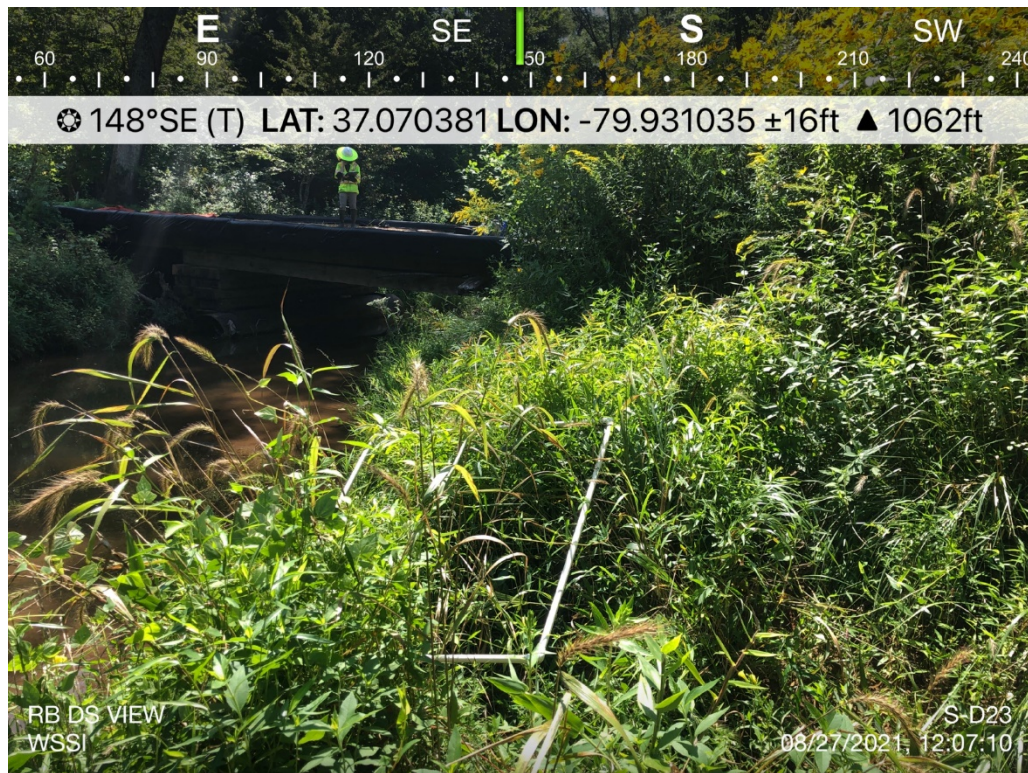
Photo Type: RB DS VIEW

Location, Orientation, Photographer Initials: Standing on RB looking downstream along the ROW looking SE, AO

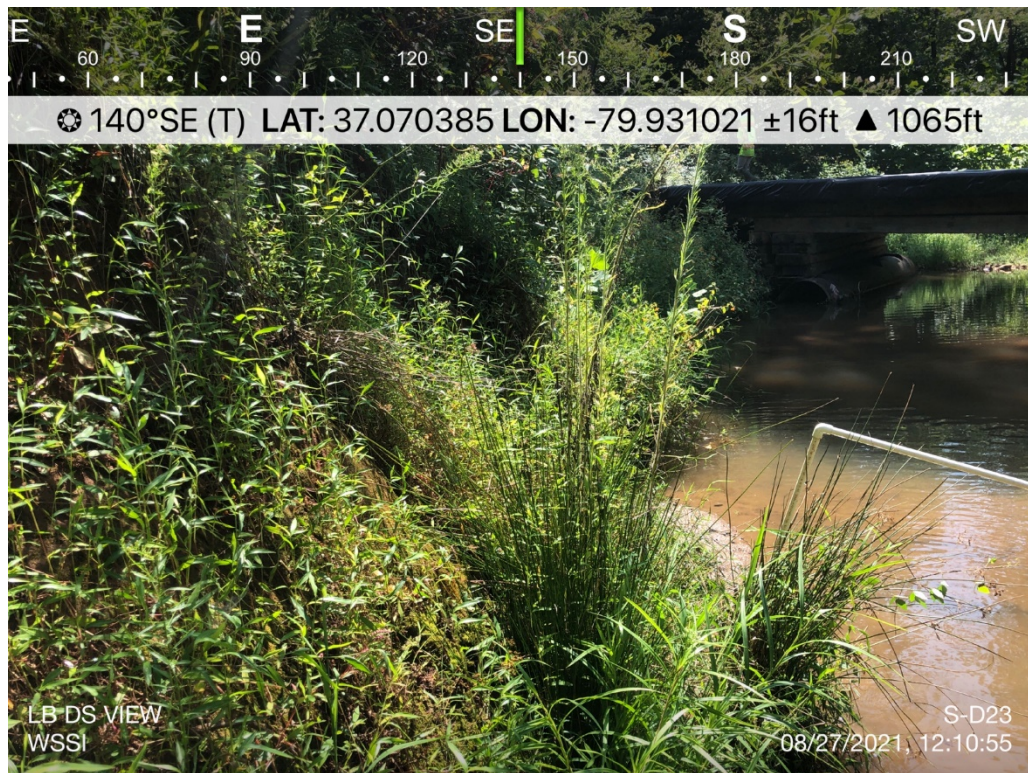
Photo Type: LB DS VIEW

Location, Orientation, Photographer Initials: Standing on LB looking downstream along the ROW looking SE, AO

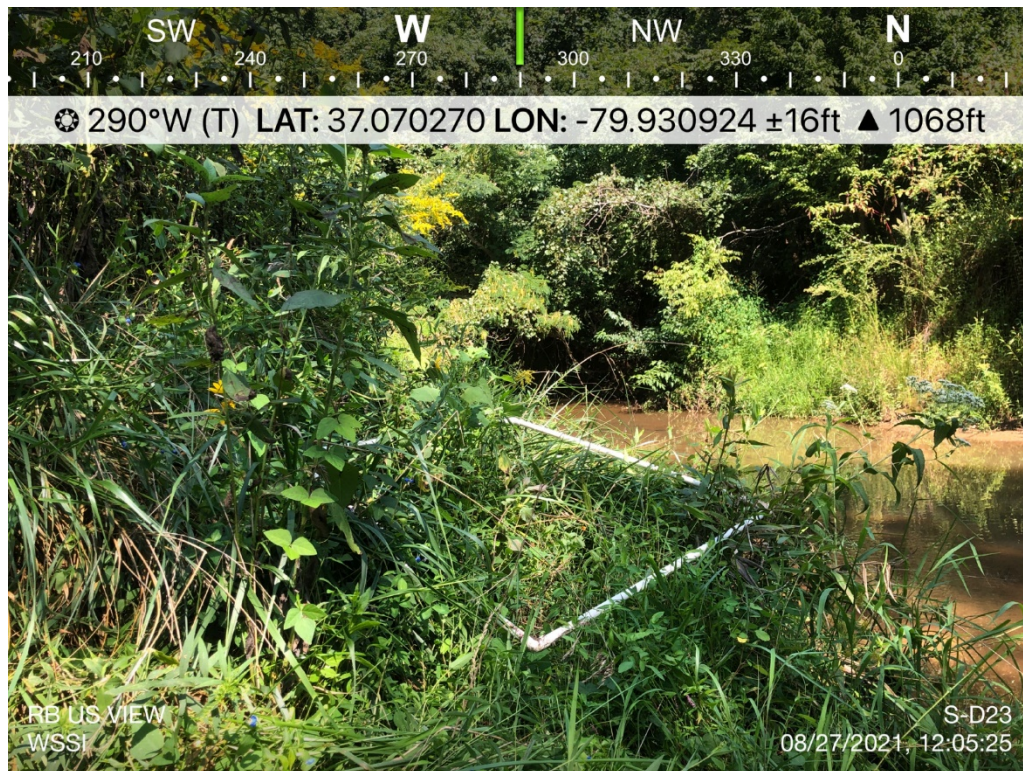
Photo Type: RB US VIEW

Location, Orientation, Photographer Initials: Standing on RB looking upstream along the ROW looking W, AO

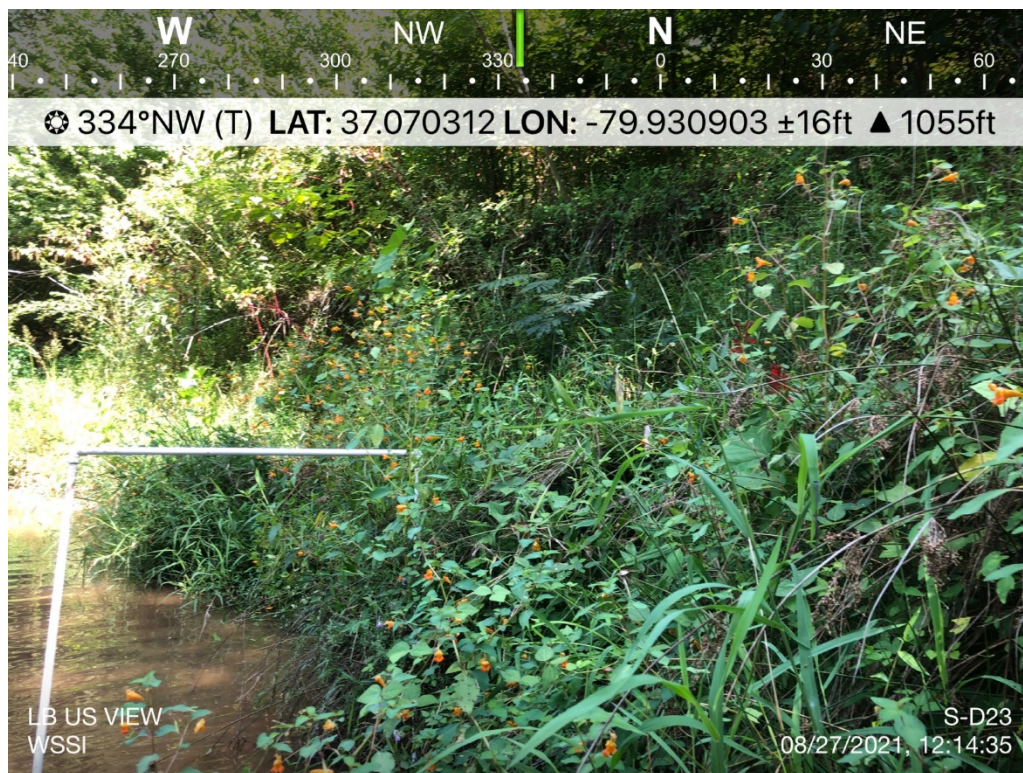
Photo Type: LB US VIEW

Location, Orientation, Photographer Initials: Standing on LB looking upstream along the ROW looking NW, AO

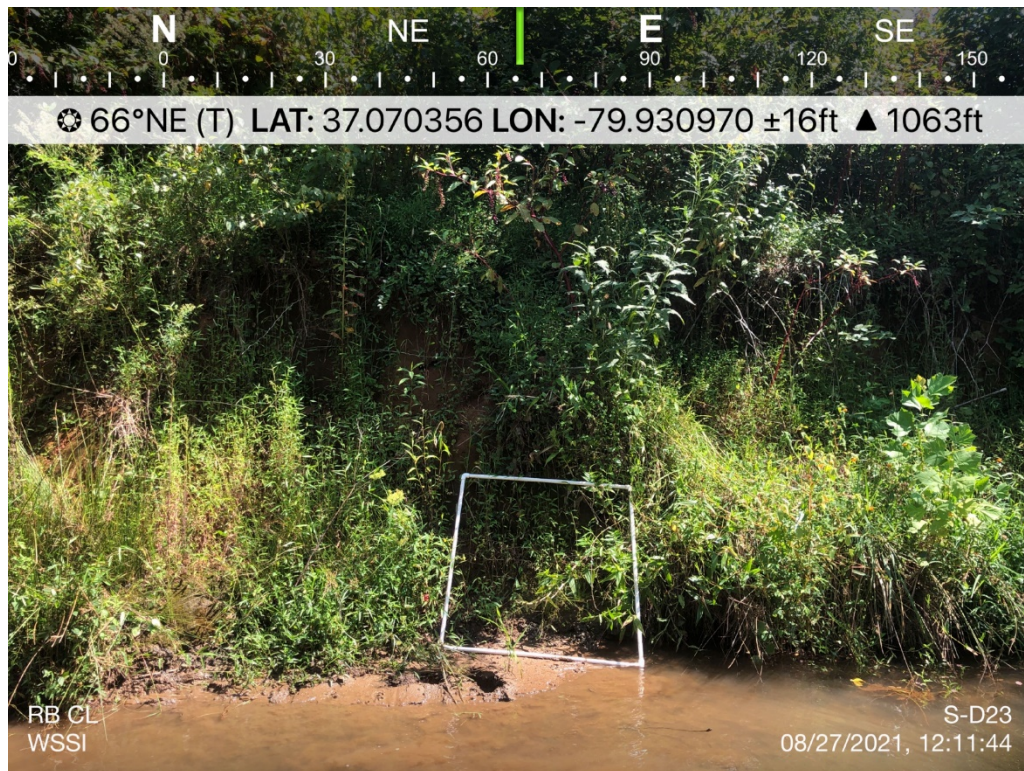
Photo Type: RB CL

Location, Orientation, Photographer Initials: Standing on RB looking at LB along pipe centerline looking NE, AO

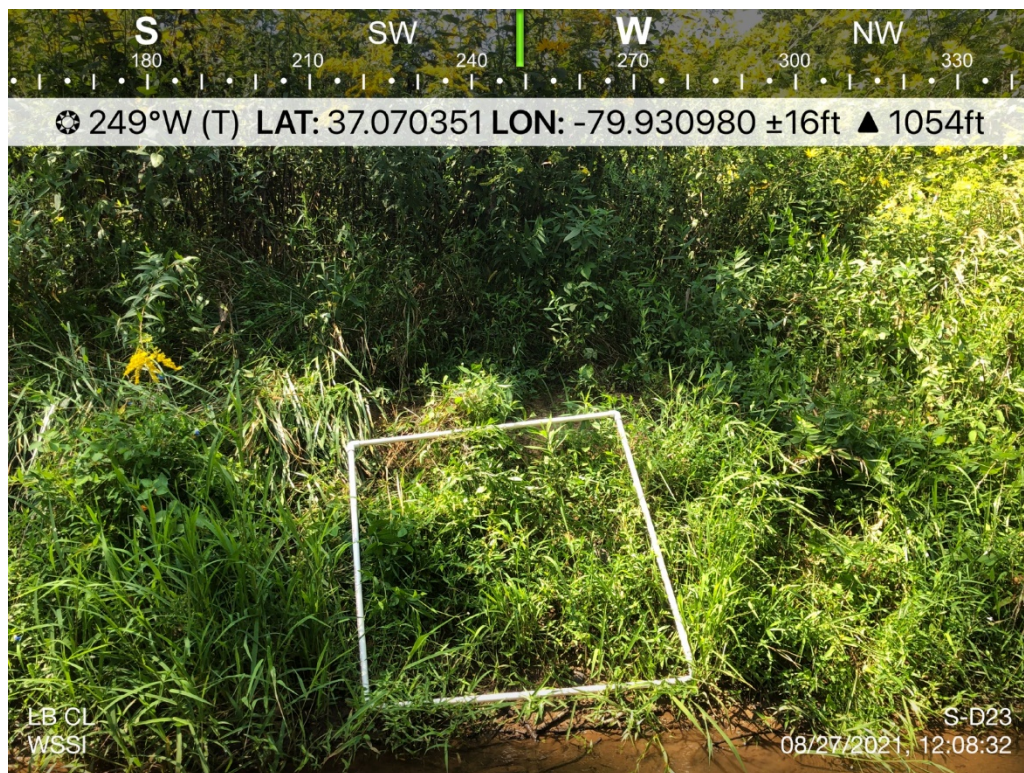
Photo Type: LB CL

Location, Orientation, Photographer Initials: Standing on LB looking at RB along pipe centerline looking W, AO

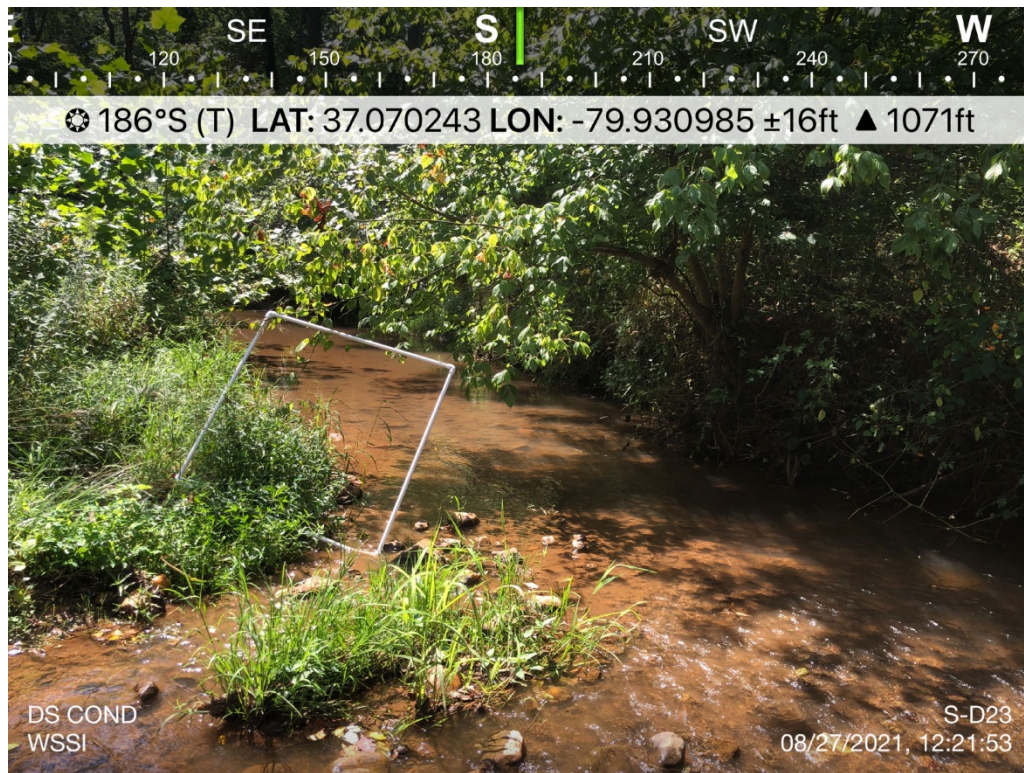
Photo Type: DS COND

Location, Orientation, Photographer Initials: Downstream conditions outside of ROW looking S, AO

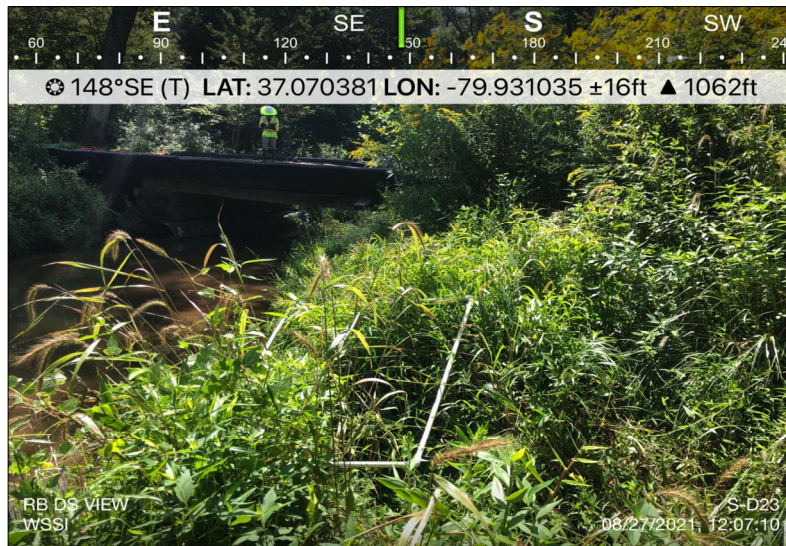
Downstream view on right bank within ROW. Assessment is limited to areas within the temporary ROW.

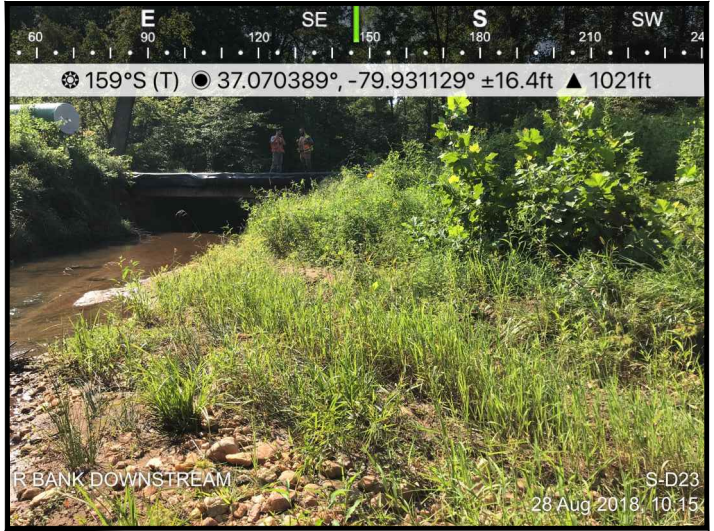
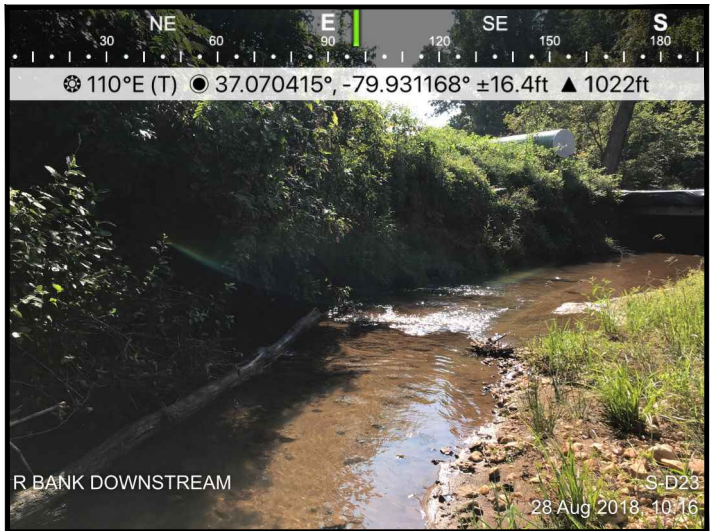
CL STAKEOUT POINTS: S-D23 CROSS SECTION B (PIPE CL)					
	PRE-CROSSING			POST-CROSSING	
PT. LOC.	NORTHING	EASTING	ELEV	VERT. DIFF.	HORIZ. DIFF.
TS-L	13461939.92	19522220.89	1068.46	----	----
BS-L	13461938.56	1952217.95	1060.62	----	----
THW	13461939.05	1952214.28	1060.13	----	----
BS-R	13461937.43	1952198.65	1060.85	----	----
TS-R	13461936.13	1952190.87	1063.12	----	----

6. Cross-section B shot at location of pipe centerline (based on best professional judgement).
