Baseline Assessment – Stream Attributes

Reach S-G20 (Timber Mat Crossing)

Spread I

Franklin County, Virginia

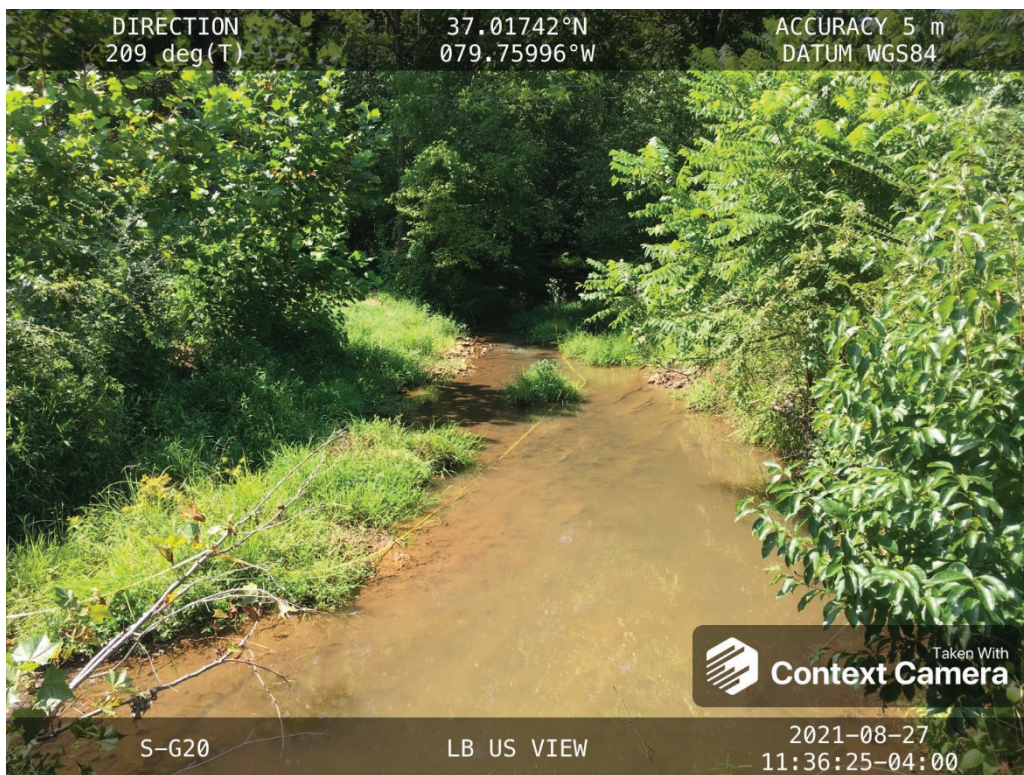
Photo Type: LB US VIEW

Location, Orientation, Photographer Initials: Downstream at ROW/LOD on the left bank looking SW upstream, CB

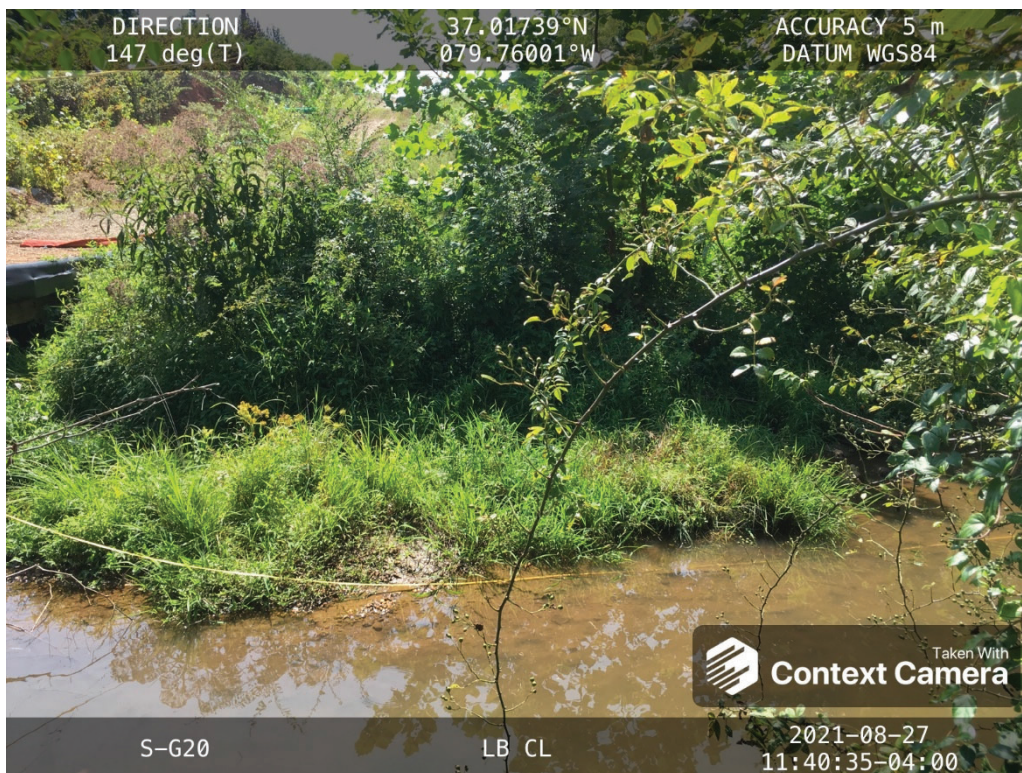
Photo Type: LB CL

Location, Orientation, Photographer Initials: On left bank at pipe centerline looking SE at right streambank, CB

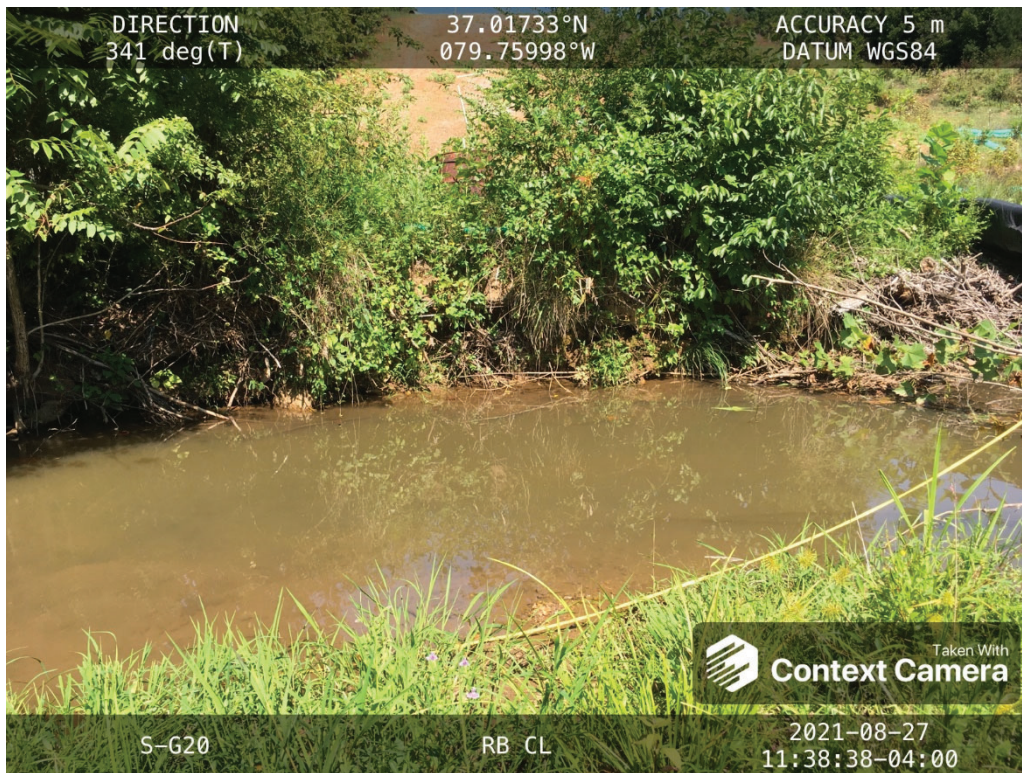
Photo Type: RB CL

Location, Orientation, Photographer Initials: On right bank at pipe centerline looking NW at left streambank, CB

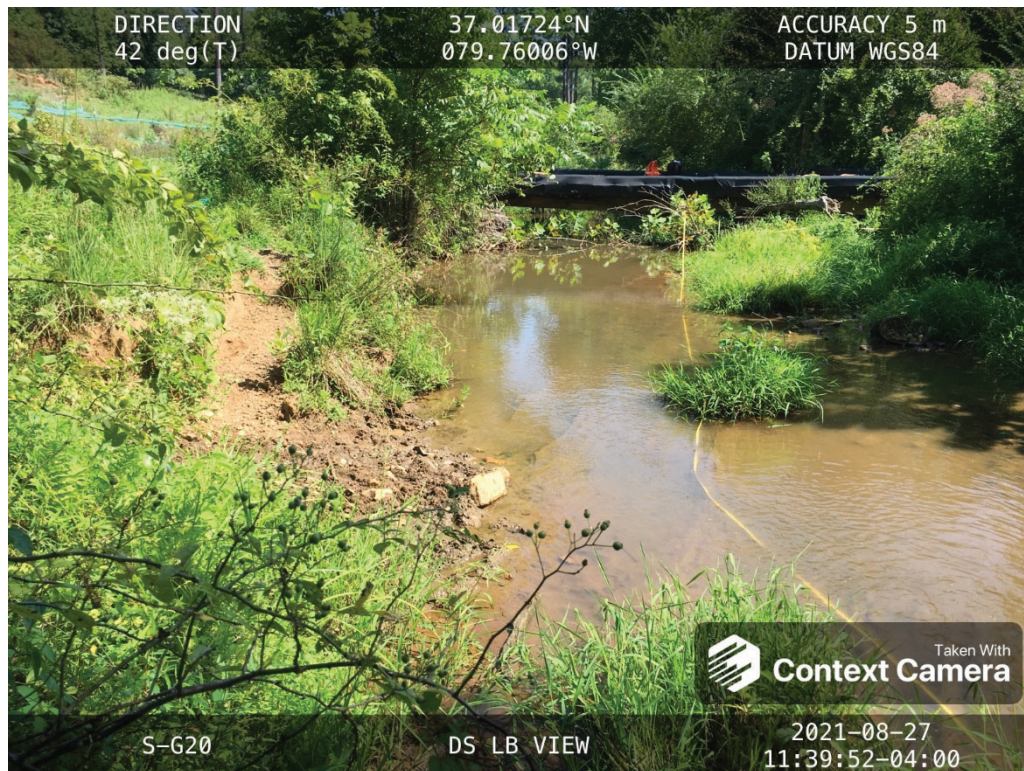
Photo Type: DS LB VIEW

Location, Orientation, Photographer Initials: Upstream at ROW/LOD on the left bank looking NE downstream, CB

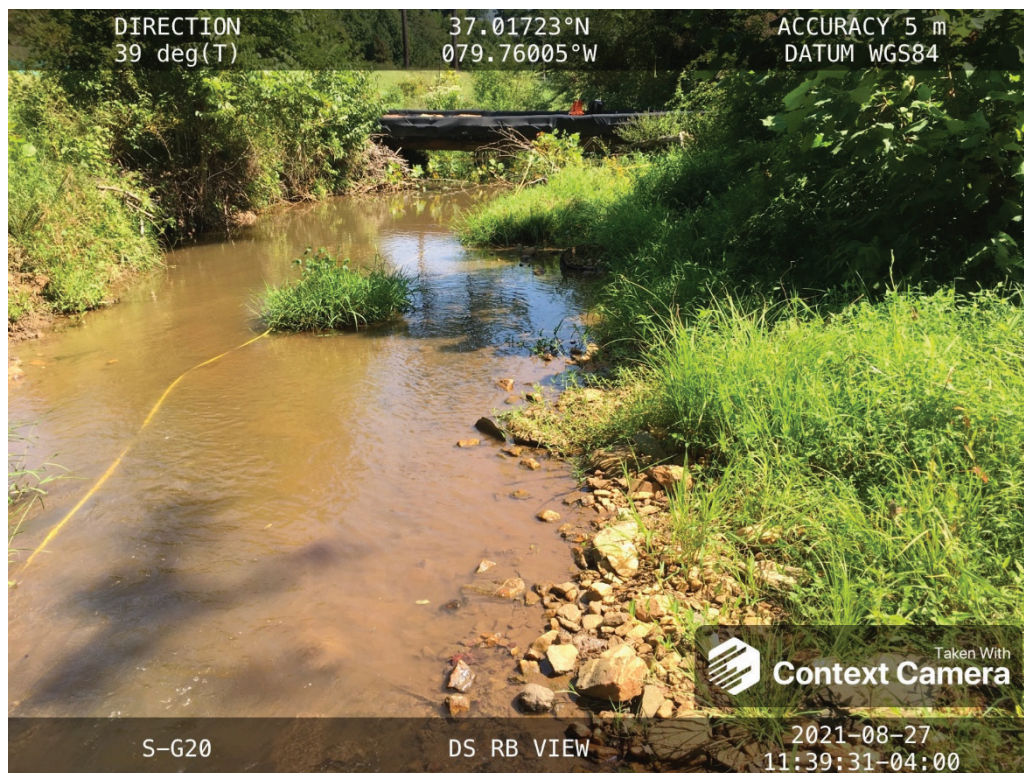
Photo Type: DS RB VIEW

Location, Orientation, Photographer Initials: Upstream at ROW/LOD on the right bank looking NE downstream, CB
