Baseline Assessment – Stream Attributes

Reach S-H34 (Timber Mat Crossing)

Franklin County, Virginia

Profile and Cross-Sections Baseline Survey

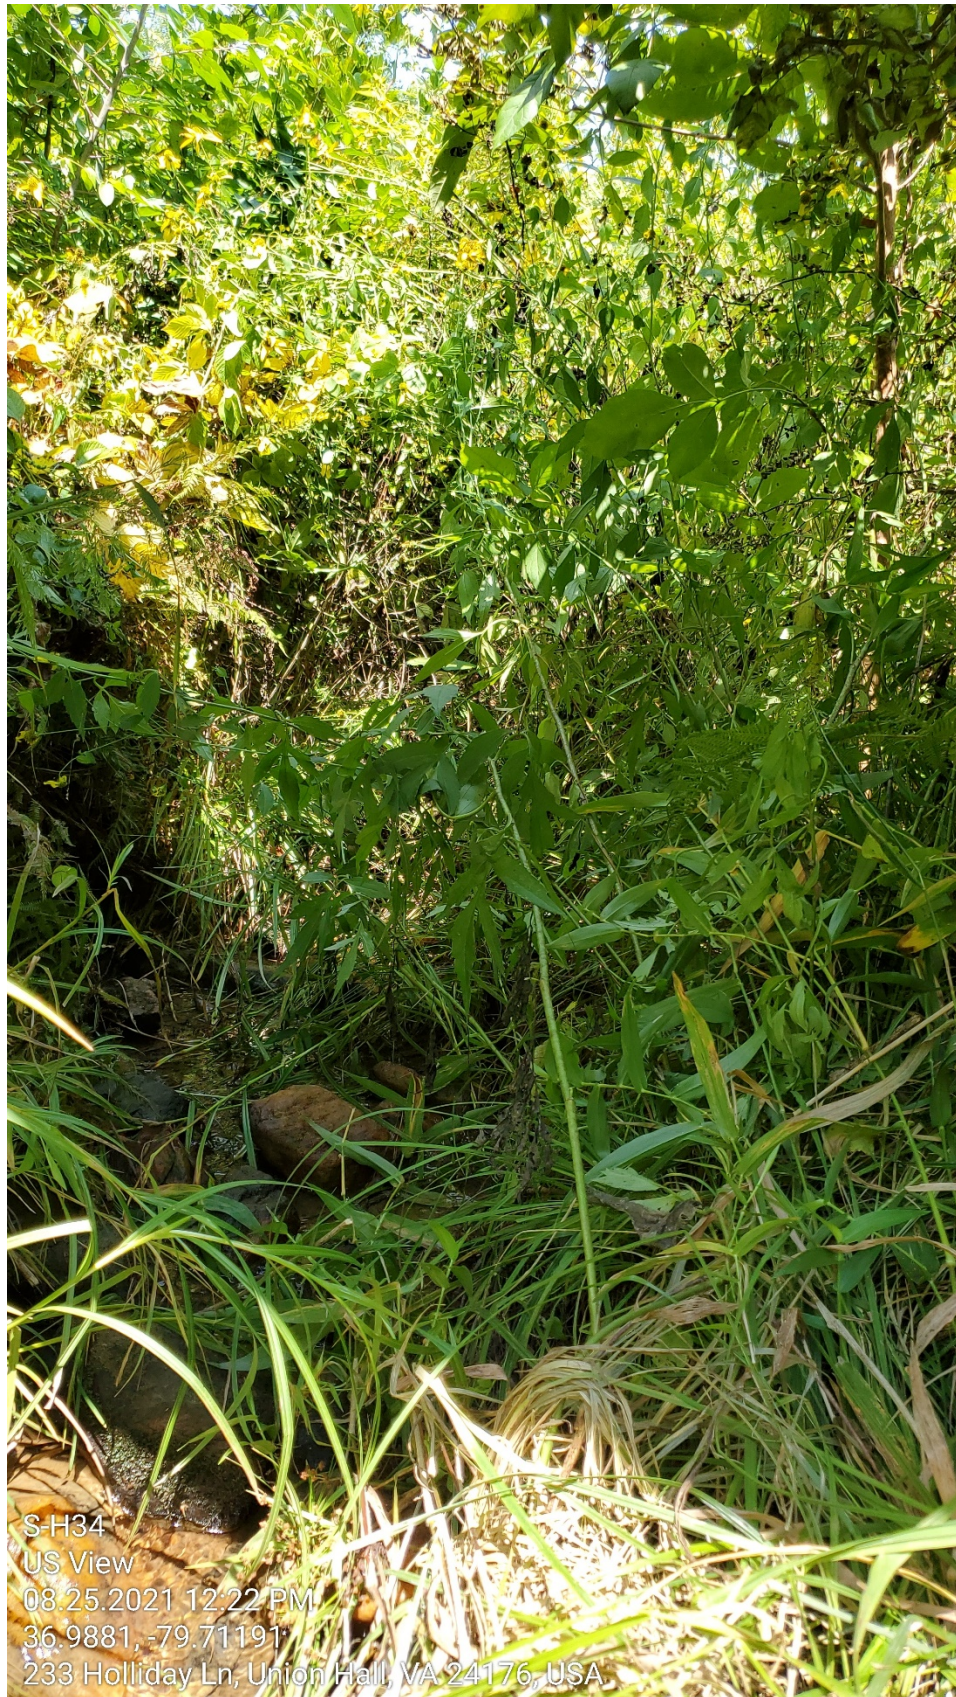
Photo Type: US VIEW

S-H34
US View
08.25.2021 12:22 PM
36.9881, -79.71191
233 Holliday Ln, Union Hall, VA 24176, USA

Location, Orientation, Photographer Initials: Downstream at S-H34 looking N upstream, DW

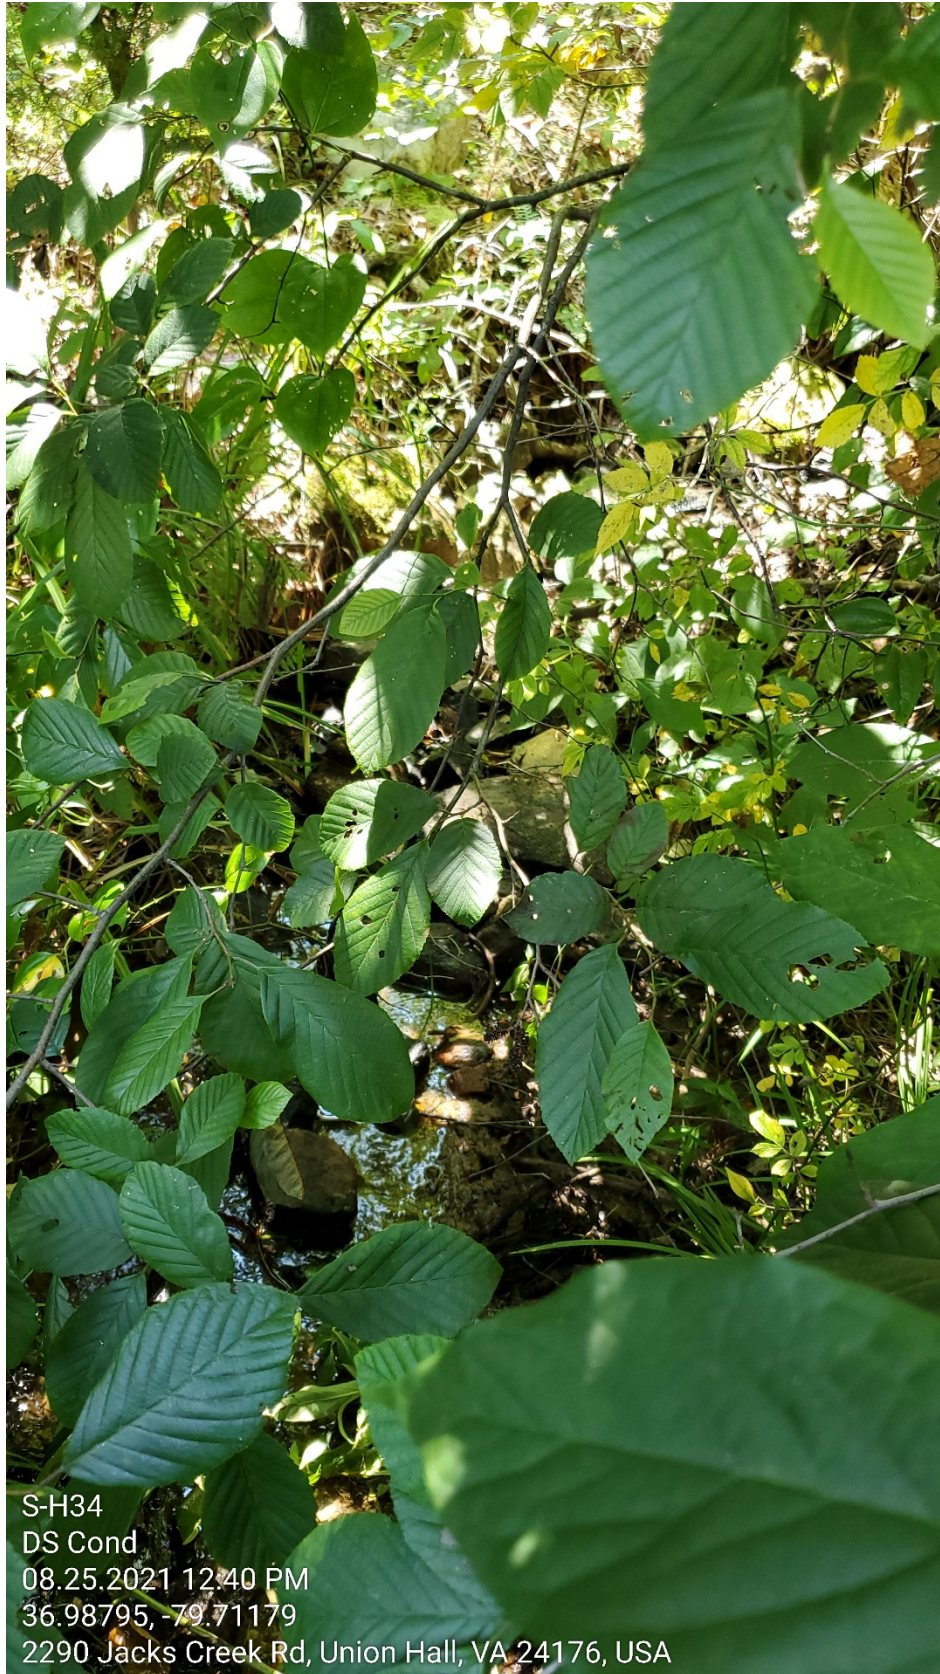
Photo Type: DS COND DS
Location, Orientation, Photographer Initials: Downstream at S-H34 looking S downstream, DW

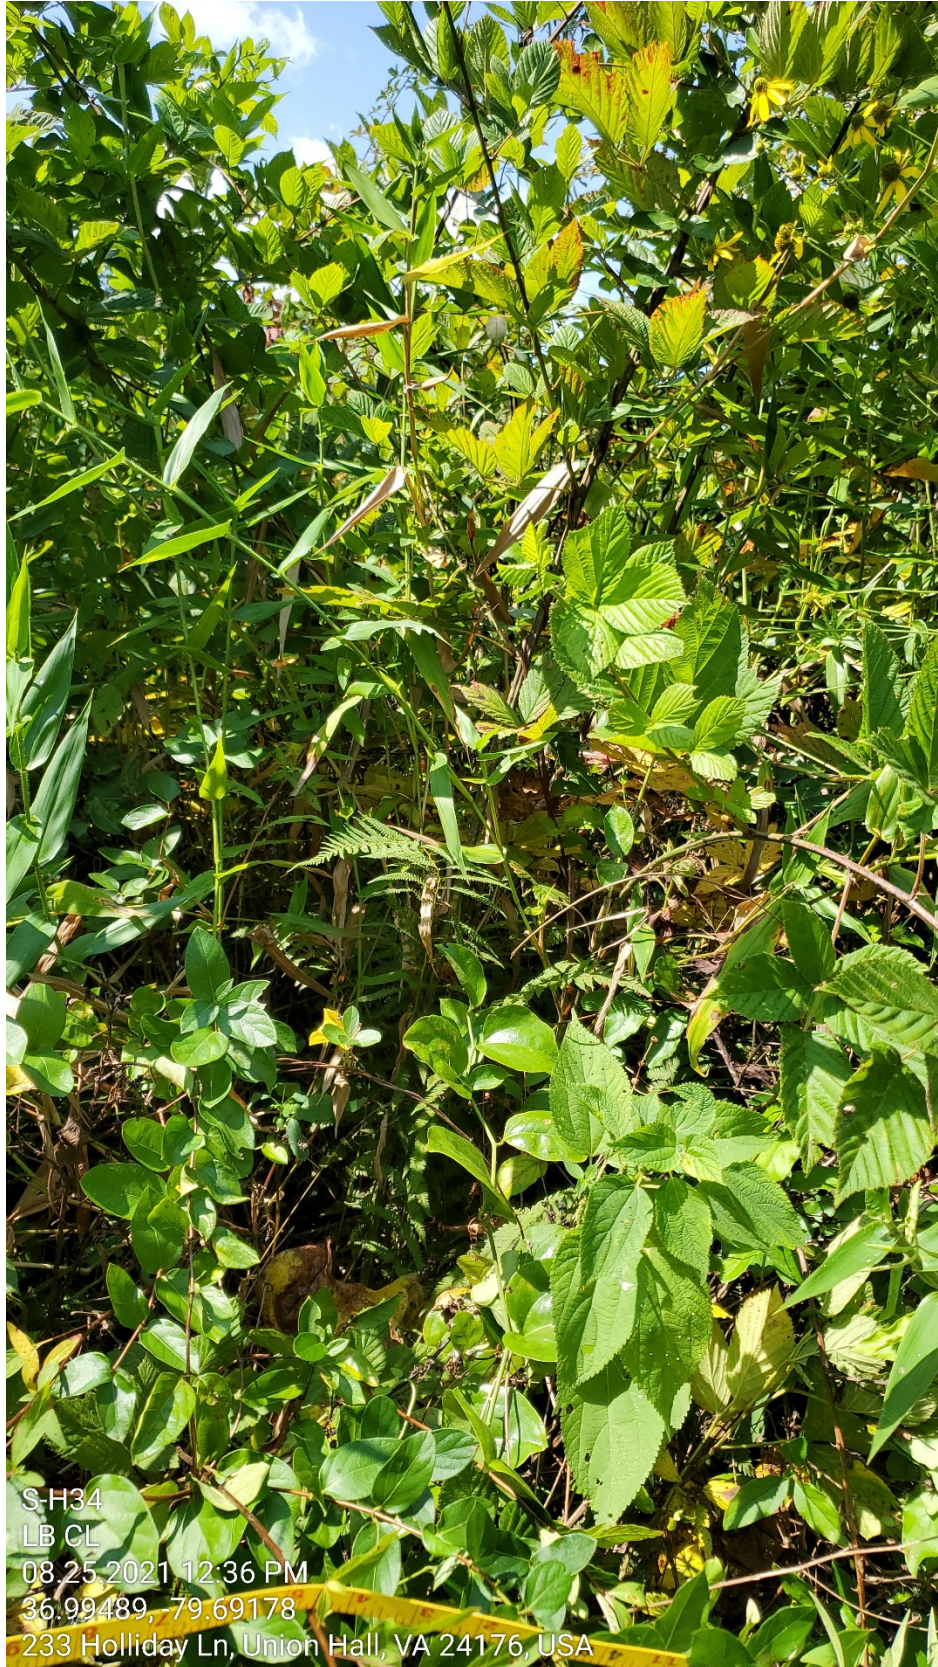
Photo Type: LB CL

Location, Orientation, Photographer Initials: On thalweg at S-H34 pipe centerline looking W at left streambank, DW

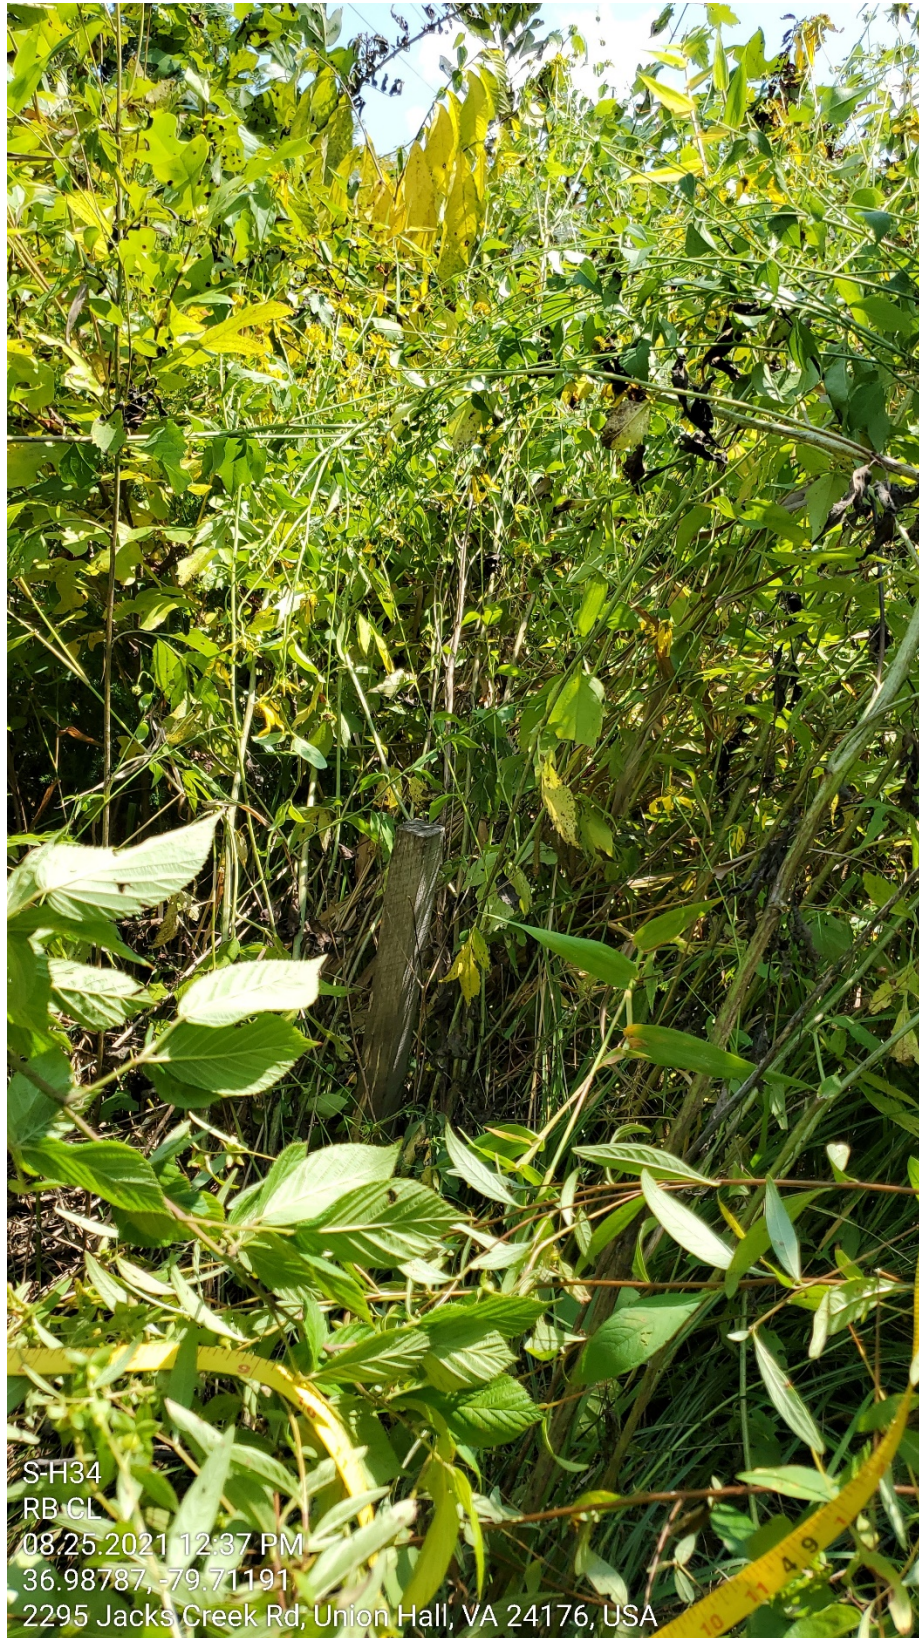
Photo Type: RB CL

S-H34
RB CL
08/25/2021 12:37 PM
36.98787, -79.71191
2295 Jacks Creek Rd, Union Hall, VA 24176, USA

Location, Orientation, Photographer Initials: On thalweg at S-H34 pipe centerline looking E at right streambank,
DW

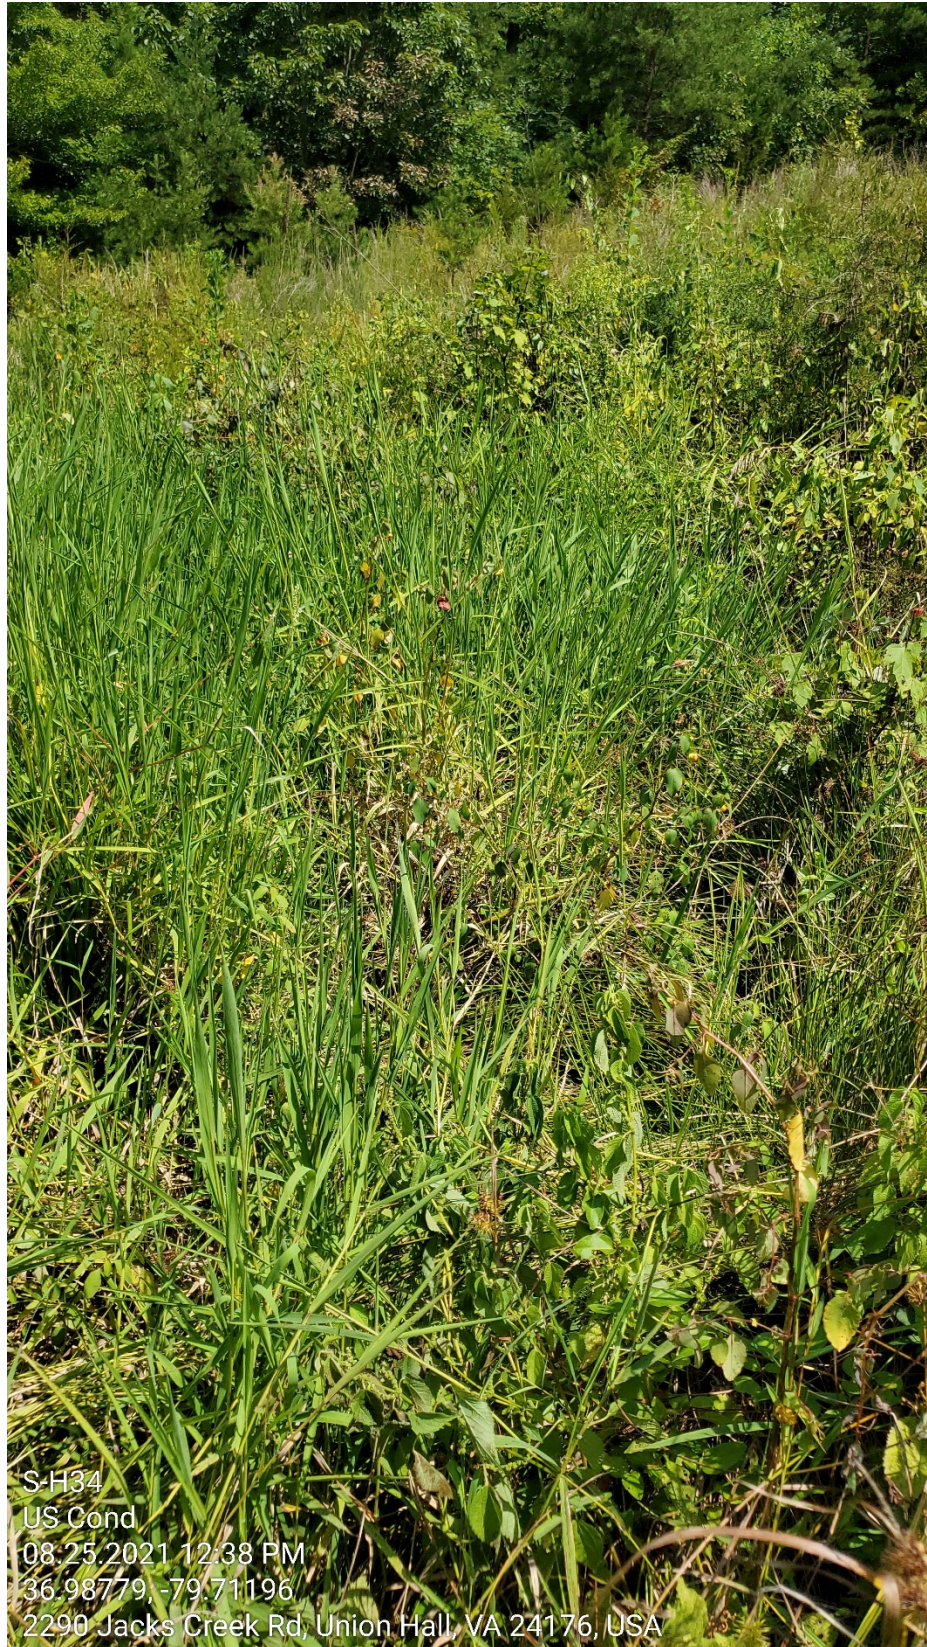
Photo Type: US COND

S-H34
US Cond
08/25/2021 12:38 PM
36.98779, -79.71196
2290 Jacks Creek Rd, Union Hall, VA 24176, USA

Location, Orientation, Photographer Initials: Upstream at S-H34 looking N upstream, DW

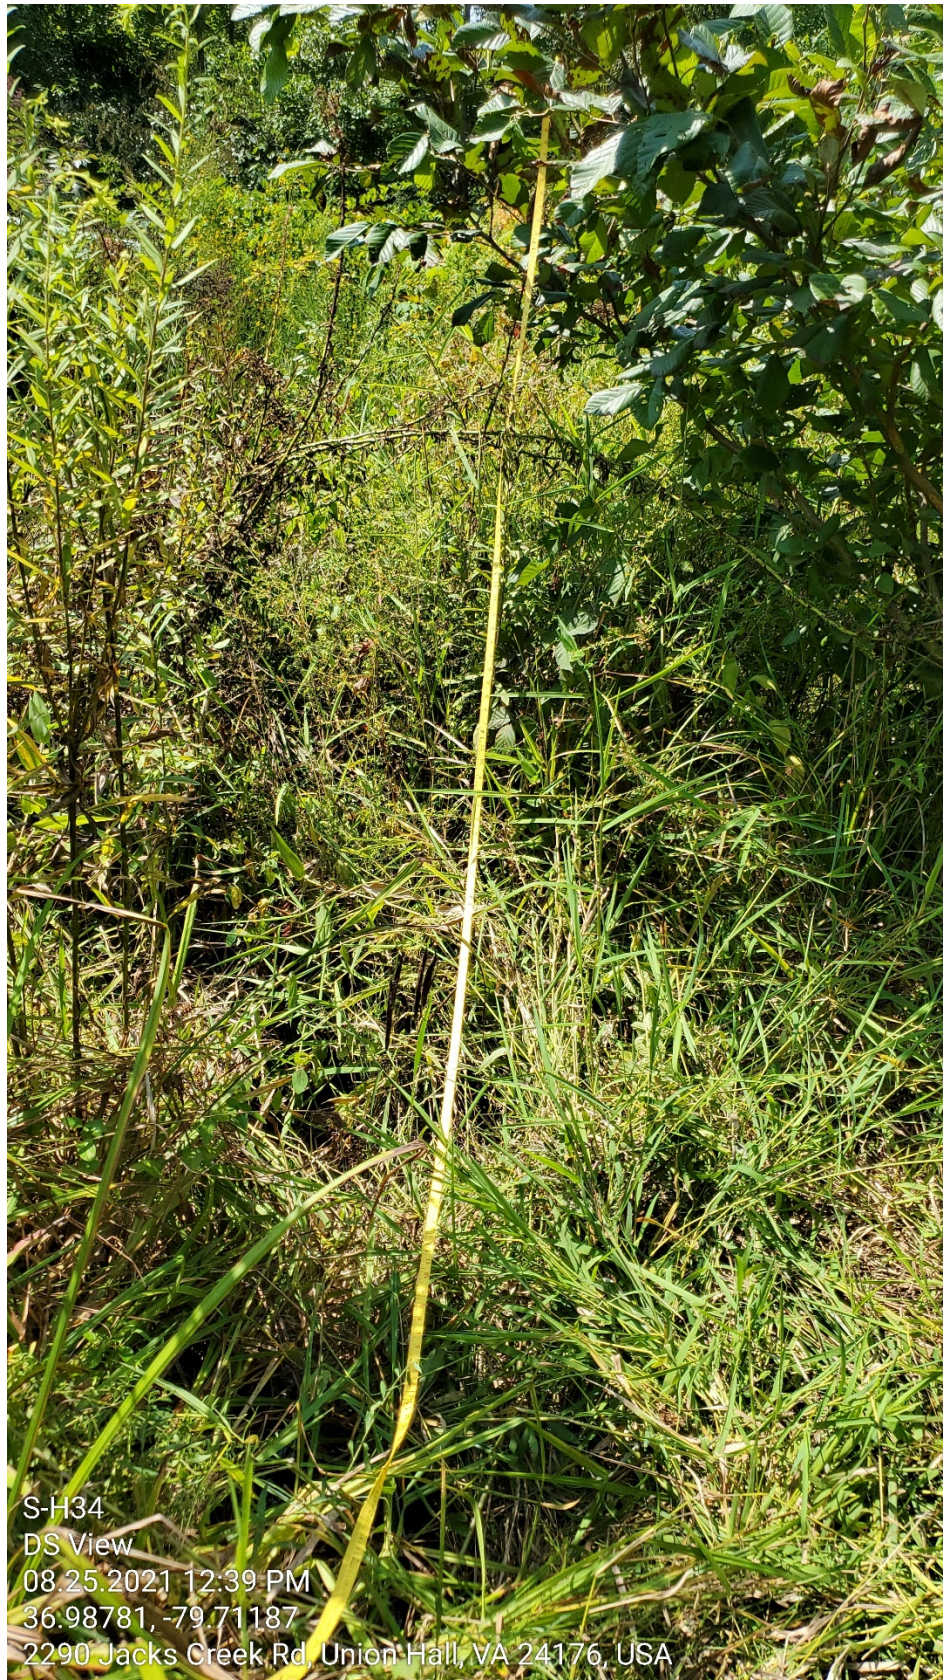
Photo Type: DS VIEW

S-H34
DS View
08.25.2021 12:39 PM
36.98781, -79.71187
2290 Jacks Creek Rd, Union Hall, VA 24176, USA

Location, Orientation, Photographer Initials: Upstream at S-H34 looking S downstream, DW

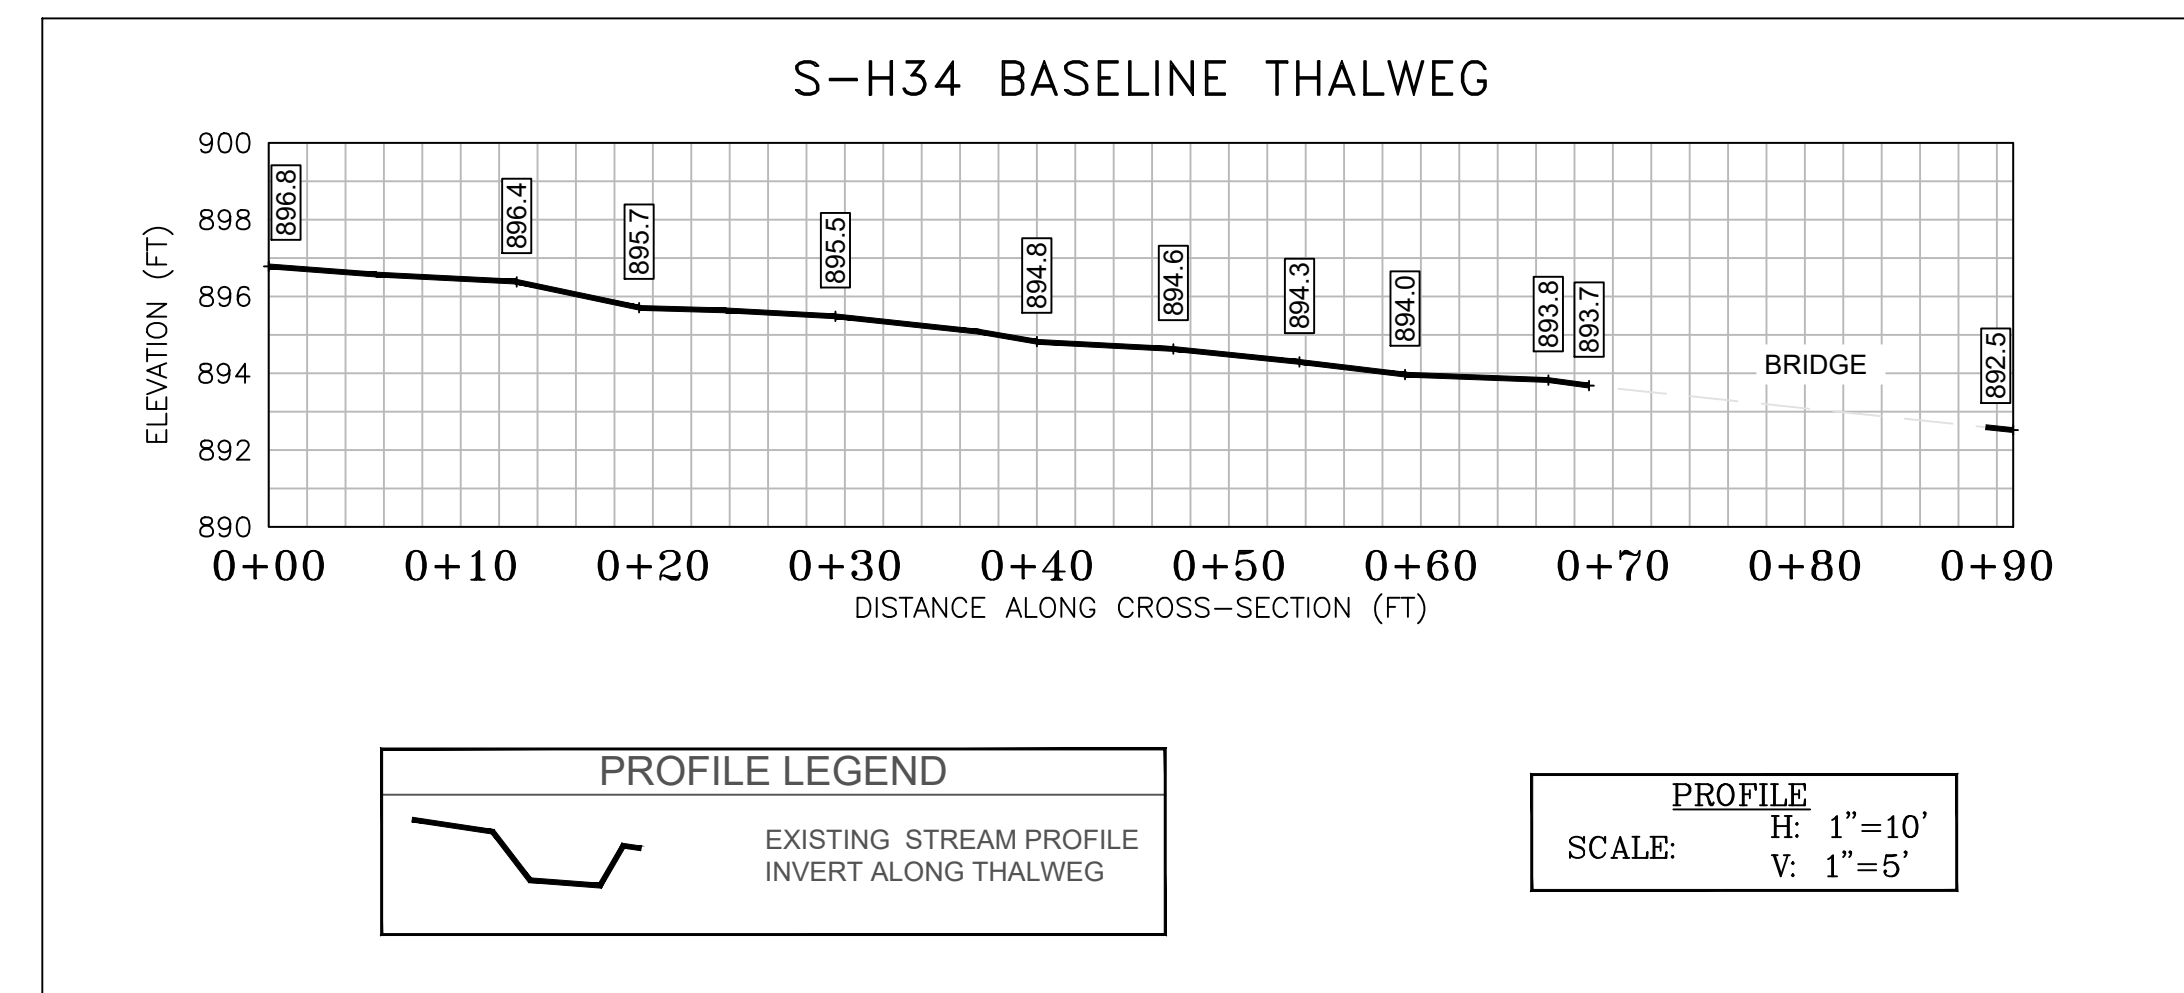
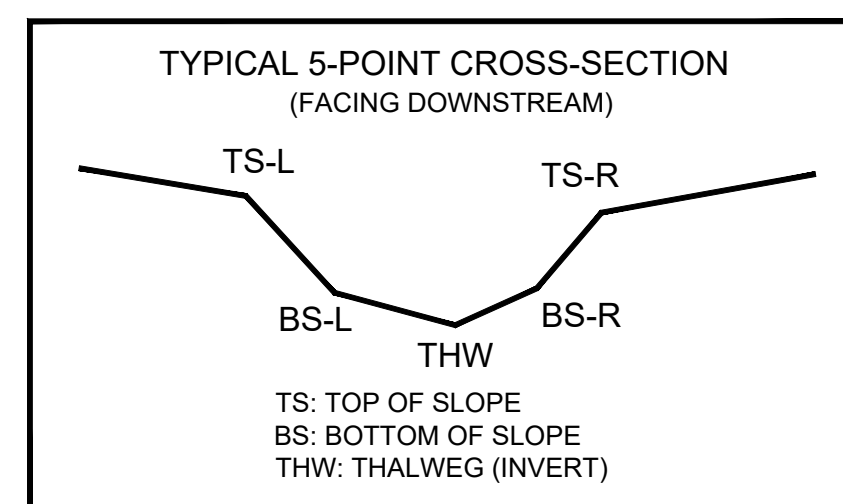
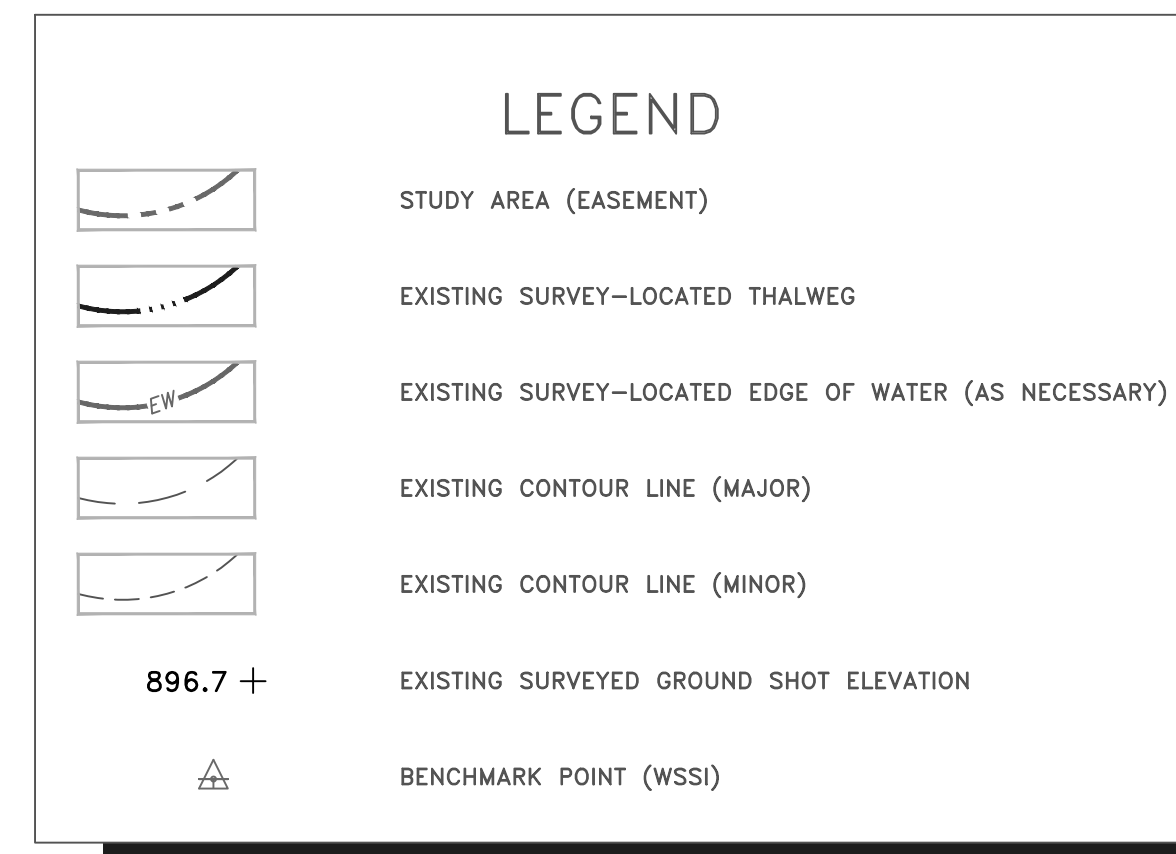
CL STAKEOUT POINTS: S-H34 CROSS SECTION B (PIPE CL)					
	PRE-CROSSING			POST-CROSSING	
PT. LOC.	NORTHING	EASTING	ELEV	VERT. DIFF.	HORZ. DIFF.
TS-L	13432766.51	2016509.07	895.32	----	----
BS-L	13432766.44	2016507.05	894.76		
THW	13432766.27	2016505.12	894.37		
BS-R	13432766.40	2016503.79	894.91	----	----
TS-R	13432766.62	2019502.58	895.98	----	----

1. This map has been oriented to NAD 1983 UTM ZONE 17N, and vertically to The North American Vertical Datum of 1988 (NAVD 88), using a Real Time Network (RTN) GPS. Field locations were completed on November, 8, 2019.
2. Monumentation, including traverse stations and fly points, shown on this drawing should be used to orient any future boundary, topographic, or location survey.
3. Easement lines shown on plan view were provided by Mountain Valley Pipeline (MVP).
4. WSSI Contour Interval = 2.0'. Contours within the channel were interpolated using stream channel breaklines (i.e. top of slopes, toe of slopes, thalweg) and cross-sectional points. Contours outside the channel were interpolated using cross-sectional spot shots.
5. All section views shown are left to right facing downstream.
6. Cross-section B shot at location of pipe centerline (based on best professional judgement).

NOTE: ALL SECTION VIEWS SHOWN LEFT TO RIGHT FACING DOWNSTREAM.
