Baseline Assessment – Stream Attributes

Reach S-H42 (Timber Mat Crossing)

Pittsylvania County, Virginia

Profile and Cross-Sections Baseline Survey. Prepared For: MVP. Crossing S-H42 - UNT to Little Cherrystone Creek (MP 302.7) Pittsylvania County, Virginia Copyright © 2021 Wetland Studies and Solutions, Inc.

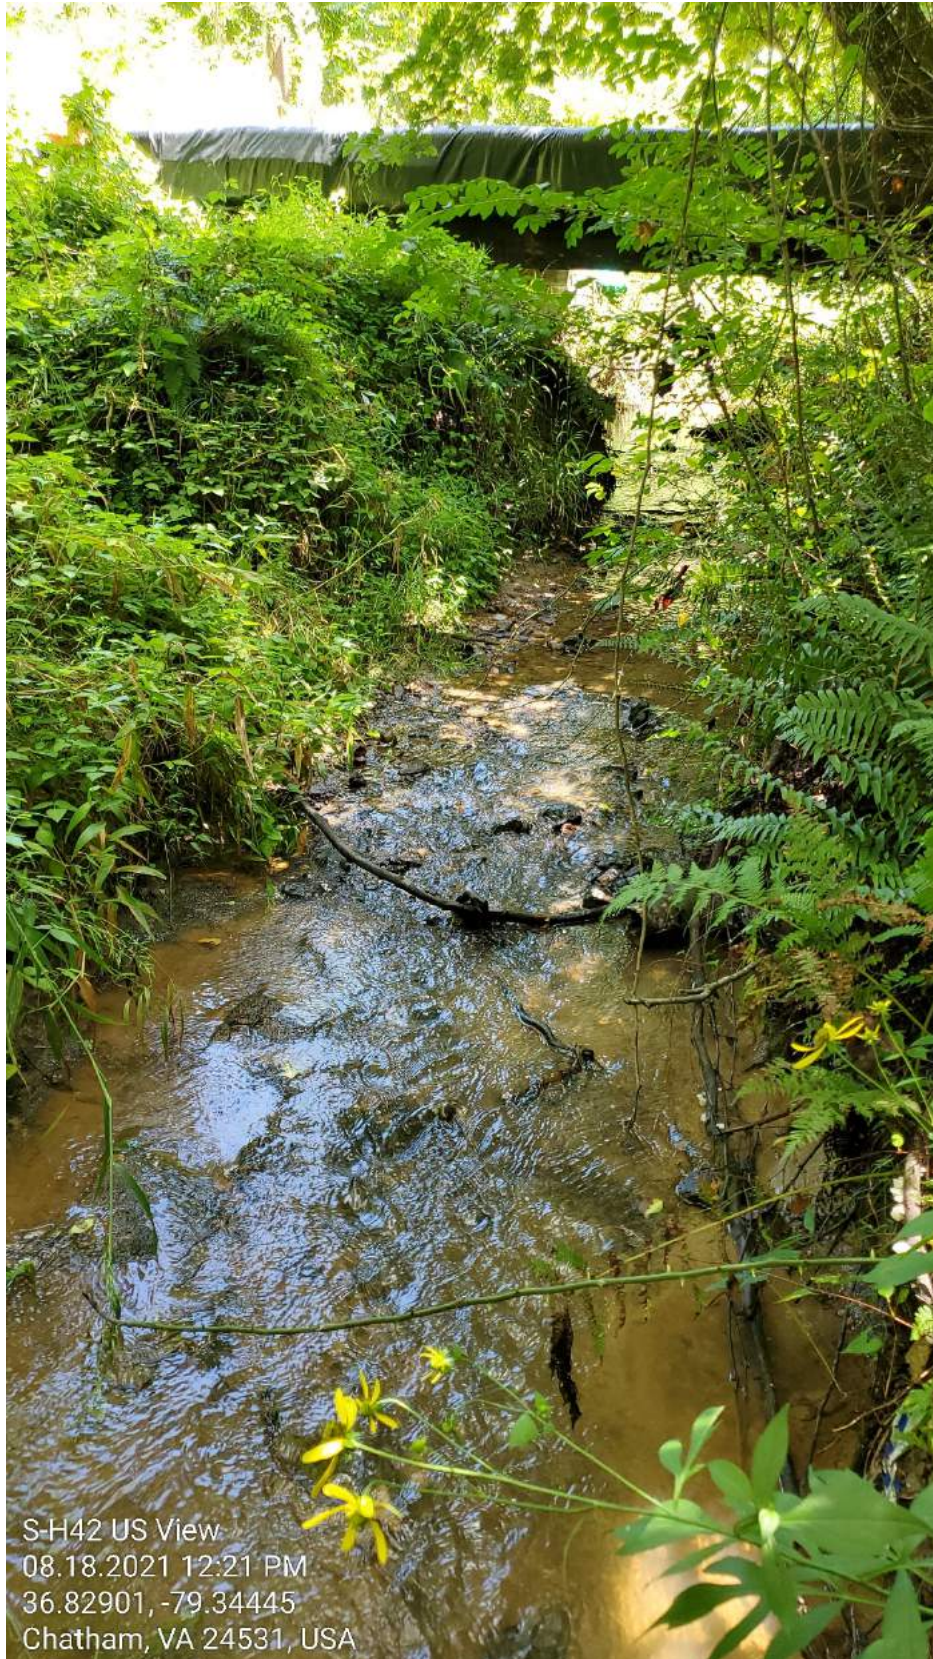
Photo Type: US VIEW

S-H42 US View
08.18.2021 12:21 PM
36.82901, -79.34445
Chatham, VA 24531, USA

Location, Orientation, Photographer Initials: Downstream at S-H42 looking SE upstream, DW

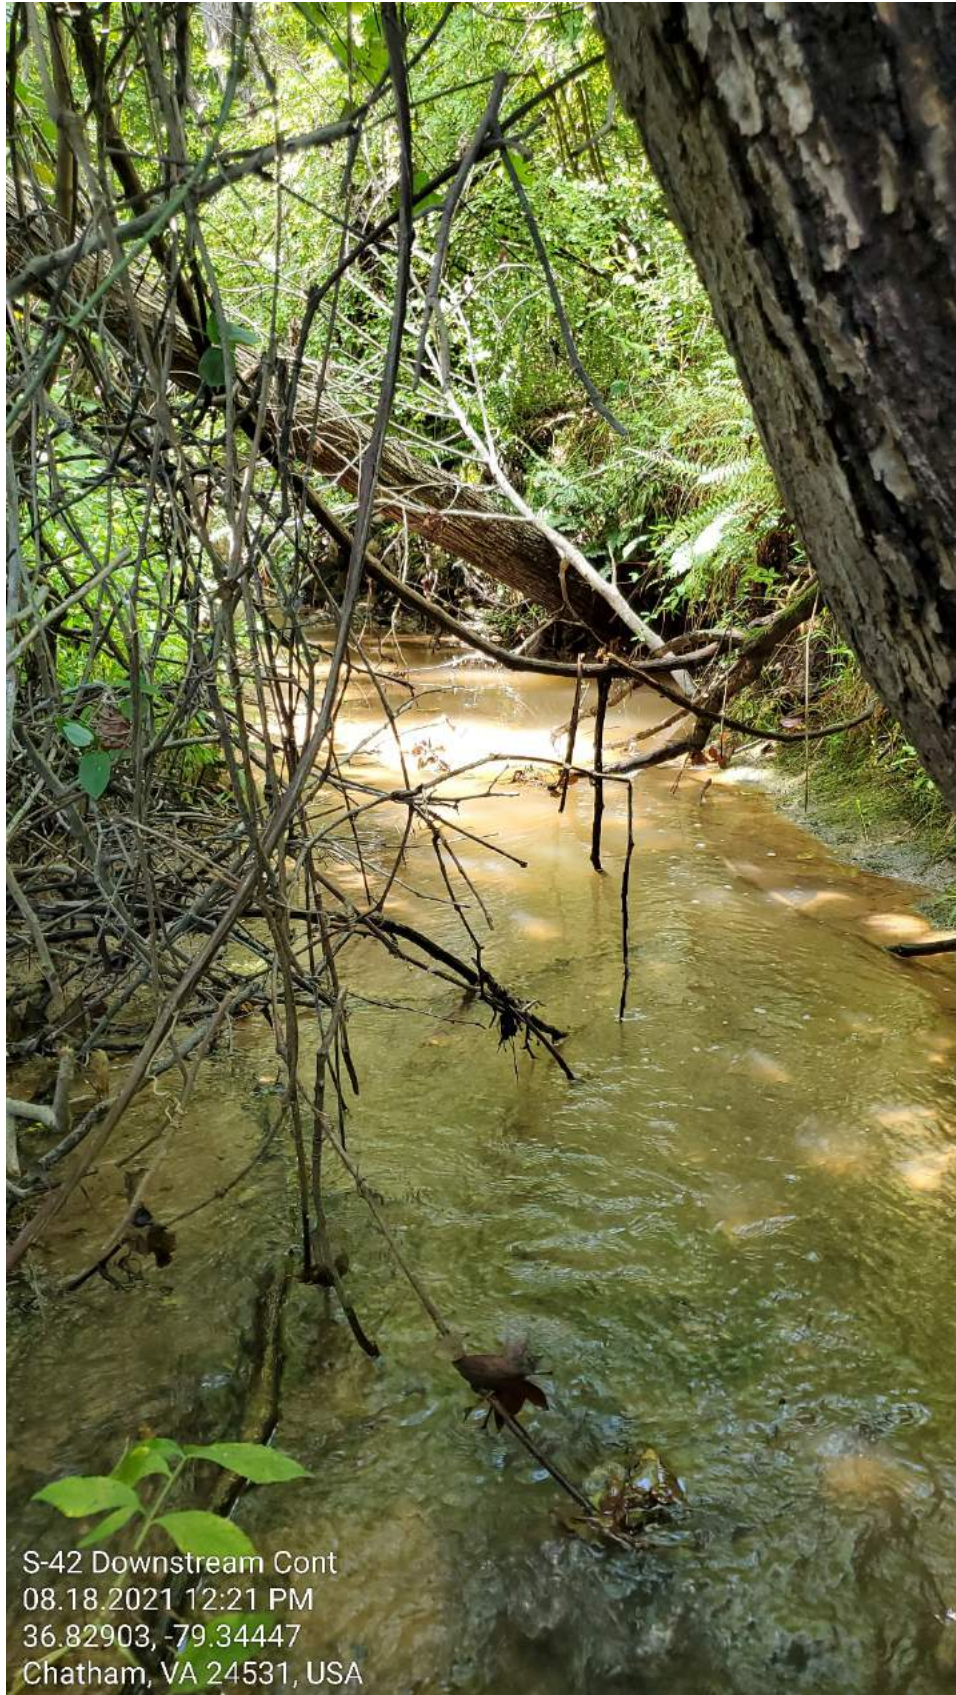
Photo Type: DS COND DS

S-42 Downstream Cont
08.18.2021 12:21 PM
36.82903, -79.34447
Chatham, VA 24531, USA

Location, Orientation, Photographer Initials: Downstream at S-H42 looking W downstream, DW

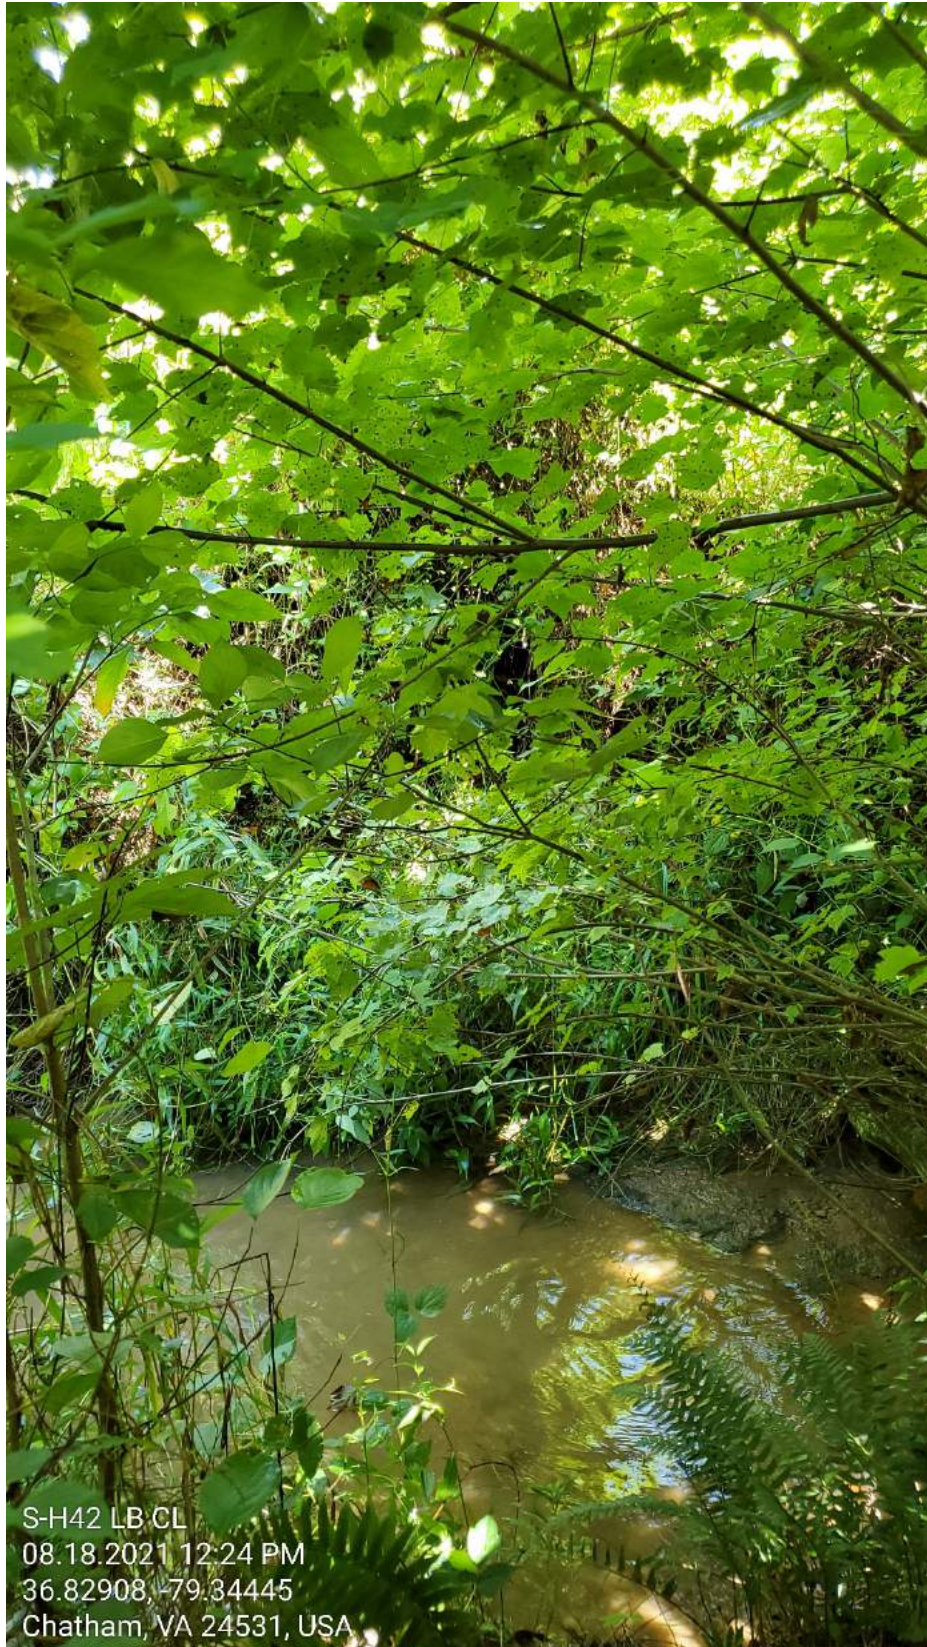
Photo Type: LB CL

Location, Orientation, Photographer Initials: On thalweg at S-H42 pipe centerline looking S at right streambank,
DW

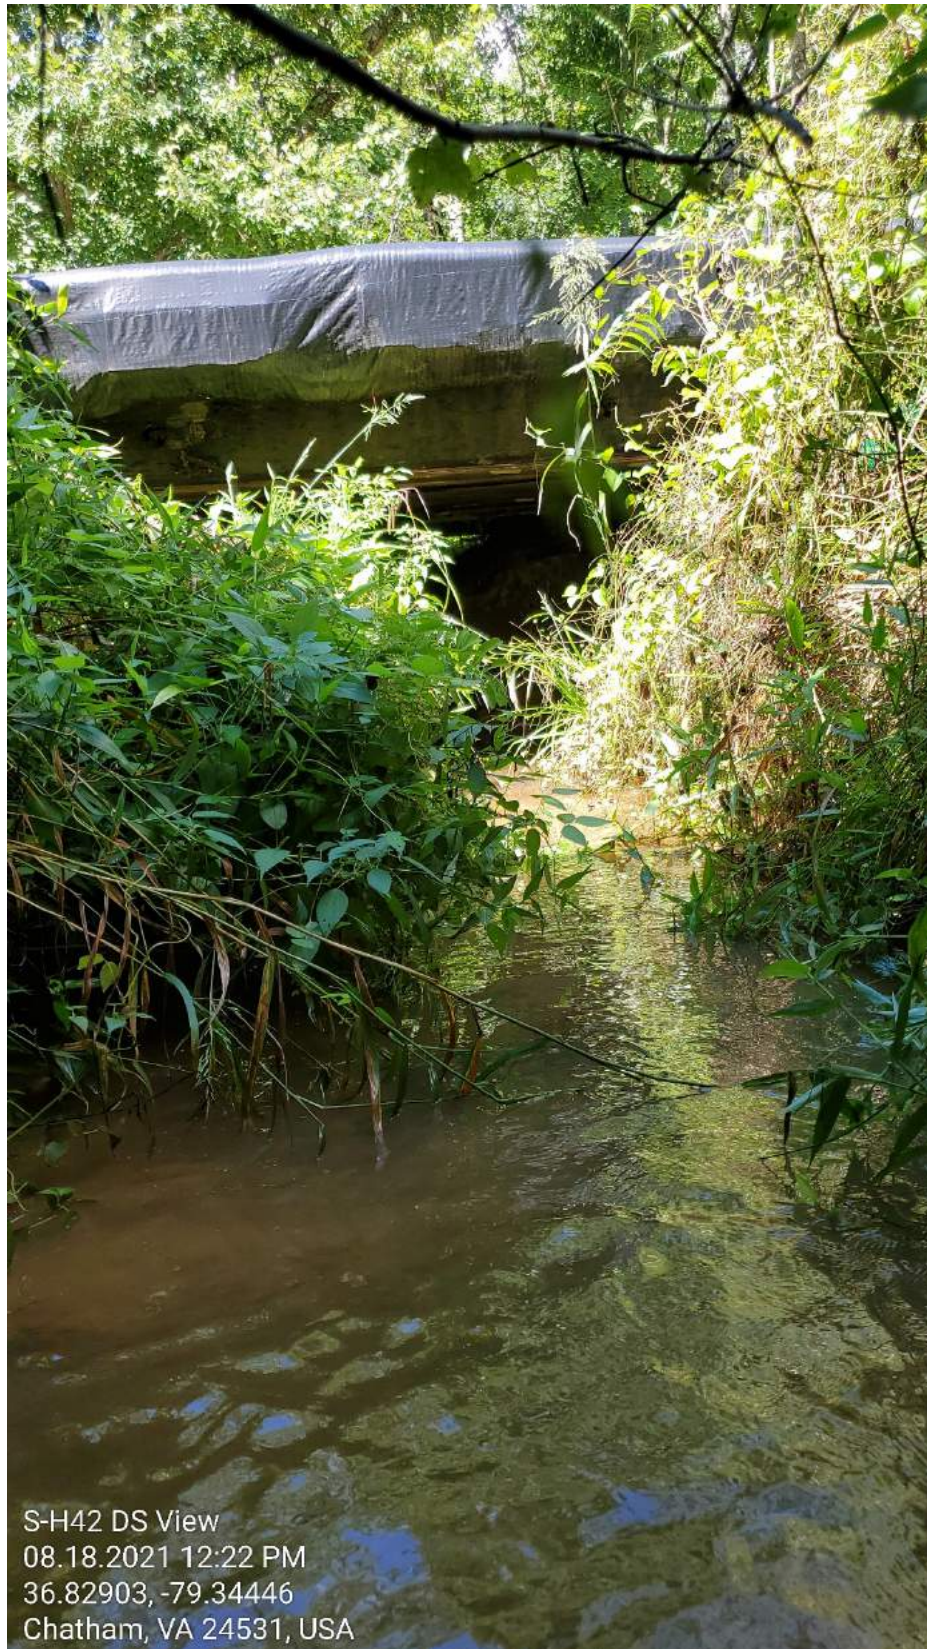
Photo Type: DS VIEW

S-H42 DS View
08.18.2021 12:22 PM
36.82903, -79.34446
Chatham, VA 24531, USA

Location, Orientation, Photographer Initials: Upstream at S-H42 looking NW downstream, DW

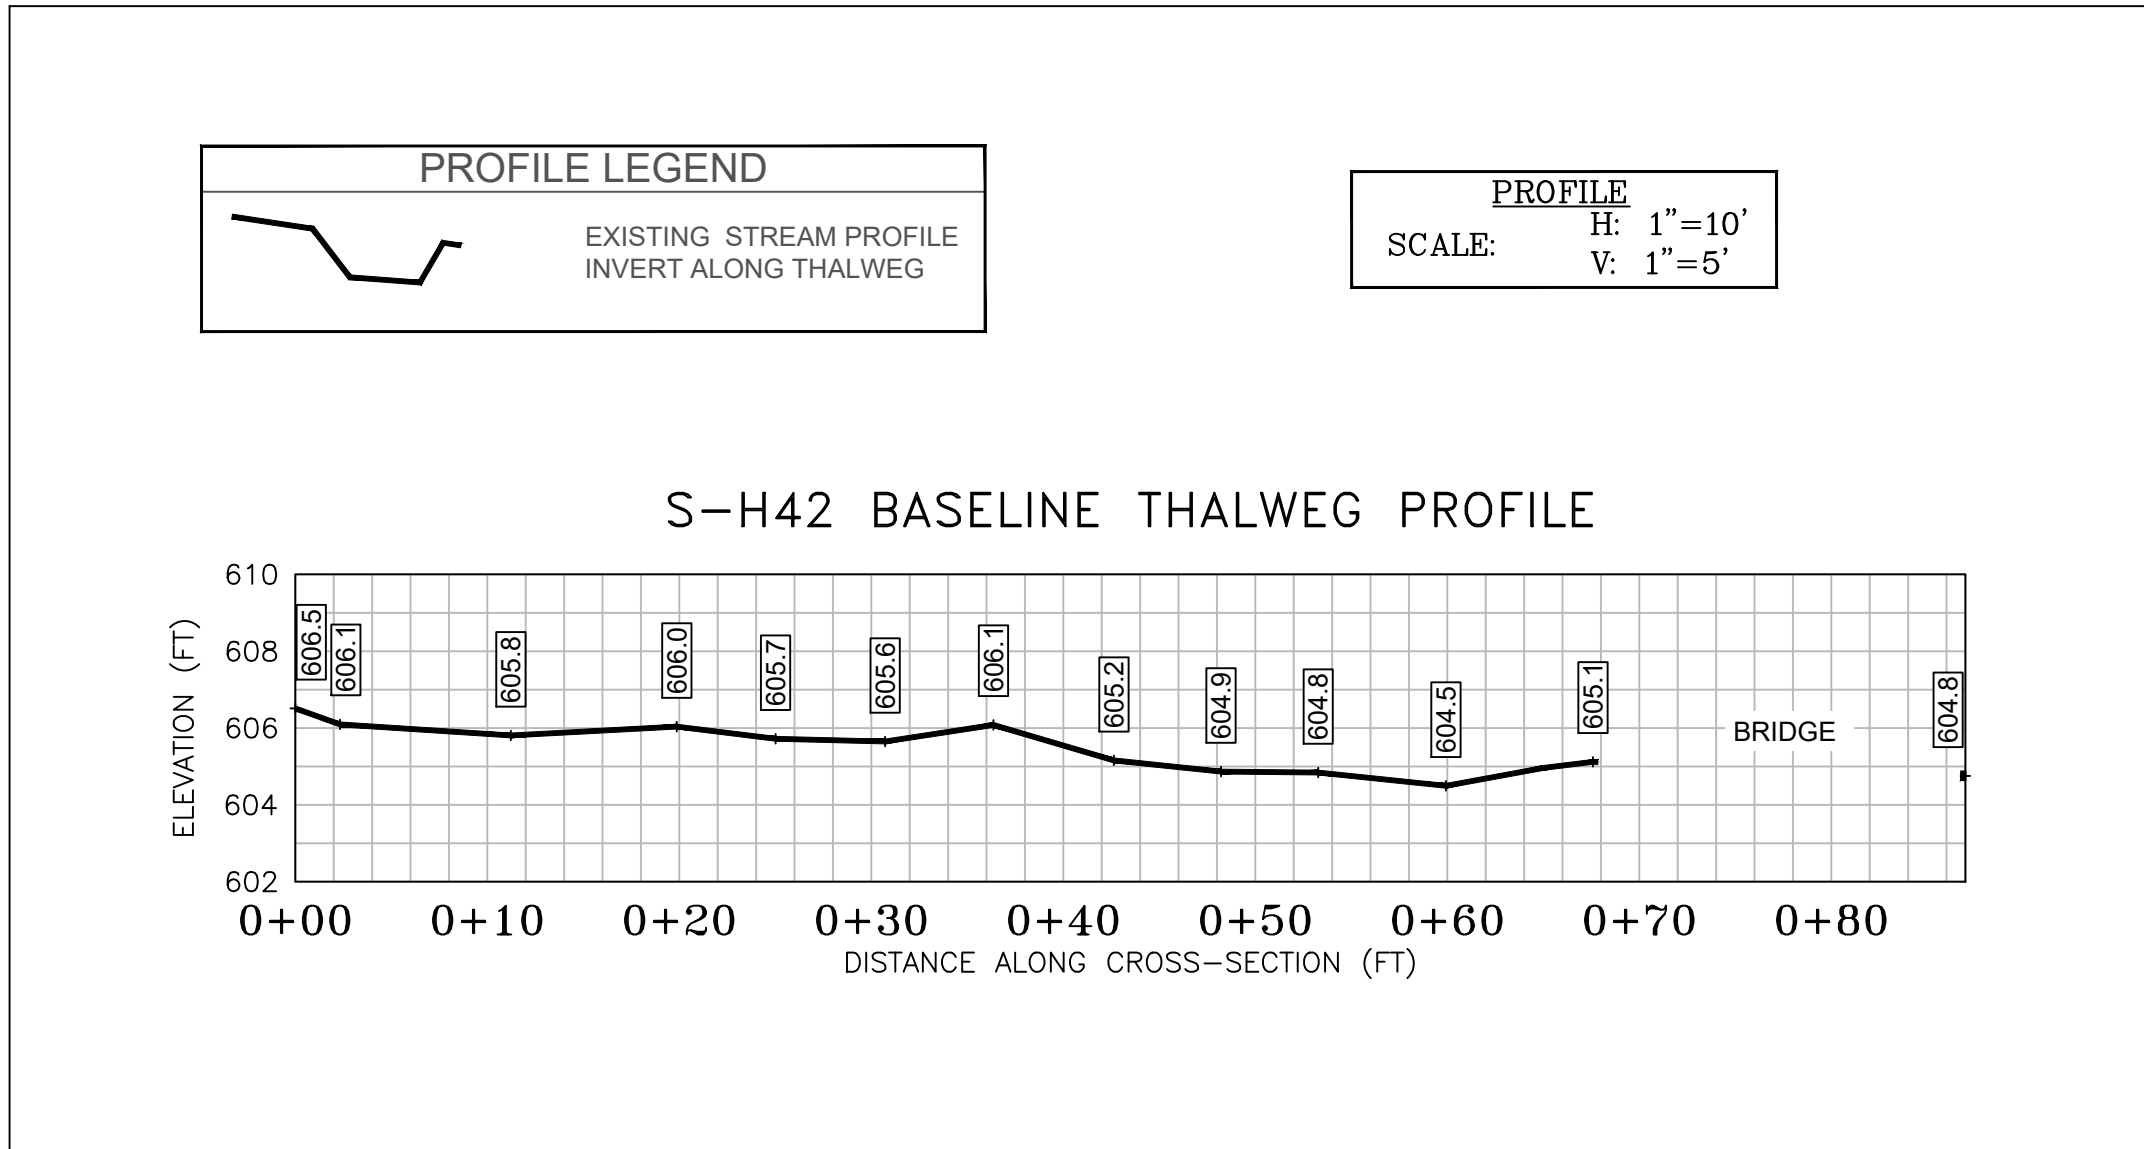
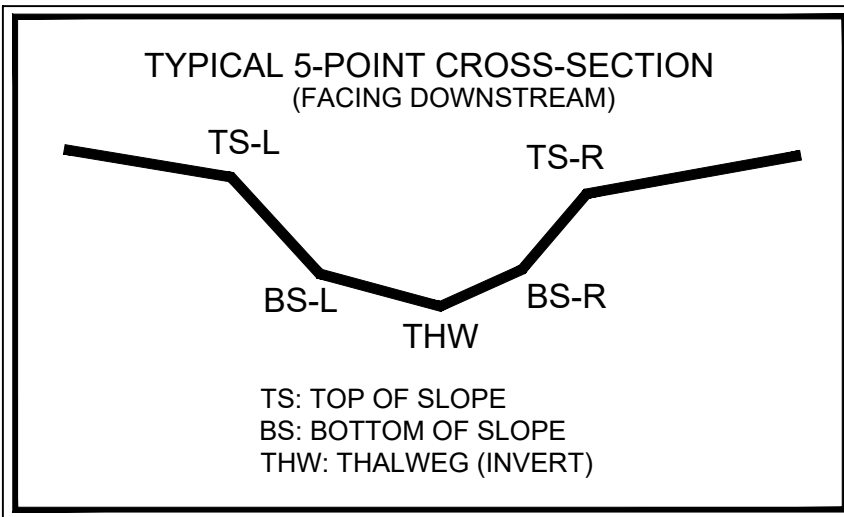
CL STAKEOUT POINTS: S-H42 CROSS SECTION B (PIPE CL)						
PRE-CROSSING				POST-CROSSING		
PT. LOC.	NORTHING	EASTING	ELEV.	VERT. DIFF.	HORZ. DIFF.	
TS-L	13376543.41	2124814.69	607.80	----	----	
BS-L	13376546.73	2124816.13	604.80	----	----	
THW	13376548.38	2124816.36	604.80	----	----	
BS-R	13376550.71	2124816.98	605.50	----	----	
TS-R	13376558.88	2124818.21	610.14	----	----

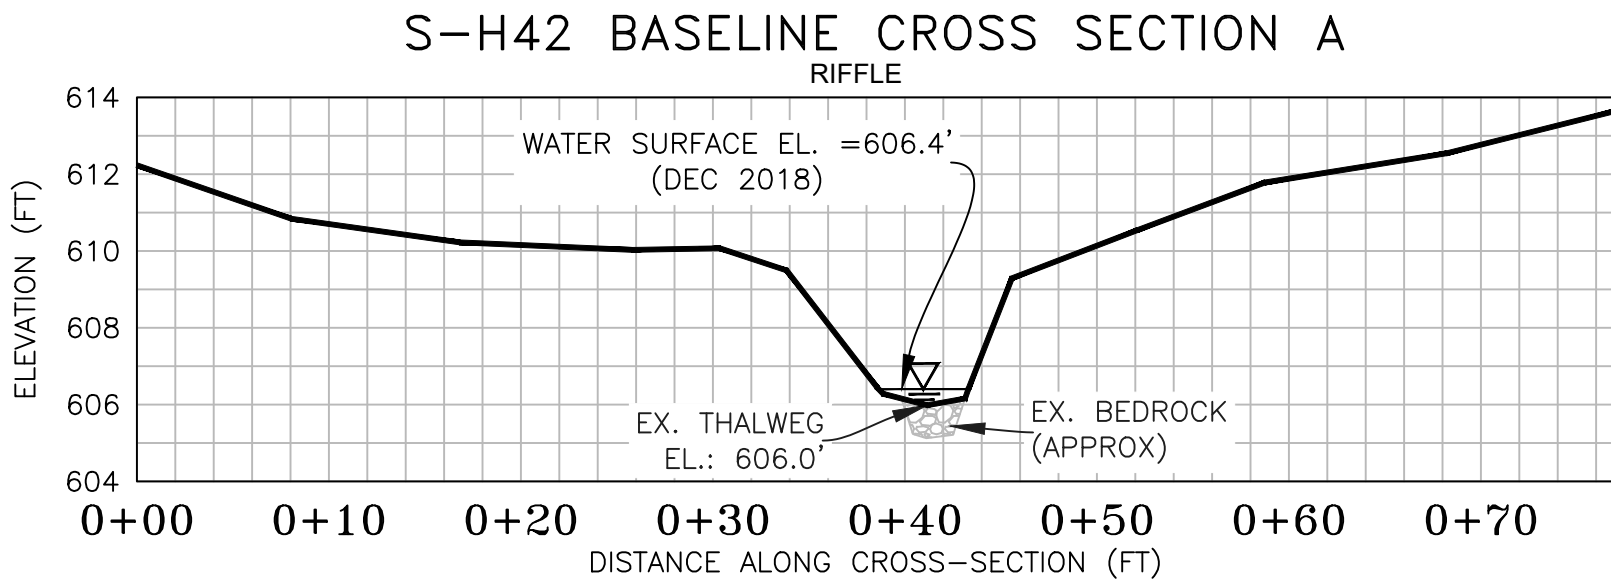
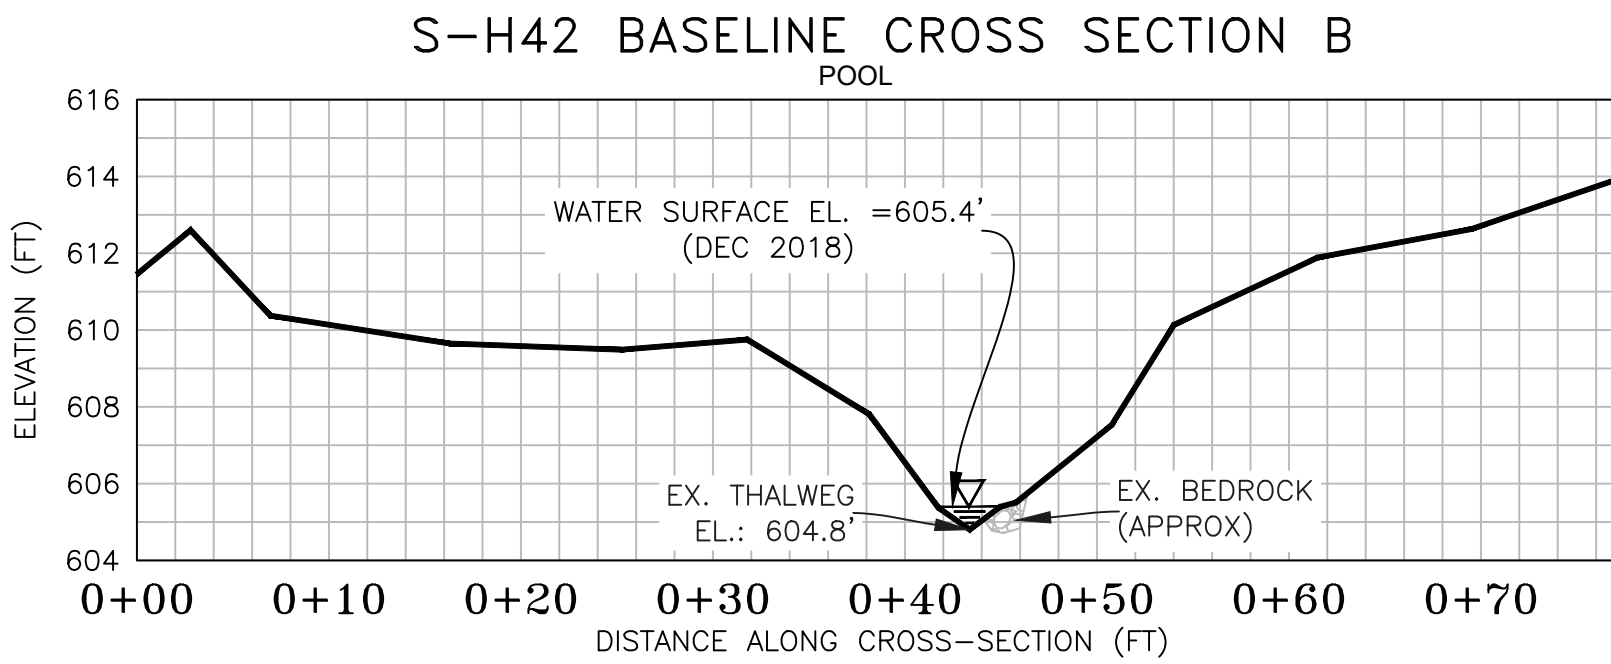
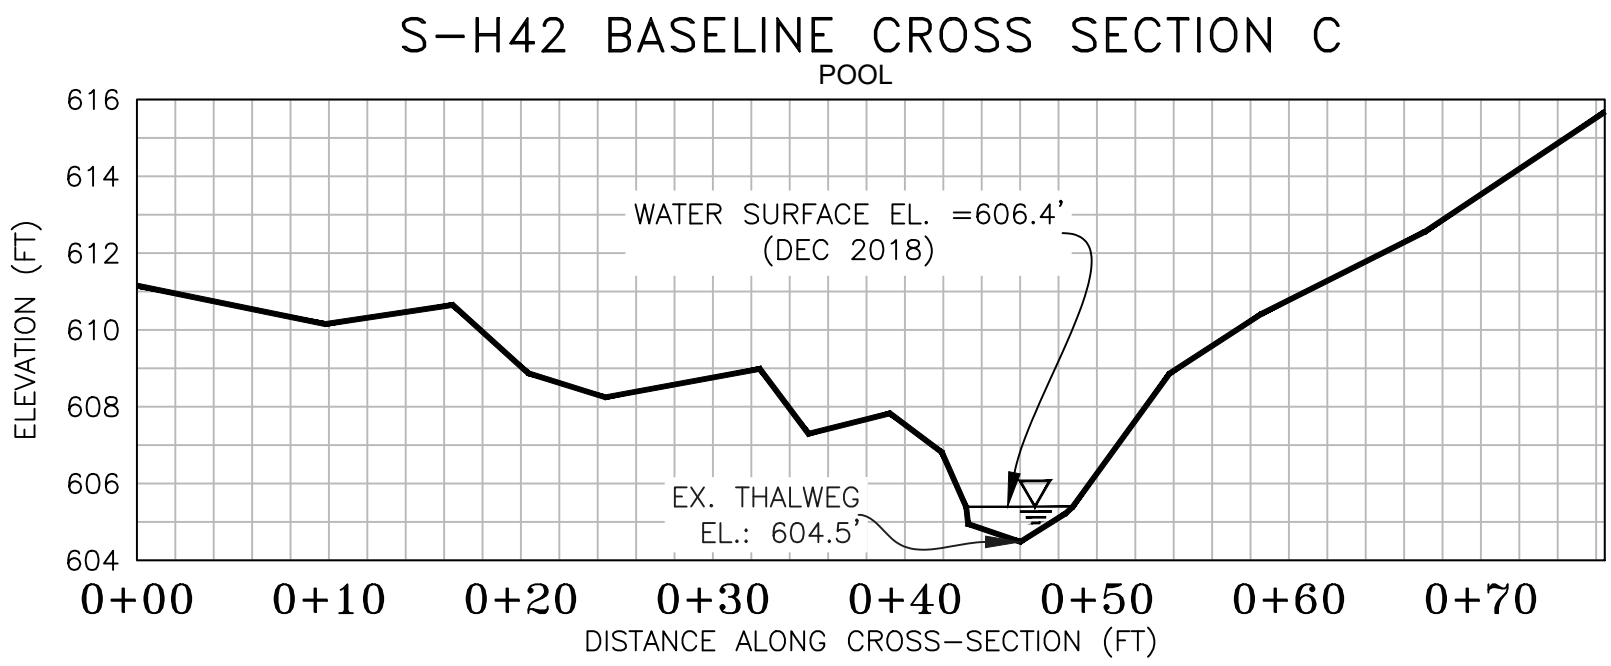
NOTE: ALL SECTION VIEWS SHOWN LEFT TO RIGHT FACING DOWNSTREAM.
