## Baseline Assessment – Stream Attributes

**Reach S-KL38 (Pipeline ROW)**

**Franklin County, Virginia**

Crossing S-KL38 - UNT to Blackwater River (MP 264.8)

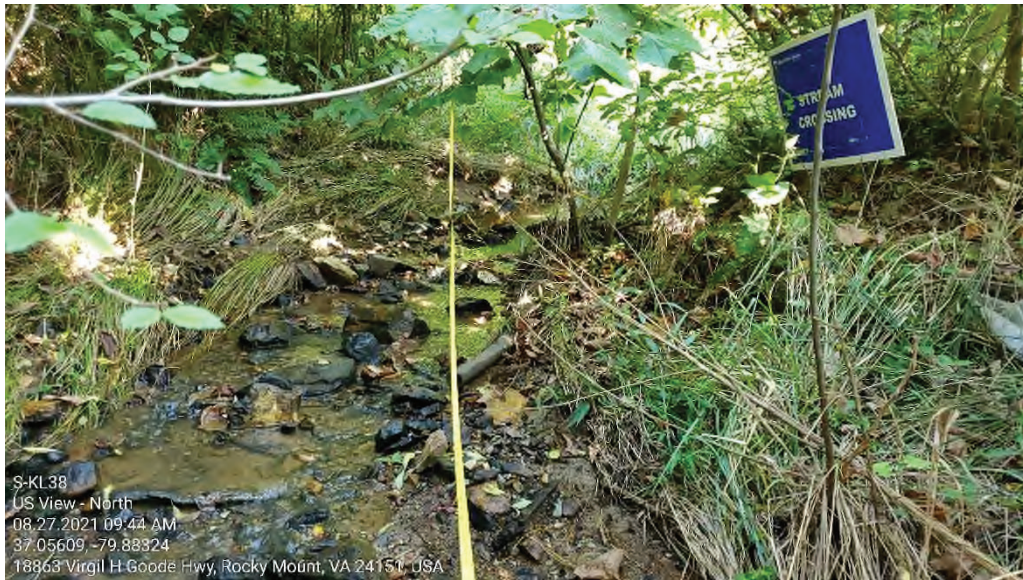
Photo Type: US VIEW

S-KL38  
US View - North  
08.27.2021 09:44 AM  
37.05609, -79.88324  
18863 Virgil H. Goode Hwy, Rocky Mount, VA 24151, USA

Location, Orientation, Photographer Initials: Downstream at ROW/LOD looking N upstream, DW

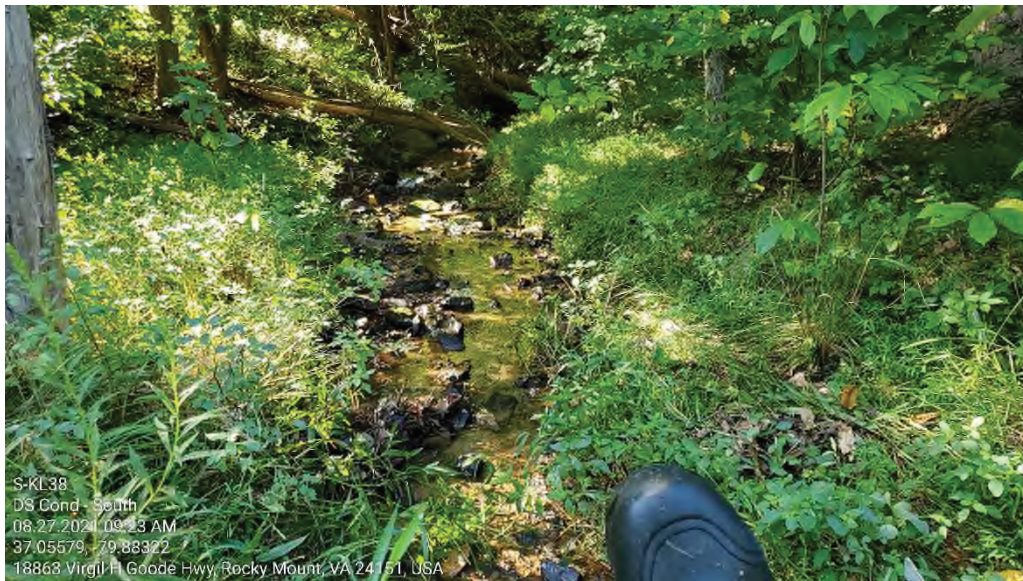
Photo Type: DS COND

S-KL38  
DS Cond - South  
08.27.2021 09:43 AM  
37.05579, -79.88322  
18863 Virgil H. Goode Hwy, Rocky Mount, VA 24151, USA

Location, Orientation, Photographer Initials: Downstream at ROW/LOD looking S downstream, DW

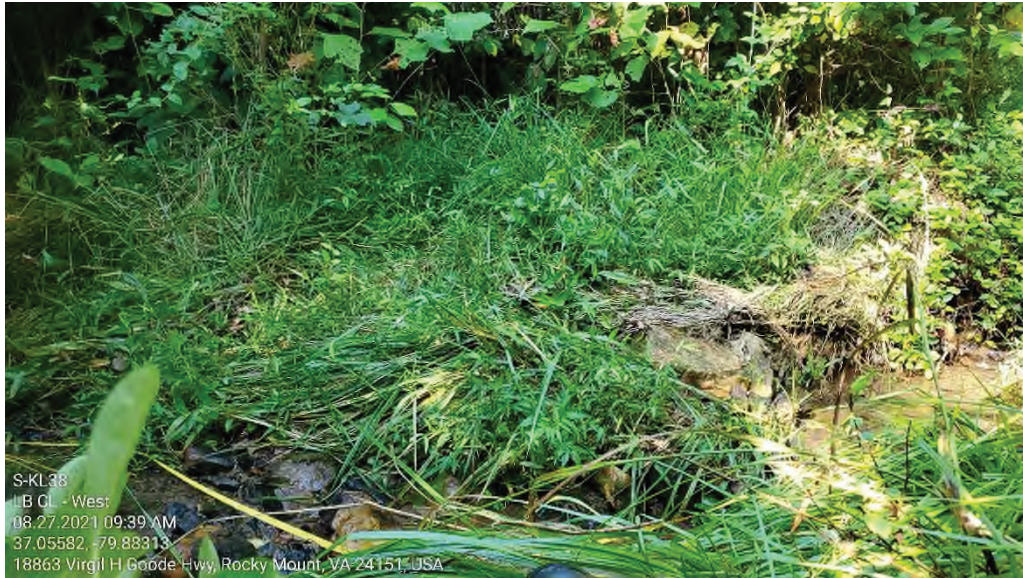
Photo Type: LB CL

Location, Orientation, Photographer Initials: On thalweg at pipe centerline looking W at right streambank, DW

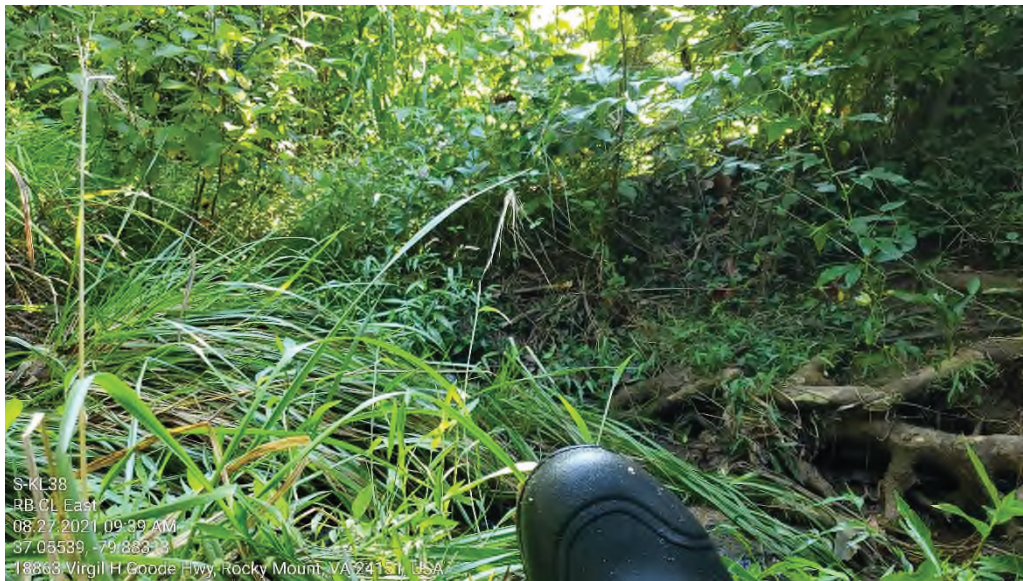
Photo Type: RB CL

Location, Orientation, Photographer Initials: On thalweg at pipe centerline looking E at left streambank, DW

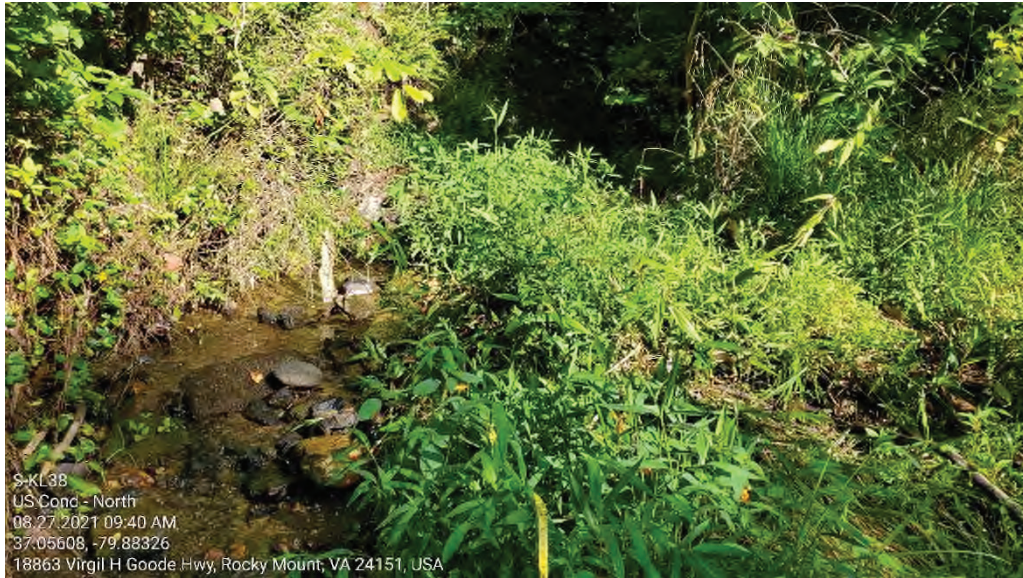
Photo Type: US COND

Location, Orientation, Photographer Initials: Upstream at ROW/LOD looking N upstream, DW

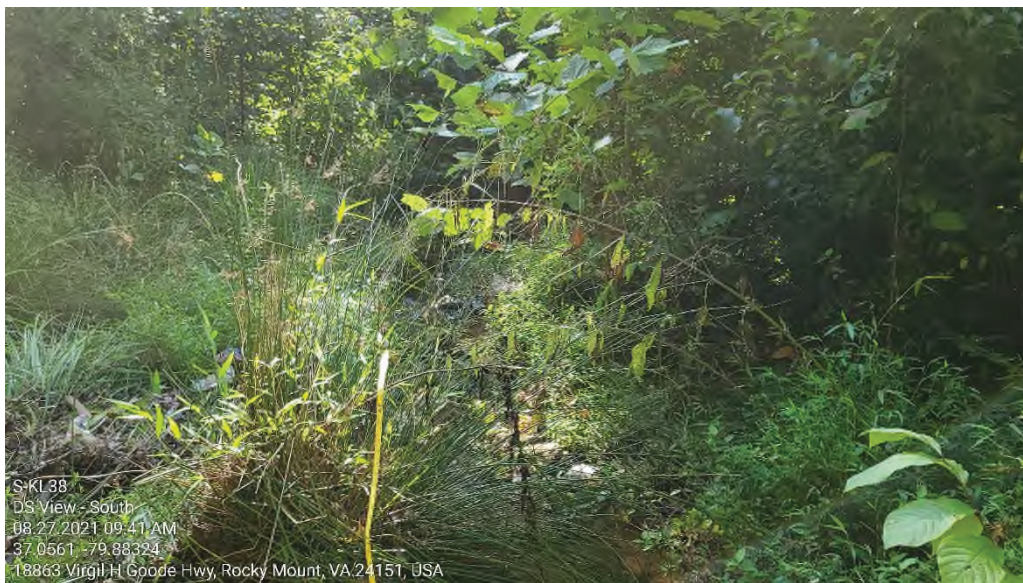
Photo Type: DS VIEW

Location, Orientation, Photographer Initials: Upstream at ROW/LOD looking S downstream, DW

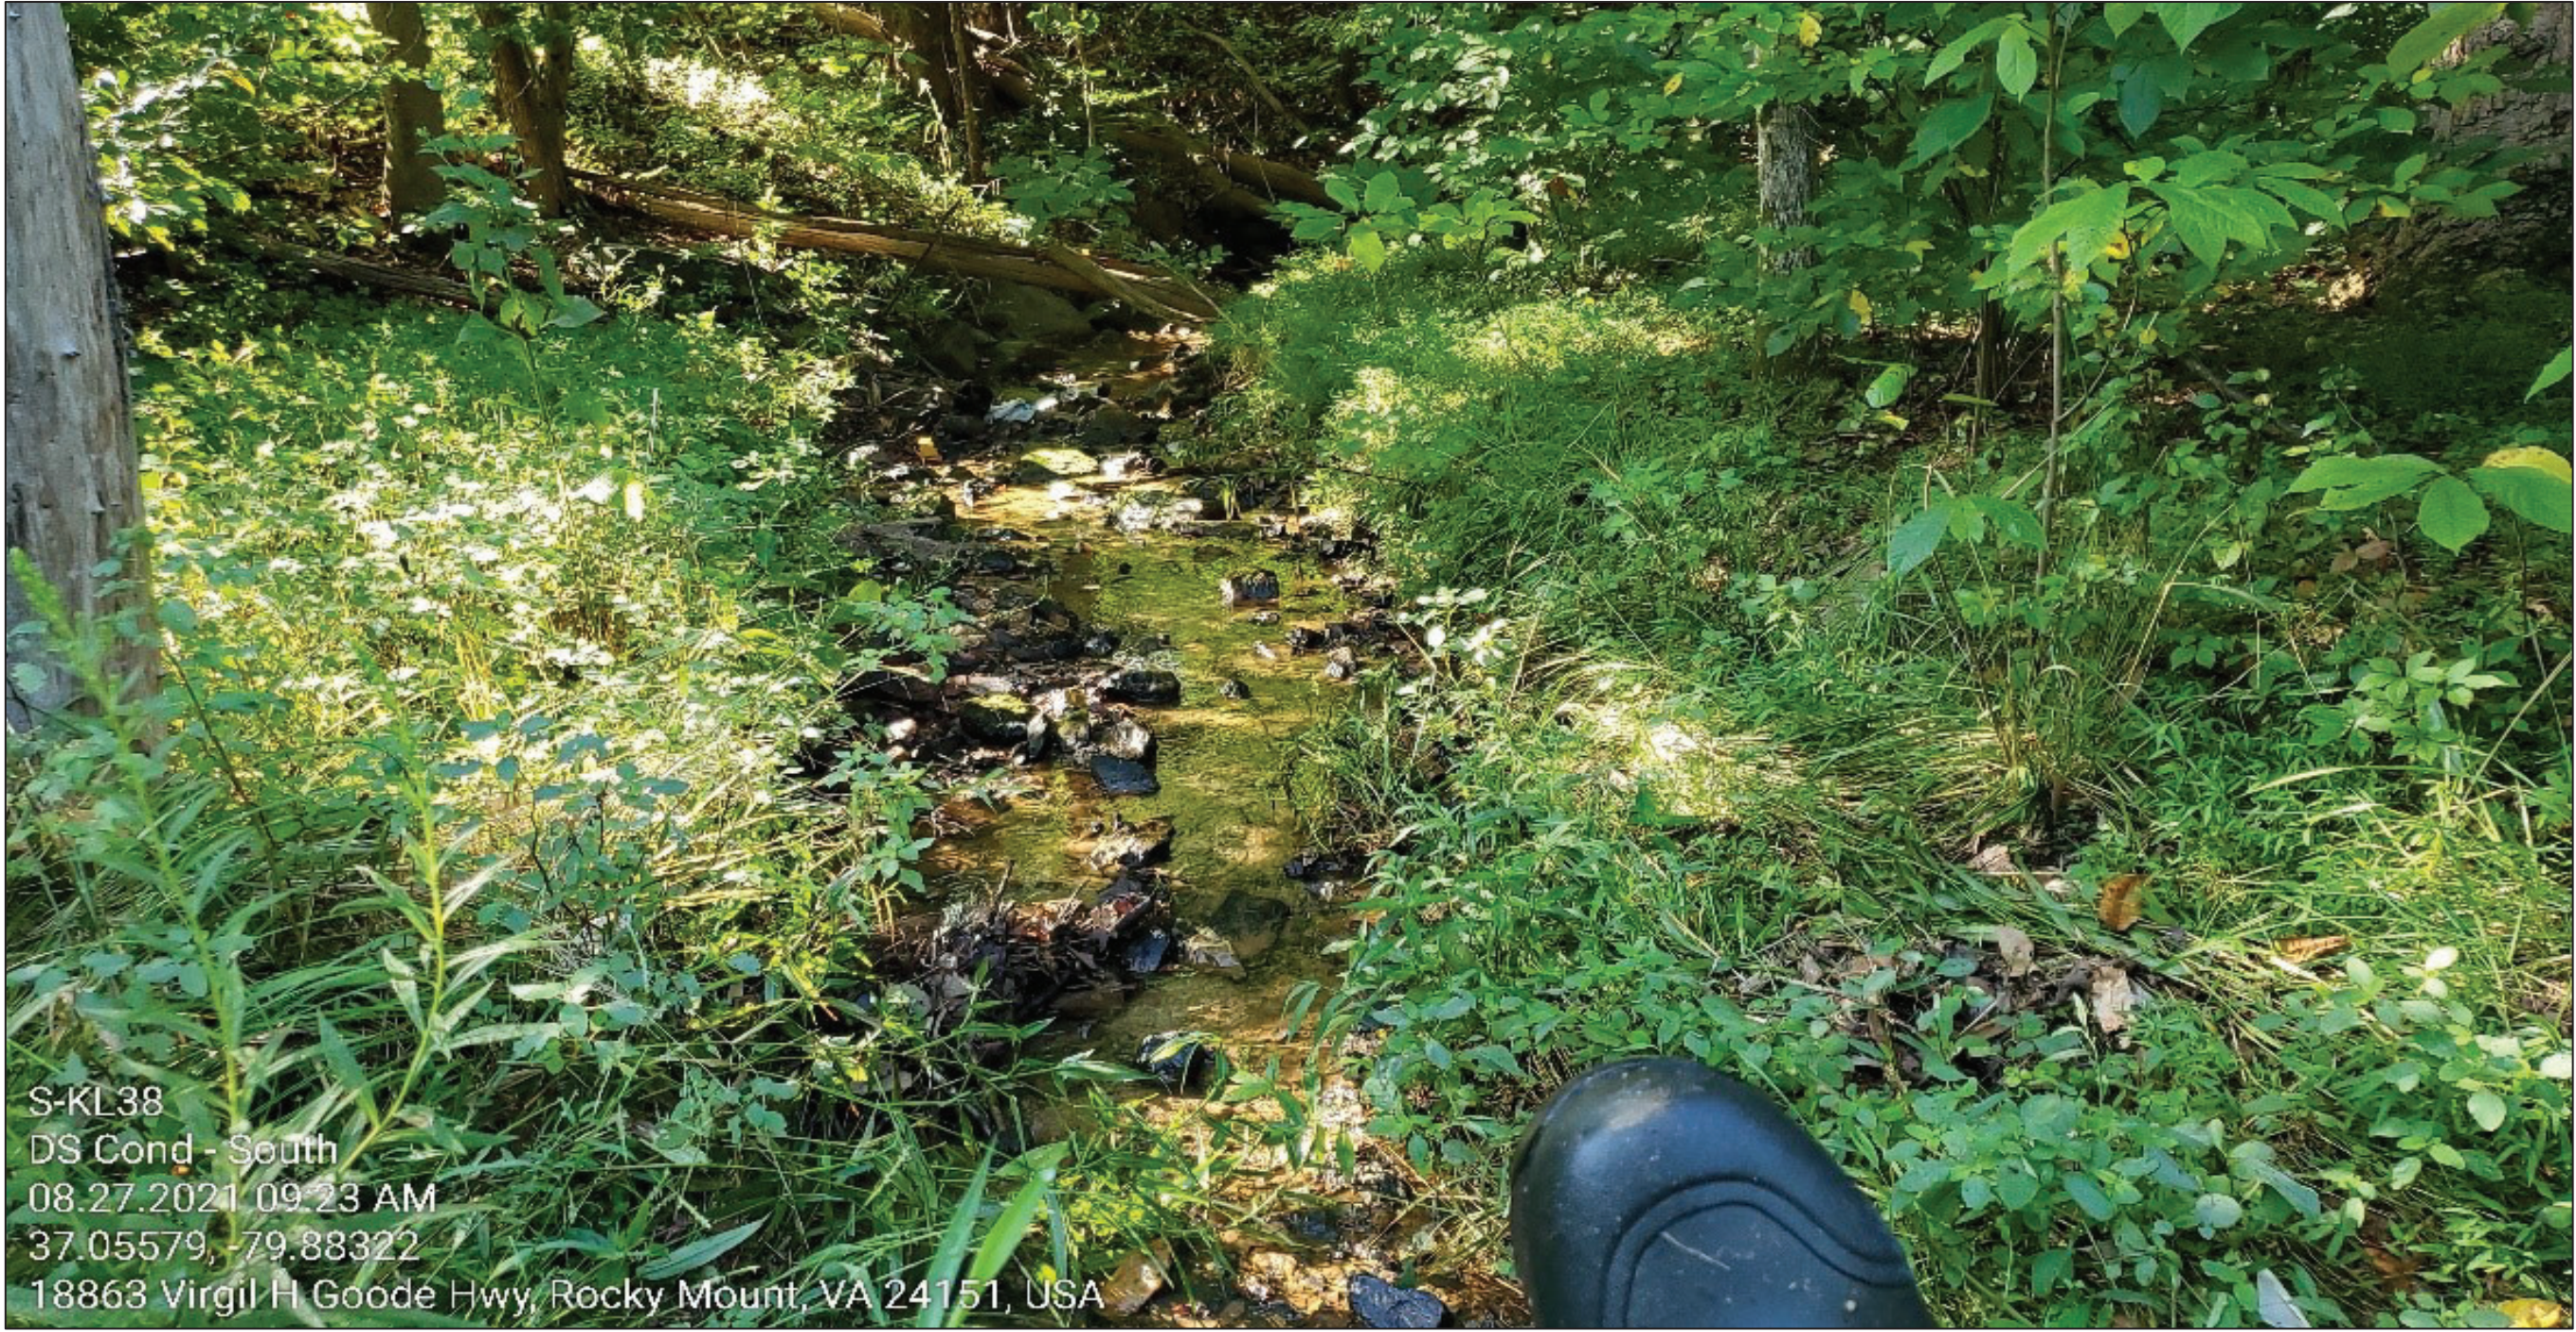
CAPTION. Assessment is limited to areas within the temporary ROW.
