Re: Mountain Valley Pipeline, LLC
Docket No. CP16-10-000
Weekly Status Report No. 100

NOTICE OF VIOLATION

Violation No **W19-09-028-JTL**

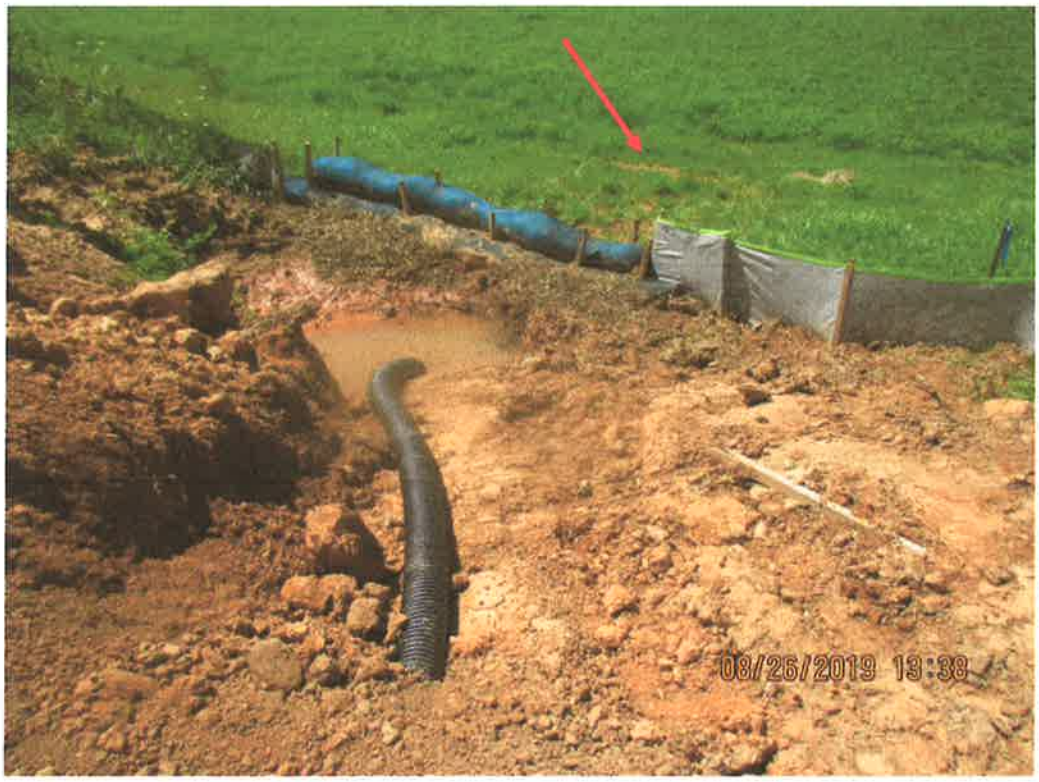
Near Station No. 1833+00. Erosion occurring on slope leading to sediment deposits being present past the LOD.
