# Visual Site Inspection Report

<b>Project Name</b> H-600 Pipeline Spread H		<b>AFE</b> 124300138	<b>Spread</b> H-600 Pipeline Spread H
<b>Contractor</b> Precision		<b>Report #</b> 5563	
<b>Inspector</b> John Brcic		<b>Date/Time</b> 7/31/2018 7:13 PM	
<b>Permit #</b> TBD	<b>Inspection Type</b> VA SWPP	<b>Station Begin</b>	12005+00
<b>State</b> VA	<b>Inspection Area</b> Partial	<b>Station End</b>	12102+69
<b>County</b> Montgomery	<b>Ground</b> Wet	<b>Temperature (°F)</b>	75.00
<b>Municipality</b> N/A	<b>Weather</b> Cloudy	<b>Rain Gauge (in)</b>	0.50
<b>GPS Location</b> 37.3086484923834, -80.0104781817074		<b>Rain Accumulation Time (days)</b>	1.00

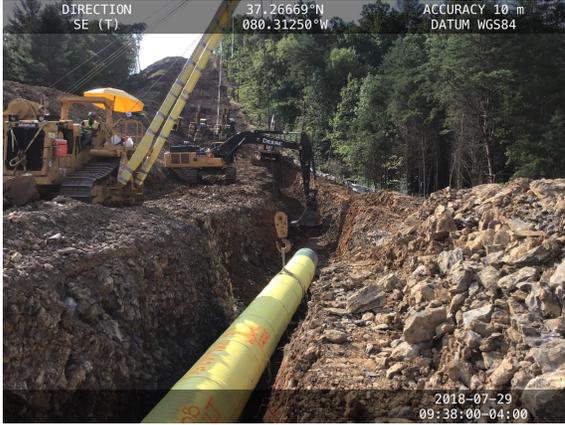
<p>DIRECTION SW (T) 37.26451°N 080.30659°W ACCURACY 5 m DATUM WGS84 12038+00: plunge pool @ stormwater drain outlet 2018-07-30 12:05:51-04:00</p>

<p>DIRECTION SE (T) 37.26669°N 080.31250°W ACCURACY 10 m DATUM WGS84 2018-07-29 09:38:00-04:00</p>		<p><b>GPS Location</b> 37.3086697828587, -80.0101702133535</p> <p><b>Description</b> Plunge pool installed @ station 12038+00 where drain pipes empty stormwater off ROW, ~MP 227.8~. See photo for location.</p>		<p><b>GPS Location</b> 37.3085168330346, -80.0101628993452</p> <p><b>Description</b> Pipe installed at stations 12017+00 to 12018+60, ~MP 227.4~. See photo for location.</p>
