Visual Site Inspection Report

Project Name	H-600 Pipeline Spread G	AFE	124300137	Spread	H-600 Pipeline Spread G
Contractor	Precision			Report #	10461
Inspector	Rob Robertson			Date/Time	11/5/2018 5:30 PM
Permit #	TBD	Inspection Type	VA SWPP	Station Begin	10458+91
State	VA	Inspection Area	Full	Station End	10459+03
County	Giles	Ground	Wet	Temperature (°F)	57.00
Municipality	N/A	Weather	Light Rain	Rain Gauge (in)	0.20
GPS Location	37.1345344299741, -80.3946846499691			Rain Accumulation Time (days)	1.00

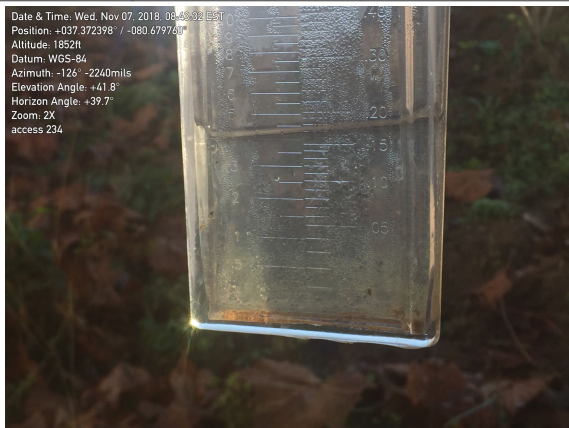
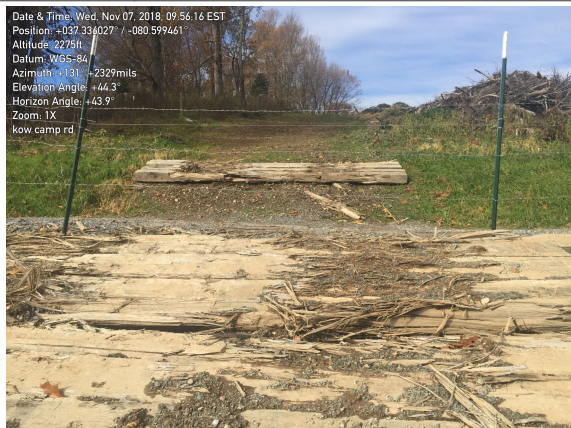
GPS Location	37.3493276490246, -80.6524636969721	GPS Location	37.3493448319261, -80.6526491046703		
Description	Buffalo Anklets 0.20" rain gauge	Description	Big Stoney Creek Rd RCE missing Stone,geo pulled up, mats twisted.10675+05

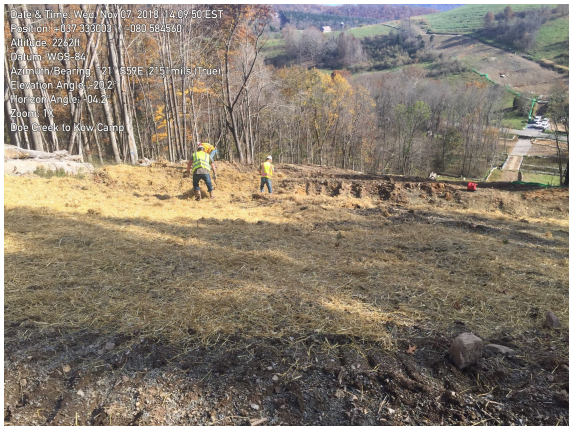
GPS Location	37.3314885283237, -80.5823874660587	GPS Location	37.3315782146876, -80.582496766076		
Description	End treatment checked off Kow Camp 1 10890+10	Description	Patty's crew 10922+00 working toward Doe Creek Rd.		
<p>Date & Time: Wed, Nov 07, 2018, 14:11:20 EST Position: +037.312558 / -080.620289 Altitude: 2262ft Datum: WGS-84 Azimuth: Bearing: 234.556W (12.56mils/True) Elevation Angle: +14.2 Horizon Angle: +05.0 Zoom: 1X Doe Creek to Kow Camp</p>

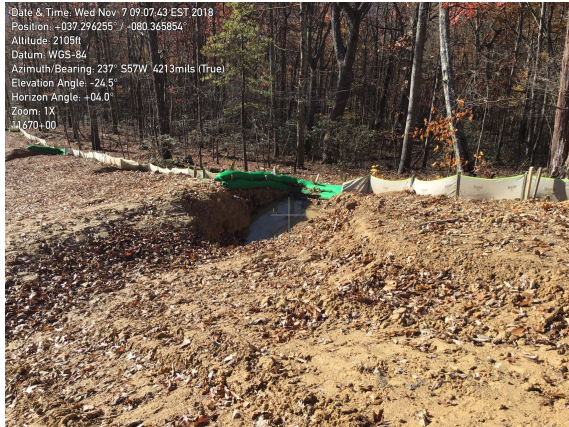
A/E	124300137	Date/Time	11/7/2018 3:58 PM	Report #	10579
Pictures					
<p>Date & Time: Wed Nov 7 09:07:43 EST 2018 Position: +037.292255° / -080.365854° Altitude: 2105ft Datum: WGS-84 Azimuth/Bearing: 237° S57W 4213mils (True) Elevation Angle: -24.5° Horizon Angle: +04.0° Zoom: 1X 11670+00</p>

GPS Location	37.2061721517968, -80.394342303284	GPS Location	37.2059318798271, -80.3942354349445		
Description	See photo for GPS location and station number. Sump pit, water bar, and end treatment in place.	Description	See photo for GPS location and station number. Rock inlet needs refreshed.		
<p>Date & Time: Wed Nov 7 10:41:07 EST 2018 Position: +037.292862° / -080.363131° Altitude: 2449ft Datum: WGS-84 Azimuth/Bearing: 099° S81E 1760mils (True) Elevation Angle: -14.7° Horizon Angle: -01.7° Zoom: 1X 11760+00</p>

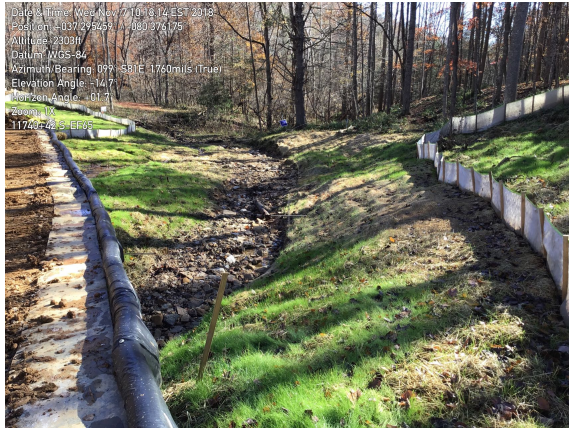
GPS Location	37.2059317363171, -80.3942353713243	GPS Location	37.2059306451038, -80.3942385947107		
Description	See photo for GPS location and station number. ECD in place at stream crossing.	Description	See photo for GPS location and station number. Rain gauge reading .2 inches of rain fall.		
<p>Date & Time: Wed Nov 7 12:09:44 EST 2018 Position: +037.294911° / -080.306446° Altitude: 2090ft Datum: WGS-84 Azimuth/Bearing: 004° N04E 0107mils (True) Elevation Angle: -08.0° Horizon Angle: -00.1° Zoom: 1X 11353+80</p>
