# Visual Site Inspection Report

<b>Project Name</b>	H-600 Pipeline Spread G	<b>AFE</b>	124300137	<b>Spread</b>	H-600 Pipeline Spread G
<b>Contractor</b>	Precision			<b>Report #</b>	10810
<b>Inspector</b>	Rob Robertson			<b>Date/Time</b>	11/12/2018 11:44 AM
<b>Permit #</b>	TBD	<b>Inspection Type</b>	VA SWPP	<b>Station Begin</b>	11668+15
<b>State</b>	VA	<b>Inspection Area</b>	Full	<b>Station End</b>	11618+91
<b>County</b>	Montgomery	<b>Ground</b>	Wet	<b>Temperature (°F)</b>	39.00
<b>Municipality</b>	N/A	<b>Weather</b>	Light Rain	<b>Rain Gauge (in)</b>	0.00
<b>GPS Location</b>	37.286163920343, -80.4070362383585			<b>Rain Accumulation Time (days)</b>	1.00

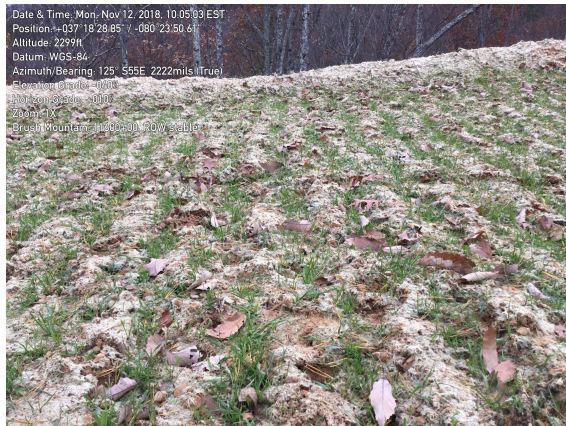
<p>Date &amp; Time: Mon, Nov 12, 2018, 10:05:03 EST Position: +037°18'28.85" / -080°23'50.61" Altitude: 2239ft Datum: WGS-84 Azimuth/Bearing: 125° S59E 222mils (True) Elevation Grade: -000% Horizon Grade: -000% Zoom: 1X Brush Mountain: 11660+00, ROW stable</p>

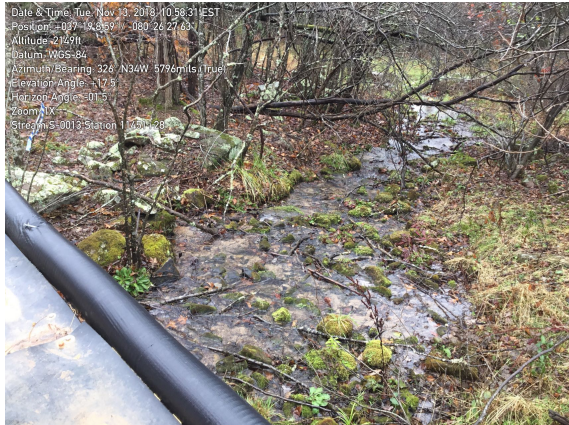
A/E	124300137	Date/Time	11/13/2018 4:41 AM	Report #	10837
Pictures					
<p>Date &amp; Time: Tue, Nov 13, 2018, 10:58:31 EST Position: +037°19'33.9" / -080°26'27.6" Altitude: 2129ft Datum: WGS-84 Azimuth/Bearing: 324° N34W 5796mils (True) Elevation Angle: +12.5° Horizon Angle: +01.5° Zoom: 1X Stream S-0013 Station 11451+28</p>

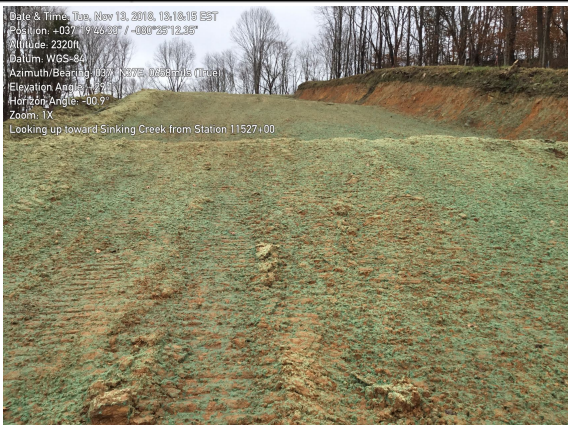
<p>Date &amp; Time: Tue, Nov 13, 2018, 12:18:15 EST Position: +037°19'53.97" / -080°25'12.98" Altitude: 2320ft Datum: WGS-84 Azimuth/Bearing: 151° S35E 0269mils (True) Elevation Angle: +0.9° Horizon Angle: -00.9° Zoom: 1X Looking up toward Sinking Creek from Station 11527+00</p>

GPS Location	37.3274567071696, -80.4247436486934	GPS Location	37.3294999637057, -80.4201498628412		
Description	P-1 with Hole Station 11513+25	Description	Looking up toward Sinking Creek from Station 11527+00

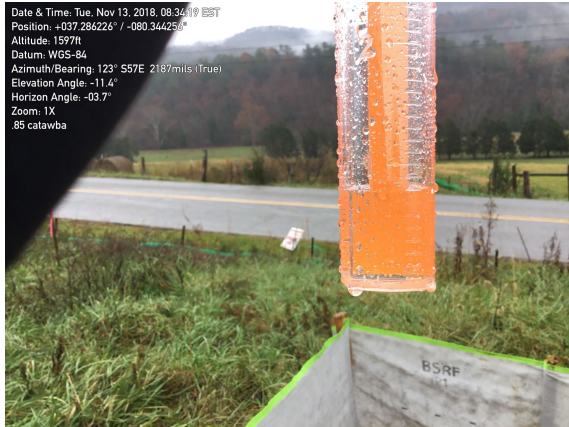
A/E	124300137	Date/Time	11/13/2018 4:41 PM	Report #	10873
Pictures					
<p>Date &amp; Time: Tue, Nov 13, 2018, 08:34:19 EST Position: +037.286226° / -080.344251° Altitude: 1597ft Datum: WGS-84 Azimuth/Bearing: 123° 55'E 2187mils (True) Elevation Angle: -11.4° Horizon Angle: -03.7° Zoom: 1X .85 catawba</p>

GPS Location	37.3337523498123, -80.7502708544105		GPS Location	37.3337622944074, -80.750265499606	
Description	.85" Catawba		Description	Rock filter outlet AR266	
<p>Date &amp; Time: Tue, Nov 13, 2018, 10:08:45 EST Position: +037.296521° / -080.364964° Altitude: 2166ft Datum: WGS-84 Azimuth/Bearing: 199° 51'W 3538mils (True) Elevation Angle: -26.8° Horizon Angle: +00.9° Zoom: 1X 11770+00</p>

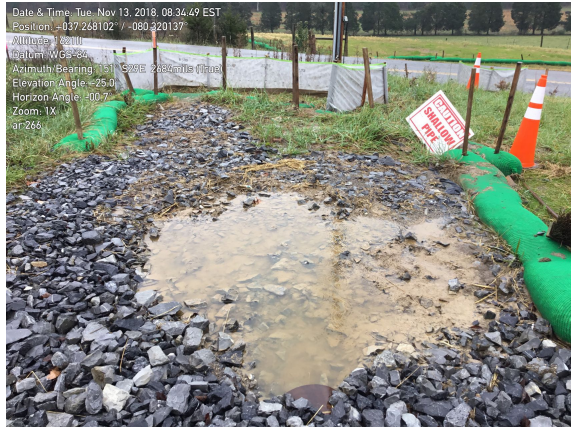
<p>Date &amp; Time: Tue, Nov 13, 2018, 08:34:49 EST Position: +037.28102° / -080.320137° Altitude: 1611ft Datum: WGS-84 Azimuth/Bearing: 131° 52'W 2047mils (True) Elevation Angle: -25.0° Horizon Angle: -00.7° Zoom: 1X gr265</p>

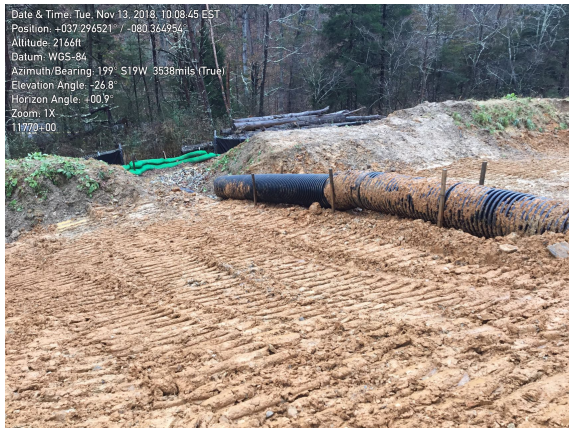
GPS Location	37.3337621490788, -80.7502655778602		GPS Location	37.3337566312249, -80.7502685490249	
Description	Clean water diversion pipe 11770+00		Description	Row 11979+00	
<p>Date &amp; Time: Tue, Nov 13, 2018, 10:15:41 EST Position: +037.296728° / -080.361391° Altitude: 1989ft Datum: WGS-84 Azimuth/Bearing: 213° 53'W 3787mils (True) Elevation Angle: -21.5° Horizon Angle: -00.9° Zoom: 1X 11785+00</p>

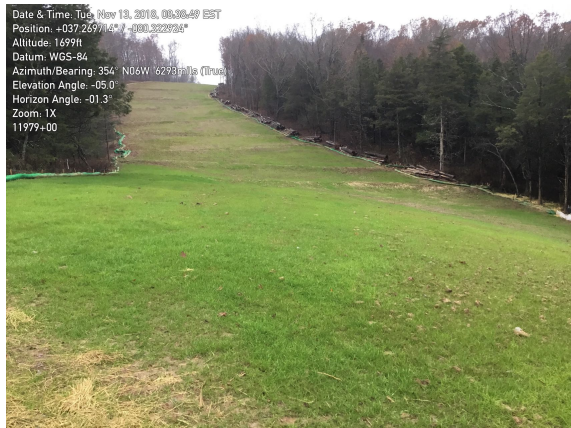
<p>Date &amp; Time: Tue, Nov 13, 2018, 08:10:49 EST Position: +037.29774° / -080.322924° Altitude: 1699ft Datum: WGS-84 Azimuth/Bearing: 354° N06W 6293mils (True) Elevation Angle: -05.0° Horizon Angle: -01.3° Zoom: 1X 11979+00</p>

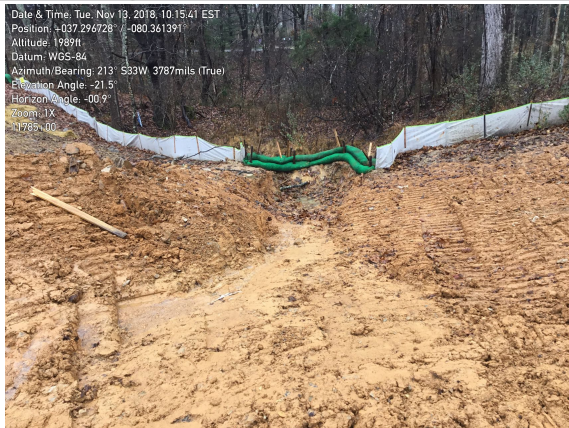
GPS Location	37.3337654095521, -80.7502638222132		GPS Location	37.3337592692055, -80.7502671285678	
Description	Sump and end treatment 11785+00		Description	Bridge 11780+00

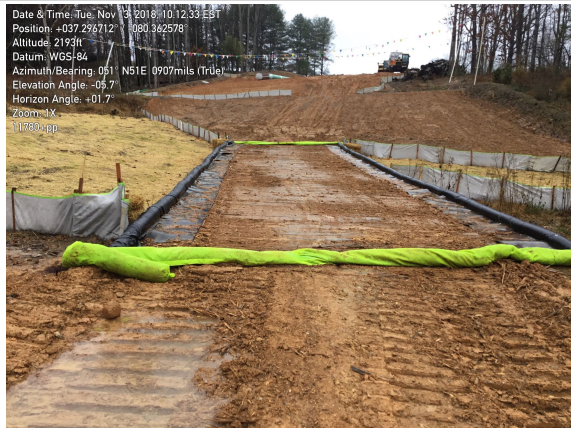
<p>Date &amp; Time: Tue, Nov 13, 2018, 10:12:33 EST Position: +037.296712° / -080.362578° Altitude: 2193ft Datum: WGS-84 Azimuth/Bearing: 051° N51E 0907mils (True) Elevation Angle: -04.7° Horizon Angle: +01.7° Zoom: 1X 11780+00</p>

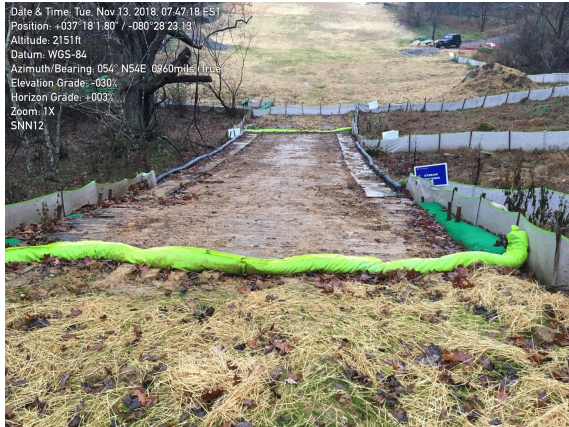
A/E	124300137	Date/Time	11/13/2018 1:25 PM	Report #	10876
Pictures					
<p>Date &amp; Time: Tue, Nov 13, 2018, 07:47:18 EST Position: +037°18'1.80" / -080°28'23.13" Altitude: 2151ft Datum: WGS-84 Azimuth/Bearing: 054° N54E 0.60mils (True) Elevation Grade: -030% Horizon Grade: +003% Zoom: 1X SNN12</p>

GPS Location	37.3043696349834, -80.4847928602998	GPS Location	37.3043696349834, -80.4847928602998		
Description	Stream crossing S-NN12	Description	Rock lined channel @ ATWS 633		
<p>Date &amp; Time: Tue, Nov 13, 2018, 07:58:20 EST Position: +037°18'4.88" / -080°28'14.52" Altitude: 2236ft Datum: WGS-84 Azimuth/Bearing: 345° S45W 4833mils (True) Elevation Grade: -000% Horizon Grade: +000% Zoom: 1X ATWS 633</p>

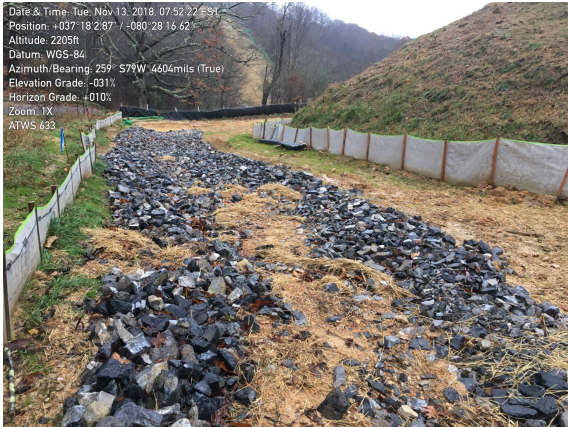
<p>Date &amp; Time: Tue, Nov 13, 2018, 07:52:22 EST Position: +037°18'2.87" / -080°28'16.62" Altitude: 2205ft Datum: WGS-84 Azimuth/Bearing: 259° S29W 4604mils (True) Elevation Grade: -031% Horizon Grade: +010% Zoom: 1X ATWS 633</p>

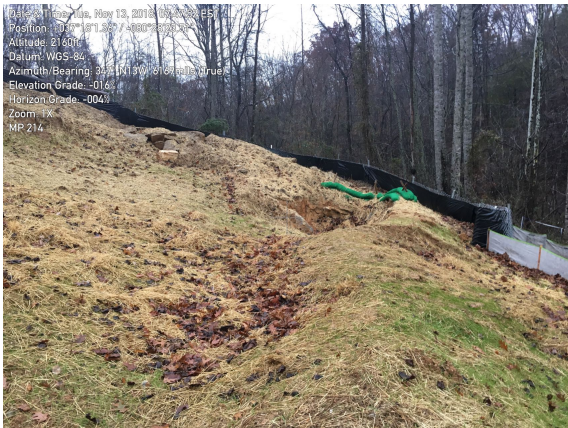
<p>Date &amp; Time: Tue, Nov 13, 2018, 08:02:26 EST Position: +037°18'21.81" / -080°28'1.46" Altitude: 2196ft Datum: WGS-84 Azimuth/Bearing: 329° N32W 5387mils (True) Elevation Grade: -014% Horizon Grade: -004% Zoom: 1X MP 214</p>

GPS Location	37.3043696349834, -80.4847928602998	GPS Location	37.3043696349834, -80.4847928602998		
Description	ROW conditions @ MP 214	Description	Waterbar and end treatment @ 11325+00		
<p>Date &amp; Time: Tue, Nov 13, 2018, 07:49:43 EST Position: +037°18'2.62" / -080°28'21.34" Altitude: 2179ft Datum: WGS-84 Azimuth/Bearing: 303° N57W 5387mils (True) Elevation Grade: -034% Horizon Grade: +005% Zoom: 1X MP 215</p>

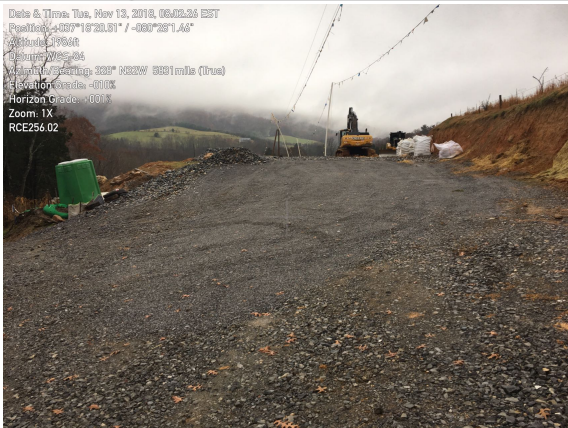
<p>Date &amp; Time: Tue, Nov 13, 2018, 08:02:26 EST Position: +037°18'21.81" / -080°28'1.46" Altitude: 2196ft Datum: WGS-84 Azimuth/Bearing: 329° N32W 5387mils (True) Elevation Grade: -014% Horizon Grade: -004% Zoom: 1X RCE256.02</p>

GPS Location	37.3043696349834, -80.4847928602998	GPS Location	37.3043696349834, -80.4847928602998		
Description	Water bar and ECD's @ 11330+00	Description	RCE @ 256.02
