# Visual Site Inspection Report

<b>Project Name</b>	H-600 Pipeline Spread G		<b>AFE</b>	124300137	<b>Spread</b>	H-600 Pipeline Spread G	
<b>Contractor</b>	Precision				<b>Report #</b>	9462	
<b>Inspector</b>	Clinton Banks				<b>Date/Time</b>	10/16/2018 4:58 AM	
<b>Permit #</b>	TBD	<b>Inspection Type</b>	VA SWPP		<b>Station Begin</b>	+28	
<b>State</b>	VA	<b>Inspection Area</b>	Full		<b>Station End</b>	+28	
<b>County</b>	Giles	<b>Ground</b>	Wet		<b>Temperature (°F)</b>	55.00	
<b>Municipality</b>	N/A	<b>Weather</b>	Cloudy		<b>Rain Gauge (in)</b>	0.00	
<b>GPS Location</b>	37.3359918734406, -80.8084184770294			<b>Rain Accumulation Time (days)</b>	1.00

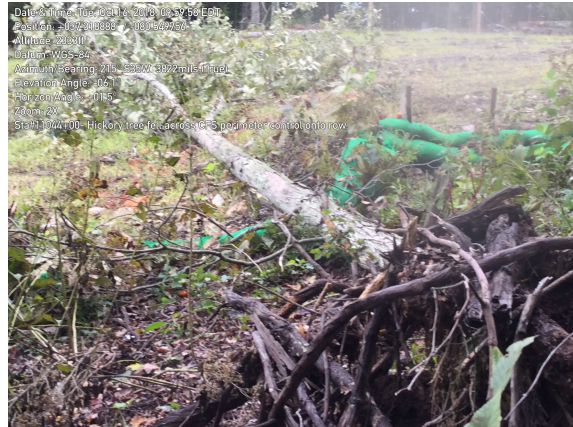
<p>Date &amp; Time: Tue, Oct 16, 2018 06:39:55 EDT Position: +037.318839500104 / -80.549823269323 Altitude: 2124ft Datum: WGS-84 Azimuth/Bearing: 170.534E 1849mils (True) Elevation Angle: +0.1 Horizon Angle: +0.1 Zoom: 2X Sta#11044+00- hickory tree fell across CFS perimeter control onto row.</p>

GPS Location	37.3013249924754, -80.5012544152145	GPS Location	37.3188339500104, -80.549823269323		
Description	Winding Way rain gauge reading- 0.20"	Description	Sta#11044+00- hickory tree fell across 18" CFS perimeter control onto row.		
<p>Date &amp; Time: Tue, Oct 16, 2018 10:20:01 EDT Position: +037.3212451 / -080.5508701 Altitude: 2365ft Datum: WGS-84 Azimuth/Bearing: 178.502E 3164mils (True) Elevation Angle: -12.5 Horizon Angle: +00.7 Zoom: 2X Sta#11043+00 to 11033+00- earth guard visible on the ground, no sign of germination.</p>

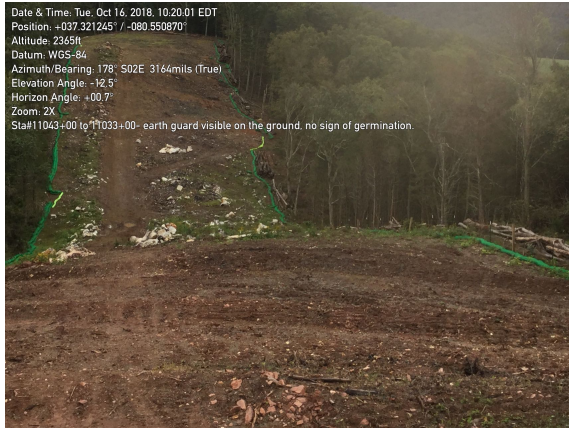
GPS Location	37.3212118959402, -80.5507939775293	GPS Location	37.3247162439277, -80.5621278193598		
Description	Sta#11043+00 to 11033+00- little to no growth.	Description	Sta#10995+50- tree fell on P1 perimeter control.		
<p>Date &amp; Time: Tue, Oct 16, 2018 11:54:55 EDT Position: +037.3272701 / -080.571106 Altitude: 2357ft Datum: WGS-84 Azimuth/Bearing: 325.735W 5776mils (True) Elevation Angle: +0.1 Horizon Angle: +0.1 Zoom: 1X Sta#10967+00 &amp; 10965+00- logs placed in water bar flow line, need to be removed.</p>

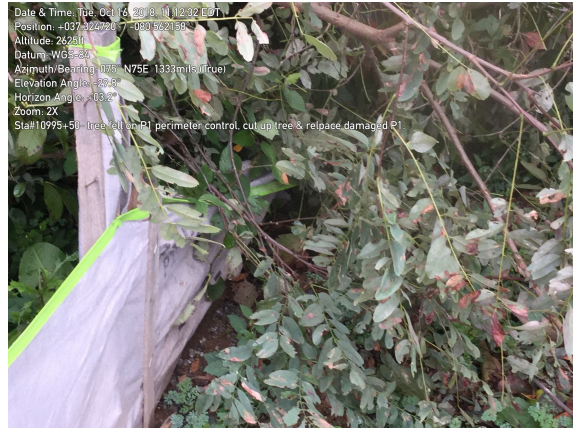
<p>Date &amp; Time: Tue, Oct 16, 2018 11:23:58 EDT Position: +037.3247162439277 / -80.5621278193598 Altitude: 2626ft Datum: WGS-84 Azimuth/Bearing: 170.75E 1333mils (True) Elevation Angle: +0.1 Horizon Angle: +0.1 Zoom: 2X Sta#10995+50- tree fell on P1 perimeter control, cut up tree &amp; replace damaged P1</p>

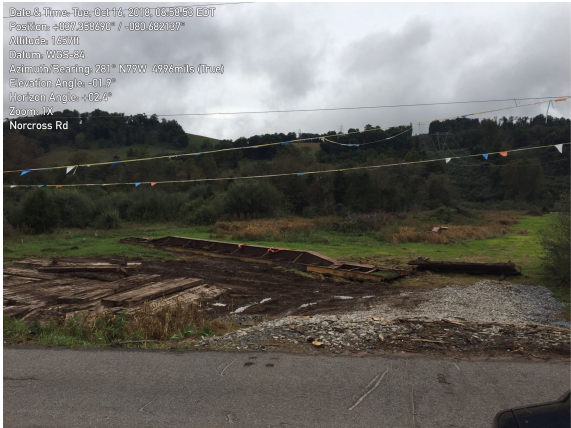
<b>GPS Location</b>	37.3425014689912, -80.6768396124995	<b>GPS Location</b>	37.3421778437098, -80.6768361759192		
<b>Description</b>	Buffalo Anklets Rd access 241.04 area growth started	<b>Description</b>	Norcross Rd area disturbed removing mats		
Insert image here		Insert image here			
<b>GPS Location</b>		<b>GPS Location</b>			
<b>Description</b>		<b>Description</b>

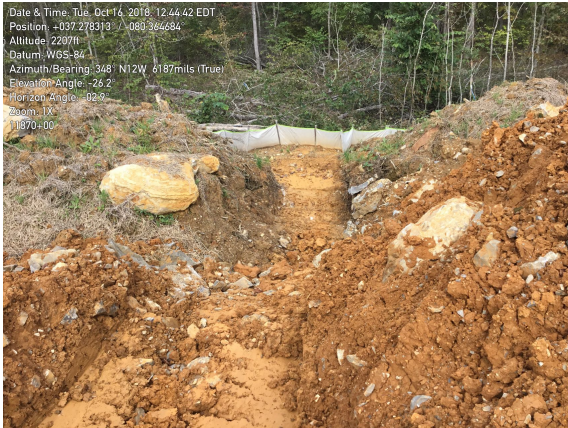
GPS Location	37.3424803046857, -80.6767998822785	GPS Location	37.3423805181285, -80.676973052398		
Description	Row 11979+00	Description	Sump and end treatment in good condition 11870+00		
<p>Date &amp; Time: Tue, Oct 16, 2018, 13:18:04 EDT Position: +037.265690° / -080.323100° Altitude: 1718ft Datum: WGS-84 Azimuth/Bearing: 120° S60E 2133mils (True) Elevation Angle: -15.3° Horizon Angle: +00.3° Zoom: 1X 11979+00</p>

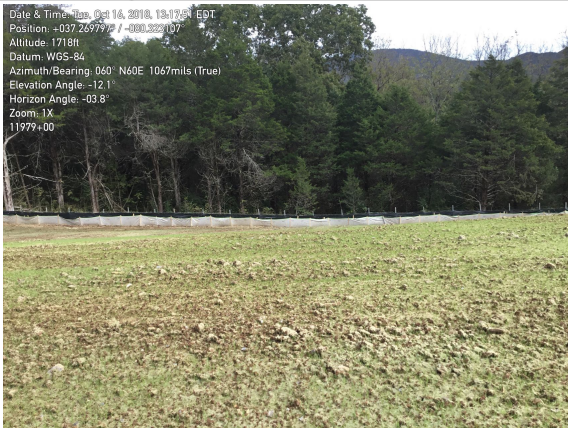
GPS Location	37.3424147162934, -80.6770162191993	GPS Location	37.3424439691355, -80.6770676002657		
Description	AR266 in good condition	Description	11979+00 ECDs in good condition

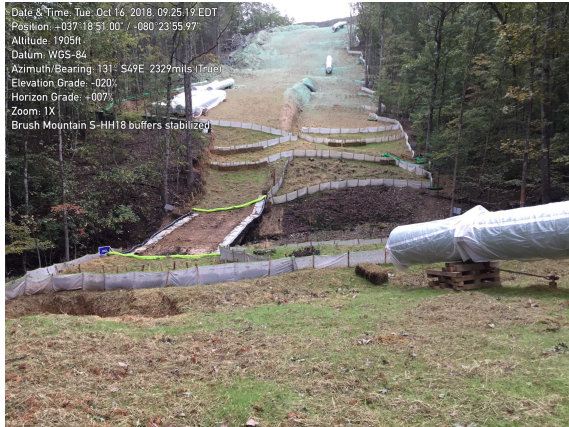
A/E	124300137	Date/Time	10/16/2018 3:57 PM	Report #	9499
Pictures					
<p>Date &amp; Time: Tue, Oct 16, 2018, 09:25:19 EDT Position: +037°18'51.00" / -080°23'55.97" Altitude: 1905ft Datum: WGS-84 Azimuth/Bearing: 131° S49E 2329mils (True) Elevation Grade: +020% Horizon Grade: +007% Zoom: 1X Brush Mountain S-HH18 buffers stabilized</p>

GPS Location	37.3138155369436, -80.4063031264398	GPS Location	37.3138155369436, -80.4063031264398		
Description	Correct coordinates on photo. Brush Mountain. Extra controls at the S-HH18 crossing.	Description	Correct coordinates on photo. Sinking Creek Mountain. Rock lined channels installed 50 control groundwater.		
<p>Date &amp; Time: Tue, Oct 16, 2018, 13:29:44 EDT Position: +037°19'14.05" / -080°24'45.22" Altitude: 2491ft Datum: WGS-84 Azimuth/Bearing: 284° N74W 5084mils (True) Elevation Grade: +008% Horizon Grade: +010% Zoom: 1X Sinking Creek Mountain, 11570-00 groundwater controlled. Area stabilized.</p>

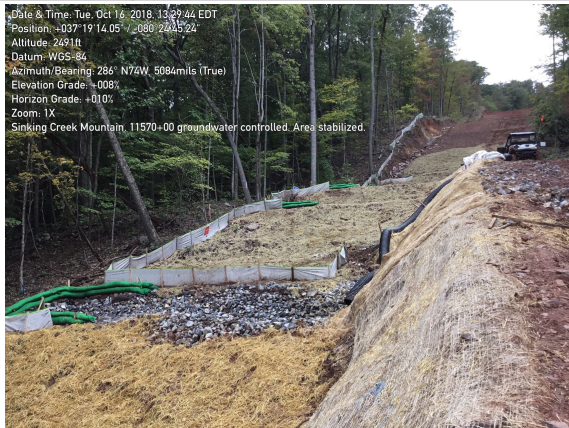
GPS Location	37.3138155369436, -80.4063031264398	GPS Location	37.3138847714638, -80.4064957425747		
Description	Correct coordinates on photo. Sinking Creek Mountain. Repairs made to erosion control matting. Rock lined channel.	Description	Correct coordinates on photo. Sinking Creek Mountain. Removal of debris and excess materials.

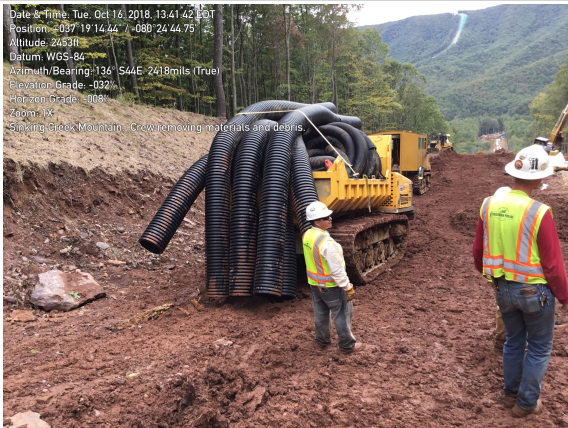
<p>Date &amp; Time: Tue, Oct 16, 2018, 13:41:42 EDT Position: +037°19'14.44" / -080°24'44.75" Altitude: 2453ft Datum: WGS-84 Azimuth/Bearing: 136° S44E 2418mils (True) Elevation Grade: +022% Horizon Grade: +008% Zoom: 1X Sinking Creek Mountain, Crew removing materials and debris</p>

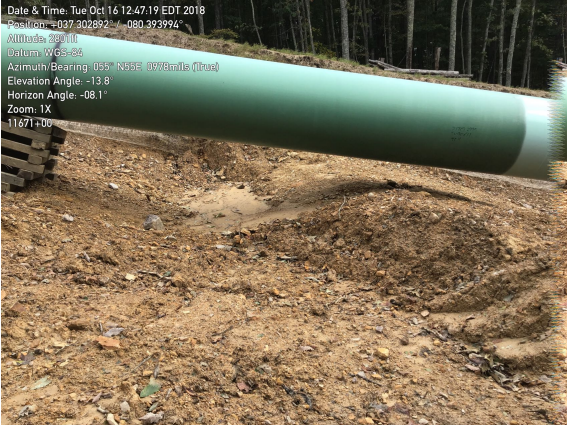
<b>GPS Location</b>	37.206001554699, -80.3942467552648	<b>GPS Location</b>	37.2060131247343, -80.3942702656755		
<b>Description</b>	See photo for GPS location and station number. Water bar throat needs sediment removal.	<b>Description</b>	See photo for GPS location and station number. Triple stack 12" CFS end treatment in place.

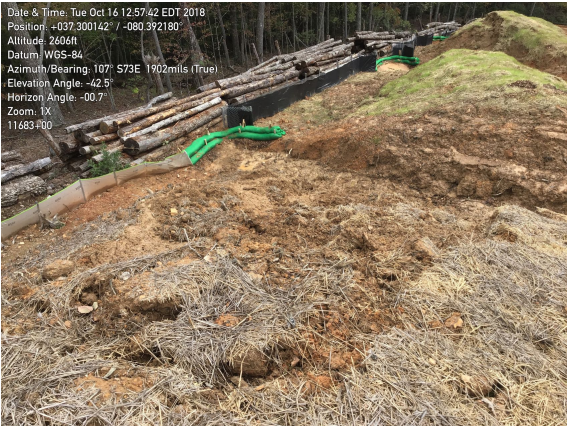
<b>GPS Location</b>	37.2060146266389, -80.3942601683652	<b>GPS Location</b>	37.2060027163787, -80.3942439638718		
<b>Description</b>	See photo for GPS location and station number. Top soil pile sloughed off into sump and waterbar throat.	<b>Description</b>	See photo for GPS location and station number. Triple stack 18" CFS, super silt fence, and priority one silt fence in place.

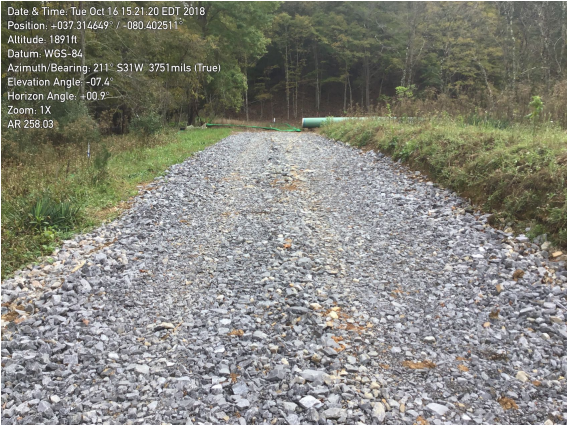
<b>Description</b>	See photo for GPS location and station number. 0.2 inches of rain fall.	<b>Description</b>	See photo for GPS location and station number. RCE in place on access road.

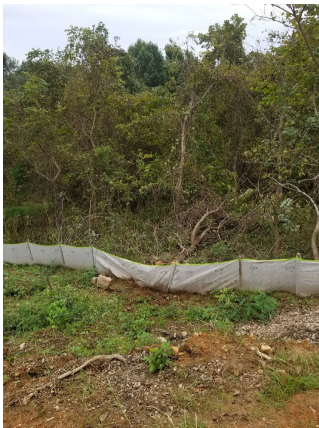
<b>GPS Location</b>	37.3422011873101, -80.6767992117262	<b>GPS Location</b>	37.342422972468, -80.6776011084026		
<b>Description</b>	10913+30 silt fence damaged by up rooted tree	<b>Description</b>	Repaired silt fence 10913+30		
<p>Date &amp; Time: Tue, Oct 16, 2018, 11:23:20 EDT Position: +037 333485 / -080 585797 Altitude: 2394ft Datum: WGS-84 Azimuth/Bearing: 169° S 11° E 3004mils (True) Elevation Angle: -22.8° Horizon Angle: -01.7° Zoom: 2X 10914+55</p>
