Visual Site Inspection Report

| Project Name | H-600 Pipeline Spread G | | AFE | 124300137 | Spread | H-600 Pipeline Spread G | |
| Contractor | Precision | | | | Report # | 9166 | |
| Inspector | Clinton Banks | | | | Date/Time | 10/10/2018 4:29 AM | |

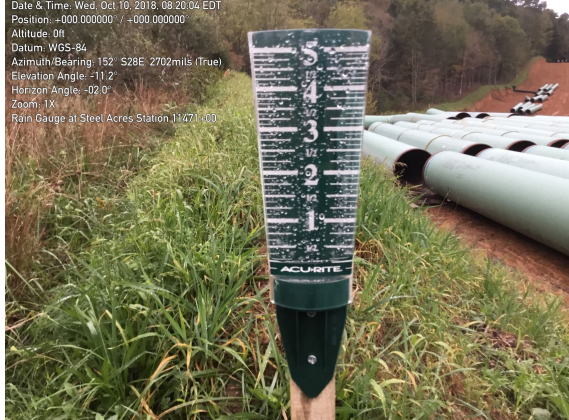
| Description | Rain Gauge at Steel Acres Station 11471+00 | Description | WaterBar at Station 11533+00 Sinking Creek | | |

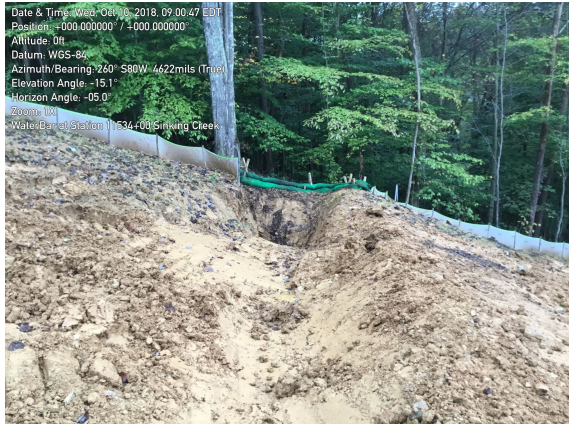
| Description | WaterBar at Station 11534+00 Sinking Creek | Description | Bridge at Station 11519+16 | | |

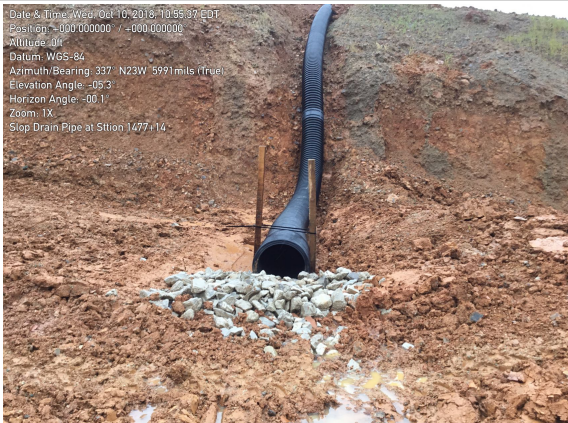
| Description | Crew installed P-1 Silt Fence to help keep Sediment off of Bridge Station 11479+22 | Description | Slop Drain Pipe at Station 11477+14 | | |

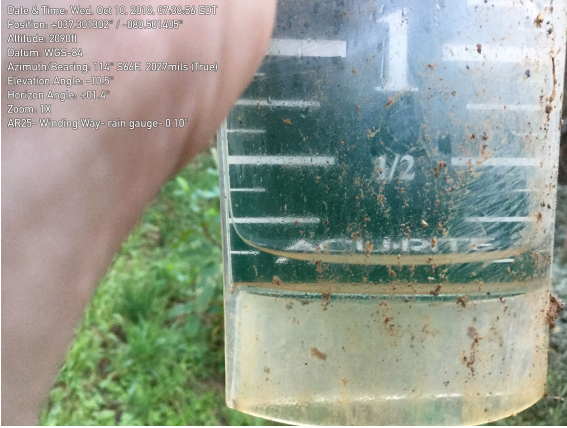
| <p>Date & Time: Wed, Oct 10, 2018, 05:06:56 EDT Position: +037.301321° / -080.501237° Altitude: 2090ft Datum: WGS-84 Azimuth/Bearing: 113° S47E 2007mils (True) Elevation Angle: +02.3° Horizon Angle: +01.4° Zoom: 1X Sta#11237+00 to 11227+00- rain gauge- 0.10"</p> | | <p>Date & Time: Wed, Oct 10, 2018, 07:06:08 EDT Position: +037.301321° / -080.501237° Altitude: 2090ft Datum: WGS-84 Azimuth/Bearing: 113° S47E 2007mils (True) Elevation Angle: +02.3° Horizon Angle: +02.5° Zoom: 1X Sta#11237+00 to 11227+00- ECD's & water bars maintained, row growth good</p> | | GPS Location 37.3012771318083, -80.5013550818716 Description Winding Way- Sta#11227+00- rain gauge- 0.10" | |

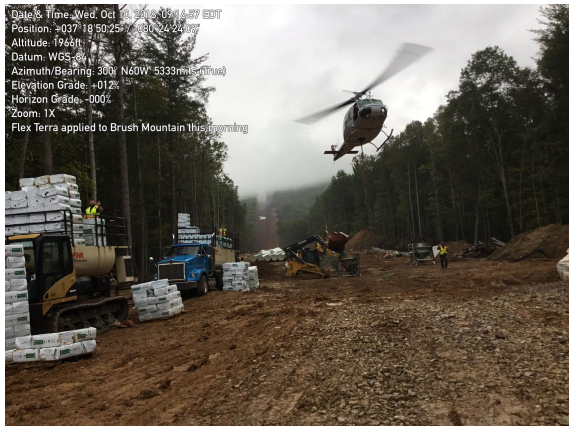
| Description | Correct coordinates on photo. Chopper worked before rain spreading hydro mulch on Brush Mountain. | Description | Correct coordinates on photo. Rock lined channel and sump to replace existing controls in effort to better control groundwater. | | |

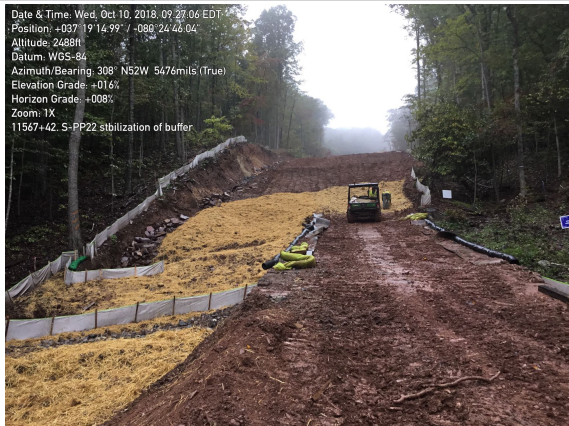
| Description | Correct coordinates on photo. Laborers stabilizing ROW upslope of the S-PP22 crossing on Sinking Creek Mountain. | Description | Correct coordinates on photo. ECD enhancements for groundwater control on Sinking Creek Mountain. | | |

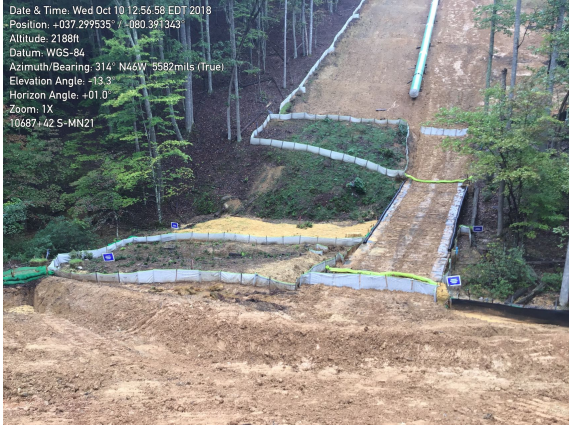
| Description | Water bars and end treatments in place. End treatments consist of triple stacked 12" CFS. | Description | Stream S-MN21. Buffer zone in place and stream back stabilized with seed and mulch. | | |

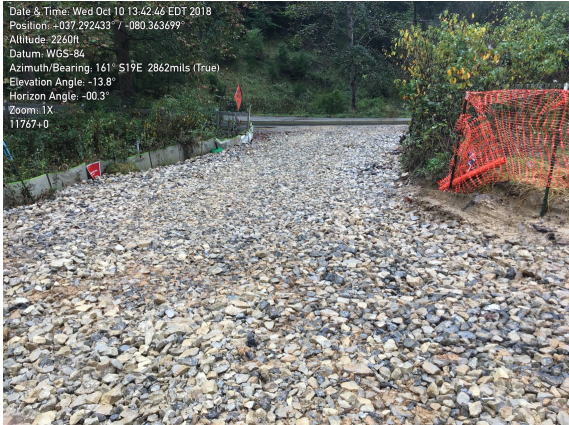
| Description | Reinforced silt fence in place. | Description | RCE in place at main line valve 26 and mount tabor road. | | |

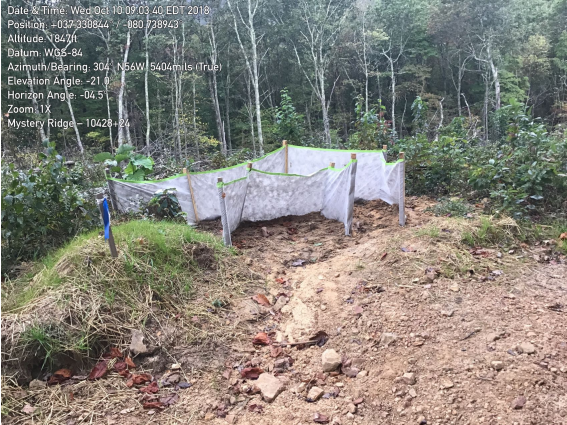
| Description | End treatment in place. | Description | CFS check dam in place. | | |

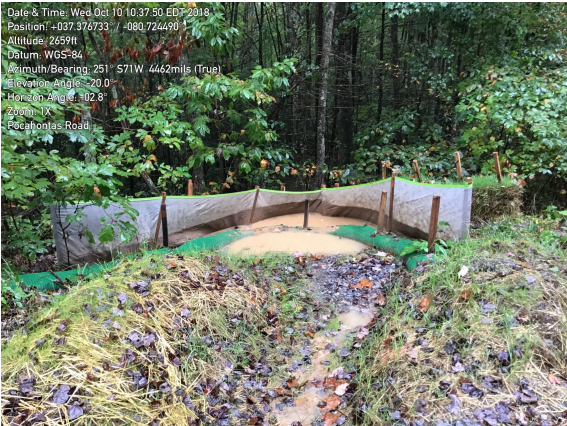
| Description | End treatment at water bar in place. | Description | | | |

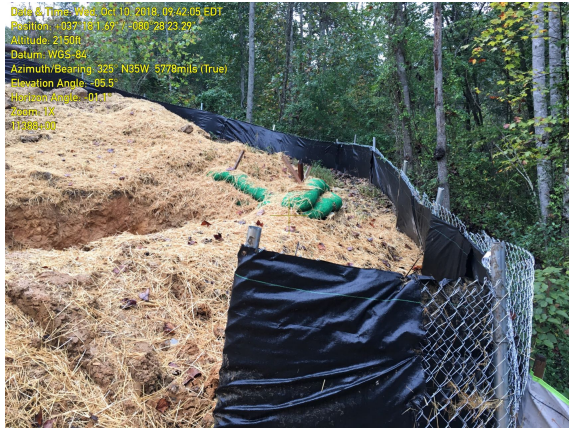
| Description | ECD's installed @ MP 214 | Description | ROW conditions water bar and stabilization @ ATWS 633 | | |

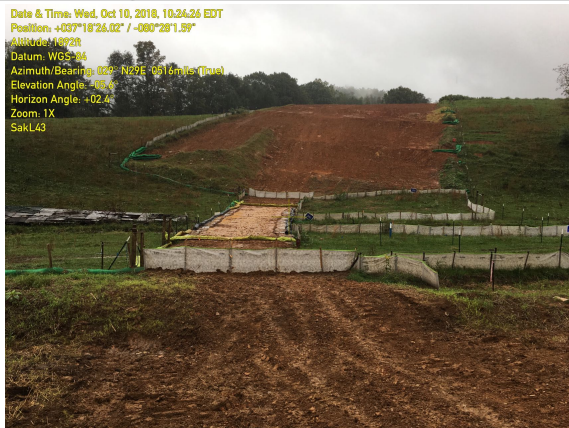
| Description | P1 installed across travel lane @ S-KL43 | Description | ROW conditions with out stabilization @ MP 215.5 | | |

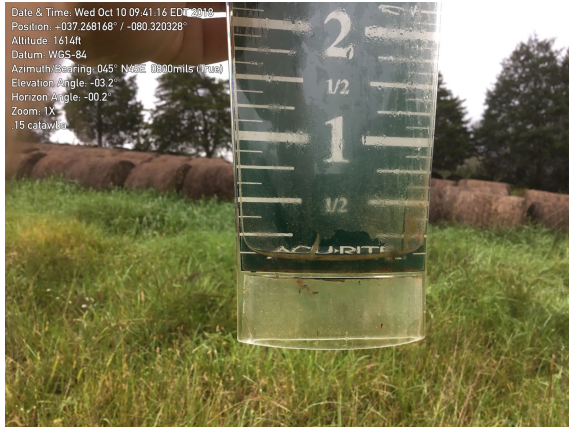
| Description | .15" Catawba | | Description | .5 mt tabor | |

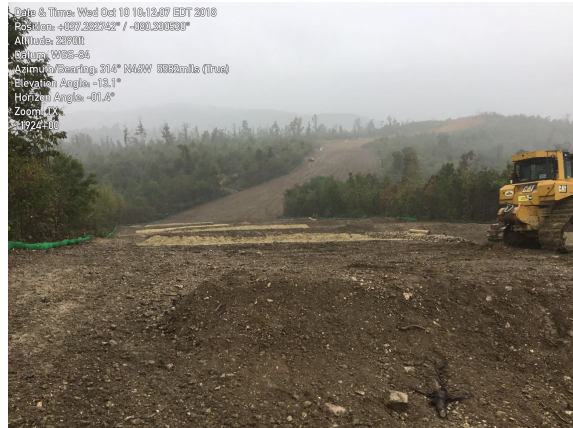
| Description | Sock replacing clean water diversion 11926+00 | | Description | Row 11924+00 | |
