Visual Site Inspection Report

Project Name	H-600 Pipeline Spread G	AFE	124300137	Spread	H-600 Pipeline Spread G
Contractor	Precision			Report #	10196
Inspector	Rob Robertson			Date/Time	10/30/2018 6:00 PM
Permit #	TBD	Inspection Type	VA SWPP	Station Begin	10458+91
State	VA	Inspection Area	Full	Station End	10459+03
County	Montgomery	Ground	Dry	Temperature (°F)	63.00
Municipality	N/A	Weather	Sunny	Rain Gauge (in)	0.00
GPS Location	37.1331819612879, -80.394651191384			Rain Accumulation Time (days)	1.00

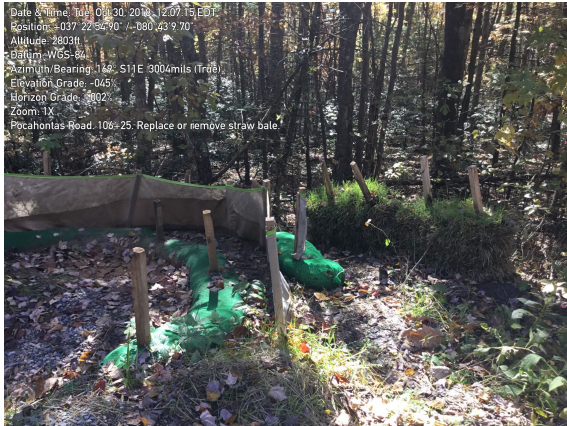
<p>Date & Time: Tue, Oct 30, 2018, 12:09:15 EDT Position: +037°23'26.70" / -080°40'57.70" Altitude: 2833ft Datum: WGS-84 Azimuth/Bearing: 166° S16E 3004mils (True) Elevation Grade: +04% Horizon Grade: +00% Zoom: 1X Pocahontas Road: 108+25. Replace or remove straw bale.</p>

GPS Location	37.1330973878849, -80.3945547156785	GPS Location	37.1330973878849, -80.3945547156785		
Description	Correct coordinates on photo. Silt fence functional but needs to be replaced soon.	Description	Correct coordinates on photo. Straw should be removed or replaced on Pocahontas Road.		
<p>Date & Time: Tue, Oct 30, 2018, 11:47:22 EDT Position: +037°22'57.16" / -080°42'37.70" Altitude: 3069ft Datum: WGS-84 Azimuth/Bearing: 092° S88E 1336mils (True) Elevation Grade: +04% Horizon Grade: +001% Zoom: 1X Pocahontas Road: 166+71. ECD functional.</p>

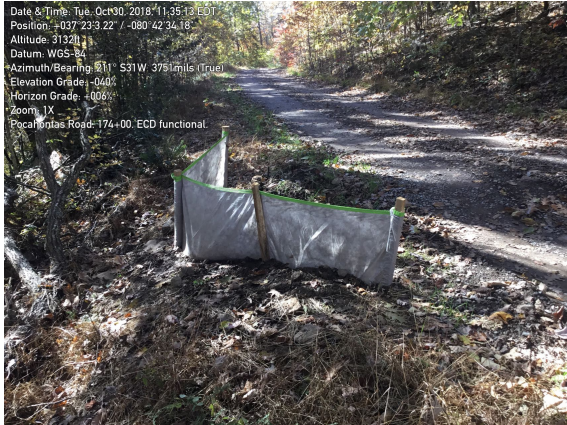
GPS Location	37.1330200648281, -80.3945228644464	GPS Location	37.1330200648281, -80.3945228644464		
Description	Correct coordinates on photo. Pocahontas Road ECD functional.	Description	Correct coordinates on photo. Pocahontas Road ECD functional.

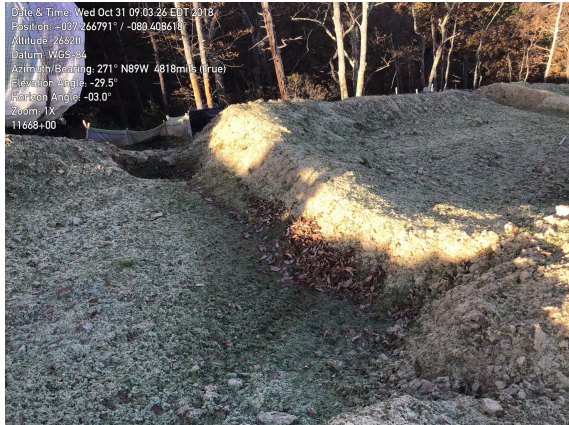
A/E	124300137	Date/Time	10/31/2018 4:52 PM	Report #	10243
Pictures					
<p>Date & Time: Wed Oct 31 09:03:26 EDT 2018 Position: +037.266791° / -089.408618° Altitude: 2262ft Datum: WGS-84 Azimuth/Bearing: 271° N89W 4818mils (True) Elevation Angle: -29.5° Horizon Angle: -03.0° Zoom: 1X 11668+00</p>

GPS Location	37.2060292143864, -80.3943068356833	GPS Location	37.2061265958445, -80.394292893972		
Description	See photo for GPS location and station number. Water bar, end treatment, and sump pit in place.	Description	See photo for GPS location and station number. Vegetation growth has begun.		
<p>Date & Time: Wed Oct 31 09:03:34 EDT 2018 Position: +037.388915° / -089.398957° Altitude: 2220ft Datum: WGS-84 Azimuth/Bearing: 345° N15W 6133mils (True) Elevation Angle: -29.8° Horizon Angle: +06.1° Zoom: 1X 11642+00</p>

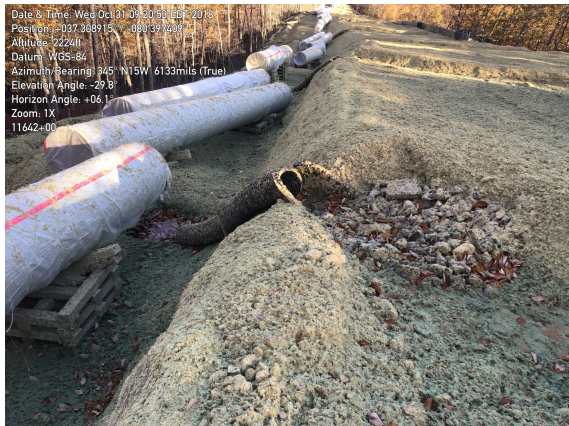
GPS Location	37.2061269385324, -80.3942928113698	GPS Location	37.2061269580908, -80.3942950685812		
Description	See photo for GPS location and station number. Slope drain with rock inlet and outlet in place.	Description	See photo for GPS location and station number. 18 inch compost filter sock in place.		
<p>Date & Time: Wed Oct 31 09:30:34 EDT 2018 Position: +037.313632° / -080.398082° Altitude: 1982ft Datum: WGS-84 Azimuth/Bearing: 304° N56W 5404mils (True) Elevation Angle: -17.3° Horizon Angle: +00.4° Zoom: 1X 11626+04 S-HH18</p>

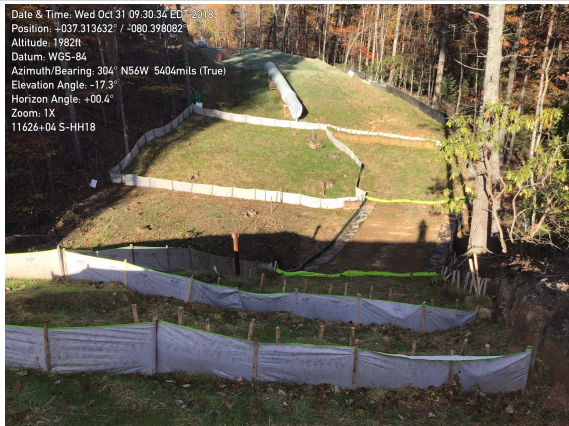
GPS Location	37.2061268444264, -80.3942951621756	GPS Location	37.2061268354322, -80.3942951660241		
Description	See photo for GPS location and station number. ECDs and sensitive resource buffer in place.	Description	See photo for GPS location and station number. RCE in place at Craig Creek access point.

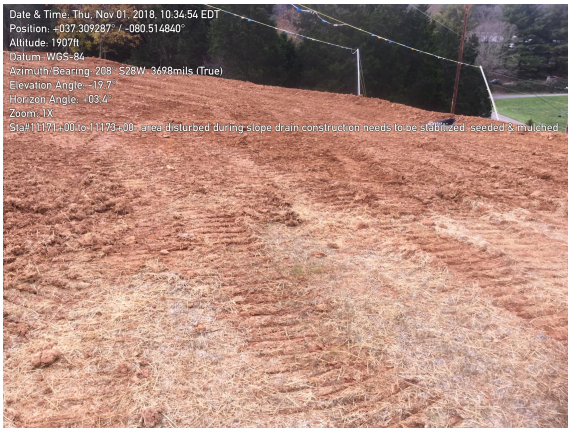
<p>Date & Time: Thu, Nov 01, 2018, 10:34:54 EDT Position: +037.309287° / -080.518440° Altitude: 1907ft Datum: WGS-84 Azimuth/Bearing: 208° S28W 3498mils (True) Elevation Angle: +19.7° Horizon Angle: +03.4° Zoom: 1X Sta#11171+00 to 11173+00- area disturbed during slope drain construction needs to be stabilized, seeded & mulched.</p>

GPS Location	37.3076969152664, -80.5120138452207	GPS Location	37.3092982359578, -80.5148423184459		
Description	Sta#11184+00 to 11183- seed & mulch area disturbed during CWD & plunge pool construction.	Description	Sta#11171+00 to 11173+00- area disturbed during slope drain construction needs to be stabilized, seeded & mulched.

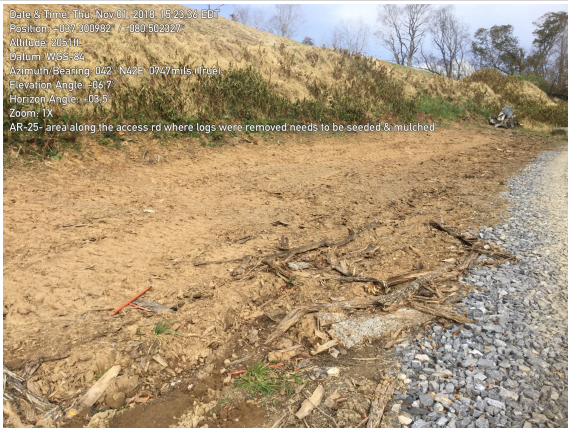
<p>Date & Time: Thu, Nov 01, 2018, 15:23:30 EDT Position: +037.300925° / -080.502376° Altitude: 2051ft Datum: WGS-84 Azimuth/Bearing: 092° N02E 0749mils (True) Elevation Angle: +06.7° Horizon Angle: +03.8° Zoom: 1X AR-25- area along the access rd where logs were removed needs to be seeded & mulched.</p>

GPS Location	37.3227706365635, -80.552769843564	GPS Location	37.3009258881559, -80.5023760814969		
Description	Sta#11024+00 to 11012+00 has been reseeded & mulched growth is very good.	Description	AR- 25- area where logs were removed needs to be stabilized, seeded & mulched.

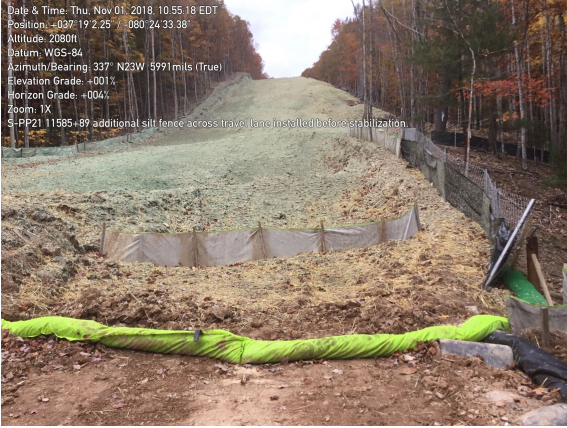
A/E	124300137	Date/Time	11/1/2018 2:28 PM	Report #	10277
Pictures					
<p>Date & Time: Thu, Nov 01, 2018, 10:55:18 EDT Position: +037°19'2.25" / -080°24'33.38" Altitude: 2080ft Datum: WGS-84 Azimuth/Bearing: 337° N23W 5991mils (True) Elevation Grade: +001% Horizon Grade: +004% Zoom: 1X S-PP21 11585+89 additional silt fence across travel lane installed before stabilization.</p>

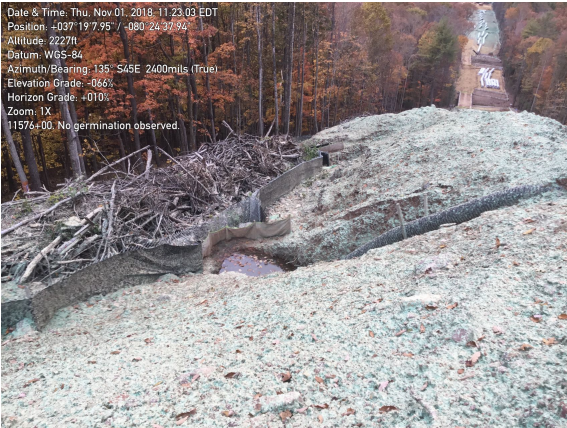
<p>Date & Time: Thu, Nov 01, 2018, 11:23:03 EDT Position: +037°19'7.95" / -080°24'37.94" Altitude: 2227ft Datum: WGS-84 Azimuth/Bearing: 135° S45E 2400mils (True) Elevation Grade: -066% Horizon Grade: +010% Zoom: 1X 11576+00. No germination observed.</p>

GPS Location	37.3146390170206, -80.4026979022477	GPS Location	37.3145086784263, -80.4028153327111		
Description	Correct coordinates and comment on photo. No germination at 11576+00 facing north.	Description	Correct coordinates and comment on photo. No germination observed at 11576+00 facing south.		
<p>Date & Time: Thu, Nov 01, 2018, 11:44:17 EDT Position: +037°19'12.73" / -080°24'25.79" Altitude: 2448ft Datum: WGS-84 Azimuth/Bearing: 202° S52W 4124mils (True) Elevation Grade: -03% Horizon Grade: +008% Zoom: 1X 11569+80. Rock lined channel. Groundwater flow has slowed.</p>

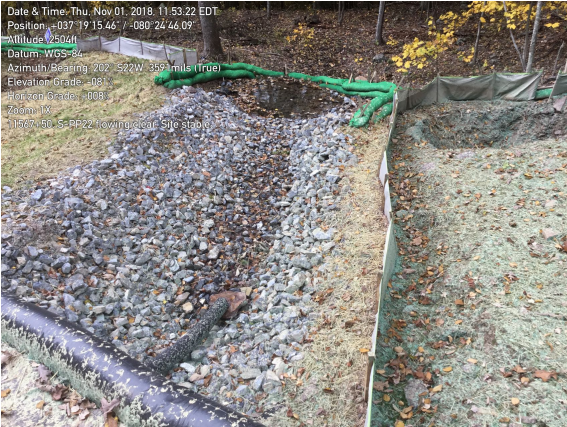
<p>Date & Time: Thu, Nov 01, 2018, 11:53:22 EDT Position: +037°19'15.46" / -080°24'46.09" Altitude: 2504ft Datum: WGS-84 Azimuth/Bearing: 202° S52W 3469mils (True) Elevation Grade: -08% Horizon Grade: +008% Zoom: 1X 11567+00. S-PP22. Groundwater flow has slowed.</p>

GPS Location	37.3145086784263, -80.4028153327111	GPS Location	37.3145086784263, -80.4028153327111		
Description	Correct coordinates and comment on photo. Groundwater is being controlled.	Description	Correct coordinates and comment on photo. Groundwater is being controlled.

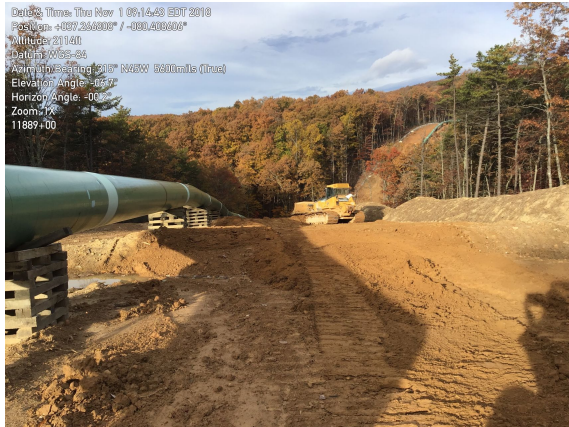
A/E	124300137	Date/Time	11/1/2018 3:51 PM	Report #	10282
Pictures					
<p>Date & Time: Thu Nov 1 09:14:53 EDT 2018 Position: +037.266015 / -080.394355 Altitude: 2114ft Datum: WGS-84 Azimuth/Bearing: 215.539W 3822mils (True) Elevation Angle: +02.9 Horizon Angle: -00.0 Zoom: 1X 11689+00</p>

GPS Location	37.20601826015, -80.3943554975313	GPS Location	37.2062904119601, -80.3944663462984		
Description	See photo for GPS location and station number. Contractor conducting water bar maintenance.	Description	See photo for GPS location and station number. End treatment and sump pit functional.		
<p>Date & Time: Thu Nov 1 11:01:34 EDT 2018 Position: +037.296176 / -080.394476 Altitude: 2361ft Datum: WGS-84 Azimuth/Bearing: 220.540W 3911mils (True) Elevation Angle: -34.1 Horizon Angle: +06.9 Zoom: 1X 11711+00</p>

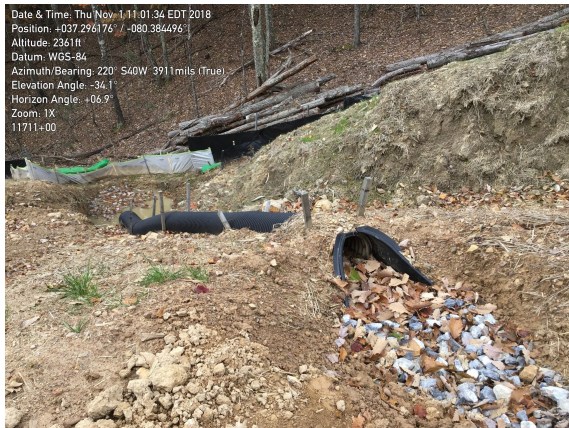
GPS Location	37.2062916653156, -80.3944668378751	GPS Location	37.2062857174021, -80.3944646399728		
Description	See photo for GPS location and station number. Slope drain over fill slope with rock inlet.	Description	See photo for GPS location and station number. Sensitive resource buffer in place at stream S-MN22.		
<p>Date & Time: Thu Nov 1 11:47:08 EDT 2018 Position: +037.293127 / -080.361872 Altitude: 2041ft Datum: WGS-84 Azimuth/Bearing: 292.568W 5191mils (True) Elevation Angle: +02.7 Horizon Angle: +01.8 Zoom: 1X 11768+00</p>

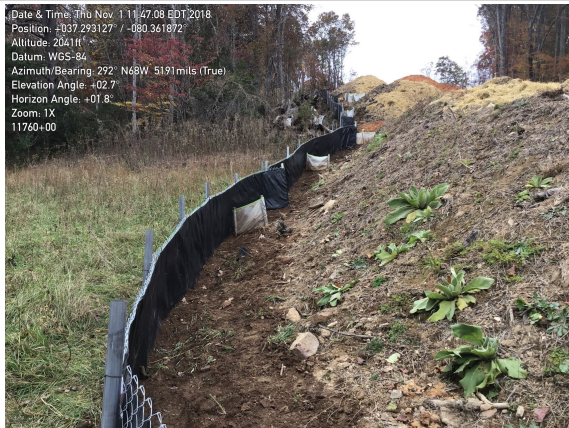
GPS Location	37.2062859316129, -80.3944647414167	GPS Location	37.2062851597634, -80.3944644271981		
Description	See photo for GPS location and station number. Reinforced silt fence with check dams in place over slope.	Description	See photo for GPS location and station number. RCE in place at mainline valve 26.

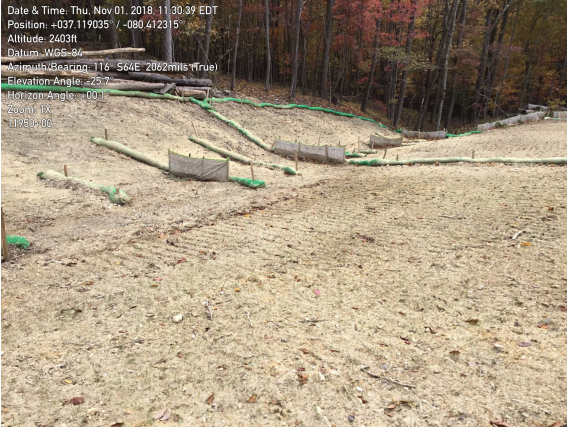
<p>Date & Time: Thu, Nov 01, 2018 11:30:39 EDT Position: +037 119035 / -080 412315 Altitude: 2403ft Datum: WGS-84 Azimuth/Bearing: 116° S64E 2082mils (True) Elevation Angle: -25.7° Horizon Angle: -00.1° Zoom: 1X 11950+00</p>		GPS Location 37.333715615357, -80.750290783951 Description Wetland p-kl2
