Visual Site Inspection Report

Project Name	H-600 Pipeline Spread I	AFE	124300139	Spread	H-600 Pipeline Spread I
Contractor	Precision			Report #	15150
Inspector	Glenn Mike Renfro			Date/Time	3/25/2019 3:35 PM
Permit #	TBD	Inspection Type	VA SWPP	Station Begin	0000+00
State	VA	Inspection Area	Full	Station End	0000+00
County	Franklin	Ground	Damp	Temperature (°F)	67.00
Municipality	N/A	Weather	Light Rain	Rain Gauge (in)	0.20
				Rain Accumulation Time (days)	6.00

Project Name	Transco Interconnect Station		AFE	124300113	Spread	Transco Interconnect Station	
Contractor	MEC				Report #	15132	
Inspector	Dave Burkhart				Date/Time	3/25/2019 8:34 AM	
Permit #	TBD	Inspection Type	VA SWPP		Station Begin	+1	
State	VA	Inspection Area	Full		Station End	+1	
County	Pittsylvania	Ground	Dry		Temperature (°F)	50.00	
Municipality	Chatham	Weather	Sunny		Rain Gauge (in)	0.00	
					Rain Accumulation Time (days)	1.00

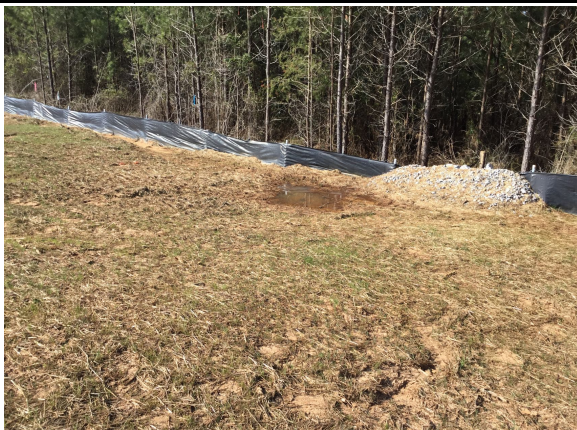
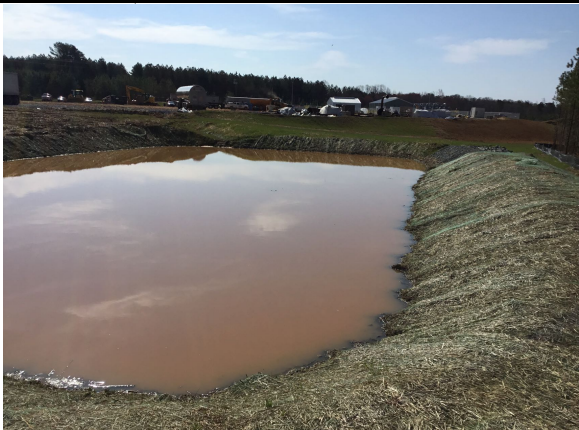
GPS Location		36.83		Field Station#		+1		GPS Location		36.83	
Field Station#		+1		GPS Location		36.83		Field Station#		+1	
Description		Sed basin						Description		Sed basin outfall and spreader structure
