# Visual Site Inspection Report

<b>Project Name</b>	H-600 Pipeline Spread G	<b>AFE</b>	124300137	<b>Spread</b>	H-600 Pipeline Spread G
<b>Contractor</b>	Precision			<b>Report #</b>	15348
<b>Inspector</b>	Garrett Barclay			<b>Date/Time</b>	4/1/2019 10:43 AM
<b>Permit #</b>	TBD	<b>Inspection Type</b>	VA SWPP	<b>Station Begin</b>	11065+00
<b>State</b>	VA	<b>Inspection Area</b>	Partial	<b>Station End</b>	11055+00
<b>County</b>	Giles	<b>Ground</b>	Dry	<b>Temperature (°F)</b>	32.00
<b>Municipality</b>	N/A	<b>Weather</b>	Sunny	<b>Rain Gauge (in)</b>	0.00
				<b>Rain Accumulation Time (days)</b>	1.00

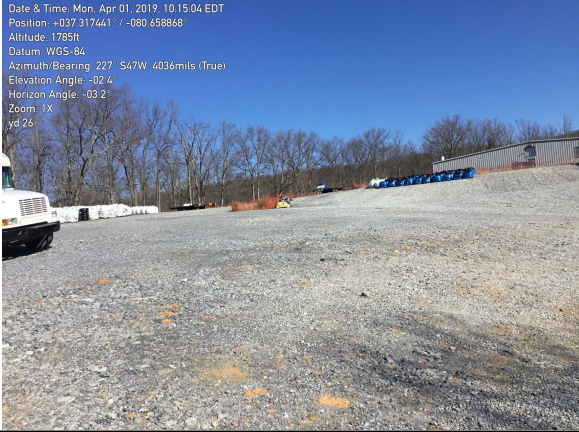
<p>Date &amp; Time: Mon, Apr 01, 2019, 10:15:04 EDT  Position: +037.317441° / -080.658868°  Altitude: 1785ft  Datum: WGS-84  Azimuth/Bearing: 227° S47°W 4036mils (True)  Elevation Angle: -02.4°  Horizon Angle: -03.2°  Zoom: 1X  yd 26</p>

<p>Date &amp; Time: Mon, Apr 01, 2019, 10:39:05 EDT  Position: +037.318712° / -080.658265°  Altitude: 1835ft  Datum: WGS-84  Azimuth/Bearing: 259° S28°W 4587mils (True)  Elevation Angle: -06.8°  Horizon Angle: -01.4°  Zoom: 1X  yd 26</p>									
<b>GPS Location</b>		37.37		<b>Field Station#</b>		+26		<b>GPS Location</b>		37.37		<b>Field Station#</b>		+26	
<b>Description</b>		Yard 26 parking area						<b>Description</b>		RCE yd 26

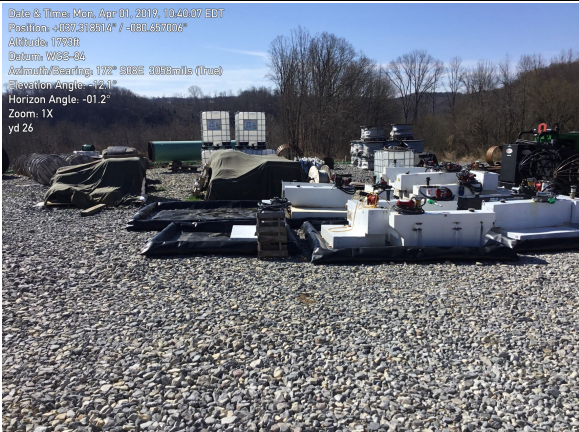
<p>Date &amp; Time: Mon, Apr 01, 2019, 10:40:07 EDT  Position: +037.318314° / -080.657066°  Altitude: 1779ft  Datum: WGS-84  Azimuth/Bearing: 172° S05E 3023mils (True)  Elevation Angle: -12.1°  Horizon Angle: -01.2°  Zoom: 1X  yd 26</p>

<b>GPS Location</b>		37.37		<b>Field Station#</b>		+26		<b>GPS Location</b>		37.37		<b>Field Station#</b>		+26	
<b>Description</b>		Drag up tank storage						<b>Description</b>		Fuel storage area					
Insert image here						Insert image here									
<b>GPS Location</b>				<b>Field Station#</b>				<b>GPS Location</b>				<b>Field Station#</b>			
<b>Description</b>								<b>Description</b>

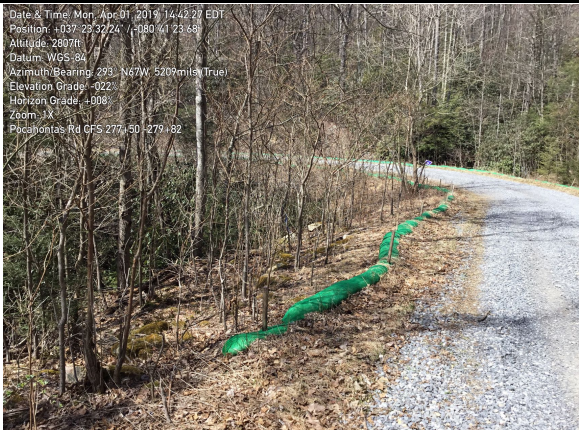
</div></div></div>					
GPS Location	37.13	Field Station#	303+15	GPS Location	37.13	Field Station#	279+82
Description	Correct coordinates on photo. No sediment beyond controls or LOD.			Description	Correct coordinates on photo. CFS is functional where placed along road edge.

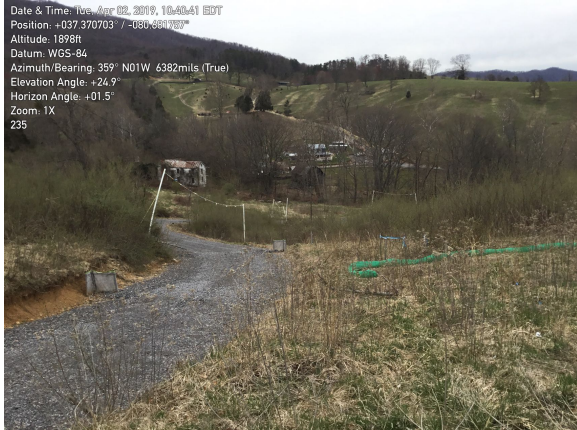
<p>Date &amp; Time: Tue, Apr 02, 2019, 10:44:16 EDT Position: +037.370703 / -080.361700 Altitude: 1896ft Datum: WGS-84 Azimuth/Bearing: 359° N01W 6382mils (True) Elevation Grade: +24.9° Horizon Grade: +01.8° Zoom: 1X 234</p>  					
GPS Location	37.31	Field Station#	2+35	GPS Location	37.31	Field Station#	2+34
Description	ECD's and ROW conditions @ AR 235			Description	ECD's and ROW conditions @ AR 234		
<p>Date &amp; Time: Tue, Apr 02, 2019, 11:44:53 EDT Position: +037.201494 / -080.361840 Altitude: 2242ft Datum: WGS-84 Azimuth/Bearing: 020° N20E 0356mils (True) Elevation Grade: -046° Horizon Grade: +008° Zoom: 1X m</p>  		<p>Date &amp; Time: Tue, Apr 02, 2019, 11:46:16 EDT Position: +037.201494 / -080.361840 Altitude: 2212ft Datum: WGS-84 Azimuth/Bearing: 304° N56W 5402mils (True) Elevation Grade: -026° Horizon Grade: +006° Zoom: 1X 333.33</p>

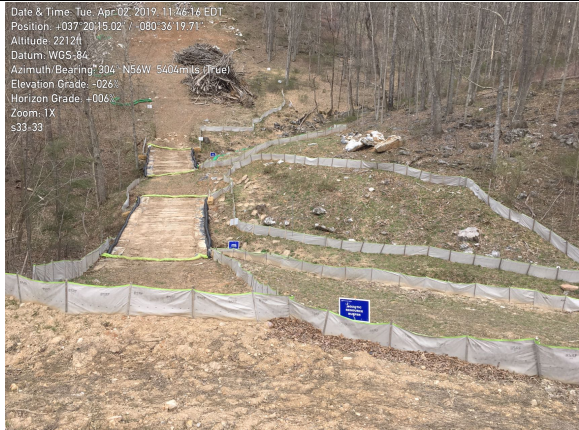
GPS Location	37.37	Field Station#	10858+18	GPS Location	37.37	Field Station#	10854+70
Description	ECD's and ROW conditions			Description	ECD's and ROW conditions		
<p>Date &amp; Time: Tue, Apr 02, 2019, 11:45:09 EDT Position: +037.201494 / -080.361840 Altitude: 2322ft Datum: WGS-84 Azimuth/Bearing: 313° N47W 5564mils (True) Elevation Grade: -023° Horizon Grade: +011° Zoom: 1X j</p>

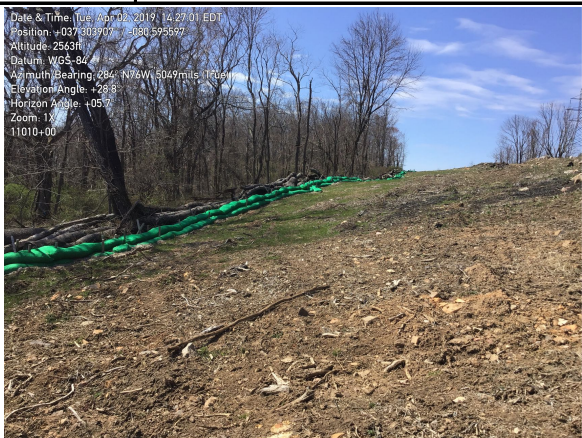
<p>Date &amp; Time: Tue, Apr 02, 2019, 14:46:59 EDT Position: +037 335742 / -080 567610 Altitude: 2324ft Datum: WGS-84 Azimuth/Bearing: 294° N65W 5227mils (True) Elevation Angle: +20.9° Horizon Angle: +02.6° Zoom: 1X 10966+00</p>

GPS Location	37.20	Field Station#	11010+00	GPS Location	37.20	Field Station#	10966+00
Description	See photo for GPS location. Triple stack 18 inch compost filter sock.			Description	See photo for GPS location. Triple protection ECD at open throat karst feature.		
<p>Date &amp; Time: Tue, Apr 02, 2019, 14:19:31 EDT Position: +037 323561 / -080 555243 Altitude: 2359ft Datum: WGS-84 Azimuth/Bearing: 324° N36W 5385mils (True) Elevation Angle: +29.8° Horizon Angle: +02.9° Zoom: 1X 11015+85 S-RR5</p>

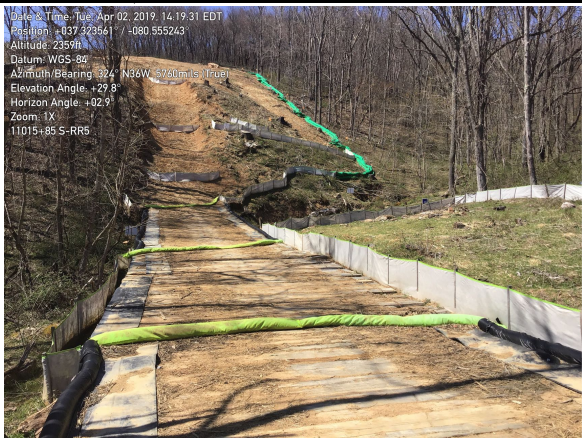
<p>Date &amp; Time: Tue, Apr 02, 2019, 15:02:13 EDT Position: +037 330875 / -080 565560 Altitude: 2248ft Datum: WGS-84 Azimuth/Bearing: 312° N68W 5547mils (True) Elevation Angle: +20.2° Horizon Angle: +04.9° Zoom: 1X 10935+00</p>

GPS Location	37.20	Field Station#	11015+85	GPS Location	37.20	Field Station#	10935+00
Description	See photo for GPS location. Sensitive resource buffer in place at stream S-RR5.			Description	See photo for GPS location. Reinforced super silt fence in place.

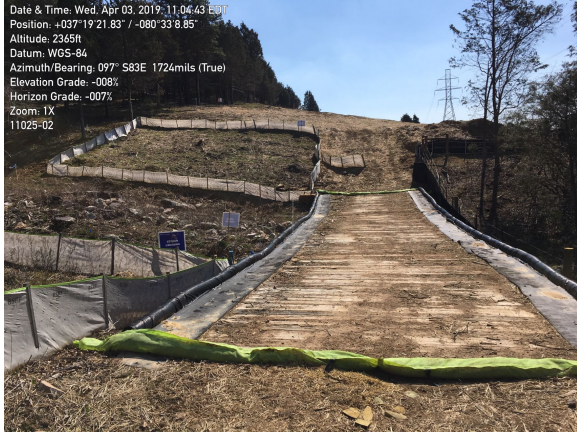
<p>Date &amp; Time: Wed, Apr 03, 2019, 11:09:02 EDT Position: +037° 19' 18.32" / -080° 33' 3.09" Altitude: 2367ft Datum: WGS-84 Azimuth/Bearing: 223° S43W 3964mils (True) Elevation Grade: -038% Horizon Grade: +005% Zoom: 1X 11031-00</p>

GPS Location	37.32	Field Station#	11025+02	GPS Location	37.32	Field Station#	11031+00
Description	ECD's and ROW conditions			Description	ECD's and ROW conditions		
<p>Date &amp; Time: Wed, Apr 03, 2019, 11:18:04 EDT Position: +037° 18' 19.09" / -080° 32' 39.03" Altitude: 2353ft Datum: WGS-84 Azimuth/Bearing: 103° S77E 1831mils (True) Elevation Grade: -044% Horizon Grade: +000% Zoom: 1X 11046-00</p>

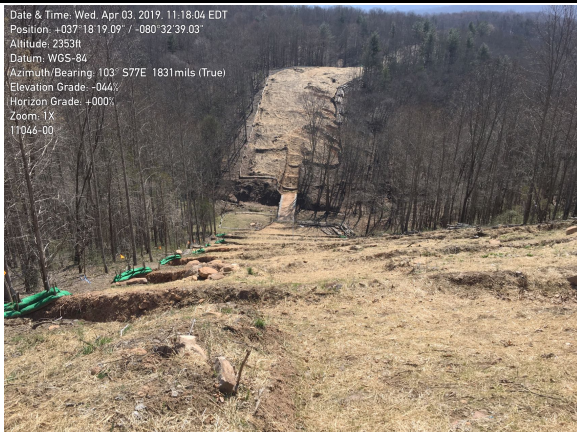
<p>Date &amp; Time: Wed, Apr 03, 2019, 11:05:18 EDT Position: +037° 18' 59.61" / -080° 32' 39.46" Altitude: 2197ft Datum: WGS-84 Azimuth/Bearing: 119° S61E 2116mils (True) Elevation Grade: -021% Horizon Grade: -002% Zoom: 1X 11056-00</p>

GPS Location	37.32	Field Station#	11046+00	GPS Location	37.32	Field Station#	11056+00
Description	ECD's and ROW conditions			Description	ECD's and ROW conditions		
<p>Date &amp; Time: Wed, Apr 03, 2019, 12:07:38 EDT Position: +037° 18' 56.92" / -080° 31' 42.56" Altitude: 2089ft Datum: WGS-84 Azimuth/Bearing: 120° S60E 2133mils (True) Elevation Grade: -034% Horizon Grade: +010% Zoom: 1X 11118-00</p>

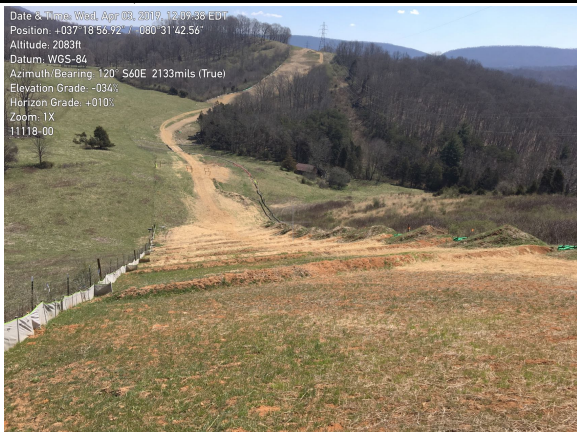
<p>Date &amp; Time: Wed, Apr 03, 2019, 13:29:35 EDT Position: +037° 20' 3.09" / -080° 48' 10.28" Altitude: 1549ft Datum: WGS-84 Azimuth/Bearing: 247° S42W 4302mils (True) Elevation Grade: -001% Horizon Grade: -001% Zoom: 1X 11128-00</p>

GPS Location	37.32	Field Station#	11118+00	GPS Location	37.32	Field Station#	+28
Description	ECD's and ROW conditions			Description	Crews working at LDY 28

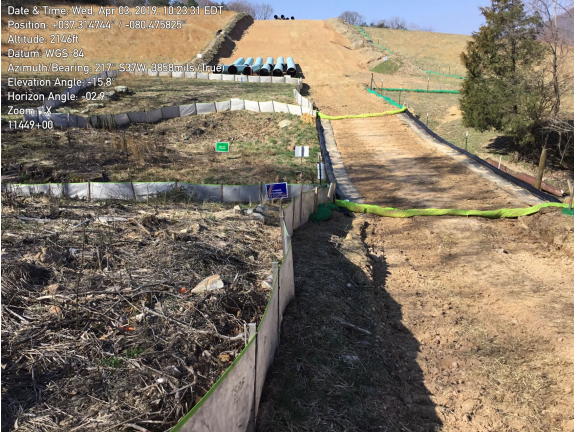
</div></div></div>		<div><div><div>Date &amp; Time: Wed, Apr 03, 2019, 10:28:34 EDT Position: +037.316319° / -080.540136° Altitude: 2123ft Datum: WGS-84 Azimuth/Bearing: 244° 56'W 433mils (True) Elevation Angle: -14.2° Horizon Angle: -03.9° Zoom: 1X 11443+00</div><div>

</div></div></div>				
GPS Location	37.32	Field Station#	11449+00	GPS Location	37.32	
Description	Stream crossing, ECDs in good condition			Description	Drainage feature crossing	
<div><div><div>Date &amp; Time: Wed, Apr 03, 2019, 10:39:32 EDT Position: +037.315249° / -080.447648° Altitude: 2183ft Datum: WGS-84 Azimuth/Bearing: 214° 53'W 380mils (True) Elevation Angle: -36.5° Horizon Angle: -04.5° Zoom: 1X 11427+00</div><div>

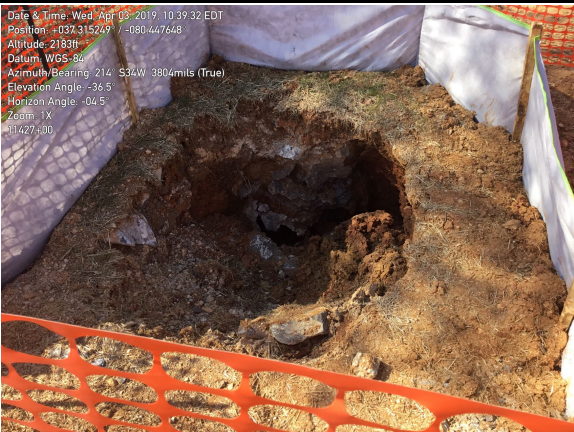
</div></div></div>		<div><div><div>Date &amp; Time: Wed, Apr 03, 2019, 10:31:59 EDT Position: +037.316961° / -080.449554° Altitude: 2132ft Datum: WGS-84 Azimuth/Bearing: 239° 55'W 424mils (True) Elevation Angle: -10.2° Horizon Angle: -01.2° Zoom: 1X 11435+00</div><div>

GPS Location	37.32	Field Station#	11427+00	GPS Location	37.32	
Description	Soil pipe containment ECDs in good condition			Description	Drainage feature crossing	
<div><div><div>Date &amp; Time: Wed, Apr 03, 2019, 11:12:05 EDT Position: +037.309030° / -080.444407° Altitude: 2006ft Datum: WGS-84 Azimuth/Bearing: 209° 52'W 371mils (True) Elevation Angle: -21.0° Horizon Angle: -01.7° Zoom: 1X 11360+00</div><div>

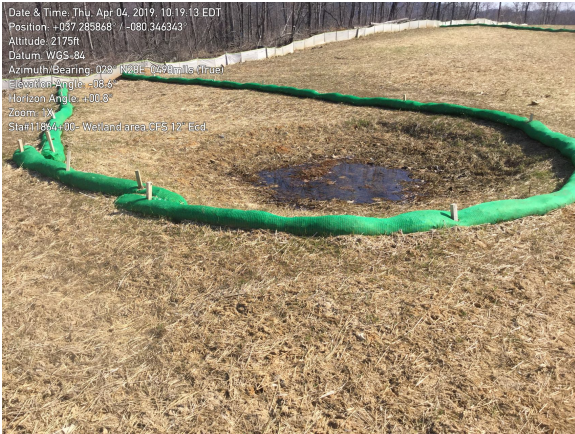
GPS Location	37.32	Field Station#	11830+00	GPS Location	37.32	Field Station#	11843+00
Description	Karst with P1 perimeter controls & signage			Description	P1 & SSF perimeter controls are in acceptable condition		
<p>Date &amp; Time: Thu, Apr 04, 2019, 10:19:13 EDT Position: +037 285868° / -080 346343° Altitude: 2176ft Datum: WGS-84 Azimuth/Bearing: 025° N64E 3231mils (True) Elevation Angle: -08.3° Horizon Angle: +00.8° Zoom: 1X Sta#11864+00- Wetland area, 375 18' bed</p>

GPS Location	37.32	Field Station#	11864+00	GPS Location	37.32	Field Station#	11865+00
Description	Wetland area with 12" CFS			Description	Water bar, level spreaders are in good condition.

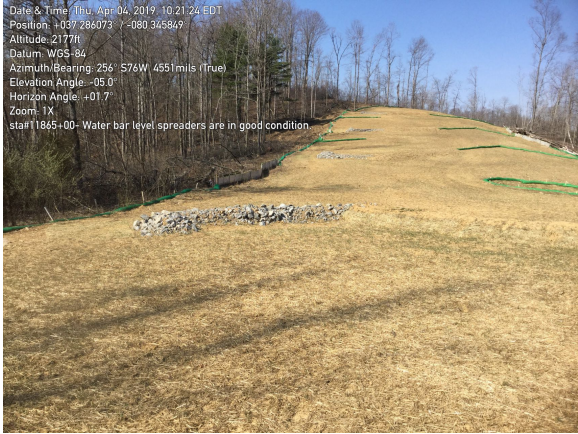
<p>Date &amp; Time: Thu, Apr 04, 2019, 10:21:24 EDT Position: +037 286073° / -080 345849° Altitude: 2177ft Datum: WGS-84 Azimuth/Bearing: 255° S76W 4551mils (True) Elevation Angle: -05.0° Horizon Angle: +01.7° Zoom: 1X Sta#11865+00- Water bar level spreaders are in good condition</p>

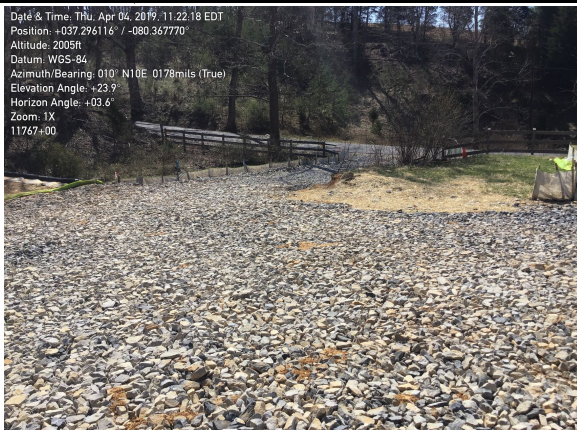
GPS Location	37.20	Field Station#	11767+00	GPS Location	37.20	Field Station#	11775+00
Description	See photo for GPS location. RCE in place at main line valve 26.			Description	See photo for GPS location. Clean water diversion pipe in place.

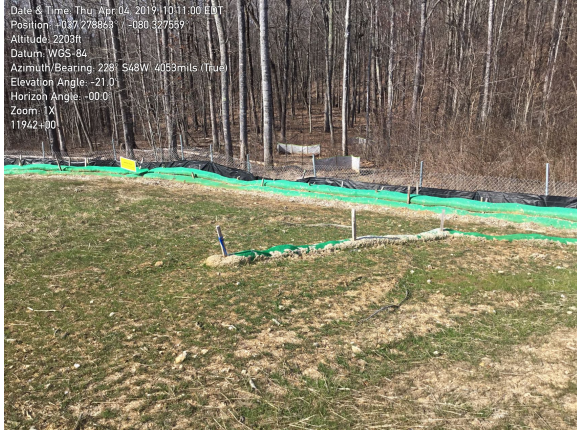
</div></div>				
GPS Location	37.33	Field Station#	11942+00	GPS Location	37.33	Field Station#	11944+00
Description	ECDs protecting karst area			Description	ECDs in good condition		
<div><div><div>Date &amp; Time: Thu, Apr 04, 2019, 10:14:00 EDT Position: +037 277957° / -080 326390° Altitude: 2051ft Datum: WGS-84 Azimuth/Bearing: 178° S02E 3164mils (True) Elevation Angle: -16.9° Horizon Angle: -01.1° Zoom: 1X 11950+00</div>

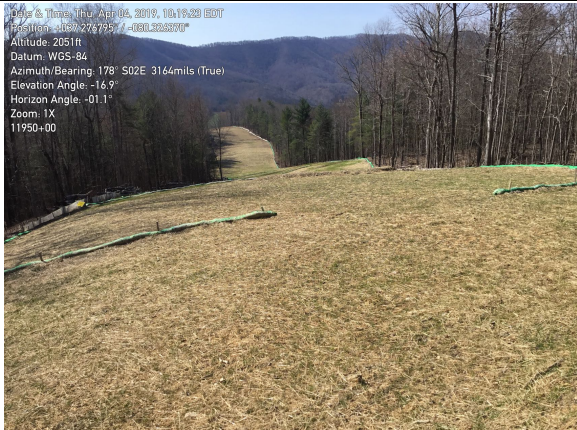
GPS Location	37.33	Field Station#	11950+00	GPS Location	37.33	Field Station#	11950+00
Description	Row stabilized			Description	ECDs protecting karst area		
<div><div><div>Date &amp; Time: Thu, Apr 04, 2019, 10:38:50 EDT Position: +037 271512° / -080 324251° Altitude: 1760ft Datum: WGS-84 Azimuth/Bearing: 125° S55E 2222mils (True) Elevation Angle: -16.9° Horizon Angle: +00.5° Zoom: 1X 11979+00</div>

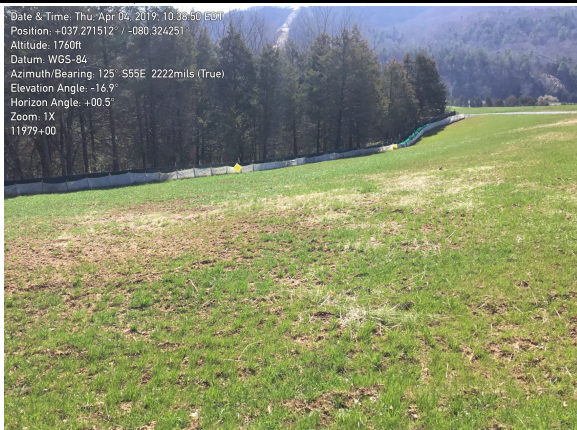
</div></div>				
GPS Location	37.33	Field Station#	11979+00	GPS Location	37.33	Field Station#	11975+00
Description	ECDs protecting karst area			Description	ECDs protecting karst area

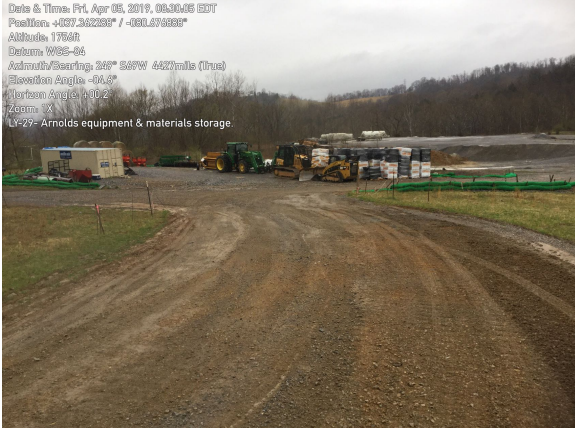
</div>				
GPS Location	37.36	Field Station#	12005+00	GPS Location	37.36	Field Station#	12005+00
Description	LY-29- Arnold's seeding equipment & Materials storage			Description	LY-29- Culvert & ECDs		
<div><p>Date &amp; Time: Fri, Apr 05, 2019, 08:35:21 EDT Position: +037.362281° / -080.677546° Altitude: 1723ft Datum: WGS-84 Azimuth/Bearing: 045° N45E 3871mils (True) Elevation Angle: -04.5° Horizon Angle: +01.6° Zoom: 1X LY-29- Triple stack CFS perimeter controls on northern perimeter of th yard.</p>

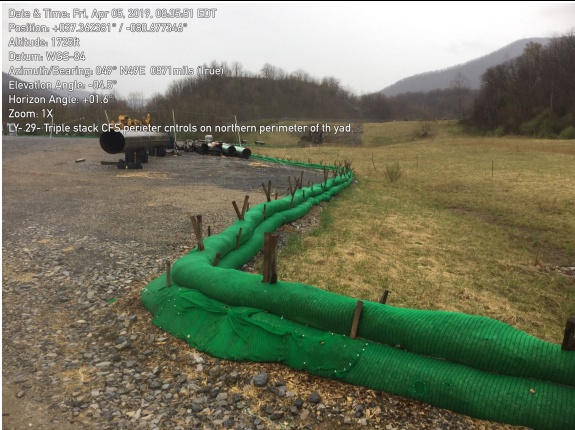
GPS Location	37.36	Field Station#	12005+00	GPS Location	37.36	Field Station#	12005+00
Description	Triple stack perimeter controls on northern side of yard.			Description	Rock surface is maintained.		
<div><p>Date &amp; Time: Fri, Apr 05, 2019, 08:43:59 EDT Position: +037.363408° / -080.676971° Altitude: 1681ft Datum: WGS-84 Azimuth/Bearing: 238° 55'W 4231mils (True) Elevation Angle: -05.8° Horizon Angle: +00.2° Zoom: 1X LY-29 - triple stack perimeter controls on west side of yard.</p>

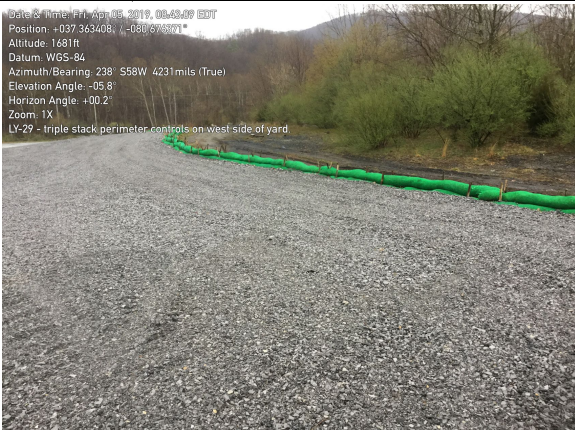
</div>				
GPS Location	37.36	Field Station#	12005+00	GPS Location	37.36	Field Station#	12005+00
Description	LY- 29- Triple stack perimeter controls on west side of yard.			Description	LY-29- Triple stack CFS perimeter controls on south side of yard.

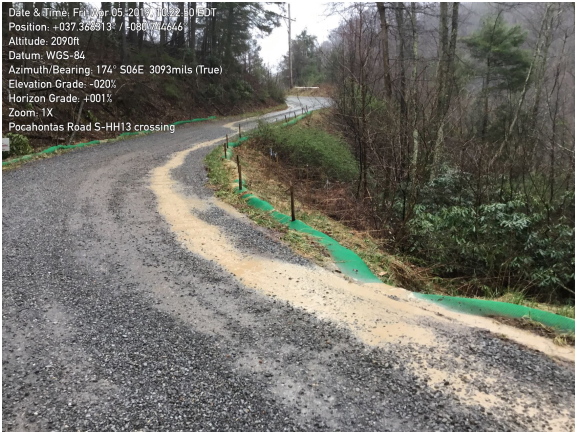
<b>AFE</b>	124300137	<b>Date/Time</b>	4/5/2019 12:44 PM	<b>Report #</b>	15507
<b>6. PCSM BMPs</b> (List BMPs and note if installed and maintained as per the plan. If corrective action is needed, a picture is required.)					
<b>PCSM BMPs</b>	<b>Compliance Level</b>	<b>Corrective Action</b>	<b>Corrective Time Frame</b>	<b>Date Repaired</b>	
<b>7. Identify all remedial measures that have been taken since the previous inspection was conducted.</b>					
<b>Comments</b> (Reference above questions as appropriate.)					
<p>A routine VADEQ SWPPP inspection was completed for Pocahontas Road. There was no FS logging activity taking place today. Light rain occurred during the inspection. Transcon inspectors Dan Danko and Steve Milauskas were on location. Neither reported any environmental concerns. A small load of stone has been placed on the road at the entrance of Pocahontas Road and the intersection of Clendennin Road. The rock was added by the logging contractor apparently. Runoff from rain shower was contained to LOD beyond area of logging traffic (station 0+00-64+00). Stream S-HH13, located between the area of logging activity and entrance to the road, was cloudy from damages to CFS (photo below). Other resources beyond the logging area that are adjacent to or crossed by the road show no evidence of impact. ECDs along road are in place and effective although there are maintenance needs that should be addressed. No impact noted at the two stream fords S-MN17 and S-HH16. The failed culverts at the S-PP19 crossing and S-PP14 show no change. The S-PP19 crossing continues to be hazardous. Road improvements such as grading, ditching and adding of rock are needed. The Forest Service will not allow any ECD maintenance or Road repair currently.</p>

GPS Location	37.31	Field Station#	18+65	GPS Location	37.31	Field Station#	18+65
Description	Correct coordinates on photo. Turbid water entering stream S-HH13. CFS has been damaged by log trucks.			Description	Correct coordinates on photo. Turbid water entering stream S-HH13. CFS damaged by log trucks.		
<p>Date &amp; Time: Fri Apr 05 2019 10:42:59 EDT Position: +037.382203 / -080.713917 Altitude: 2812ft Datum: WGS-84 Azimuth/Bearing: 110° S70E 1336mils (True) Elevation Grade: +041% Horizon Grade: +006% Zoom: 1X Pocahontas Road S-PP19 crossing at failed culvert</p>

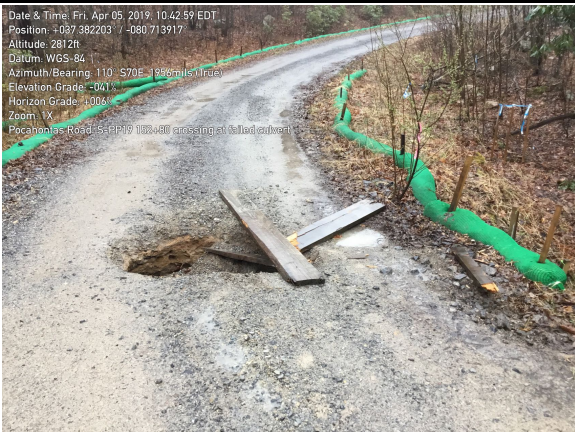
GPS Location	37.31	Field Station#	152+80	GPS Location	37.31	Field Station#	101+50
Description	Correct coordinates on photo. Failed culvert crossing is hazardous at S-PP19 crossing.			Description	Correct coordinates on photo. Ford at S-HH16 shows no impact from MVP traffic.		
<p>Date &amp; Time: Fri Apr 05 2019 11:00:37 EDT Position: +037.373988 / -080.732285 Altitude: 2206ft Datum: WGS-84 Azimuth/Bearing: 043° N3E 0754mils (True) Elevation Grade: +021% Horizon Grade: +004% Zoom: 1X Pocahontas Road S-MN17 crossing stable</p>  		<p>Date &amp; Time: Fri Apr 05 2019 11:00:37 EDT Position: +037.392775 / -080.674193 Altitude: 2660ft Datum: WGS-84 Azimuth/Bearing: 176° S04E 3129mils (True) Elevation Grade: +060% Horizon Grade: +005% Zoom: 1X Pocahontas Road failed culvert S-PP14 no impact evident</p>

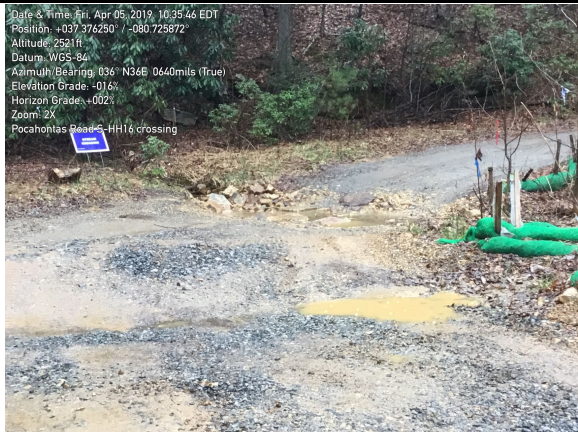
<p>Date &amp; Time: Fri Apr 05 2019 10:35:46 EDT Position: +037.376250 / -080.725872 Altitude: 2581ft Datum: WGS-84 Azimuth/Bearing: 036° N36E 0640mils (True) Elevation Grade: +016% Horizon Grade: +002% Zoom: 2X Pocahontas Road S-HH16 crossing</p>

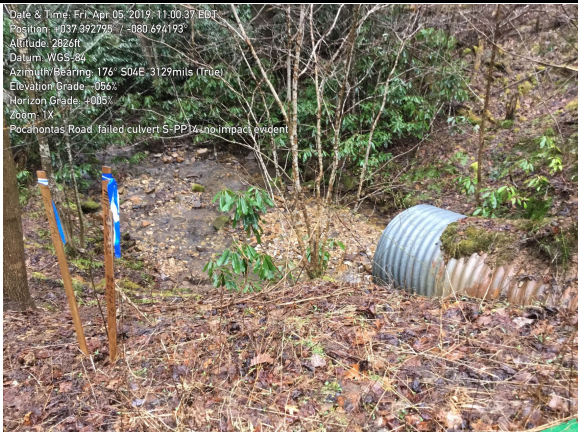
GPS Location	37.31	Field Station#	76+25	GPS Location	37.31	Field Station#	26+45
Description	Correct coordinates on photo. Ford crossing of stream S-MN17 shows no impact from MVP traffic.			Description	Correct coordinates on photo. No impact at resource S-PP14.

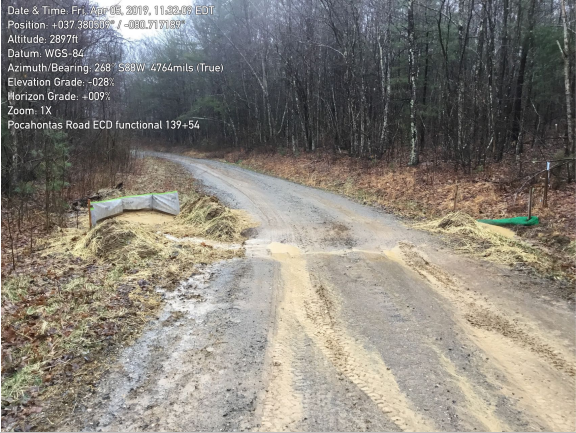
<b>AFE</b>	124300137		<b>Date/Time</b>	4/5/2019 12:44 PM		<b>Report #</b>	15507	
<b>Pictures</b>								
<small>Date &amp; Time: Fri Apr 05, 2019, 11:30:25 EDT  Position: +037.380467 / -080.724417  Altitude: 2897ft  Datum: WGS-84  Azimuth/Bearing: 268.588W 4764mils (True)  Elevation Grade: -028%  Horizon Grade: +009%  Zoom: 1X  Pocahontas Road ECD functional 139+54</small>

<b>GPS Location</b>	37.31	<b>Field Station#</b>	139+54		<b>GPS Location</b>	37.31	<b>Field Station#</b>	106+35
<b>Description</b>	Correct coordinates on photo. ECDs in place and effective. Minor maintenance needed.				<b>Description</b>	Correct coordinates on photo. ECDs in place and effective. Minor maintenance needed.

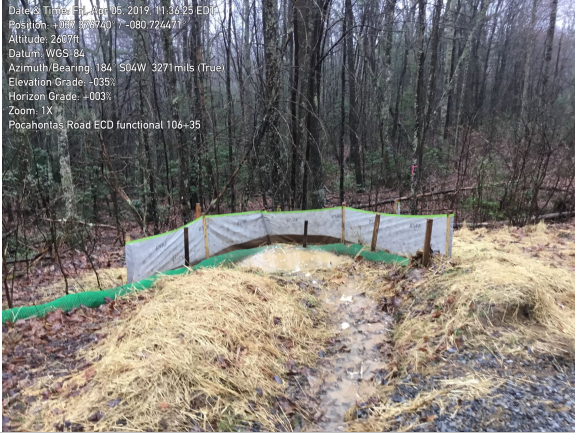
<small>Date &amp; Time: Fri Apr 05, 2019, 11:30:25 EDT  Position: +037.380467 / -080.724417  Altitude: 2897ft  Datum: WGS-84  Azimuth/Bearing: 184.504W 3271mils (True)  Elevation Grade: -035%  Horizon Grade: +003%  Zoom: 1X  Pocahontas Road ECD functional 106+35</small>

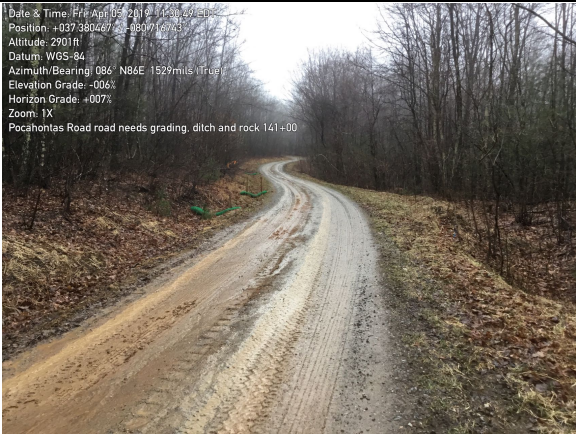
<small>Date &amp; Time: Fri Apr 05, 2019, 11:30:25 EDT  Position: +037.380467 / -080.724417  Altitude: 2901ft  Datum: WGS-84  Azimuth/Bearing: 086.186E 1529mils (True)  Elevation Grade: -006%  Horizon Grade: +007%  Zoom: 1X  Pocahontas Road road needs grading, ditch and rock 141+00</small>
