Visual Site Inspection Report

| Project Name | H-600 Pipeline Spread H | AFE | 124300138 | Spread | H-600 Pipeline Spread H |
| Inspector | Tyler Cremeens | | | Date/Time | 4/15/2019 7:13 AM |
| Permit # | TBD | Inspection Type | VA SWPP | Station Begin | 13262+62 |

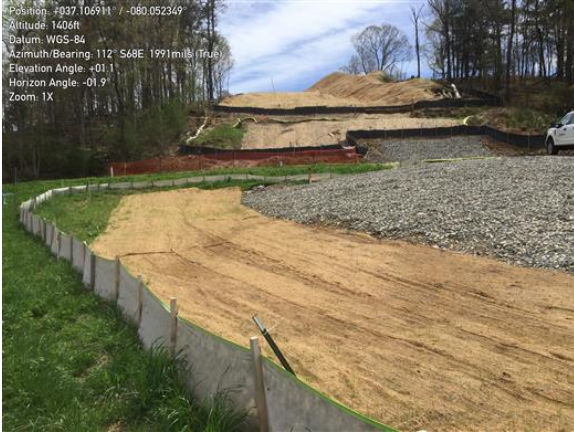
| Description | Wade's Gap Road & RCE in the background. Northern perimeter silt fence & ECB in the fore. View: Southwest, see photo for GPS data | | | Description | Stabilized waterbar in the background with sump & CFS outlet in the foreground. View: South, see photo for GPS data. | | |

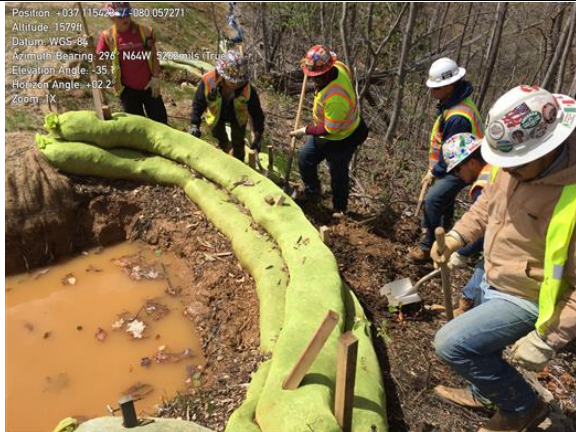
| Description | Washout undercut of CFS at waterbar's sump outlet discovered. View: Southeast, see photo for GPS data. | | | Description | Personnel repairing the undercut CFS at a sump outlet for a water bar. View: Northwest, see photo for GPS data. | | |

| E&S BMPs | Compliance Level | Corrective Action | Corrective Time Frame | Date Repaired |
|---|---|---|---|---|
| Sump Pit | Communication | Repaired washouts under CFS | Addressed | 4/15/2019 |

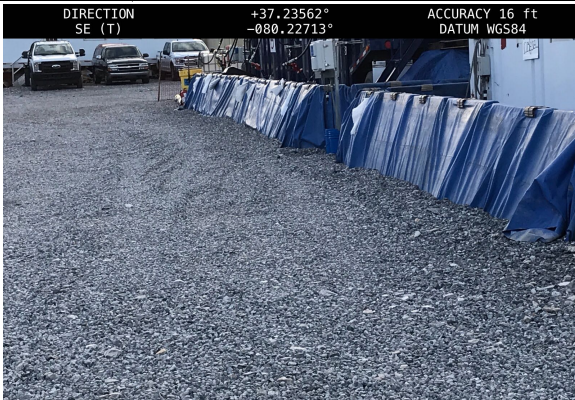
| Description | | MVP-PY-006_041519 no fluid deposits on the north side of the bulk fuel tanks. Looking SE. See photo for gps data. | | | | | | Description | | MBP-PY-006_041519 no fluid deposits on the south side of the bulk fuel tanks. Looking E. See photo for gps data. | |

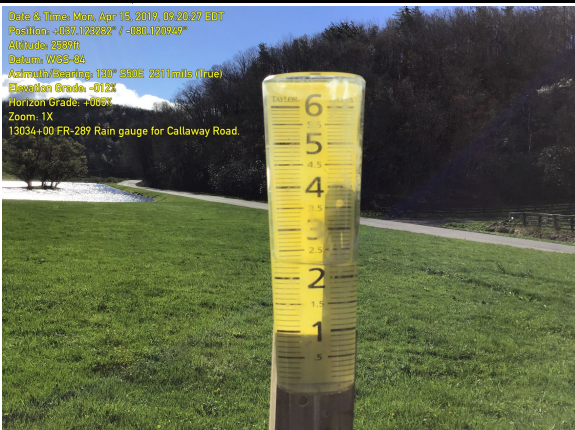
| Description | Rain gauge at Callaway road. 2.4" total precipitation for the weekend. | | | Description | No issues or impacts found in the area. | | |

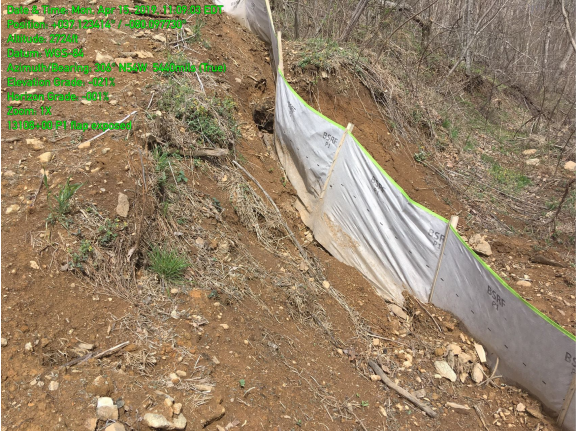
| Description | Exposed flap on P1. | | | Description | Reattach fabric to SSF | | |

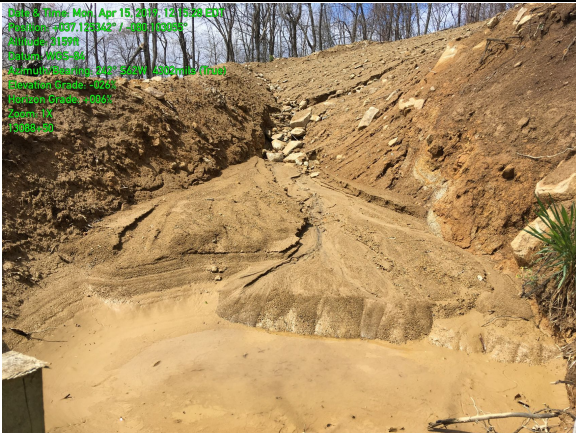
| Description | Sump needs cleaned out. | | | Description | P1 flap exposed | | |

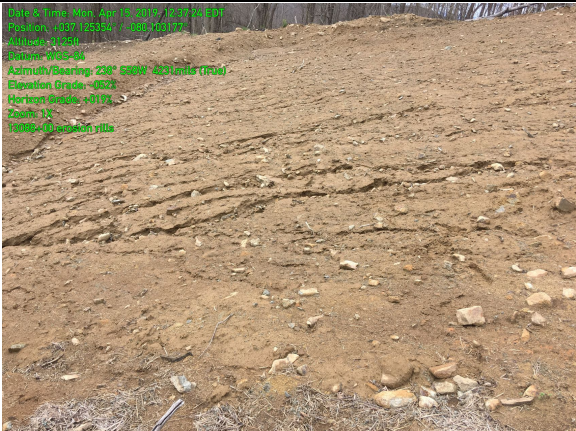
| Description | Rill erosion needs racked out and area stabilized. | | | Description | | | |

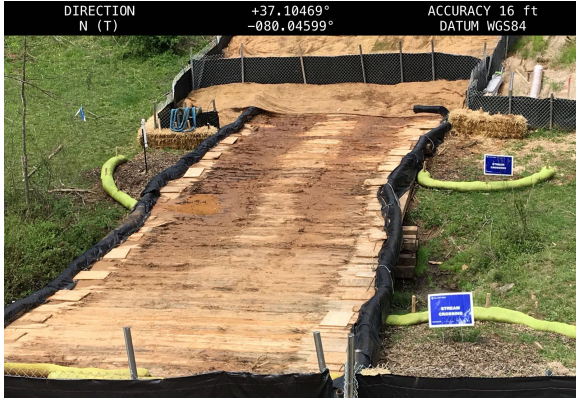
| Description | | 13337+13_041519 S-GH9 mat bridge clean and closed. Looking NW. See photo for gps data. | | Description | | 13334+17_041519 S-GH11 mat bridge clean and closed. Looking N. See photo for gps data. | |

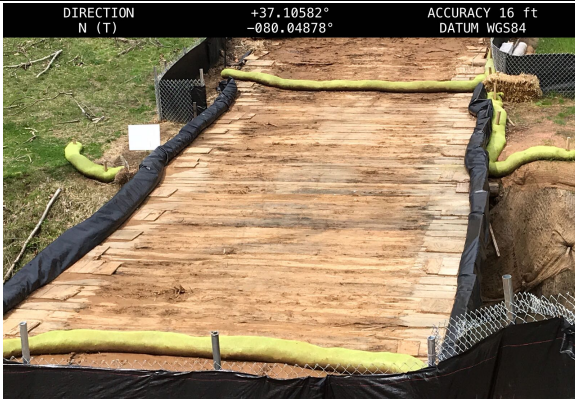
| Description | | 13325+30_041519 SGH14 mat bridge clean and closed. Looking N. See photo for gps data. | | Description | | 13334+17_041519 SRR11 mat bridge clean and closed. Looking SE. See photo for gps data. | |

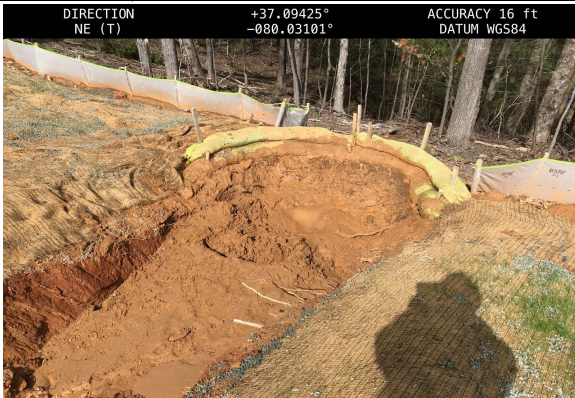
| Description | | 1341+80_041519 sump full. Looking NE. See photo for gps data. | | Description | | 13365+00_041519 end treatment undermined. No sediment off ROW. Looking SW. See photo for gps data. | |

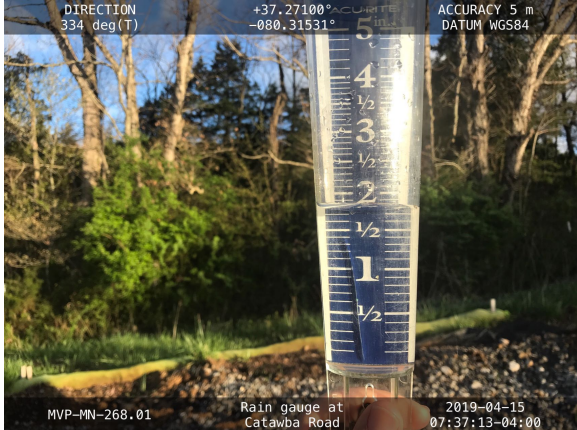
| Description | See photo for gps data. Photo shows the rain gauge at Catawba Road. 1.8" of rainfall was recorded within the last 3 days. | | | Description | See photo for gps data. Photo shows the perimeter compost filter sock between 12055+00 and 12058+00. | | |

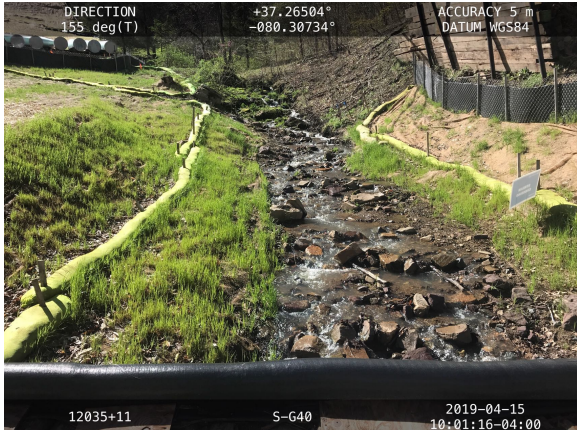
| Description | See photo for gps data. Photo shows stream S-G40. | | | Description | See photo for gps data. Photo shows the ROW condition from about 12016+00 to 12026+00. | | |

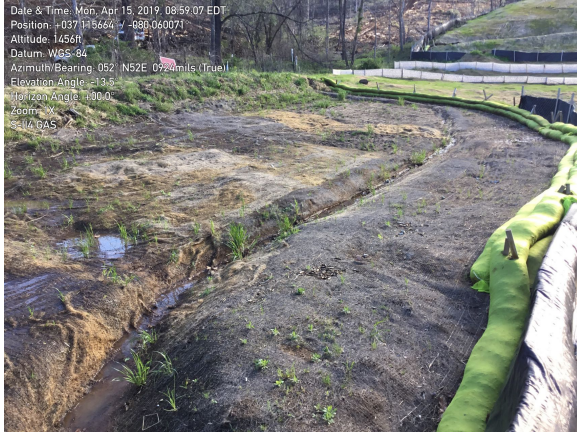
| Description | Please see photo for accurate coordinates. ATWS-1055, clean water conveyance flowing water. | | Description | Please see photo for accurate coordinates. ATWS-1055, water coming onto ROW from W-II4. | |

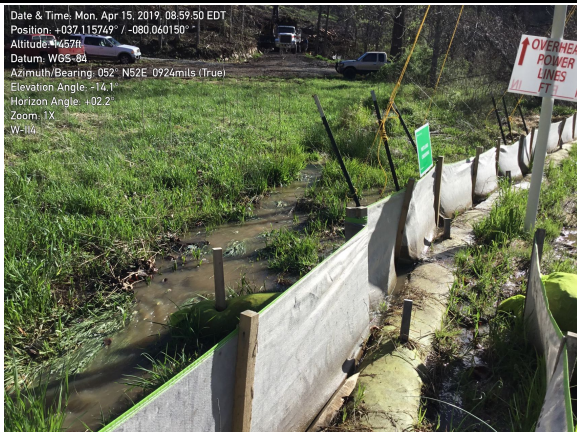
| Description | Please see photo for accurate coordinates. W-II4, channelized flow through wetland flowing outside of LOD. | | Description | Please see photo for accurate coordinates. ATWS-1055, turbid water flowing outside of LOD, entering S-II4. | |

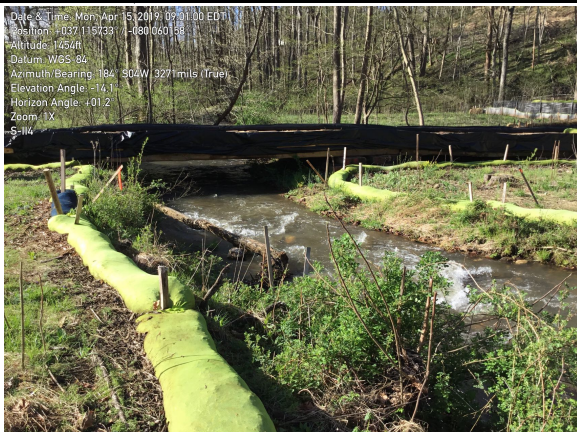
| Description | Please see photo for accurate coordinates. S-II4, high water from rain event, no ECD issues along stream or bridge. | | Description | Please see photo for accurate coordinates. ROW, clean water diversion berm flowing water into sump, water filtered through ECDs. | |

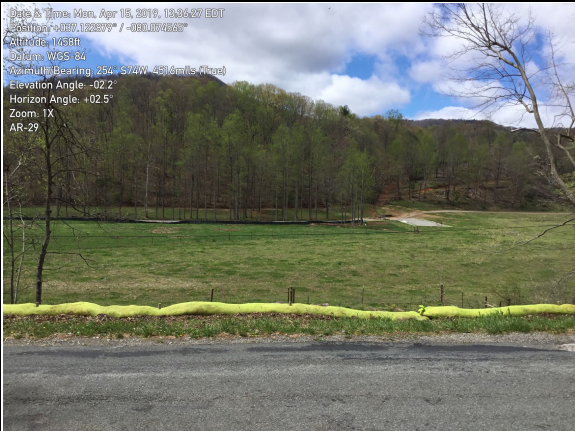
| Description | Please see photo for accurate coordinates. MVP-MLV-AR-29, ECDs functioning acceptably along access road. | | | Description | Please see photo for accurate coordinates. MVP-MLV-AR-29, ECDs functioning acceptably at S-D10. | | |

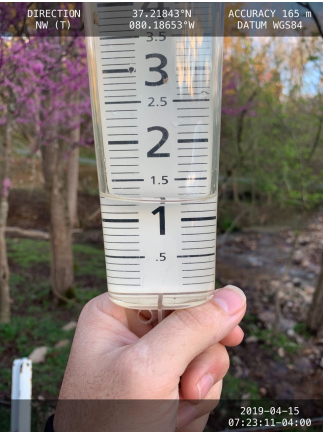
| Description | Rain Gauge with 1.3". Looking Nw. See picture for GPS data. | | | Description | Stabilized topsoil. Looking SE. See picture for GPS data. | | |

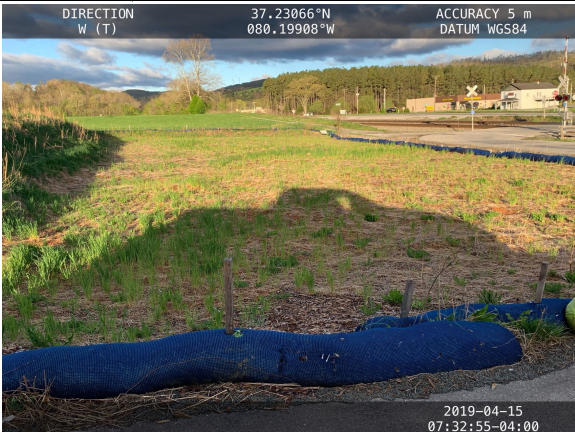
| Description | Stabilized disturbed variance. Looking W. See picture for GPS data. | | | Description | Stabilized topsoil pile. Looking SW. See picture for GPS data. | | |

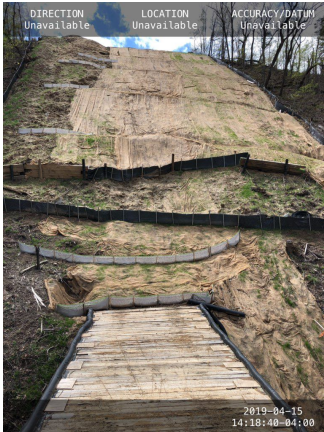
| Description | Bridge and stabilized slope crossing clear water crossing. | | | Description | Stabilized slope with water bars. Looking W. See picture for GPS data. | | |

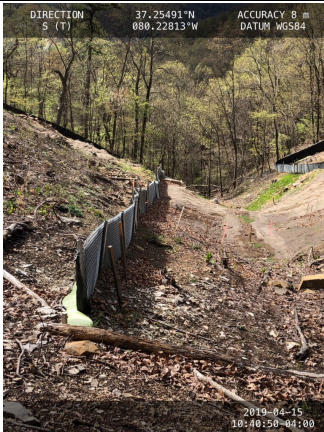
| Description | Clear water crossing. Looking S. See picture for GPS data. | | | Description | Stabilized travel lane on GAS of clear water crossing. Looking E. See picture for GPS data. | | |

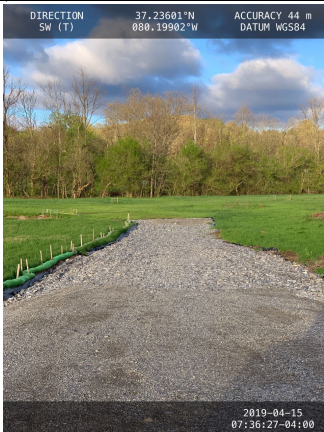
| Description | RCE. Looking SW. See picture for GPS. | | | Description | Stabilized steep slope. Looking N. See picture for GPS data. | | |

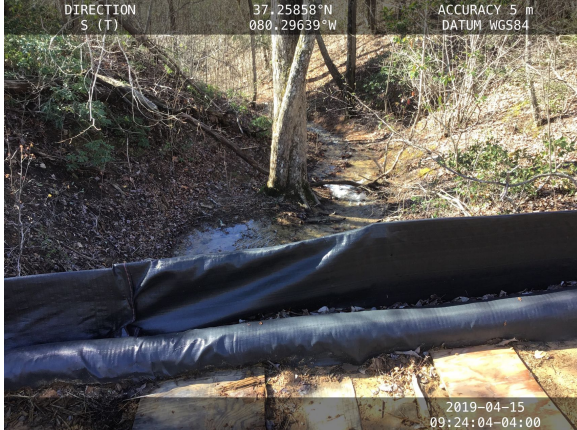
| Description | | Stream S-MM15, facing south. No impacts to the stream or surrounding ECDs. | | | | | | | | | | Description | | Stream S-MM15, facing west. | |

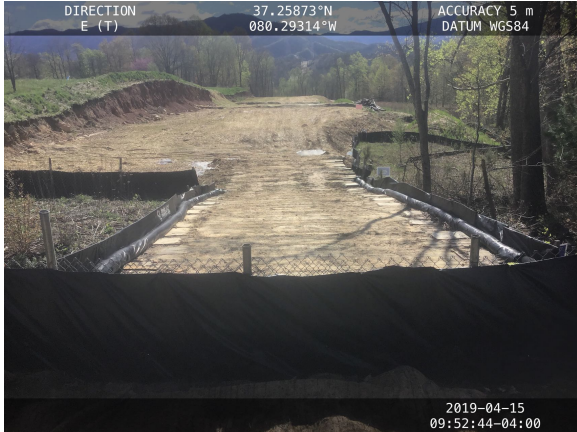
| Description | | Stream S-MM14, facing east. Bridge and ECDs in good condition, no indication of impacts from the weekend rain event. | | | | | | | | | | Description | | Stream S-MM13, facing southeast. | |

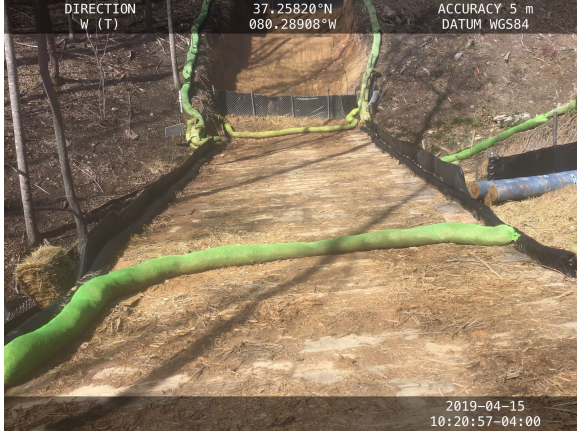
| Description | | Stream S-MM13, facing west. Bridge and ECDs in satisfactory condition. No apparent impacts from the rain event. | | | | | | | | | | Description | | Stream S-F15, facing east. Bridge and ECDs in satisfactory condition, no apparent impacts from the rain event. | |

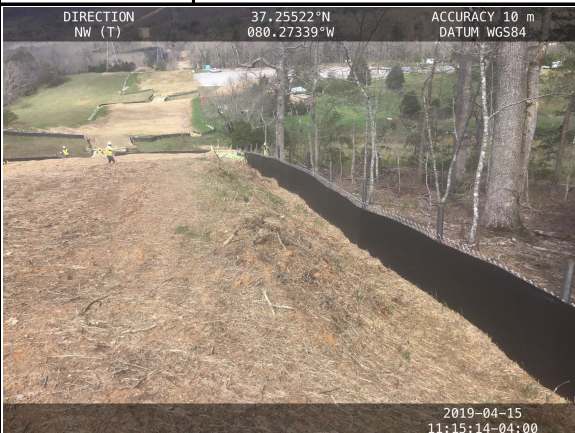
| Description | Facing northwest. Perimeter controls in good condition. | | | Description | Stream S-C25, facing east. No issues observed on bridge or surrounding ECDs. | | |

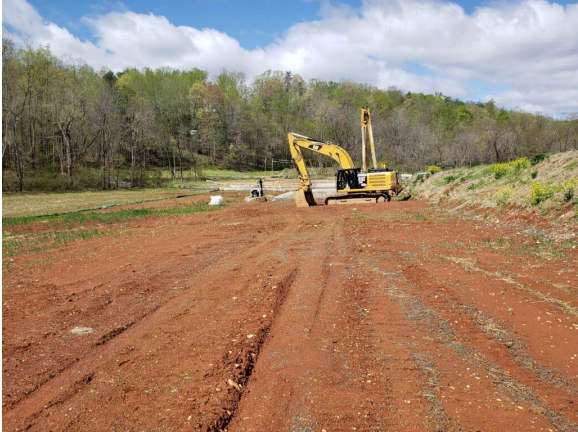
| Description | | RoW saturated with equipment staged at Leaning Oak | | Description | |

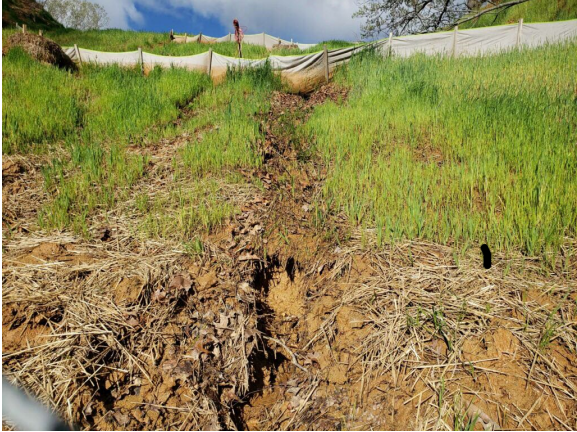
| | | | | Multiple erosion channels leading from top of slope down to the last row of silt fence, sediment build up on silt fence. | |

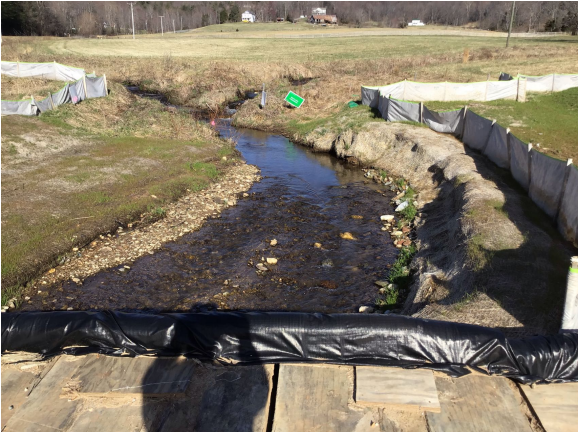
| Description | | Stream crossing S-IJ10 fowinf free and clear of sediment | | Description | |

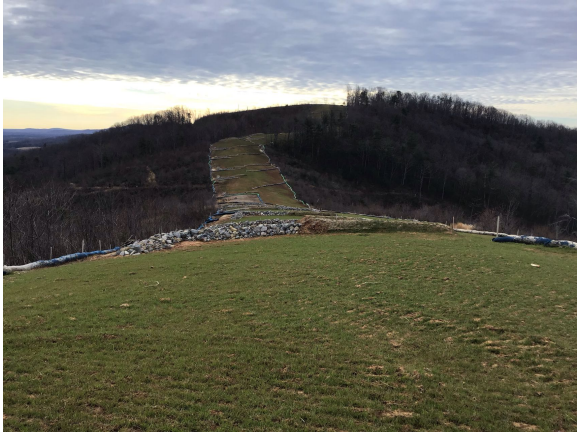
| | | | | Permanent stabilization and E&S controls in good condition. | |

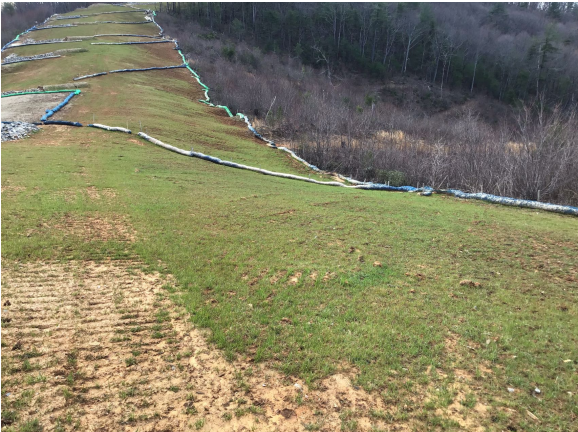
| Description | | Stabilization and perimeter controls in good condition | | Description | |

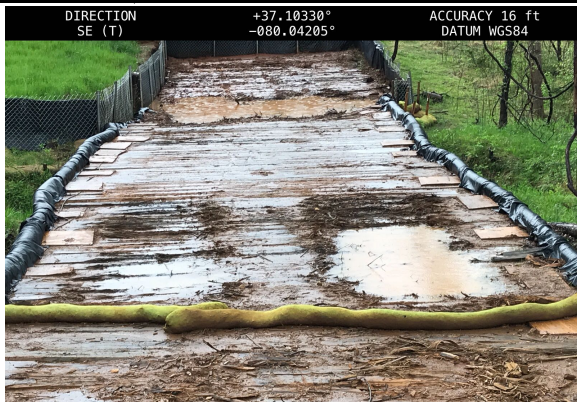
| Description | | 13348+46_041919 S-RR08 mat bridge clean and closed. Looking SE. See photo for gps data. | | Description | | 13413+05_041919 S-IJ1 mat bridges clean and closed, slope stable. Looking NW. See photo for gps data. | |

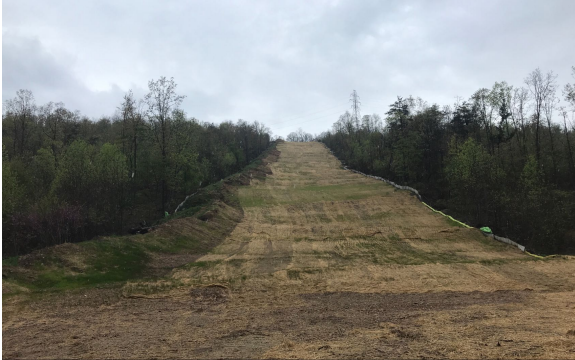
| Description | See photo for gps data. Photo shows the ROW condition from about 12062+00 to 12072+00. | | | Description | See photo for gps data. Photo shows the perimeter ECDs from 12068+00 to about 12072+00. |

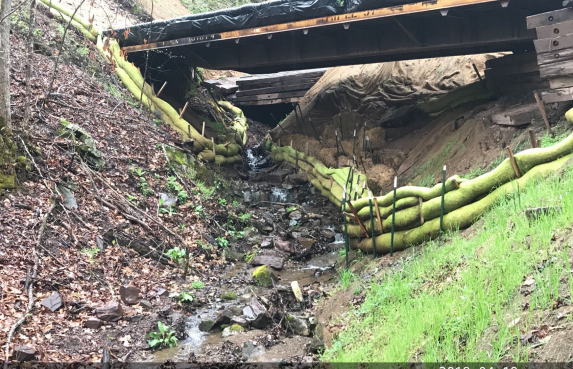
| Description | See photo for gps data. Photo shows the ROW condition from about 12036+00 to 12052+00. | | | Description | See photo for gps data. Photo shows stream S-G39. |

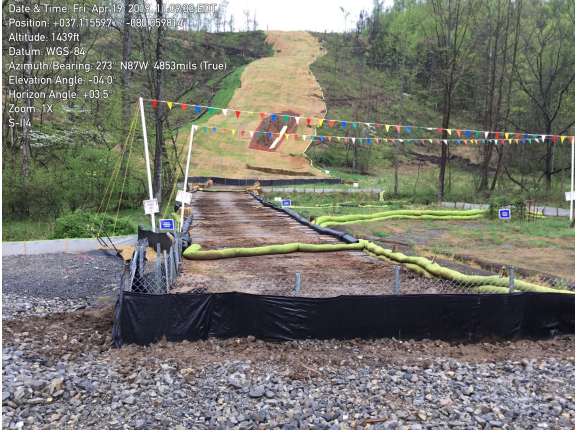
| Description | Please see photo for accurate coordinates. S-II4, ECDs functioning acceptably at stream crossing. | | | Description | Please see photo for accurate coordinates. S-II4, looking upstream, ECDs functioning acceptably along stream banks. | | |

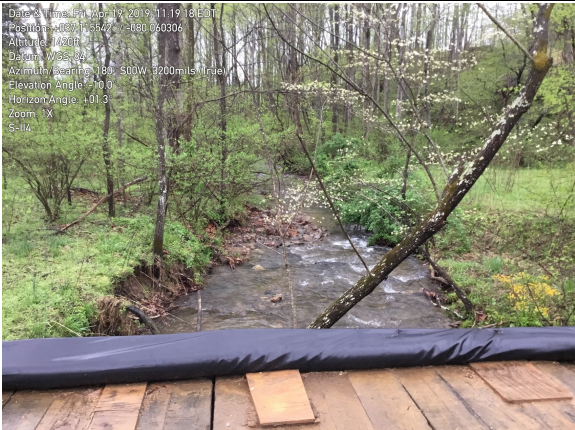
| Description | Please see photo for accurate coordinates. S-II4, looking downstream, no environmental issues observed. | | | Description | Please see photo for accurate coordinates. ROW, perimeter ECD and clean water diversion functioning acceptably. | | |

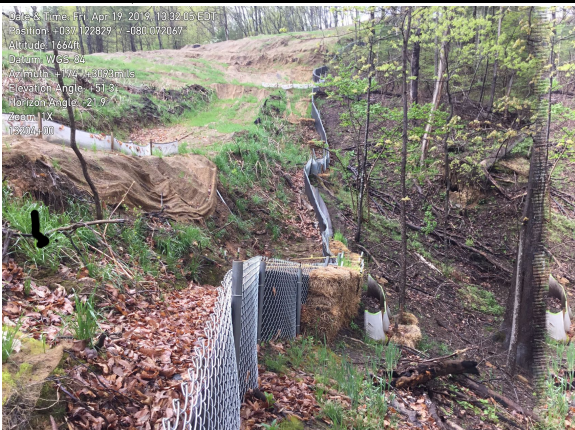
| Description | Please see photo for accurate coordinates. ROW, perimeter ECDs functioning acceptably, no environmental issues noted. | | | Description | Please see photo for accurate coordinates. MVP-MLV-AR-29, W-D4, standing water observed. | | |

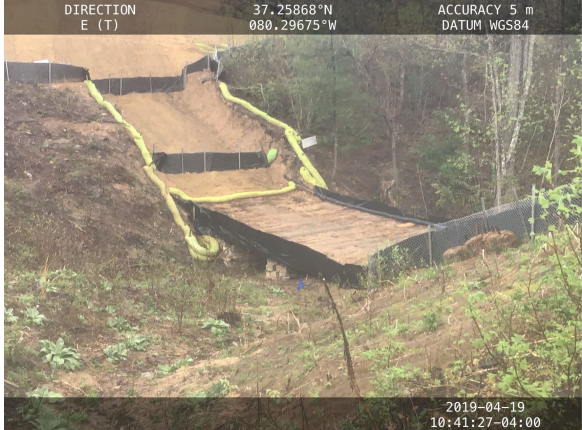
| Description | Stream S-MM15, facing east. No issues with bridge or ECDs. | | | Description | Facing west. Minimal vegetation on right-of-way, but erosion control blanket is still in good condition and providing adequate stabilization. | | |

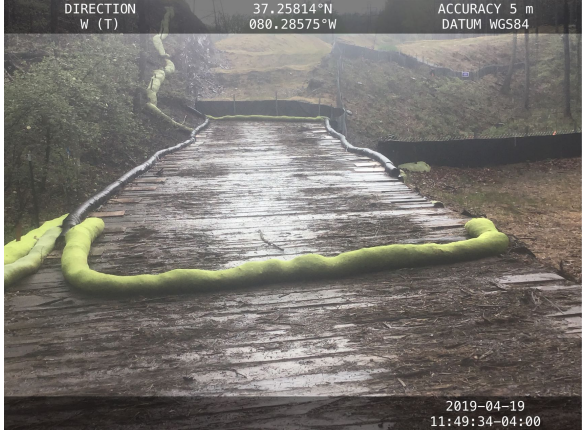
| Description | Stream S-F15, facing west. Bridge and ECDs in satisfactory condition. | | | Description | Stream S-F16A/B, facing east. No problems with bridge or ECDs. | | |

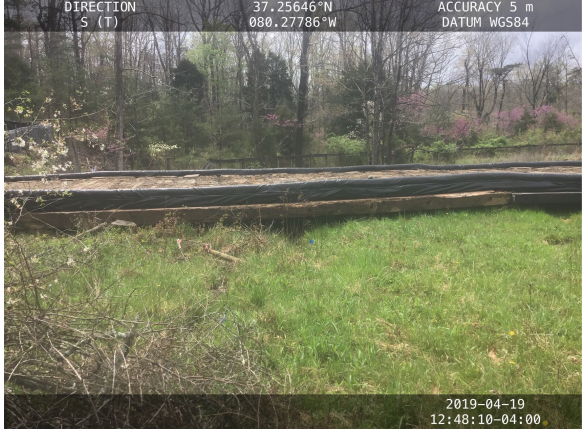
| Description | Stream S-C29, facing south. Bridge and ECDs in satisfactory condition and functioning properly. | | | Description | Wetland W-C5, facing southeast. Timber mat crossing and adjacent ECDs in satisfactory condition. | | |

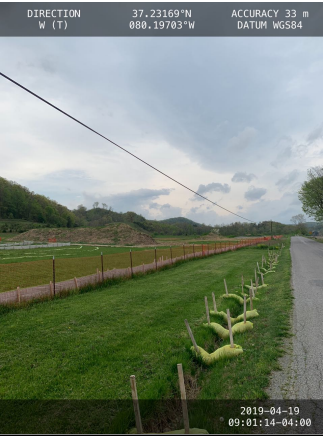
| Description | Checks in the drainage ditch. Looking W. See picture for GPS data. | | | Description | Erosion control blanket covered drain where rain water crosses the ROW. Looking SW. See picture for GPS data. | | |

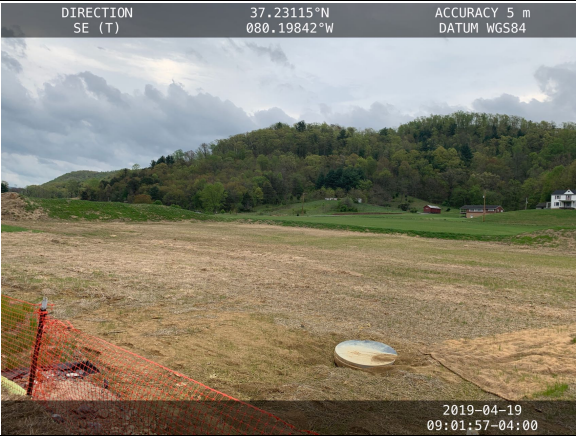
| Description | Stabilized ROW. Looking SE. See picture for GPS data. | | | Description | RCE. Looking SE. See picture for GPS data. | | |

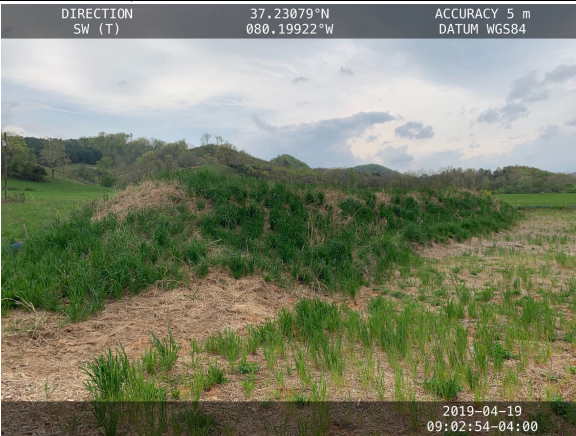
| Description | Stabilized topsoil pile. Looking SW. See picture for GPS data. | | | Description | Stabilized ROW. Looking W. See picture for GPS data. | | |

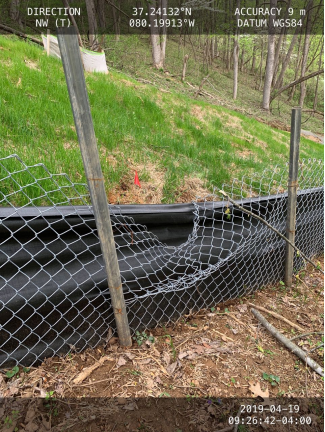
| Description | Piece of SSF where MBP found a tree limb had fallen on the fence. Looking NW. See picture for GPS data. | | | Description | Piece of SSF that was found by MBP after the environmental crew repaired it from fallen tree damage. |

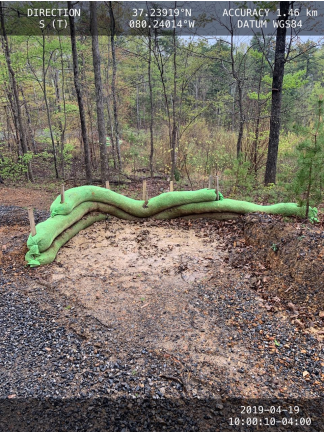
| Comments (Reference above questions as appropriate.) Went to access road MVP-MLV-AR-27 where MBP had taken a walk and found where a small tree limb had fallen and damaged the top part of the SSF and pulled the fabric loose. The environmental crew came straight to the location and repaired the damaged fence. Went to access road MVP-MN-276.03 to continue with my SWPPP inspection. While in the area I inspected all ECDs, RCEs, and stabilization. Everything was in good condition and there is no need for maintenance. Went to Lafayette road to check the conditions of the stabilized hill following the rain event. | | | | | |

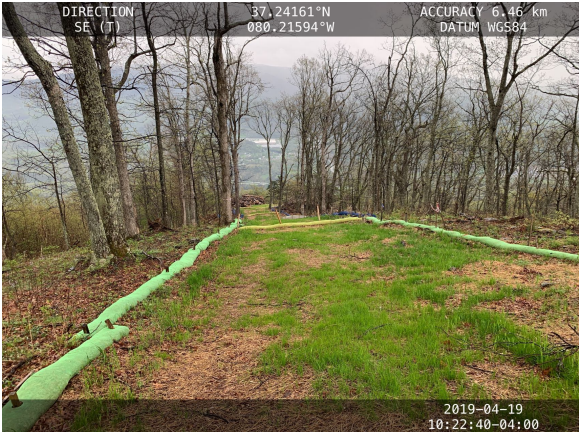
| Description | J-Hook outlet along access road MVP-MN-276.03. Looking S. See picture for GPS data. | | | Description | Stabilized steep slope. Looking SE. See picture for GPS data. |
