## Visual Site Inspection Report

<b>Project Name</b>	H-600 Pipeline Spread H	<b>AFE</b>	124300138	<b>Spread</b>	H-600 Pipeline Spread H
<b>Contractor</b>	Precision			<b>Report #</b>	16151
<b>Inspector</b>	Glenn Mike Renfro			<b>Date/Time</b>	4/22/2019 1:18 PM
<b>Permit #</b>	TBD	<b>Inspection Type</b>	VA SWPP	<b>Station Begin</b>	13415+00
<b>State</b>	VA	<b>Inspection Area</b>	Full	<b>Station End</b>	13670+00
<b>County</b>	Franklin	<b>Ground</b>	Damp	<b>Temperature (°F)</b>	67.00
<b>Municipality</b>	N/A	<b>Weather</b>	Sunny	<b>Rain Gauge (in)</b>	1.80
				<b>Rain Accumulation Time (days)</b>	6.00

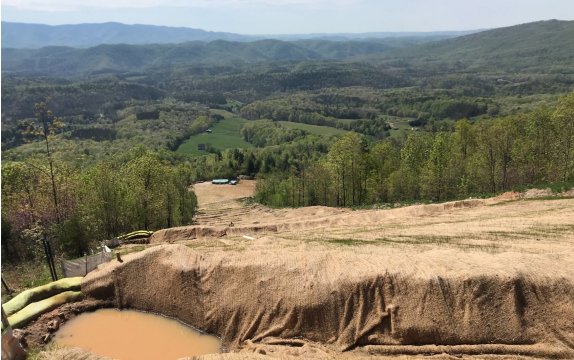
<div>12062+00 to 12072+00</div> <div>ROW condition</div> <div>2019-04-25 10:47:45-04:00</div>			<div>DIRECTION 309 deg(T)</div> <div>+37.26099° -080.29978°</div> <div>ACCURACY 5 m DATUM WGS84</div>

<div>12062+00 to 12058+00</div> <div>ROW condition</div> <div>2019-04-25 10:48:05-04:00</div>				
GPS Location	37.09	Field Station#	12062+00	GPS Location	37.09	Field Station#	12062+00
Description	See photo for gps data. Photo shows the ROW condition from about 12062+00 to 12072+00.			Description	See photo for gps data. Photo shows the ROW condition from about 12062+00 to 12058+00.		
<div>DIRECTION 328 deg(T)</div> <div>+37.26181° -080.30239°</div> <div>ACCURACY 5 m DATUM WGS84</div>

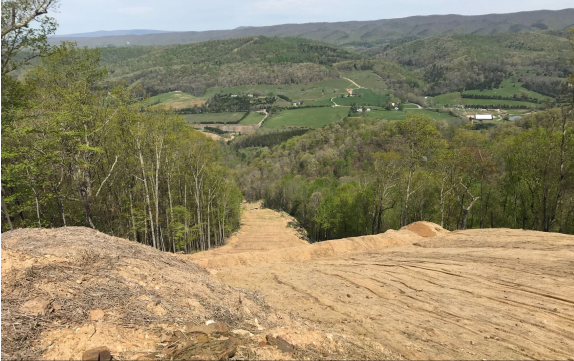
<div>12037+00 to 12054+00</div> <div>ROW condition</div> <div>2019-04-25 10:58:16-04:00</div>			<div>DIRECTION 359 deg(T)</div> <div>+37.26255° -080.30313°</div> <div>ACCURACY 10 m DATUM WGS84</div>

GPS Location	37.09	Field Station#	12054+00	GPS Location	37.09	Field Station#	12052+00
Description	See photo for gps data. Photo shows the ROW condition from about 12037+00 to 12054+00.			Description	See photo for gps data. Photo shows the perimeter ECDs from about 12052+00 to 12048+00.		
<div>DIRECTION 260 deg(T)</div> <div>+37.26489° -080.30721°</div> <div>ACCURACY 5 m DATUM WGS84</div>

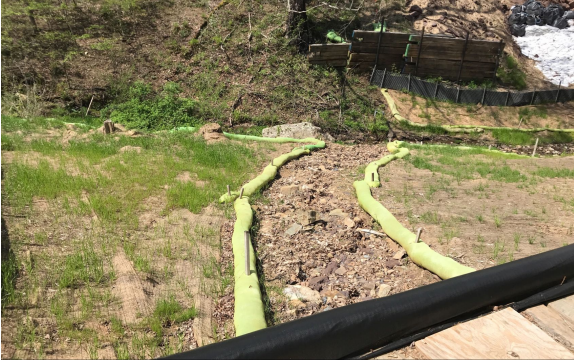
<div>12036+00</div> <div>S-PP23</div> <div>2019-04-25 11:22:22-04:00</div>			<div>DIRECTION 356 deg(T)</div> <div>+37.26481° -080.30723°</div> <div>ACCURACY 5 m DATUM WGS84</div>

<div>12035+11</div> <div>S-G40</div> <div>2019-04-25 11:23:14-04:00</div>				
GPS Location	37.09	Field Station#	12036+00	GPS Location	37.09	Field Station#	12035+11
Description	See photo for gps data. Photo shows stream S-PP23.			Description	See photo for gps data. Photo shows stream S-G40.

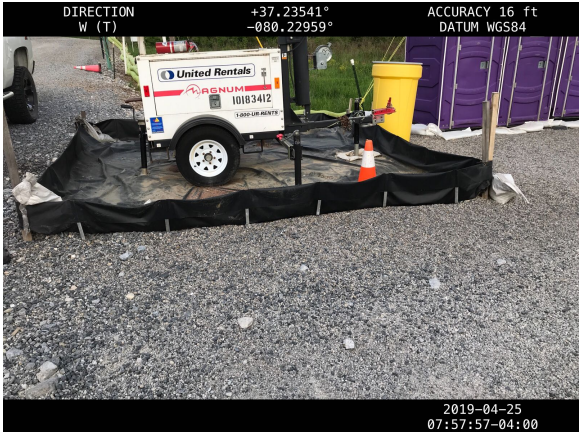
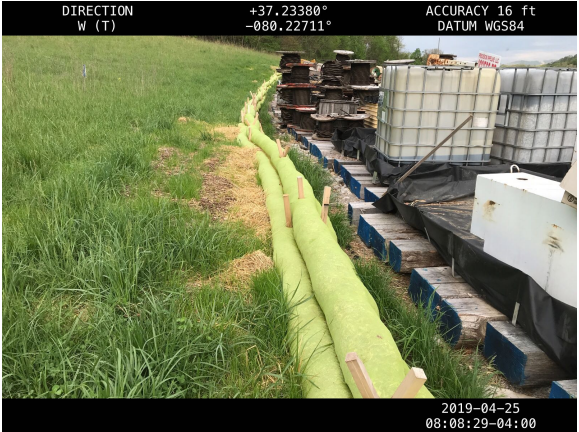
<p>DIRECTION W (T) +37.23380° -080.22711° ACCURACY 16 ft DATUM WGS84</p> <p>2019-04-25 08:08:29-04:00</p>				
GPS Location	37.23	Field Station#	+0	GPS Location	37.23	Field Station#	+0
Description	MVP-PY-006_042519 condition of containment under light plant. Looking W. See photo for gps data.			Description	MVP-PY-006_042519 condition of triple stack compost filter sock on south boundary. Looking W. See photo for gps data.

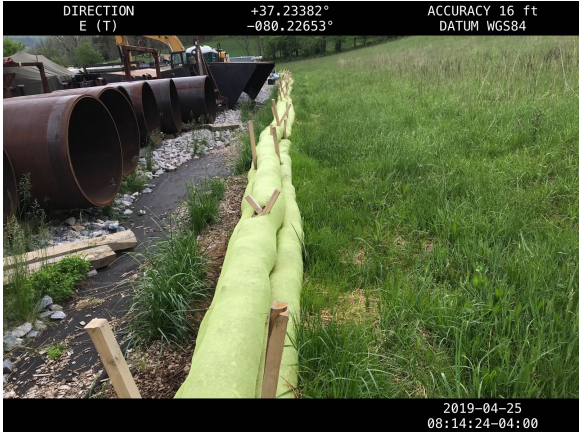
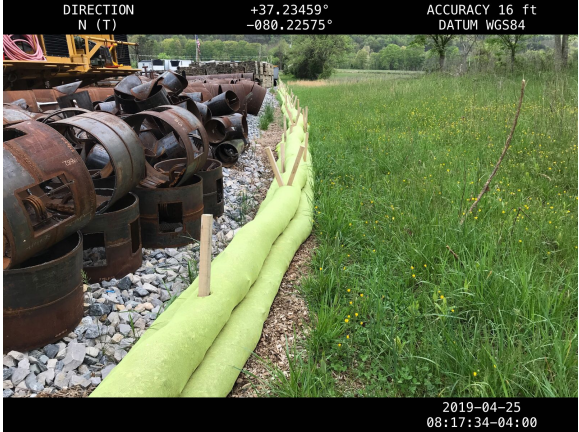
Description	MVP-PY-006_042519 condition of triple stack compost filter sock on the south boundary. Looking E. See photo for gps data.			Description	MVP-PY-006_042529 condition of triple stack compost filter sock on east boundary. Looking N. See photo for gps data.

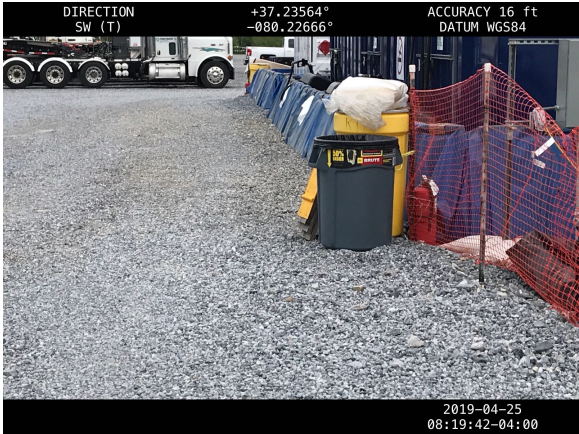
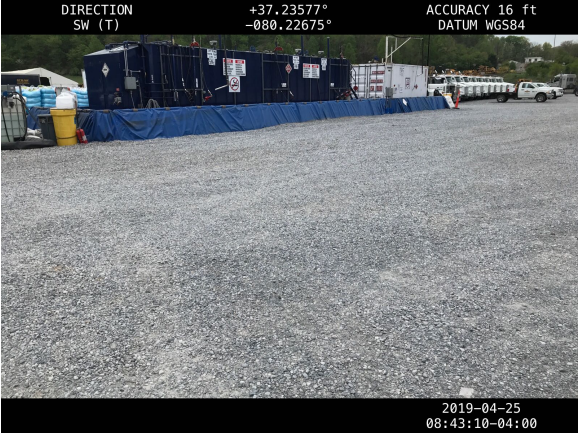
<p>DIRECTION SW (T) +37.23577° -080.22675° ACCURACY 16 ft DATUM WGS84</p> <p>2019-04-25 08:43:10-04:00</p>				
GPS Location	37.23	Field Station#	+0	GPS Location	37.23	Field Station#	+0
Description	MVP-PY-006_042519 no fluid deposits on the south side of the bulk fuel tanks. Looking SW. See photo for gps data.			Description	MVP-PY-006_042519 no fluid deposits on the north side of the bulk fuel tanks. Looking SW. See photo for gps data.

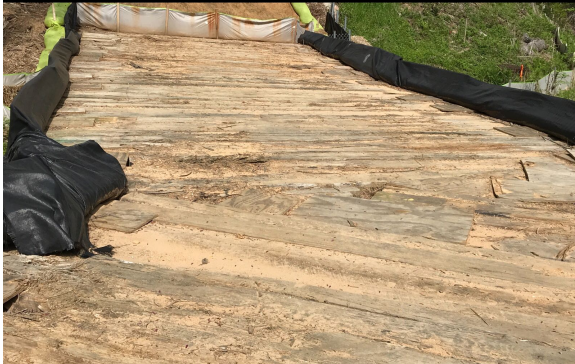
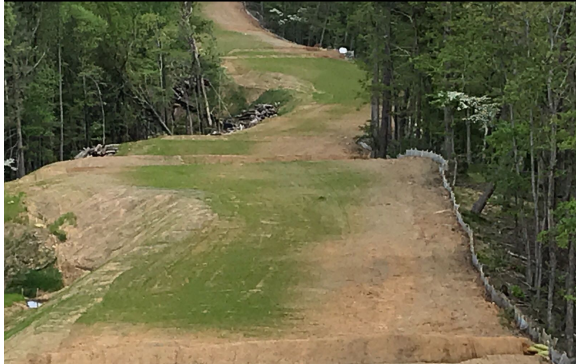
<div>2019-04-25 11:08:34-04:00</div>				
GPS Location 37.10		Field Station# 13413+05		GPS Location 37.10		Field Station# 13400+00	
Description		13413+05_042519 S-IJ1 mat bridge clean and closed. Looking N. See photo for gps data.		Description		13400+00_042519 condition of vegetation on ROW. Looking NW. See photo for gps data.	
<div>DIRECTION S (T) +37.10495° -080.04636° ACCURACY 98 ft DATUM WGS84</div>

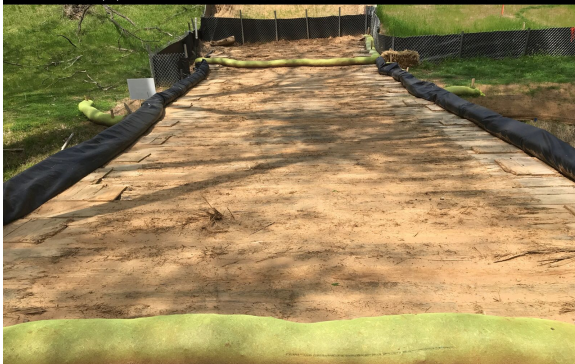
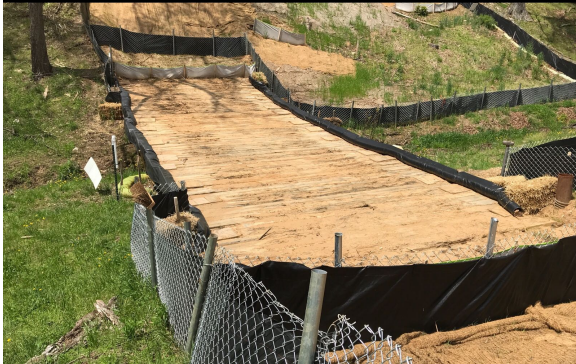
<div>2019-04-25 13:18:21-04:00</div>				
GPS Location 37.10		Field Station# 13325+30		GPS Location 37.10		Field Station# 13321+47	
Description		13325+30_042519 S-GH14 mat bridge clean and closed. Looking NW. See photo for gps data.		Description		13321+47_042519 S-GH15 mat bridge clean and closed. Looking W. See photo for gps data.

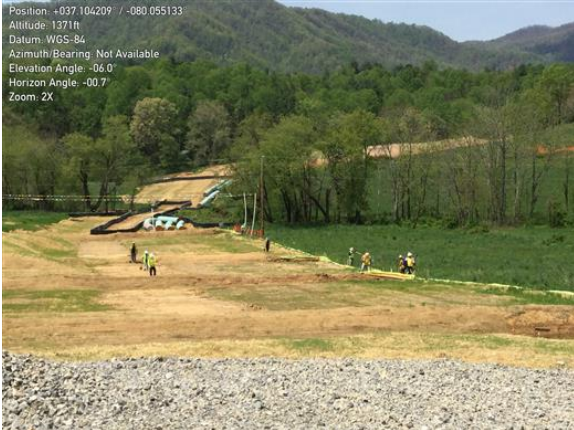
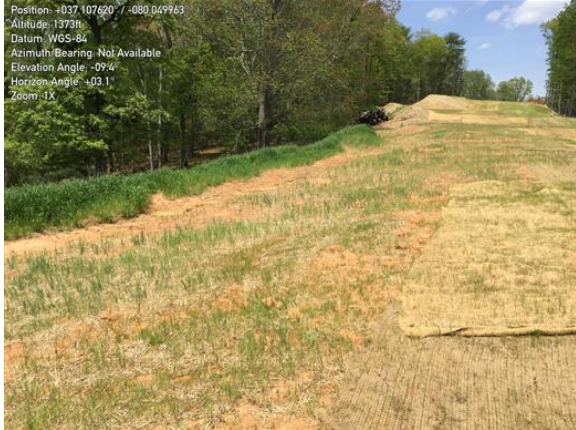
<b>GPS Location</b>	37.23	<b>Field Station#</b>	13312+50	<b>GPS Location</b>	37.23	<b>Field Station#</b>	13297+50
<b>Description</b>	Environmental crew conducting a maintenance walk-through between Flanders & Wade's Gap Road. View: West, see photo for GPS data			<b>Description</b>	Center of the LOD. Temporary vegetative stabilization. Stabilized topsoil piles to the left. View: North see photo for GPS data

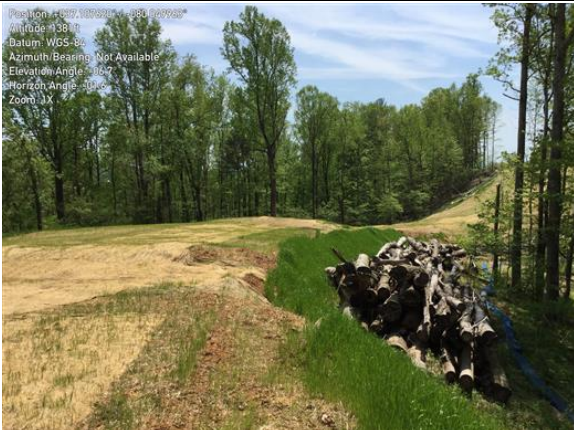
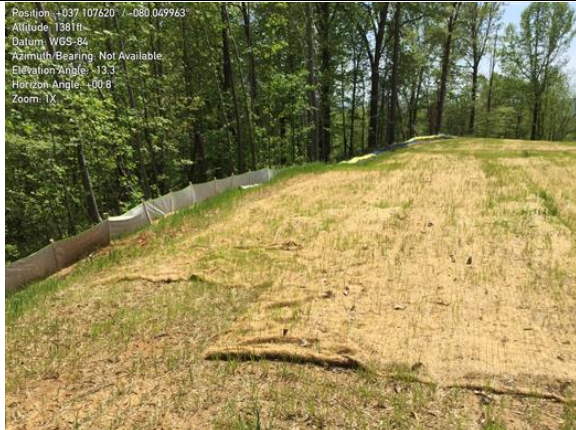
<b>GPS Location</b>	37.23	<b>Field Station#</b>	13282+50	<b>GPS Location</b>	37.23	<b>Field Station#</b>	13274+00
<b>Description</b>	Along the western edge of the LOD, stabilized topsoils and timber piles. View: South, see photo for GPS data			<b>Description</b>	Along the eastern edge of the LOD, at the PI atop the hill at the GAS of Flanders Road. View: Southeast, see photo for GPS data.

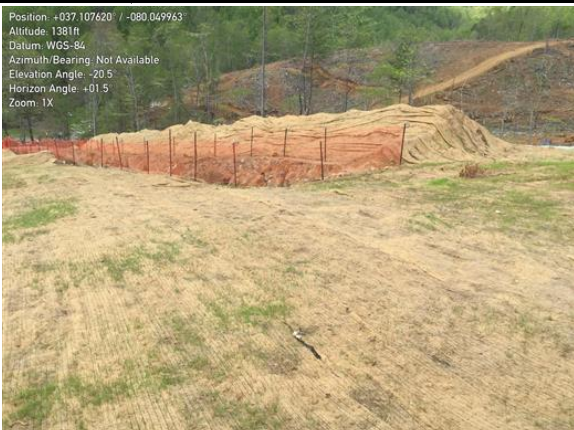
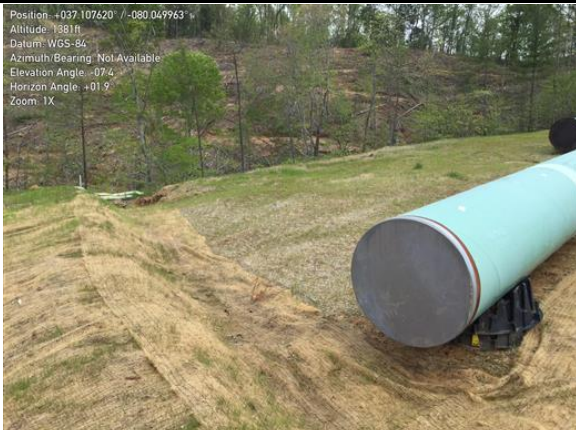
<b>GPS Location</b>	37.23	<b>Field Station#</b>	13267+50	<b>GPS Location</b>	37.23	<b>Field Station#</b>	13267+50
<b>Description</b>	Open trench and blanketed spoil piles at the GAS of Flanders Road. View: Northwest, see photo for GPS data.			<b>Description</b>	Blanketed waterbar & sump along with staged pipe. View: Northeast, see photo for GPS data

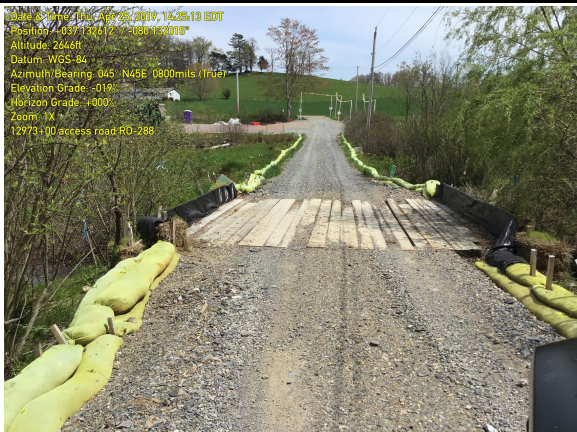
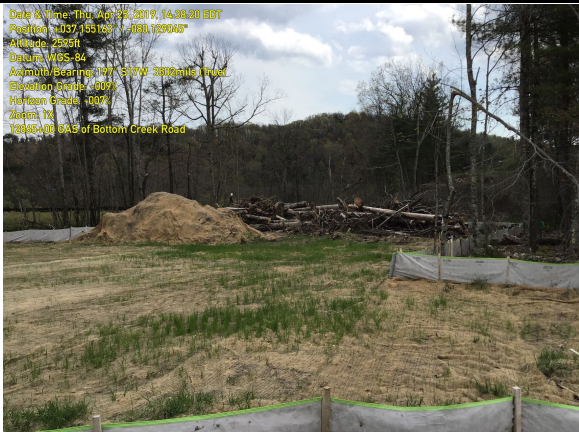
<b>GPS Location</b>		37.13	<b>Field Station#</b>		12973+00		<b>GPS Location</b>		37.15	<b>Field Station#</b>		12865+00			
<b>Description</b>		Mat Bridge over S-Q20 on access road RO-288 was in compliance.						<b>Description</b>		Good vegetation growth and no deficiencies of ECD's or stabilization.

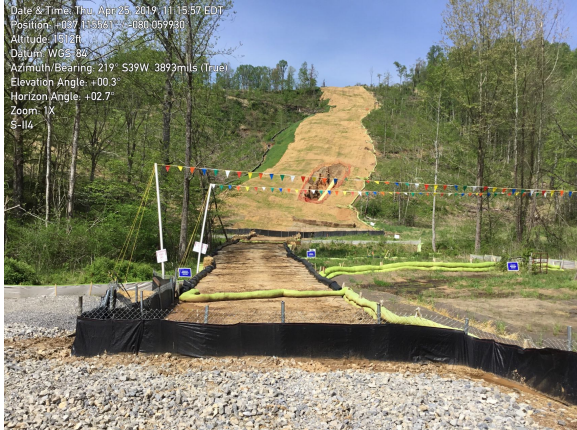
GPS Location	37.32	Field Station#	13260+75	GPS Location	37.32	Field Station#	13248+00
Description	Please see photo for accurate coordinates. S-II4, ECD functioning acceptably, no environmental issues noted.			Description	Please see photo for accurate coordinates. ROW stabilized with vegetative cover beginning to establish.

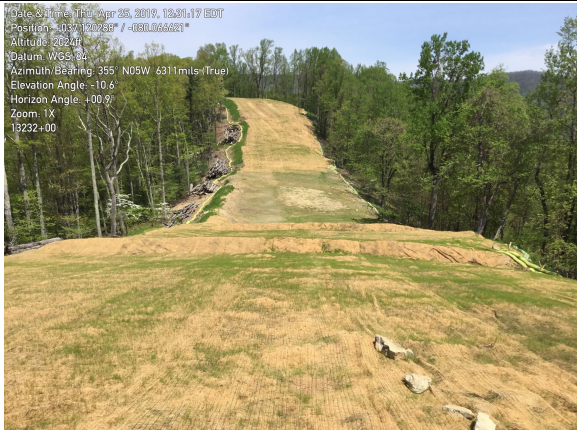
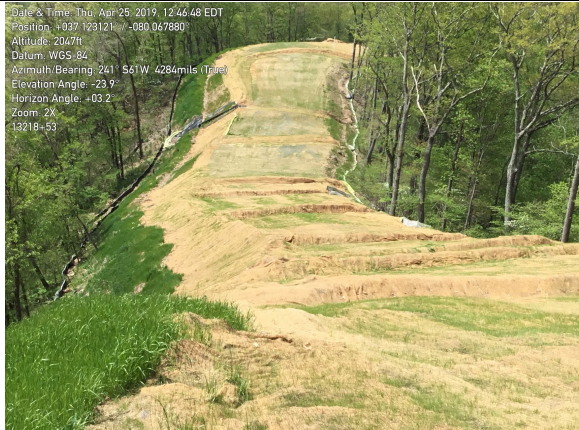
GPS Location	37.32	Field Station#	13232+00	GPS Location	37.32	Field Station#	13218+53
Description	Please see photo for accurate coordinates. ROW stabilized with earth guard and/or curlex, soil piles stabilized with vegetation.			Description	Please see photo for accurate coordinates. ROW stabilized, no environmental issues noted.

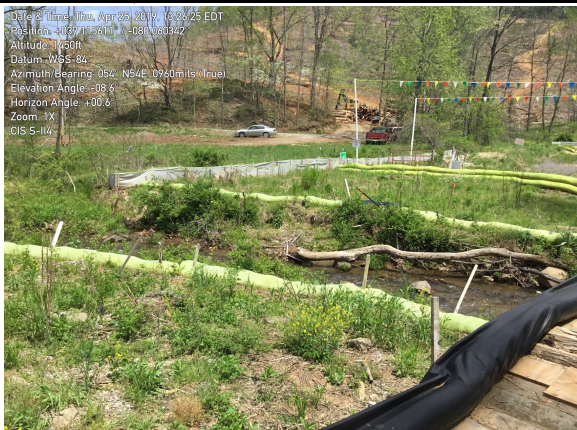
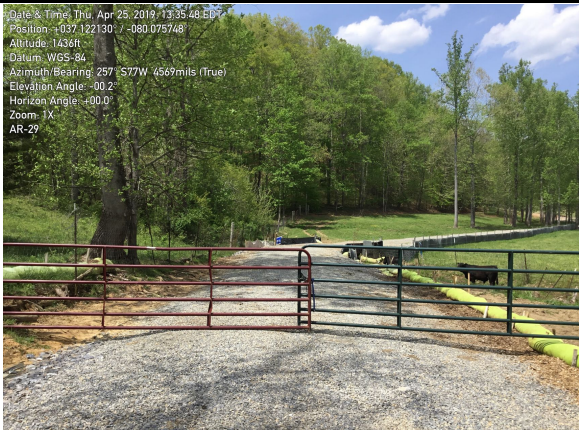
GPS Location	37.32	Field Station#	13260+69	GPS Location	37.32	Field Station#	13197+31
Description	Please see photo for accurate coordinates. S-II4, ECDs functioning acceptably along stream crossing, no environmental issues noted.			Description	Please see photo for accurate coordinates. MVP-MLV-AR-29, cattle noted in pasture, ECDs functioning acceptably.

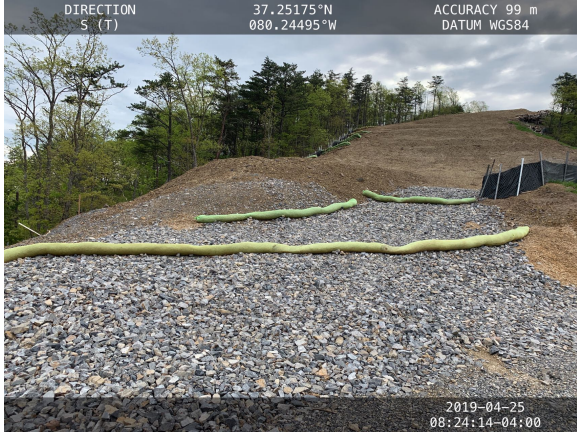
AFE		124300138		Date/Time		4/25/2019 9:36 PM		Report #		16336	
Pictures											
<div>DIRECTION S (T)</div> <div>37.25175°N 080.24495°W</div> <div>ACCURACY 99 m DATUM WGS84</div>

GPS Location		37.33		Field Station#		12234+77		GPS Location		37.33	
Description				RCE. Looking S. See picture for GPS data.				Description		Daylight drain from the trench breaker. Looking NW. See picture for GPS data.	
<div>DIRECTION NE (T)</div> <div>37.25230°N 080.24346°W</div> <div>ACCURACY 4 m DATUM WGS84</div>

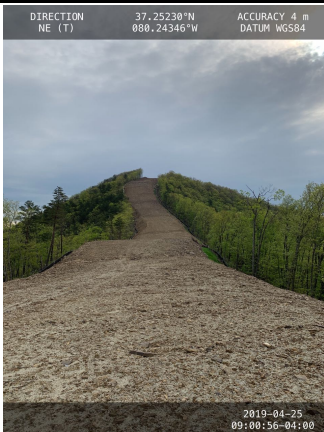
GPS Location		37.33		Field Station#		12250+00		GPS Location		37.33	
Description				Stabilized hill side. Looking NE. See picture for GPS data.				Description		Stabilized ROW. Looking S. See picture for GPS data.

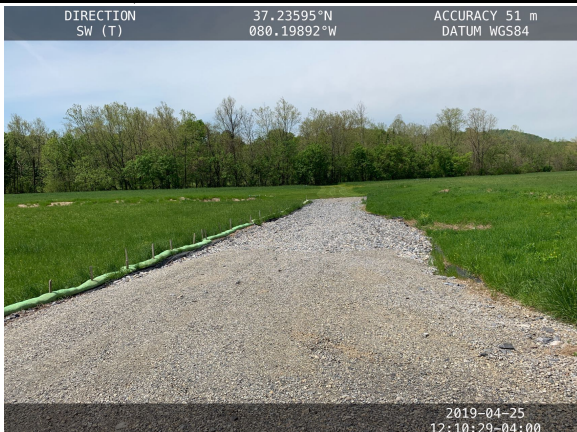
<div>DIRECTION SW (T)</div> <div>37.23595°N 080.19892°W</div> <div>ACCURACY 51 m DATUM WGS84</div>

GPS Location		37.33		Field Station#		12424+01		GPS Location		37.33	
Description				RCE. Looking SW. See picture for GPS data.				Description		Stabilized hill side. Looking W. See picture for GPS data.	
GPS Location		37.33		Field Station#		12420+00		GPS Location		37.33	
Description								Description		Stabilized hill side. Looking W. See picture for GPS data.

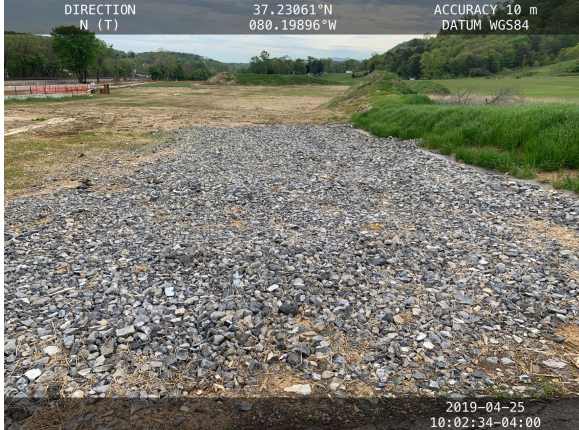
GPS Location	37.33	Field Station#	12448+12	GPS Location	37.33	Field Station#	12446+00
Description	RCE. Looking N. See picture for GPS data.			Description	Stabilized water crossing from run off. Looking SE. See picture for GPS data.

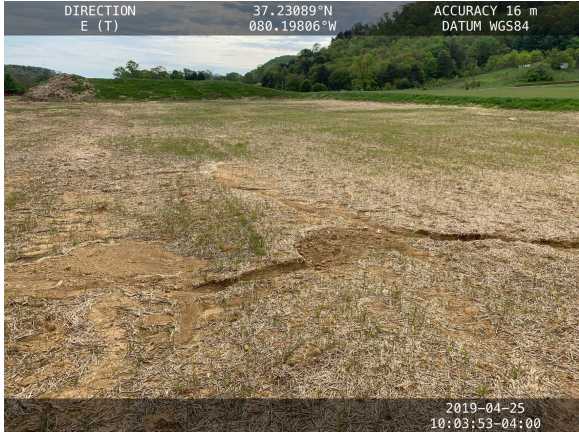
GPS Location	37.33	Field Station#	12446+50	GPS Location	37.33	Field Station#	12445+53
Description	Stabilized ROW. Looking E. See picture for GPS data.			Description	Well point pump covered with night cap. Looking NW. See picture for GPS data.

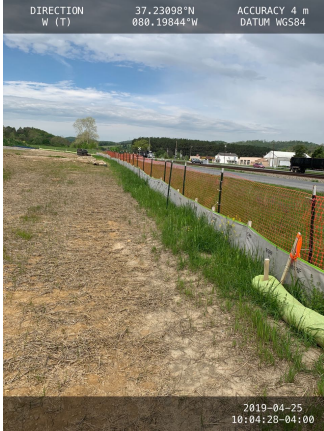
GPS Location	37.33	Field Station#	12445+53	GPS Location	37.33	Field Station#	12448+60
Description	P1 Silt fence perimeter controls. Looking W. See picture for GPS data.			Description	Stabilized disturbed variance. Looking SE. See picture for GPS data.
