# Visual Site Inspection Report

| <b>Project Name</b> | H-600 Pipeline Spread G | <b>AFE</b> | 124300137 | <b>Spread</b> | H-600 Pipeline Spread G |
| <b>Inspector</b> | Len Kruizenga | | | <b>Date/Time</b> | 4/22/2019 8:51 AM |
| <b>Permit #</b> | TBD | <b>Inspection Type</b> | VA SWPP | <b>Station Begin</b> | 11788+00 |

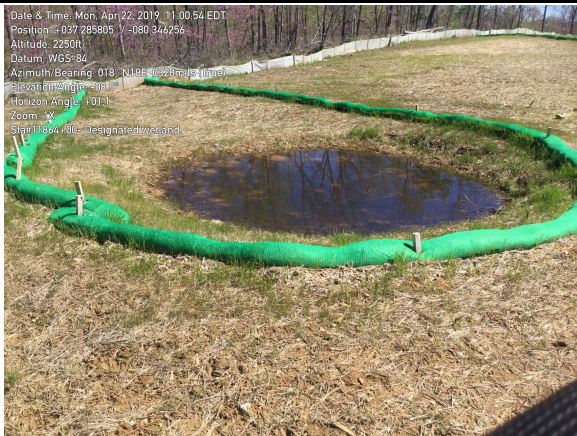
| GPS Location | 37.28 | Field Station# | 11864+00 | GPS Location | 37.28 |

| Description | | P1 perimeter control has a hole in it. | | | |

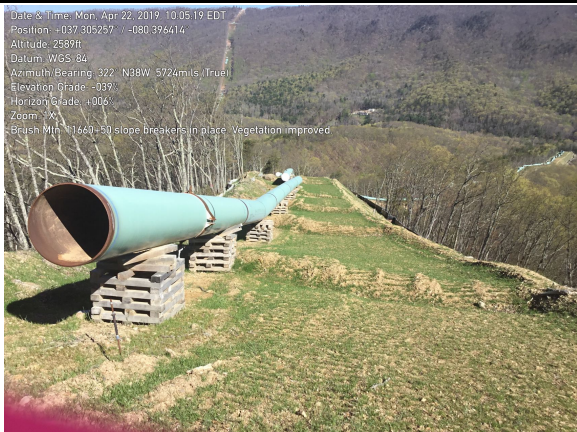
| GPS Location | 37.31 | Field Station# | 11660+50 | GPS Location | 37.31 | Field Station# | 11657+00 |

| Description | Correct coordinates on photo. Brush Mountain slope breakers working properly. | | | Description | Correct coordinates on photo. End treatments are functioning as designed. | | |

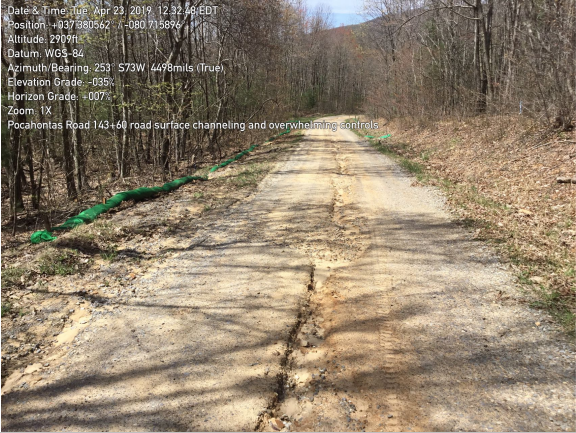
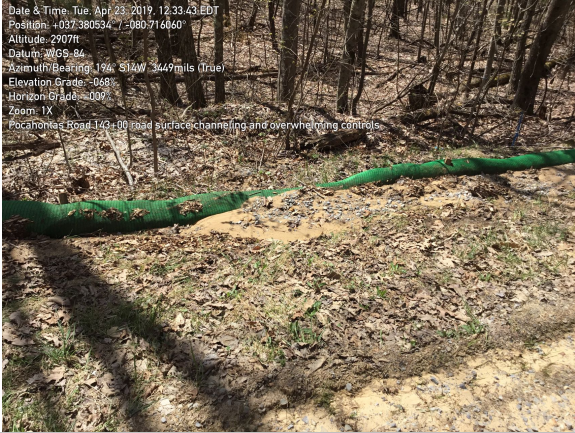
| GPS Location 37.31 | | Field Station# 143+60 | | GPS Location 37.31 | |

| <p>Date &amp; Time: Tue Apr 23, 2019 12:31:59 EDT<br/> Position: +037.980562 / -080.716860<br/> Altitude: 2907ft<br/> Datum: WGS-84<br/> Azimuth/Bearing: 253.573W 4498mils (True)<br/> Elevation Grade: -035%<br/> Horizon Grade: +007%<br/> Zoom: 1X<br/> Pocahontas Road 143+60 road surface channeling and overwhelping controls</p> | | | <p>Date &amp; Time: Tue Apr 23, 2019 12:33:43 EDT<br/> Position: +037.980534 / -080.716860<br/> Altitude: 2907ft<br/> Datum: WGS-84<br/> Azimuth/Bearing: 196.514W 3449mils (True)<br/> Elevation Grade: -068%<br/> Horizon Grade: +007%<br/> Zoom: 1X<br/> Pocahontas Road 143+00 road surface channeling and overwhelping controls</p> | | |
| Description | | Correct coordinates on photo. Runoff channels in Pocahontas Road. | | Description | |
| Correct coordinates on photo. Channeling of runoff creating problems at ECD. No sediment left the LOD. | | Description | | Correct coordinates on photo. Runoff channels in Pocahontas Road. | |

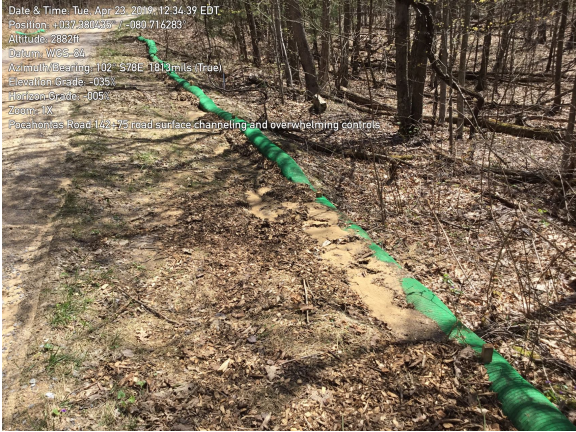
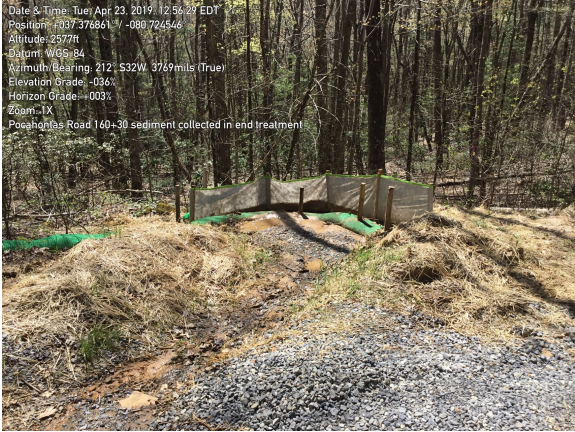
| GPS Location 37.31 | | Field Station# 142+75 | | GPS Location 37.31 | |

| <p>Date &amp; Time: Tue Apr 23, 2019 12:34:39 EDT<br/> Position: +037.980611 / -080.716283<br/> Altitude: 2882ft<br/> Datum: WGS-84<br/> Azimuth/Bearing: 102.578E 1813mils (True)<br/> Elevation Grade: +035%<br/> Horizon Grade: +005%<br/> Zoom: 1X<br/> Pocahontas Road 142+75 road surface channeling and overwhelping controls</p> | | | <p>Date &amp; Time: Tue Apr 23, 2019 12:56:29 EDT<br/> Position: +037.376861 / -080.726546<br/> Altitude: 2577ft<br/> Datum: WGS-84<br/> Azimuth/Bearing: 212.532W 3769mils (True)<br/> Elevation Grade: -036%<br/> Horizon Grade: +003%<br/> Zoom: 1X<br/> Pocahontas Road 160+30 sediment collected in end treatment</p> | | |

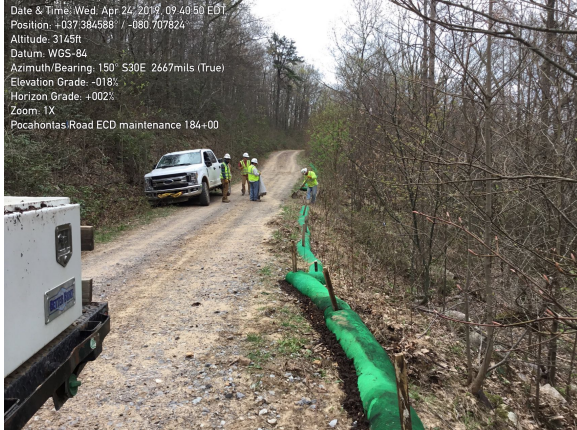
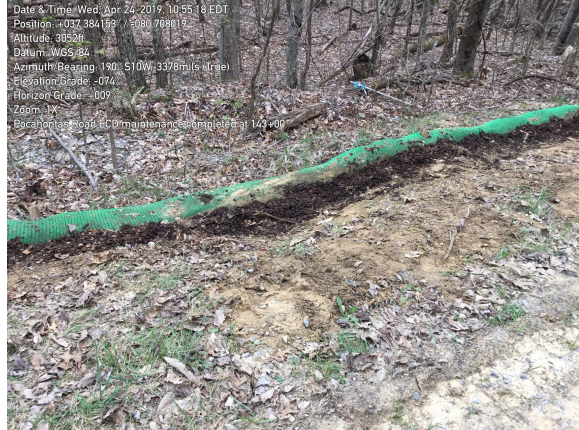
| GPS Location | 37.31 | Field Station# | 184+00 | GPS Location | 37.29 | Field Station# | 143+00 |

| Description | Correct coordinates on photo. ECD maintenance completed on Pocahontas Road. | | | Description | Correct coordinates on photo. ECD maintenance was completed on Pocahontas Road today. | | |

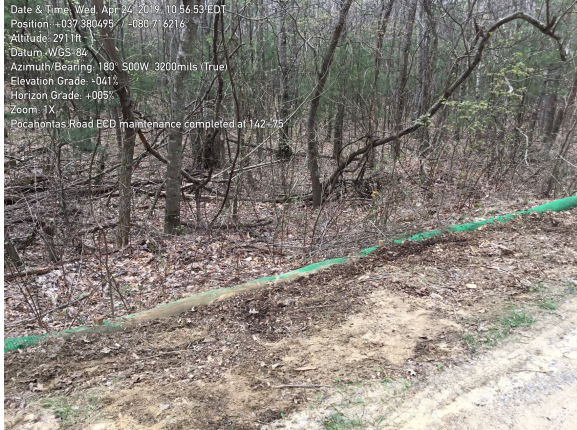
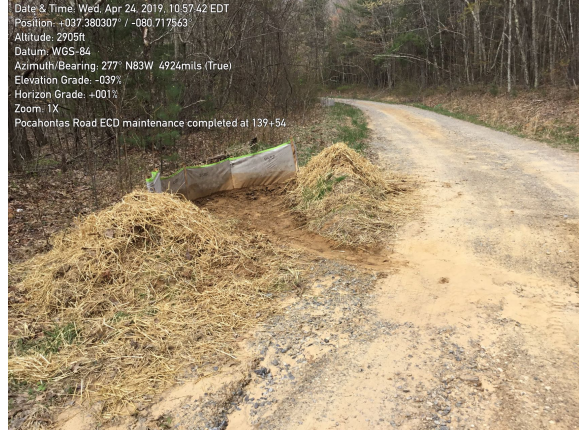
| GPS Location | 37.31 | Field Station# | 142+75 | GPS Location | 37.31 | Field Station# | 139+54 |

| Description | Correct coordinates on photo. ECD repairs completed on Pocahontas Road today. | | | Description | Correct coordinates on photo. ECD maintenance completed on Pocahontas Road today. | | |

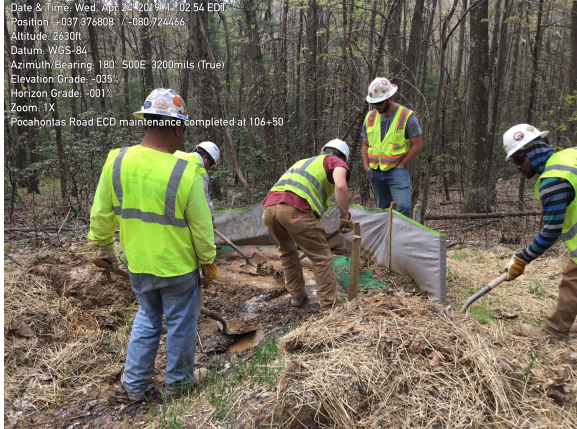
| GPS Location | 37.31 | Field Station# | 106+50 | GPS Location | | Field Station# | |

| Description | Correct coordinates on photo. ECD maintenance in progress on Pocahontas Road. | | | Description | | | |

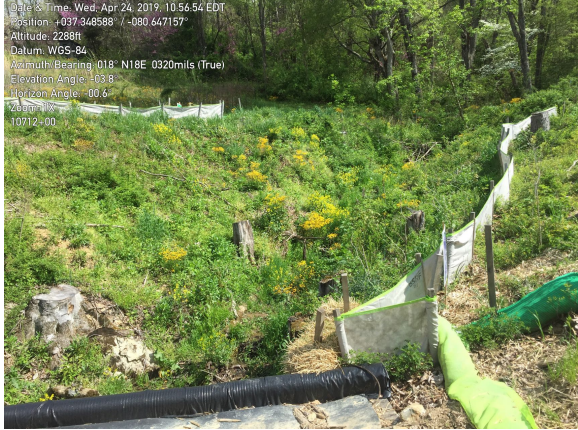
| GPS Location | 37.23 | Field Station# | 10734+00 | GPS Location | 37.23 | Field Station# | 10712+00 |

| Description | Maintenance needed on CFS check | | | Description | ECDs in good condition on stream buffer | | |

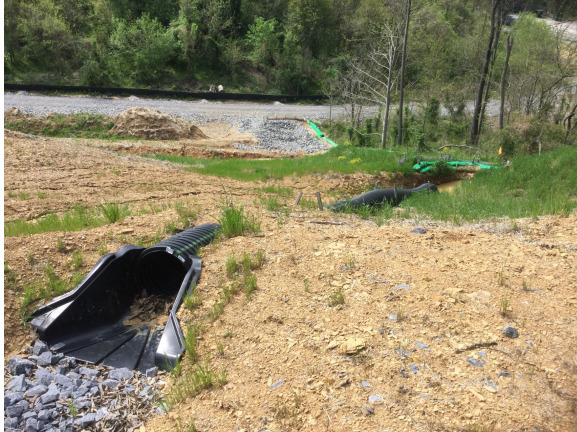
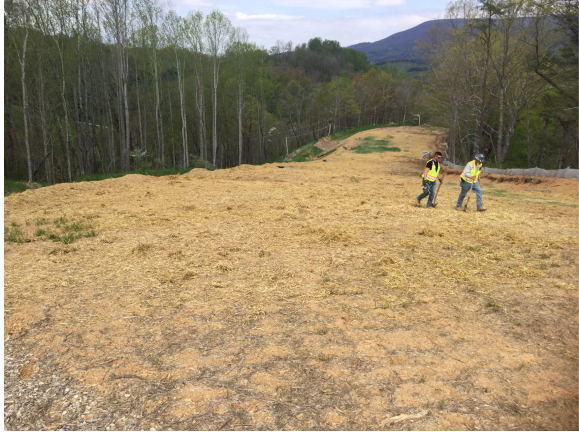
| GPS Location | 37.31 | Field Station# | 11225+00 | GPS Location | 37.31 | |

| Description | Re- freshed slope drain inlet rock | | | Description | Water bar flow line eroded | |

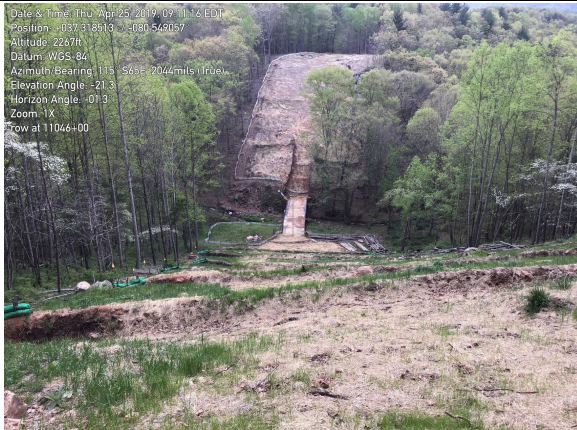
| GPS Location | 37.31 | Field Station# | 11046+00 | GPS Location | 37.31 | Field Station# | 11050+10 |

| Description | ROW conditions at 11046+00. ECDs in good condition, vegetation growing. | | | Description | Stream s-ij16b | | |

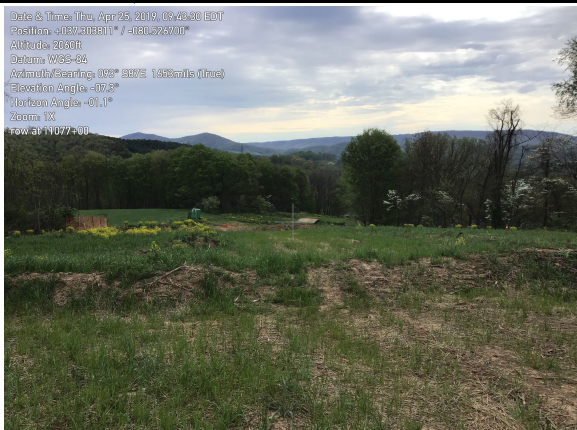
| Description | ROW conditions at 11077+00. ECDs in good condition, vegetation growing. | | | Description | ROW conditions at 11105+00. ECDs in good condition, vegetation growing. | | |

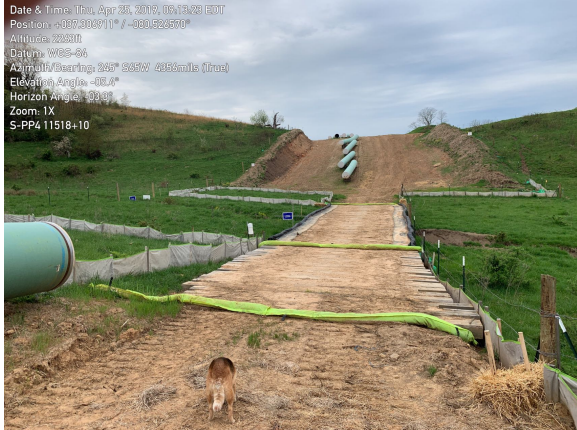
| Description | See photo for GPS location. Sensitive resource buffer in place at stream S-PP4. | | | Description | See photo for GPS location. Plunge pool in place. | | |

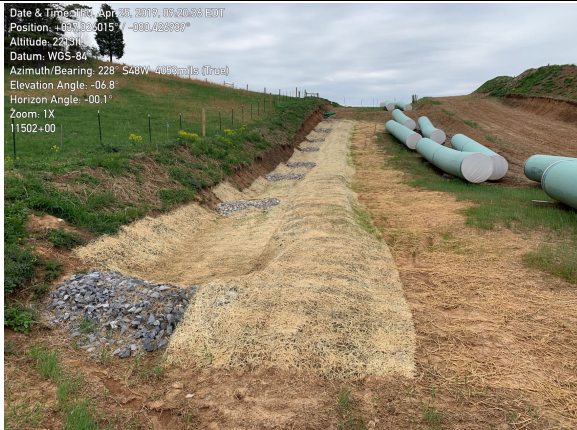
| Description | See photo for GPS location. Conveyance channel with rock checks and ECB in place. | | | Description | See photo for GPS location. Water bar, end treatment, and sump pit in place. | | |

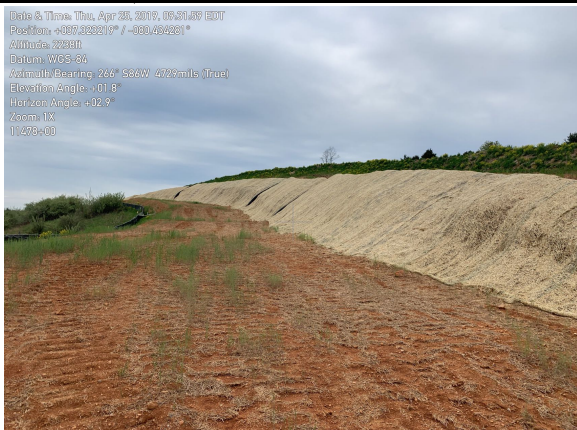
| Description | See photo for GPS location. Two tone with slope drains and ECB in place. | | | Description | See photo for GPS location. Rock lined channel in place. | | |

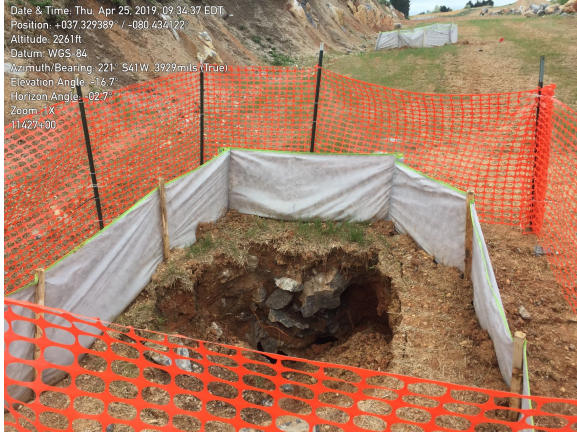
| Description | Soil pipe in blast area contained | | | Description | RFO | | |

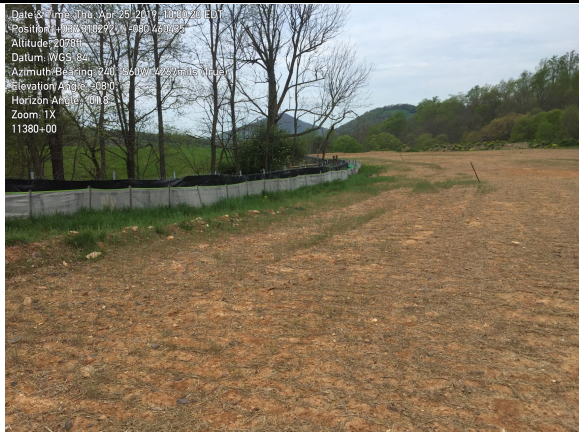
| Description | Row | | | Description | ECDs in good condition | | |

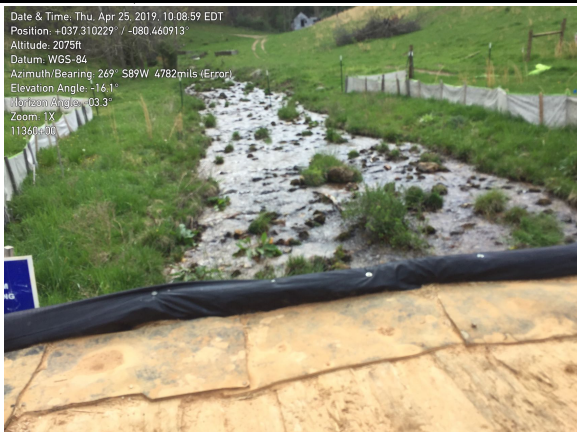
| Description | Stream ECDs in good condition | | | Description | Water breaker with end treatment | | |

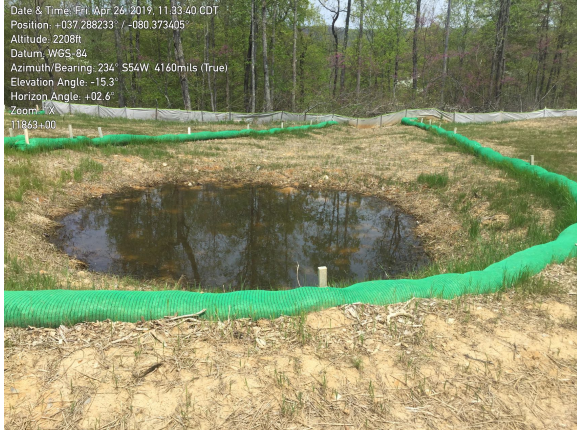
| Description | Wetland ECD are in good condition | | | Description | Super silt fence in good condition | | |

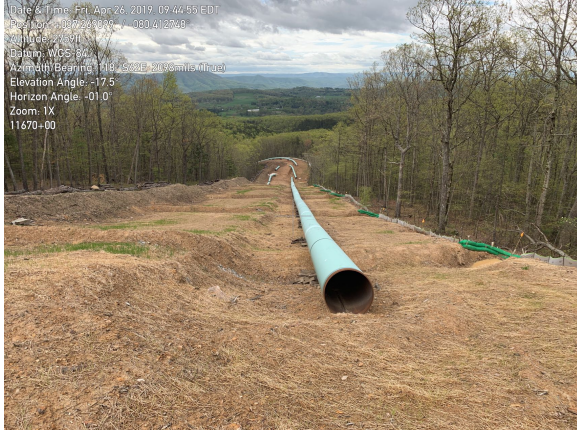
| Description | See photo for GPS location. Water bars and treatments in place. ROW stabilized with seed and mulch. | | | Description | See photo for GPS location. Rock lined channel in place over two tone. | | |

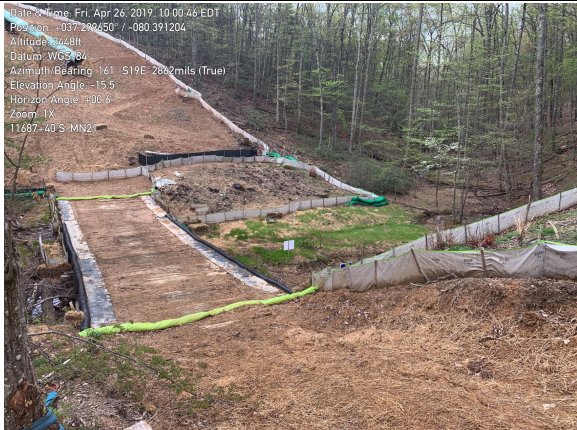
| Description | See photo for GPS location. Sensitive resource buffer in place at stream S-MN21 | | | Description | See photo for GPS location. Vegetation growth present on ROW. | | |

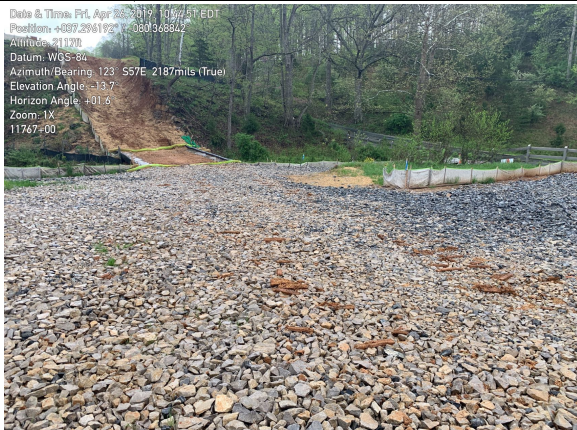
| Description | See photo for GPS location. RCE in place at main line valve 26. | | | Description | See photo for GPS location. Clean water diversion pipe in place. | | |

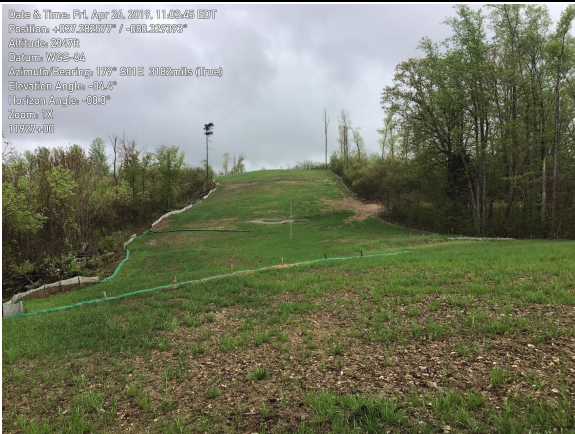
| Description | Vegetation growth at 11927+00 | | | Description | Stabilized ROW at 11939+00 | | |

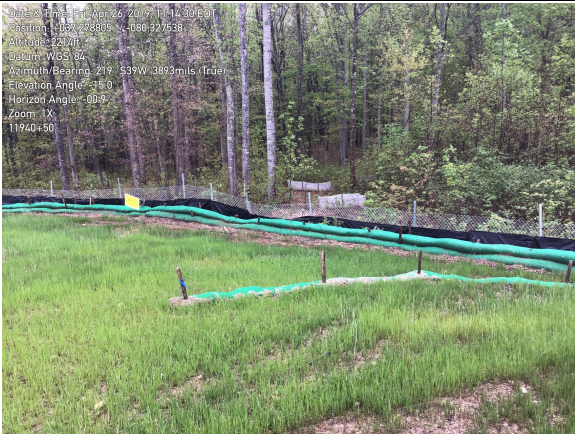
| Description | Karst Feature at 11940+50 | | | Description | Stabilized ROW at 11969+00 | | |

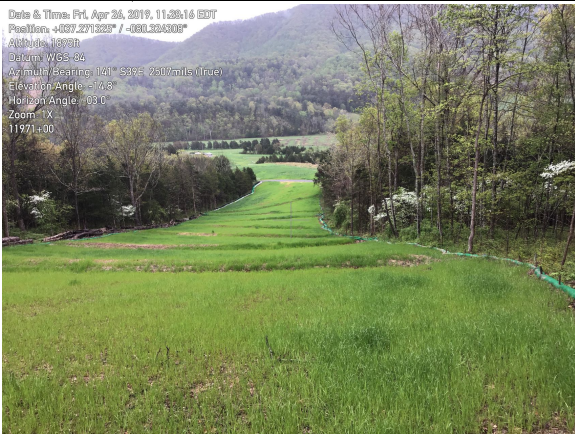
| Description | Stabilized ROW at 11971+00 | | | Description | Karst Feature at 11975+00 | | |
