Visual Site Inspection Report

Project Name	H-600 Pipeline Spread H	AFE	124300138	Spread	H-600 Pipeline Spread H	
Contractor	Precision			Report #	16588	
Inspector	Pat Davis			Date/Time	5/1/2019 5:24 PM	
Permit #	TBD	Inspection Type	VA SWPP	Station Begin	+0	
State	VA	Inspection Area	Partial	Station End	+0	
County	Montgomery	Ground	Dry	Temperature (°F)	90.00	
Municipality	N/A	Weather	Sunny	Rain Gauge (in)	0.00	
				Rain Accumulation Time (days)	0.00

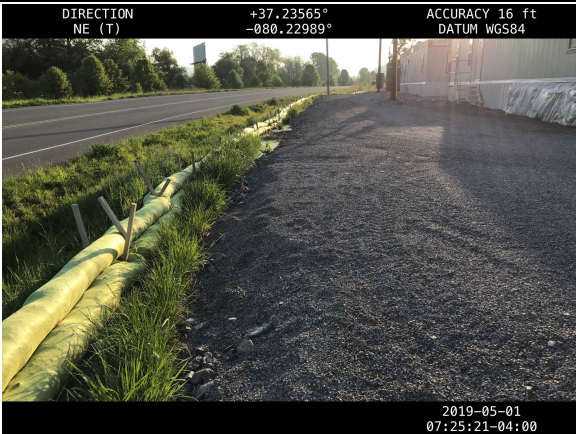
<div>2019-05-01 07:26:27-04:00</div>				
GPS Location	37.23	Field Station#	+0	GPS Location	37.23	Field Station#	+0
Description	MVP-PY-006_050119 condition of triple stack CFS along north boundary. Looking NE. See photo for gps data.			Description	MVP-PY-006_050119 condition of triple stack CFS along drive. Looking SW. See photo for gps data.		
<div>DIRECTION SW (T) +37.23539° -080.22957° ACCURACY 16 ft DATUM WGS84</div>

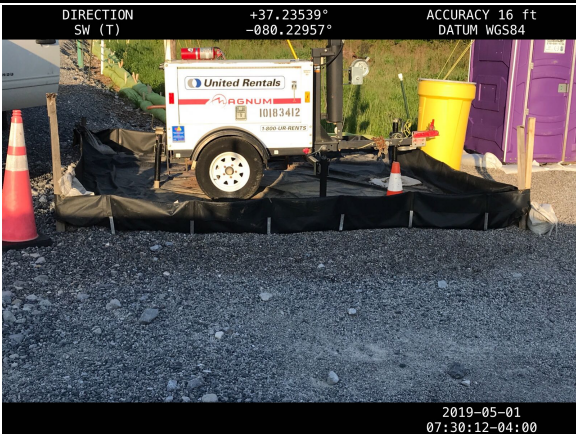
Description	MVP-PY-006_050119 condition of containment under light plant. Looking SW. See photo for gps data.			Description	MVP-PY-050119 signage and buffer flagging around feature. Looking NE. See photo for gps data.		
<div>DIRECTION SW (T) +37.23572° -080.22673° ACCURACY 16 ft DATUM WGS84</div>

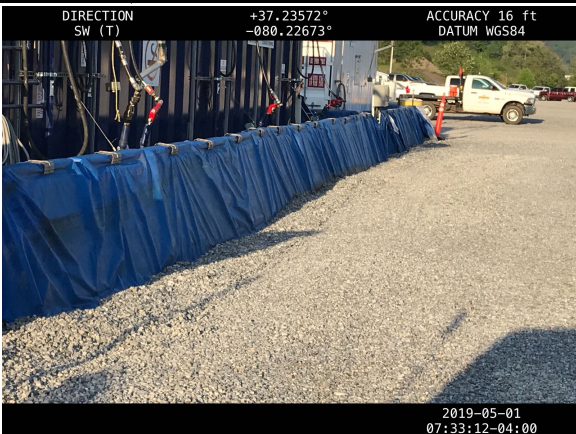
<div>2019-05-01 07:33:49-04:00</div>				
GPS Location	37.23	Field Station#	+0	GPS Location	37.23	Field Station#	+0
Description	MVP-PY-006_050119 no fluid deposits on the north side of the bulk fuel tanks. Looking SW. See photo for gps data.			Description	MVP-PY-006_050119 condition of containment under light plant. Looking W. See photo for gps data.

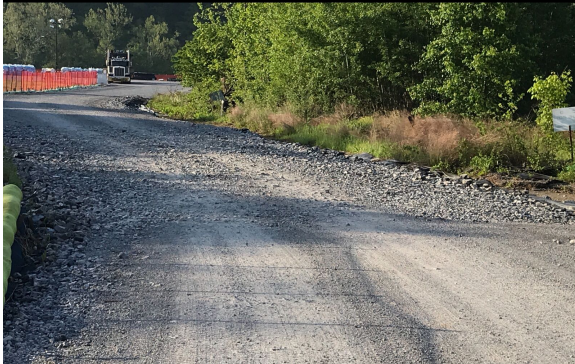
<div>2019-05-01 07:55:37-04:00</div>																			
GPS Location		37.27		Field Station#		+0		GPS Location		37.27		Field Station#		+0									
Description		MVP-LY-049_050119 condition of rock entrance on the center drive. Looking S. See photo for gps data.										Description		MVP-LY-049_050119 condition of CFS and safety fence along drive. Looking SE. See photo for gps data.									
<div>DIRECTION N (T)</div> <div>+37.27099° -080.12191°</div> <div>ACCURACY 16 ft DATUM WGS84</div>

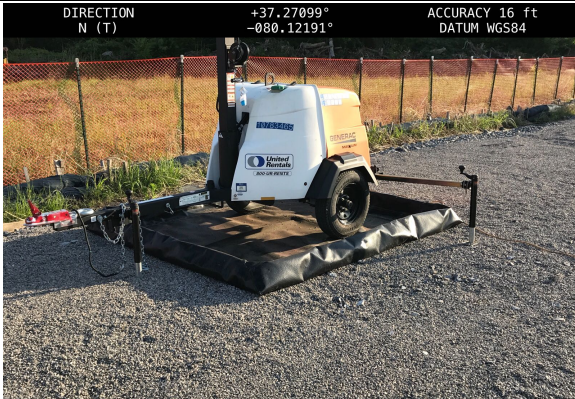
GPS Location		37.27		Field Station#		+0		GPS Location		37.27		Field Station#		+0									
Description		MVP-LY-049_050119 condition of containment under light plant. Looking N. See photo for gps data.										Description		MVP-LY-049_050119 condition of CFS and safety fence along north boundary. Looking NE. See photo for gps data.									
<div>DIRECTION SE (T)</div> <div>+37.27154° -080.12029°</div> <div>ACCURACY 16 ft DATUM WGS84</div>

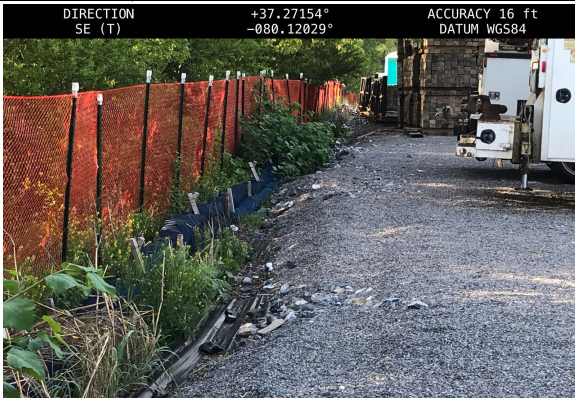
<div>2019-05-01 08:01:21-04:00</div>																			
GPS Location		37.27		Field Station#		+0		GPS Location		37.27		Field Station#		+0									
Description		MVP-LY-049_050119 condition of CFS and safety fence along east boundary. Looking SE. See photo for gps data.										Description		MVP-LY-049_050119 condition of CFS and safety fence along south boundary. Looking SW. See photo for gps data.

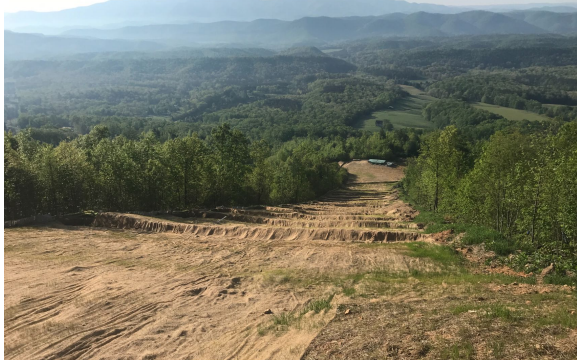
<div>12062+00 to 12072+00</div> <div>ROW condition</div> <div>2019-05-01 08:22:03-04:00</div>			<div>DIRECTION 308 deg(T)</div> <div>+37.26100° -080.29978°</div> <div>ACCURACY 5 m DATUM WGS84</div>

<div>12056+00 to 12062+00</div> <div>ROW condition</div> <div>2019-05-01 08:22:55-04:00</div>				
GPS Location	37.25	Field Station#	12062+00	GPS Location	37.25	Field Station#	12062+00
Description	See photo for gps data. Photo shows the ROW condition from 12062+00 to about 12072+00.			Description	See photo for gps data. Photo shows the ROW condition from about 12056+00 to 12062+00.		
<div>DIRECTION 339 deg(T)</div> <div>+37.26186° -080.30263°</div> <div>ACCURACY 5 m DATUM WGS84</div>

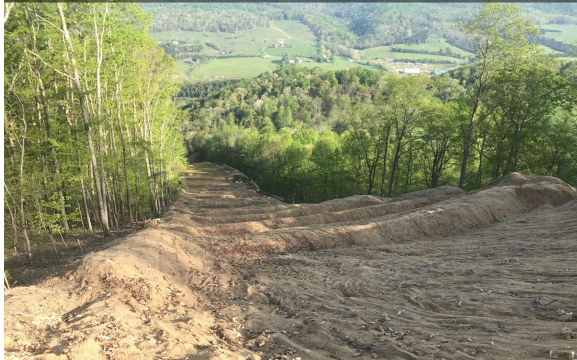
<div>12052+00 to 12039+00</div> <div>ROW condition</div> <div>2019-05-01 08:36:15-04:00</div>			<div>DIRECTION 293 deg(T)</div> <div>+37.26592° -080.31110°</div> <div>ACCURACY 5 m DATUM WGS84</div>

GPS Location	37.25	Field Station#	12052+00	GPS Location	37.25	Field Station#	12923+00
Description	See photo for gps data. Photo shows the ROW condition from about 12039+00 to 12052+00.			Description	See photo for gps data. Photo shows the newly installed triple stacked CFS j-hook at 12023+00.		
<div>DIRECTION 297 deg(T)</div> <div>+37.26597° -080.31125°</div> <div>ACCURACY 10 m DATUM WGS84</div>

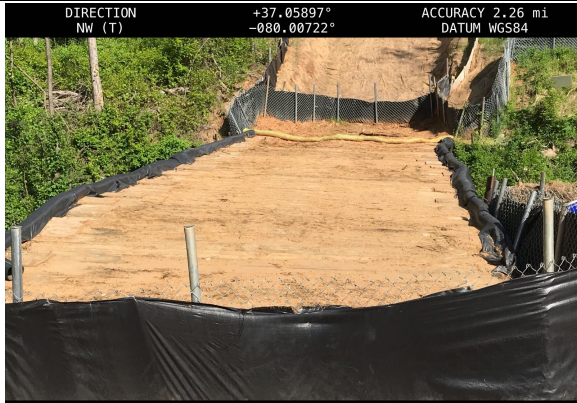
GPS Location	37.10	Field Station#	13358+64	GPS Location	37.10	Field Station#	13371+50
Description	13358+64_050119 S-RR11 mat bridge clean and closed. No stream impact. Looking NW. See photo for gps data.			Description	13371+50_050119 CFS replaced with P1 silt fence. Looking N. See photo for gps data.		
<div>DIRECTION SE (T)</div> <div>+37.10102° -080.03504°</div> <div>ACCURACY 16 ft DATUM WGS84</div>

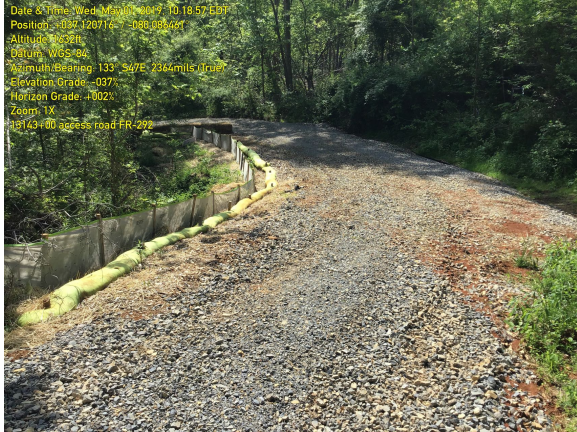
</div>				
GPS Location	37.12	Field Station#	13143+00		GPS Location	37.12	Field Station#	13117+50
Description	No issues found along access road FR-292.				Description	ROW stabilized with Curlex and vegetation growth.		
<div><p>Date & Time: Wed, May 01, 2019 12:12:49 EDT Position: -087.121746° / -080.045440° Altitude: 2630ft Datum: WGS-84 Azimuth/Bearing: +08° 50'55" 3607mils (True) Elevation Grade: +001° Horizon Grade: +001° Zoom: 1X 13062+50 GAS of FR-292</p>

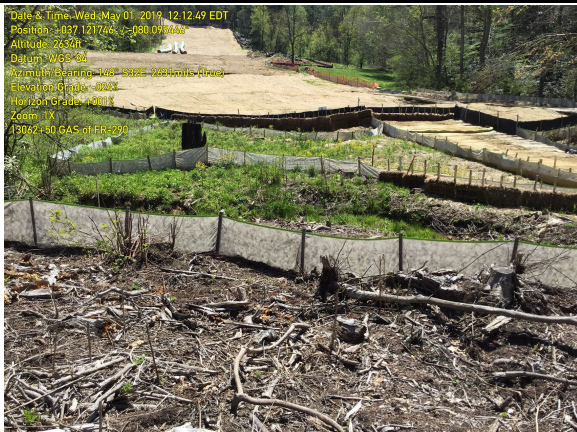
GPS Location	37.12	Field Station#	13062+50		GPS Location	37.12	Field Station#	13062+50
Description	No issues or impacts observed throughout the area.				Description	ROW remains stabilized and in good condition.		
<div><p>Date & Time: Wed, May 01, 2019 12:50:31 EDT Position: -087.124001° / -080.128350° Altitude: 2630ft Datum: WGS-84 Azimuth/Bearing: 149° 51'25" 3346mils (True) Elevation Grade: +001° Horizon Grade: +001° Zoom: 1X 13012+00 GIS of the ROW</p>

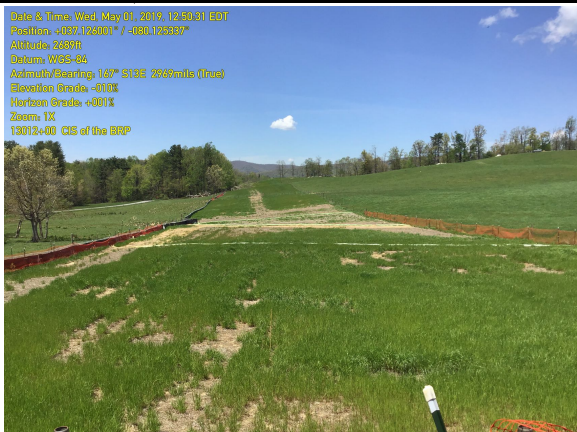
</div>				
GPS Location	37.12	Field Station#	13012+00		GPS Location	37.15	Field Station#	12865+00
Description	ROW remains well stabilized.				Description	Environmental crew applying additional seed to areas that are in need.

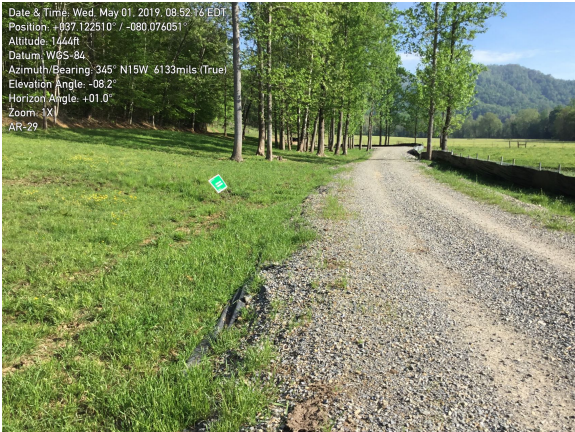
</div>				
GPS Location	37.32	Field Station#	13188+66	GPS Location	37.32	Field Station#	13197+64
Description	Please see photo for accurate coordinates. MVP-MLV-AR-29, access road maintained, no water standing in wetland W-D4.			Description	Please see photo for accurate coordinates. Dillon's Mill, no environmental issues observed at road crossing.

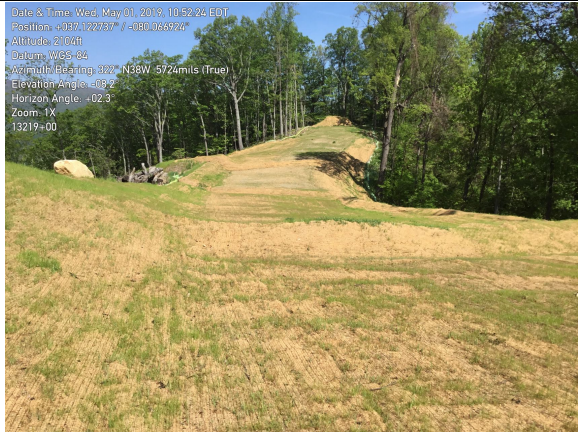
</div>				
GPS Location	37.32	Field Station#	13218+00	GPS Location	37.32	Field Station#	13219+00
Description	Please see photo for accurate coordinates. ROW, stabilized with curlex, established vegetation noted on soil piles.			Description	Please see photo for accurate coordinates. ROW, vegetation beginning to establish through curlex.		
<div><div>Date & Time: Wed, May 01, 2019, 11:16:07 EDT Position: +037.115971° / -080.064255° Altitude: 2065ft Datum: WGS-84 Azimuth/Bearing: 244° S64W 4338mils (True) Elevation Angle: -24.1° Horizon Angle: +01.9° Zoom: 1X 13247+00</div>

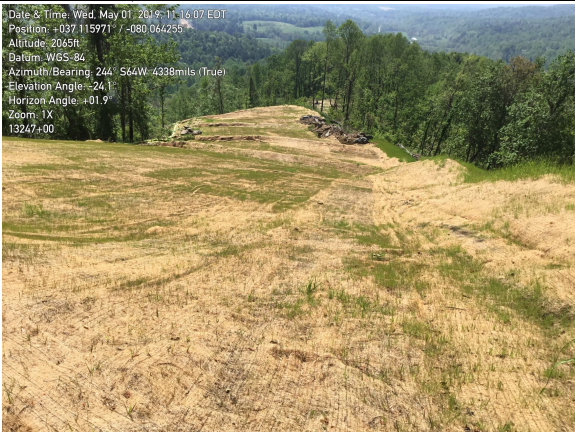
</div>			<div><div>Date & Time: Wed, May 01, 2019, 10:02:23 EDT Position: +037.115856° / -080.064329° Altitude: 1915ft Datum: WGS-84 Azimuth/Bearing: 012° N12E 0213mils (True) Elevation Angle: -25.5° Horizon Angle: +01.8° Zoom: 1X 13250+00</div>

GPS Location	37.32	Field Station#	13247+00	GPS Location	37.32	Field Station#	13250+00
Description	Please see photo for accurate coordinates. ROW, area stable, waterbars and outlets functioning acceptably.			Description	Please see photo for accurate coordinates. ROW, waterbars and outlets maintained and functioning acceptably.
