Visual Site Inspection Report

Project Name	H-600 Pipeline Spread G	AFE	124300137	Spread	H-600 Pipeline Spread G
Contractor	Precision			Report #	16510
Inspector	Len Kruizenga			Date/Time	4/29/2019 10:18 AM
Permit #	TBD	Inspection Type	VA SWPP	Station Begin	12005+00
State	VA	Inspection Area	Full	Station End	12005+00
County	Giles	Ground	Damp	Temperature (°F)	53.00
Municipality	N/A	Weather	Cloudy	Rain Gauge (in)	0.00
				Rain Accumulation Time (days)	0.00

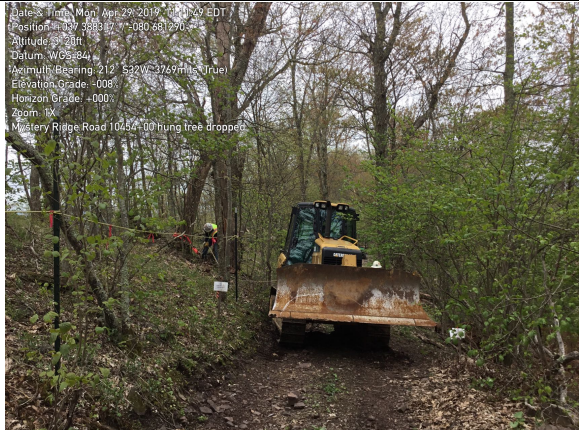
<p>Date & Time: Mon, Apr 29, 2019, 11:26:09 EDT Position: +037.388912 / -080.681290 Altitude: 3111ft Datum: WGS-84 Azimuth/Bearing: 212° S22W 3769mils (True) Elevation Grade: -008% Horizon Grade: -000% Zoom: IX Mystery Ridge Road 10454+00 hung tree dropped</p>

GPS Location	37.31	Field Station#	10454+50	GPS Location	37.31	Field Station#	10454+00
Description	Correct coordinates on photo. Two new hung trees discovered today from high winds this weekend.			Description	Correct coordinates on photo. Hung tree pulled down on Mystery Ridge Road.		
<p>Date & Time: Mon, Apr 29, 2019, 11:22:07 EDT Position: +037.387896 / -080.681634 Altitude: 3111ft Datum: WGS-84 Azimuth/Bearing: 070° S02E 3164mils (True) Elevation Grade: -00% Horizon Grade: +00% Zoom: IX Mystery Ridge Road 10449+50 hung tree dropped</p>  			<p>Date & Time: Mon, Apr 29, 2019, 12:26:09 EDT Position: +037.382559 / -080.710934 Altitude: 3019ft Datum: WGS-84 Azimuth/Bearing: 205° S25W 3644mils (True) Elevation Grade: -04% Horizon Grade: -013% Zoom: IX Pocahontas Road maintenance 166+60</p>

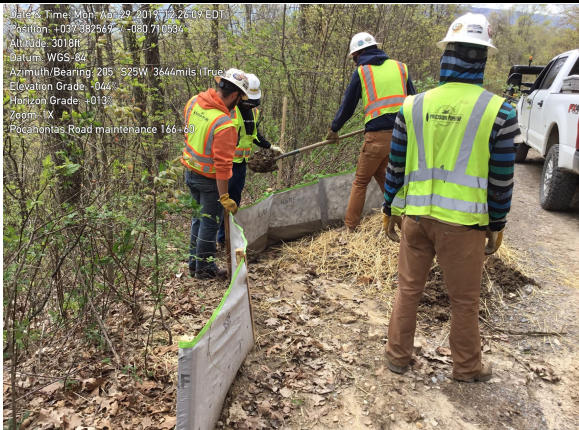
GPS Location	37.31	Field Station#	10449+50	GPS Location	37.31	Field Station#	166+60
Description	Correct coordinates on photo. Hung tree pulled down on Mystery Ridge Road.			Description	Correct coordinates on photo. ECD maintenance needs addressed.

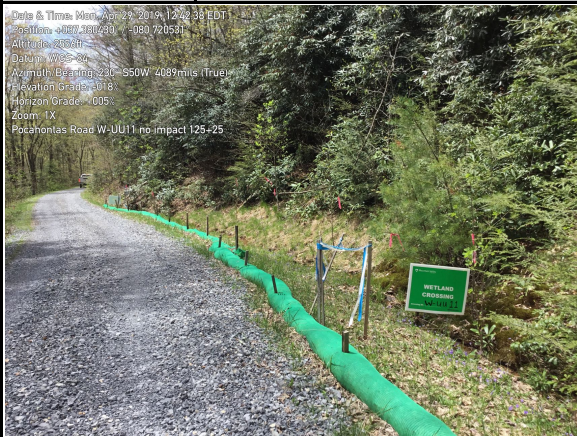
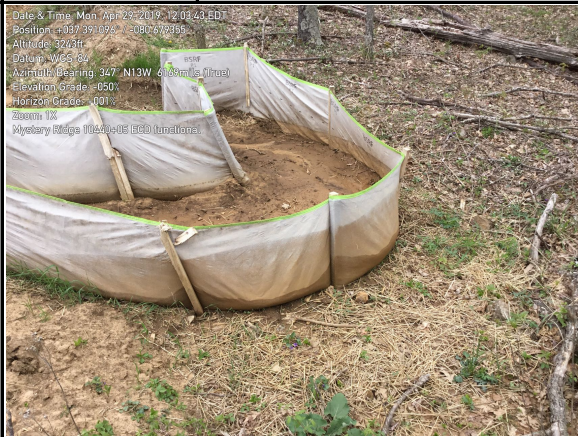
GPS Location	37.31	Field Station#	125+25	GPS Location	37.31 Field Station# 10440+05
Description	Correct coordinates on photo. No resource impact noted on Pocahontas Road.

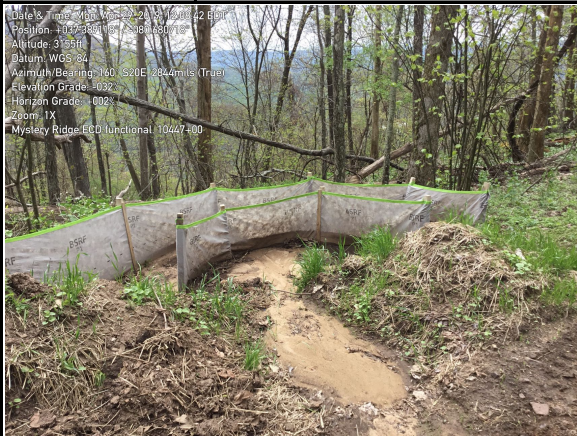
Insert image here		
GPS Location	37.38	Field Station#	104747+00	GPS Location	Field Station#
Description	Correct coordinates on photo. ECD maintenance completed on Mystery Ridge Road.				
Description	Correct coordinates on photo.

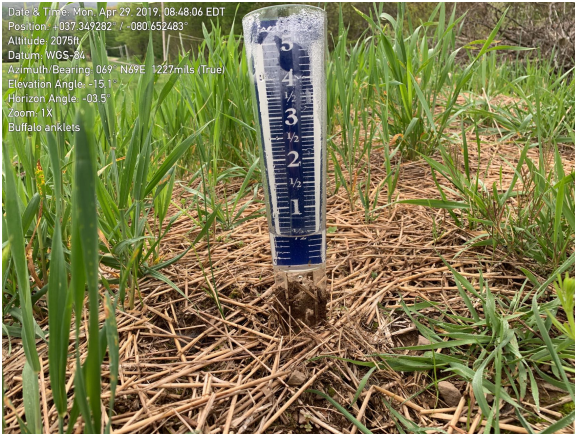
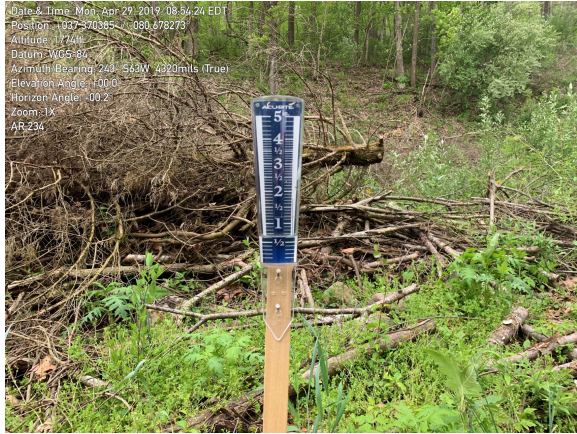
GPS Location	37.31	Field Station#	10690+00	GPS Location	37.31	Field Station#	12005+00
Description	See photo for GPS location. Rain gauge at buffalo anklets read 0.6 inches of rain fall.			Description	See photo for GPS location. Rain gauge at access road 234 reads 0.7 inches of rain fall.

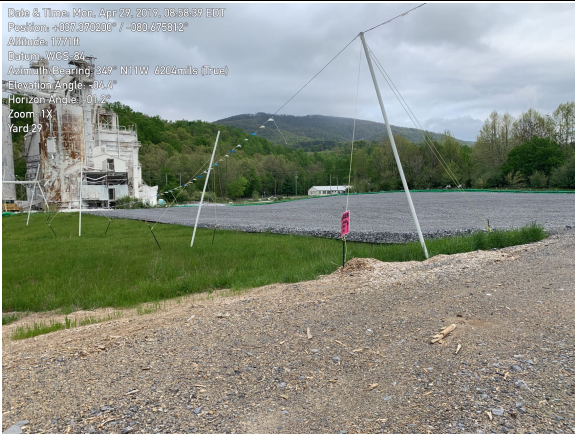
GPS Location	37.31	Field Station#	12005+00	GPS Location	37.31	Field Station#	12005+00
Description	See photo for GPS location. Lay down yard 29 covered with rock.			Description	See photo for GPS location. Triple stack compost filter sock in place

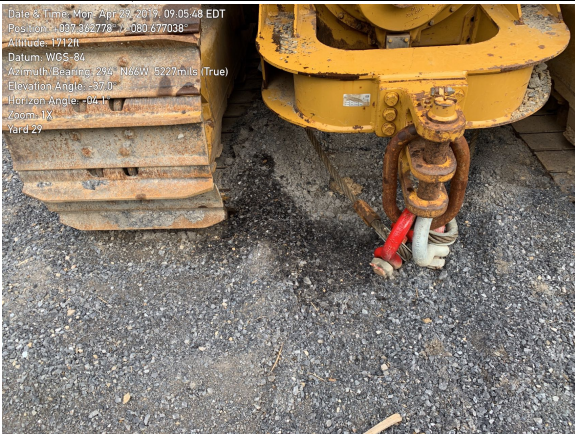
GPS Location	37.31	Field Station#	12005+00	GPS Location	37.31	Field Station#	12005+00
Description	See photo for GPS location. Spill located at lay down yard 29.			Description	See photo for GPS location. Spill cleaned up.

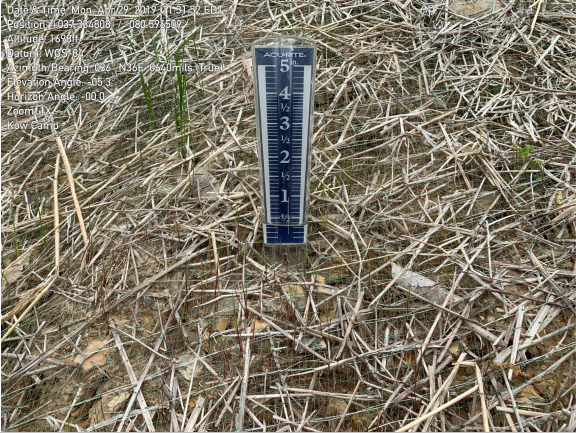
GPS Location	37.31	Field Station#	10883+50	GPS Location	
Description	See photo for GPS location. Rain gauge at Kow Camp reads 0.4 inches of rain fall.			Description	
Insert image here			Insert image here		
GPS Location		Field Station#		GPS Location	
Description				Description	
Insert image here			Insert image here		
GPS Location		Field Station#		GPS Location	
Description				Description	
Insert image here			Insert image here		
GPS Location		Field Station#		GPS Location	
Description				Description

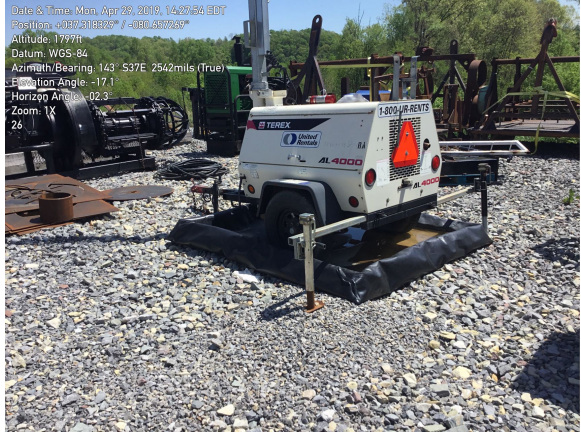
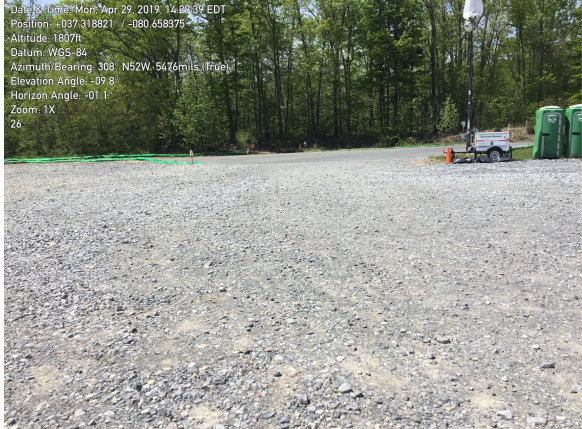
GPS Location	37.33	Field Station#	12005+00	GPS Location	37.33	Field Station#	12005+00
Description	ECDs in good condition yd 26			Description	Generator in containment yd 26

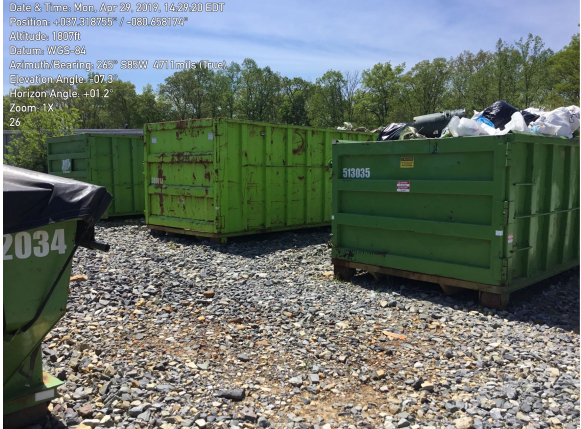
<p>Date & Time: Mon, Apr 29, 2019, 14:49:20 EDT Position: +037.318650° / -080.657469° Altitude: 1837ft Datum: WGS-84 Azimuth/Bearing: 335° 38'0" 4711mils (True) Elevation Angle: +07.5° Horizon Angle: +01.2° Zoom: 1X 26</p>				
GPS Location	37.33	Field Station#	12005+00	GPS Location	37.33	Field Station#	12005+00
Description	ECDs in good condition yd 26			Description	All waste in proper disposal areas yd 26

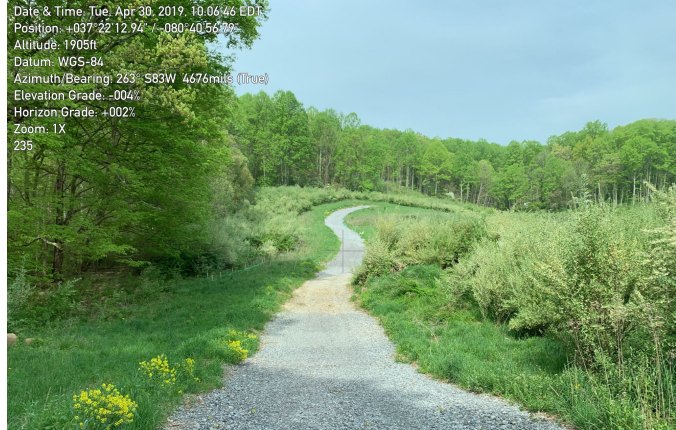
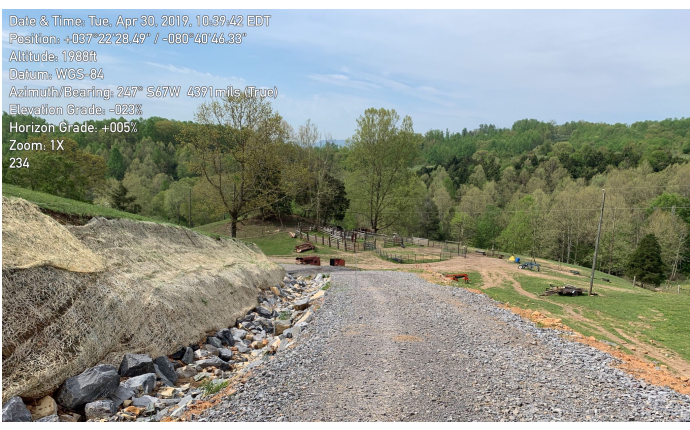
GPS Location	37.29	Field Station#	2+35	GPS Location	37.29	Field Station#	2+34
Description	ECD's and ROW conditions			Description	ECD's and ROW conditions		
<p>Date & Time: Tue, Apr 30, 2019, 10:29:00 EDT Position: +037°22'23.91" / -080°40'56.00" Altitude: 2102ft Datum: WGS-84 Azimuth/Bearing: 285° S85W 5416mils (True) Elevation Grade: -029% Horizon Grade: +003% Zoom: 1X 234</p>

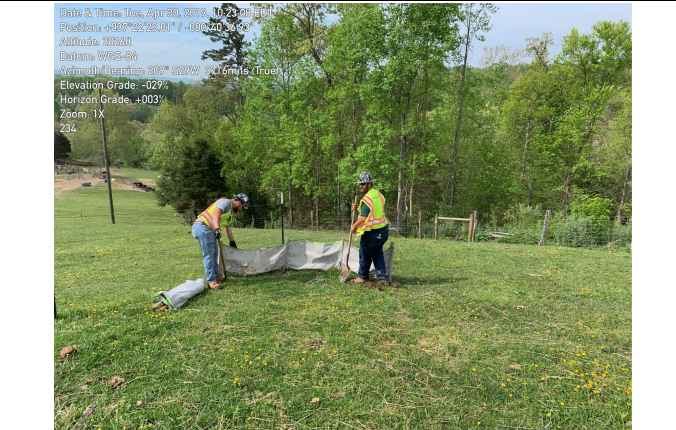
GPS Location	37.29	Field Station#	2+34	GPS Location	37.29	Field Station#	10857+00
Description	Crew replacing damaged P1 @ AR 234			Description	ECD's and ROW conditions		
<p>Date & Time: Tue, Apr 30, 2019, 12:01:59 EDT Position: +037°20'6.38" / -080°35'48.13" Altitude: 2166ft Datum: WGS-84 Azimuth/Bearing: 293° N67W 5209mils (True) Elevation Grade: -012% Horizon Grade: +004% Zoom: 1X 10883+00</p>

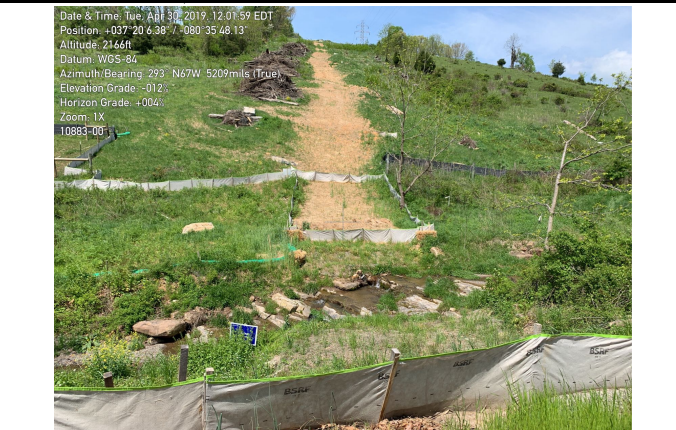
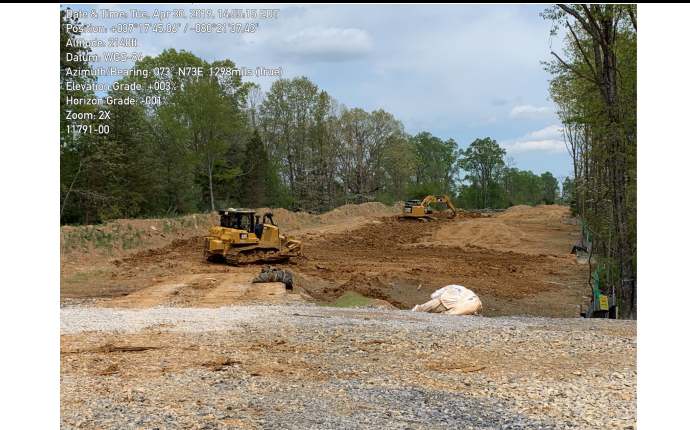
GPS Location	37.29	Field Station#	10883+00	GPS Location	37.29	Field Station#	11791+00
Description	ECD's and ROW conditions			Description	Crew restoring ROW and water bars

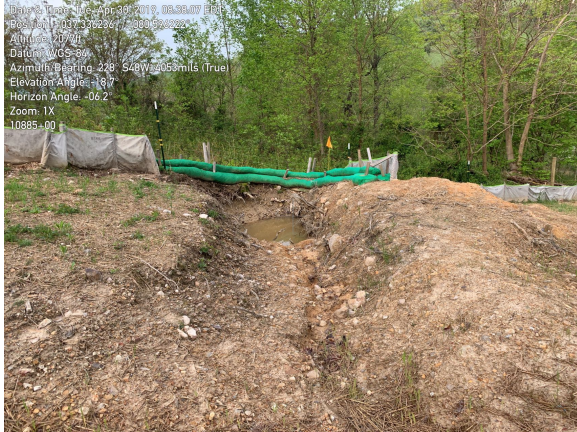
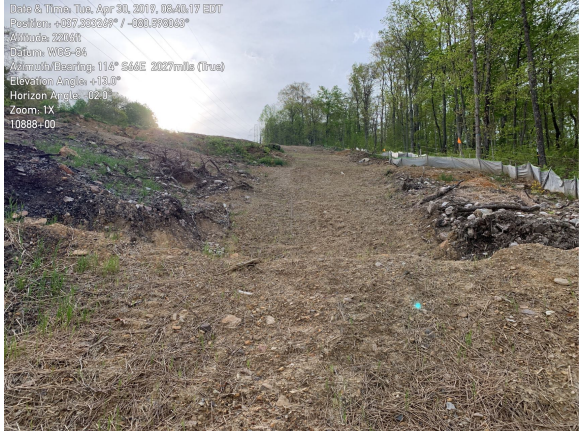
GPS Location	37.31	Field Station#	10885+00	GPS Location	37.31	Field Station#	10888+00
Description	See photo for GPS location. Waterbar, sump pit, and end treatment in place.			Description	See photo for GPS location. ROW stabilized with earth guard pellets.

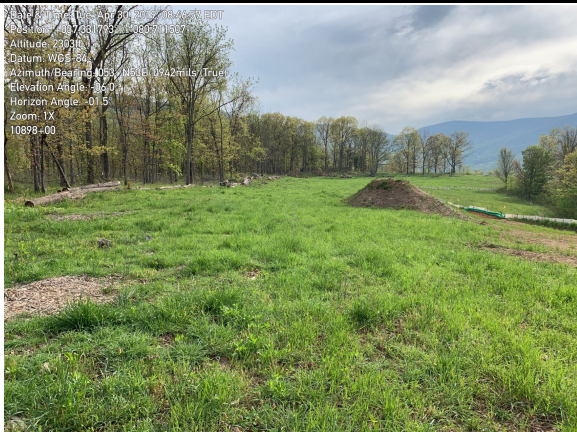
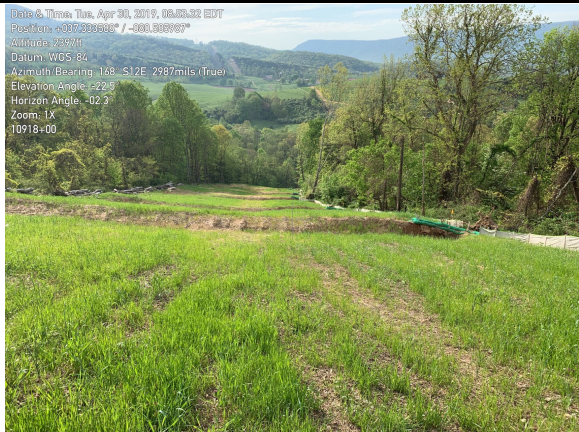
GPS Location	37.31	Field Station#	10898+00	GPS Location	37.31	Field Station#	10918+00
Description	See photo for GPS location. ROW temporarily stabilized with seed, mulch, and natural vegetation.			Description	See photo for GPS location. Waterbars in place and ROW is stabilized with seed, mulch, natural vegetation.

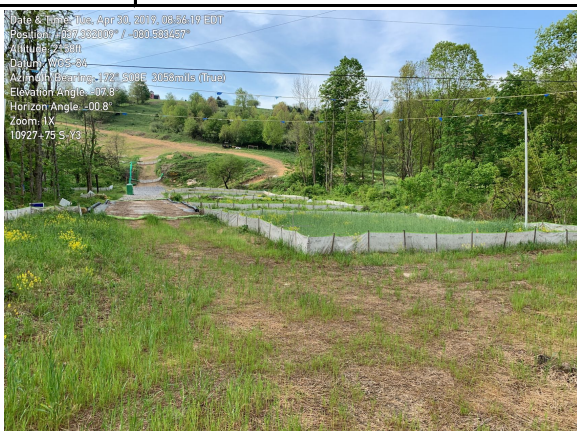
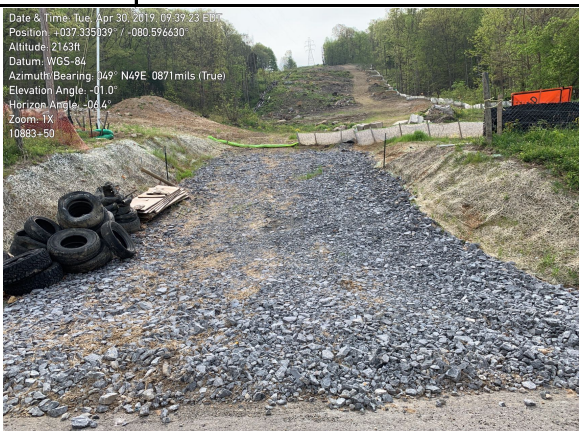
GPS Location	37.31	Field Station#	10927+75	GPS Location	37.31	Field Station#	10883+50
Description	See photo for GPS location. Sensitive resource buffer in place at stream S-Y3.			Description	See photo for GPS location. RCE in place at Kow Camp Road.

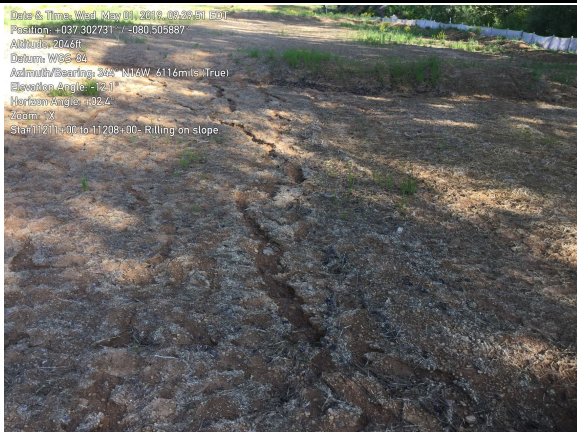
</div>			
GPS Location		37.30	Field Station#		11229+00		
Description		Water bar stable, erosion in water bar flow line.					
<div><p>Date & Time: Wed, May 01, 2019, 09:45:29 EDT Position: +037 302731° / -080 505887° Altitude: 2026ft Datum: WGS-84 Azimuth/Bearing: 322° N34W 6116mils (True) Elevation Angle: -12.9° Horizon Angle: +03.4° Zoom: 1X Sta#11211+00 to 11208+00: Rilling on slope</p>

GPS Location		37.30	Field Station#		11211+00		
Description		Rilling on slope between 11211+00 & 11208+00					
<div><p>Date & Time: Wed, May 01, 2019, 09:21:17 EDT Position: +037 301455° / -080 502694° Altitude: 2027ft Datum: WGS-84 Azimuth/Bearing: 244° S84W 4493mils (True) Elevation Angle: -10.3° Horizon Angle: +01.2° Zoom: 1X Sta#11225+00: Slope drain, end treatment, rock swale.</p>

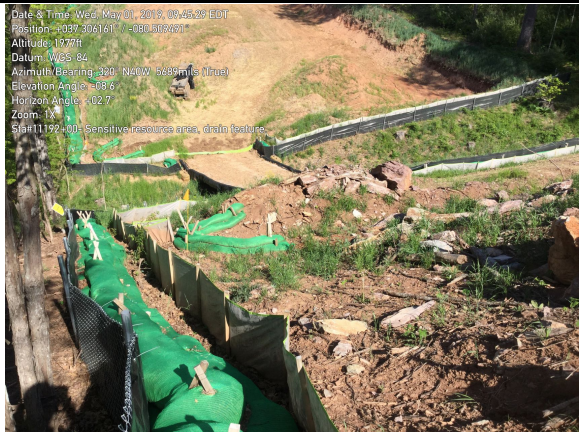
</div>				<div><p>Date & Time: Wed, May 01, 2019, 09:55:29 EDT Position: +037 306161° / -080 502971° Altitude: 1977ft Datum: WGS-84 Azimuth/Bearing: 340° N40W 6089mils (True) Elevation Angle: +08.6° Horizon Angle: +02.7° Zoom: 1X Sta#11192+00: Sensitive resource area, drain feature.</p>

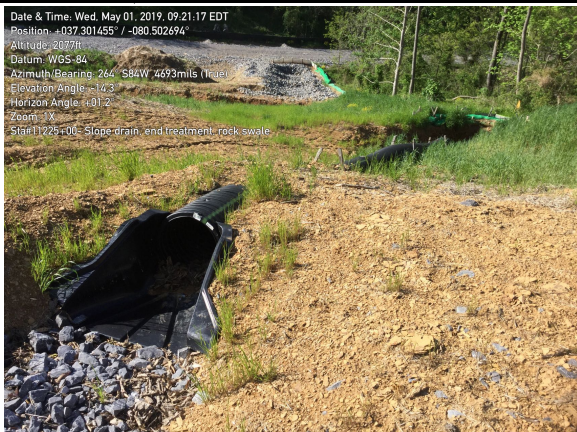
</div>			
GPS Location		37.30	Field Station#		11225+00		
Description		Slope drain, End treatment. Rock swale.					
GPS Location		37.30	Field Station#		11174+00		
Description		Sta#11174+00 to 11170+00 has been re-stabilized with straw mulch & seeded, crimped with a dozer.

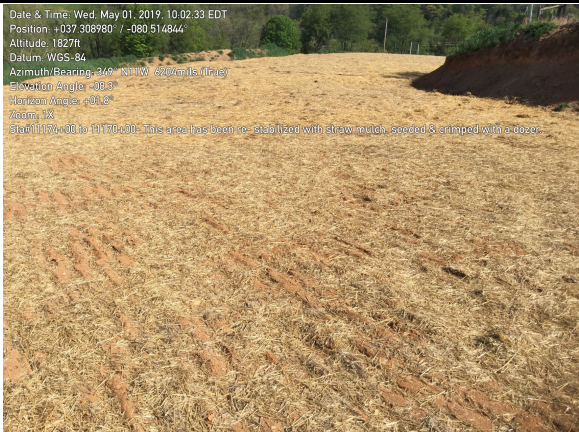
</div>				<div><p>Date & Time: Wed, May 01, 2019, 10:02:33 EDT Position: +037 306980° / -080 514844° Altitude: 1827ft Datum: WGS-84 Azimuth/Bearing: 349° N40W 6200mils (True) Elevation Angle: +03.3° Horizon Angle: +01.8° Zoom: 1X Sta#11174+00 to 11170+00: This area has been re-stabilized with straw mulch, seeded & crimped with a dozer.</p>

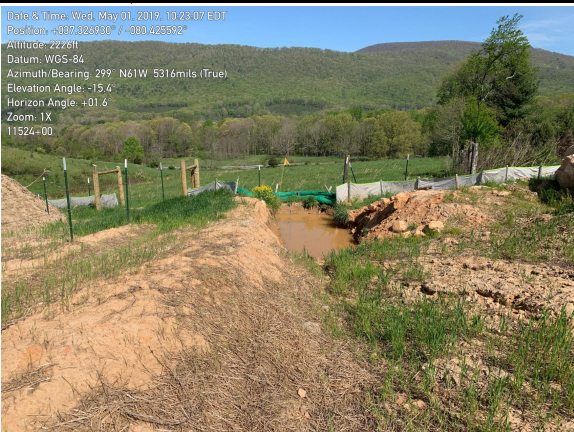
GPS Location	37.31	Field Station#	11524+00	GPS Location	37.31	Field Station#	11332+00
Description	See photo for GPS location. Waterbar, end treatment, and sump pit in place.			Description	See photo for GPS location. Rock lined channel in place.

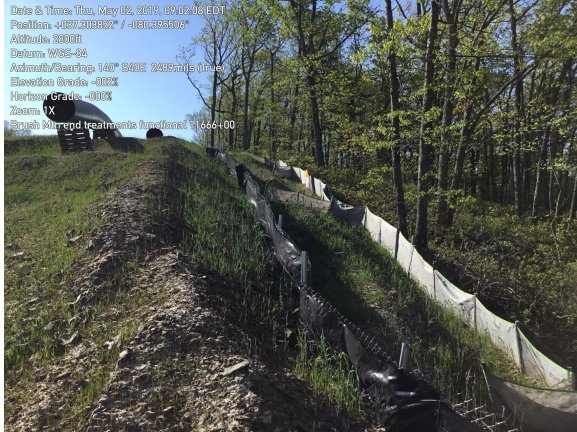
A/E	124300137	Date/Time	5/2/2019 10:59 AM	Report #	16640		
Pictures							
<p>Date & Time: Thu, May 02, 2019, 09:02:08 EDT Position: +037.216332° / +080.396094° Altitude: 300ft Datum: WGS-84 Azimuth/Bearing: 140° N31W 3849mils (True) Elevation Grade: -002° Horizon Grade: -002° Zoom: 1X Brush Mtn end treatments functional 11666+00</p>

GPS Location	37.31	Field Station#	11666+00	GPS Location	37.31	Field Station#	11663+00
Description	Correct coordinates on photo. Perimeter controls were checked for placement and effectiveness.			Description	Correct coordinates on photo. Perimeter controls are in place and functioning properly.

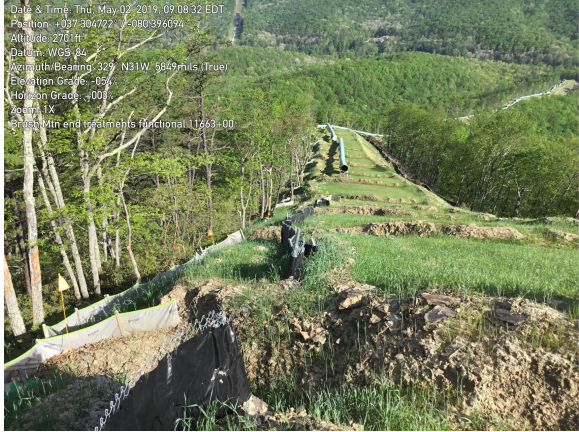
<p>Date & Time: Thu, May 02, 2019, 09:08:32 EDT Position: +037.204722° / +080.396094° Altitude: 270ft Datum: WGS-84 Azimuth/Bearing: 123° N31W 3849mils (True) Elevation Grade: -002° Horizon Grade: -002° Zoom: 1X Brush Mtn end treatments functional 11663+00</p>

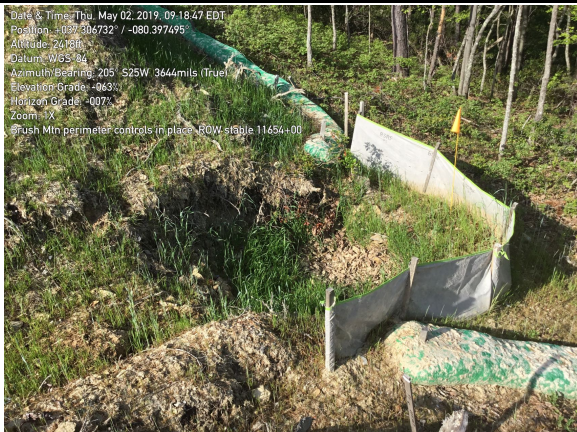
<p>Date & Time: Thu, May 02, 2019, 09:18:47 EDT Position: +037.204732° / +080.397495° Altitude: 260ft Datum: WGS-84 Azimuth/Bearing: 205° S25W 3644mils (True) Elevation Grade: -063° Horizon Grade: -007° Zoom: 1X Brush Mtn perimeter controls in place - ROW stable 11654+00</p>

GPS Location	37.31	Field Station#	11654+00	GPS Location	37.31	Field Station#	11633+00
Description	Correct coordinates on photo. End treatments are functional.			Description	Correct coordinates on photo. End treatments are working properly.		
<p>Date & Time: Thu, May 02, 2019, 09:32:18 EDT Position: +037.310682° / +080.397390° Altitude: 215ft Datum: WGS-84 Azimuth/Bearing: 250° N10W 6222mils (True) Elevation Grade: -033° Horizon Grade: -005° Zoom: 1X Brush Mtn ROW stable 11640+00</p>

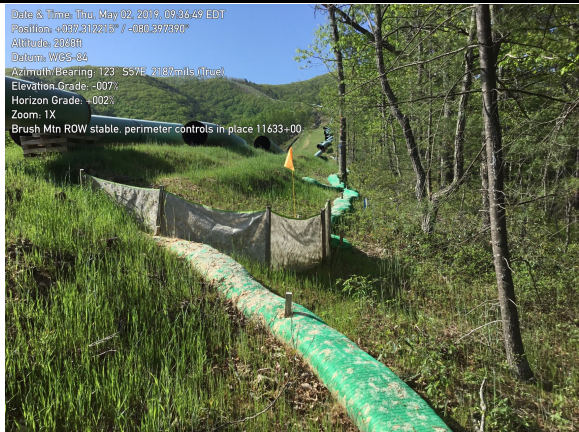
<p>Date & Time: Thu, May 02, 2019, 09:16:47 EDT Position: +037.212257° / +080.397491° Altitude: 300ft Datum: WGS-84 Azimuth/Bearing: 123° S37E 4218mils (True) Elevation Grade: -007° Horizon Grade: -002° Zoom: 1X Brush Mtn ROW stable, perimeter controls in place 11633+00</p>

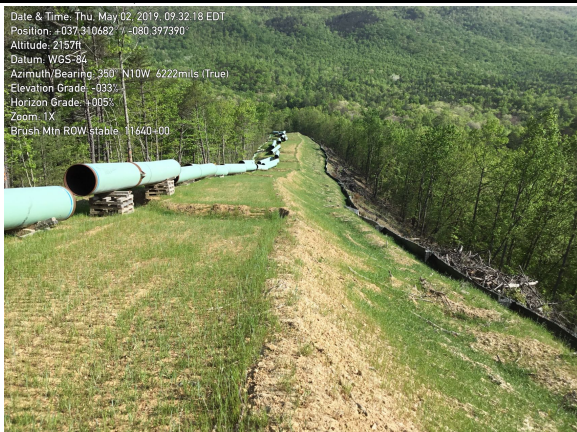
GPS Location	37.31	Field Station#	11640+00	GPS Location	37.31	Field Station#	11626+04
Description	Correct coordinates on photo. ROW stable. Slope breakers and controls effective.			Description	Correct coordinates on photo. Resource crossings are stable.

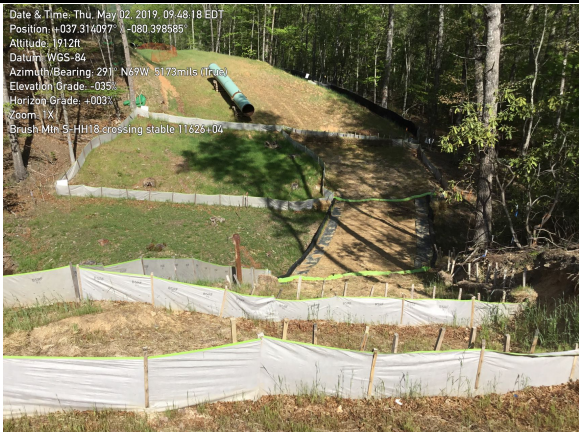
<p>Date & Time: Thu, May 02, 2019, 09:48:18 EDT Position: +037.314047° / +080.398585° Altitude: 212ft Datum: WGS-84 Azimuth/Bearing: 291° N69W 5173mils (True) Elevation Grade: -035° Horizon Grade: -003° Zoom: 1X Brush Mtn S-H418 crossing stable 11626+04</p>

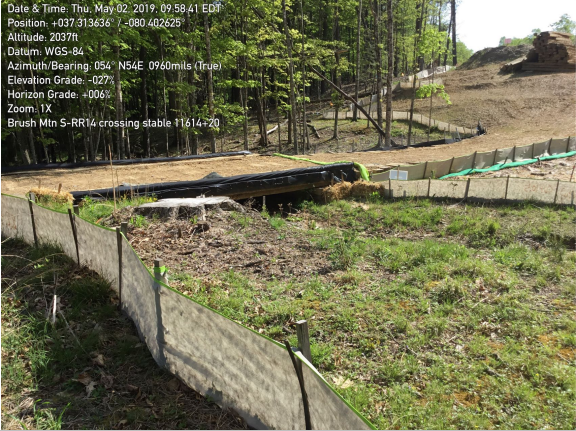
AFE 124300137		Date/Time 5/2/2019 10:59 AM		Report # 16640	
Pictures					
<small>Date & Time: Thu, May 02, 2019, 09:58:41 EDT Position: +037°31'36.36" / -080°40'26.25" Altitude: 2037ft Datum: WGS-84 Azimuth/Bearing: 054° N54E 0960mils (True) Elevation Grade: -027% Horizon Grade: +006% Zoom: 1X Brush Mtn S-RR14 crossing stable 11614+20</small>

GPS Location 37.31		Field Station# 11614+20		GPS Location 37.31	
Description		Correct coordinates on photo. Resource crossings are stable.		Description	
Description		Correct coordinates on photo. Resource crossings are stable.		Description	
<small>Date & Time: Thu, May 02, 2019, 10:10:07 EDT Position: +037°31'44.08" / -080°40'26.75" Altitude: 2067ft Datum: WGS-84 Azimuth/Bearing: 007° N07E 0142mils (True) Elevation Grade: +036% Horizon Grade: +008% Zoom: 1X Brush Mtn controls in place at S-RR crossing MN-258.04</small>

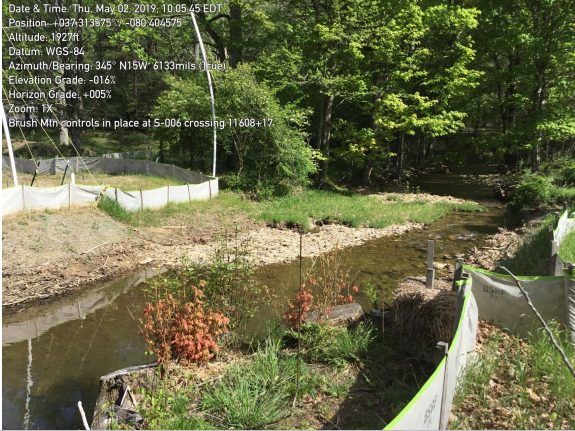
<small>Date & Time: Thu, May 02, 2019, 10:05:45 EDT Position: +037°31'36.75" / -080°40'45.76" Altitude: 1927ft Datum: WGS-84 Azimuth/Bearing: 345° N15W 6133mils (True) Elevation Grade: -016% Horizon Grade: +005% Zoom: 1X Brush Mtn controls in place at S-006 crossing 11608+17</small>

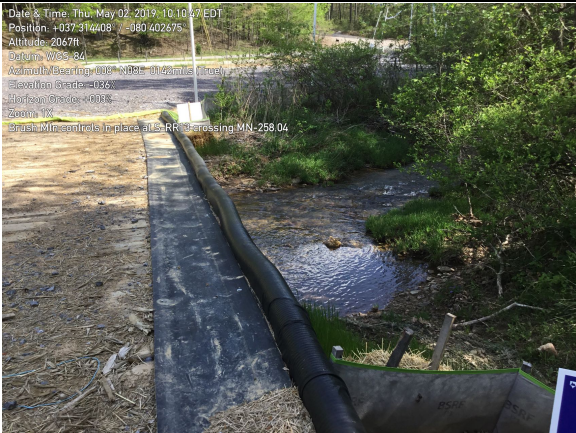
GPS Location 37.31		Field Station# 11613+69		GPS Location	
Description		Correct coordinates on photo. Resource crossings are stable.		Description	
Insert image here			Insert image here		
GPS Location		Field Station#		GPS Location	
Description				Description

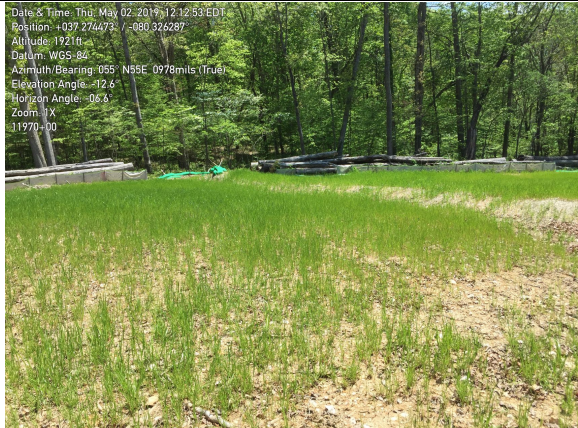
</div>			<div><div>Date & Time: Thu, May 02, 2019, 12:12:53 EDT Position: +037.274473° / -080.324287° Altitude: 1921ft Datum: WGS-84 Azimuth/Bearing: 055° N55E 0978mils (True) Elevation Angle: -12.6° Horizon Angle: -05.6° Zoom: 1X 11970+00</div>

GPS Location	37.33	Field Station#	11958+00	GPS Location	37.33	Field Station#	11970+00
Description	Row			Description	Water breaker with end treatment		
<div><div>Date & Time: Thu, May 02, 2019, 12:18:55 EDT Position: +037.269988° / -080.323177° Altitude: 1923ft Datum: WGS-84 Azimuth/Bearing: 282° N88W 5724mils (True) Elevation Angle: -08.5° Horizon Angle: -02.3° Zoom: 1X 11979+00</div>

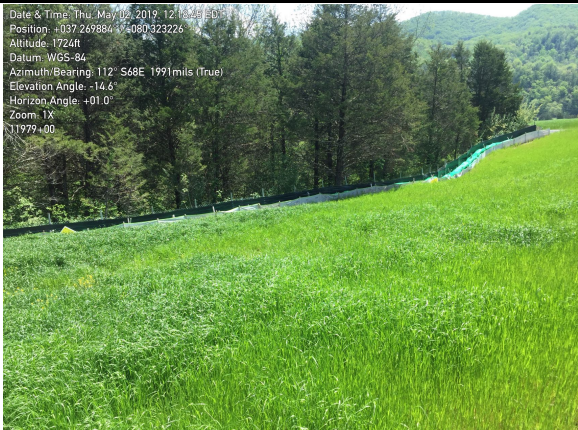
</div>			<div><div>Date & Time: Thu, May 02, 2019, 12:19:43 EDT Position: +037.269884° / -080.323226° Altitude: 1728ft Datum: WGS-84 Azimuth/Bearing: 112° S68E 1991mils (True) Elevation Angle: -14.6° Horizon Angle: +01.0° Zoom: 1X 11979+00</div>

</div>				
GPS Location	37.33	Field Station#	11979+00	GPS Location	37.33	Field Station#	11979+00
Description	Row			Description	ECDs protecting karst area

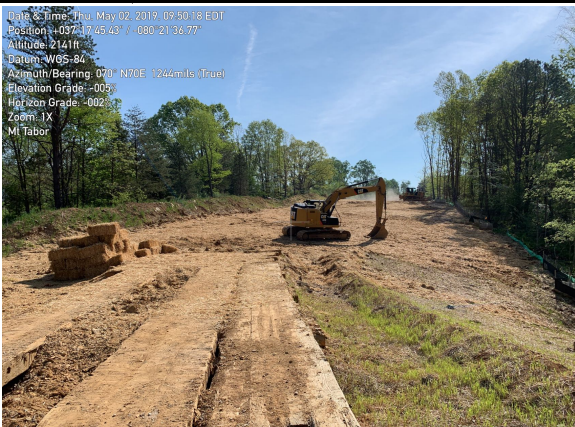
</div></div></div>				
GPS Location	37.29	Field Station#	11792+23		GPS Location	37.29	Field Station#	11792+23
Description	Crews continuing grade and water bar work			Description	Crews finished grade work and stabilized ROW

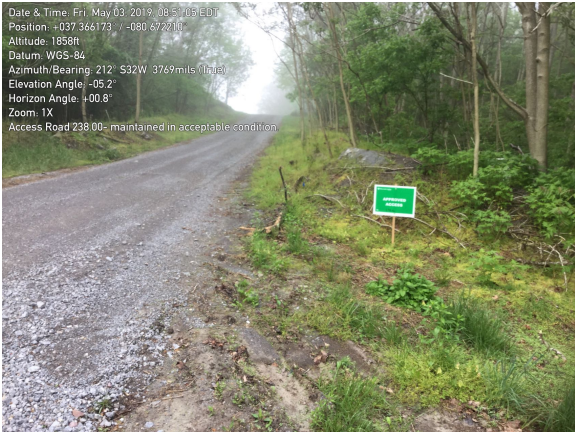
A/E	124300137	Date/Time	5/3/2019 8:47 AM	Report #	16689		
Pictures							
<div><div><div>Date & Time: Fri, May 03, 2019, 08:57:05 EDT Position: +037.366173° / -080.677211° Altitude: 1856ft Datum: WGS-84 Azimuth/Bearing: 212° S32W 3769mils (True) Elevation Angle: -05.2° Horizon Angle: +00.8° Zoom: 1X Access Road 238.00- maintained in acceptable condition.</div><div>

</div></div></div>				
GPS Location	37.36	Field Station#	12005+00	GPS Location	37.36	Field Station#	12005+00
Description	Access road 238.00- Maintained in acceptable condition			Description	LY-29- Arnold's seeding equipment & Materials storage.

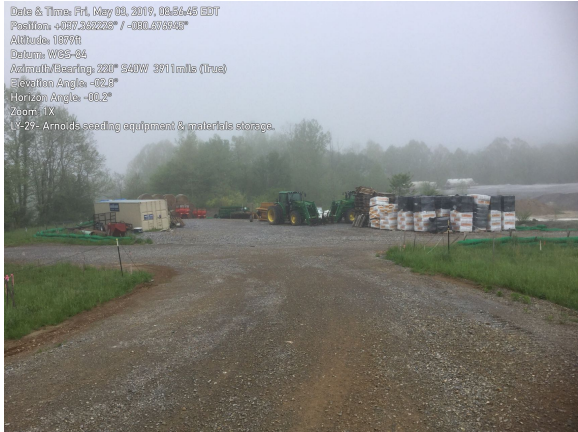
</div></div></div>			<div><div><div>Date & Time: Fri, May 03, 2019, 08:56:45 EDT Position: +037.362225° / -080.676940° Altitude: 1859ft Datum: WGS-84 Azimuth/Bearing: 220° S40W 3911mils (True) Elevation Angle: -02.6° Horizon Angle: -00.8° Zoom: 1X LY-29- Arnold's seeding equipment & materials storage.</div><div>

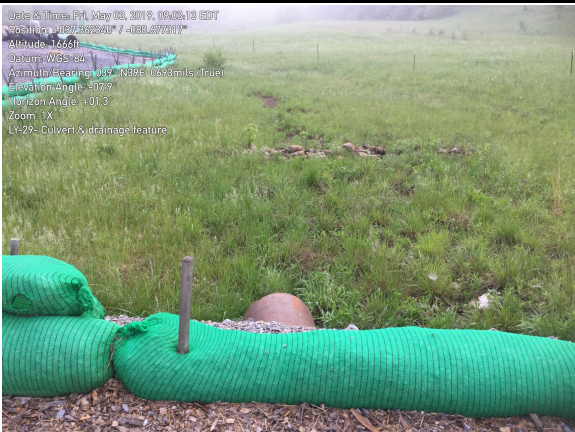
<div><div><div>Date & Time: Fri, May 03, 2019, 09:05:19 EDT Position: +037.362240° / -080.677211° Altitude: 1266ft Datum: WGS-84 Azimuth/Bearing: 033° N89E 6033mils (True) Elevation Angle: -07.9° Horizon Angle: +01.3° Zoom: 1X LY-29- Culvert & drainage feature</div><div>

</div></div></div>				
GPS Location	37.36	Field Station#	12005+00	GPS Location	37.36	Field Station#	12005+00
Description	LY-29- Culvert & drainage feature in acceptable condition.			Description	LY-29- Pipe, side boom, Triple stack CFS perimeter controls.		
<div><div><div>Date & Time: Fri, May 03, 2019, 09:11:31 EDT Position: +037.362235° / -080.676570° Altitude: 1709ft Datum: WGS-84 Azimuth/Bearing: 405° N55W 3422mils (True) Elevation Angle: -08.4° Horizon Angle: +01.2° Zoom: 1X LY-29- Rock construction surface is in acceptable condition.</div><div>

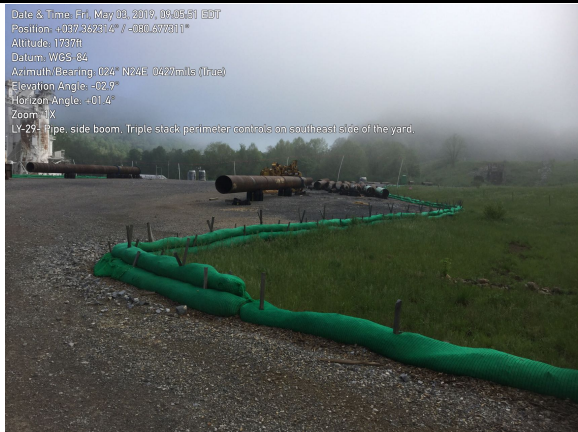
</div></div></div>			<div><div><div>Date & Time: Fri, May 03, 2019, 09:05:01 EDT Position: +037.362142° / -080.677211° Altitude: 1737ft Datum: WGS-84 Azimuth/Bearing: 024° N24E 6427mils (True) Elevation Angle: -02.9° Horizon Angle: -01.4° Zoom: 1X LY-29- Pipe, side boom, Triple stack perimeter controls on southeast side of the yard.</div><div>

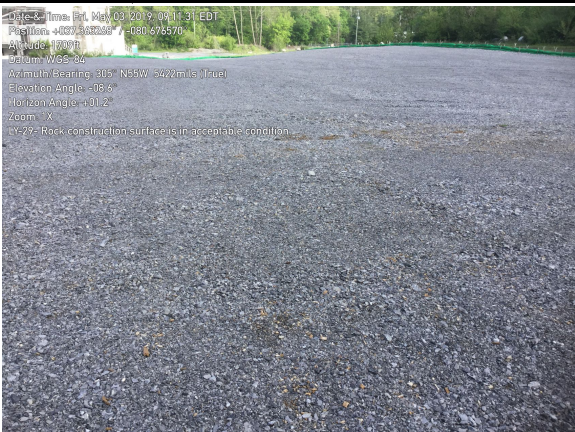
GPS Location	37.36	Field Station#	12005+00	GPS Location	37.36	Field Station#	12005+00
Description	LY-29- Rock construction surface is maintained			Description	LY-29- Triple stack CFS perimeter controls on northeast side of the yard.

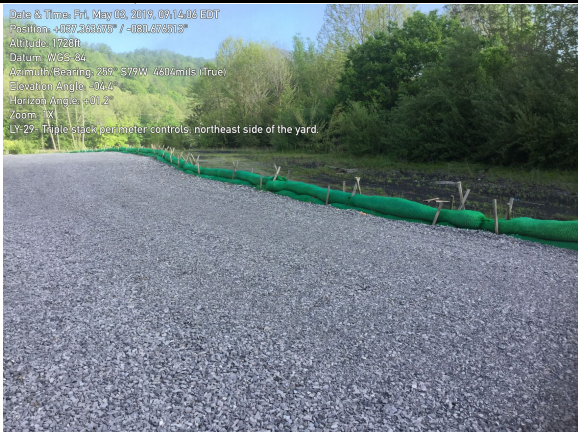
</div></div></div>			<div><div><div>Date & Time: Fri, May 03, 2019, 09:14:08 EDT Position: +037.363576° / -080.676015° Altitude: 1728ft Datum: WGS-84 Azimuth/Bearing: 485° S78W 4601mils (True) Elevation Angle: -04.2° Horizon Angle: +01.2° Zoom: 1X LY-29- Triple stack perimeter controls, northeast side of the yard.</div><div>

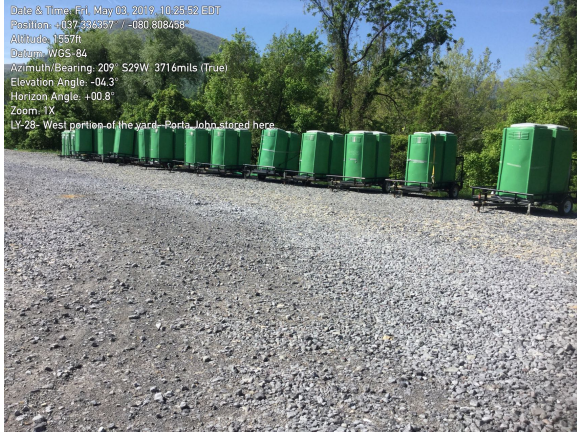
A/E	124300137	Date/Time	5/3/2019 10:20 AM	Report #	16699
Pictures					
<div><div><div>Date & Time: Fri, May 03, 2019, 10:25:52 EDT Position: +037.334357 / -080.808458 Altitude: 1557ft Datum: WGS-84 Azimuth/Bearing: 209° S29W 3716mils (True) Elevation Angle: -04.3° Horizon Angle: +00.8° Zoom: 1X LY-28- West portion of the yard- Porta John stored here</div><div>

</div></div></div>		
GPS Location	37.33	Field Station#	12005+00	GPS Location	37.33
Description	LY-28- west side of yard- Porta John storage			Description	LY-28-west side of the yard- CFS perimeter controls.
<div><div><div>Date & Time: Fri, May 03, 2019, 10:43:10 EDT Position: +037.334396 / -080.808989 Altitude: 1543ft Datum: WGS-84 Azimuth/Bearing: 101° S08E 1507mils (True) Elevation Angle: -03.8° Horizon Angle: +00.9° Zoom: 1X LY-28-West side of the yard- Transport buses stored</div><div>

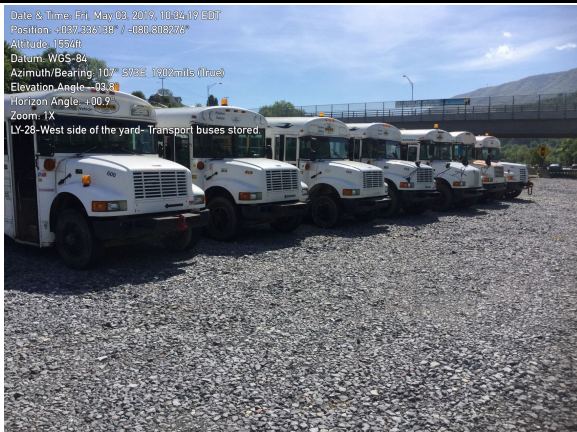
GPS Location	37.31	Field Station#	12005+00	GPS Location	37.33
Description	LY-28- West side of the yard- Transport buses			Description	LY-28-East side of the yard- Frontage road ECD's
<div><div><div>Date & Time: Fri, May 03, 2019, 10:48:11 EDT Position: +037.334145 / -080.803199 Altitude: 1560ft Datum: WGS-84 Azimuth/Bearing: 248° S68W 4409mils (True) Elevation Angle: -04.2° Horizon Angle: +01.1° Zoom: 1X LY-28- East side of the yard- Truck storage</div><div>

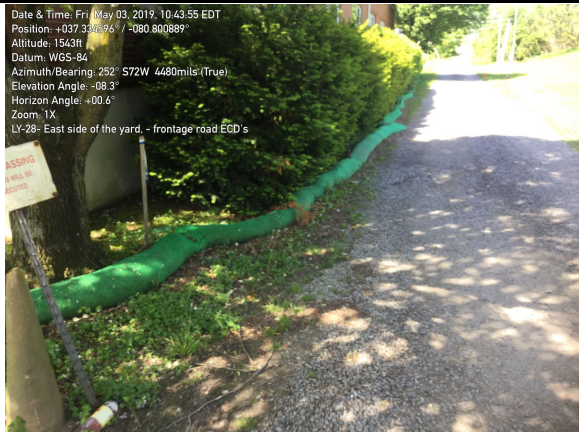
</div></div></div>			<div><div><div>Date & Time: Fri, May 03, 2019, 10:43:55 EDT Position: +037.334396 / -080.808989 Altitude: 1543ft Datum: WGS-84 Azimuth/Bearing: 252° S72W 4480mils (True) Elevation Angle: -08.3° Horizon Angle: +00.6° Zoom: 1X LY-28- East side of the yard- frontage road ECD's</div><div>

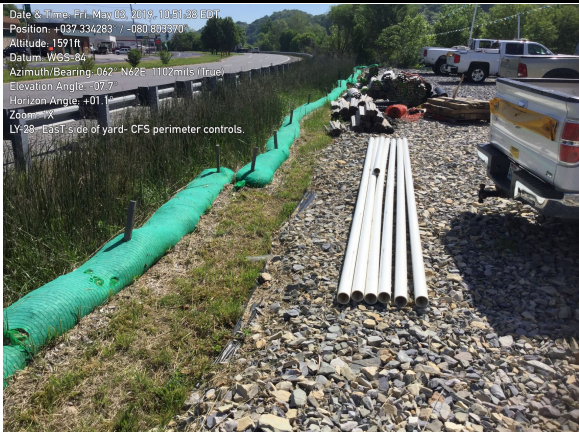
</div></div></div>			<div><div><div>Date & Time: Fri, May 03, 2019, 10:51:38 EDT Position: +037.334283 / -080.803390 Altitude: 1591ft Datum: WGS-84 Azimuth/Bearing: 062° N42E 1102mils (True) Elevation Angle: -07.7° Horizon Angle: +01.1° Zoom: 1X LY-28- East side of yard- CFS perimeter controls</div><div>

</div></div></div>		
GPS Location	37.33	Field Station#	12005+00	GPS Location	37.33
Description	LY-28-East side of the yard- Trucks stored.			Description	LY-28- East side of the yard- CFS- perimeter controls

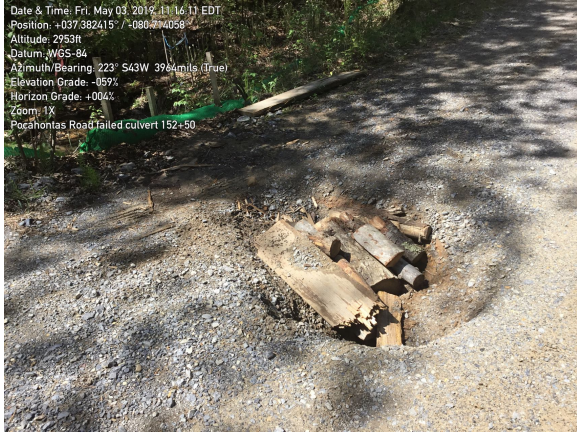
AFE	124300137	Date/Time	5/3/2019 3:13 PM	Report #	16716		
Pictures							
<p>Date & Time: Fri, May 03, 2019, 11:16:11 EDT Position: +037.382415° / -080.710059° Altitude: 2953ft Datum: WGS-84 Azimuth/Bearing: 223° S43W 394mils (True) Elevation Grade: -059% Horizon Grade: +004% Zoom: 1X Pocahontas Road failed culvert 152+50</p>

GPS Location	37.31	Field Station#	152+50	GPS Location	37.31	Field Station#	264+80
Description	Correct coordinates on photo. Security personnel have placed wood in the hole at failed culvert.			Description	Correct coordinates on photo. The culvert at the S-PP14 crossing appears to be getting in worse condition.

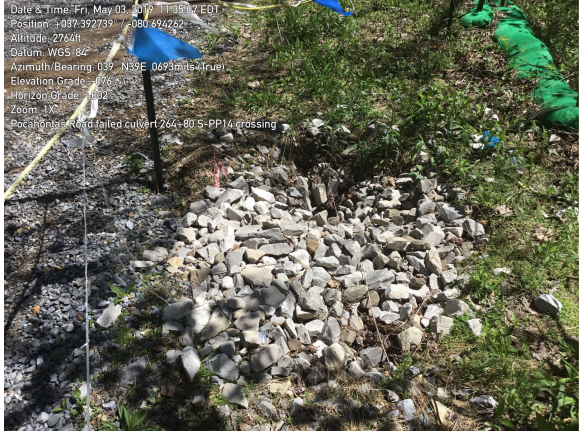
<p>Date & Time: Fri, May 03, 2019, 11:36:07 EDT Position: +037.392739° / -080.692262° Altitude: 2764ft Datum: WGS-84 Azimuth/Bearing: 039° N39E 0673mils (True) Elevation Grade: -076% Horizon Grade: +002% Zoom: 1X Pocahontas Road failed culvert 264+80 S-PP14 crossing</p>

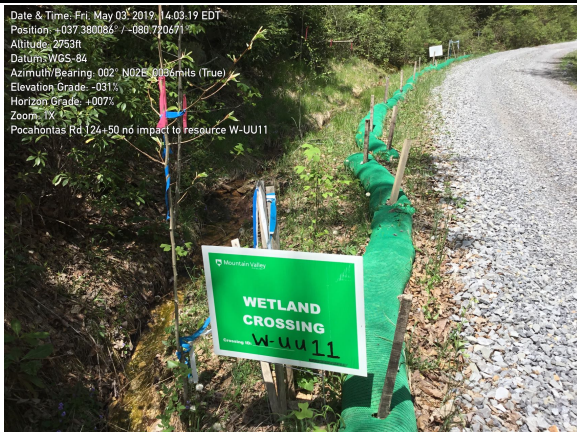
<p>Date & Time: Fri, May 03, 2019, 14:03:19 EDT Position: +037.380086° / -080.710671° Altitude: 2953ft Datum: WGS-84 Azimuth/Bearing: 002° N02E 0136mils (True) Elevation Grade: -031% Horizon Grade: +007% Zoom: 1X Pocahontas Rd 124+50 no impact to resource W-UU11</p>

GPS Location	37.31	Field Station#	124+50	GPS Location	37.31	Field Station#	115+25
Description	Correct coordinates on photo. No stream or wetland impact identified today.			Description	Correct coordinates on photo. Wetland W-UU12 adjacent to Pocahontas Road shows no evidence of impact.		
<p>Date & Time: Fri, May 03, 2019, 12:29:11 EDT Position: +037.393888° / -080.681098° Altitude: 3280ft Datum: WGS-84 Azimuth/Bearing: 253° S25W 4522mils (True) Elevation Grade: -014% Horizon Grade: +007% Zoom: 1X Mystery Ridge 10428+25 clearing yet to be completed</p>

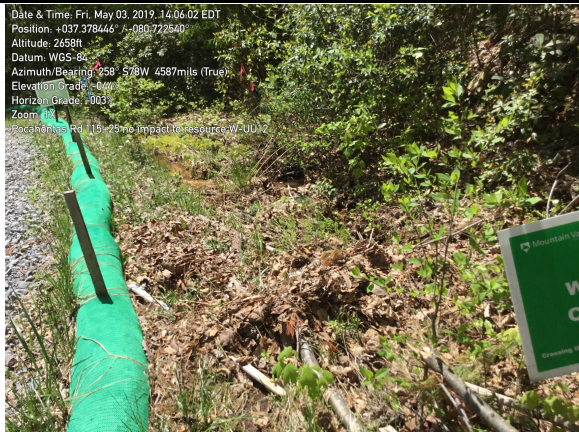
<p>Date & Time: Fri, May 03, 2019, 14:06:02 EDT Position: +037.378446° / -080.722540° Altitude: 2658ft Datum: WGS-84 Azimuth/Bearing: 258° S78W 4587mils (True) Elevation Grade: -040% Horizon Grade: +003% Zoom: 1X Pocahontas Rd 115+25 no impact to resource W-UU12</p>

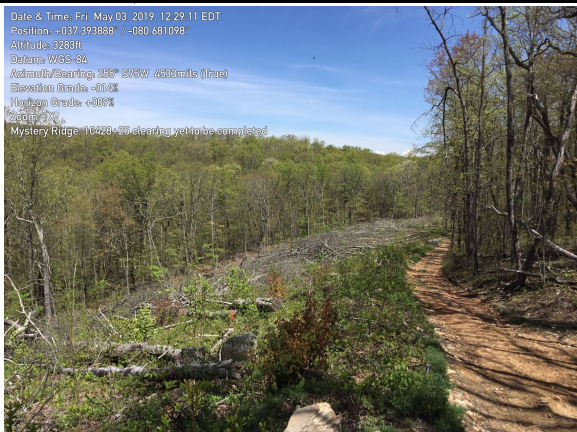
GPS Location	37.31	Field Station#	10428+25	GPS Location	37.31	Field Station#	10412+25
Description	Correct coordinates on photo. Timber has not been cleared from Peter's Mountain. Timber is rotting and of no value.			Description	Correct coordinates on photo. ECD was repaired. Waiting for FS approval to stabilize small amount of sediment off LOD.

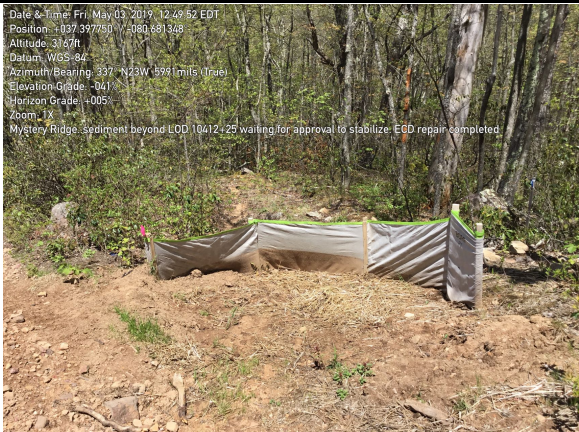
<p>Date & Time: Fri, May 03, 2019, 12:49:52 EDT Position: +037.397750° / -080.681369° Altitude: 3167ft Datum: WGS-84 Azimuth/Bearing: 337° N23W 5981mils (True) Elevation Grade: -041% Horizon Grade: +005% Zoom: 1X Mystery Ridge sediment beyond LOD 10412+25 waiting for approval to stabilize ECD repair completed</p>

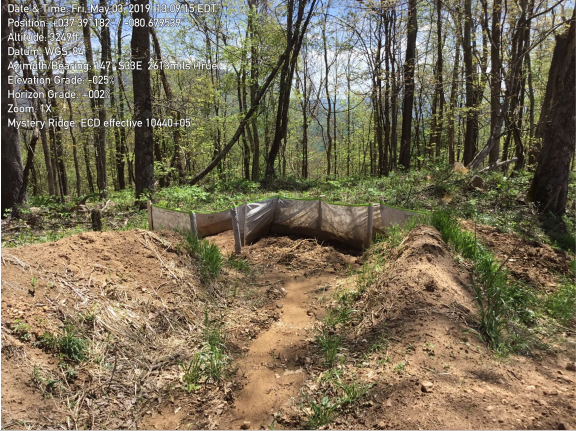
AFE	124300137	Date/Time	5/3/2019 3:13 PM	Report #	16716
Pictures					
<small> Date & Time Fri, May 03, 2019, 13:13:28 Position: +037.390137 / -080.679334 Altitude: 322ft Datum: WGS-84 Azimuth/Bearing: 147.508E 261mils (True) Elevation Grade: -02% Horizon Grade: -002% Zoom: 1X Mystery Ridge: ECD effective 10440+95 </small>

GPS Location	37.31	Field Station#	10440+05	GPS Location	37.31
Description	Correct coordinates on photo. End treatments are currently effective.				
<small> Date & Time Fri, May 03, 2019, 13:44:25 Position: +037.390513 / -080.679334 Altitude: 321ft Datum: WGS-84 Azimuth/Bearing: 152.529E 279mils (True) Elevation Grade: -03% Horizon Grade: -001% Zoom: 1X Mystery Ridge: 10442+00 waiting for approval to stabilize sediment beyond LOD. ECD has been repaired </small>

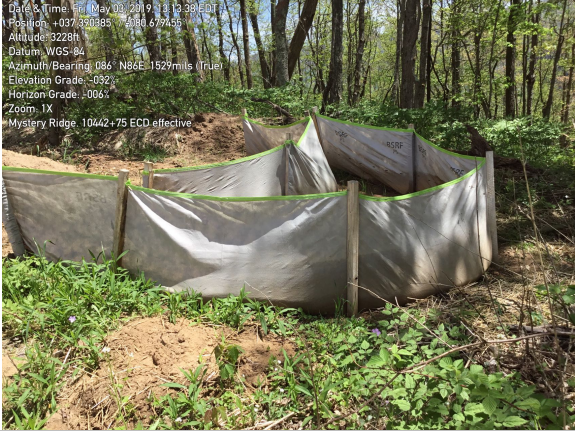
<small> Date & Time Fri, May 03, 2019, 13:28:01 Position: +037.390485 / -080.679433 Altitude: 322ft Datum: WGS-84 Azimuth/Bearing: 086.184E 152mils (True) Elevation Grade: -03% Horizon Grade: -006% Zoom: 1X Mystery Ridge: 10442+75 ECD effective </small>

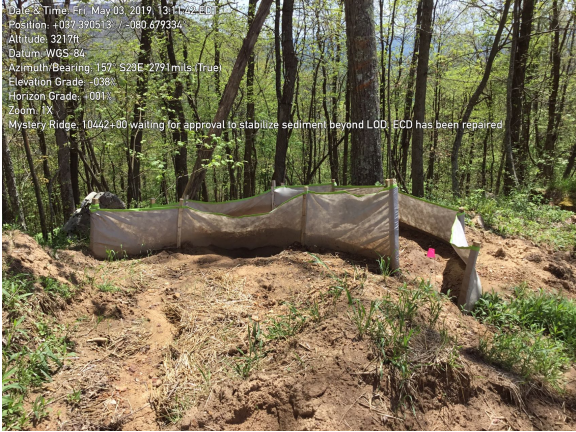
GPS Location	37.31	Field Station#	10442+00	GPS Location	
Description	Correct coordinates on photo. ECD repair complete. FS to grant approval to stabilize small sediment deposits off LOD.				
Insert image here			Insert image here		
GPS Location		Field Station#		GPS Location	
Description

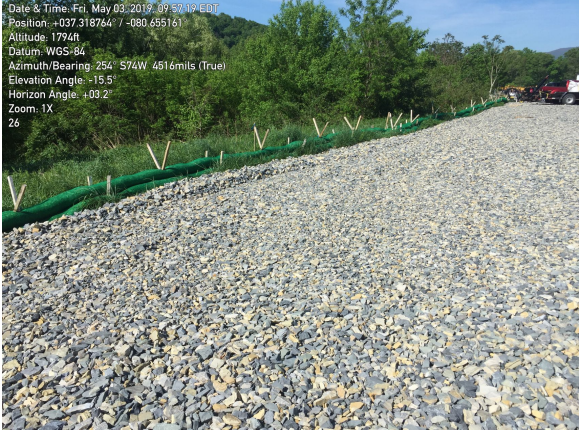
<p>Date & Time: Fri, May 03, 2019, 10:00:12 EDT Position: +037.318663 / -080.656286 Altitude: 1797ft Datum: WGS-84 Azimuth/Bearing: 346.812W 4151mils (True) Elevation Angle: -11.8 Horizon Angle: +01.6 Zoom: 1X 26</p>				
GPS Location	37.33	Field Station#	12005+00	GPS Location	37.33	Field Station#	12005+00
Description	Sock in good working condition			Description	Containment on generator

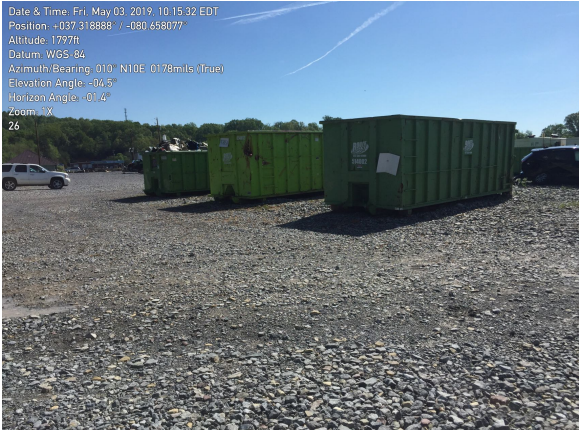
GPS Location	37.33	Field Station#	12005+00	GPS Location	37.33	Field Station#	12005+00
Description	Trash roll offs			Description	ECD		
Insert image here				Insert image here			
GPS Location		Field Station#		GPS Location		Field Station#	
Description				Description
