Visual Site Inspection Report

Project Name	H-600 Pipeline Spread G	AFE	124300137	Spread	H-600 Pipeline Spread G
Contractor	Precision			Report #	15585
Inspector	Len Kruizenga			Date/Time	4/8/2019 7:19 AM
Permit #	TBD	Inspection Type	VA SWPP	Station Begin	11022+00
State	VA	Inspection Area	Partial	Station End	10930+00
County	Giles	Ground	Wet	Temperature (°F)	54.00
Municipality	N/A	Weather	Cloudy	Rain Gauge (in)	0.30
				Rain Accumulation Time (days)	0.30

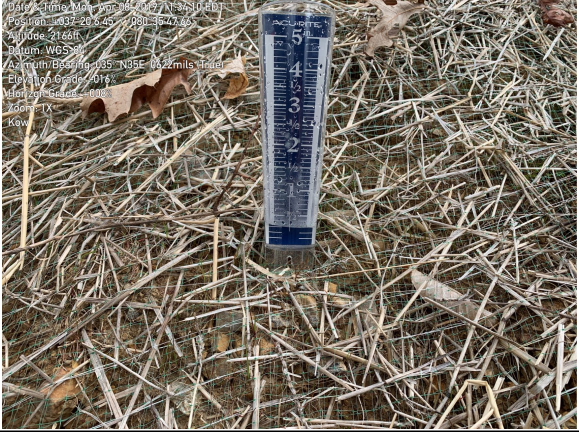
<p>GPS Location 37.24 Field Station# +1</p> <p>Description .2" of rain recorded @ AR 234</p>	
<p>Date & Time: Mon, Apr 08, 2019, 11:50:17 EDT Position: +037°22'24.43"N / -080°35'41.97"W Altitude: 1912ft Datum: WGS-84 Azimuth Bearing: 192° S01E 510mils True Elevation Grade: -027 Horizon Grade: -001 Zoom: 1X 236</p>

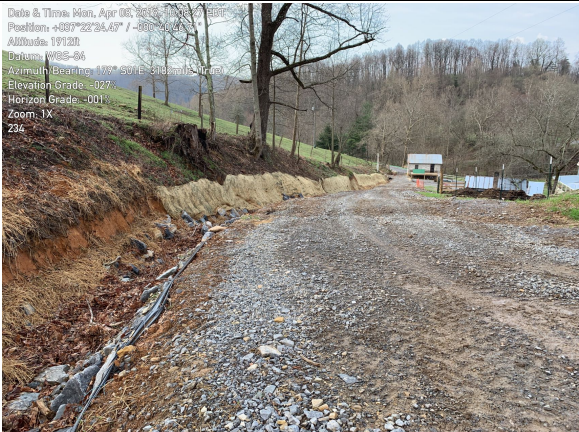
<p>GPS Location 37.24 Field Station# 2+34</p> <p>Description ECD's and ROW conditions @ AR 234</p>

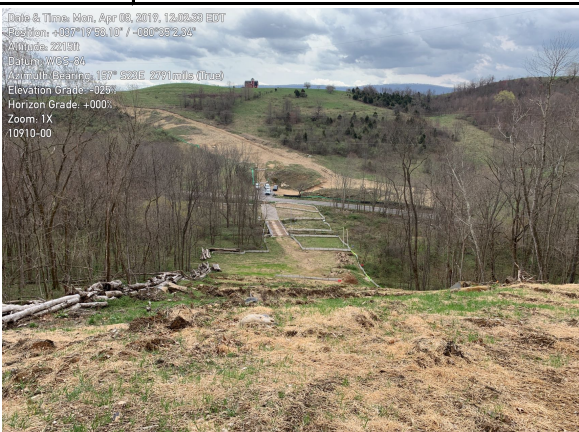
<p>GPS Location 37.24 Field Station# 10890+00</p> <p>Description ECD's and ROW conditions</p>	
<p>Date & Time: Mon, Apr 08, 2019, 10:51:38 EDT Position: +037°20'13.85"N / -080°36'12.45"W Altitude: 2302ft Datum: WGS-84 Azimuth Bearing: 306° NSW 542mils True Elevation Grade: -037 Horizon Grade: -015 Zoom: 1X 10890+00</p>

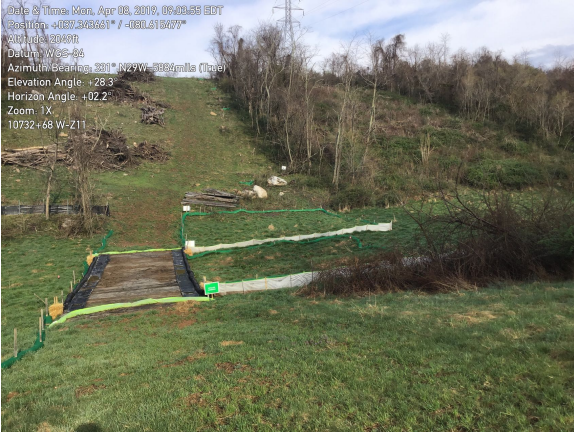
</div>				
GPS Location	37.20	Field Station#	10732+68	GPS Location	37.20	Field Station#	10725+00
Description	See photo for GPS location. Sensitive resource buffer in place at wetland W-Z11.			Description	See photo for GPS location. Waterbar and end treatment in place.		
<div><p>Date & Time: Mon, Apr 08, 2019, 09:09:46 EDT Position: +037.347022° / -080.642635° Altitude: 2411ft Datum: WGS-84 Azimuth Bearing: 001° N02W 0384mils (True) Elevation Angle: +30.7° Horizon Angle: +08.6° Zoom: 1X 10723+00</p>

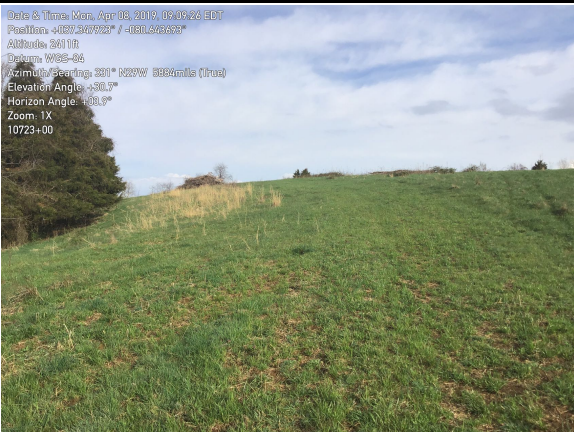
GPS Location	37.20	Field Station#	10723+00	GPS Location	37.20	Field Station#	10697+00
Description	See photo for GPS location. ROW stabilized with natural vegetation.			Description	See photo for GPS location. Rain gauge at buffalo antlklets Road. 0.2 inches.		
<div><p>Date & Time: Mon, Apr 08, 2019, 05:35:46 EDT Position: +037.346907° / -080.637017° Altitude: 2070ft Datum: WGS-84 Azimuth Bearing: 312° N62W 334mils (True) Elevation Angle: +26.1° Horizon Angle: +08.1° Zoom: 1X 10696+50</p>

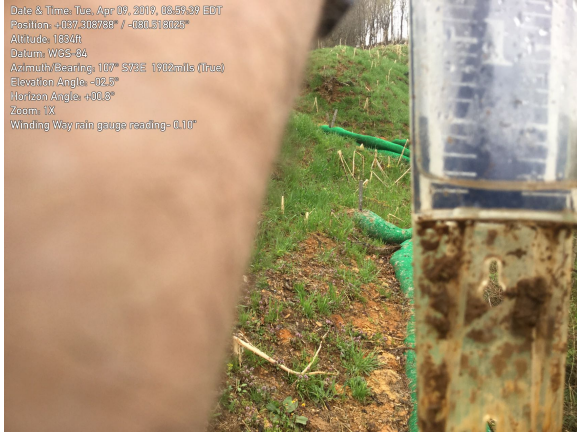
GPS Location	37.30	Field Station#	11227+55	GPS Location	37.30	Field Station#	11225+00
Description	Winding Way rain gauge reading-0.10"			Description	Slope drain, end treatment p, rock swale are in acceptable condition.		
<p>Date & Time: Tue, Apr 09, 2019, 09:14:41 EDT Position: +037.303009° / +080.506301° Altitude: 1934ft Datum: WGS-84 Azimuth/Bearing: 217° S37W 3858mils (True) Elevation Angle: -05.9° Horizon Angle: +01.3° Zoom: 1X Star11208+00- Row is stable after rain events</p>

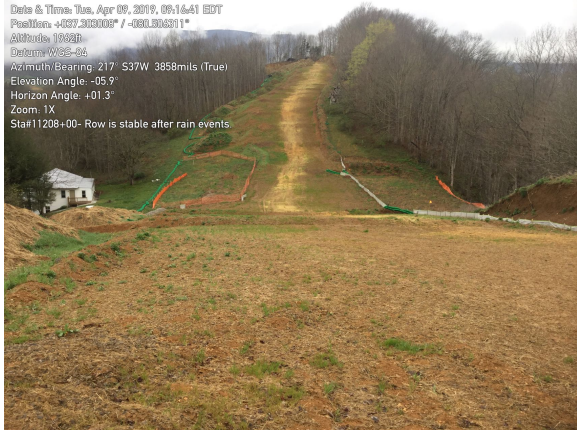
GPS Location	37.30	Field Station#	11208+00	GPS Location	37.30	Field Station#	11192+00
Description	Row stable after rain events.			Description	Sensitive resource area ECD's are in good condition		
<p>Date & Time: Tue, Apr 09, 2019, 09:43:08 EDT Position: +037.307387° / +080.510713° Altitude: 1922ft Datum: WGS-84 Azimuth/Bearing: 345° N15W 536mils (True) Elevation Angle: -09.0° Horizon Angle: +01.2° Zoom: 1X Star11184+00- CWD plunge pool rocks clean ECD's are in acceptable condition</p>

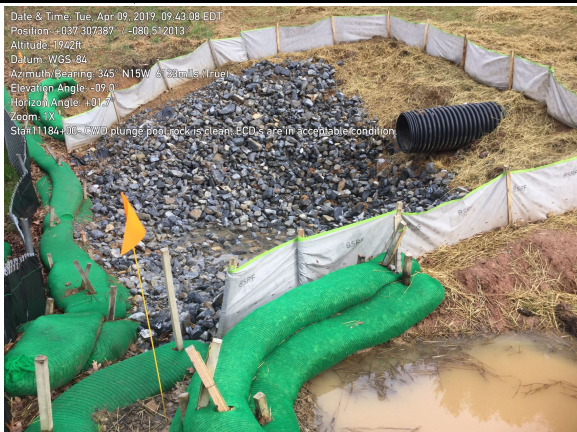
GPS Location	37.30	Field Station#	11184+00	GPS Location	37.31	Field Station#	11172+70
Description	CWD plunge pool are in good condition			Description	Slope drain CFS checks & end treatment are in good condition.

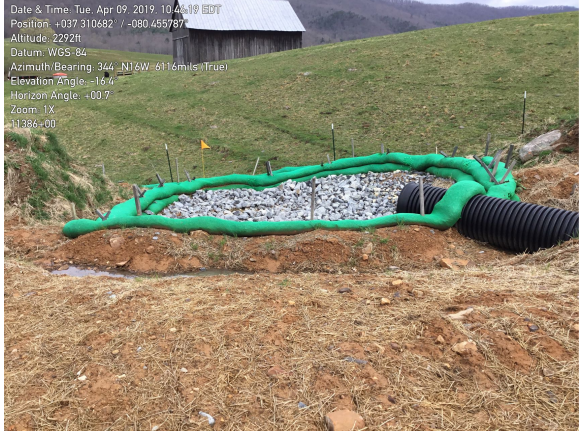
<p>Date & Time: Tue, Apr 09, 2019, 10:44:19 EDT Position: +037 310682 / -080 455787 Altitude: 2222ft Datum: WGS-84 Azimuth/Bearing: 344° N16W 6116mils (True) Elevation Angle: -16.4° Horizon Angle: -00.7° Zoom: 1X 11386+00</p>				
GPS Location	37.30	Field Station#	11472+00	GPS Location	37.30	Field Station#	11386+00
Description	Rain gauge steel acres .3"			Description	Plunge pool in good condition

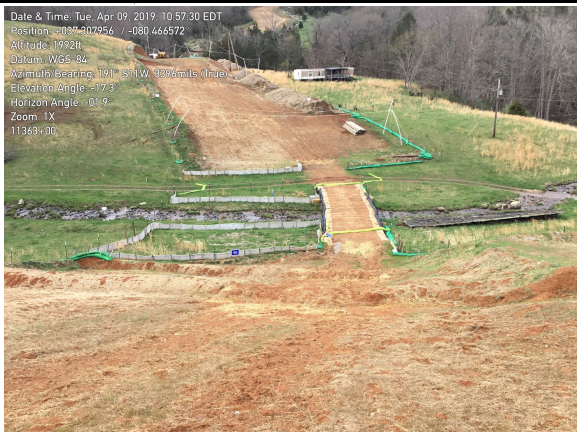
<p>Date & Time: Tue, Apr 09, 2019, 10:41:23 EDT Position: +037 312391 / -080 452199 Altitude: 2235ft Datum: WGS-84 Azimuth/Bearing: 272° N88W 4836mils (True) Elevation Angle: -20.1° Horizon Angle: -00.6° Zoom: 1X 11396+00</p>				
GPS Location	37.30	Field Station#	11363+00	GPS Location	37.30	Field Station#	11396+00
Description	Stream crossing all ECDs in good working condition			Description	Row stabilized

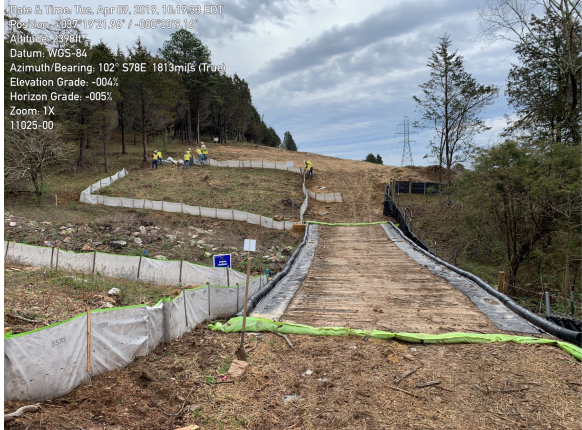
7. Identify all remedial measures that have been taken since the previous inspection was conducted.					
Comments (Reference above questions as appropriate.)					
Arrived @ LDY 26 for morning meeting Performed SWPP from MP 208.5 - MP 211 Observed damage to P1SF in multiple locations for the buffer for stream S-IJ18, contacted environmental crew and repairs were made same day. No other signs of damage was observed to ECD's installed in this area No signs of sediment outside of LOD or impacting any sensitive resources ROW conditions are stable and showing no major erosion issues Jamie Grimes Environmental crew worked repairing P1SF and installing fencing material @ MP 209 Crews left ROW @ 3:30pm					
Note: It is a condition of National Pollutant Discharge Elimination System and Erosion and Sediment permits that a maintenance program be conducted to provide for the operation and maintenance of all BMPs to be inspected on a weekly basis and after each stormwater event. Please list in the space provided comments to note if repairs or replacement are needed or have been made for BMPs as a result of the inspection. Failure to conduct the required inspection may result in permit suspension or the imposition of civil penalties. If supplemental monitoring is required as part of a permit condition this form may be used to meet those monitoring requirements.

<p>Date & Time: Tue, Apr 09, 2019, 08:30:21 EDT Position: +35° 19' 51.11" / -83° 19' 13.22" Altitude: 1855ft Datum: WGS-84 Azimuth Bearing: 152° 52' 58" (True) Elevation Grade: -020% Horizon Grade: -002% Zoom: 1X 5' @ Catawba</p>				
GPS Location	37.32	Field Station#	11025+00	GPS Location	37.32	Field Station#	2+61
Description	Crew replacing P1SF damaged from livestock			Description	.5" of rain recorded @ Catawba

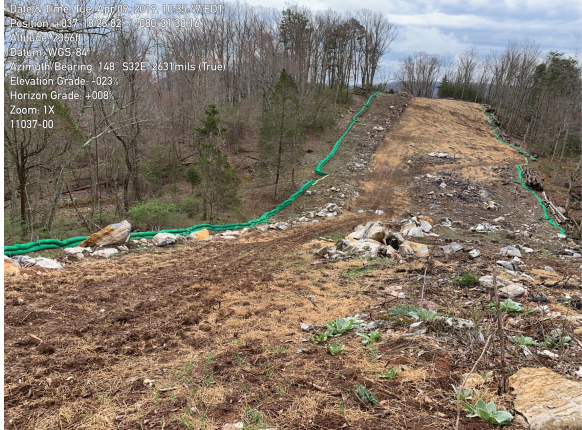
GPS Location	37.32	Field Station#	11037+00	GPS Location	37.32	Field Station#	11054+00
Description	ECD's and ROW conditions			Description	ECD's and ROW conditions

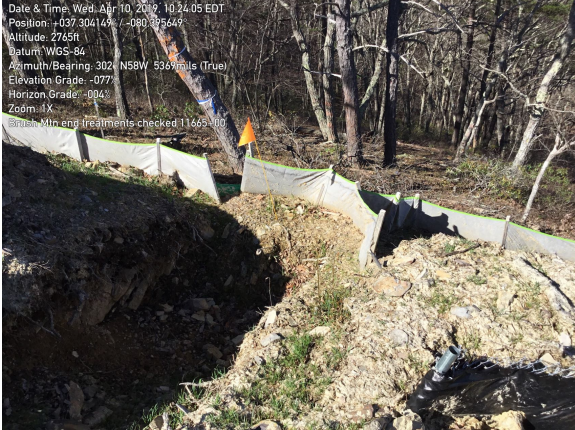
A/E	124300137	Date/Time	4/10/2019 12:28 PM		Report #	15692	
Pictures							
<div><div>Date & Time: Wed, Apr 10, 2019, 10:24:05 EDT Position: +037.304149° / -080.375649° Altitude: 2765ft Datum: WGS-84 Azimuth/Bearing: 302° N58W 536mils (True) Elevation Grade: -077% Horizon Grade: -004% Zoom: 1X Brush Min. and treatments checked 11665+00</div>

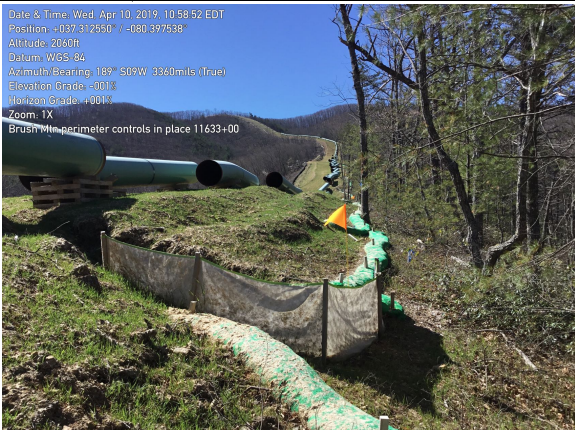
GPS Location		37.31	Field Station#		11662+50		
Description		Correct coordinates on photo.					
<div><div>Date & Time: Wed, Apr 10, 2019, 10:58:52 EDT Position: +037.312550° / -080.377538° Altitude: 2080ft Datum: WGS-84 Azimuth/Bearing: 189° S09W 3360mils (True) Elevation Grade: -001% Horizon Grade: -001% Zoom: 1X Brush Min. perimeter controls in place 11633+00</div>

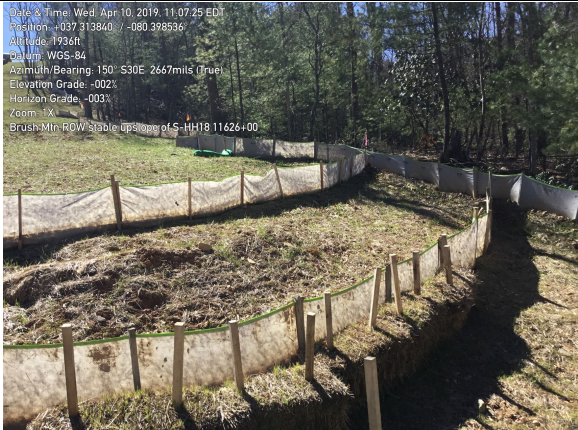
</div>				<div><div>Date & Time: Wed, Apr 10, 2019, 11:07:25 EDT Position: +037.313840° / -080.378536° Altitude: 1990ft Datum: WGS-84 Azimuth/Bearing: 150° S30E 2667mils (True) Elevation Grade: -002% Horizon Grade: -003% Zoom: 1X Brush Min. ROW stable up slope of S-HH18 11626+00</div>

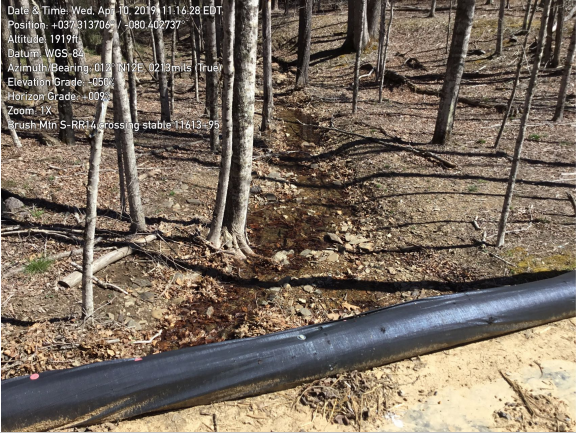
<p><small>Date & Time: Wed Apr 10 2019 11:16:28 EDT Position: +037.9137025, -080.406737 Altitude: 1919ft Datum: WGS-84 Azimuth/Bearing: 013.1012° 023mils (True) Elevation Grade: +05% Horizon Grade: +00% Zoom: 1X Brush Mtn S-RR-14 crossing stable 11613+95</small></p>

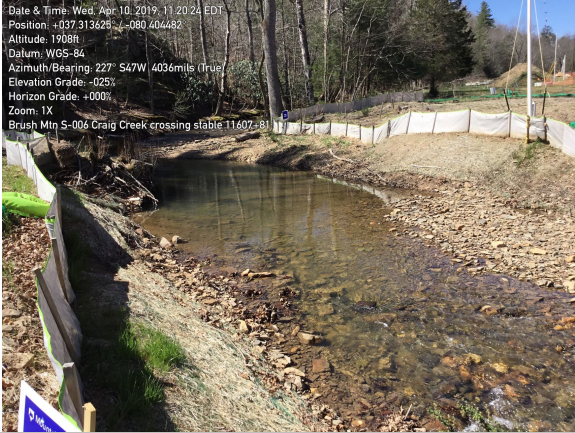
<p><small>Date & Time: Wed Apr 10 2019 11:20:24 EDT Position: +037.913625, -080.406482 Altitude: 1908ft Datum: WGS-84 Azimuth/Bearing: 227.547W 4036mils (True) Elevation Grade: -02% Horizon Grade: +00% Zoom: 1X Brush Mtn S-006 Craig Creek crossing stable 11607+81</small></p>		
GPS Location	37.31	Field Station#	11613+95	GPS Location	37.31
Description	Correct coordinates on photo.		Description	Correct coordinates on photo.	
Insert image here			Insert image here		
GPS Location		Field Station#		GPS Location	
Description			Description		
Insert image here			Insert image here

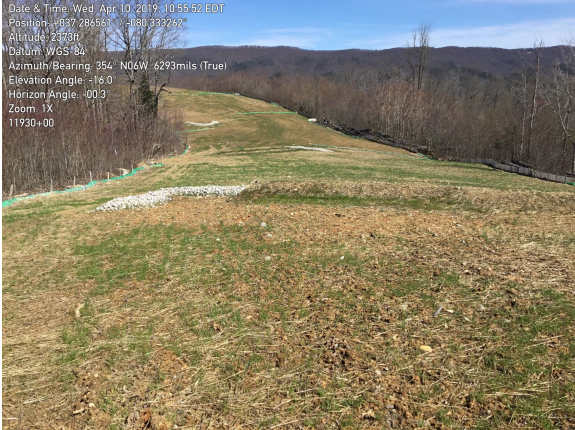
GPS Location	37.31	Field Station#	11930+00	GPS Location	37.31	Field Station#	11940+00
Description	Row 11930+00			Description	Row stabilized		
<div><div>Date & Time: Wed, Apr 10, 2019, 11:03:48 EDT Position: +037.168243 / -080.389975 Altitude: 2397ft Datum: WGS-84 Azimuth/Bearing: 158° S22E 2809mils (True) Elevation Angle: -24.9 Horizon Angle: -01.6 Zoom: 1X 11940+00</div>

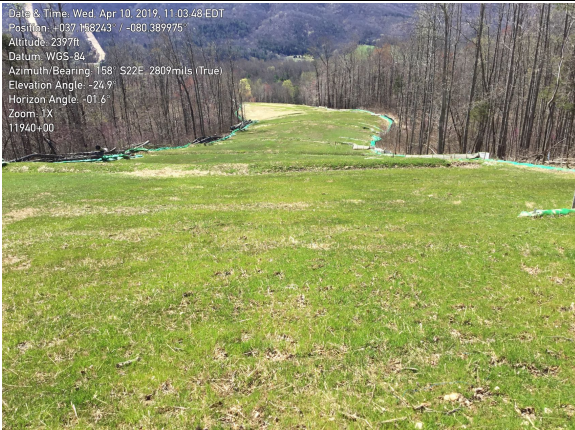
GPS Location	37.31	Field Station#	11940+00	GPS Location	37.31	Field Station#	11942+00
Description	Row stabilized			Description	ECDs protecting karst area		
<div><div>Date & Time: Wed, Apr 10, 2019, 11:10:40 EDT Position: +037.273710 / -080.324092 Altitude: 2226ft Datum: WGS-84 Azimuth/Bearing: 134° S46E 2382mils (True) Elevation Angle: -23.1 Horizon Angle: -02.7 Zoom: 1X 11950+00</div>

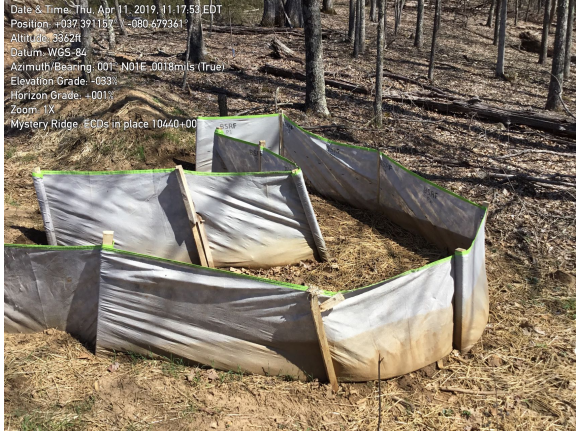
AFE	124300137	Date/Time	4/11/2019 1:16 PM	Report #	15747		
Pictures							
<p>Date & Time: Thu, Apr 11, 2019 11:20:53 EDT Position: +037.3970327, +080.6723611 Altitude: 3120ft Datum: WGS-84 Azimuth/Bearing: 001° N01E 500.8mils (True) Elevation Grade: +02% Horizon Grade: +01% Zoom: 1X Mystery Ridge, ECDs in place 10412+25</p>  		<p>Date & Time: Thu, Apr 11, 2019 11:17:53 EDT Position: +037.3971157, +080.6723611 Altitude: 3120ft Datum: WGS-84 Azimuth/Bearing: 001° N01E 500.8mils (True) Elevation Grade: +03% Horizon Grade: +01% Zoom: 1X Mystery Ridge, ECDs in place 10440+00</p>

GPS Location	37.37	Field Station#	10412+25	GPS Location	37.31	Field Station#	10440+00
Description	Correct coordinates on photo. End treatments effective.			Description	Correct coordinates on photo. End treatments effective.		
<p>Date & Time: Thu, Apr 11, 2019 11:20:18 EDT Position: +037.3889937, +080.6807064 Altitude: 3120ft Datum: WGS-84 Azimuth/Bearing: 087° N87E 154.7mils (True) Elevation Grade: +25% Horizon Grade: +01% Zoom: 1X Mystery Ridge, ECDs in place 10447+00</p>  		<p>Date & Time: Thu, Apr 11, 2019 11:16:17 EDT Position: +037.3882577, +080.6809344 Altitude: 3117ft Datum: WGS-84 Azimuth/Bearing: 092° S02W 300.3mils (True) Elevation Grade: +00% Horizon Grade: +00% Zoom: 1X Mystery Ridge, dead snag, 12' x 6" to fall</p>

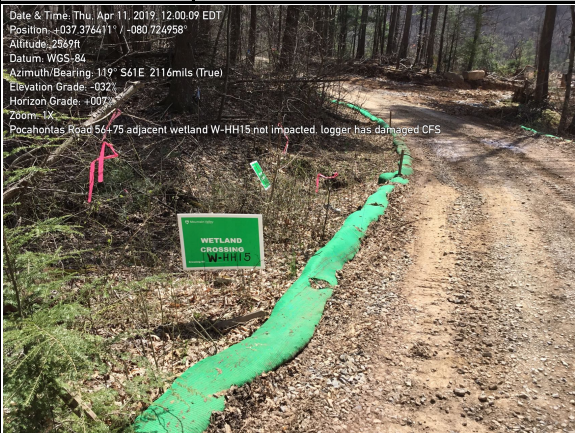
<div><div><div>Date & Time: Thu, Apr 11, 2019, 12:00:09 EDT Position: +037.376411 / -080.724958 Altitude: 2569ft Datum: WGS-84 Azimuth/Bearing: 119° S61E 2116mils (True) Elevation Grade: +032° Horizon Grade: +007° Road: 1X Pocahontas Road 56+75 adjacent wetland W-HH15 not impacted. logger has damaged CFS</div><div>

</div></div></div>				Insert image here									
GPS Location		37.31	Field Station#		56+75		GPS Location			Field Station#			
Description		Correct coordinates on photo. Adjacent resource W-HH15 has not been impacted to date.				Description							
Insert image here				Insert image here									
GPS Location			Field Station#				GPS Location			Field Station#			
Description						Description

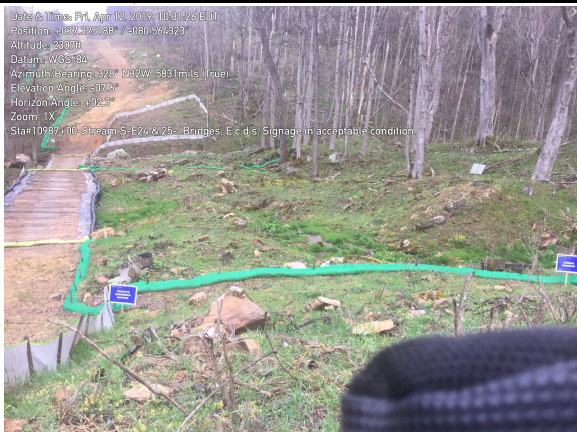
GPS Location	37.32	Field Station#	11017+00	GPS Location	37.32	Field Station#	10993+00
Description	Stream S-RR 5- Bridge, ECD's, signage.			Description	Perimeter controls on steep grade are in acceptable condition.		
<p>Date & Time: Fri, Apr 12, 2019 10:31:24 EDT Position: +037.327138° / -080.554287° Altitude: 2397ft Datum: WGS-84 Azimuth/Bearing: 328° N22W 593mils (True) Elevation Angle: -07.2° Horizon Angle: +02.3° Zoom: 1X Star10987+00- Stream S-E24 & 25- Bridges, ECD's, Signage in acceptable condition</p>

GPS Location	37.32	Field Station#	10987+00	GPS Location	37.32	Field Station#	10964+00
Description	Stream S-E24 & 25- Bridges, ECD's & Signage in acceptable condition			Description	Karst ECD's are in good condition.

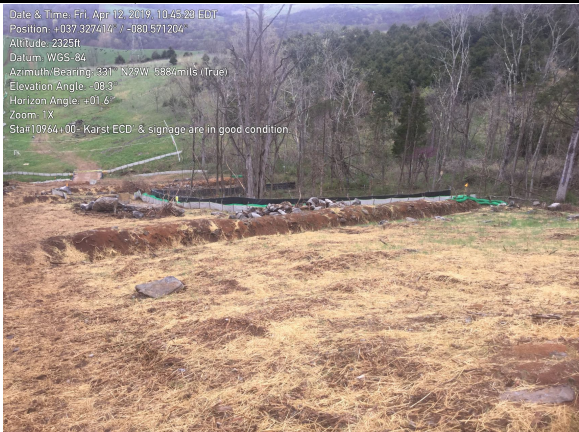
<p>Date & Time: Fri, Apr 12, 2019 10:45:20 EDT Position: +037.327417° / -080.571204° Altitude: 2325ft Datum: WGS-84 Azimuth/Bearing: 331° N29W 598mils (True) Elevation Angle: -08.3° Horizon Angle: +01.6° Zoom: 1X Star10964+00- Karst ECD's & signage are in good condition</p>

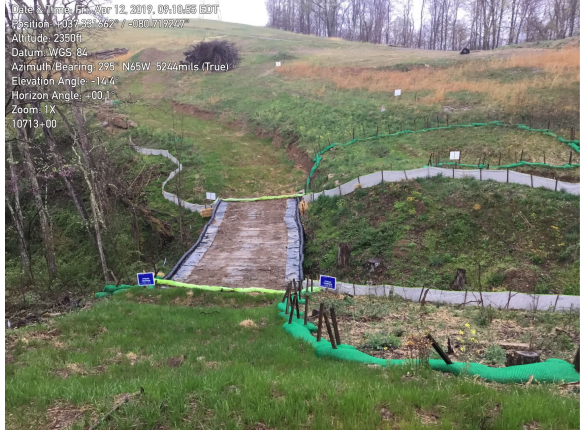
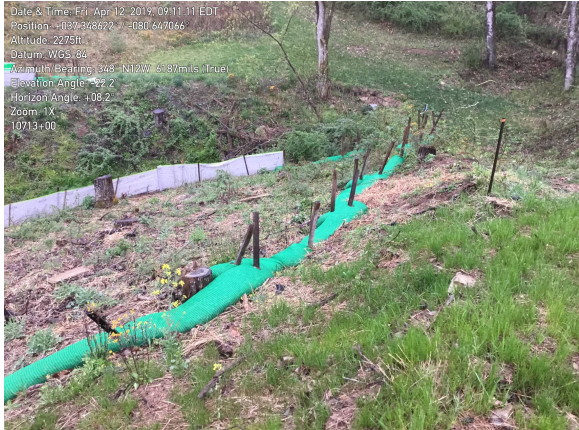
GPS Location		37.31	Field Station#		10713+00		
Description		ECDs in good condition					
<div><div><div>Date & Time: Fri, Apr 12, 2019, 09:39:01 EDT Position: +037.350322, -080.658659 Altitude: 2074ft Datum: WGS-84 Azimuth/Bearing: 096.584E 1707mils (True) Elevation Angle: -17.2 Horizon Angle: -07.2 Zoom: 1X 10612+00</div><div>

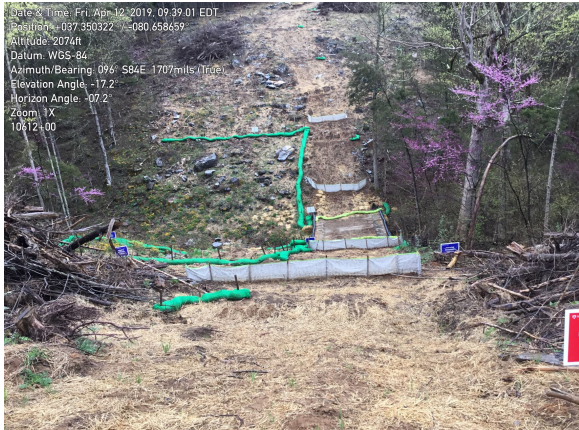
</div></div></div>				<div><div><div>Insert image here</div></div></div>			
GPS Location		37.31	Field Station#		10612+00		
Description		ECDs in good condition					
Description

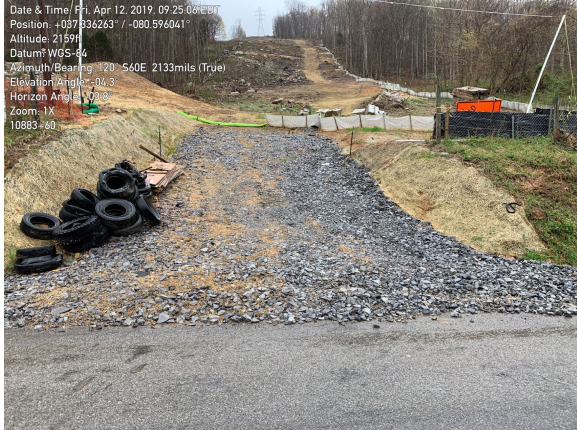
</div>				
GPS Location	37.27	Field Station#	10883+50	GPS Location	37.27	Field Station#	10889+00
Description	See photo for GPS location. RCE in place with flume pipe in place at road side ditch.			Description	See photo for GPS location. Water bar, end treatment, and sump pit in place.		
<div><div>Date & Time: Fri, Apr 12, 2019, 09:36:02 EDT Position: +037.936263° / -080.596041° Altitude: 2321ft Datum: WGS-84 Azimuth Bearing: 314° N46W 5582mils (True) Elevation Angle: -26.5° Horizon Angle: -00.0° Zoom: 1X 10901+00</div>

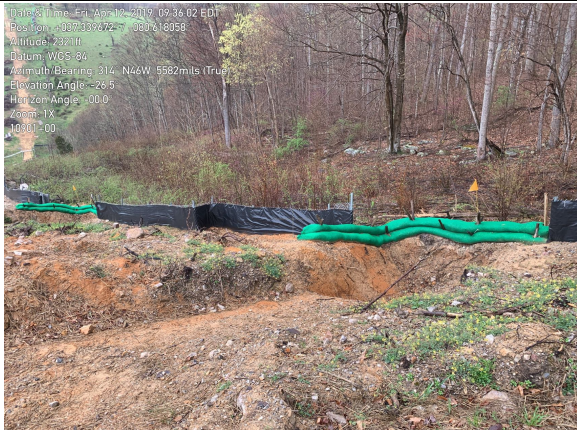
GPS Location	37.30	Field Station#	10901+00	GPS Location	37.30	Field Station#	10910+00
Description	See photo for GPS location. Reinforced super silt fence, end treatment, water bar, and sump pit in place.			Description	See photo for GPS location. ROW stabilized with seed, mulch, and natural vegetation.		
<div><div>Date & Time: Fri, Apr 12, 2019, 09:46:57 EDT Position: +037.936263° / -080.596041° Altitude: 2360ft Datum: WGS-84 Azimuth Bearing: 120° S40E 2133mils (True) Elevation Angle: -17.9° Horizon Angle: -02.0° Zoom: 1X 10920+00</div>

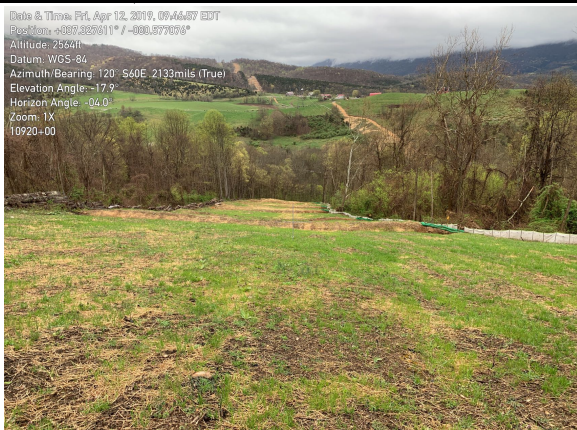
</div>				
GPS Location	37.30	Field Station#	10920+00	GPS Location	37.30	Field Station#	10927+25
Description	See photo for GPS location. ROW stabilized with seed, mulch, earth guard, minor vegetation growth.			Description	See photo for GPS location. Sensitive resource buffer in place at stream S-Y3.
