Visual Site Inspection Report

Project Name	H-600 Pipeline Spread G	AFE	124300137	Spread	H-600 Pipeline Spread G
Contractor	Precision			Report #	17133
Inspector	Len Kruizenga			Date/Time	5/13/2019 8:45 AM
Permit #	TBD	Inspection Type	VA SWPP	Station Begin	11254+88
State	VA	Inspection Area	Full	Station End	11161+00
County	Giles	Ground	Muddy	Temperature (°F)	54.00
Municipality	N/A	Weather	Light Rain	Rain Gauge (in)	0.10
				Rain Accumulation Time (days)	1.00

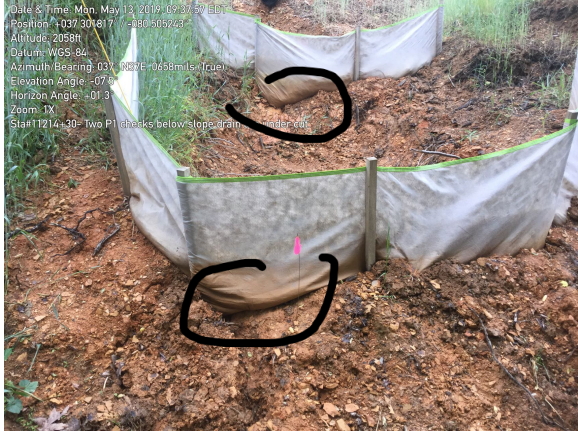
<p>Date & Time: Mon, May 13, 2019, 09:37:59 EDT Position: +037.301817° / -080.505729° Altitude: 2058ft Datum: WGS-84 Azimuth/Bearing: 033° N03E 163.8mils (True) Elevation Angle: -07.4° Horizon Angle: -01.3° Zoom: 1X Sta#11214+30- Two P1 checks below slope drain</p>

GPS Location	37.30	Field Station#	11227+00	GPS Location	37.30	Field Station#	11214+30
Description	Winding Way rain gauge reading- 0.10"			Description	Two P1 checks are under cut below slope drain.		
<p>Date & Time: Mon, May 13, 2019, 09:29:36 EDT Position: +037.301490° / -080.504624° Altitude: 2032ft Datum: WGS-84 Azimuth/Bearing: 264° S84W 449.3mils (True) Elevation Angle: -14.8° Horizon Angle: -01.7° Zoom: 2X Sta#11217+00- Sump pit has sediment build up, when row dries it will need to be cleaned</p>

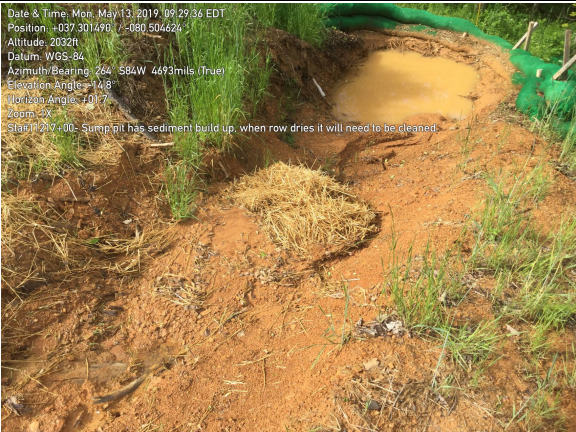
GPS Location	37.30	Field Station#	11217+00	GPS Location	37.30	Field Station#	11186+00
Description	Sumps with sediment build up, still room in sump for sediment to settle, will need to be clean when row dries out.			Description	CFS perimeter controls are in acceptable condition.		
<p>Date & Time: Mon, May 13, 2019, 10:11:48 EDT Position: +037.307222° / -080.511921° Altitude: 1997ft Datum: WGS-84 Azimuth/Bearing: 289° N71W 510.8mils (True) Elevation Angle: -01.2° Horizon Angle: +01.3° Zoom: 1X AR-249.02- Rock check dams along access road are functioning</p>

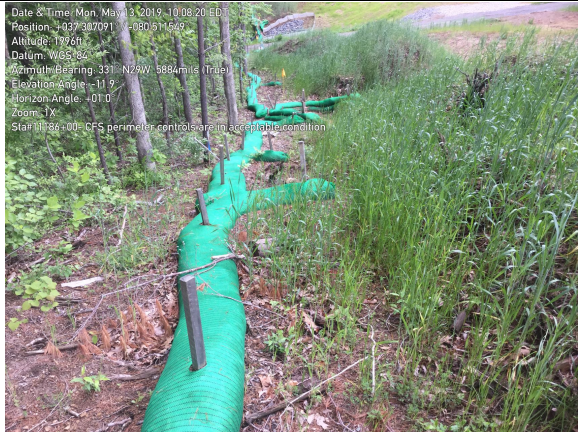
<p>Date & Time: Mon, May 13, 2019, 10:06:20 EDT Position: +037.307091° / -080.511669° Altitude: 1976ft Datum: WGS-84 Azimuth/Bearing: 331° N29W 588.4mils (True) Elevation Angle: -11.9° Horizon Angle: -01.0° Zoom: 1X Sta#11186+00- CFS perimeter controls are in acceptable condition</p>

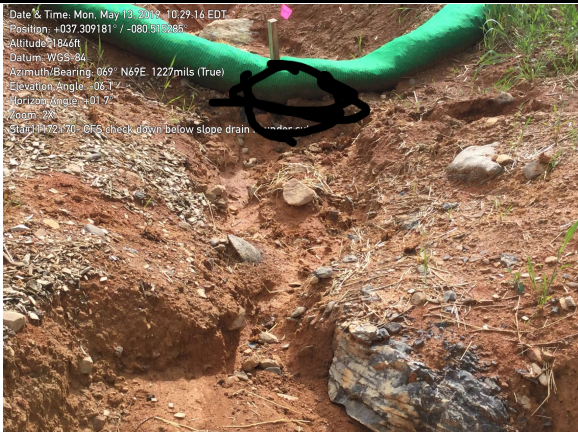
<p>Date & Time: Mon, May 13, 2019, 10:29:16 EDT Position: +037.309181° / -080.513286° Altitude: 2046ft Datum: WGS-84 Azimuth/Bearing: 069° N69E 122.7mils (True) Elevation Angle: -05.1° Horizon Angle: -01.7° Zoom: 2X Sta#11172+70- CFS check down below slope drain is under cut</p>

Description	AR- 249.02 - Rock check dams are functioning.			Description	CFS check down below slope drain is under cut.

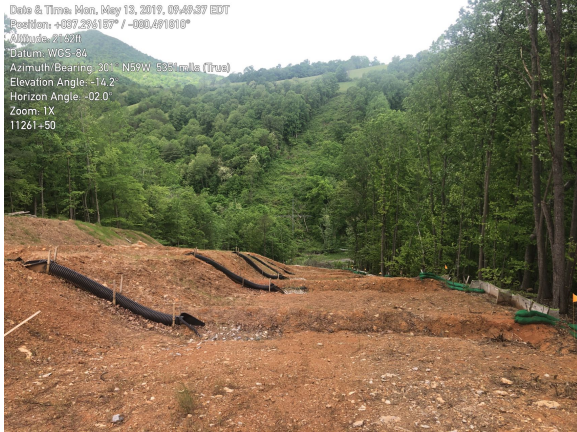
GPS Location	37.20	Field Station#	11261+50	GPS Location	37.20	Field Station#	11518+00
Description	See photo for GPS location. Slope drains with rock filter inlets and outlets in place.			Description	See photo for GPS location. Sensitive resource buffer in place at stream S-PP4.		
<p>Date & Time: Mon, May 13, 2019, 10:00:00 EDT Position: +037.296333° / -080.493816° Altitude: 2221ft Datum: WGS-84 Azimuth/Bearing: 241° S41W 4282mils (True) Elevation Angle: -06.6° Horizon Angle: +02.5° Zoom: 1X 11502+00</p>

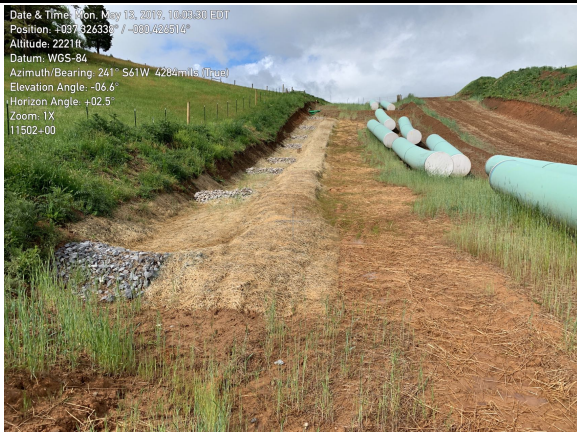
GPS Location	37.20	Field Station#	11592+00	GPS Location	37.20	Field Station#	11489+00
Description	See photo for GPS location. ECB and rock checks installed in conveyance channel.			Description	See photo for GPS location. RCE in place at Stevers Gap Road.		
<p>Date & Time: Mon, May 13, 2019, 10:59:04 EDT Position: +037.296199° / -080.494389° Altitude: 2102ft Datum: WGS-84 Azimuth/Bearing: 338° N28W 5902mils (True) Elevation Angle: -44.4° Horizon Angle: +08.5° Zoom: 1X Repair of rock silt fence at 11295+00</p>

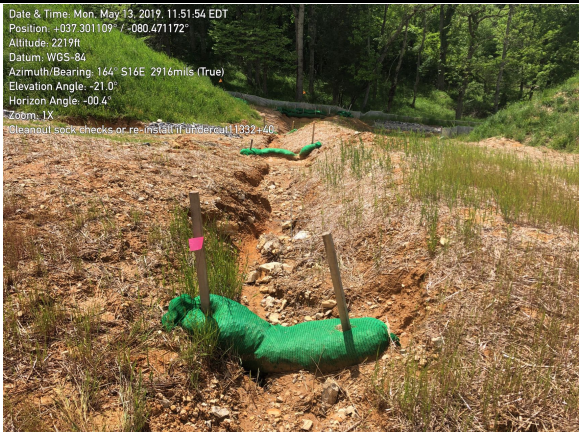
<p>Date & Time: Mon, May 13, 2019, 11:51:54 EDT Position: +037.301109° / -080.471172° Altitude: 2219ft Datum: WGS-84 Azimuth/Bearing: 164° S16E 2916mils (True) Elevation Angle: -21.0° Horizon Angle: -00.4° Zoom: 1X Cleanout sock checks or re-install them at 11332+50</p>

GPS Location	37.20	Field Station#	11295+00	GPS Location	37.20	Field Station#	11332+50
Description	See photo for GPS location. Priority one silt fence stake broke. Communicated to contractor.			Description	See photo for GPS location. Sock checks in water bar throat need maintenance. Communicated to contractor via punchlist.

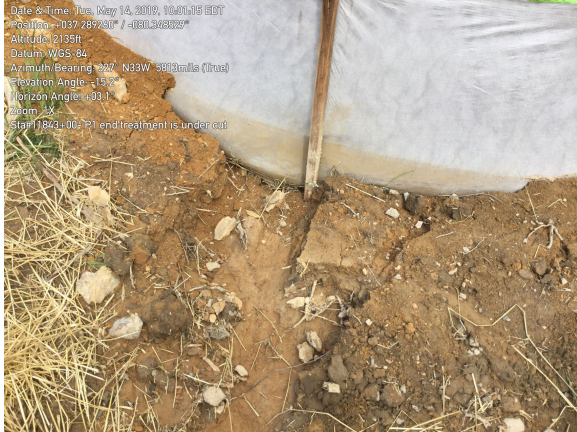
A/E	124300137	Date/Time	5/14/2019 10:02 AM	Report #	17208		
Pictures							
<div><p>Date & Time: Tue, May 14, 2019, 10:01:16 EDT Position: +037.287261° / +081.36832° Altitude: 2135ft Datum: WGS-84 Azimuth/Bearing: 227° N33W 5812mils (True) Elevation Angle: -15.2° Horizon Angle: +03.1° Zoom: 1X Sta#11843+00: P1 end treatment is under cut</p>

</div>					
GPS Location	37.28	Field Station#	11843+00	GPS Location	37.26	Field Station#	11792+28
Description	P1 end treatment under cut, Contractor was near by and addressed the issue.			Description	Karst ECD's are in acceptable condition.		
<div><p>Date & Time: Tue, May 14, 2019, 09:50:49 EDT Position: +037.292282° / +080.350967° Altitude: 2238ft Datum: WGS-84 Azimuth/Bearing: 224° S44W 3982mils (True) Elevation Angle: -07.4° Horizon Angle: +00.9° Zoom: 2X Sta#11829+00: P1 controls at Karst ECD's in good condition</p>

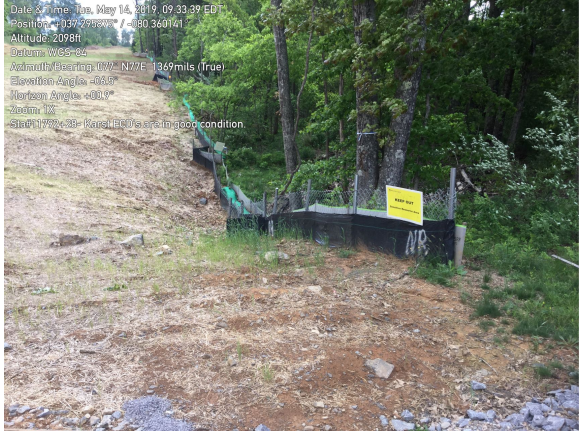
</div>		<div><p>Date & Time: Tue, May 14, 2019, 09:33:39 EDT Position: +037.279547° / +080.360141° Altitude: 2098ft Datum: WGS-84 Azimuth/Bearing: 192° N27E 1349mils (True) Elevation Angle: -0.0° Horizon Angle: +00.9° Zoom: 1X Sta#11792+28: Karst ECD's are in good condition</p>

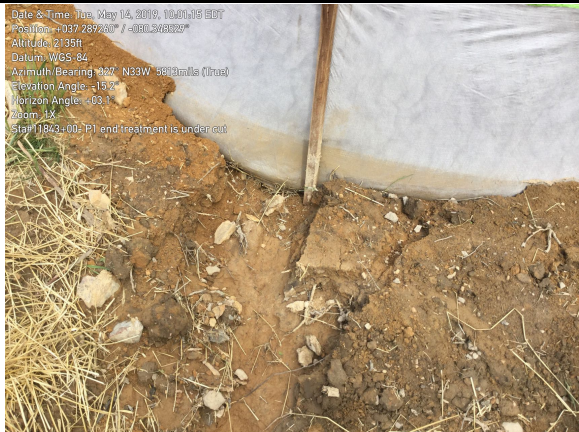
</div>		<div><p>Date & Time: Tue, May 14, 2019, 10:01:16 EDT Position: +037.287261° / +081.36832° Altitude: 2135ft Datum: WGS-84 Azimuth/Bearing: 227° N33W 5812mils (True) Elevation Angle: -15.2° Horizon Angle: +03.1° Zoom: 1X Sta#11843+00: P1 end treatment is under cut</p>

GPS Location	37.26	Field Station#	11829+00	GPS Location	37.26	Field Station#	11843+00
Description	Karst ECD's are in acceptable condition			Description	P1 end treatment is under cut, Contractor was near by and addressed the issue.		
<div><p>Date & Time: Tue, May 14, 2019, 10:48:10 EDT Position: +037.295577° / +080.352977° Altitude: 2256ft Datum: WGS-84 Azimuth/Bearing: 123° S57E 2187mils (True) Elevation Angle: -06.5° Horizon Angle: +01.2° Zoom: 1X Sta#11911+00: Vegetation is very good</p>

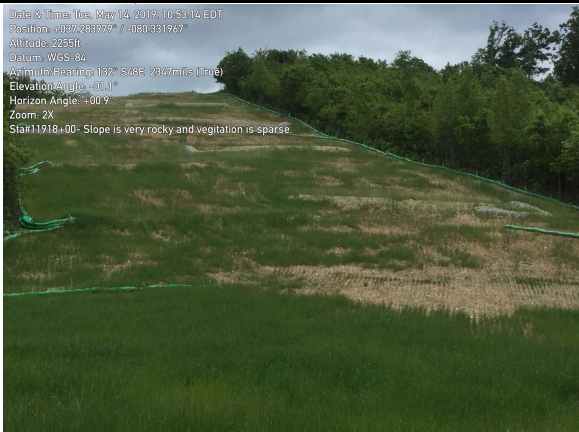
</div>		<div><p>Date & Time: Tue, May 14, 2019, 10:53:12 EDT Position: +037.295577° / +080.351967° Altitude: 2255ft Datum: WGS-84 Azimuth/Bearing: 132° S68E 2307mils (True) Elevation Angle: -01.1° Horizon Angle: +00.9° Zoom: 2X Sta#11918+00: Slope is very rocky and vegetation is sparse</p>

</div>					
GPS Location	37.26	Field Station#	11911+00	GPS Location	37.26	Field Station#	11918+00
Description	Vegetation is very good here.			Description	Vegetation on rocky slope is sparse

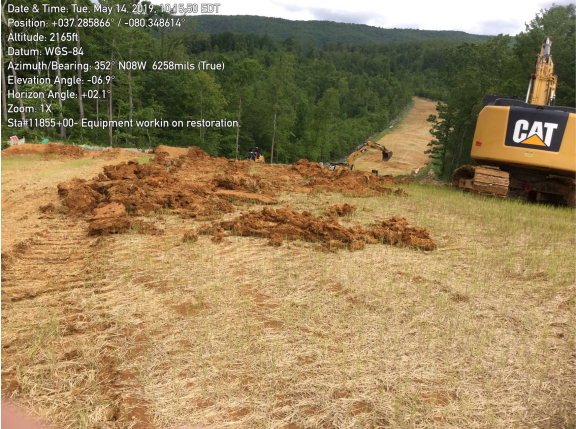
AFE	124300137	Date/Time	5/14/2019 10:02 AM	Report #	17208
Pictures					
<small>Date & Time: Tue, May 14, 2019 10:02:00 EDT Position: +037.285866° / -080.348614° Altitude: 2165ft Datum: WGS-84 Azimuth/Bearing: 352° N08W 6258mils (True) Elevation Angle: -06.9° Horizon Angle: +02.1° Zoom: 1X Star11855+00- Equipment workin on restoration.</small>

GPS Location	37.26	Field Station#	11855+00	GPS Location	37.27
Field Station#	12005+00	Description	Contractor is working on restoration in this area.		
Insert image here			Insert image here		
GPS Location		Field Station#		GPS Location

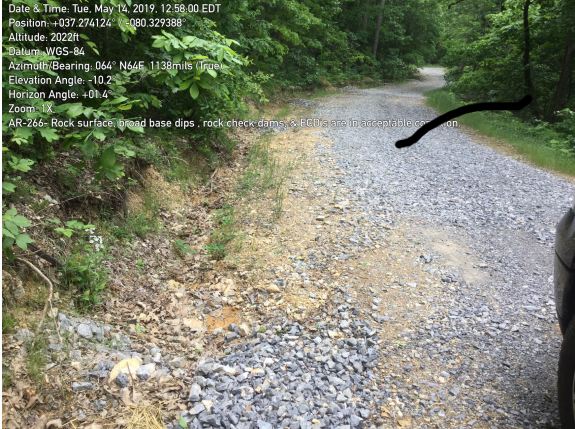
<small>Date & Time: Tue, May 14, 2019 12:58:00 EDT Position: +037.274124° / -080.329388° Altitude: 2022ft Datum: WGS-84 Azimuth/Bearing: 064° N64E 1138mils (True) Elevation Angle: -10.2° Horizon Angle: +01.4° Zoom: 1X AR-266- Rock surface, broad base dips, rock check dams, ECD's are in acceptable condition.</small>

Field Station#		Description	Access rd rock, Broad base dips, rock check dams, ECD's & signage are in acceptable condition.		
Insert image here			Insert image here		
GPS Location		Field Station#		GPS Location	
Field Station#		Description			
Insert image here			Insert image here		
GPS Location		Field Station#		GPS Location	
Field Station#		Description			
Insert image here			Insert image here

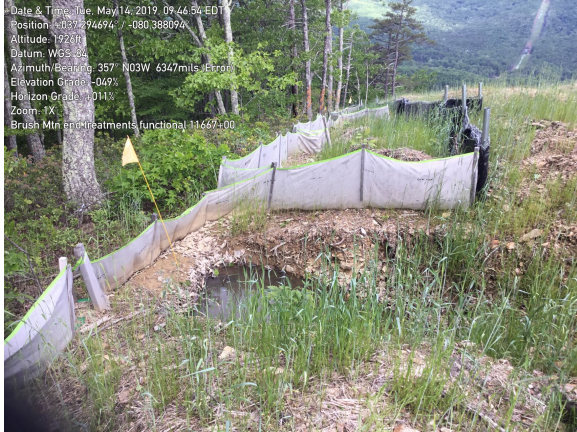
AFE	124300137	Date/Time	5/14/2019 10:54 AM	Report #	17209		
Pictures							
<p>Date & Time: Tue, May 14, 2019, 09:46:50 EDT Position: +037.294694 / -080.388076 Altitude: 1920ft Datum: WGS-84 Azimuth/Bearing: 357° N03W 6347mils (True) Elevation Grade: -049° Horizon Grade: -011° Zoom: 1X Brush Mtn end treatments functional 11667+00</p>

GPS Location	37.31	Field Station#	11667+00	GPS Location	37.31	Field Station#	11663+00
Description	Correct coordinates on photo. End treatments were checked for maintenance needs and effectiveness.			Description	Correct coordinates on photo. Perimeter controls are in place. No sediment beyond LOD located.

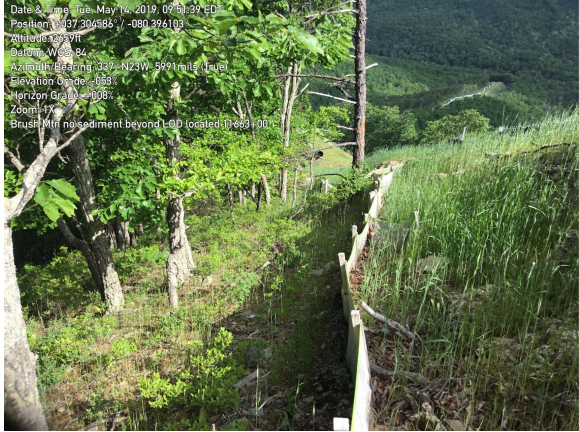
<p>Date & Time: Tue, May 14, 2019, 09:51:39 EDT Position: +037.304386 / -080.396103 Altitude: 1920ft Datum: WGS-84 Azimuth/Bearing: 322° N23W 5891mils (True) Elevation Grade: -049° Horizon Grade: -008° Zoom: 1X Brush Mtn no sediment beyond LOD located 11663+00</p>

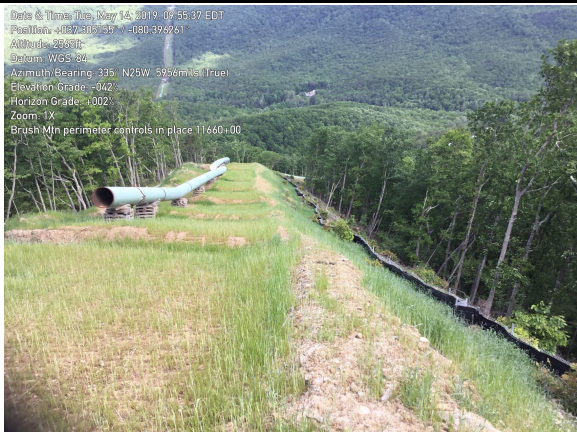
<p>Date & Time: Tue, May 14, 2019, 09:55:27 EDT Position: +037.305907 / -080.397261 Altitude: 2486ft Datum: WGS-84 Azimuth/Bearing: 335° N25W 5956mils (True) Elevation Grade: -042° Horizon Grade: -002° Zoom: 1X Brush Mtn perimeter controls in place 11660+00</p>

GPS Location	37.31	Field Station#	11660+00	GPS Location	37.31	Field Station#	11657+00
Description	Correct coordinates on photo. Perimeter controls are in place.			Description	Correct coordinates on photo. End treatments checked for maintenance needs and effectiveness.		
<p>Date & Time: Tue, May 14, 2019, 10:20:42 EDT Position: +037.280425 / -080.404016 Altitude: 2189ft Datum: WGS-84 Azimuth/Bearing: 339° N21W 6027mils (True) Elevation Grade: -045° Horizon Grade: -008° Zoom: 1X Brush Mtn end treatment functional 11632+75</p>

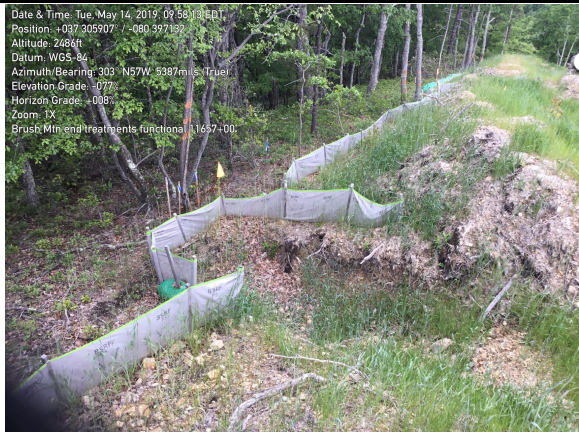
<p>Date & Time: Tue, May 14, 2019, 09:58:18 EDT Position: +037.305907 / -080.397132 Altitude: 2486ft Datum: WGS-84 Azimuth/Bearing: 303° N37W 5387mils (True) Elevation Grade: -077° Horizon Grade: -008° Zoom: 1X Brush Mtn end treatments functional 11657+00</p>

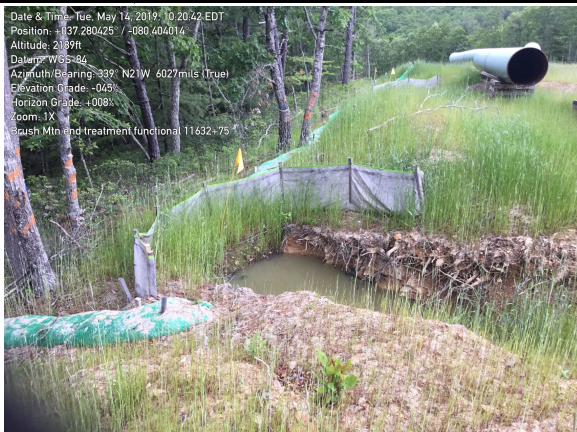
GPS Location	37.31	Field Station#	11632+75	GPS Location	37.31	Field Station#	11626+04
Description	Correct coordinates on photo. Perimeter controls in this area found effective.			Description	Correct coordinates on photo. No impact to resources identified.

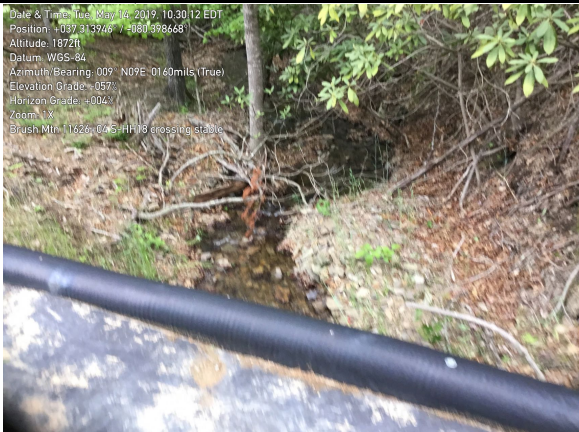
<p>Date & Time: Tue, May 14, 2019, 10:30:12 EDT Position: +037.313576 / -080.398668 Altitude: 1872ft Datum: WGS-84 Azimuth/Bearing: 009° N09E 0160mils (True) Elevation Grade: -057° Horizon Grade: -004° Zoom: 1X Brush Mtn 11626+04 S. RH 18 crossing grade</p>

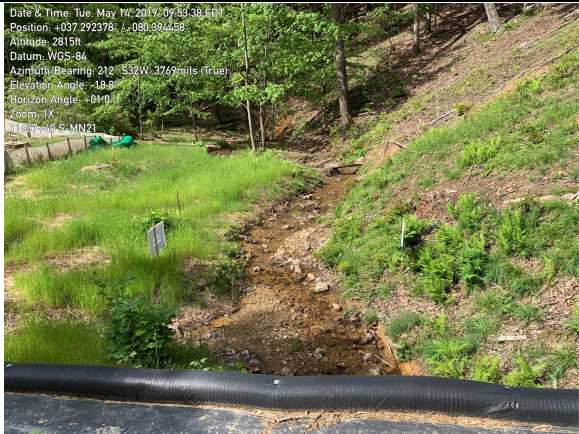
GPS Location	37.32	Field Station#	1167+00	GPS Location	37.32	Field Station#	11687+40
Description	See photo for GPS location. Water bar and end treatments in place.			Description	See photo for GPS location. Stream S-MN21 flowing.

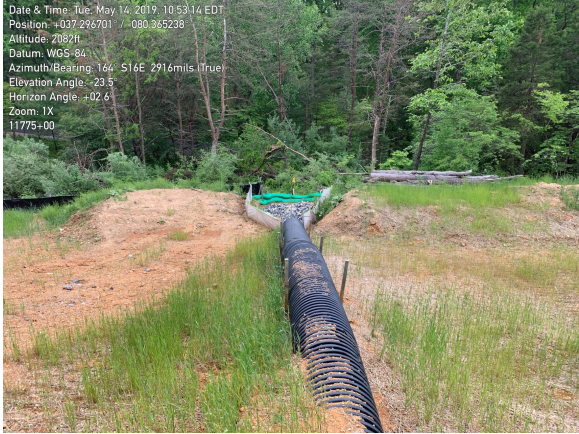
GPS Location	37.32	Field Station#	11772+00	GPS Location	37.32	Field Station#	11775+00
Description	See photo for GPS location. Clean water diversion berm and clean water diversion pipe inlet in place.			Description	See photo for GPS location. Clean water diversion pipe and plunge pool in place.

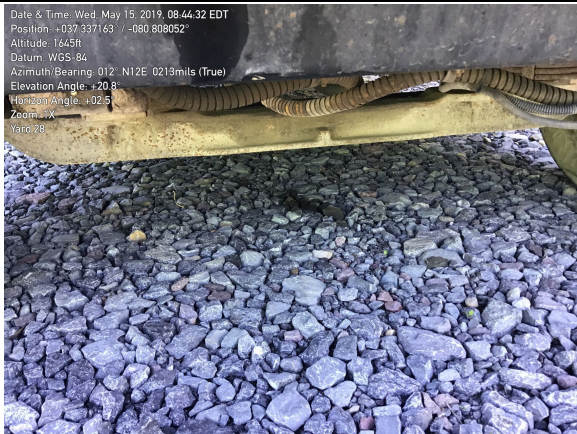
GPS Location	37.20	Field Station#	12005+00	GPS Location	37.20	Field Station#	12005+00
Description	See photo for GPS location. Spill found under bus 600.			Description	See photo for GPS location. Spill found under bus 619.		
<p>Date & Time: Wed, May 15, 2019, 08:56:30 EDT Position: +037.334126 / -080.803278 Altitude: 1253ft Datum: WGS-84 Azimuth/Bearing: 298° N62W 5298mils (True) Elevation Angle: +27.2° Horizon Angle: +03.5° Zoom: 1X Yard: 28</p>

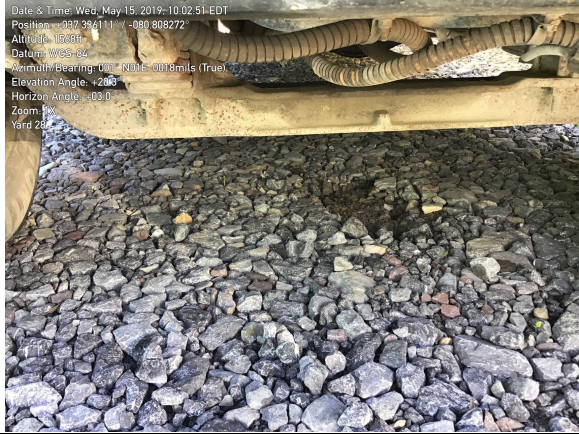
GPS Location	37.20	Field Station#	12005+00	GPS Location	37.20	Field Station#	12005+00
Description	See photo for GPS location. Staged equipment at yard 28.			Description	See photo for GPS location. Spill cleaned up under bus 600.		
<p>Date & Time: Wed, May 15, 2019, 10:06:07 EDT Position: +037.333043 / -080.808324 Altitude: 1576ft Datum: WGS-84 Azimuth/Bearing: 019° N19E 0338mils (True) Elevation Angle: +17.9° Horizon Angle: +00.7° Zoom: 1X Yard: 28</p>

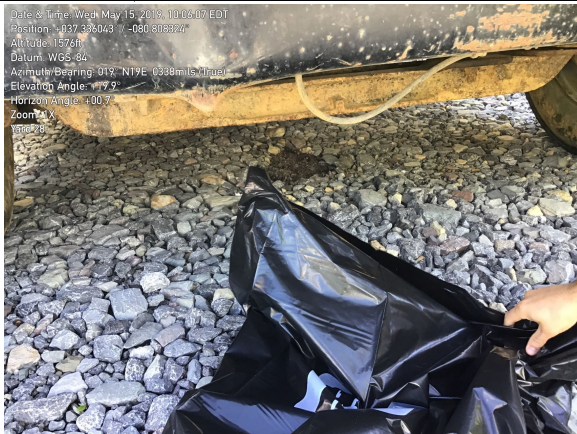
GPS Location	37.20	Field Station#	12005+00	GPS Location	37.20	Field Station#	12005+00
Description	See photo for GPS location. Spill cleaned up under bus 619.			Description	See photo for GPS location. Containment placed under bussing leaking motor oil.

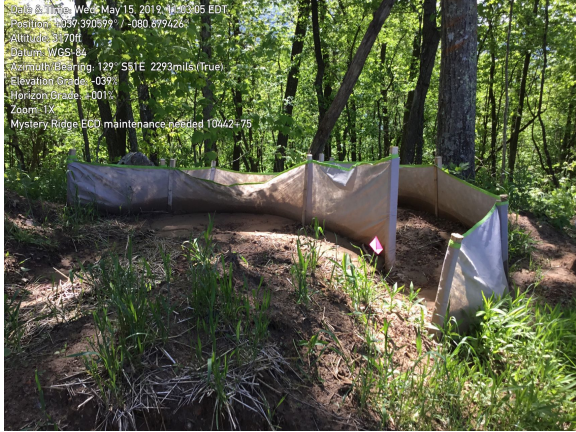
AFE	124300137	Date/Time	5/15/2019 4:40 PM	Report #	17270		
Pictures							
<p>Date & Time: Wed, May 15, 2019, 09:41:35 EDT Position: +037.389211 / -080.714483 Altitude: 299ft Datum: WGS-84 Azimuth/Bearing: 129° 58'E 2293mils (True) Elevation Grade: -049% Horizon Grade: +009% Zoom: 1X Pocahontas Road 152+70 failed culvert at 5-PP19 crossing has been repaired.</p>  		<p>Date & Time: Wed, May 15, 2019, 10:30:55 EDT Position: +037.390599 / -080.679426 Altitude: 377ft Datum: WGS-84 Azimuth/Bearing: 129° 58'E 2293mils (True) Elevation Grade: -039% Horizon Grade: +001% Zoom: 1X Mystery Ridge ECD maintenance needed 10442+75</p>

GPS Location	37.13	Field Station#	152+70	GPS Location	37.13	Field Station#	10442+75
Description	Correct coordinates on photo. Pocahontas. Hole filled on Pocahontas by security contractor without authorization.			Description	Correct coordinates on photo. Mystery Ridge. End treatment in need of maintenance.

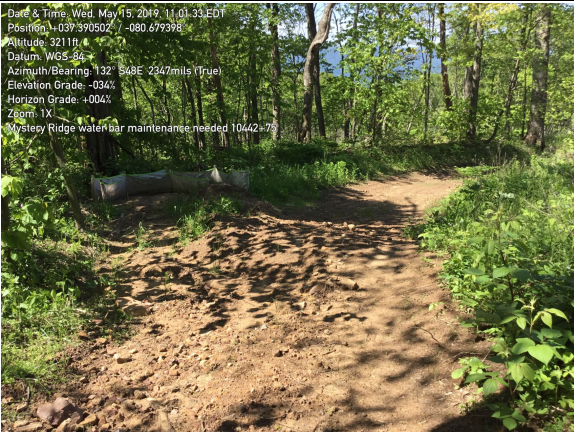
<p>Date & Time: Wed, May 15, 2019, 11:01:33 EDT Position: +037.390502 / -080.679398 Altitude: 321ft Datum: WGS-84 Azimuth/Bearing: 132° 54'E 2347mils (True) Elevation Grade: -034% Horizon Grade: +004% Zoom: 1X Mystery Ridge water bar maintenance needed 10442+75</p>

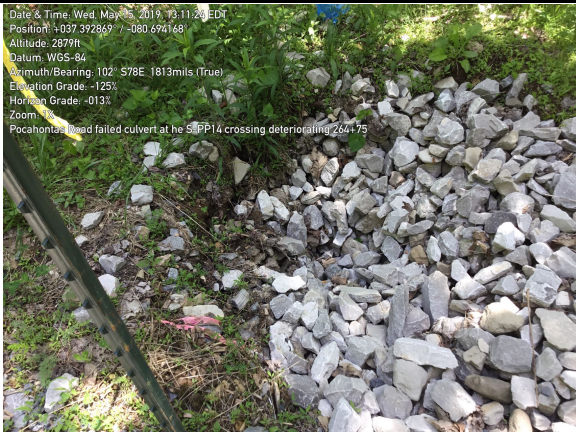
<p>Date & Time: Wed, May 15, 2019, 13:11:26 EDT Position: +037.392869 / -080.676168 Altitude: 297ft Datum: WGS-84 Azimuth/Bearing: 102° 57'E 1813mils (True) Elevation Grade: -125% Horizon Grade: -013% Zoom: 1X Pocahontas Road failed culvert at the 5-PP14 crossing deteriorating 264+75</p>

GPS Location	37.13	Field Station#	10449+00	GPS Location	37.13	Field Station#	264+75
Description	Correct coordinates on photo.			Description	Correct coordinates on photo. Failed culvert conditions on Pocahontas slowly deteriorating.

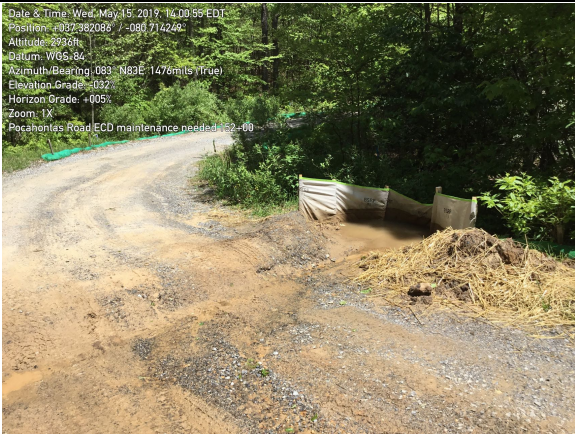
<p>Date & Time: Wed, May 15, 2019, 14:00:55 EDT Position: +037.382088 / -080.714269 Altitude: 2936ft Datum: WGS-84 Azimuth/Bearing: 083° N83E 1476mils (True) Elevation Grade: +03% Horizon Grade: +00% Zoom: 1X Pocahontas Road ECD maintenance needed at 152+00</p>

GPS Location	37.13	Field Station#	173+50	GPS Location	37.13	Field Station#	152+00
Description	Correct coordinates on photo. Pocahontas. Potholes developing and water bar maintenance needed.			Description	Correct coordinates on photo. Pocahontas. End treatment and water bar maintenance needed.		
<p>Date & Time: Wed, May 15, 2019, 14:01:28 EDT Position: +037.382010 / -080.714206 Altitude: 2939ft Datum: WGS-84 Azimuth/Bearing: 220° S40W 3911mils (True) Elevation Grade: -02% Horizon Grade: -00% Zoom: 1X Pocahontas Road channeling/runoff at 152+00</p>

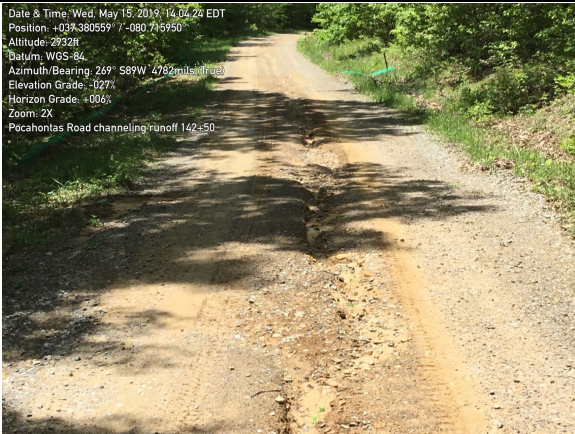
<p>Date & Time: Wed, May 15, 2019, 14:04:26 EDT Position: +037.380559 / -080.715950 Altitude: 2932ft Datum: WGS-84 Azimuth/Bearing: 269° S89W 4762mils (True) Elevation Grade: -027% Horizon Grade: +00% Zoom: 2X Pocahontas Road channeling/runoff at 142+50</p>

Description	Correct coordinates on photo. Pocahontas. Road surface channeling runoff.			Description	Correct coordinates on photo. Pocahontas. Runoff channeling on road surface.

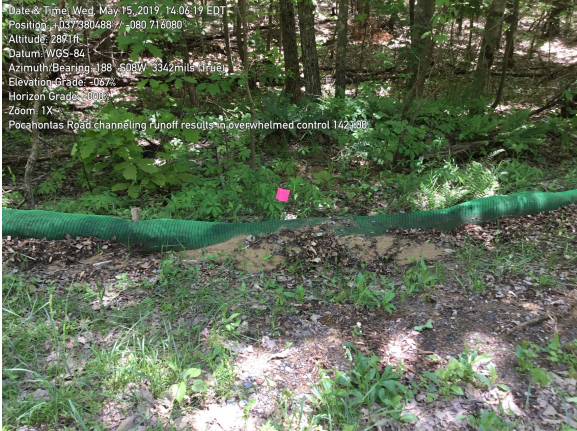
<p><small>Date & Time: Wed May 15 2019 14:02:39 EDT Position: +037.980488° / -080.716089° Altitude: 2821ft Datum: WGS-84 Azimuth/Bearing: 188° S09W 3342mils (True) Elevation Grade: +06% Horizon Grade: +00% Zoom: 1X Pocahontas Road channeling runoff results in overwhelmed control 142+00.</small></p>

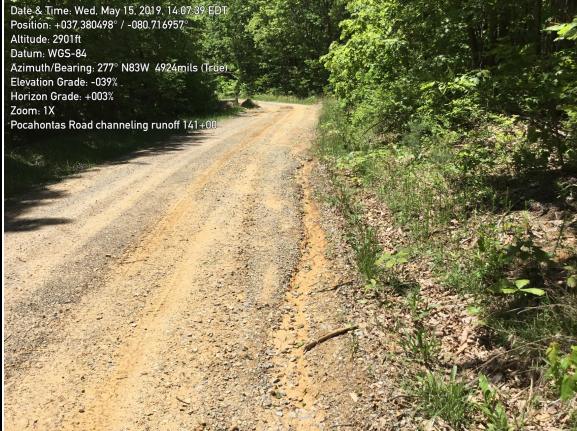
<p><small>Date & Time: Wed May 15 2019 14:02:39 EDT Position: +037.980498° / -080.716957° Altitude: 2901ft Datum: WGS-84 Azimuth/Bearing: 277° N83W 4924mils (True) Elevation Grade: -03% Horizon Grade: +003% Zoom: 1X Pocahontas Road channeling runoff 141+00.</small></p>		
GPS Location	37.13	Field Station#	142+00	GPS Location	37.13
Description	Correct coordinates on photo. Pocahontas. ECD maintenance needed. Control overwhelmed.				
Insert image here			Insert image here		
GPS Location		Field Station#		GPS Location	
Description

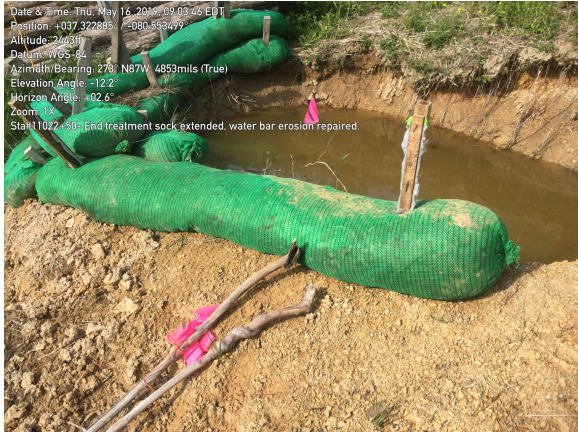
<p>Date & Time: Thu, May 16, 2019, 09:03:46 EDT Position: +037.322885° / -080.553497° Altitude: 2303ft Datum: WGS-84 Azimuth Bearing: 275° N87W 4853mils (True) Elevation Angle: -12.2° Horizon Angle: +02.6° Zoom: 1X Star 11022+50: End treatment sock extended, water bar erosion repaired.</p>

GPS Location	37.32	Field Station#	11022+00	GPS Location	37.32	Field Station#	11022+50
Description	AR-244- Stream S-IJ18- Equipment bridge, ECD's, sensitive resource signage.			Description	Sock has been extended, water bar erosion repaired.

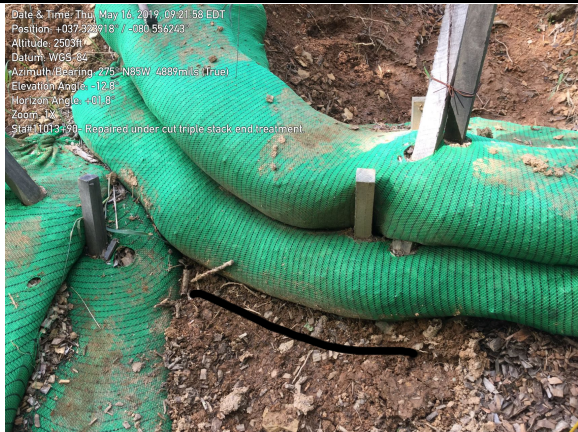
<p>Date & Time: Thu, May 16, 2019, 09:21:56 EDT Position: +037.323218° / -080.553223° Altitude: 2503ft Datum: WGS-84 Azimuth Bearing: 275° N85W 4888mils (True) Elevation Angle: -12.8° Horizon Angle: +01.8° Zoom: 1X Star 11013+90: Repaired under cut triple stack end treatment.</p>

GPS Location	37.32	Field Station#	11018+75	GPS Location	37.32	Field Station#	11013+90
Description	Damaged P1 perimeter controls have been replaced.			Description	Repaired under cut end treatment.		
<p>Date & Time: Thu, May 16, 2019, 09:28:48 EDT Position: +037.324083° / -080.556319° Altitude: 2505ft Datum: WGS-84 Azimuth Bearing: 280° N07W 5276mils (True) Elevation Angle: -16.5° Horizon Angle: +01.4° Zoom: 1X Star 11013+25: Repaired CFS fabric on perimeter controls.</p>

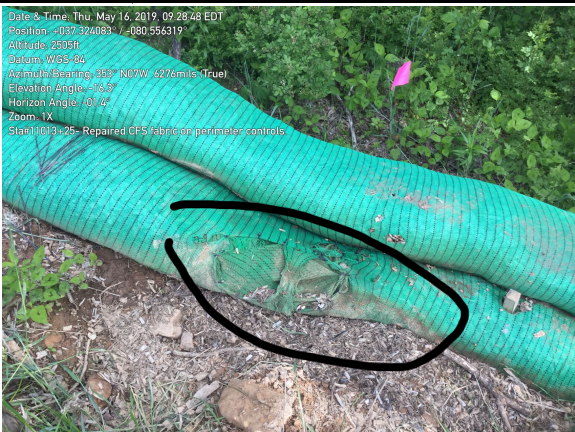
GPS Location	37.32	Field Station#	11013+25	GPS Location	37.32	Field Station#	11006+50
Description	Repaired fabric on CFS perimeter controls.			Description	Rest waddle across perimeter gap, added another waddle, cleaned sediment from waddle

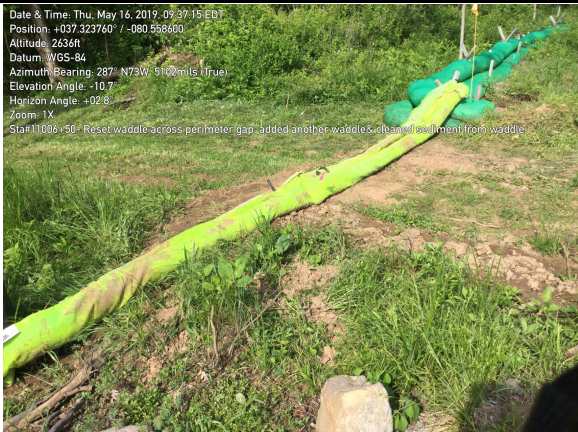
<p>Date & Time: Thu, May 16, 2019, 09:37:15 EDT Position: +037.323760° / -080.558600° Altitude: 2636ft Datum: WGS-84 Azimuth Bearing: 287° N73W 5102mils (True) Elevation Angle: -10.7° Horizon Angle: +02.8° Zoom: 1X Star 11006+50: Reset waddle across perimeter gap, added another waddles, cleaned sediment from waddle.</p>

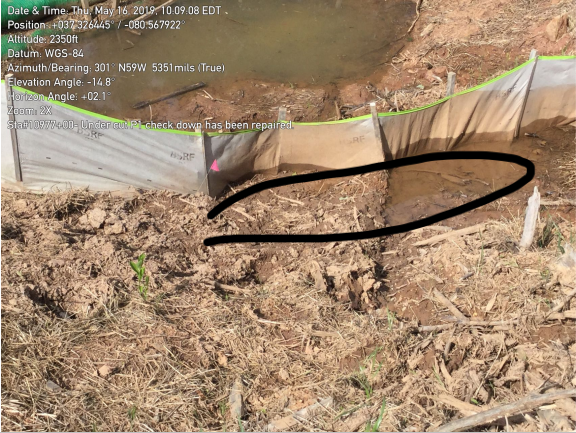
<p><small>Date & Time: Thu, May 16, 2019, 10:09:08 EDT Position: +037.327643° / -080.567922° Altitude: 2350ft Datum: WGS-84 Azimuth/Bearing: 301° N59W 5351mils (True) Elevation Angle: -14.8° Horizon Angle: +02.1° Zoom: 2X Sta#10977+00- Under cut P1 check down has been repaired.</small></p>

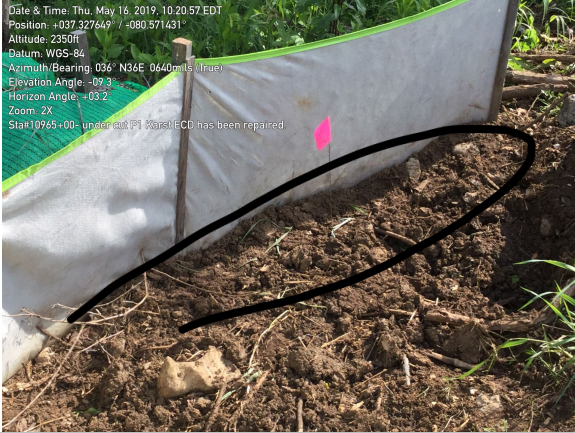
<p><small>Date & Time: Thu, May 16, 2019, 10:20:57 EDT Position: +037.327643° / -080.571431° Altitude: 2350ft Datum: WGS-84 Azimuth/Bearing: 036° N36E 0440mils (True) Elevation Angle: -09.3° Horizon Angle: +03.2° Zoom: 2X Sta#10965+00- Under cut P1 Karst ECD has been repaired.</small></p>		
GPS Location 37.32		Field Station# 10977+00		GPS Location 37.32	
Description		Under cut P1 check down has been repaired.		Description	
Description		Under cut P1 at Karst has been repaired.		Description

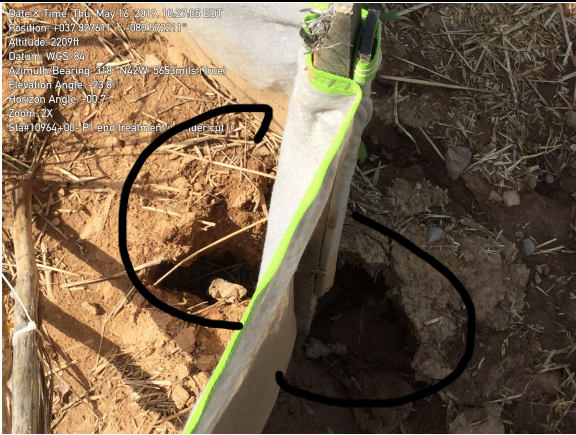
<p><small>Date & Time: Thu, May 16, 2019, 10:27:05 EDT Position: +037.327643° / -080.572211° Altitude: 2209ft Datum: WGS-84 Azimuth/Bearing: 148° N142W 5652mils (True) Elevation Angle: +12.8° Horizon Angle: +00.7° Zoom: 2X Sta#10964+00- P1 end treatment has been repaired.</small></p>

GPS Location 37.32		Field Station# 10964+00		GPS Location 37.32	
Description		P1 end treatment is under cut.		Description	
Description		Doe Creek Farms- Land owner opened gate & is grazing row, sta#10950+00 to 10939+72, there is P1 drainage buffer that will be damaged.		Description	
Insert image here			Insert image here		
GPS Location		Field Station#		GPS Location	
Description		Description		Description

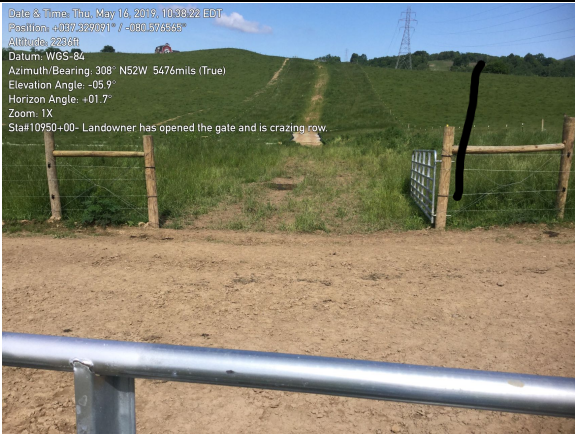
<p><small>Date & Time: Thu, May 16, 2019, 10:48:22 EDT Position: +037.327643° / -080.574331° Altitude: 2209ft Datum: WGS-84 Azimuth/Bearing: 308° N52W 5476mils (True) Elevation Angle: -05.9° Horizon Angle: +01.7° Zoom: 1X Sta#10950+00- Landowner has opened the gate and is crazing row.</small></p>

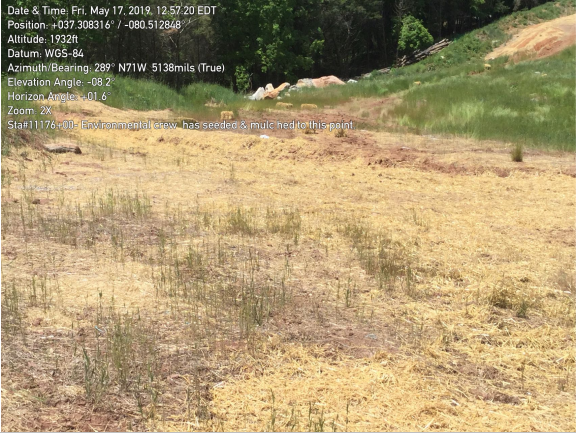
AFE	124300137	Date/Time	5/17/2019 7:25 AM	Report #	17330		
Pictures							
<small>Date & Time: Fri, May 17, 2019, 12:57:20 EDT Position: +037.908316° / -080.512878° Altitude: 1932ft Datum: WGS-84 Azimuth/Bearing: 289° N71W 5138mils (True) Elevation Angle: -08.2° Horizon Angle: +01.6° Zoom: 2X Sta#11176+00- Environmental crew has seeded & mulched to this point</small>

GPS Location	37.30	Field Station#	11176+00	GPS Location	37.30	Field Station#	11174+00
Description	Environmental crew has seeded & mulched from 11227+00 to 11176+00 so far.			Description	Hoe has cleaned sumps & refreshed water bars from sta#11227+00 to 11161+00

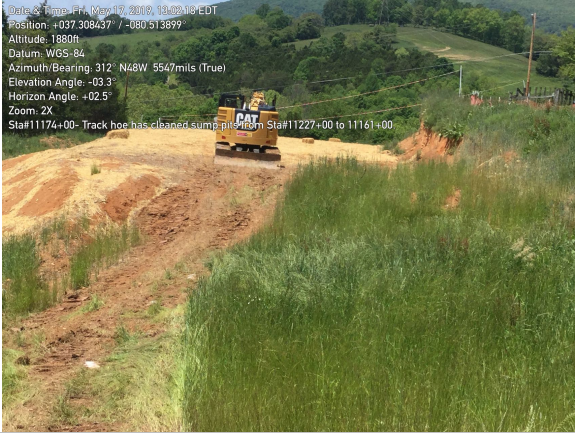
<small>Date & Time: Fri, May 17, 2019, 12:58:18 EDT Position: +037.908437° / -080.513879° Altitude: 1880ft Datum: WGS-84 Azimuth/Bearing: 312° N48W 5547mils (True) Elevation Angle: -03.3° Horizon Angle: +02.5° Zoom: 2X Sta#11174+00- Track hoe has cleaned sump pits from Sta#11227+00 to 11161+00</small>

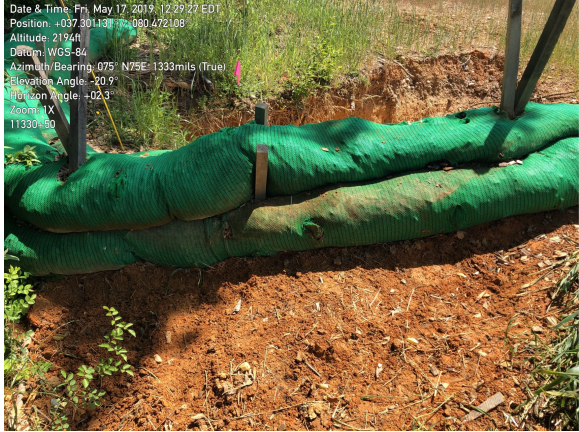
</div></div>			<div><div><div>Date & Time: Fri, May 17, 2019, 12:29:27 EDT Position: +037 301131° / -080 472108° Altitude: 2194ft Datum: WGS-84 Azimuth/Bearing: 075° N75E 1333mils (True) Elevation Angle: -20.9° Horizon Angle: -02.3° Zoom: 1X 11330+50</div>

</div></div>				
GPS Location	37.18	Field Station#	11327+50	GPS Location	37.18	Field Station#	11332+00
Description	See photo for GPS location. Sensitive resource buffer in place at stream S-NN11.			Description	See photo for GPS location. Undermined end treatment repaired from last inspection.		
<div><div><div>Date & Time: Fri, May 17, 2019, 12:30:35 EDT Position: +037 301013° / -080 470952° Altitude: 1996ft Datum: WGS-84 Azimuth/Bearing: 149° S31E 2649mils (True) Elevation Angle: -15.0° Horizon Angle: -00.3° Zoom: 1X 11332+50</div>

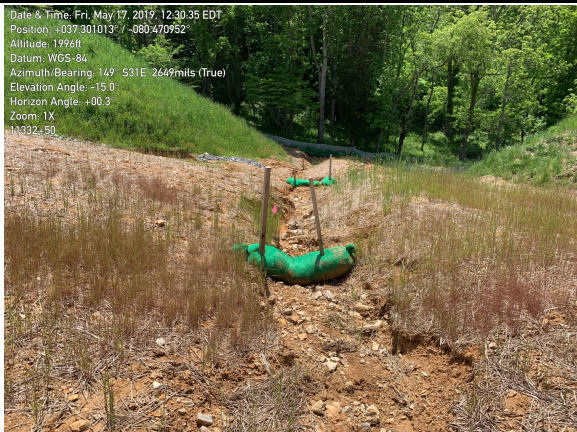
GPS Location	37.18	Field Station#	11332+50	GPS Location	37.18	Field Station#	11489+00
Description	See photo for GPS location. Sock checks in place in water bar throat.			Description	See photo for GPS location. RCE in place at Stevers Gap Road.		
<div><div><div>Date & Time: Fri, May 17, 2019, 13:32:57 EDT Position: +037 321941° / -080 435826° Altitude: 2226ft Datum: WGS-84 Azimuth/Bearing: 041° N41E 0729mils (True) Elevation Angle: -00.6° Horizon Angle: -00.1° Zoom: 1X 11472+00</div>

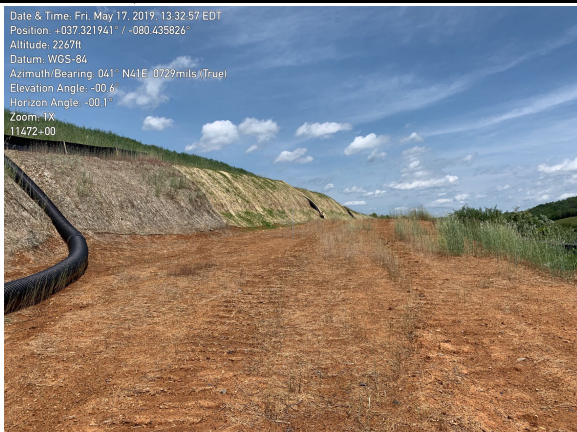
</div></div>				
GPS Location	37.18	Field Station#	11471+00	GPS Location	37.18	Field Station#	11487+00
Description	See photo for GPS location. Two tone section stabilized with ECB and slope drains in place.			Description	See photo for GPS location. Plunge pool in place.
