Visual Site Inspection Report

Project Name	H-600 Pipeline Spread G	AFE	124300137	Spread	H-600 Pipeline Spread G
Contractor	Precision			Report #	17457
Inspector	Len Kruizenga			Date/Time	5/20/2019 7:46 AM
Permit #	TBD	Inspection Type	VA SWPP	Station Begin	11524+00
State	VA	Inspection Area	Full	Station End	11600+00
County	Giles	Ground	Damp	Temperature (°F)	65.00
Municipality	N/A	Weather	Cloudy	Rain Gauge (in)	0.10
				Rain Accumulation Time (days)	2.00

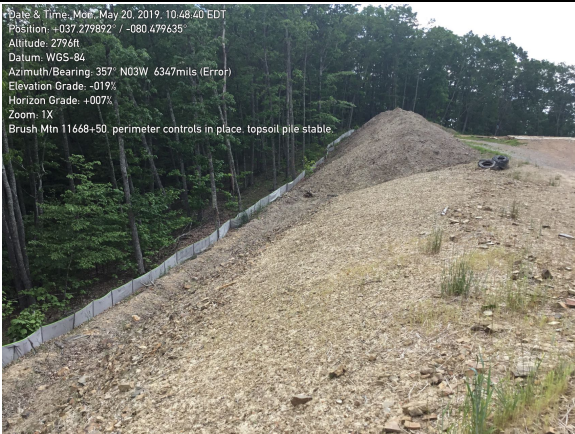
AFE	124300137	Date/Time	5/20/2019 12:28 PM	Report #	17478		
Pictures							
<p>Date & Time: Mon, May 20, 2019, 10:48:40 EDT Position: +037.279822 / -080.479635 Altitude: 2796ft Datum: WGS-84 Azimuth/Bearing: 357° N03W 6347mils (Error) Elevation Grade: -019% Horizon Grade: +007% Zoom: 1X Brush Mtn 11668+50, perimeter controls in place, topsoil pile stable.</p>

GPS Location	37.29	Field Station#	11668+50	GPS Location	37.29	Field Station#	11662+00
Description	Correct coordinates on photo. Topsoil pile stable.			Description	Correct coordinates on photo. End treatments were checked for effectiveness and maintenance needs.

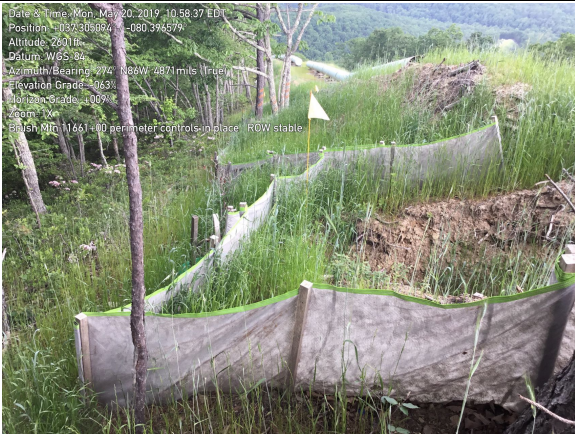
<p>Date & Time: Mon, May 20, 2019, 10:58:40 EDT Position: +037.304864 / -080.396579 Altitude: 2601ft Datum: WGS-84 Azimuth/Bearing: 274° N86W 2871mils (True) Elevation Grade: -063% Horizon Grade: -009% Zoom: 1X Brush Mtn 11661+00 perimeter controls in place, ROW stable.</p>

GPS Location	37.29	Field Station#	11661+00	GPS Location	37.29	Field Station#	11642+80
Description	Correct coordinates on photo. No sediment has migrated beyond LOD.			Description	Correct coordinates on photo. Punch list item for repair of erosion blanket has been completed.		
<p>Date & Time: Mon, May 20, 2019, 11:46:48 EDT Position: +037.313822 / -080.398513 Altitude: 1943ft Datum: WGS-84 Azimuth/Bearing: 312° N49W 5547mils (True) Elevation Grade: -031% Horizon Grade: -008% Zoom: 1X Brush Mtn 11626+04 S-HA19 crossing stable.</p>

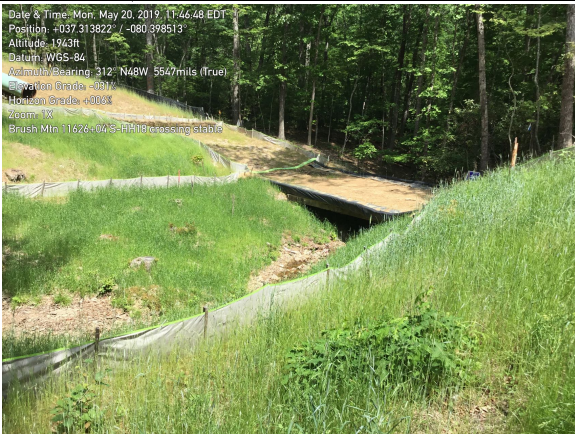
GPS Location	37.29	Field Station#	11626+04	GPS Location	37.29	Field Station#	11614+75
Description	Correct coordinates on photo. Resource crossings are stable.			Description	Correct coordinates on photo. End treatments checked for effectiveness and maintenance needs.

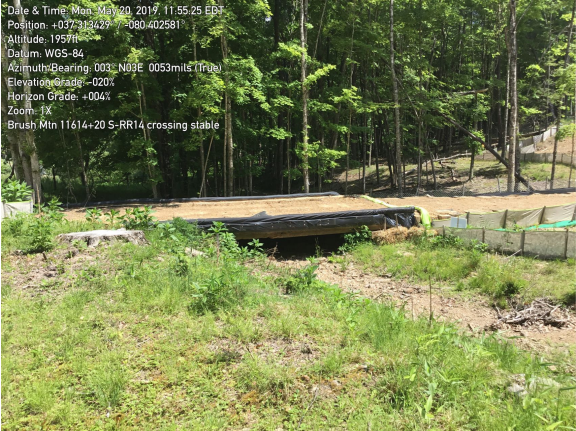
AFE 124300137		Date/Time 5/20/2019 12:28 PM		Report # 17478	
Pictures					
<small>Date & Time: Mon May 20, 2019, 11:55:25 EDT Position: +037°31'42N, -080°40'25W Altitude: 1957ft Datum: WGS-84 Azimuth/Bearing: 003° N03E 0053mils (True) Elevation Grade: -020% Horizon Grade: +004% Zoom: 1X Brush Mtn 11614+20 S-RR14 crossing stable</small>

GPS Location 37.29		Field Station# 11614+20		GPS Location 37.29	
Description		Correct coordinates on photo. Resource crossings are stable.		Description	
Description		Correct coordinates on photo. Resource crossings are stable.		Description	
<small>Date & Time: Mon May 20, 2019, 11:57:47 EDT Position: +037°31'43N, -080°40'26W Altitude: 1914ft Datum: WGS-84 Azimuth/Bearing: 011° N11E 0196mils (True) Elevation Grade: +017% Horizon Grade: +004% Zoom: 1X Brush Mtn 11613+69 S-RR13 crossing stable</small>

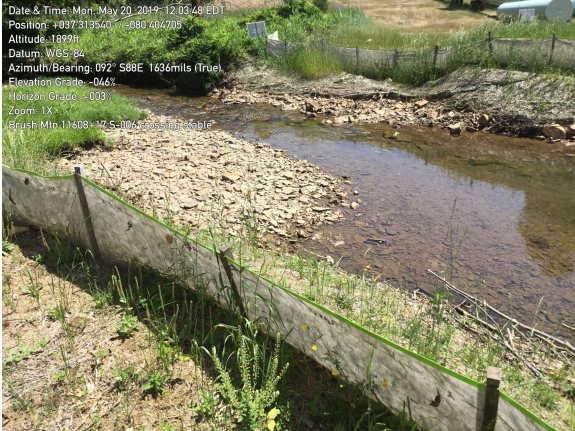
<small>Date & Time: Mon May 20, 2019, 12:03:48 EDT Position: +037°31'54N, -080°40'47W Altitude: 1899ft Datum: WGS-84 Azimuth/Bearing: 092° S88E 1636mils (True) Elevation Grade: -046% Horizon Grade: -003% Zoom: 1X Brush Mtn 11608+17 S-RR14 crossing stable</small>

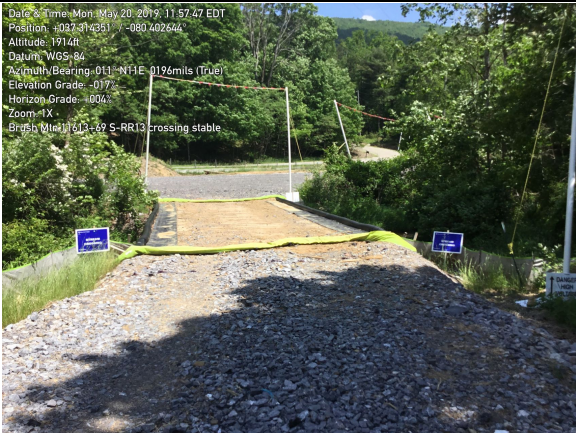
GPS Location 37.29		Field Station# 11613+69		GPS Location	
Description		Correct coordinates on photo. Resource crossings are stable.		Description	
Insert image here			Insert image here		
GPS Location		Field Station#		GPS Location	
Description				Description

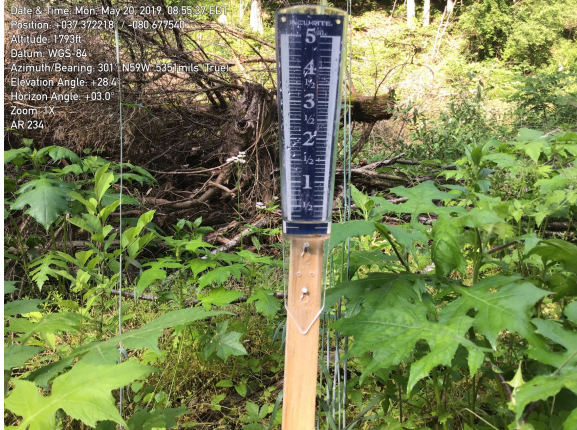
A/E	124300137	Date/Time	5/20/2019 3:32 PM	Report #	17484		
Pictures							
<p>Date & Time: Mon, May 20, 2019, 08:55:37 EDT Position: +037.372218° / -080.677546° Altitude: 1793ft Datum: WGS-84 Azimuth/Bearing: 301° N89W 53.5mils (true) Elevation Angle: +28.6° Horizon Angle: +03.0° Zoom: 1X AR 234</p>

GPS Location	37.18	Field Station#	12005+00	GPS Location	37.18	Field Station#	10688+00
Description	See photo for GPS location. Rain gauge at AR 234.			Description	See photo for GPS location. Rain gauge at Buffalo Anklets.		
<p>Date & Time: Mon, May 20, 2019, 09:11:49 EDT Position: +037.310178° / -080.775685° Altitude: 2133ft Datum: WGS-84 Azimuth/Bearing: 208° N20E 0107mils (true) Elevation Angle: +35.5° Horizon Angle: +02.2° Zoom: 1X Kow Camp</p>

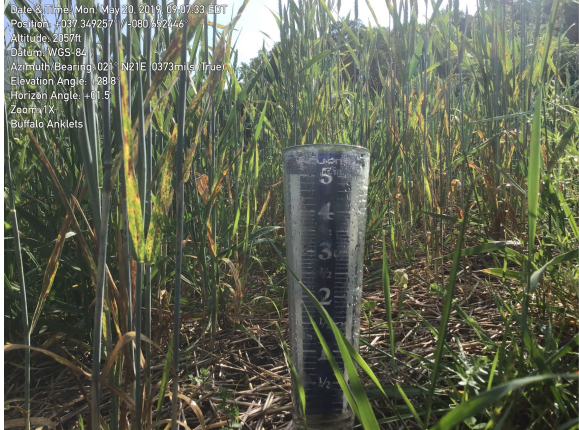
<p>Date & Time: Mon, May 20, 2019, 09:07:33 EDT Position: +037.349257° / -080.672426° Altitude: 1657ft Datum: WGS-84 Azimuth/Bearing: 021° N21E 0373mils (true) Elevation Angle: +28.8° Horizon Angle: +01.5° Zoom: 1X Buffalo Anklets</p>

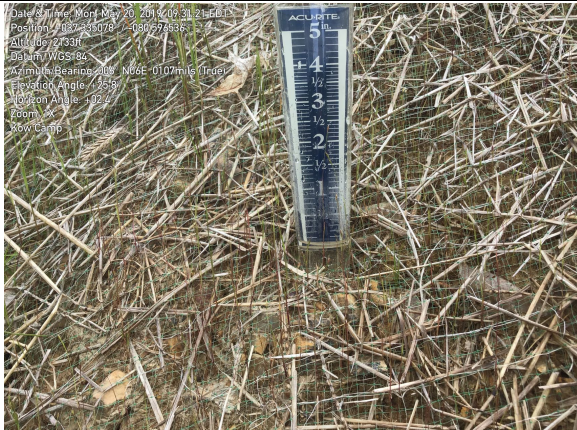
GPS Location	37.18	Field Station#	10883+50	GPS Location	37.18	Field Station#	12005+00
Description	See photo for GPS location. Rain gauge at Kow Camp Road.			Description	See photo for GPS location. Rain gauge at at AR 244.		
<p>Date & Time: Mon, May 20, 2019, 12:50:58 EDT Position: +037.296182° / -080.367861° Altitude: 2016ft Datum: WGS-84 Azimuth/Bearing: 348° N12W 6187mils (true) Elevation Angle: +17.6° Horizon Angle: +00.3° Zoom: 1X 11676+00</p>

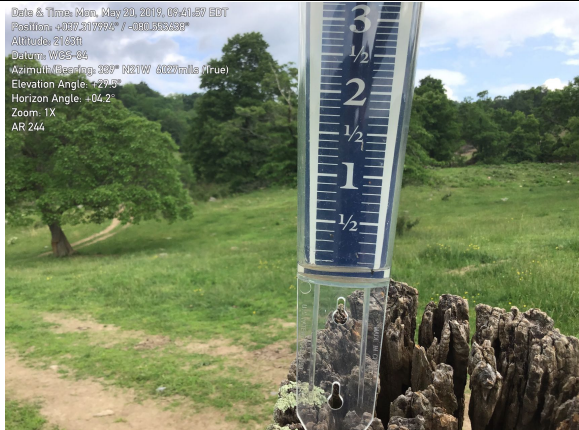
<p>Date & Time: Mon, May 20, 2019, 09:41:47 EDT Position: +037.217992° / -080.838357° Altitude: 2161ft Datum: WGS-84 Azimuth/Bearing: 235° N21W 0022mils (true) Elevation Angle: +27.3° Horizon Angle: +04.2° Zoom: 1X AR 244</p>

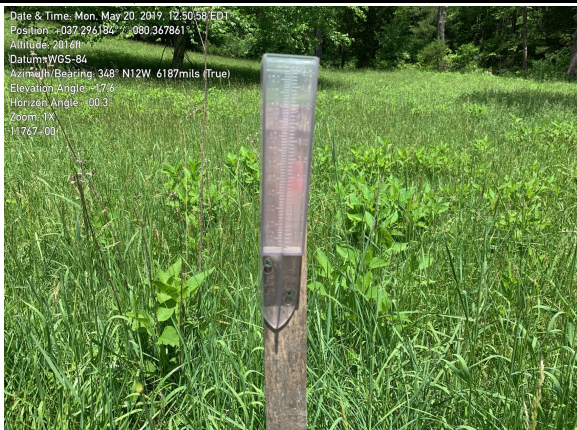
GPS Location	37.18	Field Station#	11676+00	GPS Location	37.18	Field Station#	11670+00
Description	See photo for GPS location. Rain gauge at Mount Tabor Road.			Description	See photo for GPS location. ROW stabilized with seed and mulch. Water bars in place.

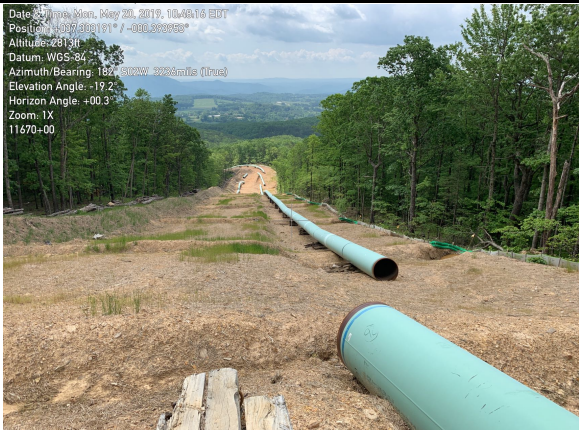
<p>Date & Time: Mon, May 20, 2019, 10:46:16 EDT Position: +037.261161° / -080.323363° Altitude: 2131ft Datum: WGS-84 Azimuth/Bearing: 182° S00W 7734mils (true) Elevation Angle: +19.2° Horizon Angle: +00.3° Zoom: 1X 11670+00</p>

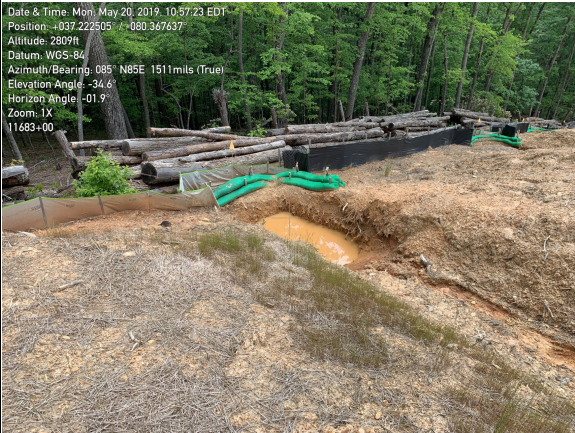
AFE	124300137	Date/Time	5/20/2019 3:32 PM	Report #	17484		
Pictures							
<p>Date & Time: Mon, May 20, 2019, 10:57:23 EDT Position: +037.222505, -080.367637 Altitude: 2809ft Datum: WGS-84 Azimuth/Bearing: 085° N85E 1511mils (True) Elevation Angle: -34.6 Horizon Angle: -01.9 Zoom: 1X 11683+00</p>

GPS Location	37.18	Field Station#	11683+00	GPS Location	37.18	Field Station#	11676+00
Description	See photo for GPS location. Sump pit, waterbar, and end treatment in place.			Description	See photo for GPS location. Sensitive resource buffer in place at stream S-MN21.		
<p>Date & Time: Mon, May 20, 2019, 12:50:42 EDT Position: +037.236128, -080.367929 Altitude: 2907ft Datum: WGS-84 Azimuth/Bearing: 105° S75E 1867mils (True) Elevation Angle: -08.6 Horizon Angle: +01.2 Zoom: 1X 11767+00</p>

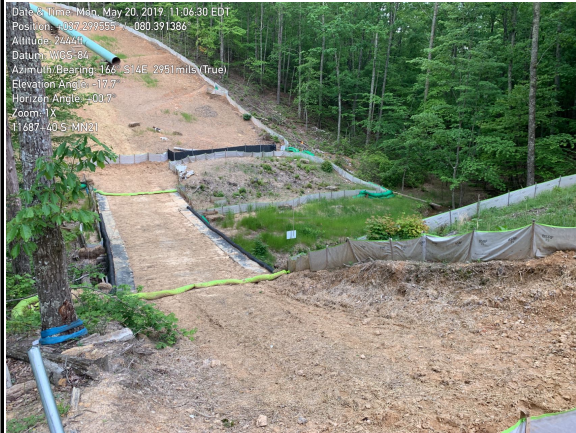
<p>Date & Time: Mon, May 20, 2019, 11:06:30 EDT Position: +037.236553, -080.391386 Altitude: 2902ft Datum: WGS-84 Azimuth/Bearing: 166° S44E 2451mils (True) Elevation Angle: -07.2 Horizon Angle: -00.7 Zoom: 1X 11687+00</p>

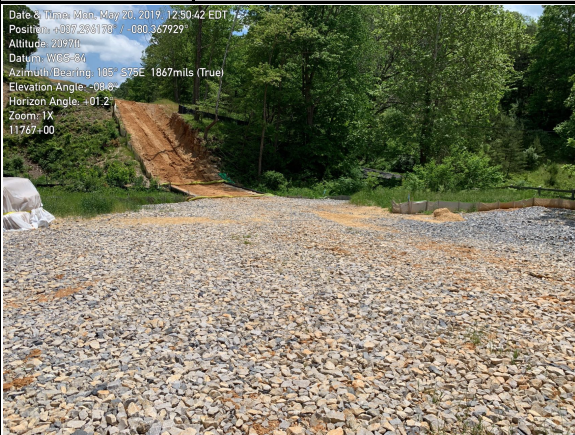
GPS Location	37.18	Field Station#	11676+00	GPS Location	37.18	Field Station#	11770+00
Description	See photo for GPS location. RCE in place at main line valve 26.			Description	See photo for GPS location. Original grade reestablished and vegetation growth present.		
<p>Date & Time: Mon, May 20, 2019, 12:55:36 EDT Position: +037.294283, -080.366014 Altitude: 2052ft Datum: WGS-84 Azimuth/Bearing: 186° S06W 3307mils (True) Elevation Angle: -23.9 Horizon Angle: -04.5 Zoom: 2X 11772+00</p>

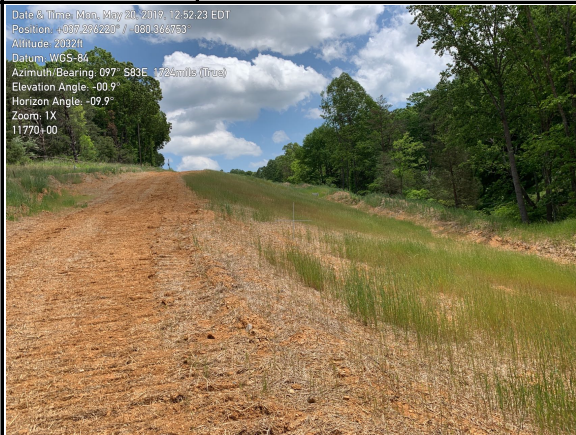
<p>Date & Time: Mon, May 20, 2019, 12:52:23 EDT Position: +037.236227, -080.367353 Altitude: 2902ft Datum: WGS-84 Azimuth/Bearing: 097° S83E 1734mils (True) Elevation Angle: -00.9 Horizon Angle: -02.9 Zoom: 1X 11770+00</p>

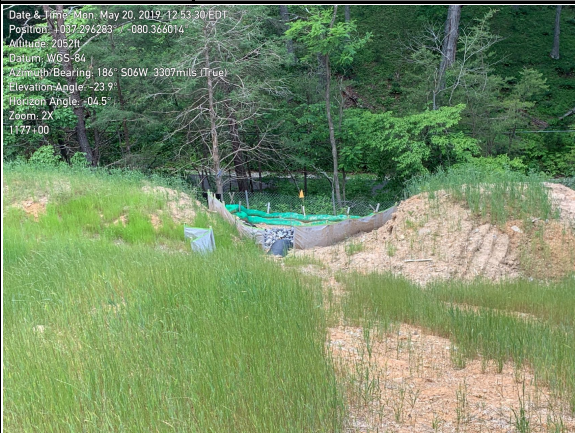
GPS Location	37.18	Field Station#	11772+00	GPS Location	37.18	Field Station#	11776+00
Description	See photo for GPS location. Clean water diversion pipe and plunge pool in place.			Description	See photo for GPS location. Reinforced super silt fence in place.

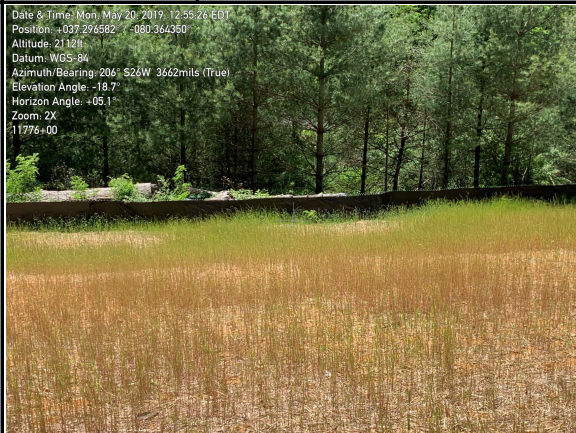
<p>Date & Time: Mon, May 20, 2019, 12:55:26 EDT Position: +037.296582, -080.364350 Altitude: 2112ft Datum: WGS-84 Azimuth/Bearing: 204° S26W 3662mils (True) Elevation Angle: -18.7 Horizon Angle: +05.1 Zoom: 2X 11776+00</p>

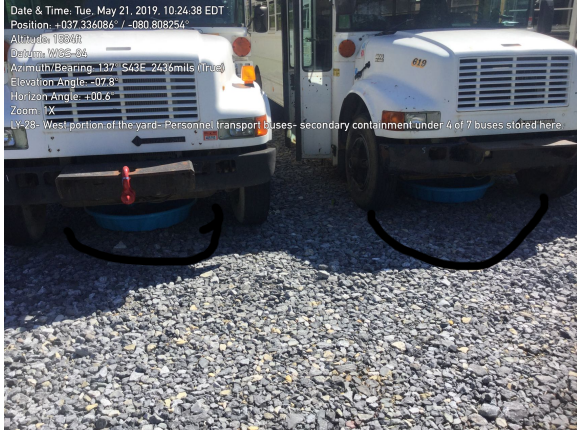
AFE	124300137	Date/Time	5/21/2019 10:19 AM	Report #	17518		
Pictures							
<p>Date & Time: Tue, May 21, 2019, 10:24:38 EDT Position: +037 336086° / -080 808254° Altitude: 1550ft Datum: WGS-84 Azimuth/Bearing: 132° S43E 243mils (True) Elevation Angle: -07.3° Horizon Angle: +00.6° Zoom: 1X LY-28- West portion of the yard- Personnel transport buses- secondary containment under 4 of 7 buses stored here.</p>

GPS Location	37.33	Field Station#	12005+00	GPS Location	37.33	Field Station#	12005+00
Description	LY-28- West Portion of yard- Secondary containment under 4 of 7 buses stored here.			Description	LY- 28- West side of the yard- Rock surface is maintained in acceptable condition.

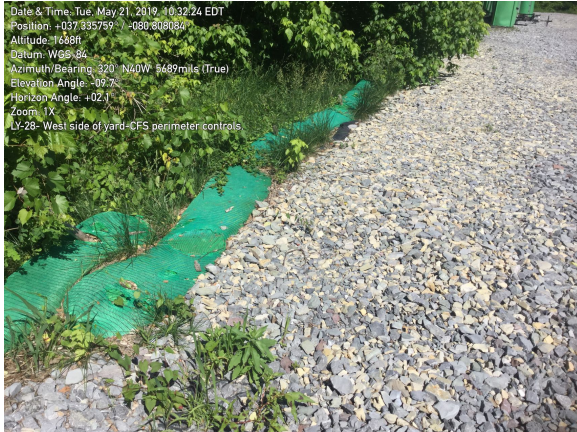
<p>Date & Time: Tue, May 21, 2019, 10:32:24 EDT Position: +037 335759° / -080 808084° Altitude: 1638ft Datum: WGS-84 Azimuth/Bearing: 320° N40W 548mils (True) Elevation Angle: -09.7° Horizon Angle: +02.1° Zoom: 1X LY-28- West side of yard- CFS perimeter controls.</p>

GPS Location	37.33	Field Station#	12005+00	GPS Location	37.33	Field Station#	12005+00
Description	LY-28-West side of yard- CFS perimeter controls.			Description	LY-28- East side of yard primarily used for trunk & trailer parking.		
<p>Date & Time: Tue, May 21, 2019, 10:47:58 EDT Position: +037 334036° / -080 802929° Altitude: 1593ft Datum: WGS-84 Azimuth/Bearing: 315° N55W 538mils (True) Elevation Angle: -07.3° Horizon Angle: +00.1° Zoom: 1X LY-28- East side of yard- Rock surface is maintained in acceptable condition.</p>

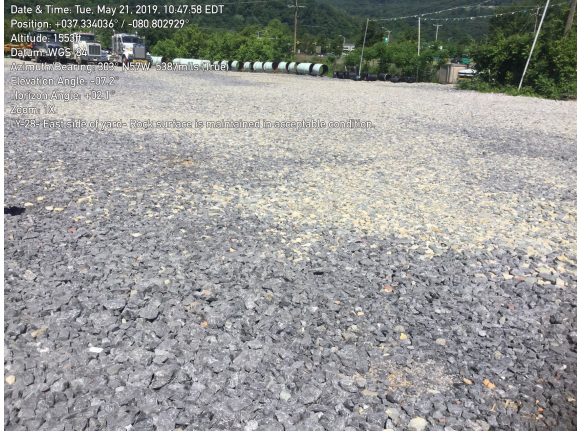
GPS Location	37.33	Field Station#	12005+00	GPS Location	37.33	Field Station#	12005+00
Description	LY-28- East side of yard- Rock surface is maintained in acceptable condition.			Description	LY-28- East side of yard- CFS perimeter controls and electric line goal posts & flags are in acceptable condition.

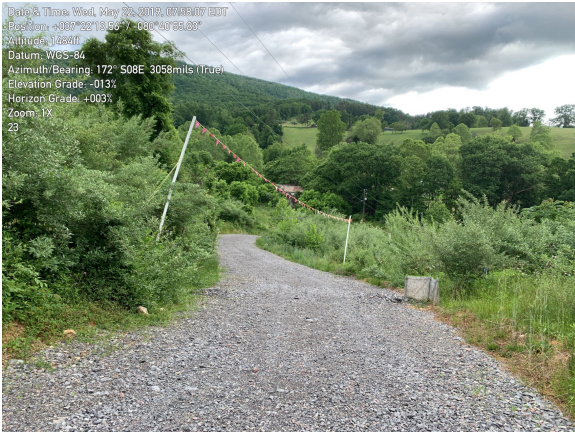
<p>Date & Time: Wed, May 22, 2019, 09:30:07 EDT Position: +037° 22' 13.53" N / -080° 35' 55.63" W Altitude: 1917ft Datum: WGS-84 Azimuth/Bearing: 172° S08E 3058mils (True) Elevation Grade: -013% Horizon Grade: +003% Zoom: 1X 10893-00</p>

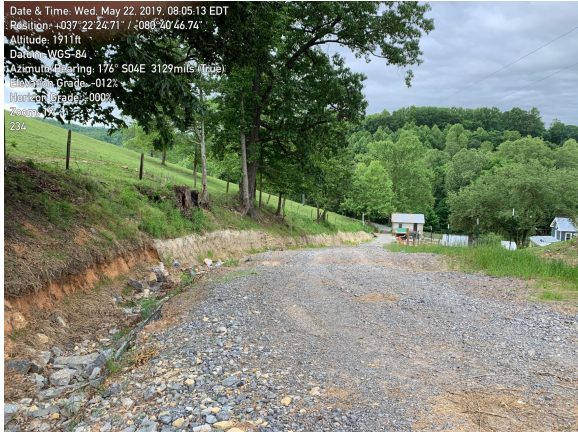
<p>Date & Time: Wed, May 22, 2019, 08:05:13 EDT Position: +037° 22' 24.71" N / -080° 30' 46.74" W Altitude: 1917ft Datum: WGS-84 Azimuth/Bearing: 176° S04E 3129mils (True) Elevation Grade: -012% Horizon Grade: -000% Zoom: 1X 10893-00</p>				
GPS Location	37.31	Field Station#	2+35	GPS Location	37.31	Field Station#	2+34
Description	ECD's and ROW conditions ar 235			Description	ECD's and ROW conditions ar 234

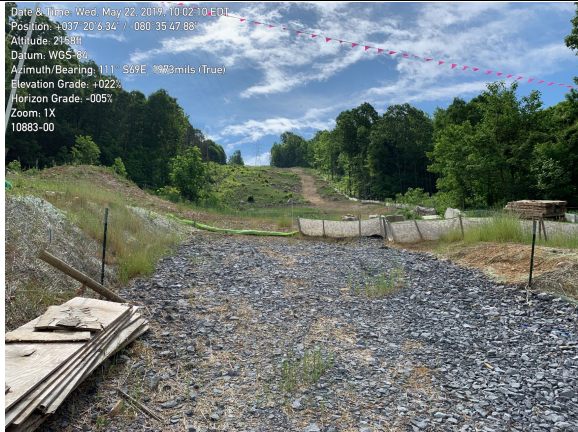
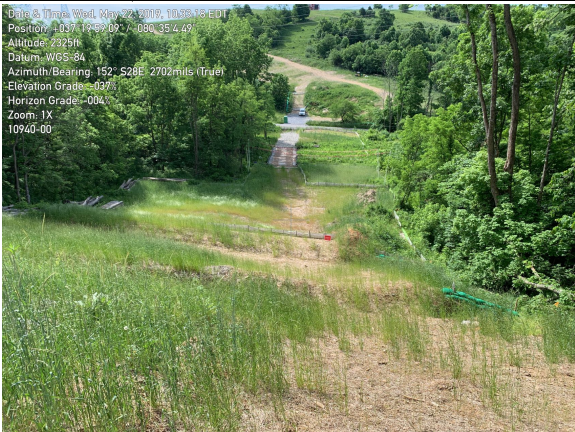
GPS Location	37.31	Field Station#	10856+04	GPS Location	37.31	Field Station#	10883+00
Description	Water bar and end treatment			Description	ECD's and ROW conditions

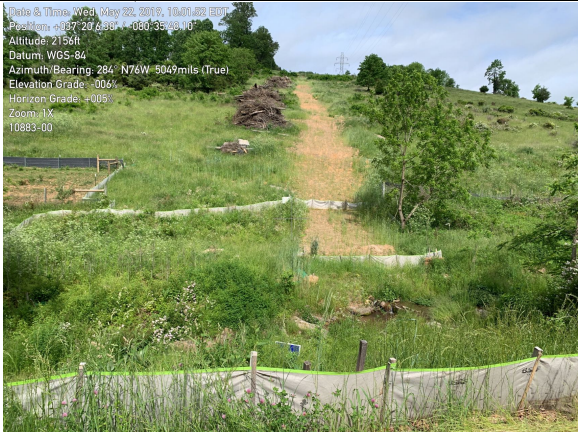
<p>Date & Time: Wed, May 22, 2019, 10:01:07 EDT Position: +037° 20' 6.53" N / -080° 35' 46.10" W Altitude: 2158ft Datum: WGS-84 Azimuth/Bearing: 284° N76W 5049mils (True) Elevation Grade: -006% Horizon Grade: +009% Zoom: 1X 10883-00</p>				
GPS Location	37.31	Field Station#	10940+00	GPS Location	37.31	Field Station#	10883+00
Description	ECD's and ROW conditions			Description	ECD's and ROW conditions

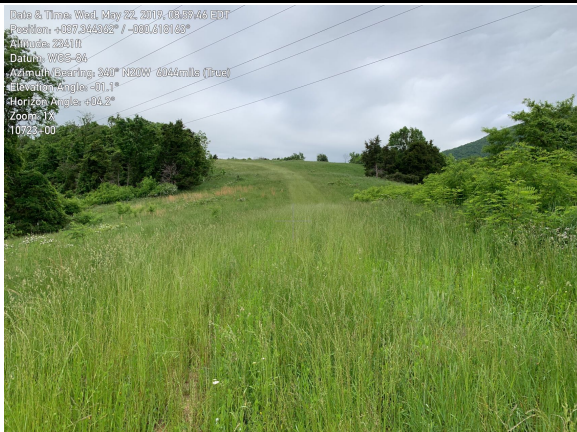
GPS Location	37.18	Field Station#	10732+00	GPS Location	37.18	Field Station#	10696+00
Description	See photo for GPS location. ROW stabilized with natural vegetation.			Description	See photo for GPS location. RCE in place at Buffalo Anklets Road.		
<div><div><div>Date & Time: Wed, May 22, 2019, 09:30:07 EDT Position: +037.350302° / -080.657929° Altitude: 2074ft Datum: WGS-84 Azimuth/Bearing: 282° N78W 5011mils (True) Elevation Angle: -18.0° Horizon Angle: +03.6° Zoom: 1X 10683+50 S-G30</div><div>

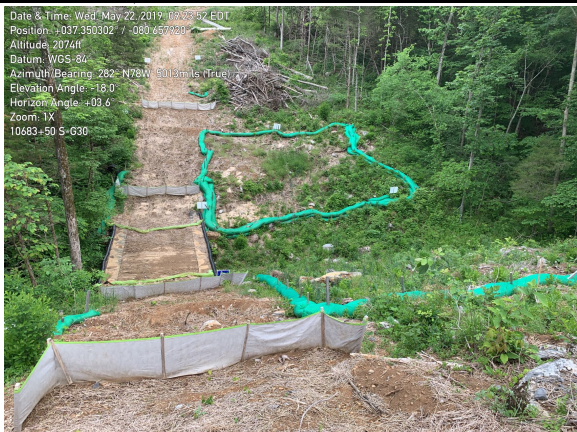
</div></div></div>				
GPS Location	37.18	Field Station#	10683+50	GPS Location	37.18	Field Station#	10721+00
Description	See photo for GPS location. Sensitive resource buffer in place at stream S-G30.			Description	See photo for GPS location. Water bar with end treatment in place in travel lane.

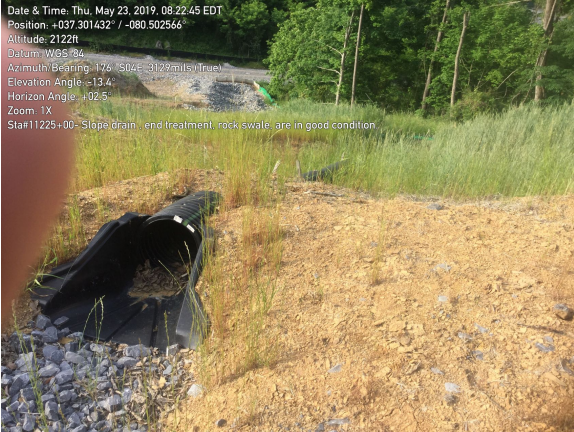
<p>Date & Time: Thu, May 23, 2019, 08:22:45 EDT Position: +037.301432° / -080.502566° Altitude: 2122ft Datum: WGS-84 Azimuth/Bearing: 126° N50E 319mils (True) Elevation Angle: -13.4° Horizon Angle: +02.5° Zoom: 1X Sta#11225+00- Slope drain, end treatment, rock swale, are in good condition.</p>

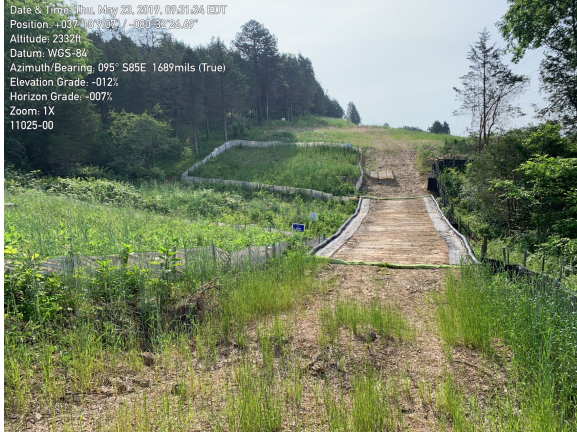
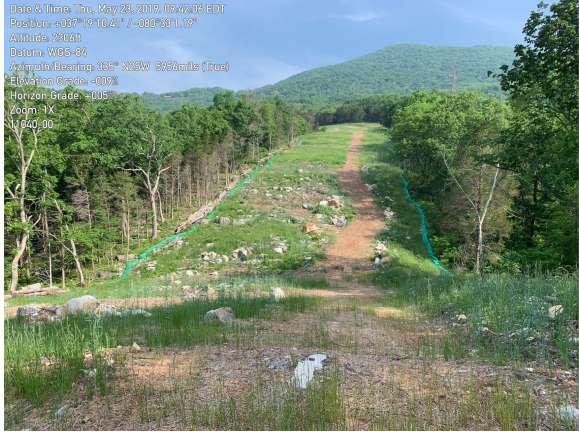
GPS Location	37.24	Field Station#	11025+00	GPS Location	37.24	Field Station#	11040+00
Description	ECD's and ROW conditions			Description	ECD's and ROW conditions		
<p>Date & Time: Thu, May 23, 2019, 10:01:20 EDT Position: +037.191342° / -080.312318° Altitude: 2196ft Datum: WGS-84 Azimuth/Bearing: 164° S16E 270mils (True) Elevation Grade: -017% Horizon Grade: +002% Zoom: 1X 11054+00</p>

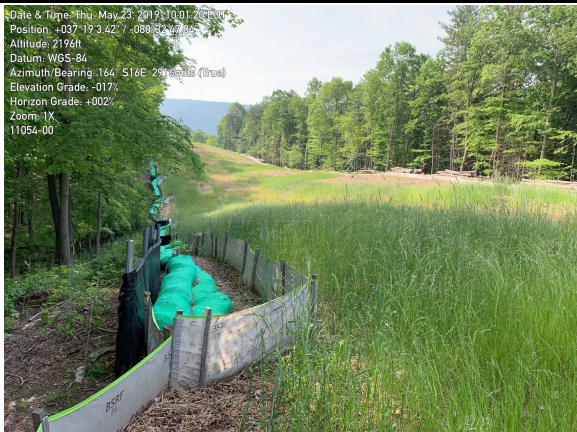
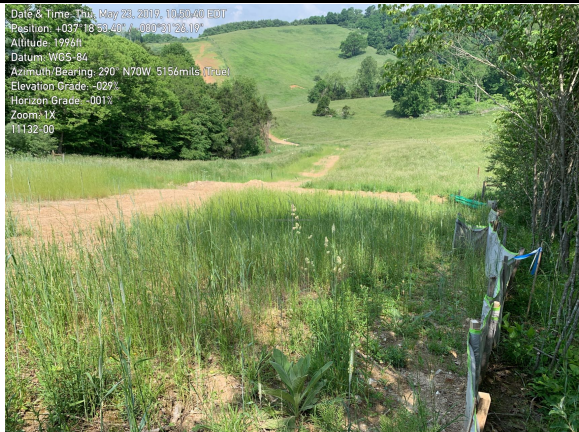
GPS Location	37.24	Field Station#	11054+00	GPS Location	37.24	Field Station#	11132+00
Description	ECD's and ROW conditions			Description	ECD's and ROW conditions		
<p>Date & Time: Thu, May 23, 2019, 10:08:08 EDT Position: +037.191342° / -080.312318° Altitude: 2113ft Datum: WGS-84 Azimuth/Bearing: 149° S49E 2448mils (True) Elevation Grade: +002% Horizon Grade: +001% Zoom: 1X 11132+00</p>

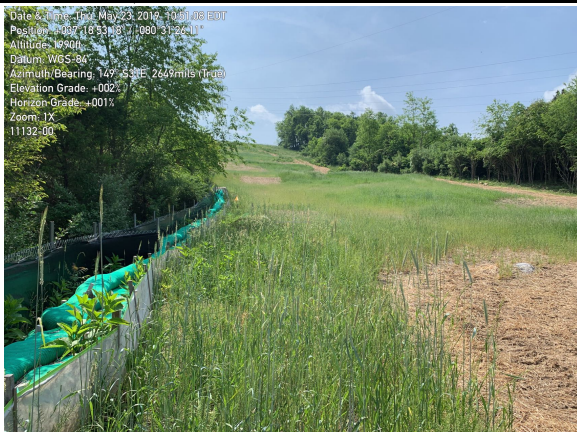
GPS Location	37.24	Field Station#	11132+00	GPS Location	37.24	Field Station#	11750+00
Description	ECD's and ROW conditions			Description	Undermined CFS discovered

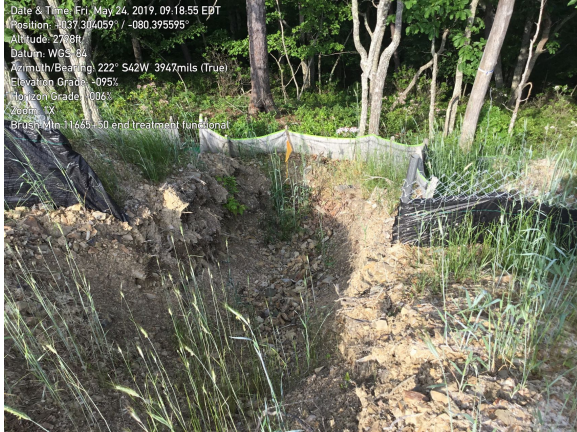
A/E	124300137	Date/Time	5/24/2019 1:02 PM	Report #	17649		
Pictures							
<p>Date & Time: Fri, May 24, 2019, 09:18:55 EDT Position: +037.304059° / -080.395595° Altitude: 2708ft Datum: WGS 84 Azimuth/Bearing: 222° S42W 3947mils (True) Elevation Grade: +095% Horizon Grade: +006% Zoom: 1X Brush Mtn 11665+50 end treatment functional</p>

GPS Location	37.31	Field Station#	11665+50	GPS Location	37.31	Field Station#	11663+50
Description	Correct coordinates on photo. End treatments were checked for maintenance needs and effectiveness.			Description	Correct coordinates on photo. End treatment functional.		
<p>Date & Time: Fri, May 24, 2019, 09:25:29 EDT Position: +037.310439° / -080.396124° Altitude: 2670ft Datum: WGS 84 Azimuth/Bearing: 296° N44W 5262mils (True) Elevation Grade: +051% Horizon Grade: +002% Zoom: 1X Brush Mtn 11662+00 ROW stable currently</p>

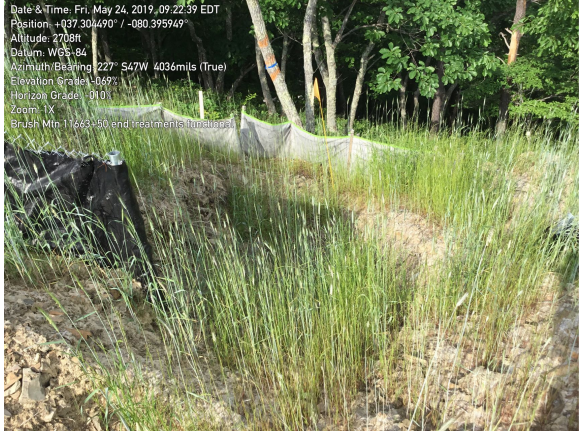
<p>Date & Time: Fri, May 24, 2019, 09:22:39 EDT Position: +037.304490° / -080.395949° Altitude: 2708ft Datum: WGS 84 Azimuth/Bearing: 227° S47W 4036mils (True) Elevation Grade: +069% Horizon Grade: +010% Zoom: 1X Brush Mtn 11663+50 end treatment functional</p>

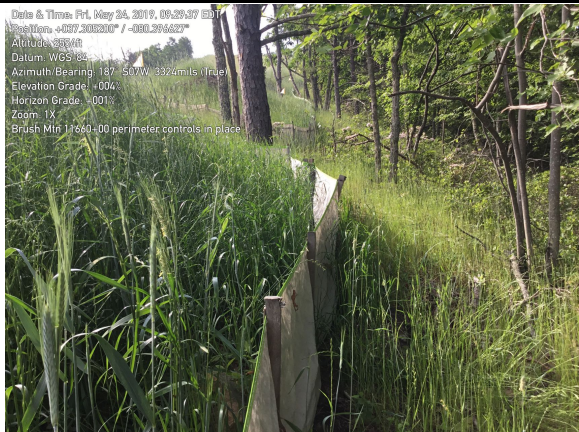
<p>Date & Time: Fri, May 24, 2019, 09:26:37 EDT Position: +037.308200° / -080.396623° Altitude: 2659ft Datum: WGS 84 Azimuth/Bearing: 187° S07W 3324mils (True) Elevation Grade: +004% Horizon Grade: +001% Zoom: 1X Brush Mtn 11660+00 perimeter controls in place</p>

GPS Location	37.31	Field Station#	11662+00	GPS Location	37.31	Field Station#	11660+00
Description	Correct coordinates on photo. Slope breakers are functional. ROW surface stable.			Description	Correct coordinates on photo. Perimeter controls in place.		
<p>Date & Time: Fri, May 24, 2019, 09:30:56 EDT Position: +037.310397° / -080.395636° Altitude: 2526ft Datum: WGS 84 Azimuth/Bearing: 164° S66E 3561mils (True) Elevation Grade: +008% Horizon Grade: +008% Zoom: 1X Brush Mtn 11658+00 perimeter controls in place. ROW stable</p>

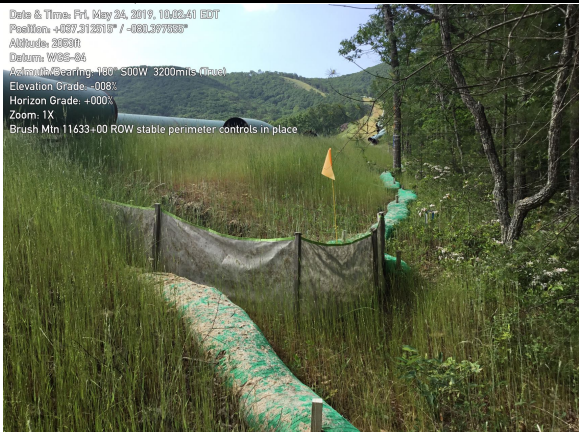
<p>Date & Time: Fri, May 24, 2019, 10:42:41 EDT Position: +037.312316° / -080.397036° Altitude: 2660ft Datum: WGS 84 Azimuth/Bearing: 169° S00W 3200mils (True) Elevation Grade: +008% Horizon Grade: +000% Zoom: 1X Brush Mtn 11633+00 ROW stable perimeter controls in place</p>

Description	Correct coordinates on photo. ROW stable. Controls are in place.			Description	Correct coordinates on photo. No sediment migration beyond LOD.

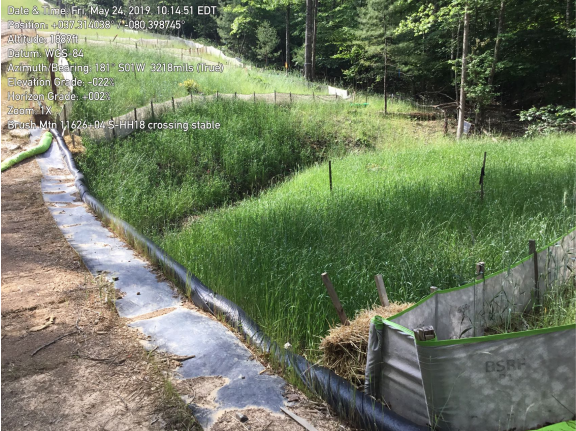
<p>Date & Time: Fri, May 24, 2019, 10:14:51 EDT Position: +037 313677 / +080 406437 Altitude: 1928ft Datum: WGS 84 Azimuth Bearing: 181° S01W 3218mils (True) Elevation Grade: +022% Horizon Grade: +002% Zoom: 1X Brush Mit: 1/624/0% S-FH18 crossing stable</p>

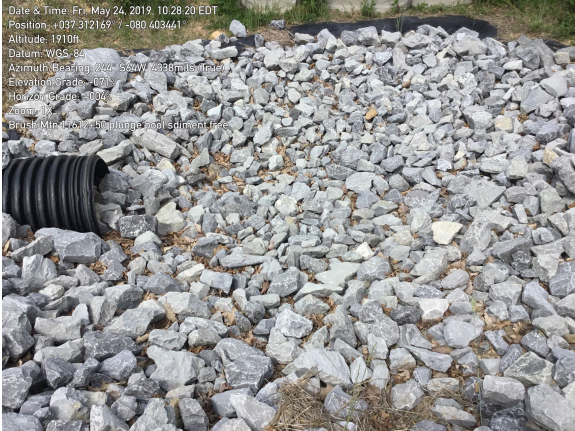
<p>Date & Time: Fri, May 24, 2019, 10:28:20 EDT Position: +037 312165 / +080 403441 Altitude: 1910ft Datum: WGS 84 Azimuth Bearing: 222° S01W 2386mils (True) Elevation Grade: +02% Horizon Grade: +002% Zoom: 1X Brush Mit: 0% S-FH18 plunge pool sediment free</p>			
GPS Location	37.31	Field Station#	11626+04	GPS Location	37.31
Field Station#	11612+50	Description	Correct coordinates on photo. Resource crossings are stable.

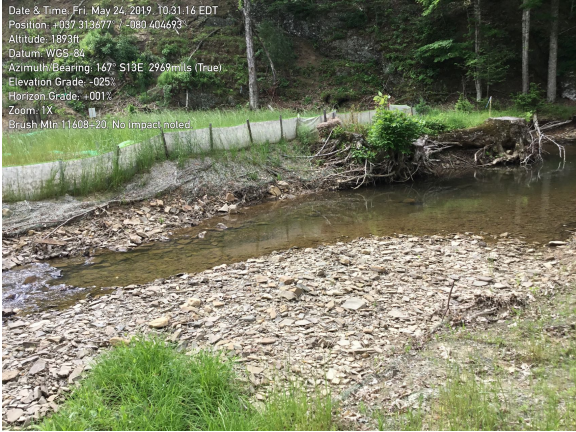
<p>Date & Time: Fri, May 24, 2019, 10:31:16 EDT Position: +037 313677 / +080 406437 Altitude: 1893ft Datum: WGS 84 Azimuth Bearing: 147° S13E 2949mils (True) Elevation Grade: +025% Horizon Grade: +001% Zoom: 1X Brush Mit: 1/1408+20 No impact noted</p>

GPS Location	37.31	Field Station#	11608+20	GPS Location	37.31
Field Station#	11600+12	Description	Correct coordinates on photo. No impact noted at the S-006 crossing.		
<p style="text-align: center;">Insert image here</p>		<p style="text-align: center;">Insert image here</p>			
GPS Location		Field Station#		GPS Location	
Description				Description

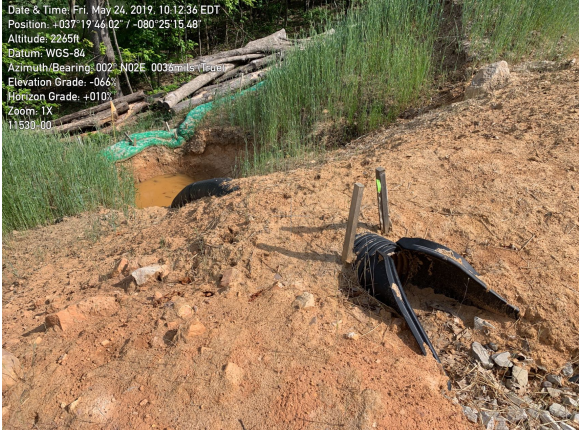
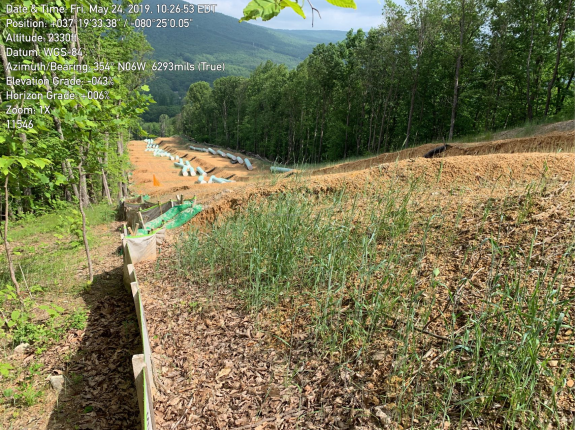
GPS Location	37.29	Field Station#	11530+00	GPS Location	37.29	Field Station#	11546+00
Description	ECD's and ROW conditions			Description	ECD's and ROW conditions

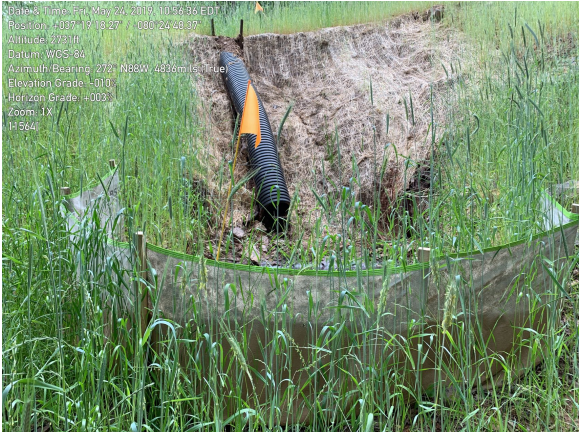
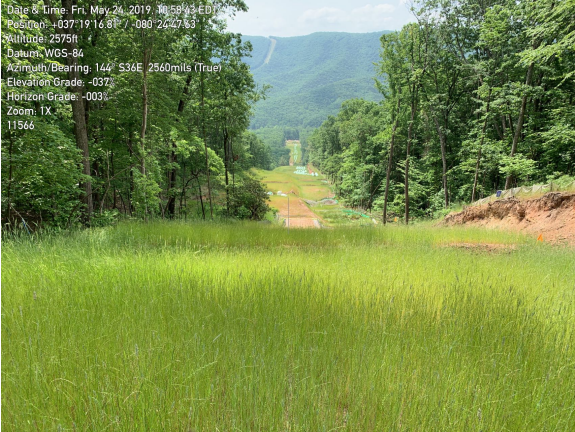
GPS Location	37.29	Field Station#	11564+00	GPS Location	37.29	Field Station#	11566+00
Description	ECD's and ROW conditions			Description	ECD's and ROW conditions

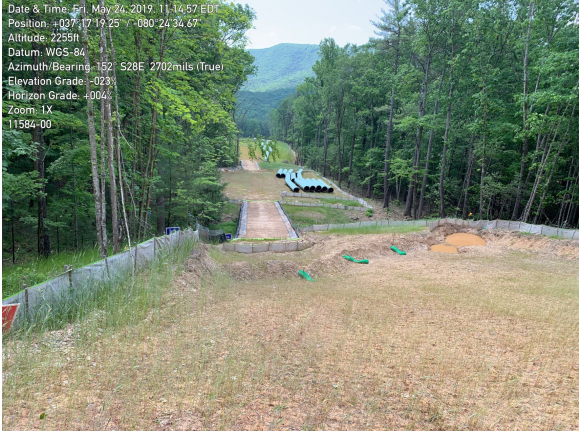
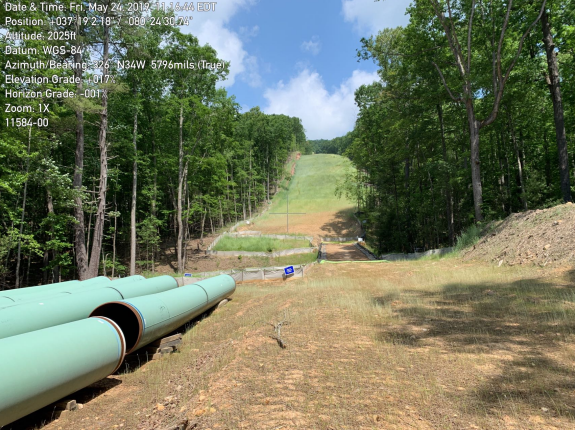
GPS Location	37.29	Field Station#	11584+00	GPS Location	37.29	Field Station#	11584+00
Description	ECD's and ROW conditions			Description	ECD's and ROW conditions

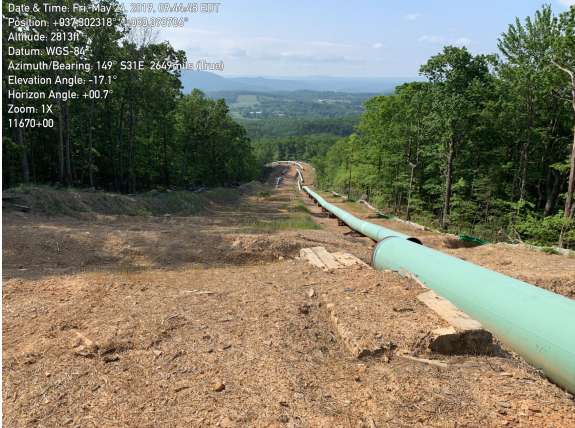
GPS Location	37.18	Field Station#	11670+00	GPS Location	37.18	Field Station#	11703+00
Description	See photo for GPS location. Waterbars and end treatment in place.			Description	See photo for GPS location. Water bar and end treatment in place.		
<p>Date & Time: Fri, May 24, 2019, 10:29:47 EDT Position: +037.297140 / -080.386898 Altitude: 243.9ft Datum: WGS-84 Azimuth/Bearing: 063° N43E 11.20mils (True) Elevation Angle: -13.2° Horizon Angle: -03.8° Zoom: 1X 11704+10 S-MN22</p>

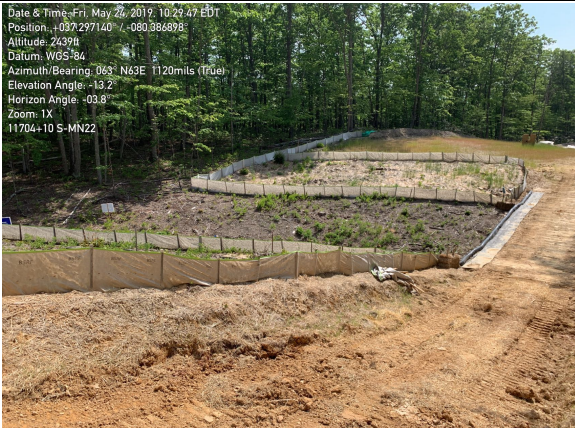
GPS Location	37.18	Field Station#	11704+10	GPS Location	37.18	Field Station#	11736+00
Description	See photo for GPS location. Sensitive resource buffer in place at stream S-MN22.			Description	See photo for GPS location. Waterbars in place. ROW stabilized with seed and mulch.		
<p>Date & Time: Fri, May 24, 2019, 11:30:35 EDT Position: +037.292985 / -080.376706 Altitude: 215.2ft Datum: WGS-84 Azimuth/Bearing: 039° N39E 06.93mils (True) Elevation Angle: -00.4° Horizon Angle: +01.3° Zoom: 1X 11753+00</p>

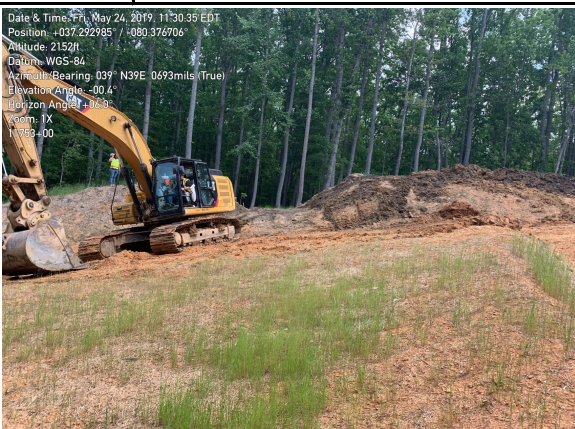
GPS Location	37.18	Field Station#	11753+00	GPS Location	37.18	Field Station#	11767+00
Description	See photo for GPS location. Environmental crew replacing LOD controls to grant landowner access.			Description	See photo for GPS location. RCE in place at main line valve 26.
