# Visual Site Inspection Report

<b>Project Name</b>	H-600 Pipeline Spread H	<b>AFE</b>	124300138	<b>Spread</b>	H-600 Pipeline Spread H	
<b>Contractor</b>	Precision			<b>Report #</b>	16855	
<b>Inspector</b>	Pat Davis			<b>Date/Time</b>	5/7/2019 6:30 PM	
<b>Permit #</b>	TBD	<b>Inspection Type</b>	VA SWPP	<b>Station Begin</b>	+0	
<b>State</b>	VA	<b>Inspection Area</b>	Partial	<b>Station End</b>	+0	
<b>County</b>	Montgomery	<b>Ground</b>	Dry	<b>Temperature (°F)</b>	75.00	
<b>Municipality</b>	N/A	<b>Weather</b>	Sunny	<b>Rain Gauge (in)</b>	0.00	
				<b>Rain Accumulation Time (days)</b>	0.00

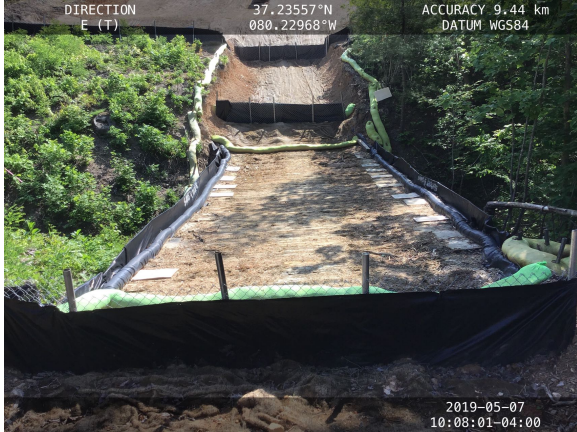
GPS Location	37.25	Field Station#	12076+95	GPS Location	37.25	Field Station#	12086+56
Description	Stream S-MM15, facing east.			Description	Stream S-MM14, facing west.

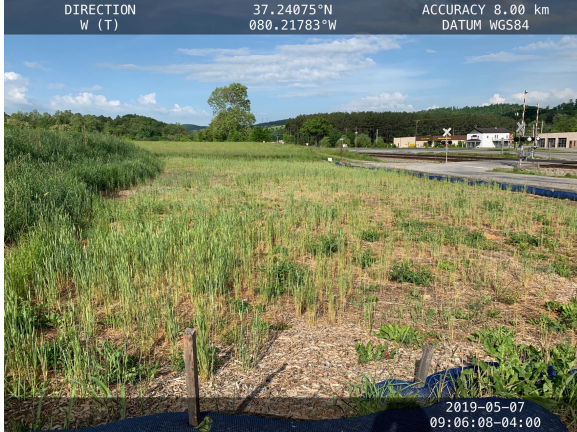
<div>2019-05-07 09:06:10-04:00</div>										
GPS Location		37.33	Field Station#		12448+50		GPS Location		37.33	Field Station#		12448+50	
Description		Stabilized row. Looking W. See picture for GPS data.				Description		Stabilized topsoil pile. Looking SW. See picture for GPS data.					
<div>DIRECTION NE (T)</div> <div>37.23063°N 080.19895°W</div> <div>ACCURACY 8 m DATUM WGS84</div>

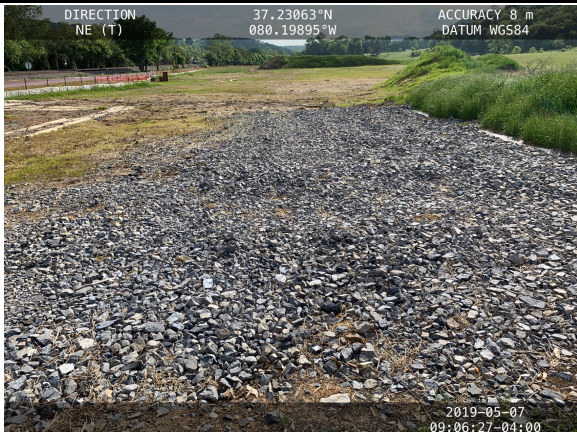
GPS Location		37.33	Field Station#		12448+12		GPS Location		37.33	Field Station#		12445+80	
Description		RCE. Looking NE. See picture for GPS data.				Description		Stabilized ROW. Looking NE. See picture for GPS data.					
<div>DIRECTION S (T)</div> <div>37.23102°N 080.19828°W</div> <div>ACCURACY 6 m DATUM WGS84</div>

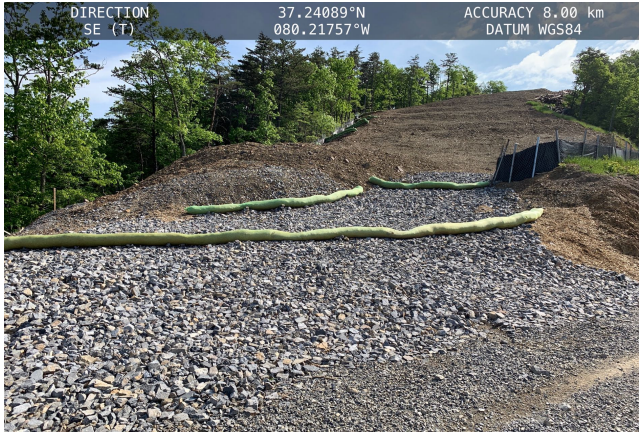
GPS Location	37.23	Field Station#	12234+77	GPS Location	37.23	Field Station#	12214+00
Description	RCE. Looking SE. See picture for GPS data.			Description	Stabilized ROW. Looking E. See picture for GPS data.

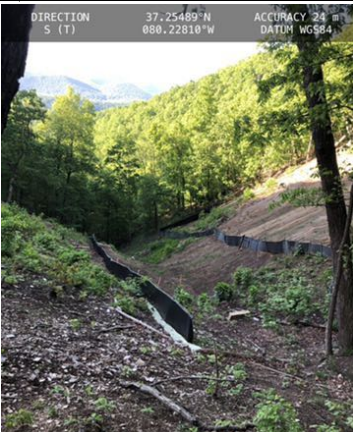
GPS Location	37.23	Field Station#	12291+64	GPS Location	37.23	Field Station#	12420+00
Description	Clear water Crossing. Looking S. See picture for GPS data.			Description	Stabilized hill side. Looking N. See picture for GPS data.
