Visual Site Inspection Report

Project Name	H-600 Pipeline Spread G	AFE	124300137	Spread	H-600 Pipeline Spread G
Contractor	Precision			Report #	16808
Inspector	Len Kruizenga			Date/Time	5/6/2019 8:43 AM
Permit #	TBD	Inspection Type	VA SWPP	Station Begin	11022+00
State	VA	Inspection Area	Full	Station End	10930+00
County	Giles	Ground	Muddy	Temperature (°F)	63.00
Municipality	N/A	Weather	Sunny	Rain Gauge (in)	0.60
				Rain Accumulation Time (days)	2.00

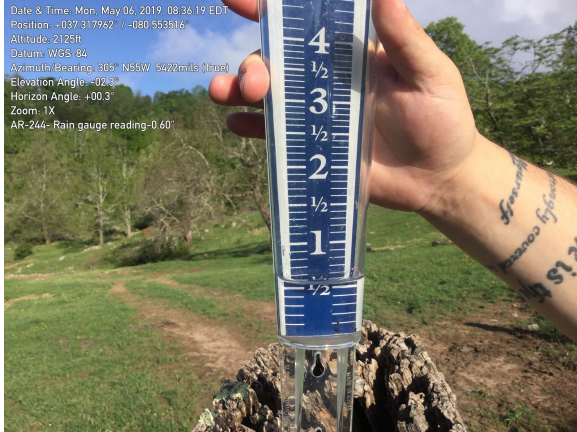
A/E	124300137	Date/Time	5/6/2019 8:43 AM	Report #	16808		
Pictures							
<p>Date & Time: Mon, May 06, 2019, 08:36:19 EDT Position: +037.317962° / -080.553516° Altitude: 2125ft Datum: WGS-84 Azimuth/Bearing: 305° N45W 342mils (True) Elevation Angle: -02.3° Horizon Angle: +00.3° Zoom: 1X AR-244- Rain gauge reading-0.60"</p>

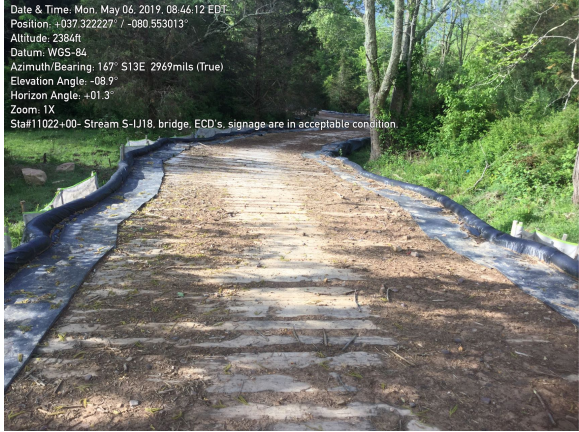
<p>Date & Time: Mon, May 06, 2019, 08:46:12 EDT Position: +037.322227° / -080.553013° Altitude: 2384ft Datum: WGS-84 Azimuth/Bearing: 167° S13E 2969mils (True) Elevation Angle: -08.9° Horizon Angle: +01.3° Zoom: 1X Sta#11022+00- Stream S-IJ18, bridge, ECD's, signage are in acceptable condition.</p>

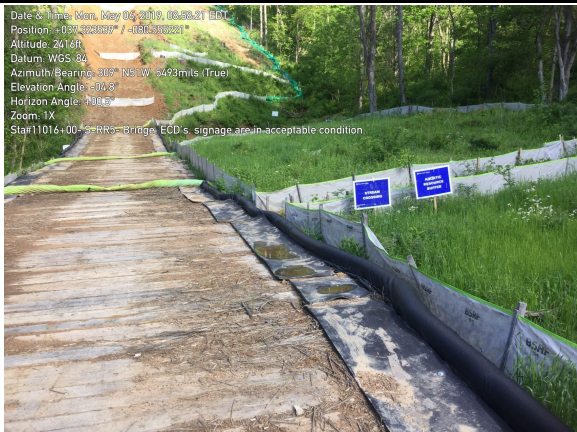
GPS Location	37.32	Field Station#	11022+00	GPS Location	37.32	Field Station#	11022+00
Description	AR-244 rain gauge reading- 0.60"			Description	Stream S-IJ18- Bridge, ECD's, Signage are in acceptable condition.		
<p>Date & Time: Mon, May 06, 2019, 09:04:21 EDT Position: +037.323708° / -080.556011° Altitude: 2416ft Datum: WGS-84 Azimuth/Bearing: 305° N61W 3493mils (True) Elevation Angle: -06.8° Horizon Angle: +00.5° Zoom: 1X Sta#11016+00- S-RR5- Bridge, ECD's, signage are in acceptable condition</p>

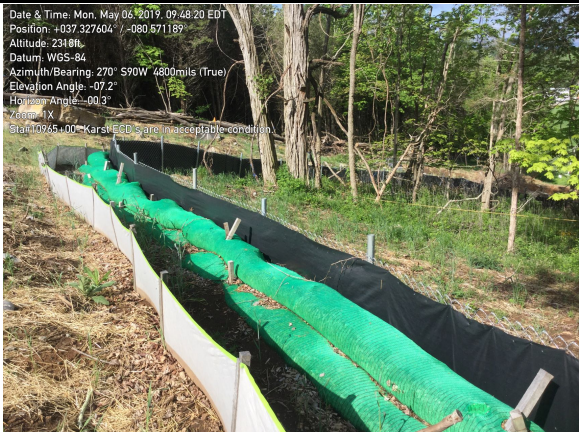
<p>Date & Time: Mon, May 06, 2019, 09:48:20 EDT Position: +037.327604° / -080.571189° Altitude: 2348ft Datum: WGS-84 Azimuth/Bearing: 270° S90W 4800mils (True) Elevation Angle: -07.2° Horizon Angle: -00.3° Zoom: 1X Sta#10965+00- Karst ECD's are in acceptable condition</p>

Description	Bridge, ECD's, Signage are in acceptable condition.			Description	Karst ECD's, are in acceptable condition.

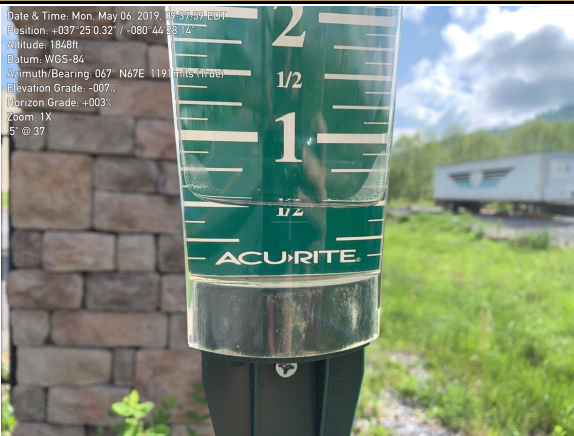
</div></div></div>				
GPS Location	37.24	Field Station#	+37	GPS Location	37.24	Field Station#	2+35
Description	.5" of rain collected @ Yard 37			Description	ECD's and ROW conditions @ AR 235		
<div><div><div>Date & Time: Mon May 06 2019 10:24:50 EDT Position: +037 22 24 55' / +080 40 24 37" Altitude: 1906ft Datum: WGS-84 Azimuth/Bearing: 349° N10W 640mils (True) Elevation Grade: +003% Horizon Grade: +001% Zoom: 1X 234'</div><div>

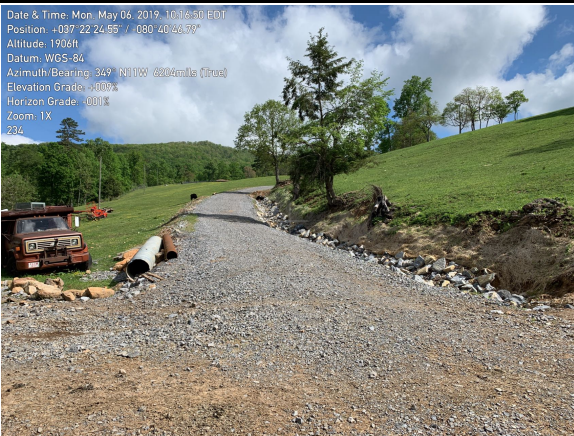
GPS Location	37.24	Field Station#	2+34	GPS Location	37.24	Field Station#	10856+00
Description	ECD's and ROW conditions @ AR 234			Description	ECD's and end treatment		
<div><div><div>Date & Time: Mon May 06 2019 10:38:40 EDT Position: +037 20 14 76' / +080 36 19 30" Altitude: 2241ft Datum: WGS-84 Azimuth/Bearing: 298° N64W 526mils (True) Elevation Grade: +026% Horizon Grade: +000% Zoom: 1X 10'</div><div>

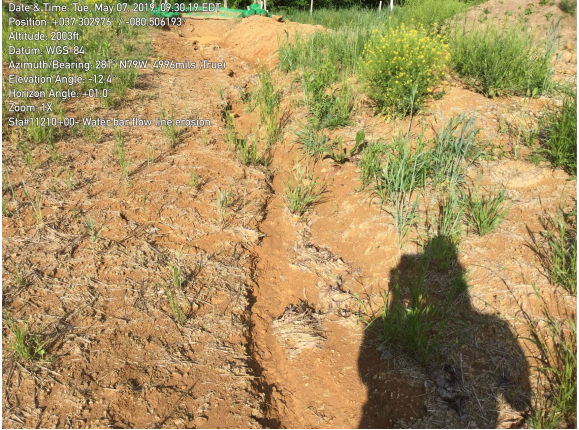
<p> Date & Time: Tue, May 07, 2019, 09:30:19 EDT Position: +037 302975° / -080 506193° Altitude: 2080ft Datum: WGS-84 Azimuth/Bearing: 88° N79W 499mils (True) Elevation Angle: -12.4° Horizon Angle: +01.0° Zoom: 1X Sta#11210+00 - Water bar flow line erosion. </p>

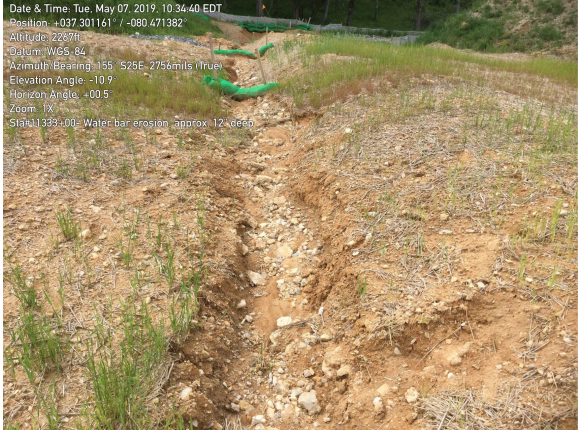
<p> Date & Time: Tue, May 07, 2019, 10:36:40 EDT Position: +037 301161° / -080 471382° Altitude: 2267ft Datum: WGS-84 Azimuth/Bearing: 155° S25E 2756mils (True) Elevation Angle: -10.9° Horizon Angle: +00.5° Zoom: 1X Sta#11333+00 - Water bar erosion, approx 12' deep. </p>

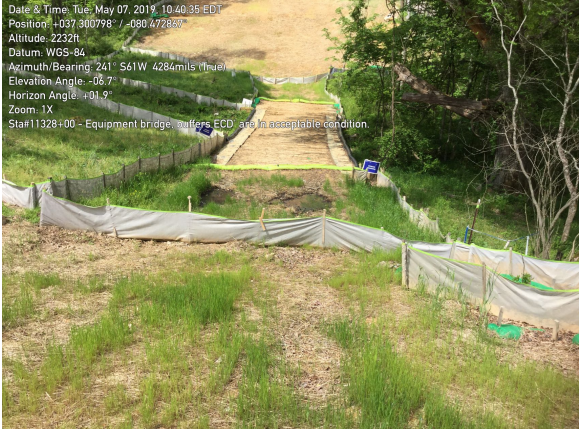
GPS Location		Field Station#	11184+00	GPS Location	Field Station# 11333+00
Description			Description		
<p> Date & Time: Tue, May 07, 2019, 10:40:35 EDT Position: +037 300798° / -080 477880° Altitude: 2232ft Datum: WGS-84 Azimuth/Bearing: 241° S61W 4284mils (True) Elevation Angle: -06.7° Horizon Angle: +01.9° Zoom: 1X Sta#11328+00 - Equipment bridge, buffers ECD, and in acceptable condition. </p>

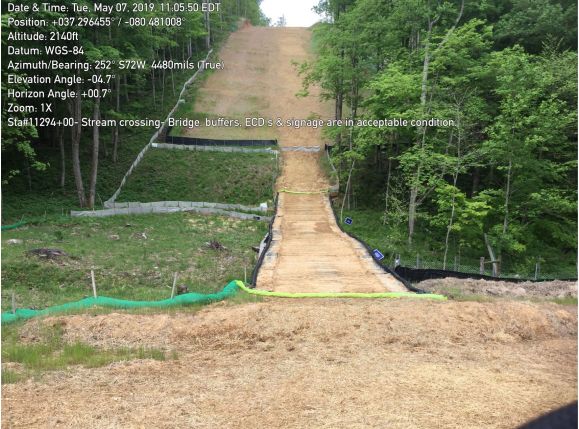
<p> Date & Time: Tue, May 07, 2019, 11:05:50 EDT Position: +037 296455° / -080 481008° Altitude: 2140ft Datum: WGS-84 Azimuth/Bearing: 252° S72W 4480mils (True) Elevation Angle: -04.7° Horizon Angle: +00.7° Zoom: 1X Sta#11294+00 - Stream crossing, Bridge, buffers, ECD's & signage are in acceptable condition. </p>

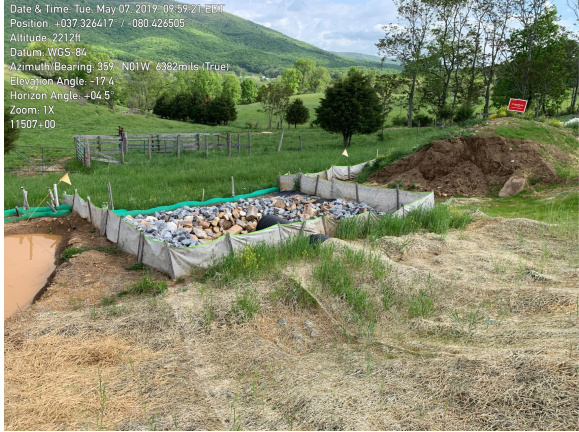
GPS Location	37.20	Field Station#	11519+00	GPS Location	37.20	Field Station#	11507+00
Description	See photo for GPS location. Sensitive resource buffer in place at stream S-PP4.			Description	See photo for GPS location. Plunge pool in place.		
<p>Date & Time: Tue, May 07, 2019, 10:00:40 EDT Position: +037.326285° / -080.426704° Altitude: 2213ft Datum: WGS-84 Azimuth/Bearing: 186° S06W 3307mils (True) Elevation Angle: -06.5° Horizon Angle: +04.1° Zoom: 1X 11504+00</p>

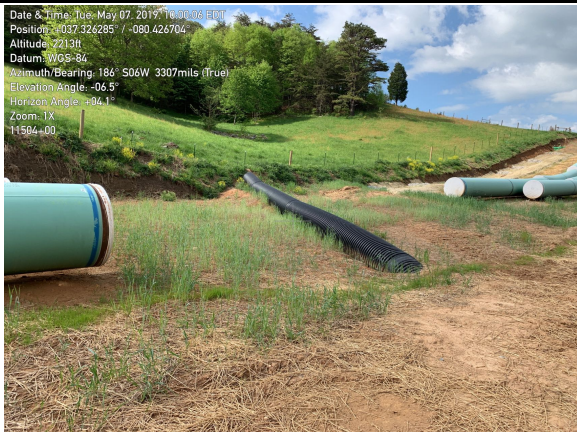
GPS Location	37.20	Field Station#	11504+00	GPS Location	37.20	Field Station#	11502+00
Description	See photo for GPS location. Clean water diversion pipe and clean water diversion berm in place.			Description	See photo for GPS location. Conveyance channel with rock checks in place.		
<p>Date & Time: Tue, May 07, 2019, 10:52:48 EDT Position: +037.310414° / -080.458188° Altitude: 2138ft Datum: WGS-84 Azimuth/Bearing: 249° S88W 4764mils (True) Elevation Angle: -23.5° Horizon Angle: +01.1° Zoom: 1X 11388+00</p>

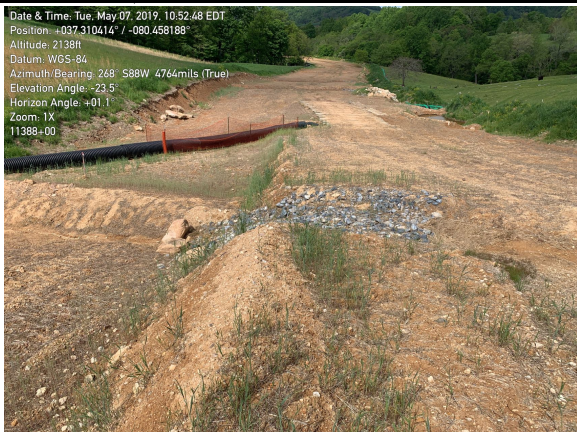
GPS Location	37.20	Field Station#	11388+00	GPS Location	37.20	Field Station#	11381+00
Description	See photo for GPS location. Rock lined channel over two tone in place.			Description	See photo for GPS location. Triple barrier ECDs in place at off ROW karst feature.

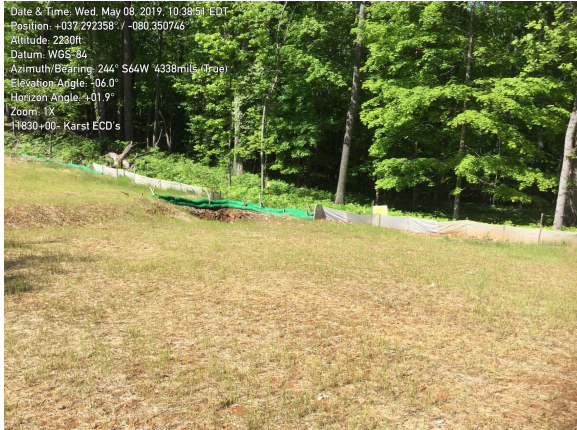
GPS Location	37.13	Field Station#	11830+00	GPS Location	37.13	Field Station#	11903+00
Description	Karst ECD's			Description	Row, water bar level spreaders

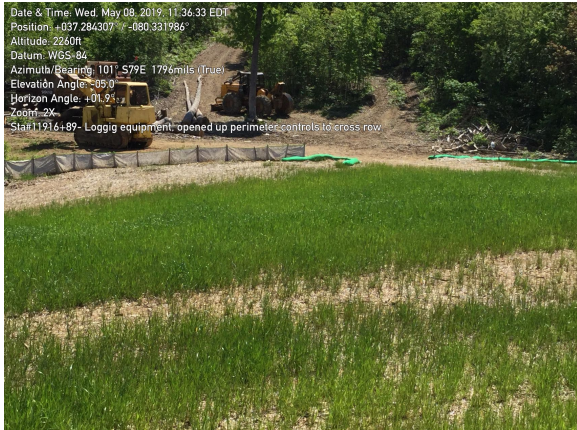
GPS Location	37.13	Field Station#	11916+00	GPS Location	37.13	Field Station#	11942+00
Description	Logging company has opened up perimeter controls and is crossing the row here.			Description	Karst ECD's

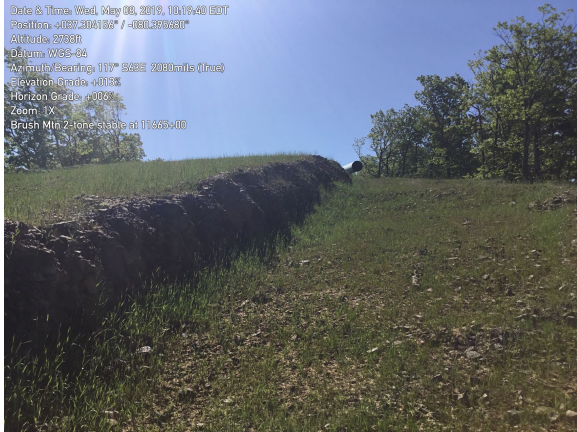
<p>Date & Time: Wed, May 08, 2019, 10:20:30 EDT Position: +037.204002° / +080.397189° Altitude: 2700ft Datum: WGS-84 Azimuth/Bearing: 010° N10E 0178mils (True) Elevation Grade: +031% Horizon Grade: +006% Zoom: 1X Brush Mtn slope breakers functional at 11665+00</p>

GPS Location	37.31	Field Station#	11665+00	GPS Location	37.31	Field Station#	11665+00
Description	Correct coordinates on photo. 2-tones stable. Vegetative coverage improved.			Description	Correct coordinates on photo. Slope breakers in place and functional.		
<p>Date & Time: Wed, May 08, 2019, 10:27:42 EDT Position: +037.305101° / +080.396348° Altitude: 2601ft Datum: WGS-84 Azimuth/Bearing: 299° N61W 5316mils (True) Elevation Grade: +071% Horizon Grade: +000% Zoom: 2X Brush Mtn end treatments functional at 11661+00</p>

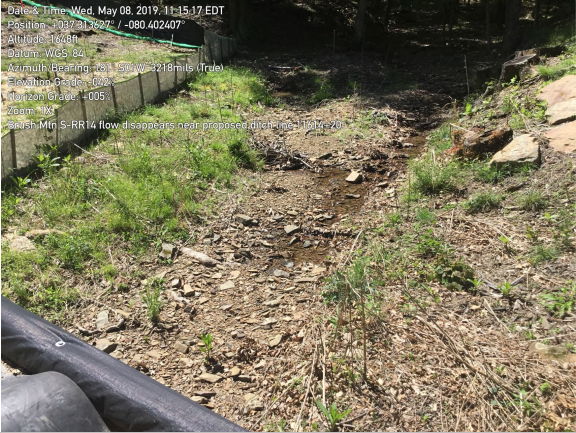
<p><small>Date & Time: Wed May 08 2019 11:15:17 EDT Position: +037 313627 / -080 402407 Altitude: 1887ft Datum: WGS 84 Azimuth Bearing: 233.50W 2218mils (True) Elevation Grade: +023% Horizon Grade: +005% Zoom: 1X Brush Mtn S-RR14 flow disappears near proposed ditch line 11614+20</small></p>

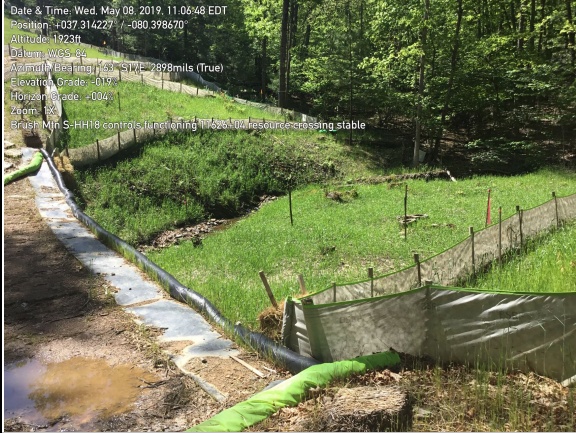
<p><small>Date & Time: Wed May 08 2019 11:06:48 EDT Position: +037 314227 / -080 398670 Altitude: 1823ft Datum: WGS 84 Azimuth Bearing: 233.51W 2898mils (True) Elevation Grade: +019% Horizon Grade: +004% Zoom: 1X Brush Mtn S-HH18 controls functioning 11626+04 resource crossing stable</small></p>		
GPS Location 37.31		Field Station# 11614+20		GPS Location 37.31	
Description		Correct coordinates on photo. Flow in stream S-RR14 disappears near the proposed centerline.		Description	
				Correct coordinates on photo. Resource S-HH18 crossing is stable.

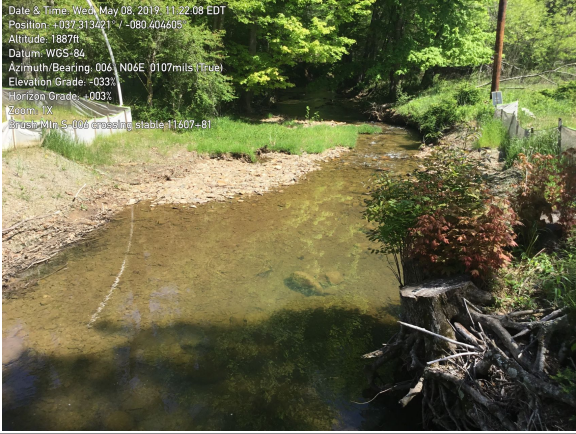
<p><small>Date & Time: Wed May 08 2019 11:22:08 EDT Position: +037 313421 / -080 402605 Altitude: 1887ft Datum: WGS 84 Azimuth Bearing: 006 N06E 0107mils (True) Elevation Grade: +033% Horizon Grade: +003% Zoom: 1X Brush Mtn S-006 crossing stable 11607+81</small></p>

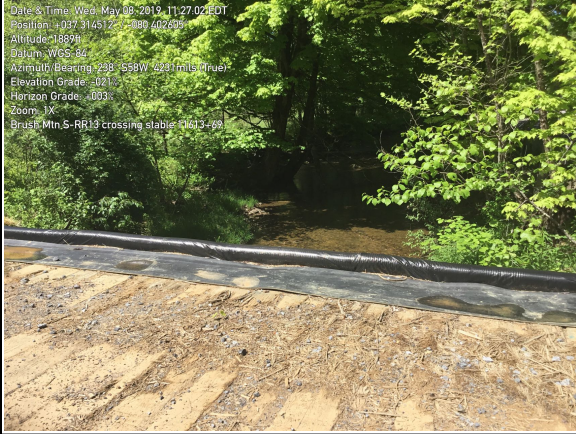
<p><small>Date & Time: Wed May 08 2019 11:27:02 EDT Position: +037 314512 / -080 402605 Altitude: 1889ft Datum: WGS 84 Azimuth Bearing: 233.558W 4231mils (True) Elevation Grade: +021% Horizon Grade: +003% Zoom: 1X Brush Mtn S-RR13 crossing stable 11613+69</small></p>		
GPS Location 37.31		Field Station# 11607+81		GPS Location 37.31	
Description		Correct coordinates on photo. S-006 crossing is stable.		Description	
				Correct coordinates on photo. S-RR13 crossing is stable.	
Insert image here			Insert image here		
GPS Location		Field Station#		GPS Location	
Description				Description

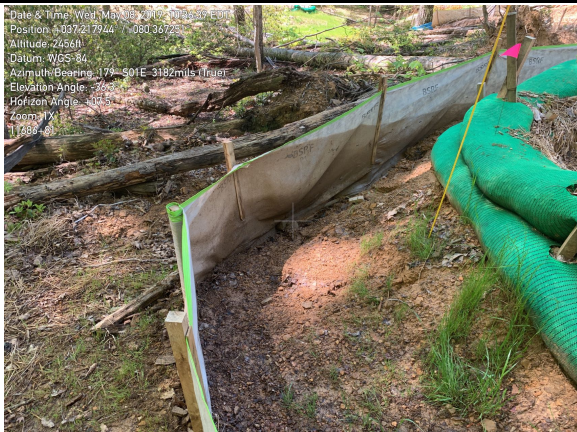
GPS Location	37.20	Field Station#	11686+81	GPS Location	37.20	Field Station#	11704+00
Description	See photo for GPS location. Undermined end treatment resulting in sediment off ROW.			Description	See photo for GPS location. Undermined end treatment resulting in sediment off ROW.		
<p>Date & Time: Wed, May 08, 2019, 13:12:35 EDT Position: +037.295703 / +080.368394 Altitude: 2028ft Datum: WGS-84 Azimuth/Bearing: +053°-0942mils Elevation Angle: +39.5° Horizon Angle: -81.0° Zoom: 1X 11765+00</p>

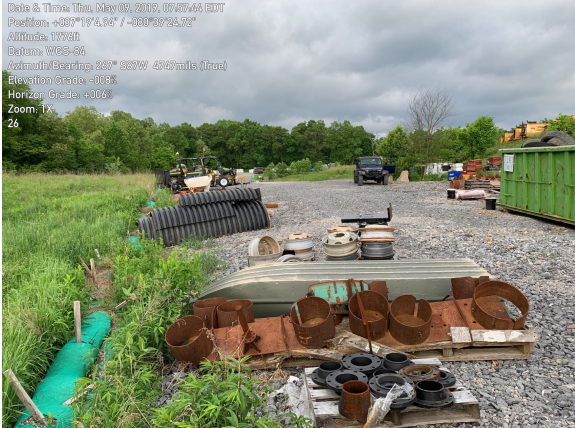
GPS Location	37.29	Field Station#	+26	GPS Location	37.29	Field Station#	+26
Description	ECD's and ROW conditions .			Description	ECD's and ROW conditions		
<p>Date & Time: Thu, May 09, 2019, 08:05:58 EDT Position: +00°17'42.12" / -080°39'27.94" Altitude: 1727ft Datum: WGS-84 Azimuth/Bearing: 160° 52'0E 2844mils (True) Elevation Grade: -015% Horizon Grade: -001% Zoom: 1X 26</p>  		<p>Date & Time: Thu, May 09, 2019, 12:47:04 EDT Position: +037°17'49.44" / -80°23'12.78" Altitude: 2437ft Datum: WGS-84 Azimuth/Bearing: 150° 53'0E 2667mils (True) Elevation Grade: -020% Horizon Grade: -006% Zoom: 1X 11723+00</p>

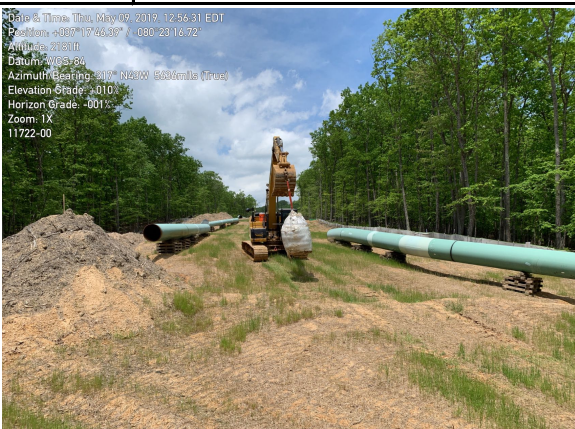
GPS Location	37.29	Field Station#	11722+00	GPS Location	37.29	Field Station#	11720+00
Description	Crew bringing in additional CFS			Description	Crews emptying out sump

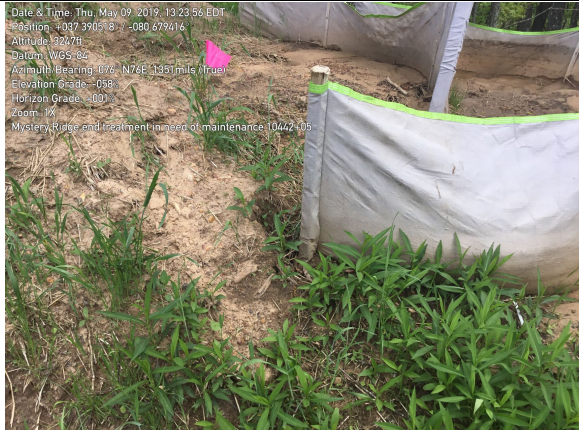
<p>Date & Time: Thu, May 09, 2019, 13:23:56 EDT Position: +037 390518 / -080 679414 Altitude: 3227ft Datum: WGS 84 Azimuth/Bearing: 076 / N76E 135mils (True) Elevation Grade: -058 Horizon Grade: -001 Zoom: 1X Mystery Ridge end treatment in need of maintenance 10442+05</p>

GPS Location	37.31	Field Station#	10440+05	GPS Location	37.31	Field Station#	10442+05
Description	Correct coordinates on photo. Waiting on approval to complete maintenance from USFS.			Description	Correct coordinates on photo. Waiting for approval from Forest Service to conduct maintenance.

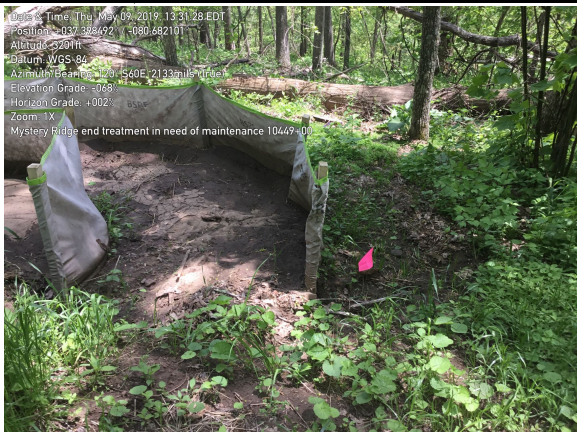
<p>Date & Time: Thu, May 09, 2019, 13:31:28 EDT Position: +037 398492 / -080 682101 Altitude: 3270ft Datum: WGS 84 Azimuth/Bearing: 041 / S40E 213mils (True) Elevation Grade: -068 Horizon Grade: +002 Zoom: 1X Mystery Ridge end treatment in need of maintenance 10449+00</p>			  <p>Date & Time: Thu, May 09, 2019, 14:03:32 EDT Position: +037 392877 / -080 676244 Altitude: 2670ft Datum: WGS 84 Azimuth/Bearing: 011 / N11E 019mils (True) Elevation Grade: -025 Horizon Grade: +004 Zoom: 1X Pocahontas Road 264+50 S-PP14 crossing. No change at failed culvert.</p>				
GPS Location	37.31	Field Station#	10449+00	GPS Location	37.31	Field Station#	264+50

Description	Correct coordinates on photo. Maintenance needed on end treatment on Mystery Ridge Road. Waiting for USFS approval.			Description	Correct coordinates on photo. Failed culvert on Pocahontas Road. Conditions are unchanged since last inspection

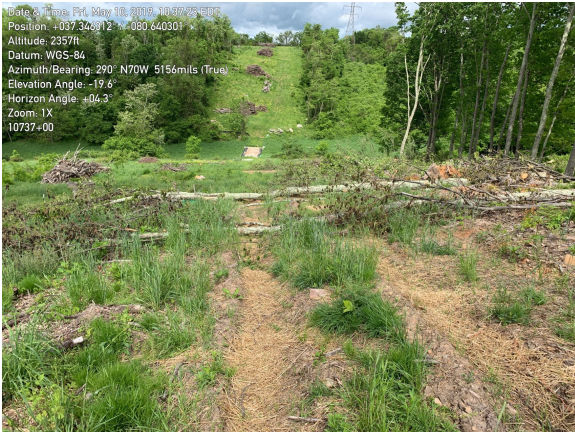
GPS Location	37.20	Field Station#	10737+00	GPS Location	37.20	Field Station#	10732+62
Description	See photo for GPS location. Power line crew has cut trees and trees fell onto ROW.			Description	See photo for GPS location. Sensitive resource buffer in place at wetland W-Z11.

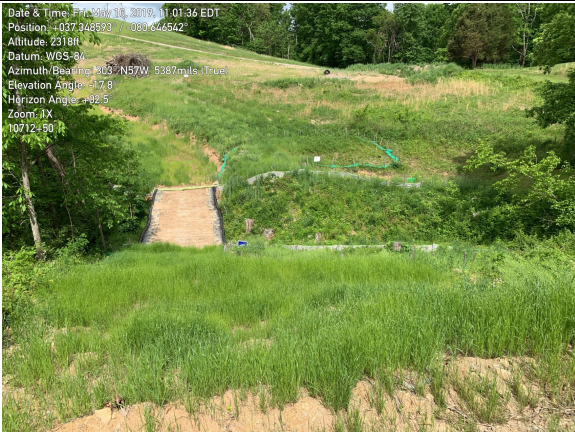
GPS Location	37.20	Field Station#	10712+50	GPS Location	37.20	Field Station#	10968+00
Description	See photo for GPS location. Sensitive resource buffer in place at stream S-G33.			Description	See photo for GPS location. RCE in place at Buffalo Anklets Road.

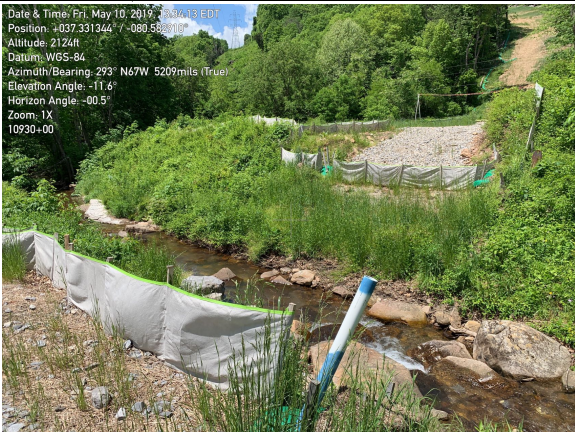
GPS Location	37.20	Field Station#	10930+00	GPS Location	37.20	Field Station#	10883+50
Description	See photo for GPS location. Timber mat bridge removed and ECDs in at stream S-Y2.			Description	See photo for GPS location. RCE in place at Kow Camp Road.

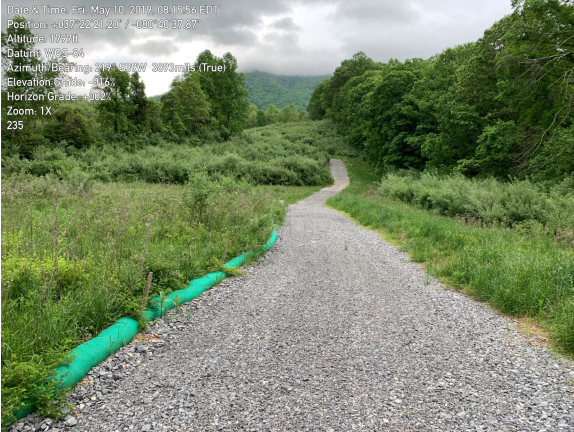
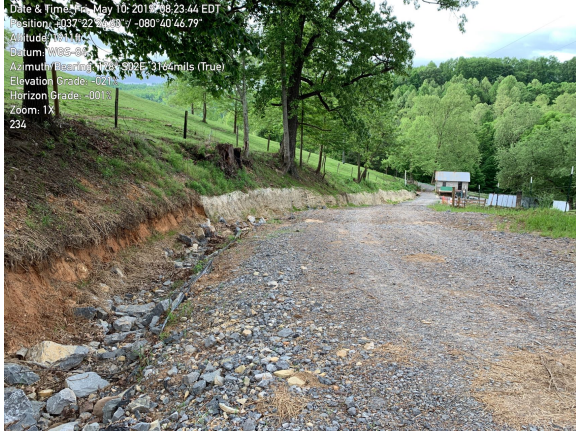
GPS Location		37.24	Field Station#		2+35
Description		ECD's and ROW conditions

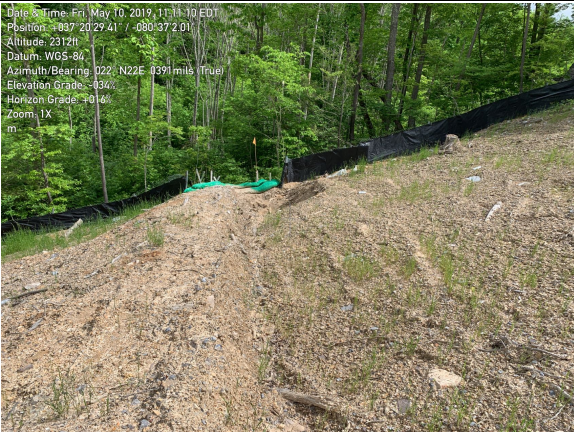
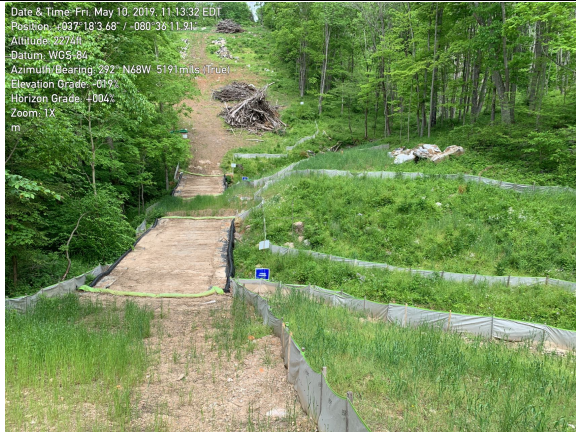
GPS Location		37.24	Field Station#		10843+00
Description		ECD's and ROW conditions

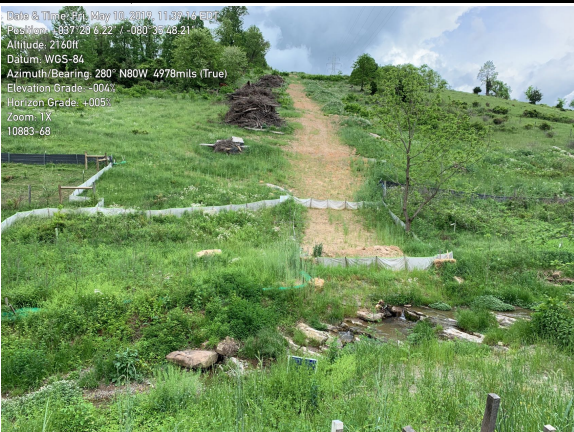
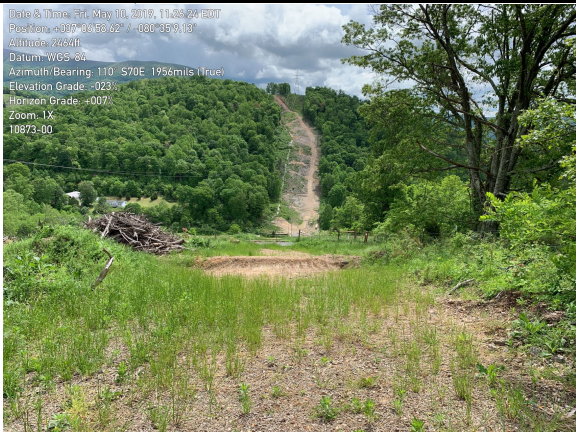
GPS Location		37.24	Field Station#		10883+68
Description		ECD's and ROW conditions
