Visual Site Inspection Report

Project Name	H-600 Pipeline Spread G	AFE	124300137	Spread	H-600 Pipeline Spread G
Contractor	Precision			Report #	11078
Inspector	Clinton Banks			Date/Time	11/19/2018 4:18 AM
Permit #	TBD	Inspection Type	VA SWPP	Station Begin	+28
State	VA	Inspection Area	Full	Station End	+28
County	Giles	Ground	Damp	Temperature (°F)	58.00
Municipality	N/A	Weather	Sunny	Rain Gauge (in)	0.00
GPS Location	37.3338975292047, -80.803012987674			Rain Accumulation Time (days)	0.00

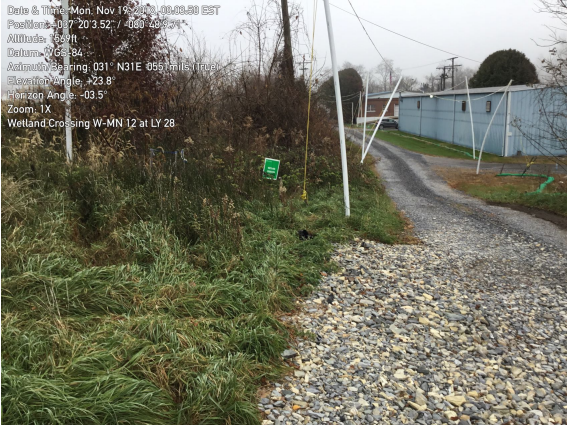
<p>Date & Time: Mon, Nov 19, 2018 08:00:00 EST Position: -037.20352° / -080.48301° Altitude: 1527ft Datum: WGS-84 Azimuth/Heading: 031° N31E 089mils (True) Bearing Angle: +23.8° Horizon Angle: -03.5° Zoom: 1X Wetland Crossing W-MN 12 at LY 28</p>			
GPS Location	37.3338029813369, -80.8030935377635	GPS Location	37.3343617190023, -80.8025843371458		
Description	Tree Limb was removed off of Compost Filter Sock at LY 28	Description	Wetland Crossing W-MN 12 at LY 28		
Insert image here		Insert image here			
GPS Location		GPS Location			
Description		Description

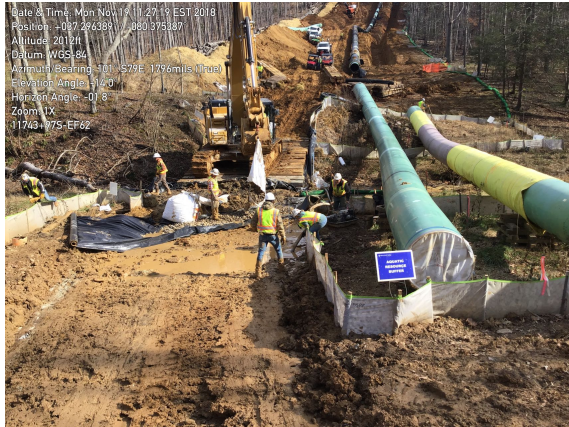
A/E	124300137	Date/Time	11/19/2018 5:33 PM	Report #	11121
Pictures					
<p>Date & Time: Mon Nov 19 11:27:19 EST 2018 Position: +037.264389 / -80.375387 Altitude: 2012ft Datum: WGS-84 Azimuth/Bearing: 251° S21W 4422mils (True) Elevation Angle: -13.5° Horizon Angle: -01.8° Zoom: 1X 11743+005-EP62</p>

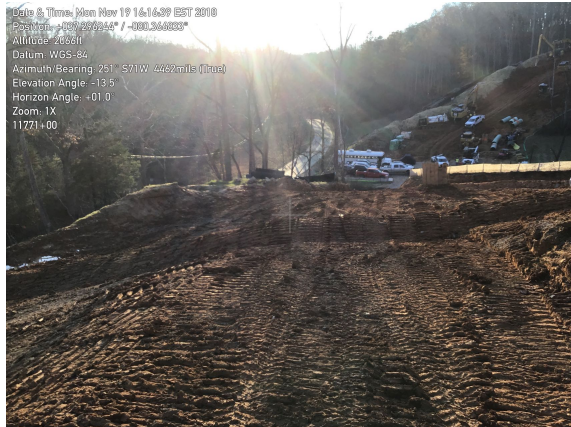
<p>Date & Time: Mon Nov 19 16:16:39 EST 2018 Position: +037.2060336357664 / -80.3943250934094 Altitude: 2658ft Datum: WGS-84 Azimuth/Bearing: 251° S21W 4422mils (True) Elevation Angle: -13.5° Horizon Angle: -01.0° Zoom: 1X 11721+00</p>

GPS Location	37.2062061428839, -80.39441230307	GPS Location	37.2060336357664, -80.3943250934094		
Description	See photo for GPS location and station number. Environmental crew extending air bridge over spring in the travel lane.	Description	See photo for GPS location and station number. Water bar in place		
<p>Date & Time: Mon Nov 19 16:17:28 EST 2018 Position: +037.2060891420991 / -80.3944186955847 Altitude: 1988ft Datum: WGS-84 Azimuth/Bearing: 123° S57E 2187mils (True) Elevation Angle: -07.5° Horizon Angle: -01.2° Zoom: 1X 11767+00</p>  		<p>Date & Time: Mon Nov 19 16:17:28 EST 2018 Position: +037.2060891420991 / -80.3944186955847 Altitude: 1988ft Datum: WGS-84 Azimuth/Bearing: 123° S57E 2187mils (True) Elevation Angle: -07.5° Horizon Angle: -01.2° Zoom: 1X 11767+00</p>

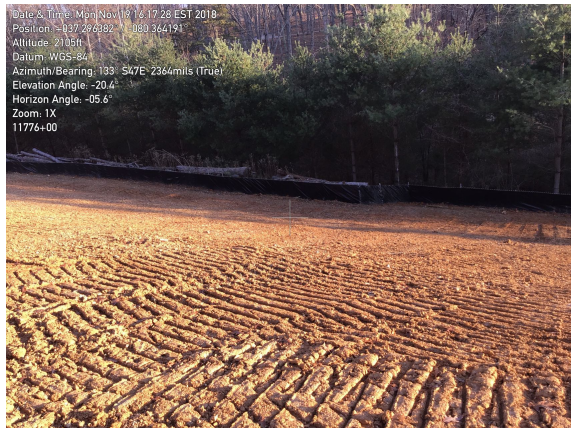
GPS Location	37.2060891420991, -80.3944186955847	GPS Location	37.2059740126479, -80.393908638582		
Description	See photo for GPS location and station number. Sump pit with end treatment in place.	Description	See photo for GPS location and station number. Cut has been restored with sub grade. Reinforced silt fence in place.		
<p>Date & Time: Mon Nov 19 16:17:49 EST 2018 Position: +037.2060225857768 / -80.3938909527663 Altitude: 2120ft Datum: WGS-84 Azimuth/Bearing: 072° N75E 1333mils (True) Elevation Angle: -03.1° Horizon Angle: -00.2° Zoom: 1X 11778+00</p>

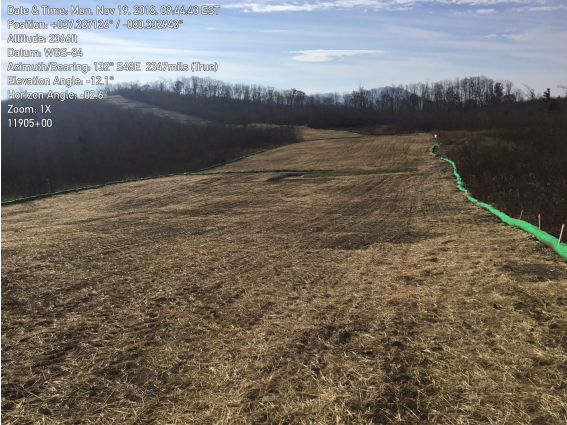
GPS Location	37.3337835147713, -80.7502426501073	GPS Location	37.3337790520829, -80.750244963642		
Description	RFO needs refreshed 11988+50	Description	Row stabilized 11905+00

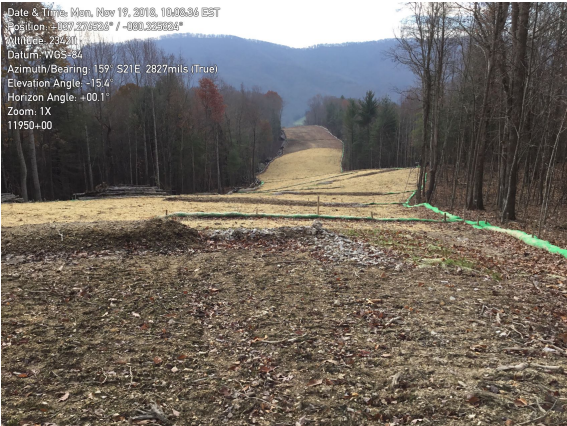
GPS Location	37.3337771622953, -80.7502459433406	GPS Location	37.3337477564376, -80.7502611878453		
Description	Row stabilized 11950+00	Description	Level spreader 11920+00

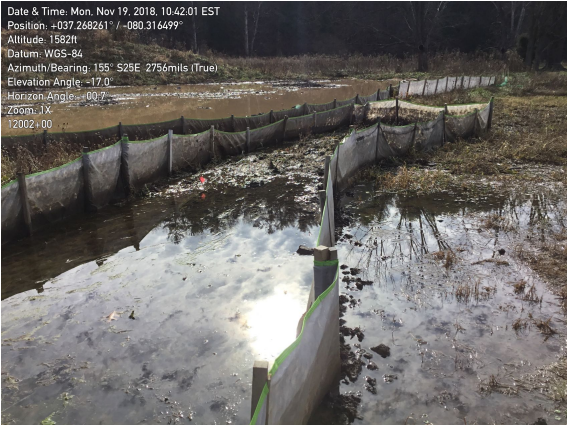
GPS Location	37.3337484324408, -80.7502608373936	GPS Location	37.3337773360963, -80.7502458532392		
Description	Wetland 12002+00	Description	Tree overtopped P1 silt fence 11965+50

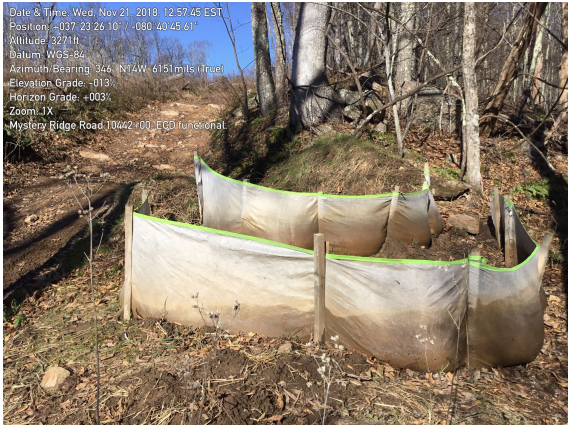
<p>Date & Time: Wed Nov 21, 2018 12:57:45 EST Position: +037 23 26 10 / -080 40 45 61" Altitude: 327ft Datum: WGS-84 Azimuth/Bearing: 345 N14W 6151mils (True) Elevation Grade: +013 Horizon Grade: +003 Zoom: 1X Mystery Ridge Road 10442+00. ECD functional.</p>

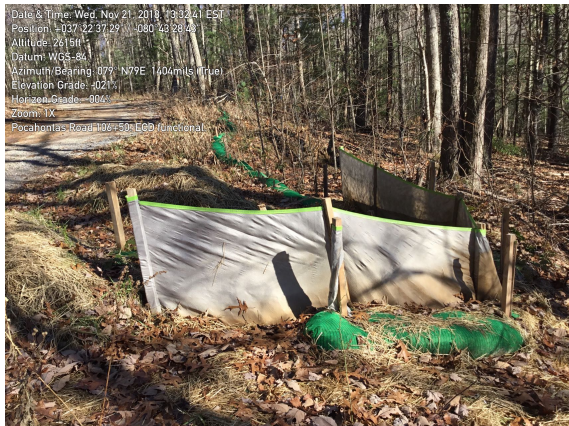
GPS Location	37.1542296745229, -80.3359356243912	GPS Location	37.1542296745229, -80.3359356243912		
Description	Correct coordinates on photo. Mystery Ridge Road IS CDs in place and functional.	Description	Correct coordinates on photo. Mystery Ridge Road ECDs in place and functional.		
<p>Date & Time: Wed Nov 21, 2018 13:31:01 EST Position: +037 22 29 48 / -080 43 37 95" Altitude: 254ft Datum: WGS-84 Azimuth/Bearing: 079 N79E 1404mils (True) Elevation Grade: +021 Horizon Grade: -004 Zoom: 1X Pocahontas Road 106750. ECD functional.</p>

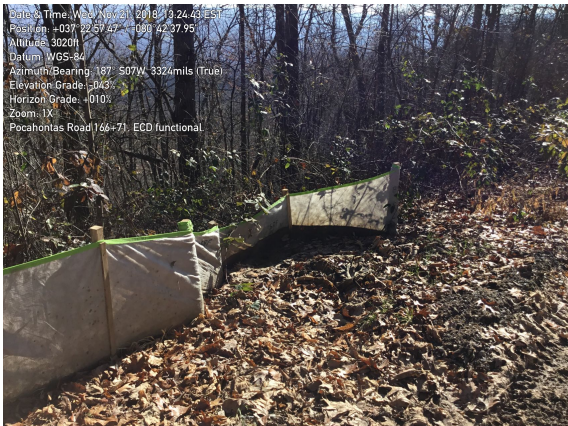
<p>Date & Time: Wed Nov 21, 2018 13:24:33 EST Position: +037 22 29 48 / -080 43 37 95" Altitude: 302ft Datum: WGS-84 Azimuth/Bearing: 187 S07W 3324mils (True) Elevation Grade: -043 Horizon Grade: +010 Zoom: 1X Pocahontas Road 166+71. ECD functional.</p>

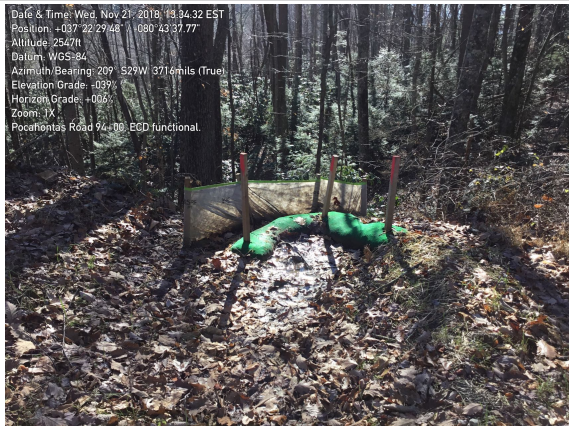
GPS Location	37.1544294152755, -80.3360412363711	GPS Location	37.1544294152755, -80.3360412363711		
Description	Correct coordinates on photo. ECDs on Pocahontas Road ECDs in place with no immediate concerns.	Description	Correct coordinates on photo. Pocahontas Road ECDs in place with no immediate concerns.		
<p>Date & Time: Wed Nov 21, 2018 13:34:32 EST Position: +037 22 29 48 / -080 43 37 77" Altitude: 254ft Datum: WGS-84 Azimuth/Bearing: 209 S20W 3716mils (True) Elevation Grade: +039 Horizon Grade: +005 Zoom: 1X Pocahontas Road 94+00. ECD functional.</p>

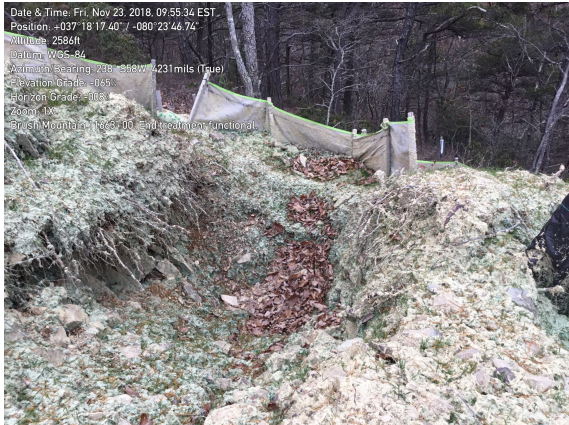
<p>Date & Time: Fri, Nov 23, 2018, 09:55:34 EST Position: +037° 18' 17.40" N -080° 23' 46.74" W Altitude: 2586ft Datum: WGS-84 Azimuth Bearing: 247° 58' 56" W 4231mils (True) Elevation Grade: +005% Horizon Grade: +005% Zoom: 1X Brush Mountain 11650+00 end treatment functional.</p>

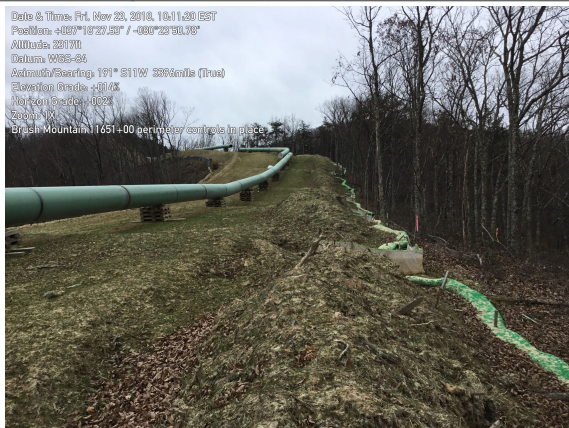
<p>Date & Time: Fri, Nov 23, 2018, 10:11:30 EST Position: +037° 18' 23.55" N -080° 23' 46.39" W Altitude: 2517ft Datum: WGS-84 Azimuth Bearing: 191° 51' 11" W 3264mils (True) Elevation Grade: +014% Horizon Grade: +002% Zoom: 1X Brush Mountain 11651+00 perimeter controls in place.</p>

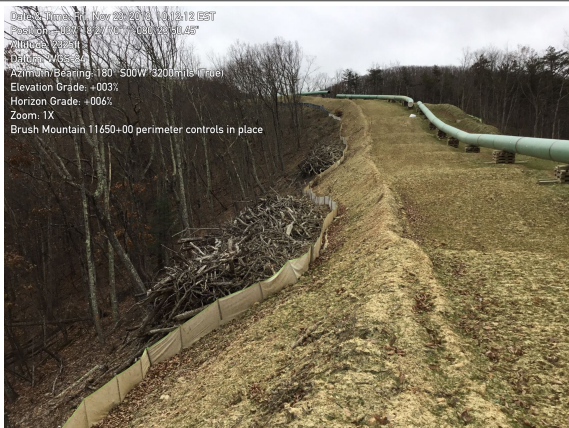
<p>Date & Time: Fri, Nov 23, 2018, 10:11:30 EST Position: +037° 18' 23.55" N -080° 23' 46.39" W Altitude: 2517ft Datum: WGS-84 Azimuth Bearing: 180° 50' 00" W 3200mils (True) Elevation Grade: +003% Horizon Grade: +006% Zoom: 1X Brush Mountain 11650+00 perimeter controls in place.</p>
