Visual Site Inspection Report

Project Name	H-600 Pipeline Spread G	AFE	124300137	Spread	H-600 Pipeline Spread G
Contractor	Precision			Report #	11978
Inspector	Rob Robertson			Date/Time	12/11/2018 4:34 PM
Permit #	TBD	Inspection Type	VA SWPP	Station Begin	11618+91
State	VA	Inspection Area	Full	Station End	11669+87
County	Montgomery	Ground	Muddy	Temperature (°F)	36.00
Municipality	N/A	Weather	Sunny	Rain Gauge (in)	0.00
GPS Location	37.13304644, -80.39505926			Rain Accumulation Time (days)	0.00

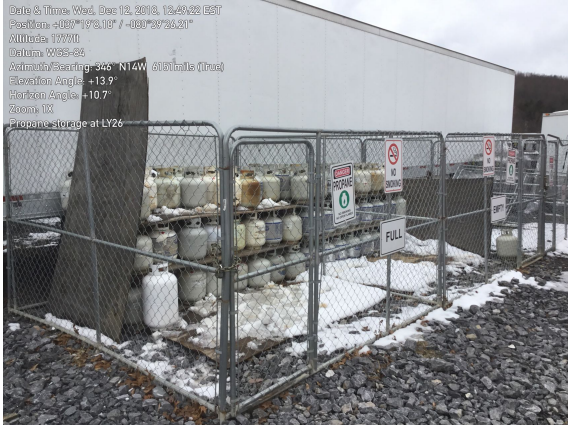
<p>Date & Time: Wed, Dec 12, 2018, 13:44:44 EST Position: +089°19'4.97" / -080°37'34.31" Altitude: 1777ft Datum: WGS-84 Azimuth/Heading: 311° 84°W 002mils (True) Elevation Angle: +30.4° Horizon Angle: +08.7° Zoom: 1X Fuel Containment at LY 26</p>

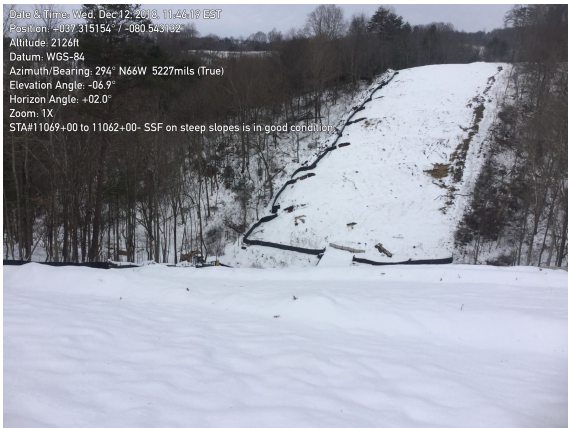
<p>Date & Time: Wed, Dec 12, 2018, 11:44:19 EST Position: +037.315154° / -080.543102° Altitude: 2126ft Datum: WGS-84 Azimuth/Bearing: 294° N66W 5227mils (True) Elevation Angle: -06.9° Horizon Angle: +02.0° Zoom: 1X Sta#11069+00 to 11062+00- SSF on steep slopes is in good condition.</p>

GPS Location	37.3110713856642, -80.5182716064905	GPS Location	37.3151630116974, -80.5431886576866		
Description	AR-249- pine tree over hanging access rd, blocking vehicle access.	Description	Sta#11069+00 to 11062+00- SSF on slopes in good condition.		
<p>Date & Time: Wed, Dec 12, 2018, 13:00:25 EST Position: +037.323387° / -080.554125° Altitude: 2434ft Datum: WGS-84 Azimuth/Bearing: 296° N64W 5262mils (True) Elevation Angle: -06.1° Horizon Angle: +01.8° Zoom: 1X Sta#11015+00- stream R- 55. ECD's are in good condition. Stream is flowing.</p>

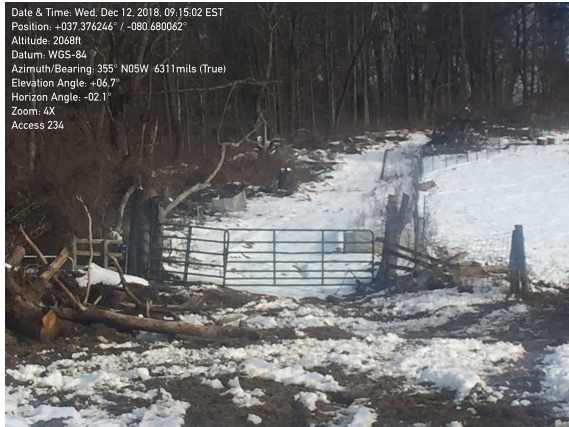
AFE	124300137	Date/Time	12/12/2018 9:35 AM	Report #	12019
Pictures					
<p>Date & Time: Wed, Dec 12, 2018, 09:15:02 EST Position: +037.376244° / -080.680062° Altitude: 2068ft Datum: WGS-84 Azimuth/Bearing: 355° N05W 6311mils (True) Elevation Angle: +06.7° Horizon Angle: -02.1° Zoom: 4X Access 234</p>

GPS Location	37.3474357612049, -80.6552520745286	GPS Location	37.3493755096917, -80.652780449093		
Description	10510+00 access 234 area stable no issues	Description	Access 234 super and P1 fence ok In ATWS area 10511+00		
<p>Date & Time: Wed, Dec 12, 2018, 10:24:05 EST Position: +037.349280° / -080.682183° Altitude: 2061ft Datum: WGS-84 Azimuth/Bearing: 105° S85E 1489mils (True) Elevation Angle: +03.3° Horizon Angle: -00.9° Zoom: 4X Buffalo Anklets</p>

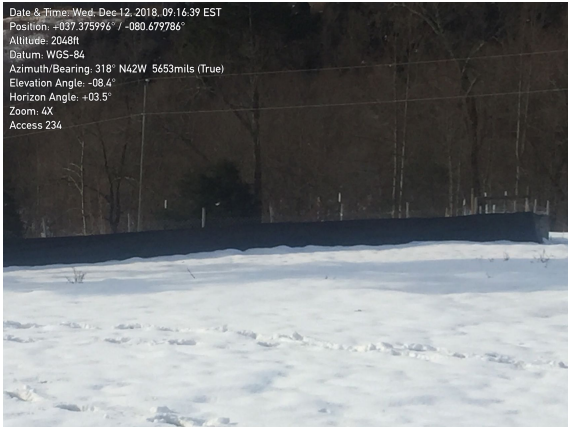
<p>Date & Time: Wed, Dec 12, 2018, 09:16:39 EST Position: +037.375996° / -080.679786° Altitude: 2048ft Datum: WGS-84 Azimuth/Bearing: 318° N42W 5653mils (True) Elevation Angle: -08.4° Horizon Angle: +03.5° Zoom: 4X Access 234</p>

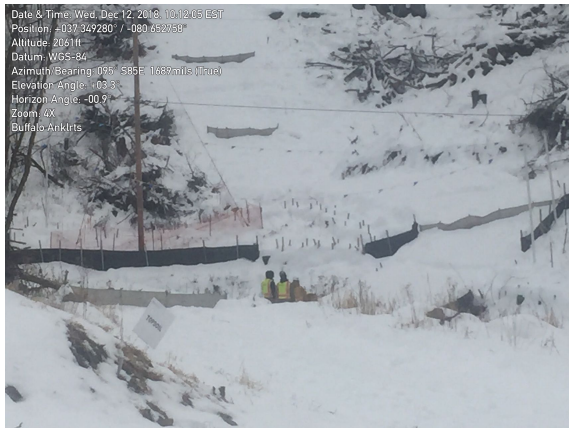
GPS Location	37.3726893430129, -80.6801472539292	GPS Location	37.3726893430129, -80.6801472539292		
Description	Buffalo Anklets stream SA32 crew checking fence no Issues	Description	Access 241.04 Buffalo Anklets Rd Row stable no issue 10713+00		
<p>Date & Time: Wed, Dec 12, 2018, 11:21:53 EST Position: +037.307251° / -080.604718° Altitude: 2237ft Datum: WGS-84 Azimuth/Bearing: 200° N69W 5533mils (True) Elevation Angle: +04.8° Horizon Angle: -05.8° Zoom: 2X Kow camp 2</p>

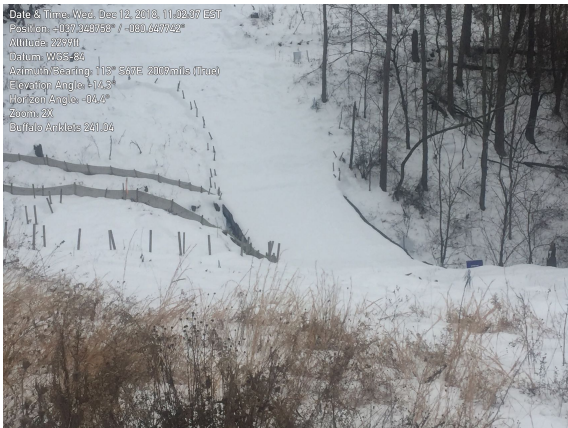
<p>Date & Time: Wed, Dec 12, 2018, 11:02:10 EST Position: +037.349353° / -080.681723° Altitude: 2250ft Datum: WGS-84 Azimuth/Bearing: 118° S57E 2007mils (True) Elevation Angle: +14.5° Horizon Angle: -04.4° Zoom: 2X Buffalo Anklets 241.04</p>

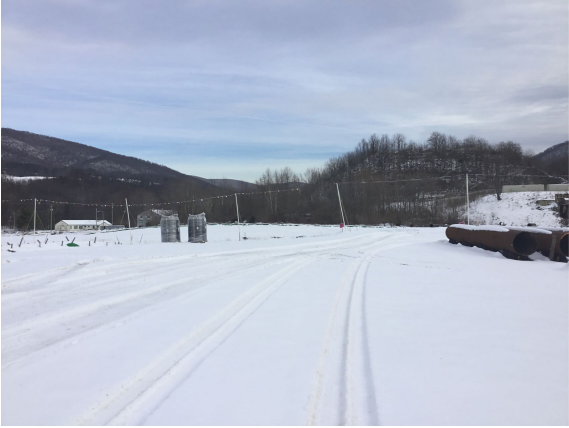
GPS Location	37.3627315275719, -80.6772380881763		GPS Location	37.3627315275719, -80.6772380881763	
Description	New area no issues		Description	Area of yard toward Access 238

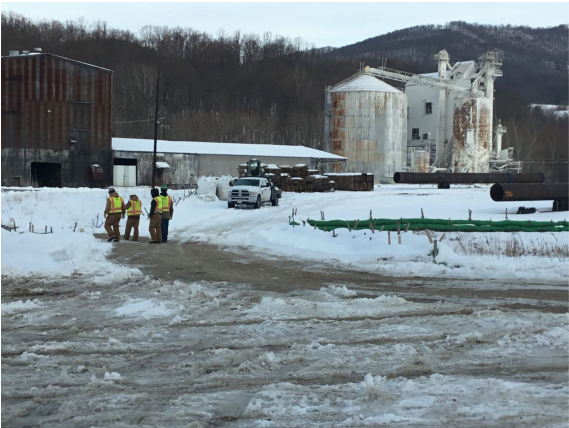
GPS Location	37.3627045378437, -80.677327103988		GPS Location	37.3343742153559, -80.634453394397	
Description	Area were Arnold's seed storing equipment		Description	Crew repaired some small holes in filter sock	
Insert image here			Insert image here		
GPS Location			GPS Location		
Description			Description

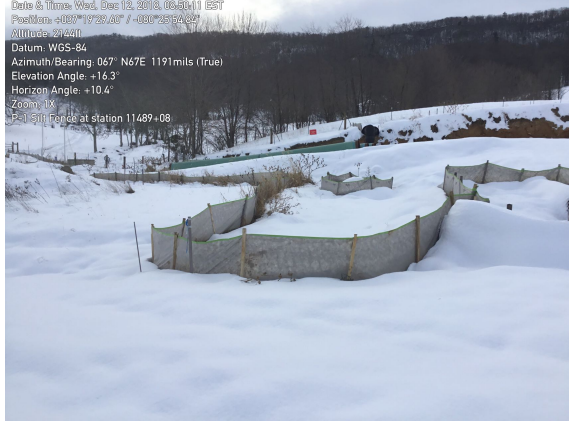
AFE	124300137	Date/Time	12/12/2018 8:32 AM	Report #	12024
Pictures					
<p>Date & Time: Wed, Dec 12, 2018, 06:56:11 EST Position: +037°19'23.41" / -080°43'52.82" Altitude: 2124ft Datum: WGS-84 Azimuth/Bearing: 067° N67E 1191mils (True) Elevation Angle: +16.3° Horizon Angle: +10.4° Zoom: 1X P-1 Silt Fence at station 11489+08</p>

GPS Location	37.3249171162372, -80.4318859522049	GPS Location	37.323423544911, -80.4334118776772		
Description	P-1 Silt Fence at station 11489+08	Description	EndTreatment at station 11482+00		
<p>Date & Time: Wed, Dec 12, 2018, 09:43:16 EST Position: +037°19'23.41" / -080°43'52.82" Altitude: 2124ft Datum: WGS-84 Azimuth/Bearing: 067° N67E 1191mils (True) Elevation Angle: +16.3° Horizon Angle: +10.4° Zoom: 1X Super Silt Fence at from station 11479+05</p>

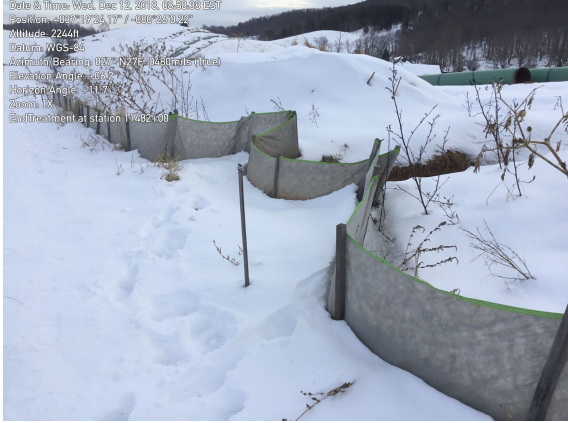
<p>Date & Time: Wed, Dec 12, 2018, 06:56:10 EST Position: +037°19'23.17" / -080°43'50.22" Altitude: 2224ft Datum: WGS-84 Azimuth/Bearing: 047° N67E 1191mils (True) Elevation Angle: +16.3° Horizon Angle: +10.4° Zoom: 1X EndTreatment at station 11482+00</p>

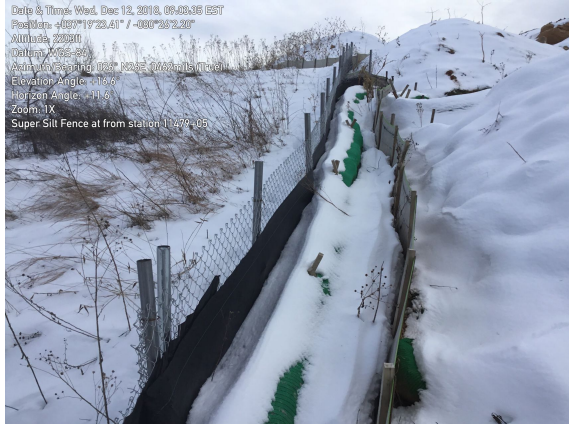
GPS Location	37.3231002129962, -80.4339240957801	GPS Location	37.3191027576451, -80.4403885547821		
Description	Super Silt Fence from station 11479+05	Description	EndTreatment at station 11452+98		
<p>Date & Time: Wed, Dec 12, 2018, 09:43:46 EST Position: +037°19'8.62" / -080°43'52.82" Altitude: 2124ft Datum: WGS-84 Azimuth/Bearing: 067° N67E 1191mils (True) Elevation Angle: +16.3° Horizon Angle: +10.4° Zoom: 1X P-1 Silt Fence from station 11452+98</p>

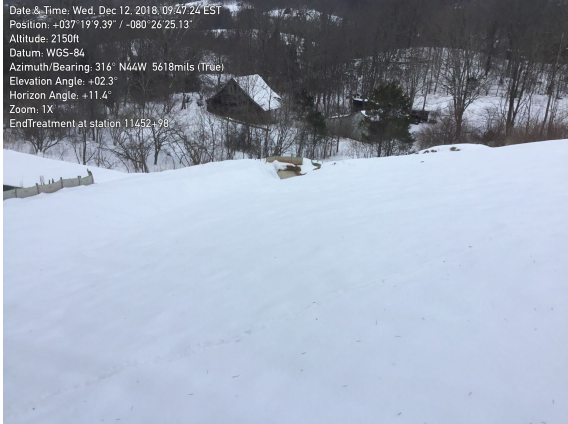
<p>Date & Time: Wed, Dec 12, 2018, 09:43:24 EST Position: +037°19'9.39" / -080°26'25.13" Altitude: 2150ft Datum: WGS-84 Azimuth/Bearing: 316° N44W 5618mils (True) Elevation Angle: +02.3° Horizon Angle: +11.4° Zoom: 1X EndTreatment at station 11452+98</p>

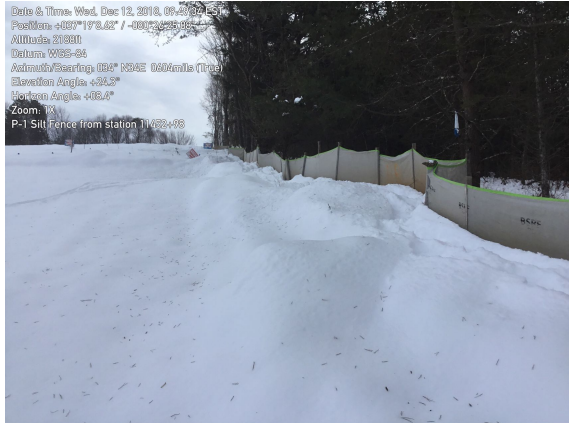
GPS Location	37.3191258078789, -80.4404230044041	GPS Location	37.3247879930188, -80.4314495903258		
Description	P-1 Silt Fence from station 11452+98	Description	Access Rd Stevers Gap Trail station 11489+70

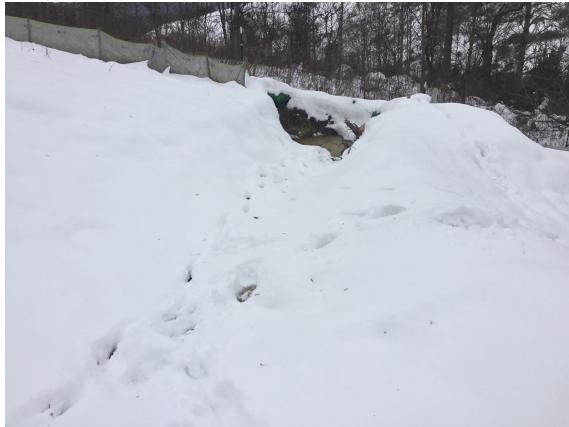
GPS Location	37.3349260725429, -80.5962445960199		GPS Location	37.3349923314874, -80.5960210506624	
Description	Kow Camp Rd 1 end treatment ok 10881+00		Description	10882+00 Kow Camp Rd 1 no issues with P1 in area

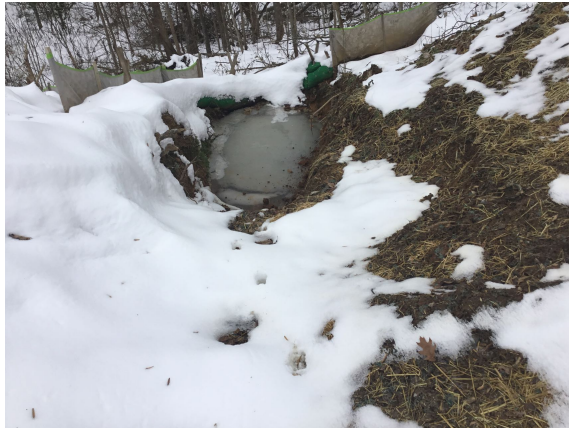
GPS Location	37.326006354026, -80.5929794492976		GPS Location	37.3323936062281, -80.5839758367097	
Description	Doe Creek rd end treatment ok 10925+10		Description	Looking toward Doe Creek Rd water bars and end treatments stable 10923+00

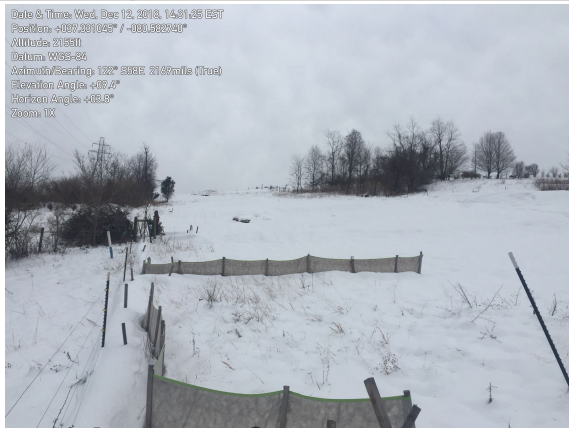
<p>Insert image here</p>			
GPS Location	37.3296011021418, -80.5902229732314		GPS Location		
Description	Doe Creek Rd 10932+00 no issues with P1 silt fence		Description

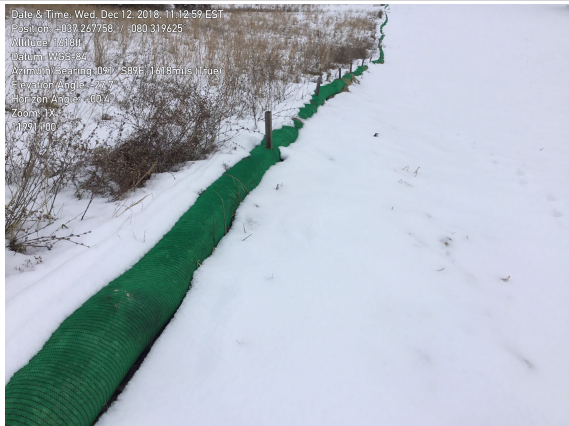
GPS Location	37.2958564712082, -80.360661735833		GPS Location	37.2960096923982, -80.3606136237088	
Description	Row 11990+00		Description	ECDs around wetland 12002+00	
<p>Date & Time: Wed, Dec 12, 2018, 11:12:59 EST Position: +037.267758° / -80.319625° Altitude: 149ft Datum: WGS-84 Azimuth/Bearing: 101° SSW 17.6mils (True) Elevation Angle: -10.9° Horizon Angle: -03.3° Zoom: 1X 11991+00</p>

GPS Location	37.2958781384279, -80.3604815249148		GPS Location	37.2960730176766, -80.3607422021035	
Description	CFS in good condition 11991+00		Description	RCE in need of refreshing 11789+00

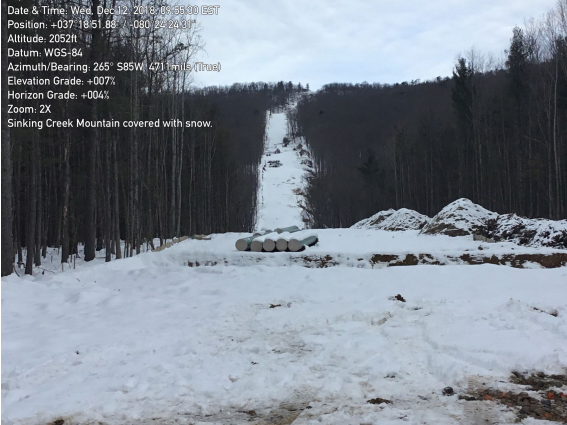
<p> Date & Time: Wed, Dec 12, 2018 3:25 PM EST Position: +037°18'51.88" / -080°22'20.31" Altitude: 2052ft Datum: WGS-84 Azimuth/Bearing: 265° S85W/ 401 (True) (True) Elevation Grade: +007% Horizon Grade: +004% Zoom: 2X Sinking Creek Mountain covered with snow. </p>		Insert image here			
GPS Location	37.1331758844081, -80.3944936954234		GPS Location		
Description	Correct coordinates on photo. ROW is frozen and stable currently.		Description		
Insert image here		Insert image here			
GPS Location			GPS Location		
Description			Description		
Insert image here		Insert image here			
GPS Location			GPS Location		
Description			Description

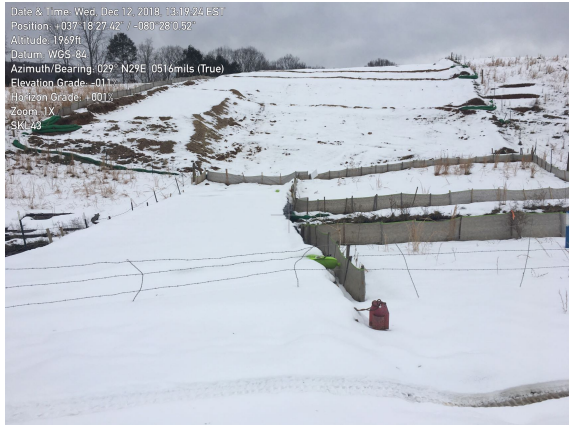
A/E	124300137	Date/Time	12/12/2018 3:49 PM	Report #	12039
Pictures					
<p>Date & Time: Wed, Dec 12, 2018, 13:19:24 EST Position: +037° 18' 27.42" / -080° 28' 0.52" Altitude: 1969ft Datum: WGS-84 Azimuth/Bearing: 029° N29E 0516mils (True) Elevation Grade: -011% Horizon Grade: -001% Zoom: 1X S-KL43</p>

GPS Location	37.2426610999156, -80.4292468261723	GPS Location	37.2429402783296, -80.429292735763		
Description	ECD 's @ S-KL43	Description	Slope drain and end treatment for water bar @ MP 215		
<p>Date & Time: Wed, Dec 12, 2018, 13:27:12 EST Position: +037° 18' 32.12" / -080° 27' 52.06" Altitude: 2030ft Datum: WGS-84 Azimuth/Bearing: 020° N20E 3366mils (True) Elevation Grade: -036% Horizon Grade: -005% Zoom: 1X MP216</p>

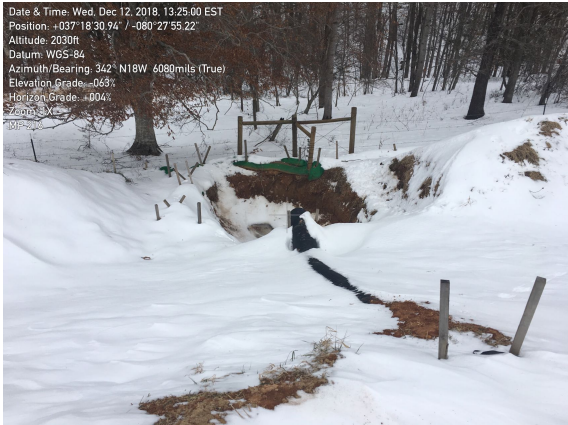
<p>Date & Time: Wed, Dec 12, 2018, 13:25:00 EST Position: +037° 18' 30.94" / -080° 27' 55.22" Altitude: 2030ft Datum: WGS-84 Azimuth/Bearing: 342° N18W 6080mils (True) Elevation Grade: -063% Horizon Grade: -004% Zoom: 1X mp215</p>

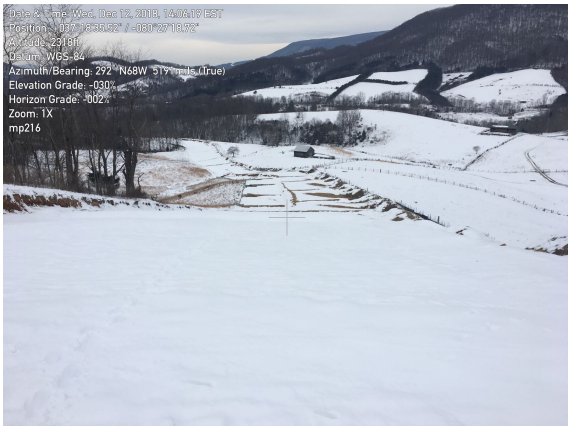
<p>Date & Time: Wed, Dec 12, 2018, 13:28:15 EST Position: +037° 18' 33.82" / -080° 27' 18.97" Altitude: 2231ft Datum: WGS-84 Azimuth/Bearing: 292° N68W 5197mils (True) Elevation Grade: -030% Horizon Grade: -002% Zoom: 1X mp216</p>

GPS Location	37.2426703619186, -80.4293633346264	GPS Location	37.2427074518402, -80.4293294717375		
Description	CWD Plunge Pool @ MP 214	Description	ROw conditions @ MP 216		
<p>Date & Time: Wed, Dec 12, 2018, 15:01:28 EST Position: +037° 18' 22.51" / -080° 28' 20.22" Altitude: 2041ft Datum: WGS-84 Azimuth/Bearing: 289° N71W 5138mils (True) Elevation Grade: -019% Horizon Grade: -002% Zoom: 3X S-NN12</p>

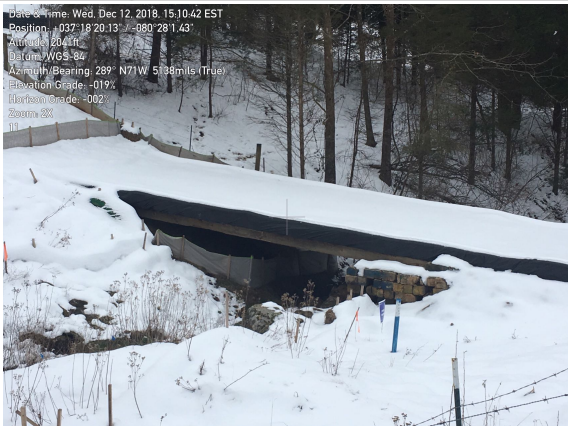
<p>Date & Time: Wed, Dec 12, 2018, 15:10:42 EST Position: +037° 18' 20.13" / -080° 28' 11.43" Altitude: 2041ft Datum: WGS-84 Azimuth/Bearing: 289° N71W 5138mils (True) Elevation Grade: -019% Horizon Grade: -002% Zoom: 3X S-NN11</p>

GPS Location	37.2427074518402, -80.4293294717375	GPS Location	37.2427074518402, -80.4293294717375		
Description	ECD's @ S-NN 12	Description	ECD's @ S-NN11

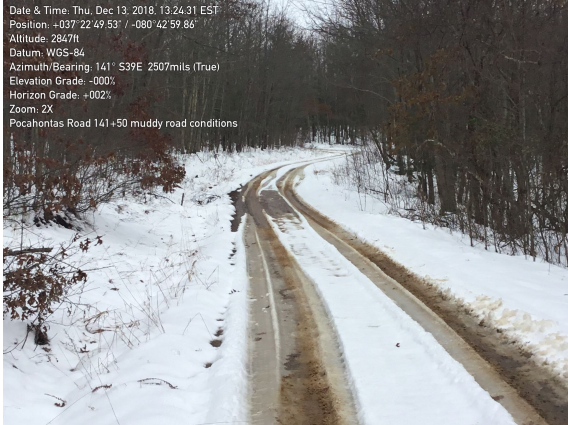
<p>Date & Time: Thu, Dec 13, 2018, 13:24:31 EST Position: +037° 22' 49.53" / -080° 42' 59.86" Altitude: 2847ft Datum: WGS-84 Azimuth/Bearing: 141° S39E 2507mils (True) Elevation Grade: -000% Horizon Grade: +002% Zoom: 2X Pocahontas Road 141+50 muddy road conditions</p>

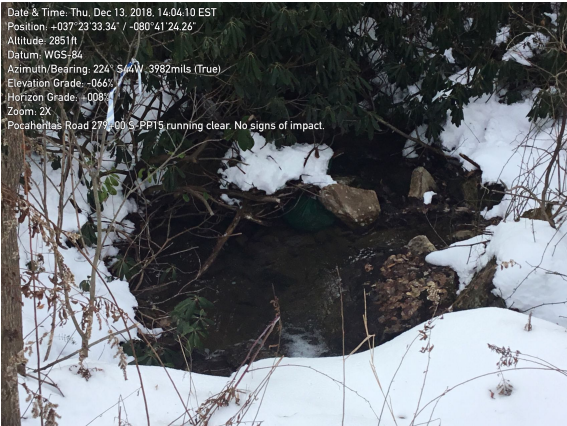
GPS Location	37.133246962947, -80.3945589904491	GPS Location	37.133246962947, -80.3945589904491		
Description	Correct coordinates on photo. No sediment in runoff in roadside ditch.	Description	Correct coordinates on photo. Grading and rock needed.		
<p>Date & Time: Thu, Dec 13, 2018, 14:04:10 EST Position: +037° 23' 33.34" / -080° 41' 24.26" Altitude: 2851ft Datum: WGS-84 Azimuth/Bearing: 224° S44W 3982mils (True) Elevation Grade: -066% Horizon Grade: +008% Zoom: 2X Pocahontas Road 275+00 S-PPT's running clear. No signs of impact.</p>

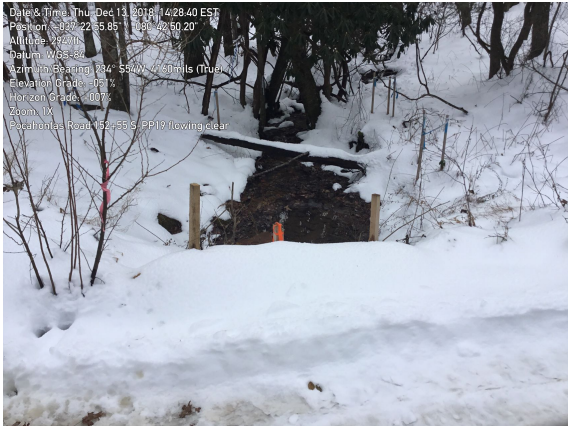
<p>Date & Time: Thu, Dec 13, 2018, 14:08:40 EST Position: +037° 23' 33.85" / -080° 40' 50.20" Altitude: 2851ft Datum: WGS-84 Azimuth/Bearing: 134° S54W 4480mils (True) Elevation Grade: -057% Horizon Grade: +007% Zoom: 1X Pocahontas Road 152+50 S-PPT's flowing clear.</p>

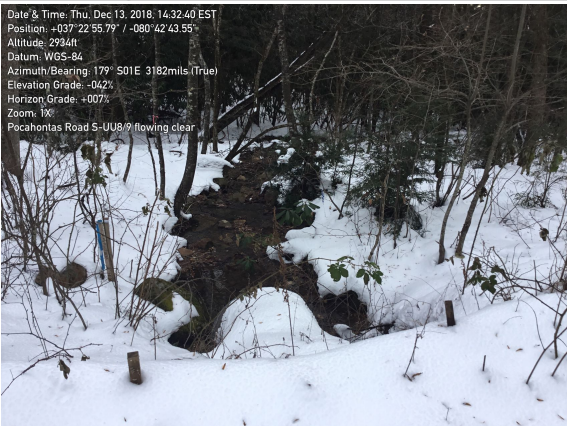
GPS Location	37.1333730686802, -80.3945695516471	GPS Location	37.1333730686802, -80.3945695516471		
Description	Correct coordinates on photo. Stream flowing clear	Description	Correct coordinates on photo. Stream flowing clear.		
<p>Date & Time: Thu, Dec 13, 2018, 14:32:40 EST Position: +037° 22' 55.79" / -080° 42' 43.55" Altitude: 2934ft Datum: WGS-84 Azimuth/Bearing: 179° S01E 3182mils (True) Elevation Grade: -042% Horizon Grade: +007% Zoom: 1X Pocahontas Road 5-UU8-9 flowing clear</p>
