Visual Site Inspection Report

Project Name	H-600 Pipeline Spread G	AFE	124300137	Spread	H-600 Pipeline Spread G
Contractor	Precision			Report #	12246
Inspector	Rob Robertson			Date/Time	12/17/2018 4:18 PM
Permit #	TBD	Inspection Type	VA SWPP	Station Begin	11669+87
State	VA	Inspection Area	Full	Station End	11618+91
County	Montgomery	Ground	Damp	Temperature (°F)	47.00
Municipality	N/A	Weather	Sunny	Rain Gauge (in)	0.20
GPS Location	37.1328725561528, -80.3944302947873			Rain Accumulation Time (days)	1.00

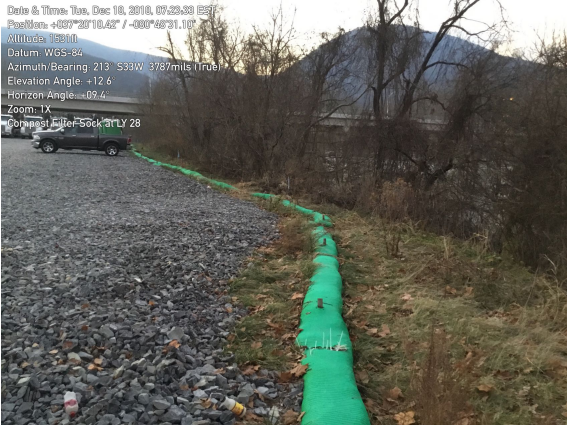
<p>Date & Time: Thu, Dec 18, 2018, 07:25:39 EST Position: +037°20'10.42" / -080°48'21.10" Altitude: 1550 ft Datum: WGS-84 Azimuth Bearing: 213.533W 3787mils (True) Elevation Angle: +12.6 Horizon Angle: -09.4 Zoom: 1X Compost Filter Sock at LY 28</p>

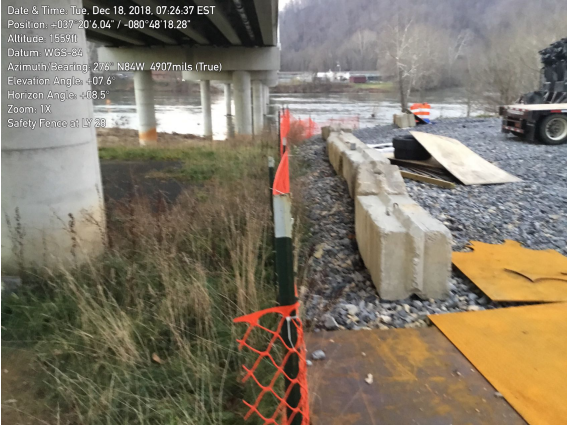
<p>Date & Time: Thu, Dec 18, 2018, 07:26:37 EST Position: +037°20'10.42" / -080°48'18.28" Altitude: 1550 ft Datum: WGS-84 Azimuth Bearing: 220.884W 4907mils (True) Elevation Angle: +07.6 Horizon Angle: +08.5 Zoom: 1X Safety Fence at LY 28</p>		GPS Location 37.3362794565385, -80.808581337408	
Description Compost Filter Sock at LY 28		Description Safety Fence at LY 28

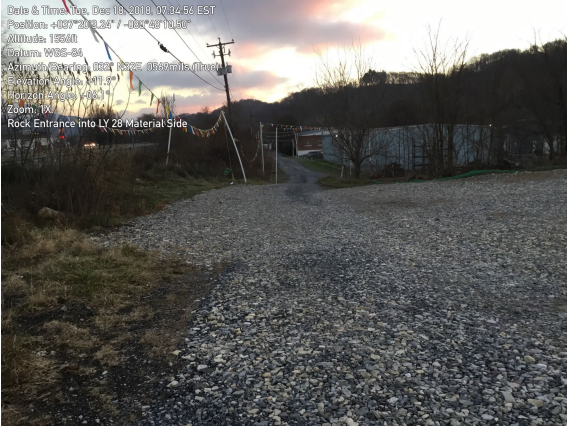
<p>Date & Time: Thu, Dec 18, 2018, 07:26:56 EST Position: +037°20'10.42" / -080°48'18.28" Altitude: 1550 ft Datum: WGS-84 Azimuth Bearing: 220.884W 4907mils (True) Elevation Angle: +07.6 Horizon Angle: +08.5 Zoom: 1X Rock Entrance into LY 28 Material Side</p>		<p>Insert image here</p>

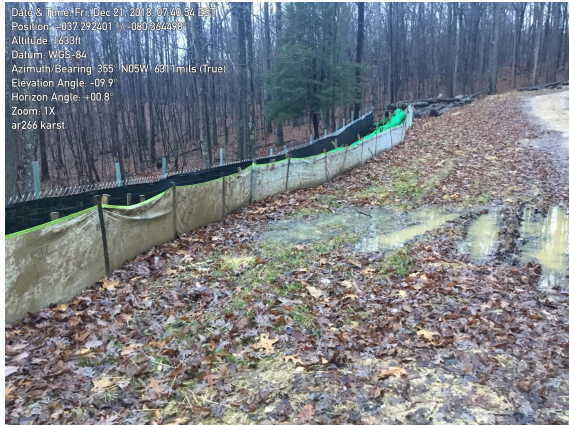
GPS Location	38.028958383983, -81.35702418171	GPS Location	38.0192450574022, -81.3539185189468		
Description	ECDs protecting karst in good condition AR266	Description	ECDs protecting karst in good condition 11942+00		
<p>Date & Time: Fri, Dec 21, 2018, 08:00:28 EST Position: +037 276974° / -080 326431° Altitude: 2052ft Datum: WGS-84 Azimuth/Bearing: 124° S56E 2204mils (True) Elevation Angle: -22.5° Horizon Angle: -01.5° Zoom: 1X 11950+00 karst</p>

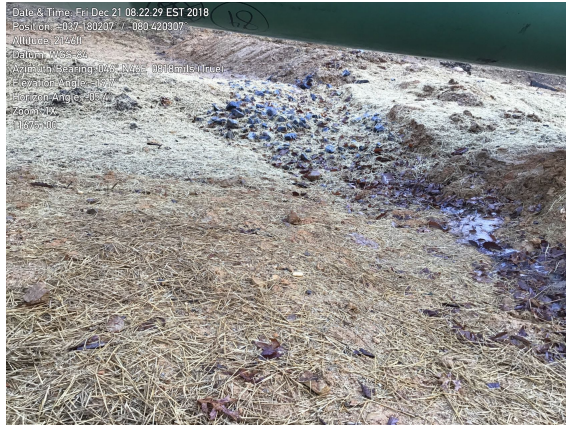
GPS Location	37.2058968446754, -80.3946620857456	GPS Location	37.2060338258825, -80.3945354622571		
Description	See photo for GPS location and station number. ROW stabilized and water bars in place.	Description	See photo for GPS location and station number. Rock filter over two tone section to minimize erosion.		
<p>Date & Time: Fri Dec 21 08:30:45 EST 2018 Position: -037.299644° / -080.391271° Altitude: 2432ft Datum: WGS-84 Azimuth/Bearing: 090° N90E 1400mils (True) Elevation Angle: -25.3° Horizon Angle: -03.9° Zoom: 1X 11687+00 CFS undermined</p>

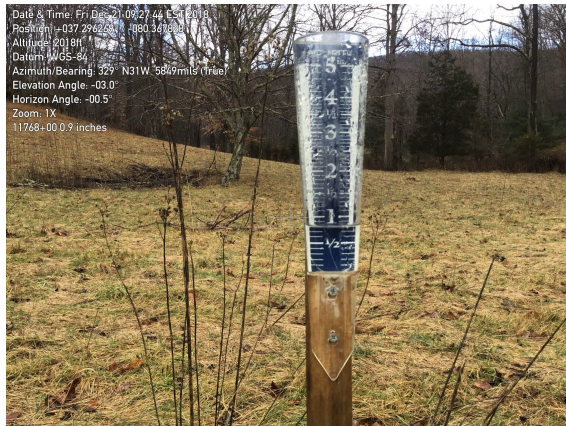
GPS Location	37.2060335926613, -80.3945398043169	GPS Location	37.2060340897592, -80.3945365552197		
Description	See photo for GPS location and station number. Triple stack CFS undermined.	Description	See photo for GPS location and station number. 0.9 inches of rain fall at Mount Tabor Road.		
<p>Date & Time: Fri Dec 21 09:05:55 EST 2018 Position: -037.295714° / -080.376102° Altitude: 2027ft Datum: WGS-84 Azimuth/Bearing: 132° S49W 1330mils Elevation Angle: -58.2° Horizon Angle: -01.6° Zoom: 1X 11740+00</p>

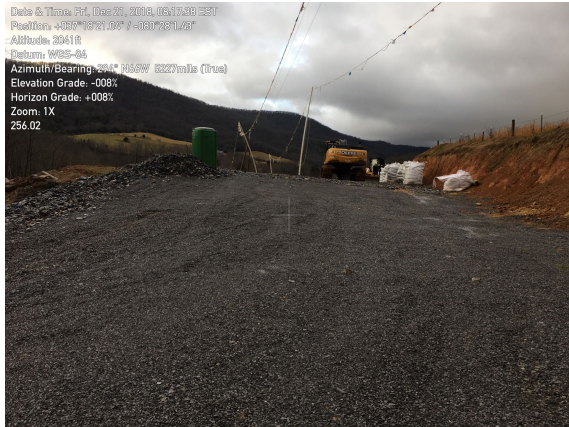
</div></div></div>			
GPS Location	37.2427040571694, -80.4292140529309		GPS Location	37.2427101340492, -80.4292292241756	
Description	RCE @ 256.02		Description	1" of rain recorded @ Steel Acres AR	
<div><div><div>Date & Time: Fri, Dec 21, 2018, 09:04:08 EST Position: +037°18'22.73" / -080°28'20.82" Altitude: 2176ft Datum: WGS-84 Azimuth/Bearing: 284° N76W 50.9mils (True) Elevation Grade: -021% Horizon Grade: +008% Zoom: 2X MP 214</div><div>

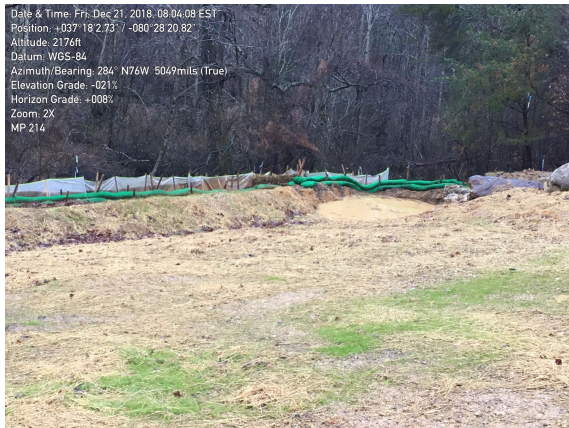
GPS Location	37.2427101340492, -80.4292292241756		GPS Location	37.2427101340492, -80.4292292241756	
Description	Waterbar and end treatment @ 11329+00		Description	Rock lined channel and sump @ ATWS 633	
<div><div><div>Date & Time: Fri, Dec 21, 2018, 09:17:16 EST Position: +037°18'23.14" / -080°28'11.60" Altitude: 2023ft Datum: WGS-84 Azimuth/Bearing: 284° S75W 4533mils (True) Elevation Grade: -01% Horizon Grade: +002% Zoom: 1X SNN11</div><div>

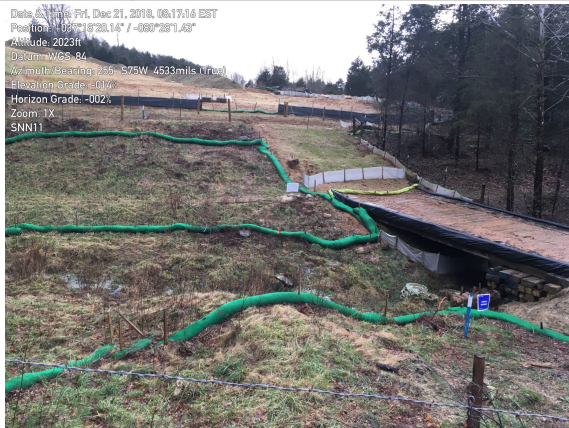
</div></div></div>			
GPS Location	37.2427101340492, -80.4292292241756		GPS Location	37.2427101340492, -80.4292292241756	
Description	ECD's and ROW conditions @ S-NN11		Description	ECD's and ROW conditions @ S-NN12

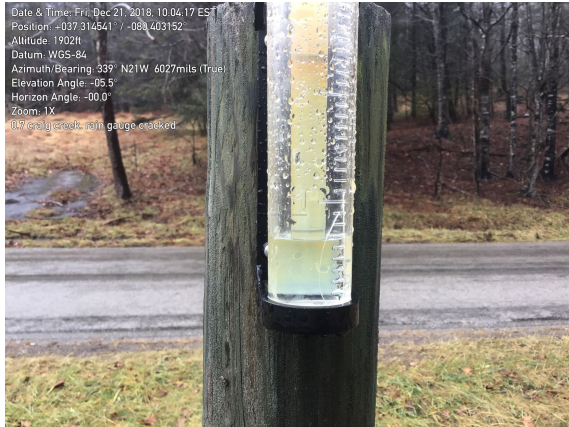
A/E	124300137	Date/Time	12/21/2018 5:09 PM	Report #	12420
Pictures					
<p>Date & Time: Fri, Dec 21, 2018, 10:04:17 EST Position: +037.314541° / -088.403152° Altitude: 1902ft Datum: WGS-84 Azimuth/Bearing: 339° N21W 6027mils (True) Elevation Angle: -05.5° Horizon Angle: -00.0° Zoom: 1X 0.7 inch creek rain gauge checked</p>

GPS Location	37.1360831060124, -80.3942106842706	GPS Location	37.1361166332263, -80.3941842355583		
Description	0.7 inches of rain at Craig creek road	Description	Stream s-pp20 flowing clear during rain event		
<p>Date & Time: Fri, Dec 21, 2018, 11:05:55 EST Position: +037.317201° / -088.408250° Altitude: 2041ft Datum: WGS-84 Azimuth/Bearing: 028° N28E 0498mils (True) Elevation Angle: -09.5° Horizon Angle: -00.2° Zoom: 1X s-pp21</p>

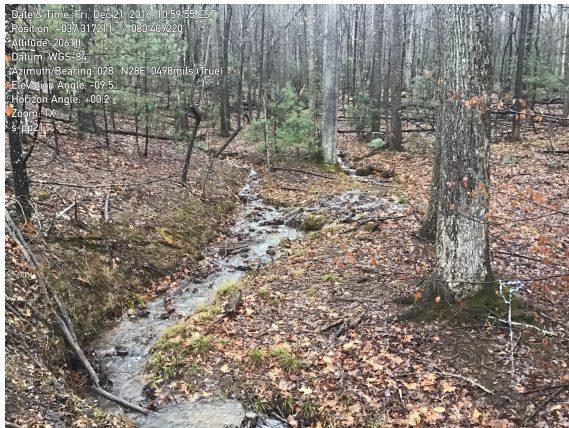
GPS Location	37.1360158827502, -80.3940331098441	GPS Location	37.1360210376206, -80.3940319363776		
Description	Stream s-pp21 flowing clear during rain event.	Description	Stabilized ROW conditions along sinking creek mountain.		
<p>Date & Time: Fri, Dec 21, 2018, 11:06:22 EST Position: +037.313834° / -088.415425° Altitude: 2020ft Datum: WGS-84 Azimuth/Bearing: 141° N41W 3529mils (True) Elevation Angle: -08.1° Horizon Angle: -01.2° Zoom: 1X installed super silt fence in good working condition</p>

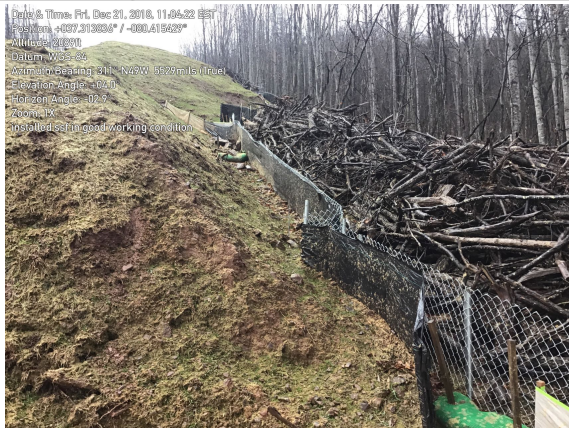
<p>Date & Time: Fri, Dec 21, 2018, 11:20:00 EST Position: +037.312399° / -088.411930° Altitude: 2054ft Datum: WGS-84 Azimuth/Bearing: 203° S22W 3591mils (True) Elevation Angle: -11.0° Horizon Angle: -01.6° Zoom: 1X installed silt fence</p>  			
GPS Location	37.1359956823635, -80.3941452597085	GPS Location	37.1359969815585, -80.3940641228858		
Description	Installed super silt fence along sinking creek mountain.	Description	Installed silt fence along sinking creek mountain.
