Visual Site Inspection Report

Project Name	H-600 Pipeline Spread G		AFE	124300137	Spread	H-600 Pipeline Spread G	
Contractor	Precision				Report #	12491	
Inspector	Jared Saunders				Date/Time	12/26/2018 6:44 PM	
Permit #	TBD	Inspection Type	VA SWPP		Station Begin	0+00	
State	VA	Inspection Area	Partial		Station End	0+00	
County	Giles	Ground	Muddy		Temperature (°F)	50.00	
Municipality	N/A	Weather	Cloudy		Rain Gauge (in)	0.00	
GPS Location	37.206002562847, -80.3943528542494				Rain Accumulation Time (days)	1.00

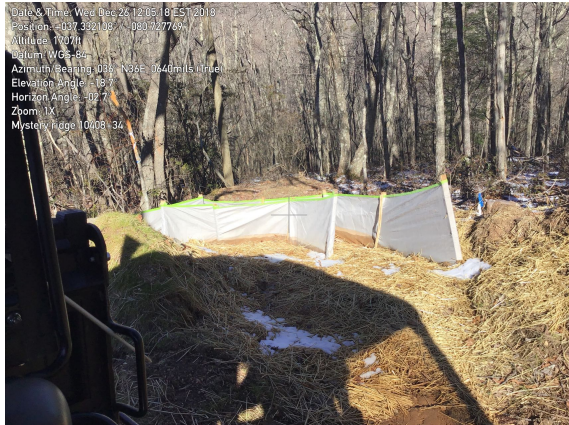
<p>Date & Time: Wed Dec 26 12:35:10 EST 2018 Position: -037.332108 / -80.127764 Altitude: 1007ft Datum: WGS-84 Azimuth/Bearing: 159° S06E 1640mils (True) Elevation Angle: -03.0 Horizon Angle: -02.7 Zoom: 1X Mystery Ridge 1008-34</p>

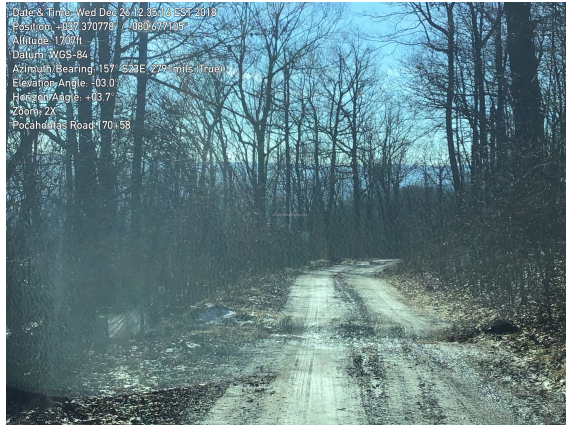
<p>Date & Time: Wed Dec 26 12:35:10 EST 2018 Position: -037.370778 / -80.067710 Altitude: 1020ft Datum: WGS-84 Azimuth/Bearing: 159° S06E 220mils (True) Elevation Angle: -03.0 Horizon Angle: -03.7 Zoom: 2X Pocahontas Road 170-58</p>			
GPS Location	37.2060247438037, -80.3943271794705		GPS Location	37.2060021065148, -80.394411087417	
Description	See photo for GPS location and station number. Water bar with end treatment on mystery ridge road.		Description	See photo for GPS location and station number. Water bar with end treatment on Pocahontas Road.
