# Visual Site Inspection Report

<b>Project Name</b>	H-600 Pipeline Spread G	<b>AFE</b>	124300137	<b>Spread</b>	H-600 Pipeline Spread G
<b>Contractor</b>	Precision			<b>Report #</b>	12685
<b>Inspector</b>	Rob Robertson			<b>Date/Time</b>	1/4/2019 3:02 PM
<b>Permit #</b>	TBD	<b>Inspection Type</b>	VA SWPP	<b>Station Begin</b>	11669+87
<b>State</b>	VA	<b>Inspection Area</b>	Full	<b>Station End</b>	11600+12
<b>County</b>	Montgomery	<b>Ground</b>	Damp	<b>Temperature (°F)</b>	39.00
<b>Municipality</b>	N/A	<b>Weather</b>	Light Rain	<b>Rain Gauge (in)</b>	0.00
<b>GPS Location</b>	37.1330981003466, -80.3944576532397			<b>Rain Accumulation Time (days)</b>	1.00

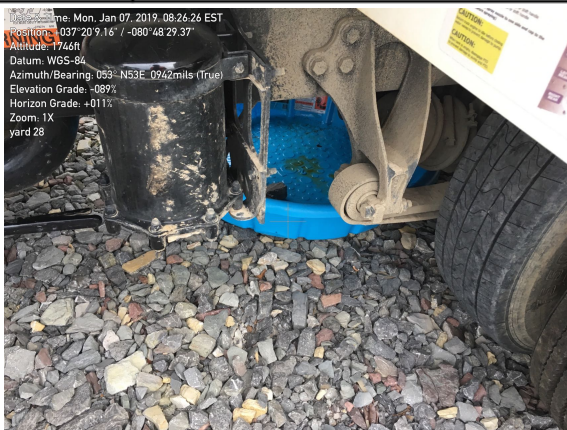
GPS Location	37.336324425449, -80.8086478897192	GPS Location	37.336324425449, -80.8086478897192		
Description	Secondary containment for leaking vehicles @ LDY 28	Description	Secondary containment for leaking vehicles @ LDY 28		
<p>Date &amp; Time: Mon, Jan 07, 2019, 09:41:08 EST Position: +037°17'43.04" / -080°22'3.66" Altitude: 3002ft Datum: WGS-84 Azimuth/Bearing: 265° S65W 4911mils (True) Elevation Grade: +013% Horizon Grade: +001% Zoom: 1X MLV26</p>  		<p>Date &amp; Time: Mon, Jan 07, 2019, 08:27:56 EST Position: +037°20'12.40" / -080°48'29.01" Altitude: 1609ft Datum: WGS-84 Azimuth/Bearing: 311° N49W 5529mils (True) Elevation Grade: -034% Horizon Grade: +003% Zoom: 1X yard 28</p>  			
GPS Location	37.336324425449, -80.8086478897192	GPS Location	37.336324425449, -80.8086478897192		
Description	Crews working @ MLV 26	Description	ECD's at LDY 26

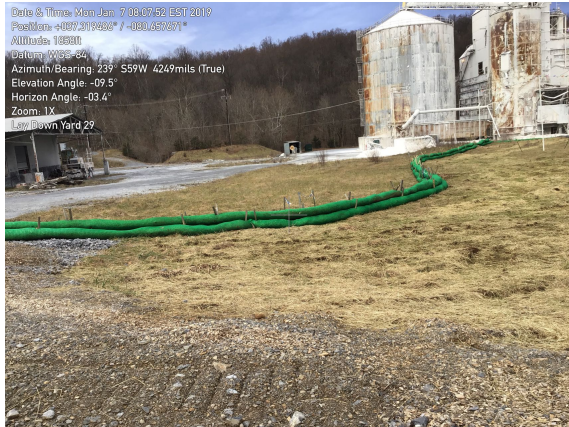
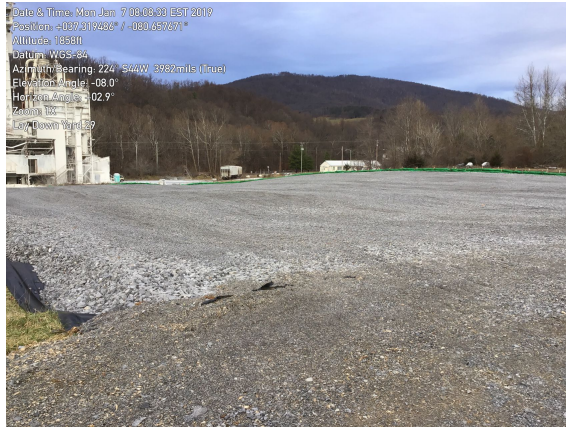
<p>Date &amp; Time: Mon Jan 7 08:08:30 EST 2019 Position: +037 219262° / -080.65767° Altitude: 1839ft Datum: WGS-84 Azimuth/Bearing: 226° S64W 3922mils (True) Elevation Angle: -08.0° Horizon Angle: -02.9° Zoom: 1X Lay Down Yard 29</p>			
GPS Location	37.2060564989331, -80.3941229807518	GPS Location	37.2060723358237, -80.3940767760981		
Description	See photo for GPS location and station number. Triple stack compost filter sock in place at lay down yard 29.	Description	See photo for GPS location and station number. Lay down yard 29.

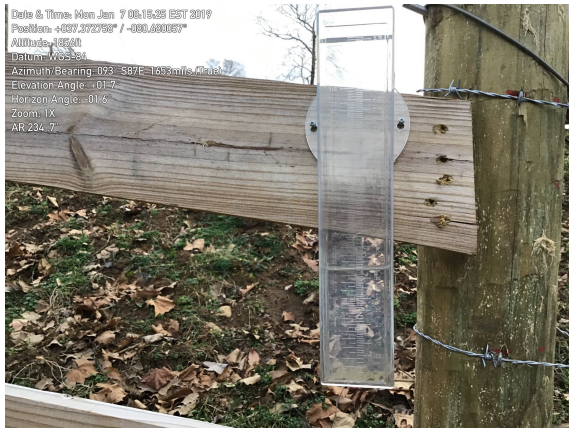
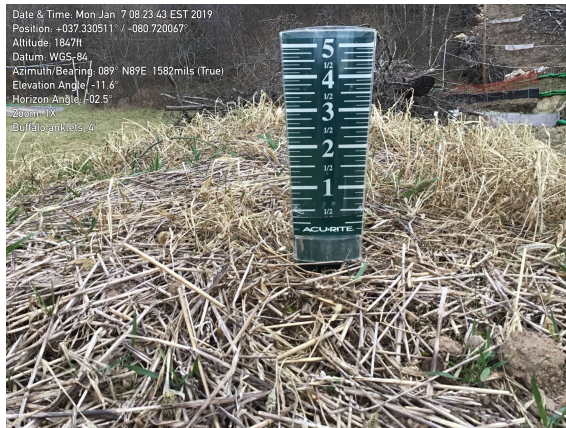
GPS Location	37.2060719067943, -80.3940750772334	GPS Location	37.2060642086896, -80.3943009744517		
Description	See photo for GPS location and station number. Rain gauge at AR234.	Description	See photo for GPS location and station number. Rain gauge at buffalo anklets.

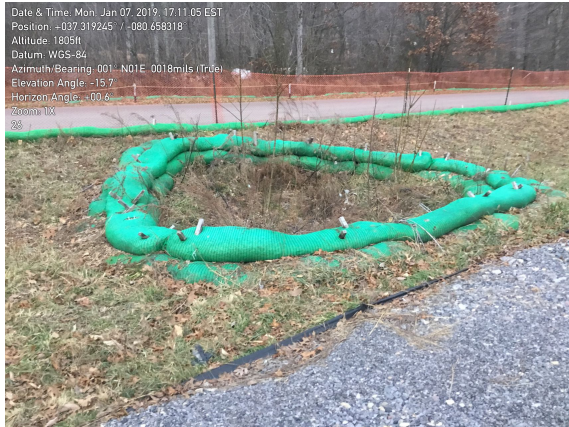
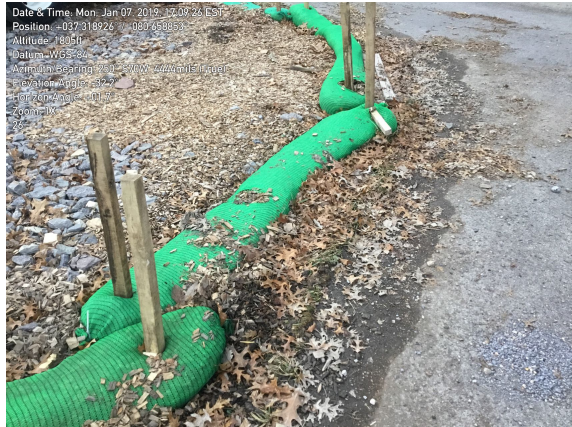
GPS Location	37.3328059958642, -80.7503838558502		GPS Location	37.3328550299977, -80.7504074928171	
Description	ECDs at yd26 in good condition		Description	Minor holes in CFS west side of yard 26	
<p>Date &amp; Time: Mon Jan 07, 2019, 17:10:36 EST Position: +037.319063° / -080.658543° Altitude: 1805ft Datum: WGS-84 Azimuth/Bearing: 225° S45W 4000mils (True) Elevation Angle: -12.8 Horizon Angle: +01.7 Zoom: 1X 26</p>

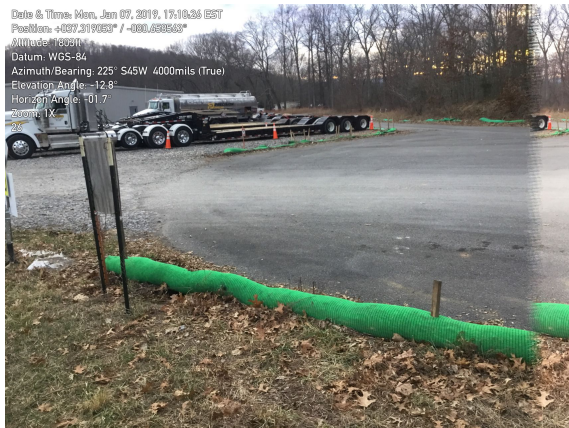
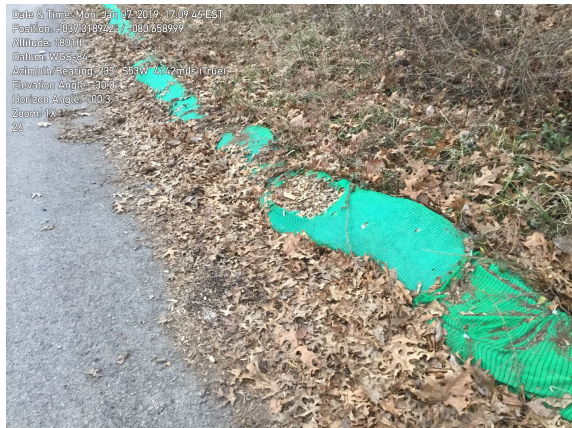
GPS Location	37.3329380527486, -80.750528778956		GPS Location	37.3328550299977, -80.7504074928171	
Description	Road free of any debris from yard 26		Description	Hole in CFS on west side of yard 26	
<p>Date &amp; Time: Mon Jan 07, 2019, 17:10:00 EST Position: +037.318712 / -080.658575 Altitude: 1801ft Datum: WGS-84 Azimuth/Bearing: 335° N25W 895mils (True) Elevation Angle: +13.3 Horizon Angle: +02.8 Zoom: 1X 26</p>

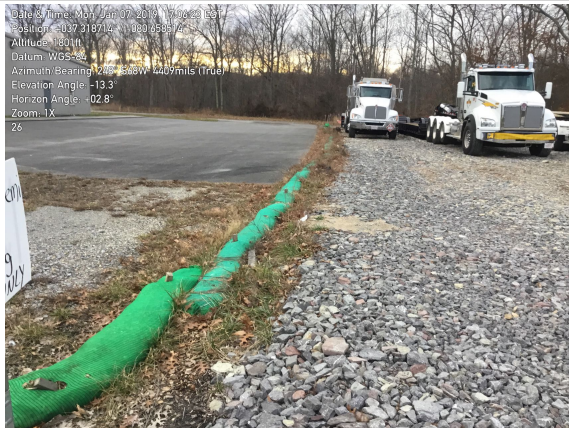
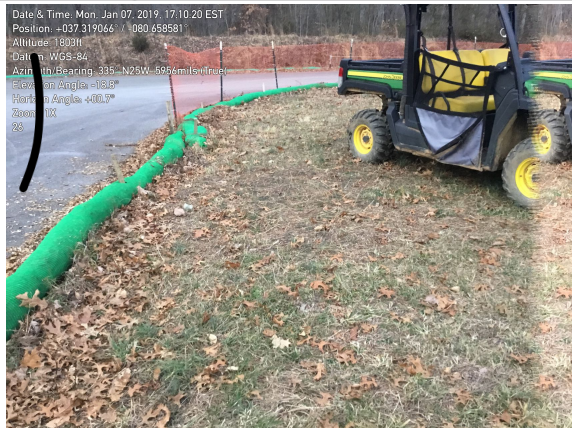
GPS Location	37.3338788829382, -80.7501870225961		GPS Location	37.3334485440723, -80.7508034359969	
Description	CFS in good condition yd 26		Description	CFS in good condition yard 26

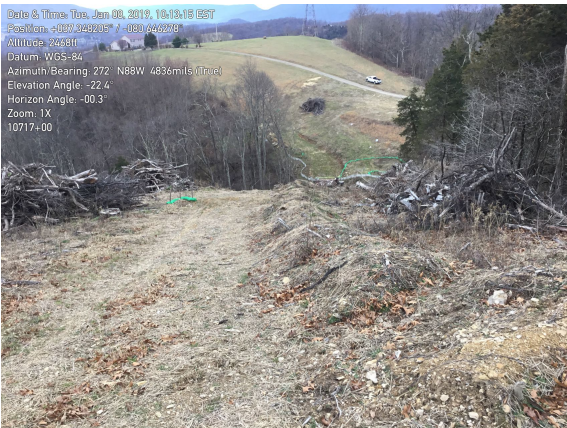
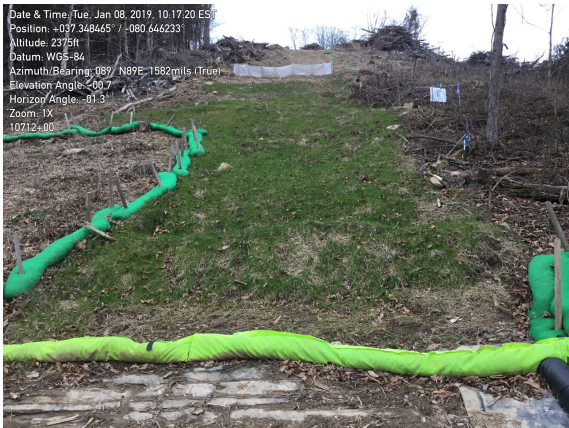
<b>GPS Location</b>	37.3328578798448, -80.7506285236038	<b>GPS Location</b>	37.3328357516204, -80.7506377436973		
<b>Description</b>	Row facing west 10717+00	<b>Description</b>	ECDs in good condition 10712+00		
<p>Insert image here</p>

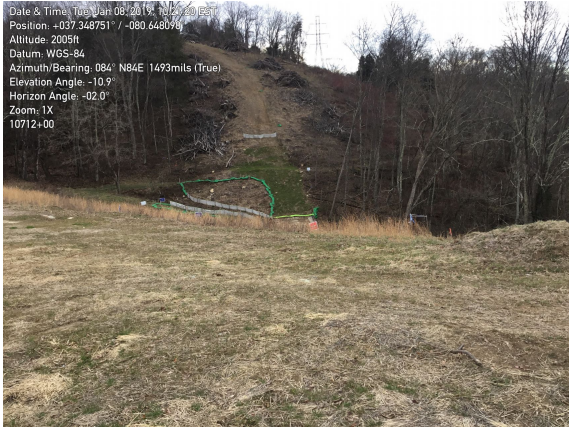
<b>GPS Location</b>		<b>GPS Location</b>	37.3334913435765, -80.7506777166396		
<b>Description</b>		<b>Description</b>	Row facing east 10712+00

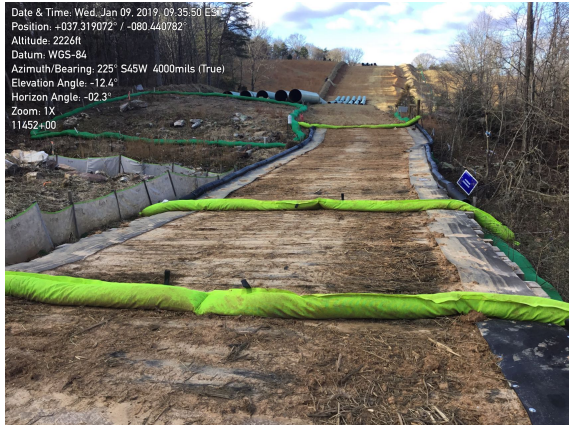
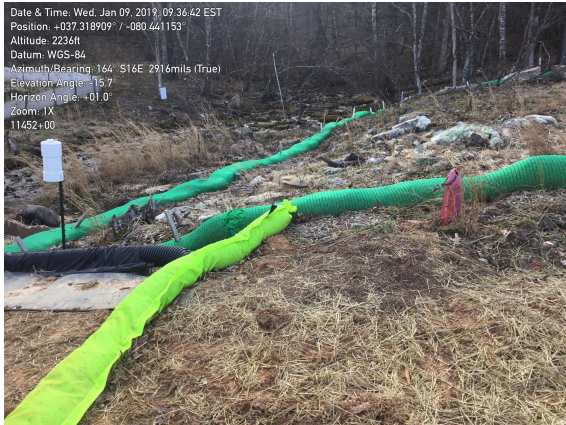
GPS Location	37.332898029161, -80.7503654156632	GPS Location	37.3329871287917, -80.7504184731103		
Description	ECDs in good condition 11452+00	Description	11452+00 ECDs in good condition		
<p>Date &amp; Time: Wed, Jan 09, 2019, 10:24:46 EST Position: +037.307027° / -080.633937° Altitude: 1927ft Datum: WGS-84 Azimuth/Bearing: 210° S30W 3733mils (True) Elevation Angle: -07.5° Horizon Angle: -00.5° Zoom: 1X 11360+00</p>

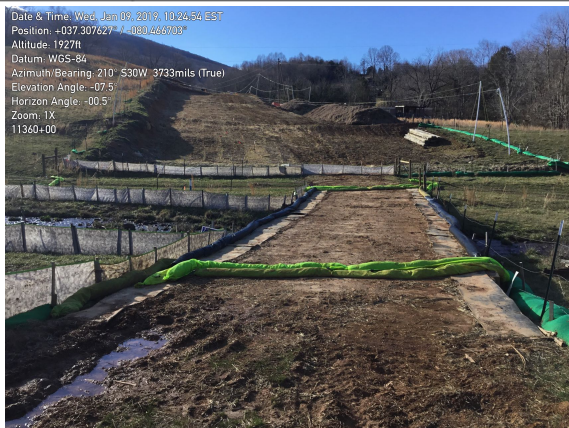
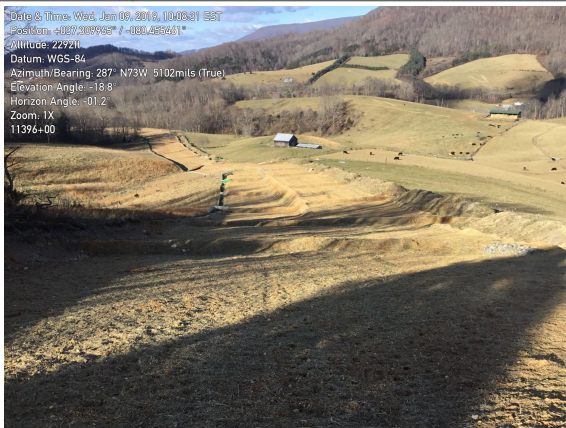
GPS Location	37.3339125378327, -80.7501632287709	GPS Location	37.3338952162294, -80.7501716340065		
Description	Stream crossing in good condition 11360+00	Description	Row 11396+00		
<p>Date &amp; Time: Wed, Jan 09, 2019, 10:36:04 EST Position: +037.307000° / -080.633925° Altitude: 1953ft Datum: WGS-84 Azimuth/Bearing: 274° N86W 4871mils (True) Elevation Angle: -15.2° Horizon Angle: -01.8° Zoom: 1X 11360+00</p>

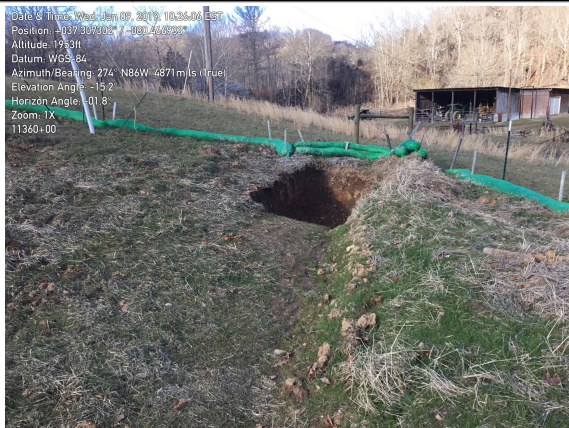
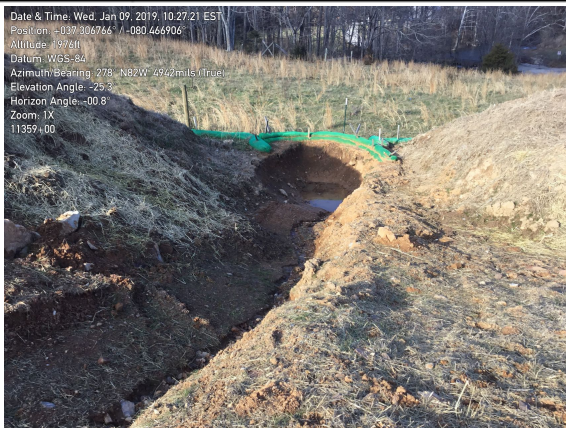
GPS Location	37.3339917804012, -80.7500875550081	GPS Location	37.3339917804012, -80.7500875550081		
Description	Sump and end treatment in good condition 11360+00	Description	Sump and end treatment in good condition 11359+00

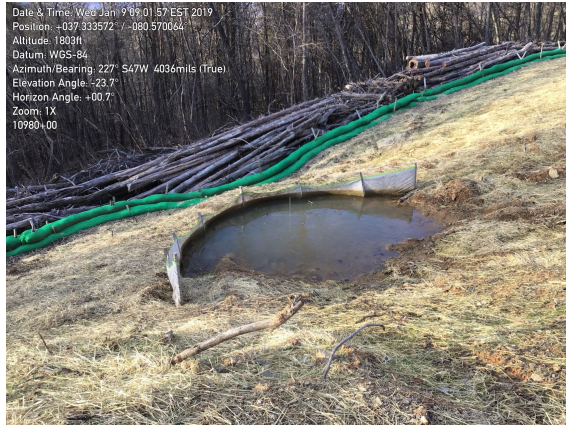
GPS Location	37.2061506651439, -80.393936740752		GPS Location	37.2061506651439, -80.393936740752	
Description	See photo for station number and GPS location. Stream S-RR4 sensitive resource buffer in place.		Description	See photo for station number and GPS location. P-1 silt fence added to punch list from lack of filter capability.	
<p>Date &amp; Time: Wed Jan 9 11:26:47:45 EST 2019 Position: +037.295316 / -080.482524 Altitude: 2202ft Datum: WGS-84 Azimuth/Bearing: 334° S16E 2916mils (True) Elevation Angle: -08.3° Horizon Angle: -07.9° Zoom: 1X 11272+00</p>

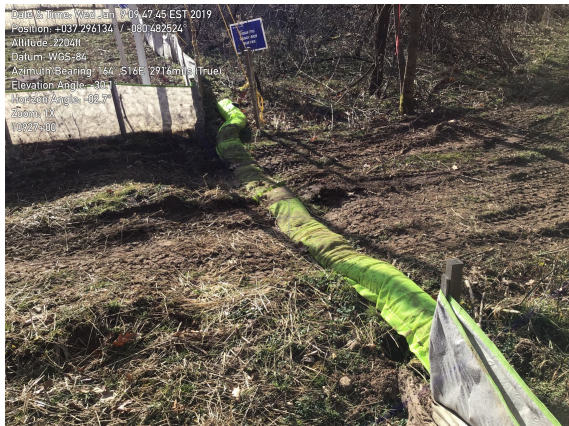
GPS Location	37.2060752660383, -80.3938566707823		GPS Location	37.2060752660383, -80.3938566707823	
Description	See photo for station number and GPS location. Coir logs needs replaced at land owner access point.		Description	See photo for station number and GPS location. Top soil pile sloughing off.	
<p>Date &amp; Time: Wed Jan 9 11:26:20 EST 2019 Position: +037.295316 / -080.500146 Altitude: 2176ft Datum: WGS-84 Azimuth/Bearing: 232° S52W 4124mils (True) Elevation Angle: -35.1° Horizon Angle: +04.3° Zoom: 1X 11269+00</p>  		<p>Date &amp; Time: Wed Jan 9 11:26:09 EST 2019 Position: +037.295316 / -080.500146 Altitude: 2176ft Datum: WGS-84 Azimuth/Bearing: 253° S73W 4498mils (True) Elevation Angle: -21.7° Horizon Angle: +20.8° Zoom: 1X 11269+00</p>  			
GPS Location	37.2060752660383, -80.3938566707823		GPS Location	37.2060752660383, -80.3938566707823	
Description	See photo for station number and GPS location. Plunge pool in place at clean water drainage pipe.		Description	See photo for station number and GPS location. Fill under slope pipe sloughed off.

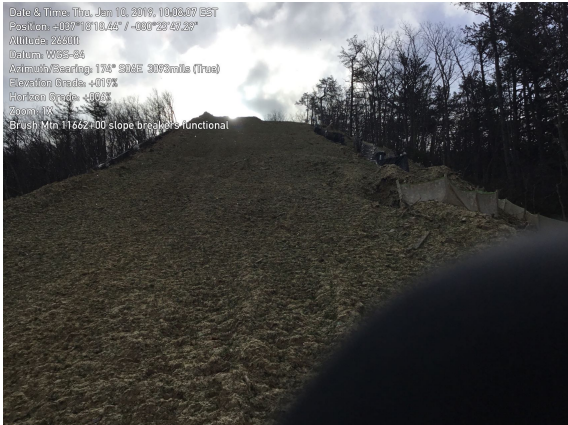
GPS Location	37.1331208991233, -80.394474249408	GPS Location	37.1331208991233, -80.394474249408		
Description	Correct coordinates on photo. Flex Terra and grasses holding soils on surface.	Description	Correct coordinates on photo. Slope breakers and end treatments functional.

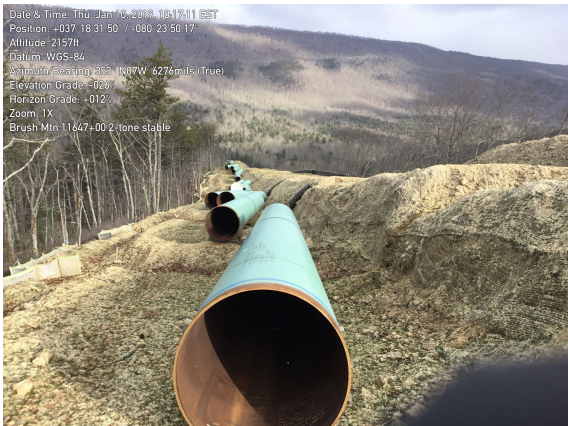
GPS Location	37.1331208991233, -80.394474249408	GPS Location	37.1331208991233, -80.394474249408		
Description	Correct coordinates on photo. End treatment effective.	Description	Correct coordinates on photo. 2-tone stable.		
<p>Date &amp; Time: Thu Jan 10, 2019, 10:28:51 EST Position: +037° 18' 47.77" / -080° 23' 51.71" Altitude: 2018ft Datum: WGS-84 Azimuth/Bearing: 300° N60W 5333mils (True) Elevation Grade: +039% Horizon Grade: +008% Zoom: 1X Brush Mtn 1030+00 slope breakers and sumps effective</p>

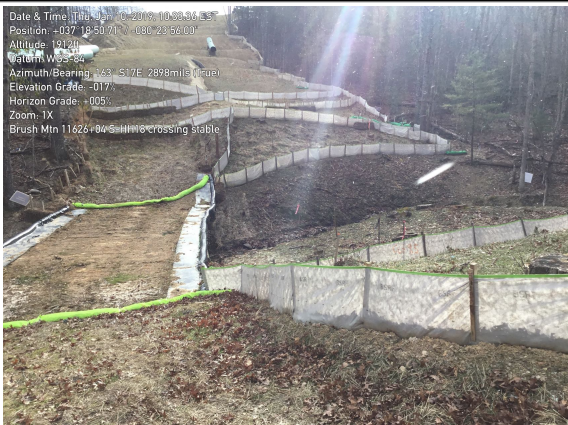
<p>Date &amp; Time: Thu Jan 10, 2019, 10:33:56 EST Position: +037° 18' 50.71" / -080° 23' 56.00" Altitude: 1912ft Datum: WGS-84 Azimuth/Bearing: 343° S17E 2898mils (True) Elevation Grade: -017% Horizon Grade: +005% Zoom: 1X Brush Mtn 11626+00 S-HH18 crossing stable</p>

GPS Location	37.1330578253019, -80.3945910093192	GPS Location	37.1330578253019, -80.3945910093192		
Description	Correct coordinates on photo. Slope breakers, sumps and end treatments functional.	Description	Correct coordinates on photo. S-HH18 crossing stable.

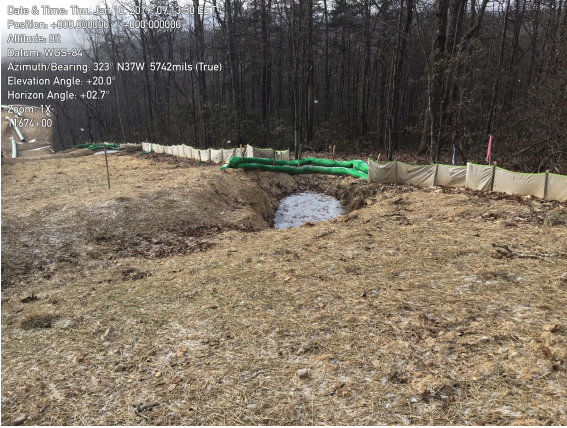
<b>Description</b>	See photo for station number and GPS location. Water bar, sump pit and end treatment in place.	<b>Description</b>	See photo for station number and GPS location. Rock fillet over two-tone in place to minimize erosion.		
<p>Date &amp; Time: Thu, Jan 10, 2019, 09:29:57 EST  Position: +037.299731° / -080.390277°  Altitude: 1847ft  Datum: WGS-84  Azimuth/Bearing: 350° N10W 6222mils (True)  Elevation Angle: +20.1°  Horizon Angle: +04.4°  Zoom: 1X  11687+40 S MN21</p>

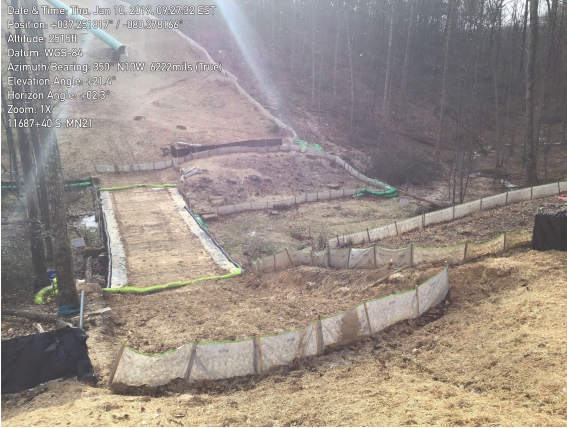
<b>GPS Location</b>	37.3275296297272, -80.486236391664	<b>GPS Location</b>	37.3275296297272, -80.486236391664		
<b>Description</b>	See photo for station number and GPS location. Stream S-MN21 sensitive resource buffer zone in place.	<b>Description</b>	See photo for station number and GPS location. Rock lined sump pit in place.

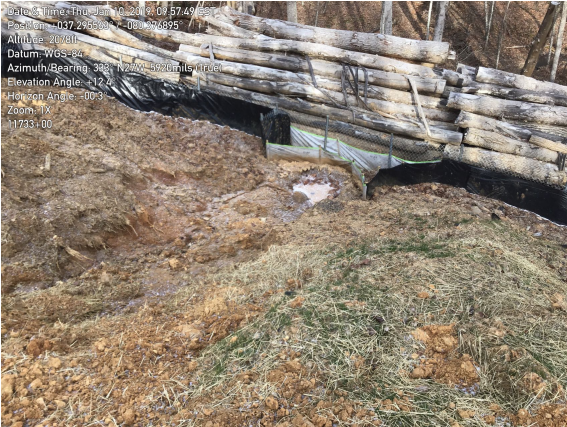
<p>Date &amp; Time: Thu, Jan 10, 2019, 10:14:56 EST  Position: +037.296083° / -080.367958°  Altitude: 2121ft  Datum: WGS-84  Azimuth/Bearing: 333° N27W 5920mils (True)  Elevation Angle: +24.2°  Horizon Angle: +01.4°  Zoom: 1X  11768+30</p>

<b>GPS Location</b>	37.3275296297272, -80.486236391664	<b>GPS Location</b>	37.3275296297272, -80.486236391664		
<b>Description</b>	See photo for station number and GPS location. Sump pit fill with soil due to spoil pile sloughing off.	<b>Description</b>	See photo for station number and GPS location. RCE in place at main line valve 26.

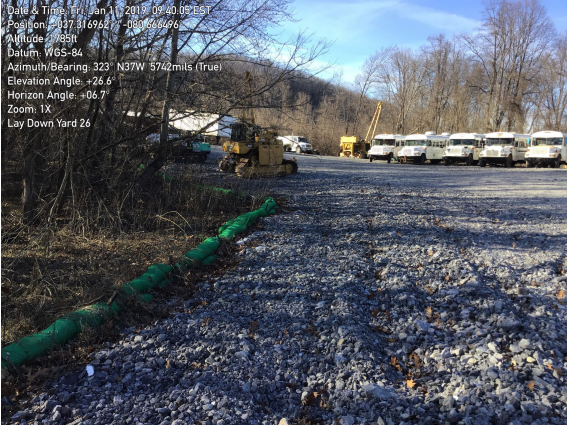
<b>GPS Location</b>	37.3275262790205, -80.4859333606858	<b>GPS Location</b>	37.3275262790205, -80.4859333606858		
<b>Description</b>	See photo for station number and GPS location. Triple stack CFS in place.	<b>Description</b>	See photo for station number and GPS location. Entire yard has rock in place to prevent track out.

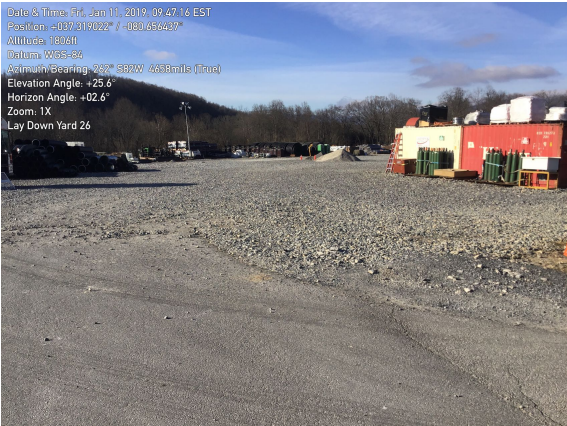
<b>GPS Location</b>	37.327604438213, -80.4858255107705	<b>GPS Location</b>	37.3275068309506, -80.4858500697468		
<b>Description</b>	See photo for station number and GPS location. RCE in place leaving lay down yard 26.	<b>Description</b>	See photo for station number and GPS location. CFS and safety fence in place.		
<p>Insert image here</p>		<p>Insert image here</p>			
<b>GPS Location</b>		<b>GPS Location</b>			
<b>Description</b>		<b>Description</b>
