Visual Site Inspection Report

Project Name	H-600 Pipeline Spread G	AFE	124300137	Spread	H-600 Pipeline Spread G
Contractor	Precision			Report #	13199
Inspector	Len Kruizenga			Date/Time	1/21/2019 8:19 AM
Permit #	TBD	Inspection Type	VA SWPP	Station Begin	11254+88
State	WV	Inspection Area	Partial	Station End	11162+00
County	Monroe	Ground	Frozen	Temperature (°F)	4.00
Municipality	N/A	Weather	Sunny	Rain Gauge (in)	0.00
GPS Location	37.3275867800037, -80.4861710299966			Rain Accumulation Time (days)	1.00

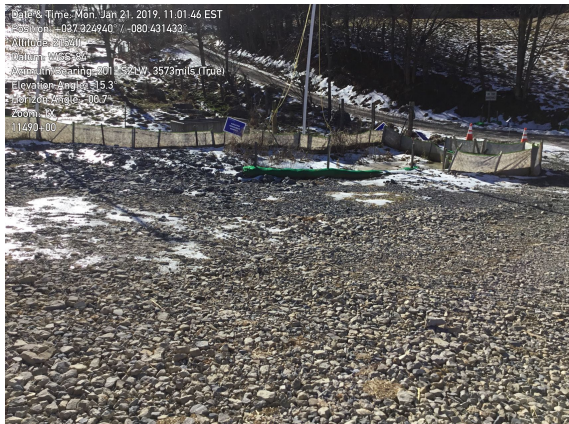
GPS Location	37.333928355883, -80.7501630100022		GPS Location	37.3339289483505, -80.7501625062535	
Description	11490+00 row		Description	Row 11471+00	
Insert image here			Insert image here		
GPS Location			GPS Location		
Description			Description

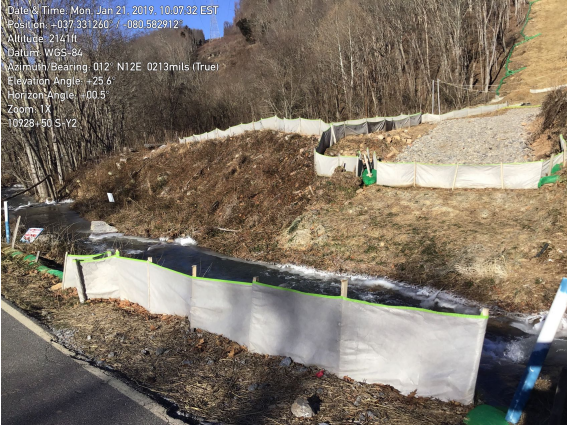
<p>Date & Time: Mon Jan 21, 2019, 10:07:32 EST Position: +037 331260 / -080 582912 Altitude: 2141ft Datum: WGS-84 Azimuth/Bearing: 012 N12E 0213mils (True) Elevation Angle: +23.6 Horizon Angle: +04.3 Zoom: 1X 10929+00 S-Y2</p>			
GPS Location	37.2107780100001, -80.39625397	GPS Location	37.21077801, -80.39625397		
Description	See photo for station number and GPS location. RCE at Kow Camp Road.	Description	See photo for station number and GPS location. Sensitive resource buffer in place at stream S-Y2.

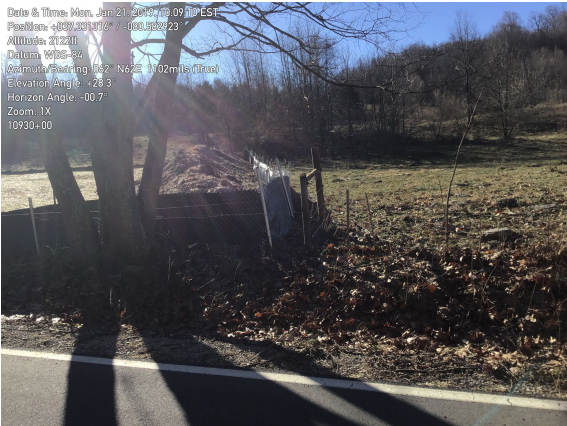
GPS Location	37.2060488630433, -80.3940004204217	GPS Location	37.2060488630433, -80.3940004204217		
Description	See photo for station number and GPS location. Reinforced filter fabric.	Description	See photo for station number and GPS location. Stream S-RR4 sensitive resource buffer.		
<p>Insert image here</p>		<p>Insert image here</p>			
GPS Location		GPS Location			
Description		Description

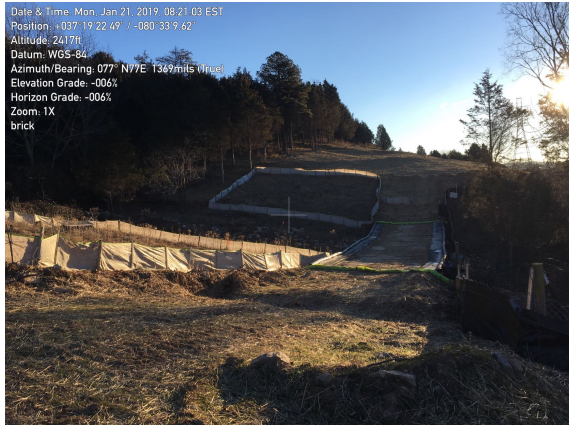
GPS Location	37.2426685598094, -80.4292838741843	GPS Location	37.2428996283701, -80.4291832490459		
Description	Row and ECD conditions @ 11020+00	Description	ECD's and end treatment @ MP 208.5		
<p>Date & Time: Mon Jan 21, 2019, 09:12:07 EST Position: +037° 18' 22.29" -080° 28' 20.55" Altitude: 2145ft Datum: WGS-84 Azimuth/Bearing: 238° S55W 4178mils (True) Elevation Grade: -001% Horizon Grade: -003% Zoom: 1X MP 214</p>

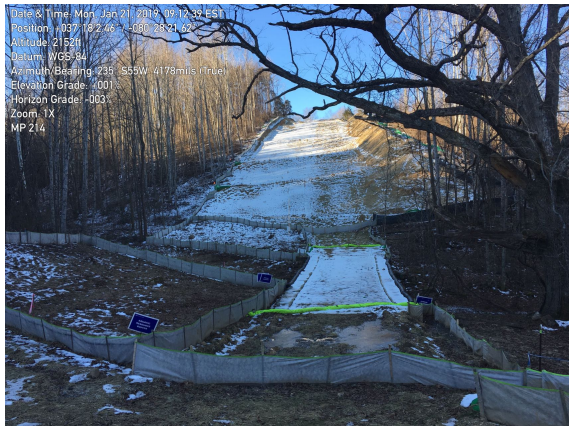
GPS Location	37.2427020036031, -80.4292973690484	GPS Location	37.2427020036031, -80.4292973690484		
Description	ROW conditions and ECD's for S-NN12	Description	Water bar and end treatment @ 11330+00		
<p>Date & Time: Mon Jan 21, 2019, 08:41:38 EST Position: +037° 18' 45.22" -080° 31' 5.70" Altitude: 2021ft Datum: WGS-84 Azimuth/Bearing: 046° N46E 0818mils (True) Elevation Grade: -019% Horizon Grade: -006% Zoom: 1X MountainLake</p>

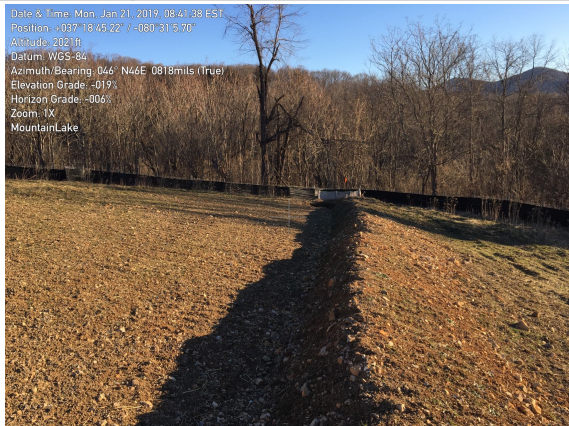
GPS Location	37.2427020036031, -80.4292973690484	GPS Location	37.2427020036031, -80.4292973690484		
Description	Water bar and end treatment @ MP 209.5	Description	Row conditions and ECDs for s-Nn11

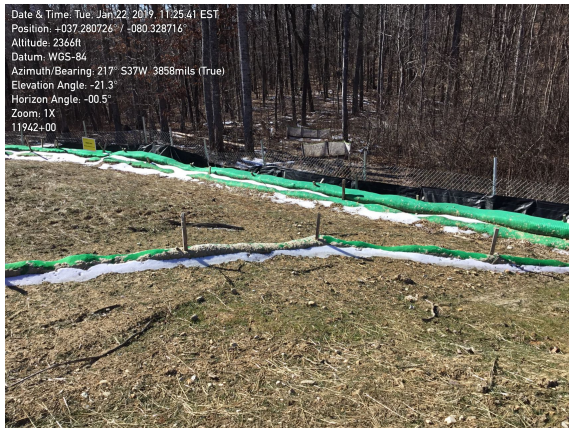
GPS Location	37.2962335730319, -80.3676747065786	GPS Location	37.2960503865381, -80.3676118423048		
Description	11942+00 karst	Description	Drainage to karst 11950+00		
<p>Date & Time: Tue Jan 22, 2019, 11:44:32 EST Position: +037.269904° / -080.323189° Altitude: 1689ft Datum: WGS-84 Azimuth/Bearing: 83° 42'6W 5938mils (True) Elevation Angle: -28.0° Horizon Angle: -00.3° Zoom: 1X 11979+00</p>

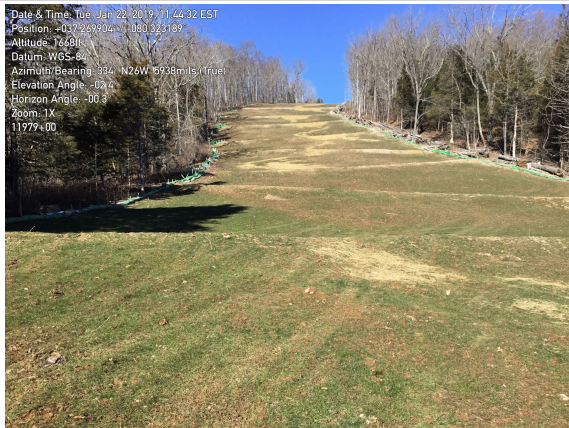
GPS Location	37.2963313898419, -80.3678151034567	GPS Location	37.2959588561554, -80.3678596951816		
Description	Row 11979+00	Description	ECDs are 11979+00

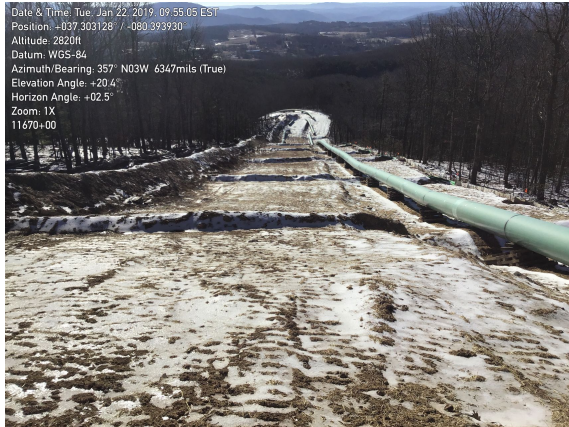
GPS Location	37.2129562637184, -80.4021221493188	GPS Location	37.2129562637184, -80.4021221493188		
Description	See photo for station number and GPS location. ROW frozen and snow covered. Water bars in place.	Description	See photo for station number and GPS location. Sump pit with end treatment in place.		
<p>Date & Time: Tue, Jan 22, 2019, 09:58:52 EST Position: +037.301843 / -080.393335 Altitude: 2681ft Datum: WGS-84 Azimuth/Bearing: 008° N08E 012mils (True) Elevation Angle: +23.7° Horizon Angle: +01.3° Zoom: 1X 11674+00</p>

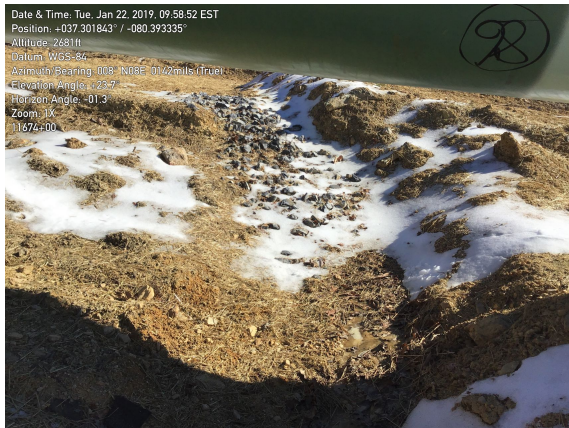
GPS Location	37.2128924774353, -80.402236143202	GPS Location	37.2129562637184, -80.4021221493188		
Description	See photo for station number and GPS location. Rock check in place over two-tone to prevent erosion.	Description	See photo for station number and GPS location. Sensitive resource buffer in place at stream S-MN21.		
<p>Date & Time: Tue, Jan 22, 2019, 11:37:47 EST Position: +037.296076 / -080.367692 Altitude: 2013ft Datum: WGS-84 Azimuth/Bearing: 341° N19W 6062mils (True) Elevation Angle: +25.8° Horizon Angle: +04.4° Zoom: 1X 11768+50</p>

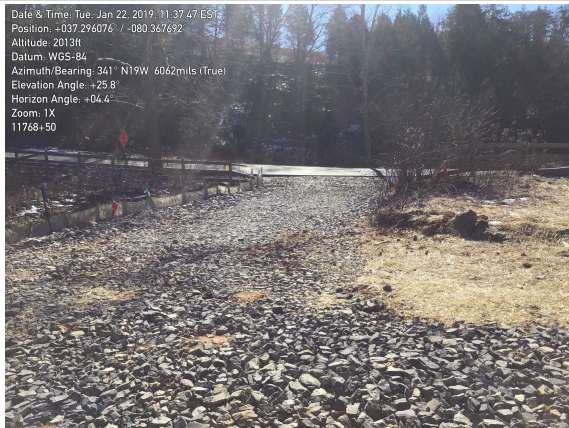
GPS Location	37.2128868615601, -80.402175542042	GPS Location	37.2128868615601, -80.402175542042		
Description	See photo for station number and GPS location. RCE in place at main line valve 26 access point.	Description	See photo for station number and GPS location. Reinforce filter fence in place.

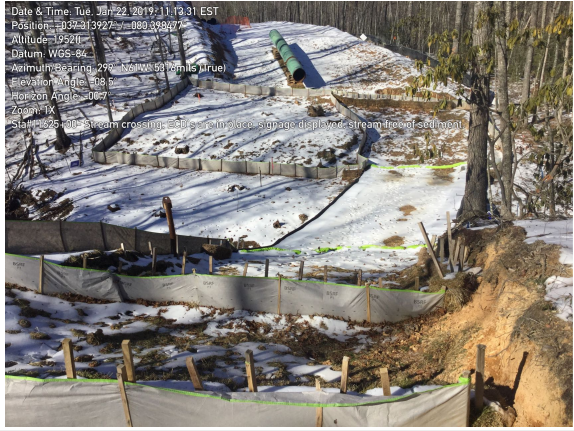
GPS Location	37.3139240406801, -80.3984840680663		GPS Location	37.3137670057242, -80.4026143346731	
Description	Sta#11625+00- Stream crossing, ECD's are good, signage displayed.		Description	Sta#11610+55- S-RR 14- ECD's in good condition, signage displayed, stream free of sediment.

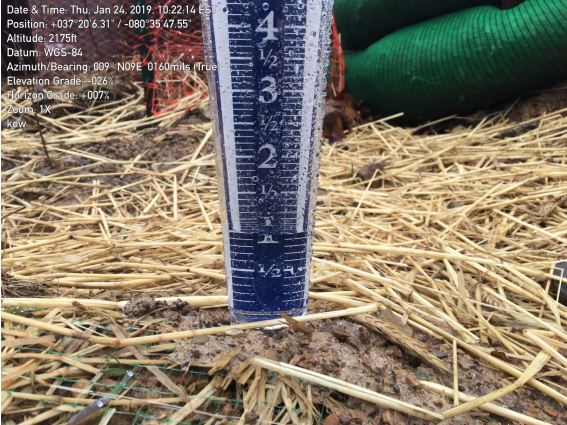
<p>Date & Time: Thu, Jan 24, 2019, 10:22:14 EST Position: +037° 20' 6.31" / -080° 35' 47.55" Altitude: 2175ft Datum: WGS-84 Azimuth/Bearing: 809° N09E 0160mils (True) Elevation Grade: -026° Horizon Grade: -007° Zoom: 1X Kow</p>		GPS Location 37.3373248055925, -80.6045000162726	
Description Damaged curlex @ AR 234		Description Rain gauge reading 1" @ Kow Camp crossing

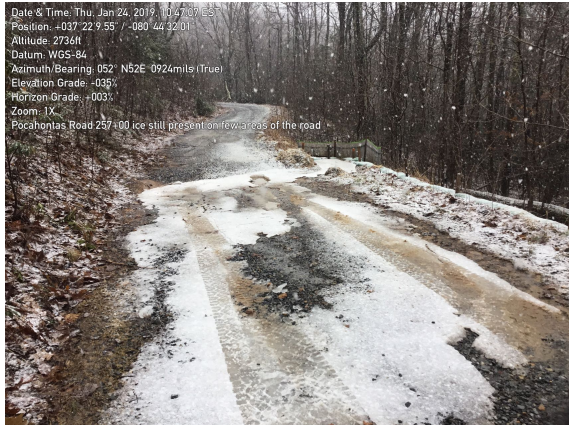
AFE	124300137	Date/Time	1/24/2019 2:30 PM	Report #	13309
Pictures					
<p>Date & Time: Thu, Jan 24, 2019, 09:17:07 EST Position: +037°22'9.55" / -080°44'32.01" Altitude: 2736ft Datum: WGS-84 Azimuth/Bearing: 052° N52E 0924mils (True) Elevation Grade: +003% Horizon Grade: +003% Zoom: 1X Pocahontas Road 257+00 ice still present on few areas of the road</p>

GPS Location	37.133117528162, -80.3944800568839	GPS Location	37.1330777857424, -80.394454186457		
Description	Correct coordinates on photo. Patches of ice are now melting.	Description	Correct coordinates on photo. No issues near intersection of Appalachian Trail and Pocahontas Road.

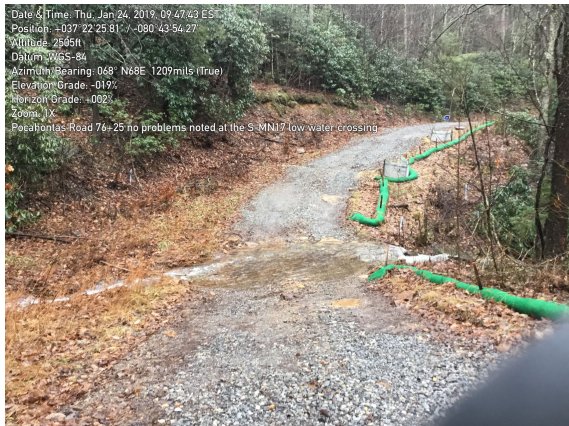
<p>Date & Time: Thu, Jan 24, 2019, 09:47:43 EST Position: +037°22'25.81" / -080°43'34.27" Altitude: 2565ft Datum: WGS-84 Azimuth/Bearing: 068° N68E 1209mils (True) Elevation Grade: -019% Horizon Grade: +002% Zoom: 1X Pocahontas Road 76+25 no problems noted at the S-MN17 low water crossing</p>

GPS Location	37.1330701466996, -80.3943931964044	GPS Location	37.1330162929717, -80.3944052663449		
Description	Correct coordinates on photo. Resources crossed by the road show no signs of impact.	Description	Correct coordinates on photo. Resources crossed by the road show no sign of impact.		
<p>Date & Time: Thu, Jan 24, 2019, 10:57:27 EST Position: +037°23'48.86" / -080°41'39.22" Altitude: 2836ft Datum: WGS-84 Azimuth/Bearing: 078° N78E 1387mils (True) Elevation Grade: +044% Horizon Grade: +004% Zoom: 1X Pocahontas Road 125+00 impact apparent to adjacent resource W-UU11</p>

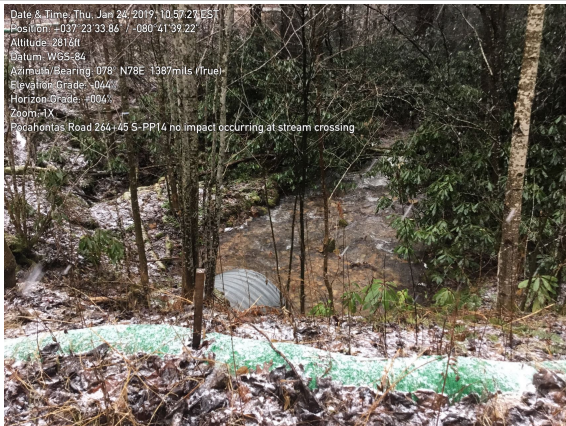
<p>Date & Time: Thu, Jan 24, 2019, 10:57:27 EST Position: +037°23'33.86" / -080°41'39.22" Altitude: 2836ft Datum: WGS-84 Azimuth/Bearing: 078° N78E 1387mils (True) Elevation Grade: +044% Horizon Grade: +004% Zoom: 1X Pocahontas Road 244+45 S-PP14 no impact occurring at stream crossing</p>

GPS Location	37.1330162929717, -80.3944052663449	GPS Location	37.1330162929717, -80.3944052663449		
Description	Correct coordinates on photo. No sediment migration originated from the roadway has impacted adjacent resources.	Description	Correct coordinates on photo. No sediment migration originated from the roadway has impacted adjacent resources.

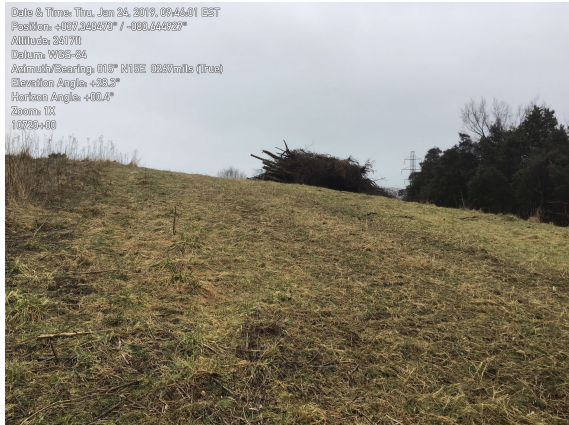
A/E	124300137	Date/Time	1/24/2019 3:01 PM	Report #	13311
Pictures					
<p>Date & Time: Thu, Jan 24, 2019, 09:44:01 EST Position: +037.26297° / -080.64292° Altitude: 2417ft Datum: WGS-84 Azimuth/Bearing: 010° N10E 022mils (True) Elevation Angle: +33.2° Horizon Angle: +00.4° Zoom: 1X 10720+00</p>

GPS Location	37.2060163831685, -80.394019698799	GPS Location	37.2060163831685, -80.394019698799		
Description	See photo for station number and GPS location. ROW is stabilized with natural vegetation.	Description	See photo for station number and GPS location. Sensitive resource buffer in place at stream crossing.		
<p>Date & Time: Thu, Jan 24, 2019, 10:58:02 EST Position: +037.24916° / -080.657245° Altitude: 2047ft Datum: WGS-84 Azimuth/Bearing: 331° N29W 588mils (True) Elevation Angle: +22.5° Horizon Angle: -02.7° Zoom: 1X 10698+15.5+630</p>

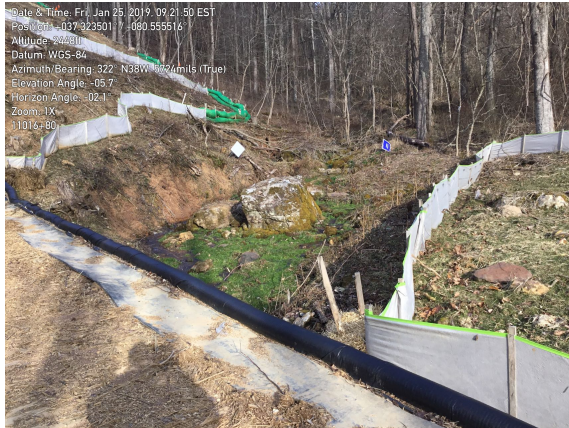
GPS Location	37.3340274159589, -80.7501116826022	GPS Location	37.3340146028741, -80.750102251989		
Description	11016+80 stream crossing with ECDs in good condition	Description	Sump and end treatment 10970+00		
<p>Date & Time: Fri, Jan 25, 2019, 11:23:39 EST Position: +037.326260 / -080.426966 Altitude: 2196ft Datum: WGS-84 Azimuth/Bearing: 310 N50W 5511mils (True) Elevation Angle: +22.3 Horizon Angle: +02.9 Zoom: 1X 11510+00</p>

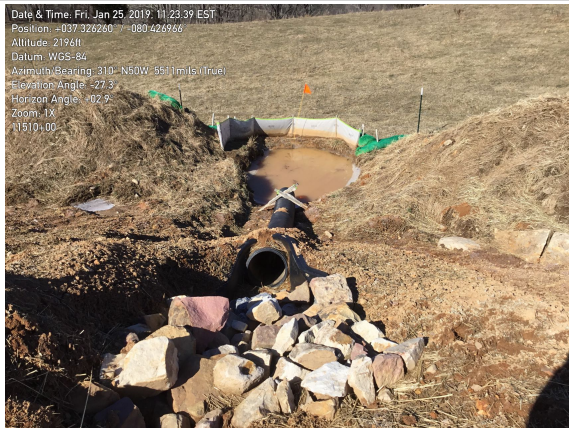
GPS Location	37.3340298667235, -80.7501109277207	GPS Location	37.3337323971163, -80.7502536096401		
Description	Slope drain into sump 11510+00	Description	11498+00 sump with end treatment

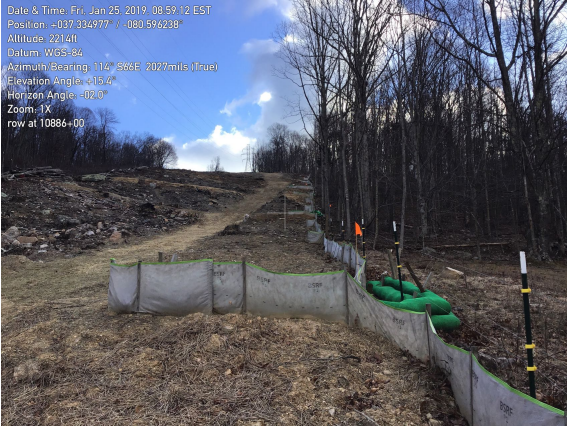
A/E	124300137	Date/Time	1/25/2019 10:58 AM	Report #	13360
Pictures					
<p>Date & Time: Fri, Jan 25, 2019, 08:59:12 EST Position: +037.332977° / -080.596238° Altitude: 2214ft Datum: WGS-84 Azimuth/Bearing: 112° S88E 2027mils (True) Elevation Angle: +15.0° Horizon Angle: -02.0° Zoom: 1X row at 10886+00</p>

GPS Location	37.325006634963, -80.4312948603932	GPS Location	37.3251023143877, -80.4312742409114		
Description	See photo for station number and GPS location. Installed perimeter controls	Description	See photo for station number and GPS location. Sump and end treatment		
<p>Date & Time: Fri, Jan 25, 2019, 09:11:10 EST Position: +037.334462° / -080.593489° Altitude: 2486ft Datum: WGS-84 Azimuth/Bearing: 093° S87E 1653mils (True) Elevation Angle: +09.5° Horizon Angle: +04.3° Zoom: 1X row at 10895+00</p>

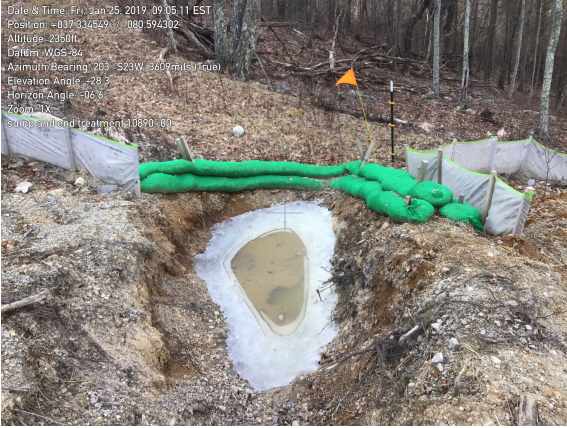
<p>Date & Time: Fri, Jan 25, 2019, 09:05:11 EST Position: +037.334529° / -080.594302° Altitude: 2350ft Datum: WGS-84 Azimuth/Bearing: 203° S23W 3009mils (True) Elevation Angle: +26.3° Horizon Angle: -05.5° Zoom: 1X Sump and end treatment at 10890+00</p>

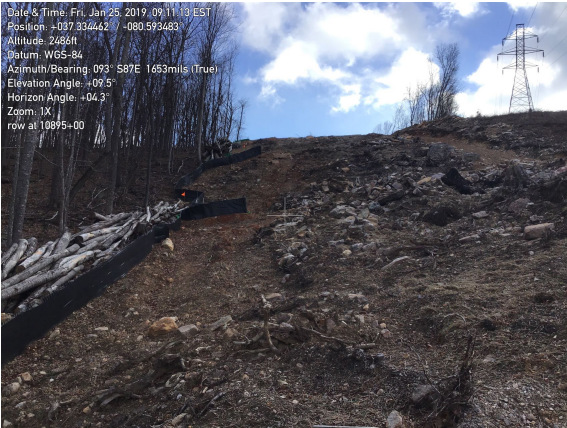
GPS Location	37.3251023143877, -80.4312742409114	GPS Location	37.3251396138569, -80.4313071817909		
Description	See photo for station number and GPS location. Reinforced silt fence	Description	See photo for station number and GPS location. Non graded ROW		
<p>Date & Time: Fri, Jan 25, 2019, 09:17:30 EST Position: +037.334032° / -080.602275° Altitude: 2563ft Datum: WGS-84 Azimuth/Bearing: 055° N55E 3078mils (True) Elevation Angle: +00.1° Horizon Angle: -01.8° Zoom: 1X row at 10900+00</p>

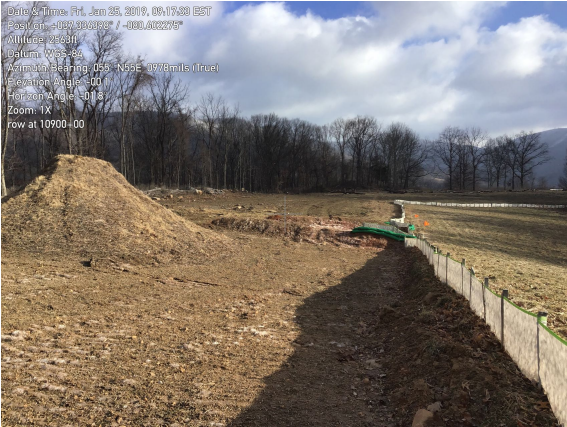
GPS Location	37.3251396138569, -80.4313071817909	GPS Location	37.3250107001861, -80.4312748276446		
Description	See photo for station number and GPS location. Priority one silt fence	Description	See photo for station number and GPS location. Stream s-y3

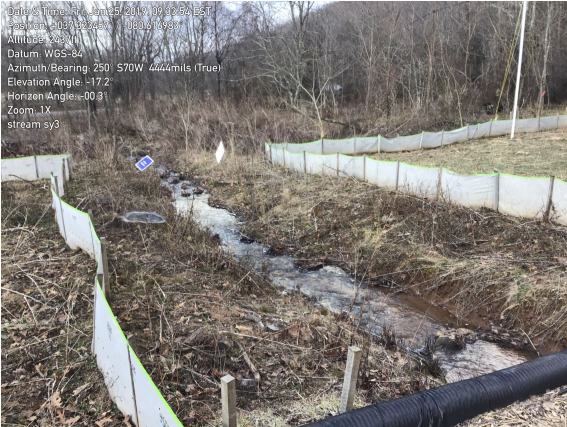
<p>Date & Time: Fri, Jan 25, 2019, 09:46:47 EST Position: +037.334032° / -080.602275° Altitude: 2563ft Datum: WGS-84 Azimuth/Bearing: 250° S70W 4444mils (True) Elevation Angle: -17.2° Horizon Angle: -00.8° Zoom: 1X stream s-y3</p>

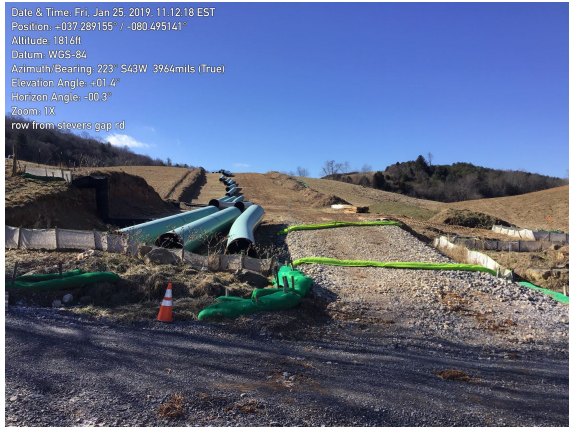
A/E	124300137	Date/Time	1/25/2019 3:37 PM	Report #	13361
Pictures					
<p>Date & Time: Fri, Jan 25, 2019 11:12:18 EST Position: +037.289155 / -080.495141 Altitude: 1816ft Datum: WGS-84 Azimuth/Bearing: 223° 54'3W 3964mils (True) Elevation Angle: +01.4° Horizon Angle: +00.3° Zoom: 1X row from stevers gap rd</p>

GPS Location	37.1361730233505, -80.3941677147145	GPS Location	37.1361677292316, -80.3942104373384		
Description	Row from stevers gap road.	Description	Plunge pool at 11487+00		
<p>Date & Time: Fri, Jan 25, 2019 11:14:31 EST Position: +037.322482 / -080.432284 Altitude: 2164ft Datum: WGS-84 Azimuth/Bearing: 232° 55'2W 4124mils (True) Elevation Angle: +00.4° Horizon Angle: +00.3° Zoom: 1X perimeter controls at 11486+00</p>

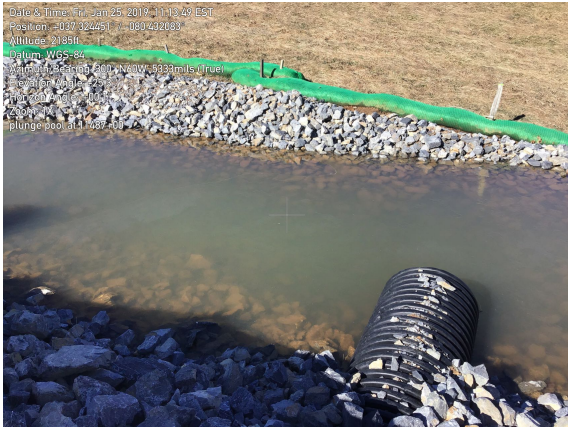
<p>Date & Time: Fri, Jan 25, 2019 11:15:49 EST Position: +037.324451 / -080.422033 Altitude: 2185ft Datum: WGS-84 Azimuth/Bearing: 223° 54'3W 3963mils (True) Elevation Angle: +01.4° Horizon Angle: +00.3° Zoom: 1X plunge pool at 11487+00</p>

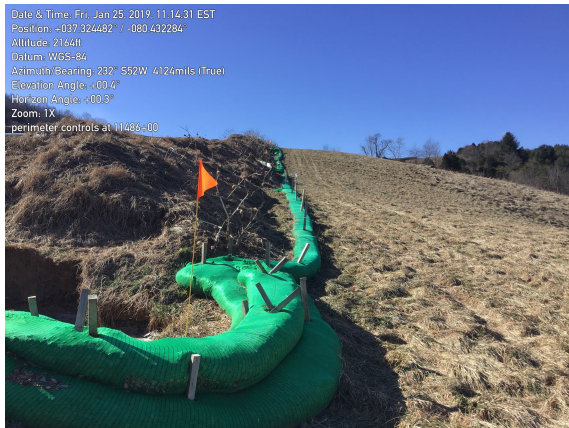
GPS Location	37.136090858874, -80.3941581678394	GPS Location	37.136090858874, -80.3941581678394		
Description	Perimeter controls at 11486+00	Description	Sump and end treatment 11483+00		
<p>Date & Time: Fri, Jan 25, 2019 11:12:04 EST Position: +037.304125 / -080.437573 Altitude: 2239ft Datum: WGS-84 Azimuth/Bearing: 231° 54'4E 4285mils (True) Elevation Angle: +01.5° Horizon Angle: +01.5° Zoom: 1X Slope drain at 11480+00</p>

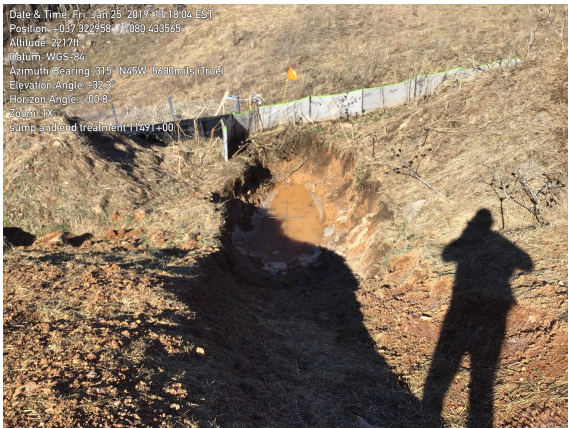
<p>Date & Time: Fri, Jan 25, 2019 11:14:04 EST Position: +037.322958 / -080.433665 Altitude: 2217ft Datum: WGS-84 Azimuth/Bearing: 315° N45W 5200mils (True) Elevation Angle: +32.3° Horizon Angle: +00.8° Zoom: 1X Sump and end treatment 11491+00</p>

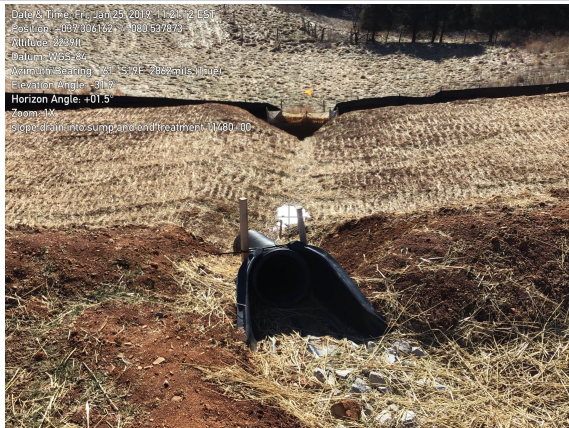
GPS Location	37.136090858874, -80.3941581678394	GPS Location	37.136090858874, -80.3941581678394		
Description	Slope drain at 11480+00	Description	Sump and end treatment 11477+00

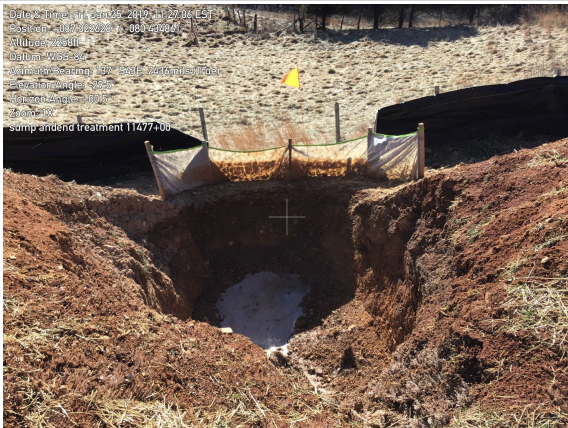
<p>Date & Time: Fri, Jan 25, 2019 11:12:04 EST Position: +037.304125 / -080.437573 Altitude: 2239ft Datum: WGS-84 Azimuth/Bearing: 231° 54'4E 4285mils (True) Elevation Angle: +01.5° Horizon Angle: +01.5° Zoom: 1X Sump and end treatment 11477+00</p>
