# Visual Site Inspection Report

<b>Project Name</b>	H-600 Pipeline Spread G	<b>AFE</b>	124300137	<b>Spread</b>	H-600 Pipeline Spread G	
<b>Contractor</b>	Precision			<b>Report #</b>	13628	
<b>Inspector</b>	Len Kruizenga			<b>Date/Time</b>	2/4/2019 7:02 AM	
<b>Permit #</b>	TBD	<b>Inspection Type</b>	VA SWPP	<b>Station Begin</b>	+0	
<b>State</b>	WV	<b>Inspection Area</b>	Full	<b>Station End</b>	+0	
<b>County</b>	Monroe	<b>Ground</b>	Frozen	<b>Temperature (°F)</b>	55.00	
<b>Municipality</b>	N/A	<b>Weather</b>	Sunny	<b>Rain Gauge (in)</b>	0.00	
<b>GPS Location</b>	37.4164080201065, -80.7403622009612			<b>Rain Accumulation Time (days)</b>	1.00

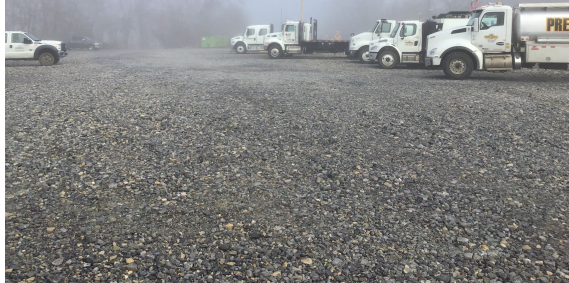
A/E	124300137	Date/Time	2/4/2019 2:25 PM	Report #	13651
Pictures					
<p>Date &amp; Time: Mon, Feb 04, 2019, 09:15:16 EST Position: +037.338918° / -080.666131° Altitude: 1525ft Datum: WGS-84 Azimuth/Bearing: 363° N179° 000mils (True) Elevation Angle: +28.4° Horizon Angle: +08.4° Zoom: 1X Lay Down Yard 28</p>

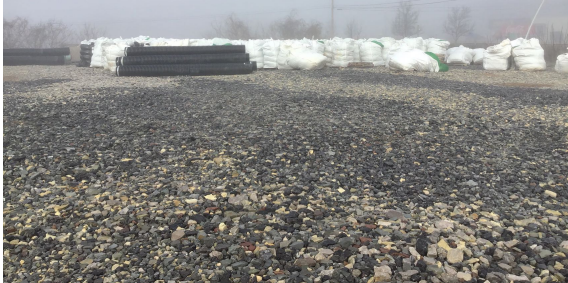
<p>Date &amp; Time: Mon, Feb 04, 2019, 09:15:37 EST Position: +037.338918° / -080.666131° Altitude: 1514ft Datum: WGS-84 Azimuth/Bearing: 363° N180° 000mils (True) Elevation Angle: +28.4° Horizon Angle: +08.4° Zoom: 1X Lay Down Yard 28</p>

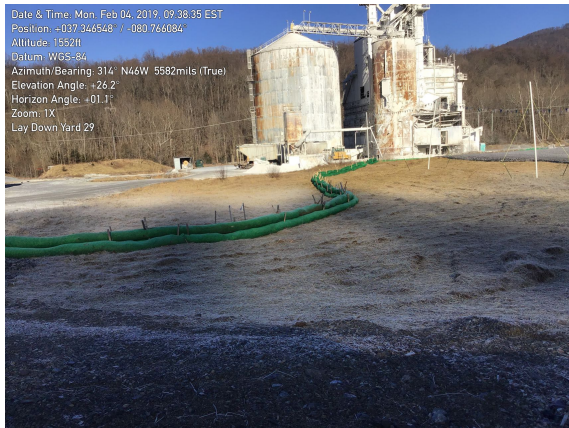
GPS Location	37.3276667576631, -80.5517086108034		GPS Location	37.3273914959629, -80.5515905936067	
Description	See photo for GPS location. Triple stack 18 inch compost filter sock in place at lay down yard 29.		Description	See photo for GPS location. RCE and 12 inch compost filter sock in place at lay down yard 28.	
<p>Date &amp; Time: Mon, Feb 04, 2019, 09:38:53 EST Position: +037.346548° / -080.676791° Altitude: 1525ft Datum: WGS-84 Azimuth/Bearing: 107° N57W 1458mils (True) Elevation Angle: +26.9° Horizon Angle: +01.5° Zoom: 1X Lay Down Yard 29</p>

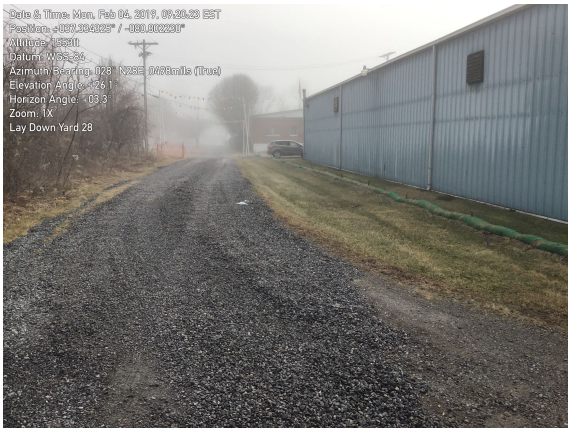
<p>Date &amp; Time: Mon, Feb 04, 2019, 09:39:31 EST Position: +037.346548° / -080.666131° Altitude: 1525ft Datum: WGS-84 Azimuth/Bearing: 028° N282° 000mils (True) Elevation Angle: +26.1° Horizon Angle: +03.3° Zoom: 1X Lay Down Yard 28</p>

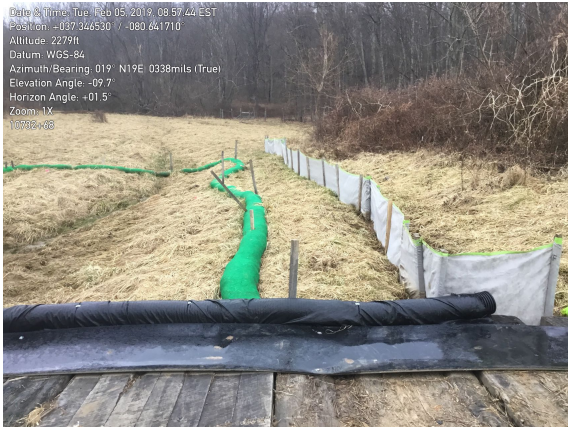
GPS Location	37.3316894844522, -80.5823006295418	GPS Location	37.3316894844522, -80.5823006295418		
Description	10732+68 wetland/ ECDs	Description	10732+68 wetland/ECDs		
<p>Date &amp; Time: Tue, Feb 05, 2019, 09:00:00 EST Position: +037.345092° / -080.645319° Altitude: 2061ft Datum: WGS-84 Azimuth/Bearing: 031° N31E 0551mils (True) Elevation Angle: -04.0° Horizon Angle: -00.2° Zoom: 1X 10677+00</p>

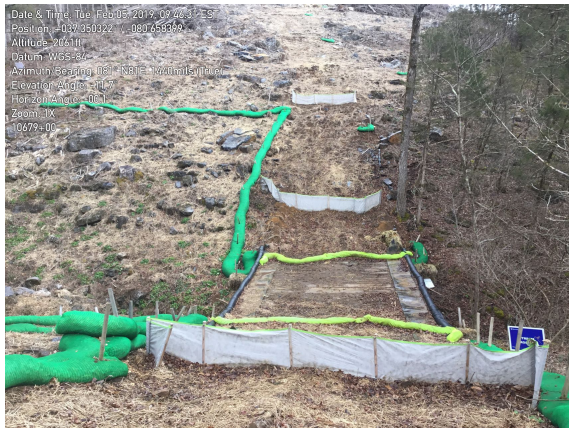
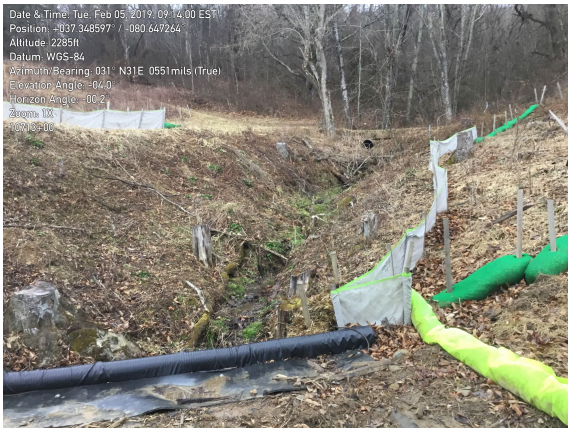
GPS Location	37.3315643845474, -80.5822028127318	GPS Location	37.3315495904883, -80.5822107755398		
Description	10713+00 ECDs in good condition	Description	Stream ECDs in good condition 10713+00		
<p>Date &amp; Time: Tue, Feb 05, 2019, 09:50:45 EST Position: +037.350393° / -080.659115° Altitude: 2156ft Datum: WGS-84 Azimuth/Bearing: 283° N77W 5031mils (True) Elevation Angle: +03.7° Horizon Angle: +00.0° Zoom: 1X 10677+00</p>

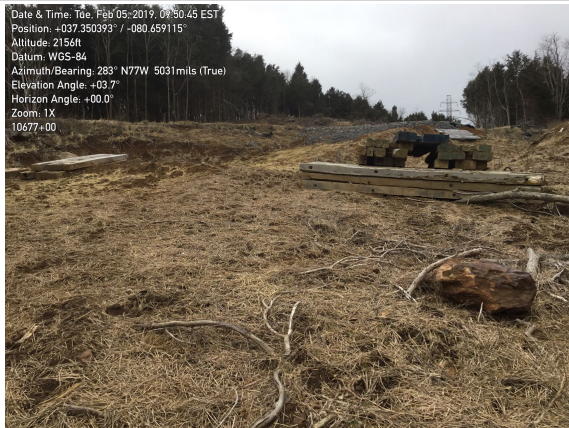
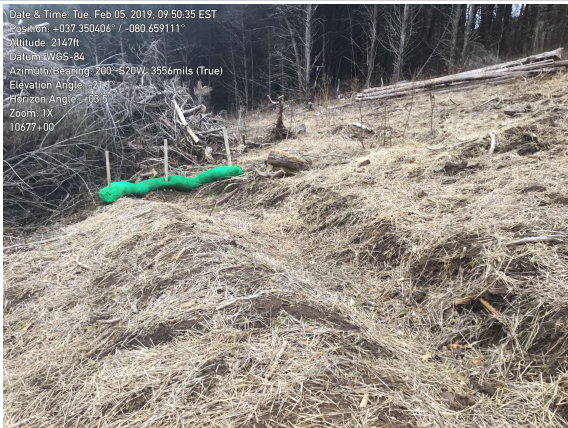
GPS Location	37.3317157617186, -80.5822461471712	GPS Location	37.3317830684011, -80.5821867194777		
Description	Row 10677+00	Description	Water breaker in good condition 10677+00

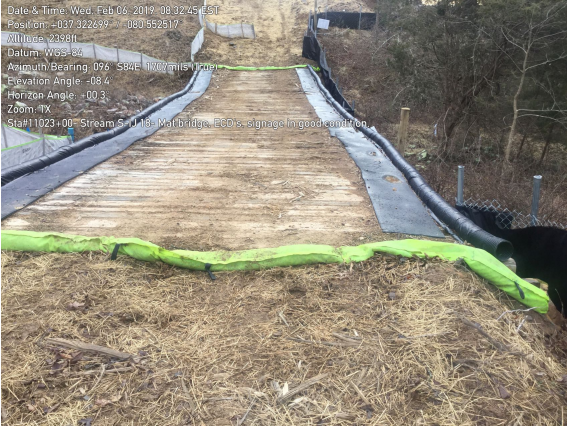
<p>Date &amp; Time: Wed, Feb 06, 2019, 08:32:45 EST Position: +037.322697, -80.552517 Altitude: 2296ft Datum: WGS-84 Azimuth/Bearing: 096° S84E 1003mils (True) Elevation Angle: -08.6° Horizon Angle: -00.3° Zoom: 1X Sta#11023+00- Stream S-IJ 18 Mat bridge, ECD's signage in good condition.</p>		  <p>Date &amp; Time: Wed, Feb 06, 2019, 08:33:28 EST Position: +037.318459, -80.548458 Altitude: 2196ft Datum: WGS-84 Azimuth/Bearing: +02° S78E 1813mils (True) Elevation Angle: -09.7° Horizon Angle: -01.5° Zoom: 1X Sta#11028+00- Stream S-IJ 16 &amp; 17- Mat bridge, ECD's signage in good condition, sediment not impacting stream.</p>		<b>GPS Location</b>	37.32759277, -80.48617247
<b>Description</b>		<b>Description</b>		<b>GPS Location</b>	37.32759277, -80.48617247
Sta#11023+00- Stream S-IJ 18		Sta# 11048+00- Stream S-IJ 16 & 17

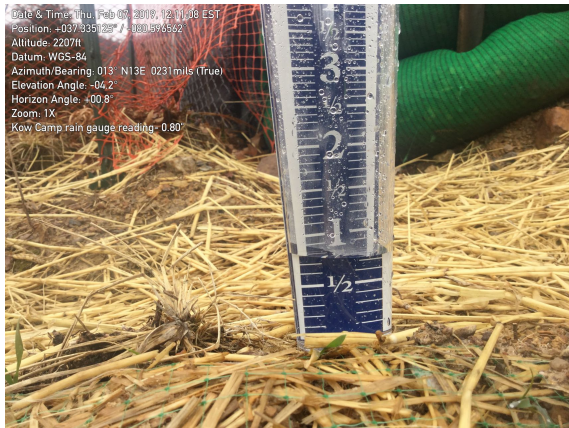
<p>Date &amp; Time: Thu, Feb 07, 2019, 12:37:03 EST Position: +037.3012077 / -080.501344° Altitude: 2207ft Datum: WGS-84 Azimuth/Bearing: 013° N13E 0231mils (True) Elevation Angle: -04.2° Horizon Angle: -00.8° Zoom: 1X Kow Camp rain gauge reading- 0.80"</p>

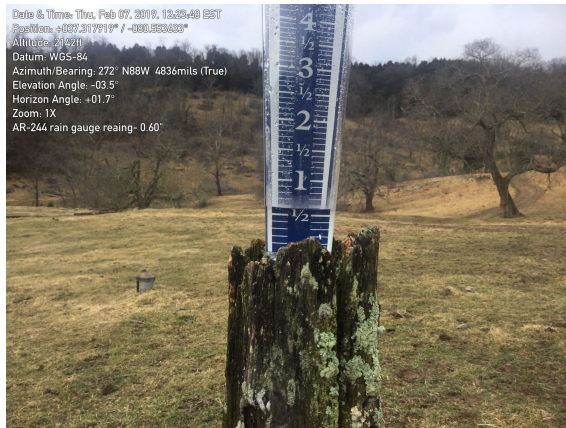
<p>Date &amp; Time: Thu, Feb 07, 2019, 12:55:04 EST Position: +037.3115222 / -080.435750° Altitude: 2253ft Datum: WGS-84 Azimuth/Bearing: 272° N88W 483mils (True) Elevation Angle: -03.5° Horizon Angle: +01.7° Zoom: 1X AR-244 rain gauge reading- 0.60"</p>

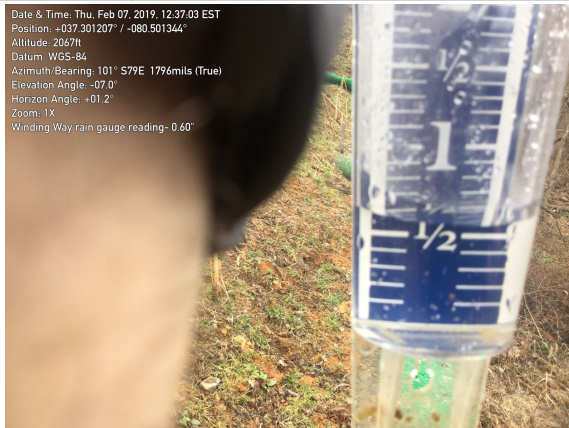
GPS Location	37.32759277, -80.48617247	GPS Location	37.32759277, -80.48617247		
Description	Kow Camp rain gauge reading- 0.80"	Description	AR-244 rain gauge reading- 0.60"		
<p>Date &amp; Time: Thu, Feb 07, 2019, 12:37:03 EST Position: +037.3012077 / -080.501344° Altitude: 2067ft Datum: WGS-84 Azimuth/Bearing: 101° S79E 1796mils (True) Elevation Angle: -07.0° Horizon Angle: +01.2° Zoom: 1X Winding Way rain gauge reading- 0.60"</p>

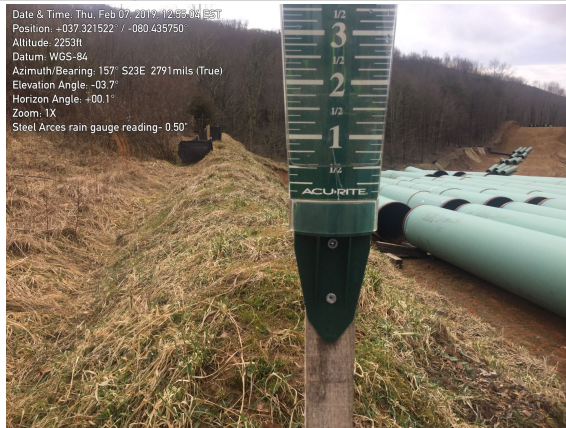
<p>Date &amp; Time: Thu, Feb 07, 2019, 12:55:04 EST Position: +037.3215222 / -080.435750° Altitude: 2253ft Datum: WGS-84 Azimuth/Bearing: 157° S23E 2791mils (True) Elevation Angle: -03.7° Horizon Angle: +00.1° Zoom: 1X Steel Acres rain gauge reading- 0.50"</p>

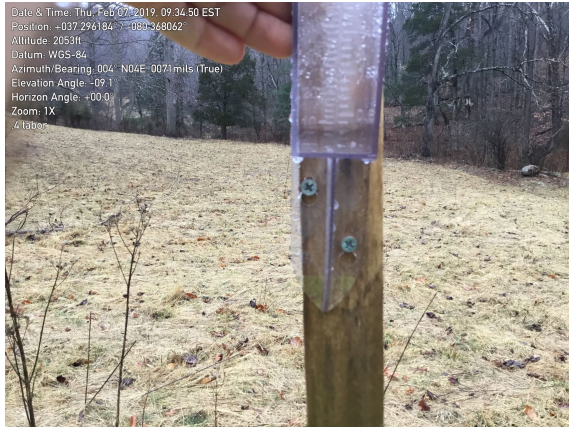
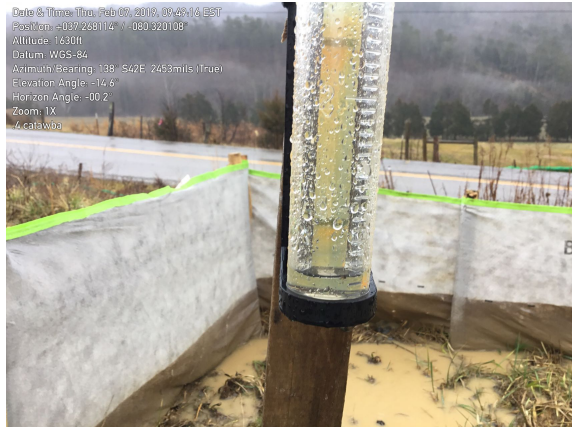
GPS Location		37.3328452650805, -80.7502814289934		GPS Location	
Description		Rain gauge mt. Tabor .4"		37.3328475281944, -80.7502748072899	
Description		Rain gauge Catawba .4"

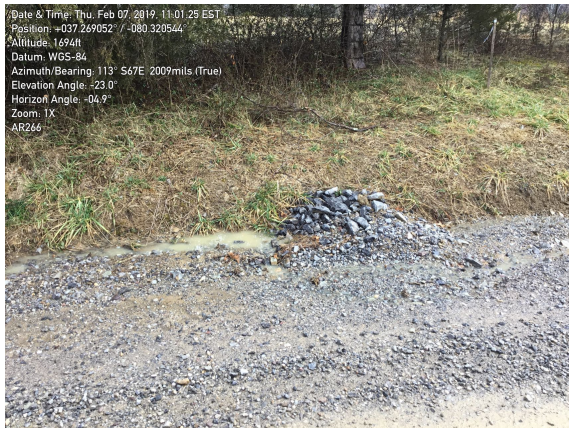
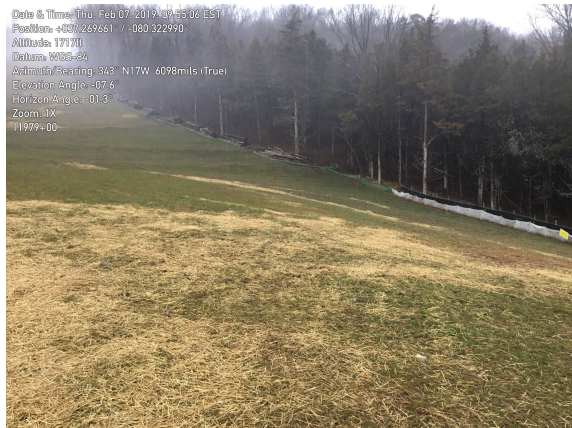
GPS Location		37.3328620288869, -80.7502557803697		GPS Location	
Description		Ditch check AR266		37.3329095123683, -80.7504286990322	
Description		Row 11979+00			
Insert image here

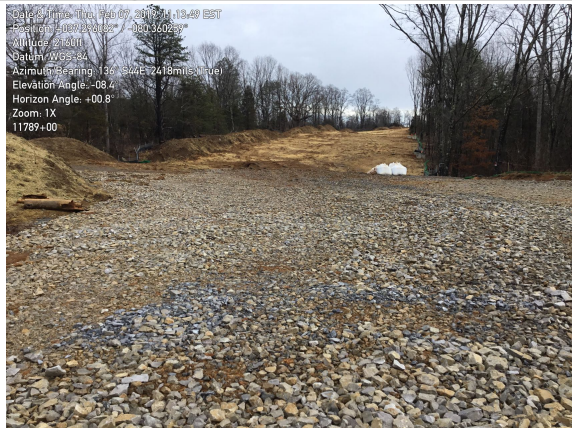
GPS Location		37.3329095123683, -80.7504286990322		GPS Location	
Description		RCE 11789+00		Description

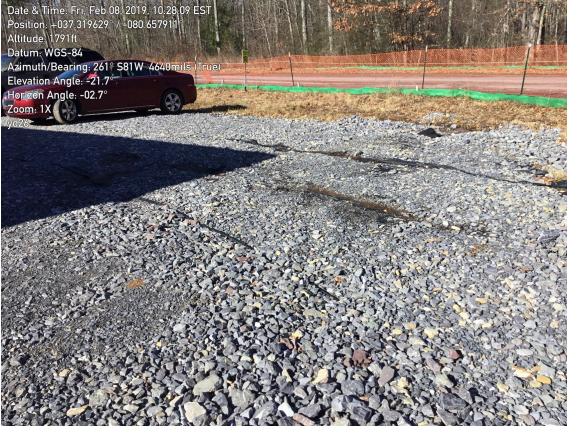
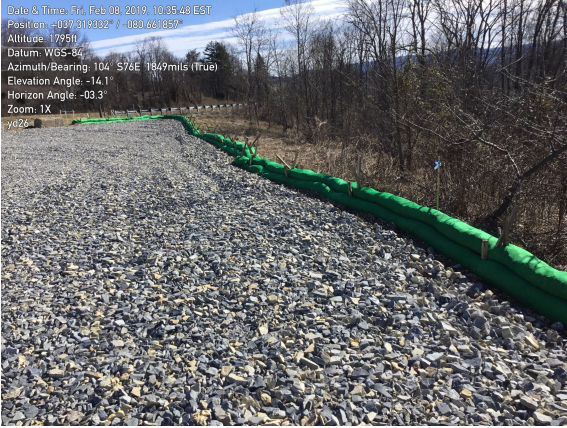
<b>GPS Location</b>	37.3192745866602, -80.6579143647856	<b>GPS Location</b>	37.3193198908468, -80.658010672853		
<b>Description</b>	Yd26	<b>Description</b>	ECDs yd26

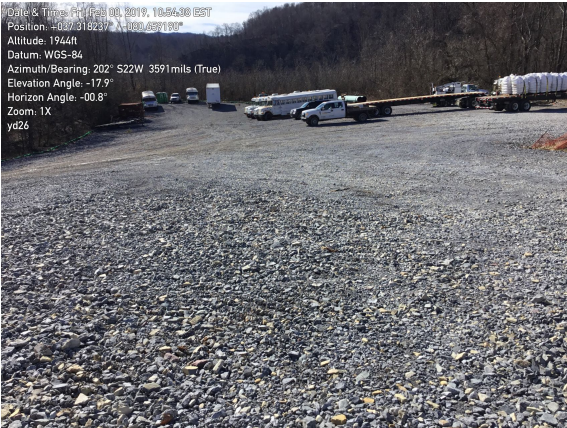
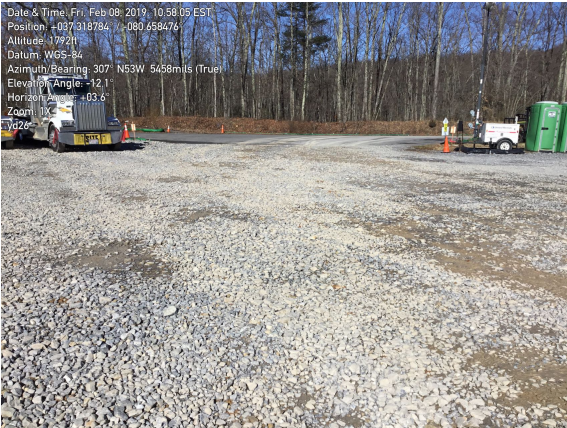
<b>GPS Location</b>	37.3192525716354, -80.6578681077584	<b>GPS Location</b>	37.3193121375864, -80.6578173023468		
<b>Description</b>	Yard 26	<b>Description</b>	RCE yd 26		
<p>Insert image here</p>		<p>Insert image here</p>			
<b>GPS Location</b>		<b>GPS Location</b>			
<b>Description</b>		<b>Description</b>
