Visual Site Inspection Report

Project Name	H-600 Pipeline Spread G	AFE	124300137	Spread	H-600 Pipeline Spread G	
Contractor	Precision			Report #	13873	
Inspector	Len Kruizenga			Date/Time	2/11/2019 8:37 AM	
Permit #	TBD	Inspection Type	VA SWPP	Station Begin	0+00	
State	WV	Inspection Area	Full	Station End	0+00	
County	Monroe	Ground	Muddy	Temperature (°F)	36.00	
Municipality	N/A	Weather	Light Rain	Rain Gauge (in)	0.50	
GPS Location	37.4166912446147, -80.7412810251869			Rain Accumulation Time (days)	1.00

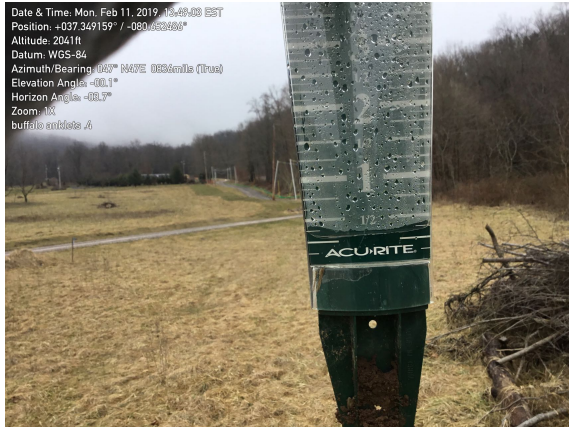
AFE	124300137	Date/Time	2/11/2019 2:17 PM	Report #	13891
Pictures					
<p>Date & Time: Mon, Feb 11, 2019, 10:40:00 EST Position: +037.349159° / -080.653466° Altitude: 2041ft Datum: WGS-84 Azimuth/Bearing: 062° N48E 055mils (True) Elevation Angle: -08.1° Horizon Angle: -08.3° Zoom: 1X buffalo anklets A</p>

GPS Location	37.319241984583, -80.657873095162	GPS Location	37.3193166638141, -80.6578472257412		
Description	.4" buffalo Anklets	Description	ECDs at wetland in good condition 10732+65		
<p>Date & Time: Mon, Feb 11, 2019, 10:48:51 EST Position: +037.350571° / -080.648321° Altitude: 2291ft Datum: WGS-84 Azimuth/Bearing: 146° S34E 2596mils (True) Elevation Angle: -04.7° Horizon Angle: -03.9° Zoom: 1X AR241</p>

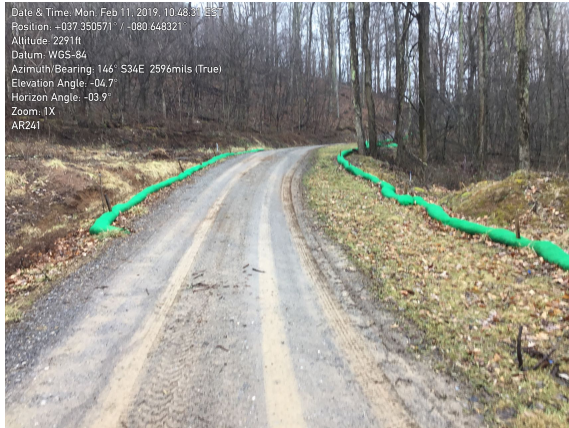
GPS Location	37.3192811664541, -80.6579994411028	GPS Location	37.319274083746, -80.6580753811455		
Description	AR241	Description	ECDs at stream crossing 10713+00		
<p>Date & Time: Mon, Feb 11, 2019, 10:59:19 EST Position: +037.349391° / -080.653429° Altitude: 1996ft Datum: WGS-84 Azimuth/Bearing: 306° N54W 5440mils (True) Elevation Angle: -14.0° Horizon Angle: -01.2° Zoom: 1X 10694+00</p>

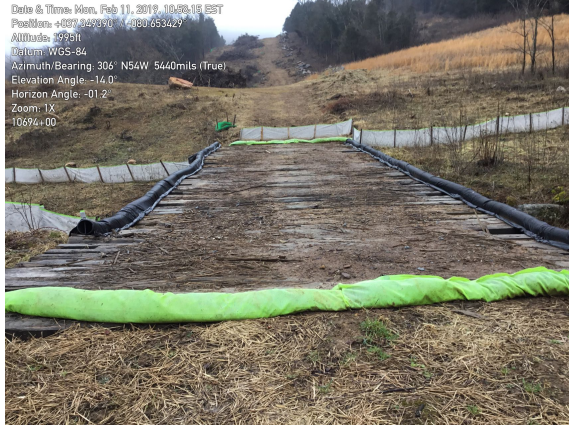
GPS Location	37.3192899674525, -80.6580261793739	GPS Location	37.3193970462655, -80.6580255088216		
Description	ECDs in good condition 10694+00	Description	ECDs on stream in good condition 10679+00

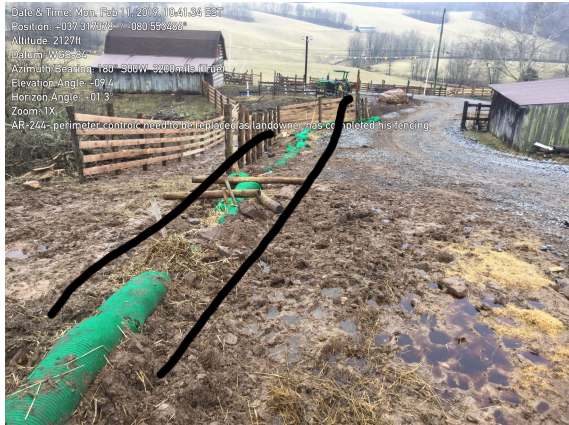
A/E	124300137	Date/Time	2/11/2019 10:50 AM	Report #	13893
Pictures					
<p>Date & Time: Mon, Feb 11, 2019, 10:41:36 EST Position: -037.312247 / -80.553212 Altitude: 2127ft Datum: WGS-84 Azimuth/Bearing: 184° S30W 2667mils (True) Elevation Angle: -07.8° Horizon Angle: -01.3° Zoom: 1X AR-244- perimeter controls need to be replaced as (landowner has completed his fencing)</p>

GPS Location	37.3224791558807, -80.5530568399285	GPS Location	37.3224012460907, -80.5531655532127		
Description	AR-244- CFS perimeter controls need to be reinstalled.	Description	Sta#11022+00- Stream S-IJ 18- Bridge & ECD's		
<p>Date & Time: Mon, Feb 11, 2019, 11:00:22 EST Position: -037.325427 / -80.564296 Altitude: 2406ft Datum: WGS-84 Azimuth/Bearing: 304° N56W 5500mils (True) Elevation Angle: -03.3° Horizon Angle: -01.6° Zoom: 1X Sta#11015+00- Stream S-RR 5</p>

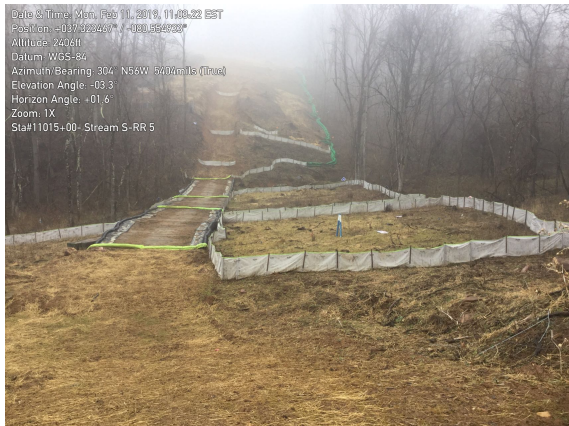
GPS Location	37.3254286218782, -80.5643145740783	GPS Location	37.3253651708712, -80.5642329343414		
Description	Sta#1106+00- Stream S- RR 5, Bridge & ECD's are in good condition	Description	Sta#10986+00 Double stream, Bridge & ECD's are in good condition.		
<p>Date & Time: Mon, Feb 11, 2019, 12:41:25 EST Position: -037.321657 / -80.567353 Altitude: 2060ft Datum: WGS-84 Azimuth/Bearing: 097° S89E 1618mils (True) Elevation Angle: -06.4° Horizon Angle: -00.1° Zoom: 1X Winding Way rain gauge - 0.40"</p>

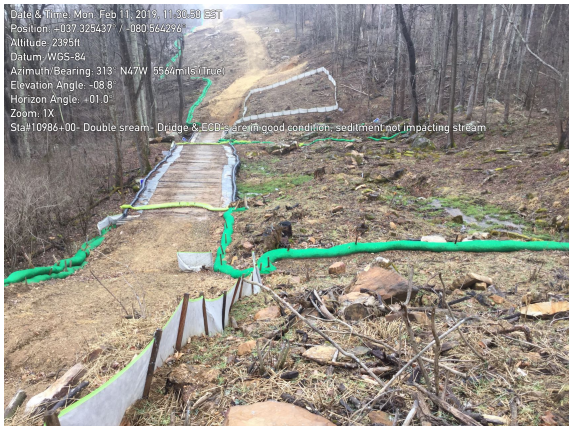
<p>Date & Time: Mon, Feb 11, 2019, 11:00:30 EST Position: -037.325427 / -80.564296 Altitude: 2335ft Datum: WGS-84 Azimuth/Bearing: 313° N47W 5564mils (True) Elevation Angle: -08.8° Horizon Angle: -01.0° Zoom: 1X Sta#10986+00- Double stream- Bridge & ECD's are in good condition- sediment not impacting stream</p>

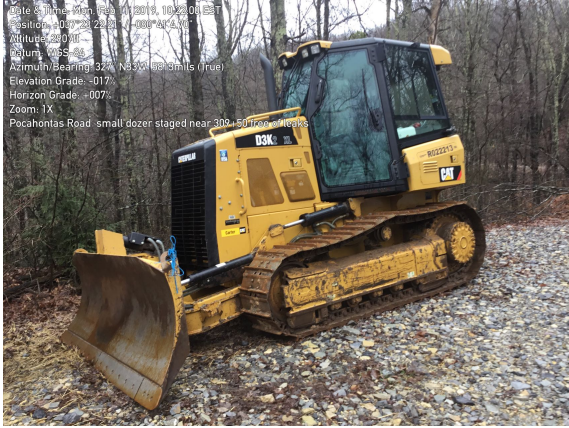
<p>Date & Time: Mon, Feb 11, 2019, 10:59:41 EST Position: +037° 22' 56.49" / -080° 43' 5.52" Altitude: 2958ft Datum: WGS-84 Azimuth/Bearing: 061° N61E 1084mils (True) Elevation Grade: -010% Horizon Grade: +005% Zoom: 1X Pocahontas Road small dozer staged near 309+50 trees - leaks</p>

GPS Location	37.13305196, -80.39505864	GPS Location	37.13305196, -80.39505864		
Description	Correct coordinates on photo. Failed culvert resulting in hole on road surface at S-PP19 crossing near 152+79.	Description	Correct coordinates on photo. Equipment staged on road is free of leaks.

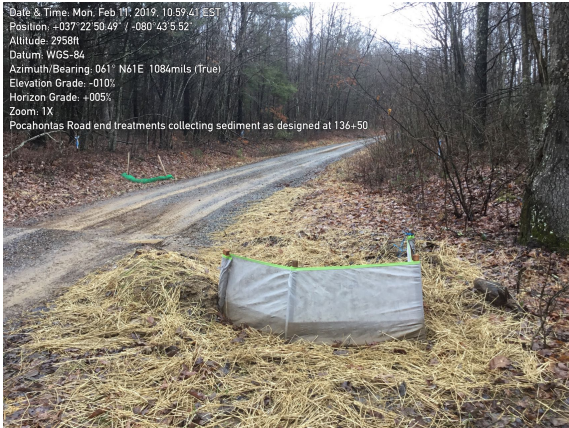
<p>Date & Time: Mon, Feb 11, 2019, 10:10:21 EST Position: +037° 13' 50.02" / -080° 43' 1.89" Altitude: 2943ft Datum: WGS-84 Azimuth/Bearing: 236° S36W 1796mils (True) Elevation Grade: -050% Horizon Grade: +010% Zoom: 1X Pocahontas Road S-PP15 crossing no obvious impact near 278+50</p>  		<p>Date & Time: Mon, Feb 11, 2019, 10:59:41 EST Position: +037° 22' 50.49" / -080° 43' 5.52" Altitude: 2958ft Datum: WGS-84 Azimuth/Bearing: 061° N61E 1084mils (True) Elevation Grade: -010% Horizon Grade: +005% Zoom: 1X Pocahontas Road end treatments collecting sediment as designed at 136+50</p>

GPS Location	37.1331866970632, -80.3944750875983	GPS Location	37.1331343520779, -80.3944600001726		
Description	Correct coordinates on photo. No impact to any resources along the road was identified.	Description	Correct coordinates on photo. ECDs in place and effective at 136+50.		
<p>Date & Time: Mon, Feb 11, 2019, 11:06:00 EST Position: +037° 22' 53.21" / -080° 43' 28.93" Altitude: 2977ft Datum: WGS-84 Azimuth/Bearing: 075° S05E 974mils (True) Elevation Grade: +037% Horizon Grade: -003% Zoom: 1X Pocahontas Road end treatments collecting sediment as designed at 156+00</p>

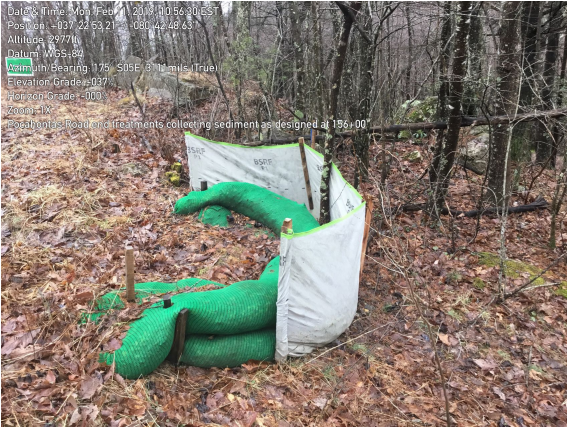
GPS Location	37.1331343520779, -80.3944600001726	GPS Location	37.1331343520779, -80.3944600001726		
Description	Correct coordinates on photo. ECDs in place and effective at 156+00.	Description	Correct coordinates on photo. ECDs in place and effective at 106+50.

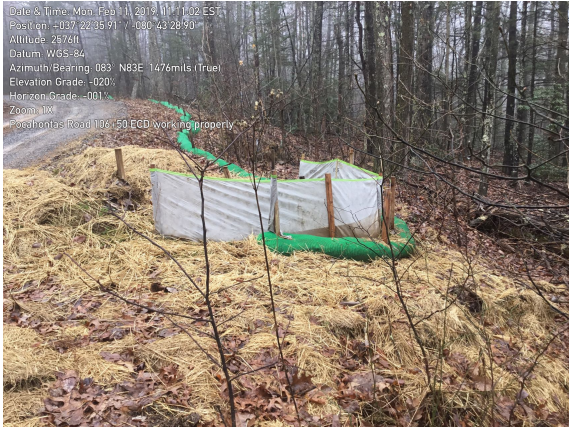
<p>Date & Time: Mon, Feb 11, 2019, 11:11:02 EST Position: +037° 22' 35.91" / -080° 43' 28.93" Altitude: 2976ft Datum: WGS-84 Azimuth/Bearing: 083° N83E 1476mils (True) Elevation Grade: -020% Horizon Grade: -001% Zoom: 1X Pocahontas Road 106+50 ECD working properly</p>

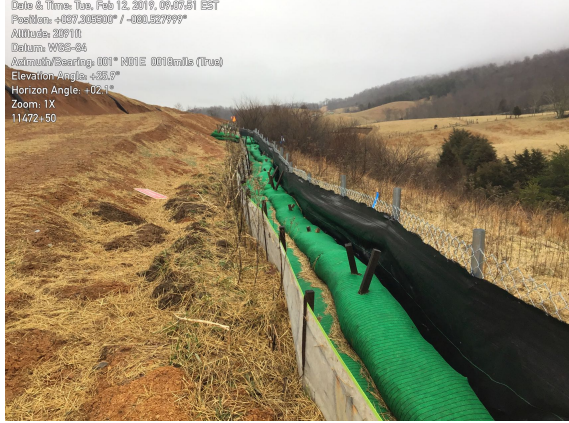
A/E	124300137	Date/Time	2/12/2019 3:30 PM	Report #	13937
Pictures					
<p>Date & Time: Tue, Feb 12, 2019, 09:07:51 EST Position: +037.305800° / -080.527799° Altitude: 2091ft Datum: WGS-84 Azimuth/Bearing: 001° N09E 0100mils (True) Elevation Angle: +02.5° Horizon Angle: +02.1° Zoom: 1X 11472+50</p>

GPS Location	37.2060983356815, -80.3941397077804	GPS Location	37.2061560186442, -80.3941603864417		
Description	See photo for station number and GPS location. Triple stack CFS, priority one silt fence, and reinforced silt fence in place.	Description	See photo for station number and GPS location. Two-tone sloughed off and covered up pipe outlet and rock outlet.

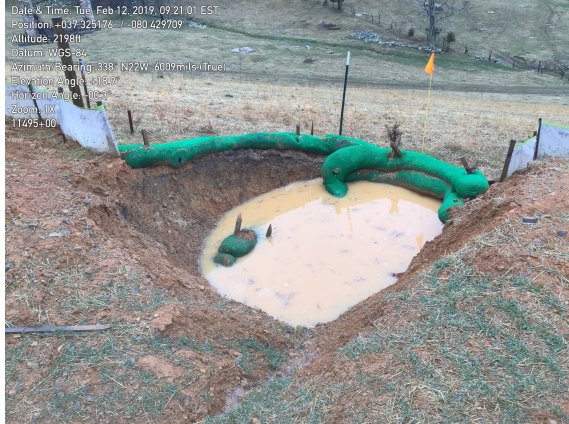
<p>Date & Time: Tue, Feb 12, 2019, 09:21:01 EST Position: +037.325176° / -080.424709° Altitude: 2198ft Datum: WGS-84 Azimuth/Bearing: 333° N22W 500mils (True) Elevation Angle: +18.5° Horizon Angle: +10.5° Zoom: 1X 11495+00</p>

GPS Location	37.2061922550829, -80.3941733763066	GPS Location	37.2061428241778, -80.393877038807		
Description	See photo for station number and GPS location. Sump pit sloughed off and CFS fell into sump.	Description	See photo for station number and GPS location. Water bars in place. ROW is stabilized with seed and mulch.		
<p>Date & Time: Tue, Feb 12, 2019, 10:37:15 EST Position: +037.300000° / -080.581722° Altitude: 2201ft Datum: WGS-84 Azimuth/Bearing: 148° N28E 283mils (True) Elevation Angle: +58.1° Horizon Angle: +17.9° Zoom: 1X 11331+25</p>

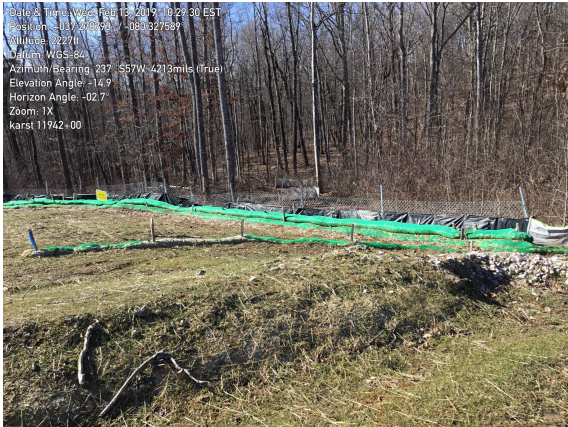
<p>Date & Time: Wed, Feb 13, 2019, 10:22:30 EST Position: +037.270199° / -080.327589° Altitude: 1227ft Datum: WGS-84 Azimuth/Bearing: 237° 55'W 4213mils (True) Elevation Angle: -16.9° Horizon Angle: -02.7° Zoom: 1X karst 11942+00</p>

GPS Location	37.3185534915303, -80.5534745101636	GPS Location	37.3174933131493, -80.5537488027836		
Description	.25" rain gauge at Catawba	Description	ECDs protecting KARST 11942+00		
<p>Date & Time: Wed, Feb 13, 2019, 10:30:54 EST Position: +037.270561° / -080.327179° Altitude: 2200ft Datum: WGS-84 Azimuth/Bearing: 132° 54'E 2347mils (True) Elevation Angle: -23.0° Horizon Angle: -01.7° Zoom: 1X karst 11940+00</p>

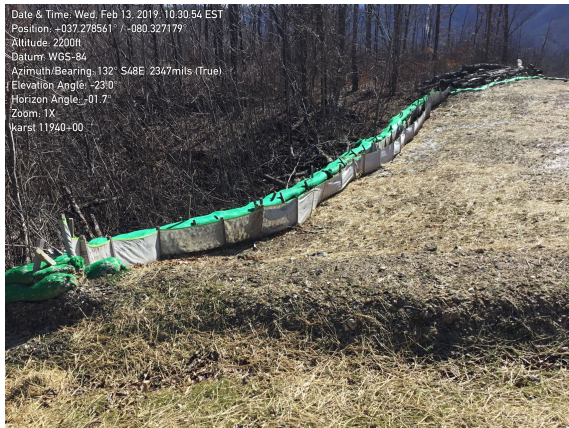
GPS Location	37.3185161501517, -80.5532916170364	GPS Location	37.3187572136869, -80.5535599217569		
Description	ECDs protecting karst 11940+00	Description	ECDs protecting karst 11950+00		
<p>Date & Time: Wed, Feb 13, 2019, 10:45:22 EST Position: +037.270632° / -080.327589° Altitude: 1749ft Datum: WGS-84 Azimuth/Bearing: 233° 55'W 4142mils (True) Elevation Angle: -14.2° Horizon Angle: +04.0° Zoom: 1X karst 11975+00</p>

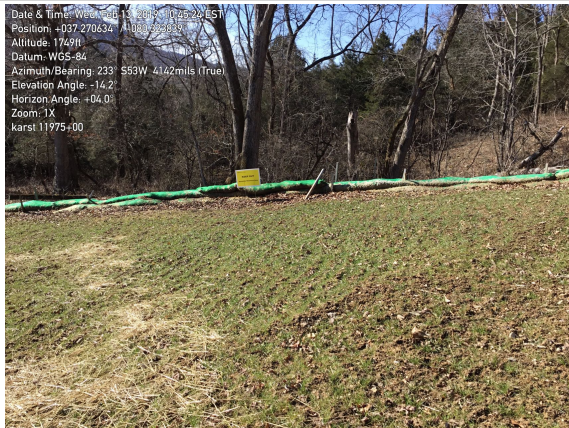
GPS Location	37.3185479594742, -80.5533844885235	GPS Location	37.3188904859473, -80.5536153261369		
Description	ECDs protecting karst 11975+00	Description	ECDs protecting karst 11979+00

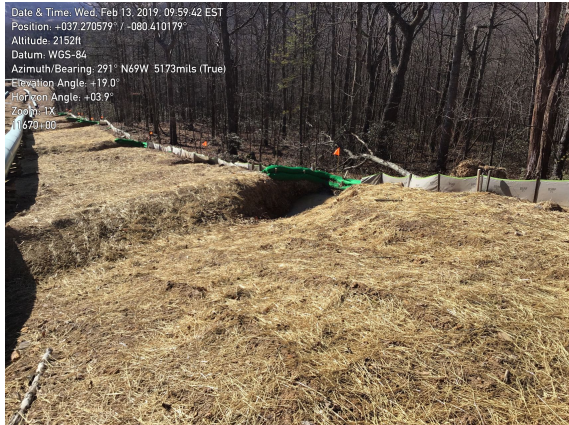
A/E	124300137	Date/Time	2/13/2019 2:39 PM	Report #	13988
Pictures					
<p>Date & Time: Wed, Feb 13, 2019, 09:59:42 EST Position: +037.270579° / -080.410179° Altitude: 2152ft Datum: WGS-84 Azimuth/Bearing: 291° N69W 5173mils (True) Elevation Angle: +19.0° Horizon Angle: +03.9° Zoom: 1X 11679+00</p>

GPS Location	37.319400773112, -80.6577150997836	GPS Location	37.3192508564731, -80.6578671215719		
Description	See photo for station number and GPS location. Sump pit, water bar and end treatment in place.	Description	See photo for station number and GPS location. Rock check over two tone in place to minimize erosion.		
<p>Date & Time: Wed, Feb 13, 2019, 10:23:24 EST Position: +037.297074° / -080.392028° Altitude: 2679ft Datum: WGS-84 Azimuth/Bearing: 351° N09W 6240mils (True) Elevation Angle: +22.3° Horizon Angle: +02.7° Zoom: 1X 11687+00 S-MN21</p>

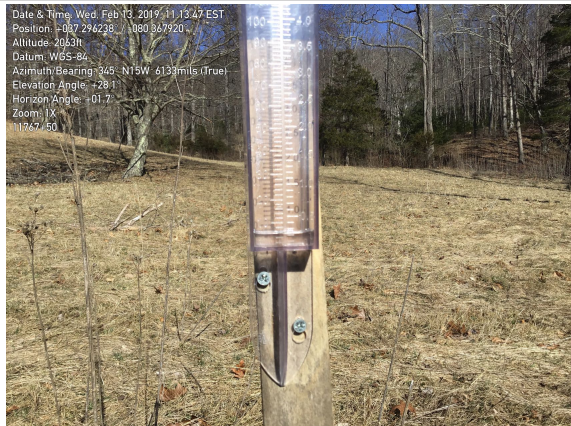
<p>Date & Time: Wed, Feb 13, 2019, 11:13:47 EST Position: +037.294238° / -080.367920° Altitude: 2063ft Datum: WGS-84 Azimuth/Bearing: 345° N15W 6133mils (True) Elevation Angle: +28.1° Horizon Angle: +01.7° Zoom: 1X 11762+00</p>

GPS Location	37.3194012372171, -80.6580227427936	GPS Location	37.3194012372171, -80.6580227427936		
Description	See photo for station number and GPS location. Priority one silt fence no longer filtering water.	Description	See photo for station number and GPS location. Rain gauge at Mount tabor reads .2 inches.

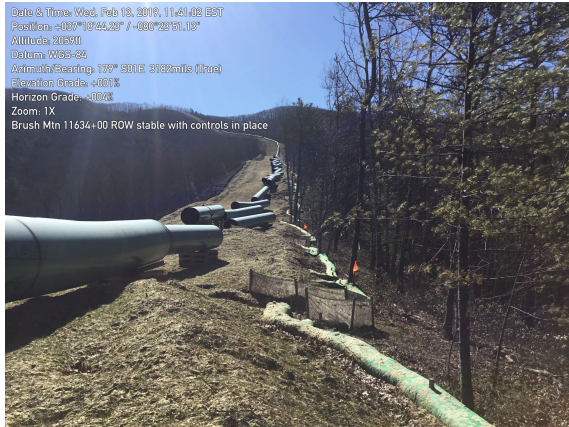
AFE	124300137	Date/Time	2/13/2019 3:12 PM	Report #	13989
Pictures					
<p>Date & Time: Wed, Feb 13, 2019, 11:43:49 EST Position: +037°18'44.20" / -080°28'51.18" Altitude: 2659ft Datum: WGS-84 Azimuth/Bearing: 192° S04E 3128mils (True) Elevation Grade: +013% Horizon Grade: +003% Zoom: 1X Brush Mtn 11634+00 ROW stable with controls in place</p>

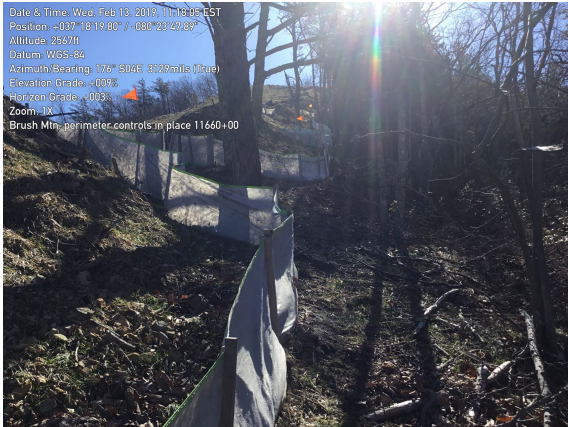
<p>Date & Time: Wed, Feb 13, 2019, 11:51:05 EST Position: +037°18'19.80" / -080°28'27.83" Altitude: 2557ft Datum: WGS-84 Azimuth/Bearing: 130° S04E 3128mils (True) Elevation Grade: +013% Horizon Grade: +003% Zoom: 1X Brush Mtn perimeter controls in place 11660+00</p>

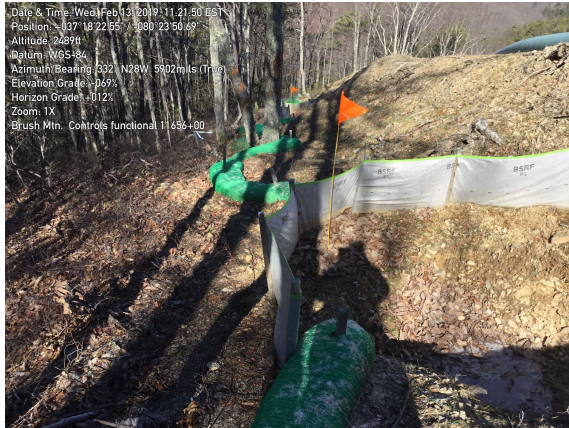
GPS Location	37.3192497256233, -80.657864379255	GPS Location	37.3193267220979, -80.6579277758306		
Description	Correct coordinates on photo. ECDs are in place and we're checked for effectiveness.	Description	Correct coordinates on photo. Perimeter controls are in place.		
<p>Date & Time: Wed, Feb 13, 2019, 11:51:50 EST Position: +037°18'22.55" / -080°29'50.69" Altitude: 2689ft Datum: WGS-84 Azimuth/Bearing: 332° N28W 5902mils (True) Elevation Grade: +06% Horizon Grade: +012% Zoom: 1X Brush Mtn Controls functional 11696+00</p>

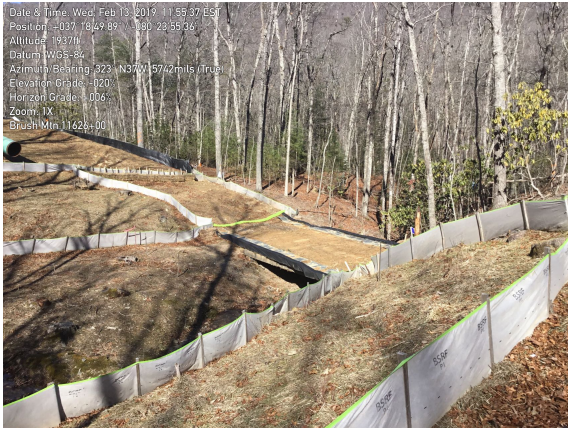
<p>Date & Time: Wed, Feb 13, 2019, 11:59:37 EST Position: +037°18'49.89" / -080°29'55.93" Altitude: 1937ft Datum: WGS-84 Azimuth/Bearing: 323° N37W 5942mils (True) Elevation Grade: +020% Horizon Grade: +006% Zoom: 1X Brush Mtn 11626+00</p>

GPS Location	37.3193267220979, -80.6579277758306	GPS Location	37.3193267220979, -80.6579277758306		
Description	Correct coordinates on photo. No maintenance needs were identified.	Description	Correct coordinates on photo. S-HH18 crossing stable.		
<p>Date & Time: Wed, Feb 13, 2019, 12:15:58 EST Position: +037°18'49.60" / -080°24'16.58" Altitude: 1913ft Datum: WGS-84 Azimuth/Bearing: 338° N22W 6009mils (True) Elevation Grade: +017% Horizon Grade: +005% Zoom: 1X Brush Mtn 8+00 S-006 crossing stable</p>

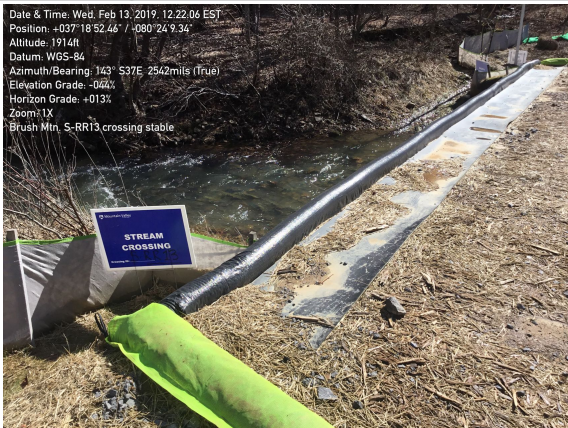
<p>Date & Time: Wed, Feb 13, 2019, 12:22:06 EST Position: +037°18'52.46" / -080°24'9.34" Altitude: 1914ft Datum: WGS-84 Azimuth/Bearing: 143° S37E 2542mils (True) Elevation Grade: +040% Horizon Grade: +013% Zoom: 1X Brush Mtn S-RR13 crossing stable</p>

GPS Location	37.3193267220979, -80.6579277758306	GPS Location	37.3193267220979, -80.6579277758306		
Description	Correct coordinates on photo. S-006 crossing stable with no evidence of impact.	Description	Correct coordinates on photo. S-RR13 crossing stable.

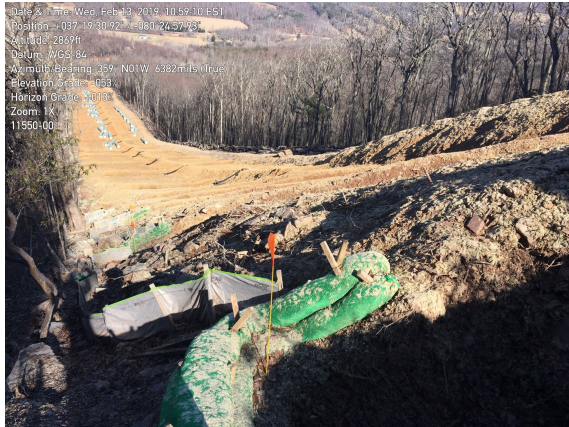
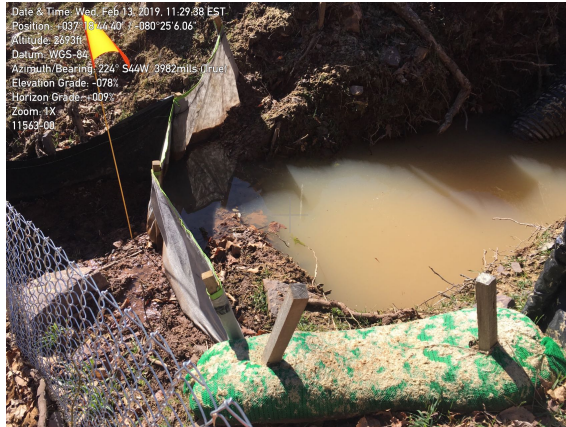
GPS Location	37.2425574576829, -80.4293077626083	GPS Location	37.2429753096408, -80.4291819136262		
Description	ROW conditions and ECD's @ MP 218	Description	Water bar and end treatment @ 11563+00

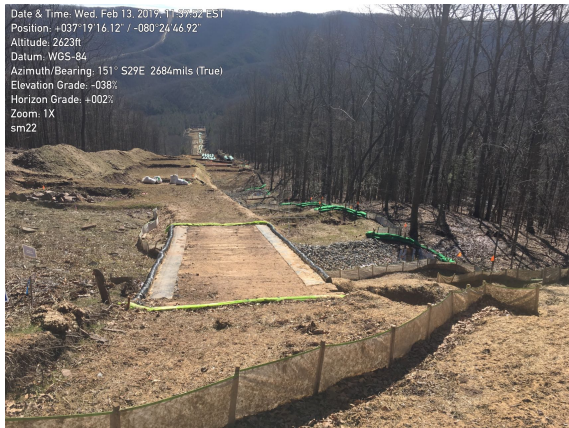
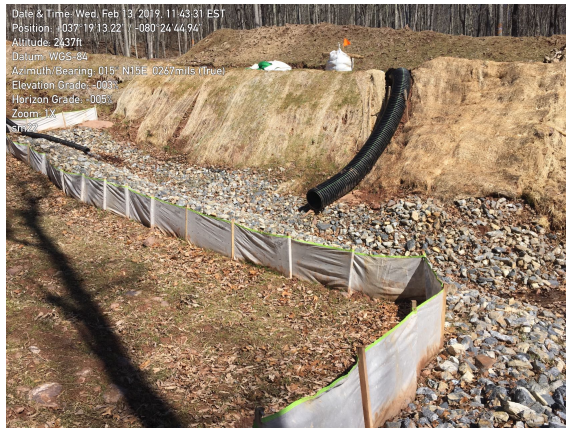
GPS Location	37.2427131096248, -80.4292893224214	GPS Location	37.2426910233099, -80.4293300584708		
Description	ROW conditions and ECD's @ SN22	Description	ROW conditions and ECD's @ MP 219

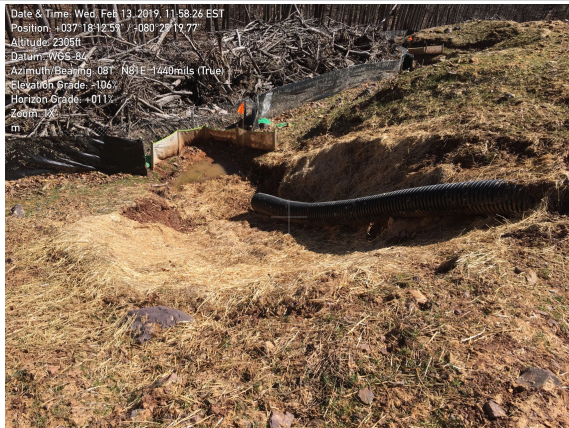
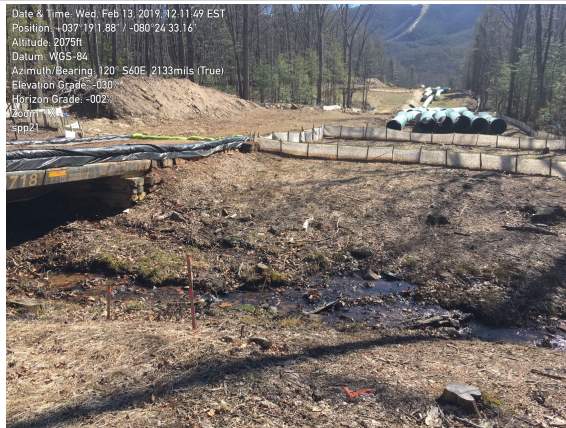
GPS Location	37.2426961362709, -80.4292653501783	GPS Location	37.2427031770695, -80.4292686191205		
Description	ROW conditions and ECD's @ MP 219	Description	ROW conditions and ECD's @ Snn20

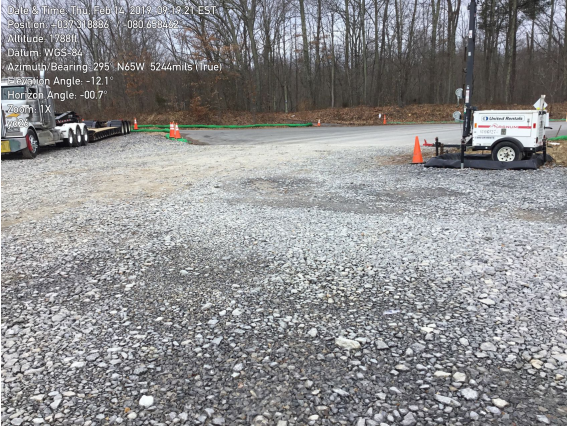
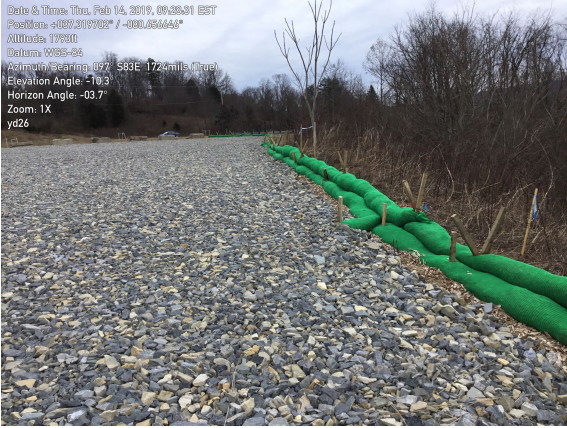
GPS Location	37.3192517878835, -80.6578913983709	GPS Location	37.3194660451489, -80.6576961851685		
Description	RCE yd 26	Description	ECDs in good condition yd26

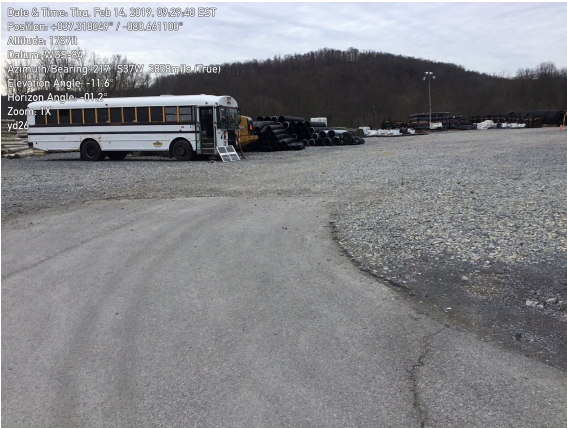
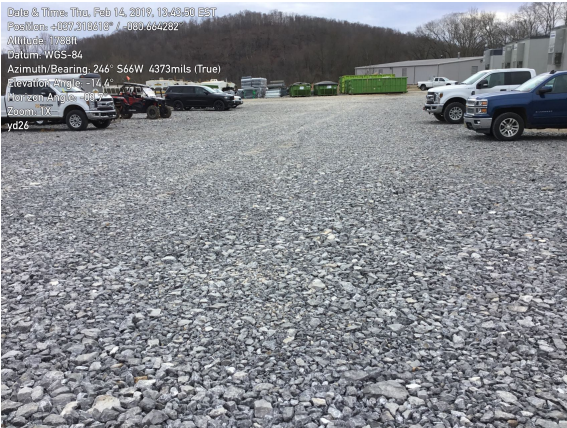
GPS Location	37.3193291109403, -80.6580328848964	GPS Location	37.3193465033894, -80.6580553483969		
Description	RCE yd26	Description	Yd 26		
<p>Insert image here</p>		<p>Insert image here</p>			
GPS Location		GPS Location			
Description		Description

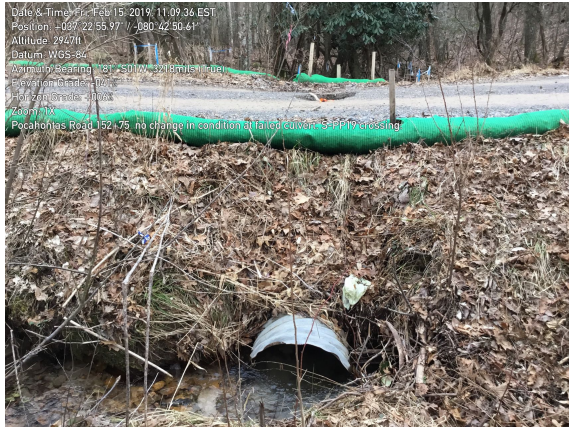
A/E	124300137	Date/Time	2/15/2019 2:33 PM	Report #	14069
Pictures					
<p>Date & Time: Fri, Feb 15, 2019 11:09:36 EST Position: +037 22 55.97 / -080 42 50.41 Altitude: 2927ft Datum: WGS-84 Azimuth/Bearing: 040° N40E 071mils (True) Elevation Grade: +031 Horizon Grade: +006 Zoom: 1X Pocahontas Road 152+75: no change in condition at failed culvert S-PP19 crossing</p>

GPS Location	37.1331384592104, -80.3945039213452		GPS Location	37.1331680892381, -80.3945542127643	
Description	Correct coordinates on photo. Failed culvert produced hole in Road surface near 152+75.		Description	Correct coordinates on photo. Failed culvert produced hole in Road surface near 152+75.

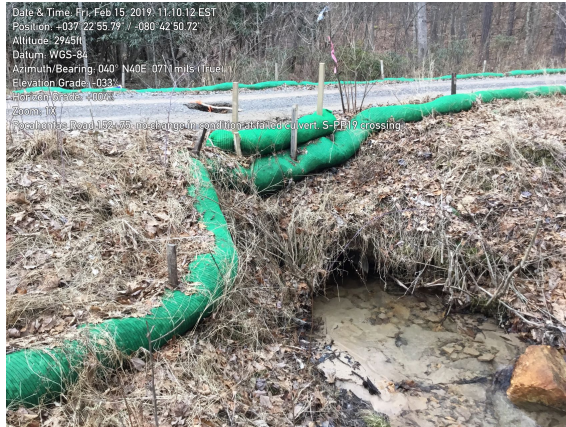
<p>Date & Time: Fri, Feb 15, 2019 11:10:12 EST Position: +037 22 55.79 / -080 42 50.72 Altitude: 2945ft Datum: WGS-84 Azimuth/Bearing: 040° N40E 071mils (True) Elevation Grade: +031 Horizon Grade: +006 Zoom: 1X Pocahontas Road 152+75: no change in condition at failed culvert S-PP19 crossing</p>

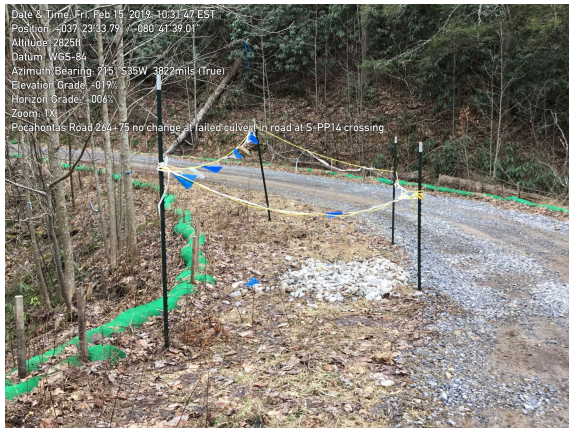
<p>Date & Time: Fri, Feb 15, 2019 10:31:24 EST Position: +037 23 13.79 / -080 41 39.01 Altitude: 2826ft Datum: WGS-84 Azimuth/Bearing: 715° S35W 392mils (True) Elevation Grade: +019 Horizon Grade: +006 Zoom: 1X Pocahontas Road 264+75: no change at failed culvert in road at S-PP14 crossing</p>

GPS Location	37.1324107423771, -80.3948749881987		GPS Location	37.1330639021817, -80.3946816176925	
Description	Correct coordinates on photo. Condition of road at failed culvert near 264+75 remains unchanged.		Description	Correct coordinates on photo. No resource impact located.	
<p>Date & Time: Fri, Feb 15, 2019 10:34:22 EST Position: +037 23 33.25 / -080 41 25.43 Altitude: 2788ft Datum: WGS-84 Azimuth/Bearing: 089° N89E 1582mils (True) Elevation Grade: +007 Horizon Grade: +004 Zoom: 1X Pocahontas Road 278+50 controls along edge of road functional at S-PP15 crossing</p>

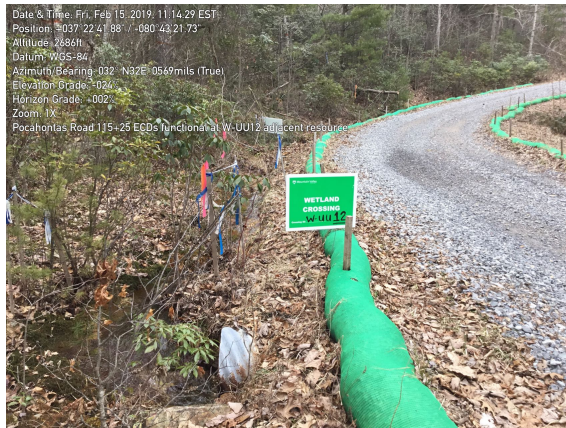
<p>Date & Time: Fri, Feb 15, 2019 11:14:29 EST Position: +037 22 41.98 / -080 43 21.73 Altitude: 2826ft Datum: WGS-84 Azimuth/Bearing: 032° N32E 0569mils (True) Elevation Grade: +024 Horizon Grade: +002 Zoom: 1X Pocahontas Road 115+25 ECDs functional at W-U012 adjacent resource</p>

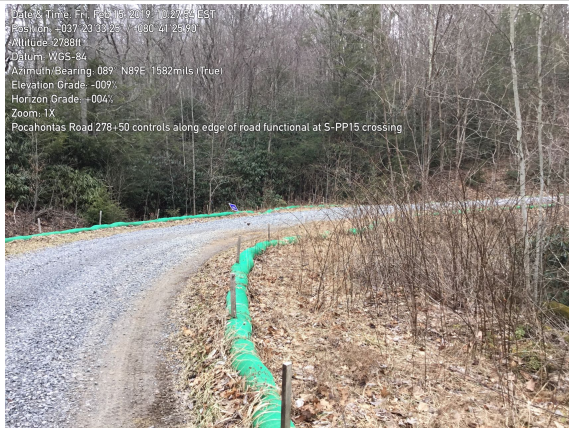
GPS Location	37.1330979746181, -80.3946415521953		GPS Location	37.133101704565, -80.3945731558654	
Description	Correct coordinates on photo. No evidence of sediment deposits beyond the approved LOD.		Description	Correct coordinates on photo. ECDs are in place where needed and working.

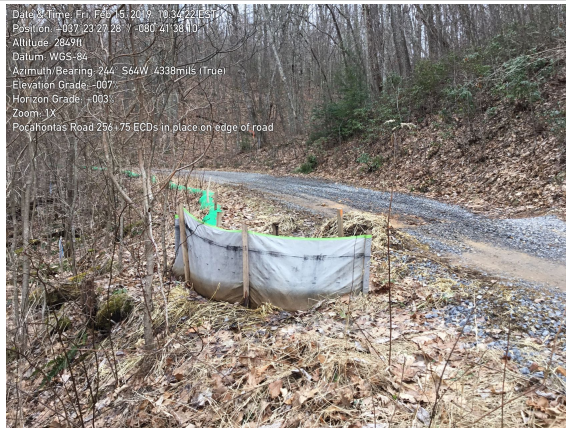
<p>Date & Time: Fri, Feb 15, 2019 10:34:22 EST Position: +037 23 27.28 / -080 41 38.10 Altitude: 2849ft Datum: WGS-84 Azimuth/Bearing: 244° S64W 4338mils (True) Elevation Grade: +007 Horizon Grade: +003 Zoom: 1X Pocahontas Road 256+75 ECDs in place on edge of road</p>

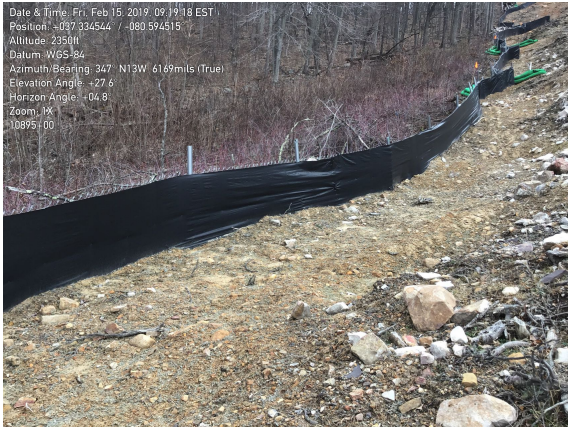
GPS Location	37.3192654922952, -80.6578620617098	GPS Location	37.3192654922952, -80.6578620617098		
Description	See photo for station number and GPS location. Water bar end treatment and sump pit in place.	Description	See photo for station number and GPS location. Reinforced silt fence in place.		
<p>Date & Time: Fri, Feb 15, 2019, 09:16:22 EST Position: +037.3307173° / -080.665397° Altitude: 2261ft Datum: WGS-84 Azimuth/Bearing: 307° N05W 604mils (True) Elevation Angle: +27.6° Horizon Angle: +00.6° Zoom: 1X 10910+00</p>  		<p>Date & Time: Fri, Feb 15, 2019, 09:20:19 EST Position: +037.3307173° / -080.665397° Altitude: 2261ft Datum: WGS-84 Azimuth/Bearing: 307° N53W 5458mils (True) Elevation Angle: +25.6° Horizon Angle: +00.4° Zoom: 1X 10927+25 S-Y3</p>
