# Visual Site Inspection Report

<b>Project Name</b>	H-600 Pipeline Spread G	<b>AFE</b>	124300137	<b>Spread</b>	H-600 Pipeline Spread G
<b>Contractor</b>	Precision			<b>Report #</b>	14132
<b>Inspector</b>	Len Kruizenga			<b>Date/Time</b>	2/18/2019 8:58 AM
<b>Permit #</b>	TBD	<b>Inspection Type</b>	VA SWPP	<b>Station Begin</b>	11254+88
<b>State</b>	VA	<b>Inspection Area</b>	Partial	<b>Station End</b>	11161+00
<b>County</b>	Giles	<b>Ground</b>	Muddy	<b>Temperature (°F)</b>	43.00
<b>Municipality</b>	N/A	<b>Weather</b>	Cloudy	<b>Rain Gauge (in)</b>	1.00
<b>GPS Location</b>	37.3275343655025, -80.4861149378871			<b>Rain Accumulation Time (days)</b>	2.00

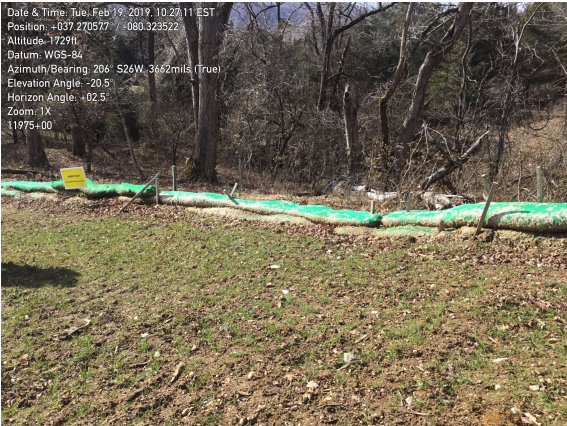
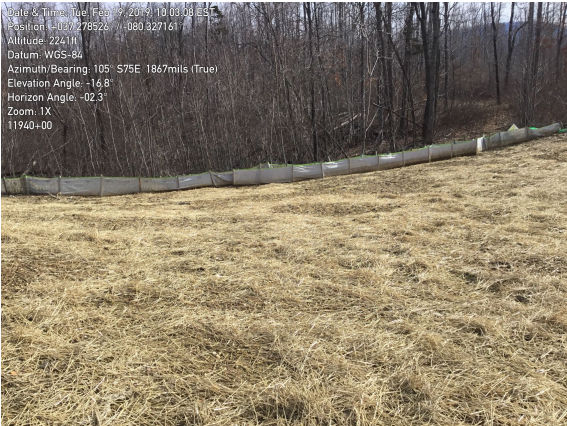
<b>GPS Location</b>	37.3193794058179, -80.6577440536532	<b>GPS Location</b>	37.3193353973677, -80.6578185596323		
<b>Description</b>	ECDs protecting karst 11975+00	<b>Description</b>	ECDs protecting karst 11940+00		
<p>Insert image here</p>		<p>Insert image here</p>			
<b>GPS Location</b>		<b>GPS Location</b>			
<b>Description</b>		<b>Description</b>

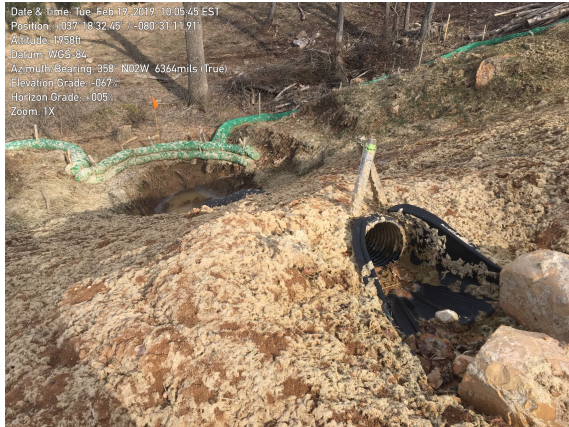
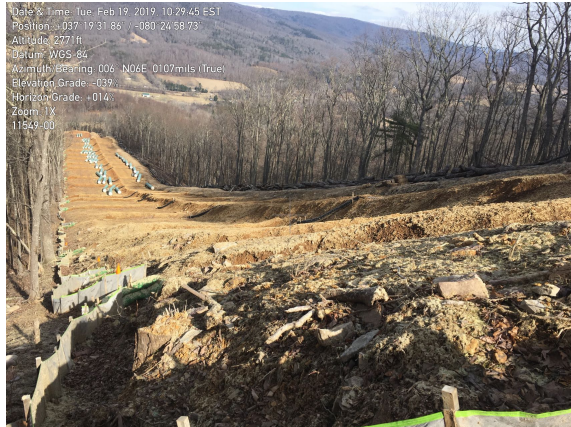
GPS Location	37.3193255486314, -80.6578622293478	GPS Location	37.3193086432258, -80.6578236659029		
Description	Slope drain and end treatment for MP 218	Description	Row conditions and ECD's @ mp 218.5		
<p>Date &amp; Time: Tue, Feb 19, 2019, 10:48:25 EST Position: +037 19 28 01 / -080 24 55 35 Altitude: 2076ft Datum: WGS 84 Azimuth/Bearing: 171 S09E 3040mils (True) Elevation Grade: -063 Horizon Grade: -020 Zoom: 1X 11355-00</p>

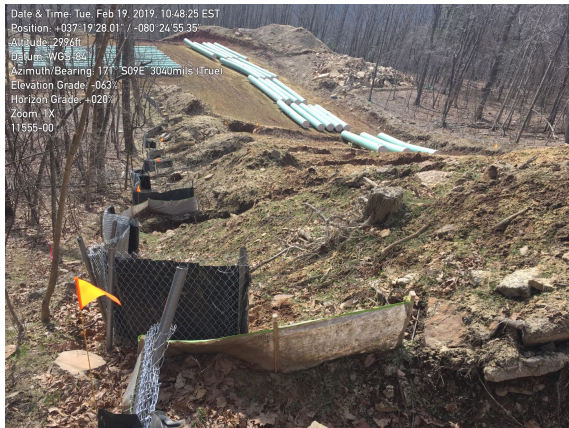
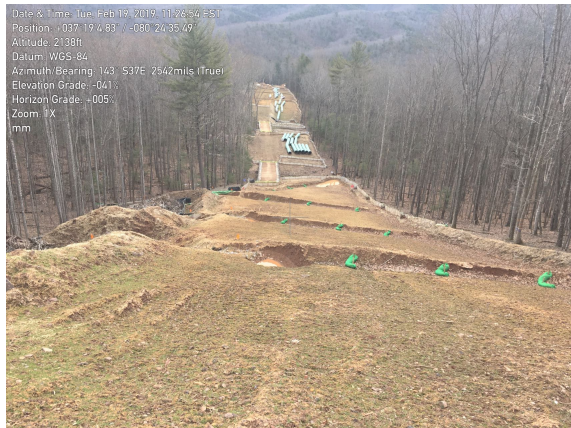
GPS Location	37.3193353135486, -80.6578594633198	GPS Location	37.3193353135486, -80.6578594633198		
Description	ECD's and ROW conditions for MP 219	Description	ECD's and ROW conditions @ MP 218.5		
<p>Date &amp; Time: Tue, Feb 19, 2019, 11:34:32 EST Position: +037 18 59 76 / -080 24 31 73 Altitude: 2032ft Datum: WGS 84 Azimuth/Bearing: 118 S42E 2098mils (True) Elevation Grade: -022 Horizon Grade: -002 Zoom: 1X spp20</p>

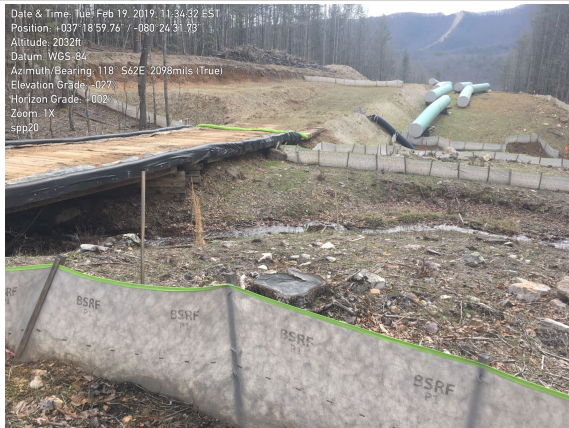
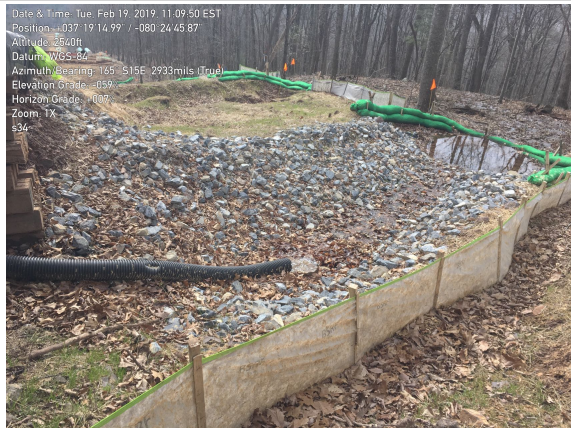
GPS Location	37.3193353135486, -80.6578594633198	GPS Location	37.3193353135486, -80.6578594633198		
Description	ECD's and ROW conditions for S-Pp20	Description	ECD's and ROW conditions for S-Pp20

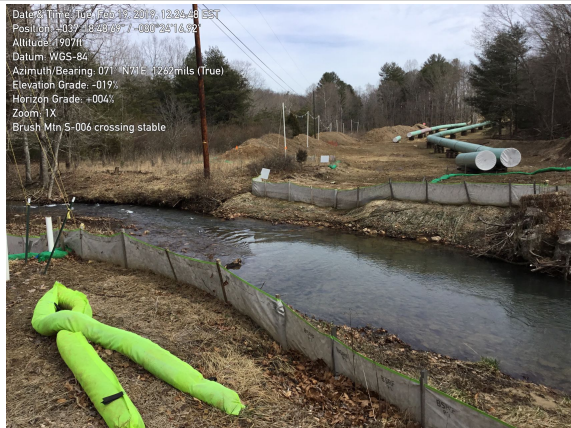
<p>Date &amp; Time: Tue, Feb 19, 2019, 12:44:48 EST Position: +037° 18' 53.26" / -080° 24' 16.52" Altitude: 1907ft Datum: WGS-84 Azimuth/Bearing: 071° N01E 1222mils (True) Elevation Grade: +019% Horizon Grade: +004% Zoom: 1X Brush Mtn S-006 crossing stable</p>

GPS Location	37.1331918100241, -80.3943908494715	GPS Location	37.1331918100241, -80.3943908494715		
Description	Correct coordinates on photo. Resources in the area have functional controls in place with no sign of impact.	Description	Correct coordinates on photo. Resources in the area have functional controls in place with no sign of impact.

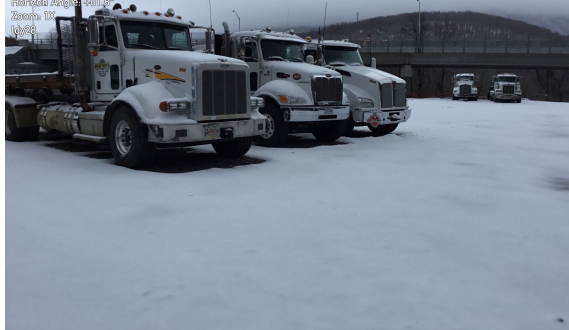
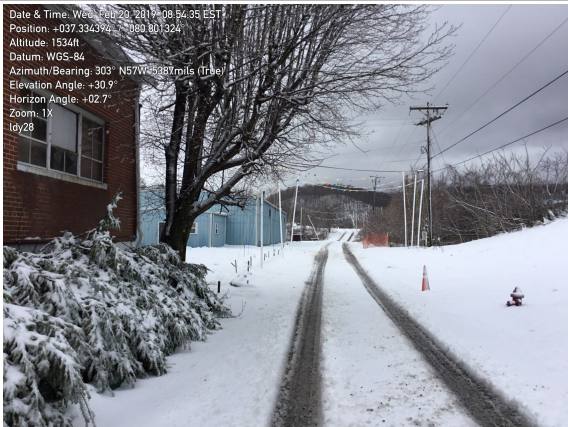
GPS Location	37.3194188392137, -80.6578748022026	GPS Location	37.3194121336912, -80.6579803303635		
Description	Conditions @ LDY 28	Description	Conditions @ LDY 28		
<p>Date &amp; Time: Wed, Feb 20, 2019, 08:56:19 EST Position: +037.334058° / -080.803272° Altitude: 1566ft Datum: WGS-84 Azimuth/Bearing: 313° N33W 5796mils (True) Elevation Angle: +27.0° Horizon Angle: +00.7° Zoom: 1X Id:28</p>

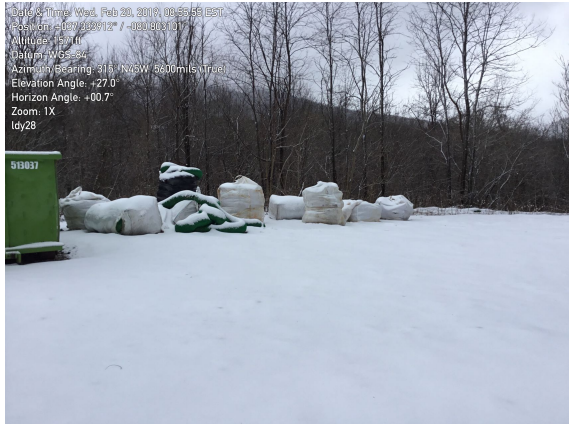
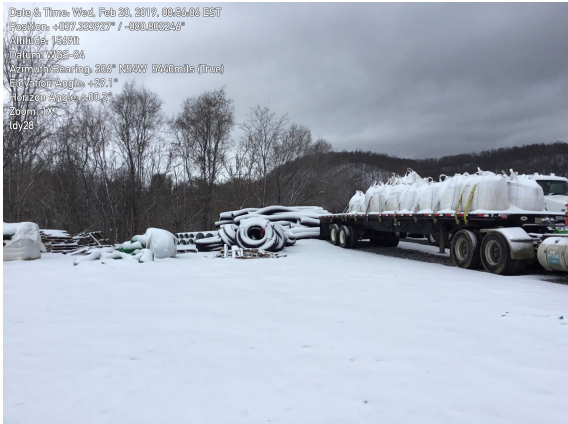
GPS Location	37.3194121336912, -80.6579803303635	GPS Location	37.3193711461847, -80.658037159667		
Description	Conditions @ LDY 28	Description	Conditions @ LDY 28		
<p>Date &amp; Time: Wed, Feb 20, 2019, 08:56:19 EST Position: +037.334058° / -080.803272° Altitude: 1566ft Datum: WGS-84 Azimuth/Bearing: 326° N34W 5796mils (True) Elevation Angle: +29.4° Horizon Angle: +00.6° Zoom: 1X Id:28</p>

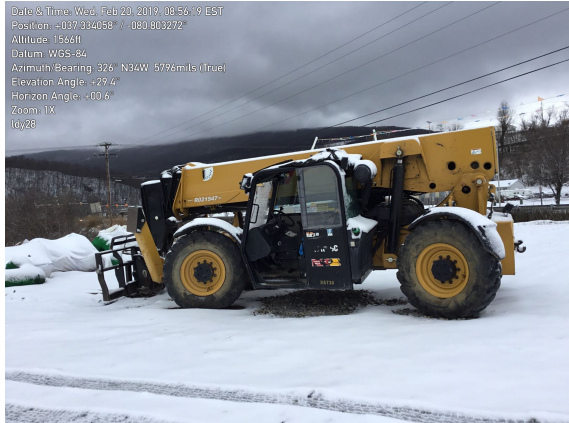
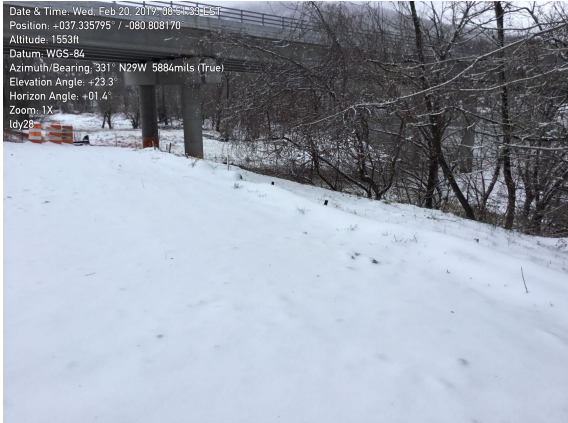
GPS Location	37.2427145764579, -80.4292033240948	GPS Location	37.2425512550746, -80.4296137858931		
Description	Conditions @ LDY 28	Description	Conditions and ECD's @ LDY 28

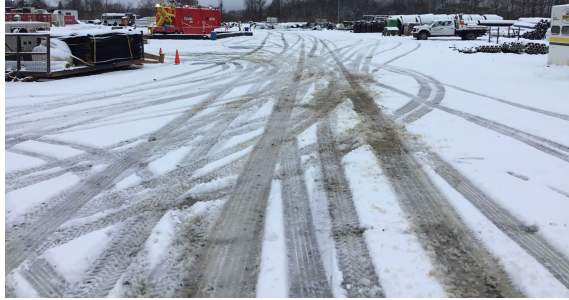
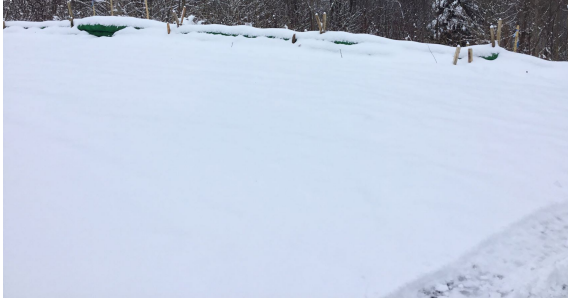
</div></div>					
GPS Location		37.3328150064101, -80.750444205553		GPS Location		37.3328385176485, -80.7504819241173	
Description		Yard26		Description		CFS yd26	
<div><div><div>Date &amp; Time: Wed, Feb 20, 2019, 09:09:17 EST Position: -037.318858° / -80.655784° Altitude: 1781ft Datum: WGS-84 Azimuth/Bearing: 201° S21W 3573mils (True) Elevation Angle: -18.1° Horizon Angle: -01.5° Zoom: 1X yd26</div>

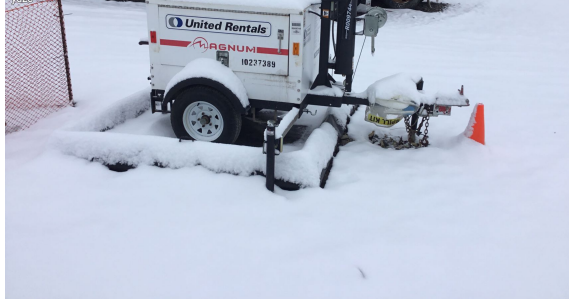
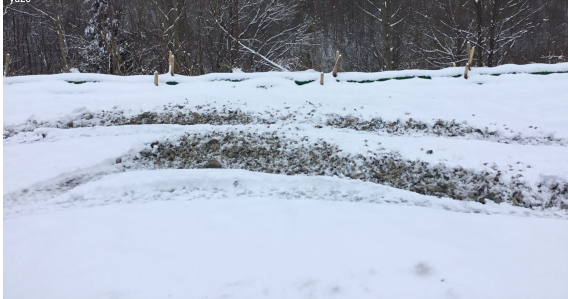
GPS Location		37.3327969853183, -80.7504204847671		GPS Location		37.3328404873957, -80.7504579518742	
Description		Light plant in containment yd26		Description		CFS yd26	
Insert image here		<div><div><div>Date &amp; Time: Wed, Feb 20, 2019, 09:09:30 EST Position: -037.318824° / -80.656036° Altitude: 1783ft Datum: WGS-84 Azimuth/Bearing: 139° S38W 3086mils (True) Elevation Angle: -11.0° Horizon Angle: -02.0° Zoom: 1X yd26</div>

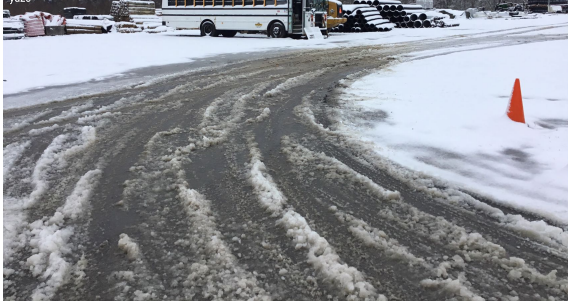
</div></div>					
GPS Location				GPS Location		37.3327954765757, -80.7505633123971	
Description				Description		RCE yd26

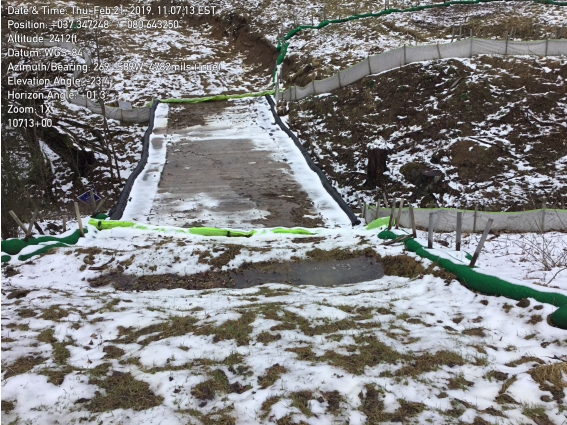
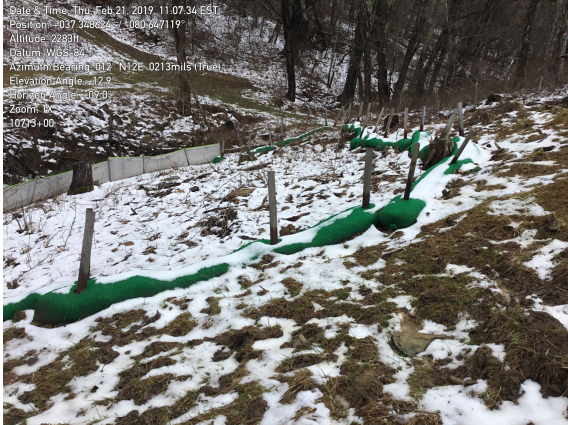
<b>GPS Location</b>	37.3193862571233, -80.6577218198611	<b>GPS Location</b>	37.3192758020361, -80.6578977686173		
<b>Description</b>	Stream st11713+00	<b>Description</b>	ECDs protecting stream 10713+00

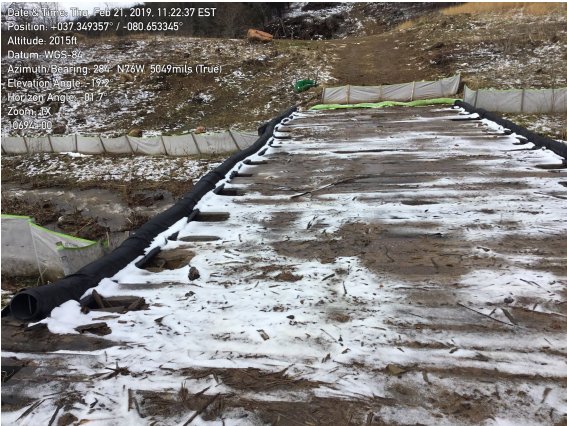
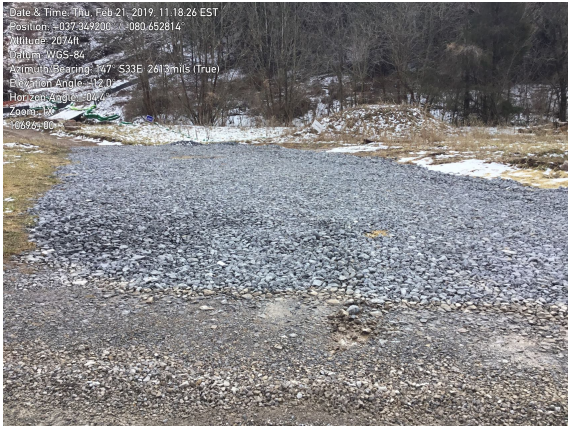
<b>GPS Location</b>	37.3192719463607, -80.6579098385579	<b>GPS Location</b>	37.3193503590648, -80.6579247583455		
<b>Description</b>	Timber mat crossing 10694+00	<b>Description</b>	RCE 10696+00		
<p>Insert image here</p>		<p>Insert image here</p>			
<b>GPS Location</b>		<b>GPS Location</b>			
<b>Description</b>		<b>Description</b>

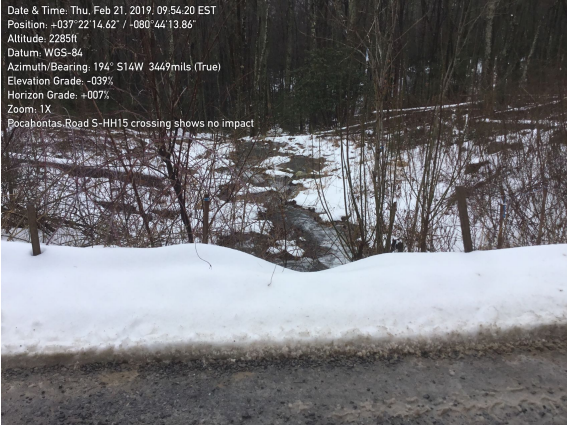
<b>A/E</b>	124300137	<b>Date/Time</b>	2/21/2019 12:38 PM	<b>Report #</b>	14233
<b>Pictures</b>					
<p>Date &amp; Time: Thu, Feb 21, 2019, 09:54:20 EST  Position: +037° 22' 14.62" / -080° 44' 13.86"  Altitude: 2285ft  Datum: WGS-84  Azimuth/Bearing: 194° S14W 3449mils (True)  Elevation Grade: -039%  Horizon Grade: +007%  Zoom: 1X  Pocahontas Road S-HH15 crossing shows no impact</p>

<b>GPS Location</b>	37.3192284861927, -80.6578775682306	<b>GPS Location</b>	37.3192284861927, -80.6578775682306		
<b>Description</b>	Correct coordinates on photo. No resource impact identified at the S-HH15 crossing.	<b>Description</b>	Correct coordinates on photo. Adjacent wetland W-HH15 has not been impacted.

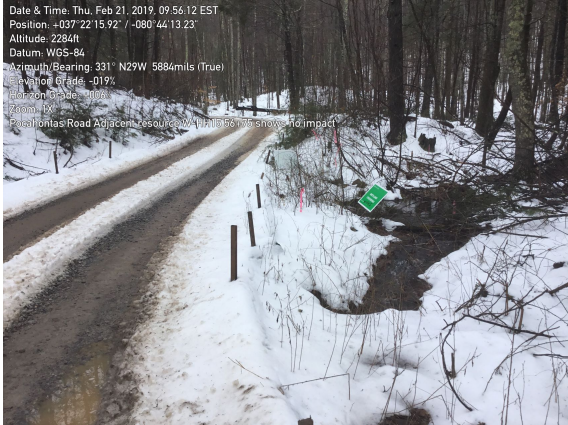
<p>Date &amp; Time: Thu, Feb 21, 2019, 09:56:12 EST  Position: +037° 22' 15.92" / -080° 44' 13.23"  Altitude: 2284ft  Datum: WGS-84  Azimuth/Bearing: 331° N29W 5884mils (True)  Elevation Grade: -019%  Horizon Grade: +007%  Zoom: 1X  Pocahontas Road Adjacent resource W-HH15 shows no impact</p>

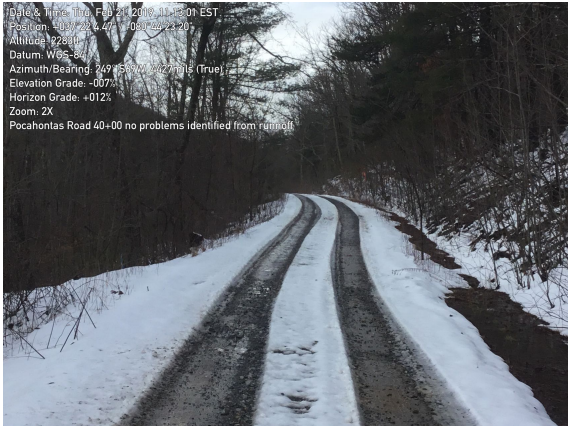
<p>Date &amp; Time: Thu, Feb 21, 2019, 10:00:11 EST  Position: +037° 22' 15.49" / -080° 44' 20.19"  Altitude: 2281ft  Datum: WGS-84  Azimuth/Bearing: 249° S50W 4027mils (True)  Elevation Grade: -007%  Horizon Grade: +012%  Zoom: 2X  Pocahontas Road 40+00 no problems identified from runoff</p>

<b>GPS Location</b>	37.3192325095062, -80.6578655821091	<b>GPS Location</b>	37.3192325095062, -80.6578655821091		
<b>Description</b>	Correct coordinates on photo. No logging activity or traffic on Pocahontas Road today.	<b>Description</b>	Correct coordinates on photo. Road should be crowned to prevent runoff traveling downslope.

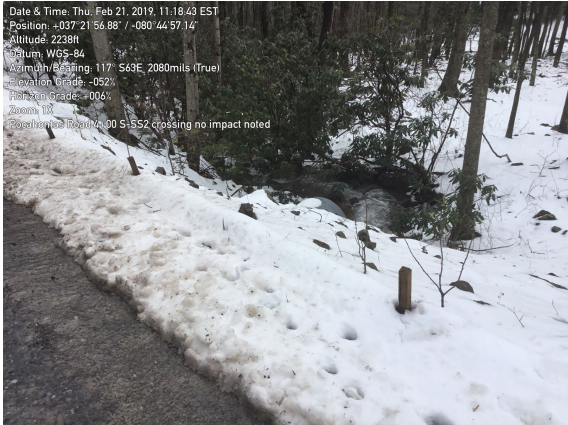
<p>Date &amp; Time: Thu, Feb 21, 2019, 11:18:43 EST  Position: +037° 21' 56.88" / -080° 44' 57.14"  Altitude: 2238ft  Datum: WGS-84  Azimuth/Bearing: 117° S43E 2080mils (True)  Elevation Grade: -052%  Horizon Grade: +006%  Zoom: 1X  Pocahontas Road 00 S-SS2 crossing no impact noted</p>

<b>GPS Location</b>	37.3192325095062, -80.6578655821091	<b>GPS Location</b>	37.3192325095062, -80.6578655821091		
<b>Description</b>	Correct coordinates on photo. No impact found at the S-HH13 crossing.	<b>Description</b>	Correct coordinates on photo. No impact noted at the S-SS2 crossing.

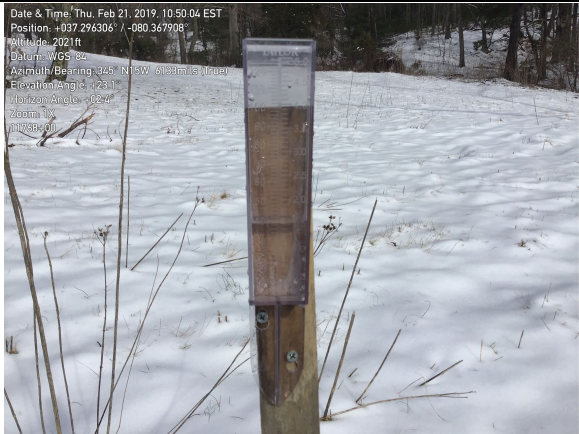
<p>Date &amp; Time: Thu, Feb 21, 2019, 10:38:28 EST Position: +037 243155° / -080 670068° Altitude: 1626ft Datum: WGS-84 Azimuth/Bearing: 342° N18W 6080mils (True) Elevation Angle: +25.2° Horizon Angle: 100.5° Zoom: 1X 11900+00</p>

<p>Date &amp; Time: Thu, Feb 21, 2019, 10:50:04 EST Position: +037 296306° / -080 367908° Altitude: 2021ft Datum: WGS-84 Azimuth/Bearing: 345° N18W 6083mils (True) Elevation Angle: +25.1° Horizon Angle: 100.7° Zoom: 1X 117350+00</p>				
GPS Location	37.31	Field Station#		GPS Location	37.31	Field Station#	
Description	See photo for station number and GPS location. Rain gauge at Catawba Road. 1.2 inches.			Description	See photo for station number and GPS location. Rain gauge at Mount Tabor Road. 1.5 inches.

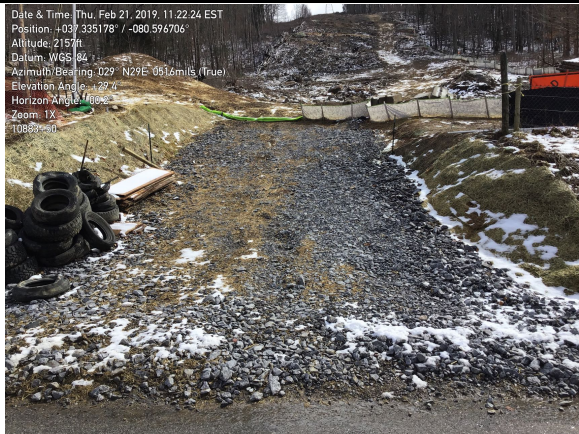
<p>Date &amp; Time: Thu, Feb 21, 2019, 11:05:05 EST Position: +037 331187° / -080 596706° Altitude: 2157ft Datum: WGS-84 Azimuth/Bearing: 358° N02W 6364mils (True) Elevation Angle: +27.6° Horizon Angle: +03.3° Zoom: 1X 10883+50</p>

GPS Location	37.31	Field Station#		GPS Location	37.31	Field Station#	
Description	See photo for station number and GPS location. Rain gauge at Kow Camp Road. 1.6 inches.			Description	See photo for station number and GPS location. RCE at Kow Camp Road in place.

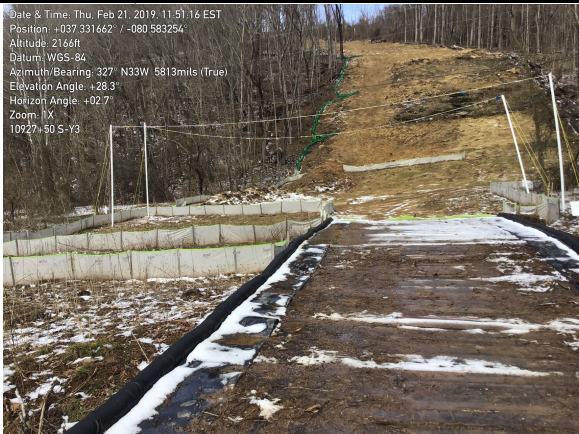
<p>Date &amp; Time: Thu, Feb 21, 2019, 11:38:44 EST Position: +037 283820° / -080 558325° Altitude: 2166ft Datum: WGS-84 Azimuth/Bearing: 027° N27E 6513mils (True) Elevation Angle: +27.6° Horizon Angle: 102.1° Zoom: 1X 10909+00</p>

<p>Date &amp; Time: Thu, Feb 21, 2019, 11:51:16 EST Position: +037 331662° / -080 583254° Altitude: 2166ft Datum: WGS-84 Azimuth/Bearing: 327° N33W 5813mils (True) Elevation Angle: +28.3° Horizon Angle: +02.7° Zoom: 1X 10927+50 S-Y3</p>				
GPS Location	37.31	Field Station#		GPS Location	37.31	Field Station#	
Description	See photo for station number and GPS location. Priority one silt fence in place.			Description	See photo for station number and GPS location. Sensitive resource buffer in place at stream S-Y3.

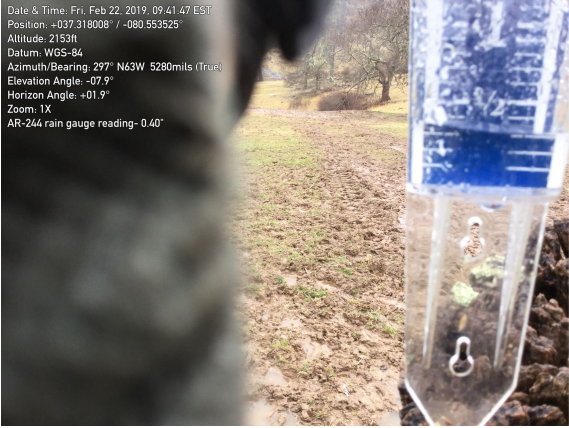
A/E	124300137	Date/Time	2/22/2019 8:15 AM	Report #	14263
Pictures					
<p>Date &amp; Time: Fri, Feb 22, 2019, 09:41:47 EST Position: +037.318008° / -080.553525° Altitude: 2153ft Datum: WGS-84 Azimuth/Bearing: 297° N43W 5280mils (True) Elevation Angle: -07.9° Horizon Angle: +01.9° Zoom: 1X AR-244 rain gauge reading- 0.40"</p>

GPS Location	37.3299590405424, -80.4864032753562	GPS Location	37.3299590405424, -80.4864032753562		
Description	AR-244 rain gauge reading- 0.40"	Description	Kow Camp rain gauge reading- 0.30"		
<p>Date &amp; Time: Fri, Feb 22, 2019, 12:16:34 EST Position: +037.372447° / -080.679836° Altitude: 1831ft Datum: WGS-84 Azimuth/Bearing: 095° S85E 1689mils (True) Elevation Angle: -03.9° Horizon Angle: +00.1° Zoom: 1X AR-234 Rain gauge reading- 0.30"</p>  		<p>Date &amp; Time: Fri, Feb 22, 2019, 10:00:10 EST Position: +037.318721° / -080.548985° Altitude: 2204ft Datum: WGS-84 Azimuth/Bearing: 086° N86E 1529mils (True) Elevation Angle: -08.8° Horizon Angle: +01.1° Zoom: 1X Sta#11046+00 to 11050+00- Stream S-IJ 17, in good condition - row stable here.</p>

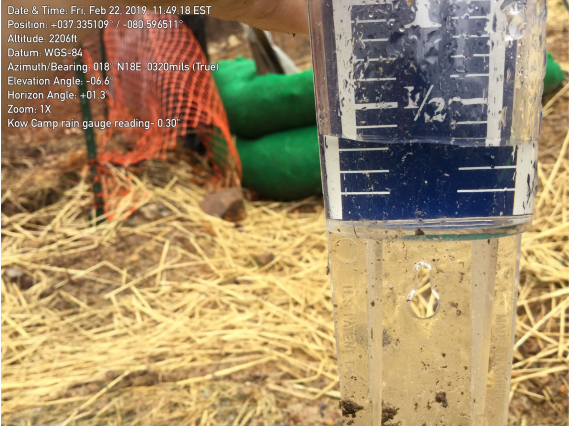
<p>Date &amp; Time: Fri, Feb 22, 2019, 11:49:18 EST Position: +037.335109° / -080.596511° Altitude: 2206ft Datum: WGS-84 Azimuth/Bearing: 018° N18E 0320mils (True) Elevation Angle: -06.6° Horizon Angle: +01.3° Zoom: 1X Kow Camp rain gauge reading- 0.30"</p>

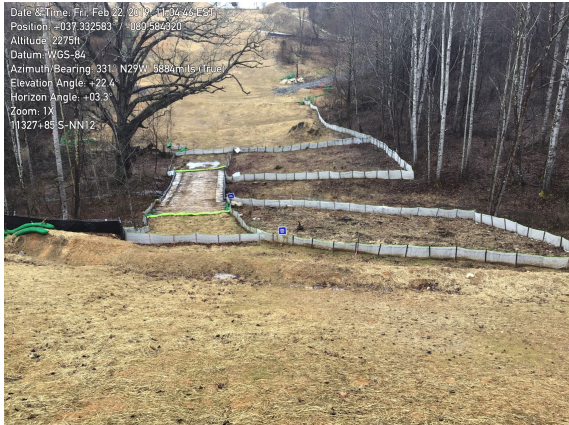
<p>Date &amp; Time: Fri, Feb 22, 2019, 11:13:44 EST Position: +037.332583 / -080.562620 Altitude: 2275ft Datum: WGS-84 Azimuth/Bearing: 331° N29W 0680mils (True) Elevation Angle: +22.4° Horizon Angle: +03.3° Zoom: 1X 11327+88 S-NN12</p>

GPS Location	37.2060959073773, -80.3941483410424	GPS Location	37.2060568677608, -80.3939590976391		
Description	See photo for station number and GPS location. Steel Acres rain gauge. .5 inches.	Description	See photo for station number and GPS location. Sensitive resource buffer in place at stream S-NN12.		
<p>Date &amp; Time: Fri, Feb 22, 2019, 11:35:21 EST Position: +037.305674 / -080.469463 Altitude: 1973ft Datum: WGS-84 Azimuth/Bearing: 349° N11W 6204mils (True) Elevation Angle: +28.6° Horizon Angle: +03.3° Zoom: 2X 11362+00</p>

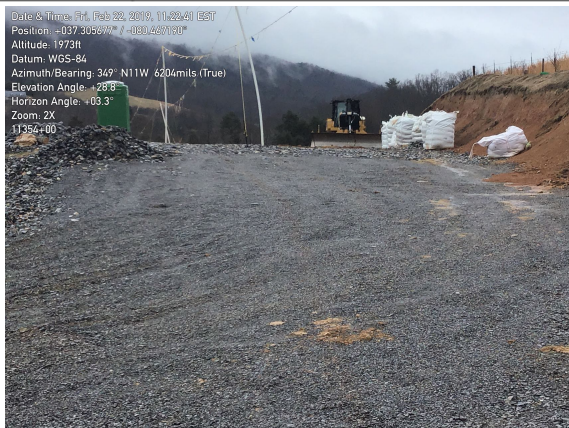
GPS Location	37.2061367053885, -80.3938339558247	GPS Location	37.2060568677608, -80.3939590976391		
Description	See photo for station number and GPS location. RCE in place at Old Furnace Road.	Description	See photo for station number and GPS location. Rock inlet and slope drain over fill slope.		
<p>Date &amp; Time: Fri, Feb 22, 2019, 11:31:34 EST Position: +037.297597 / -080.501509 Altitude: 2002ft Datum: WGS-84 Azimuth/Bearing: 323° N37W 5742mils (True) Elevation Angle: +18.5° Horizon Angle: +04.8° Zoom: 1X 11369+00</p>

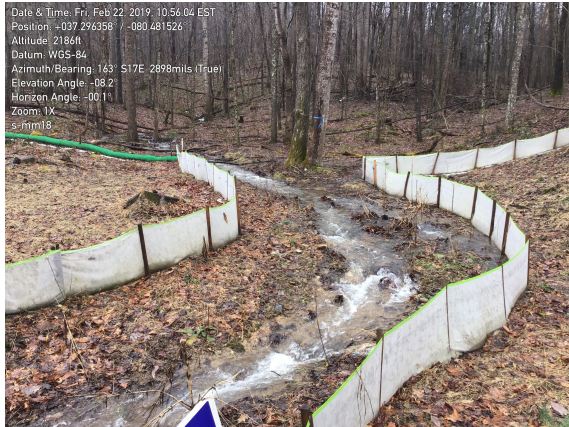
A/E	124300137	Date/Time	2/22/2019 2:05 PM	Report #	14284
Pictures					
<p>Date &amp; Time: Fri, Feb 22, 2019, 10:56:04 EST Position: +037 296358 / -080 481526 Altitude: 2186ft Datum: WGS-84 Azimuth/Bearing: 163° S17E 2898mils (True) Elevation Angle: -08.2 Horizon Angle: -00.1 Zoom: 1X s-mm18</p>

GPS Location	37.1361938716834, -80.3941534601261	GPS Location	37.1361049867678, -80.3941840555723		
Description	See photo for gps coordinates. Stream s-mm18 during rain event.	Description	See photo for gps coordinates. Plunge pool discharging clean water at 11487+70		
<p>Date &amp; Time: Fri, Feb 22, 2019, 11:05:00 EST Position: +037 322582 / -080 438445 Altitude: 2163ft Datum: WGS-84 Azimuth/Bearing: 267° S87W 4747mils (True) Elevation Angle: -17.6 Horizon Angle: +01.3 Zoom: 1X 11494+00</p>

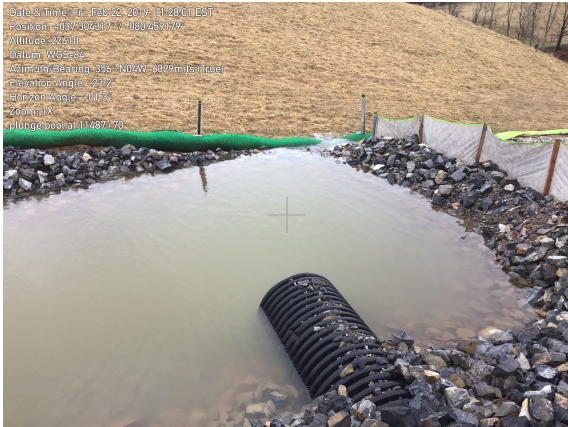
<p>Date &amp; Time: Fri, Feb 22, 2019, 11:20:01 EST Position: +037 494177 / -080 457177 Altitude: 2320ft Datum: WGS-84 Azimuth/Bearing: 332° N82W 6039mils (True) Elevation Angle: -0.2 Horizon Angle: -00.2 Zoom: 1X plunge pool at 11487+70</p>

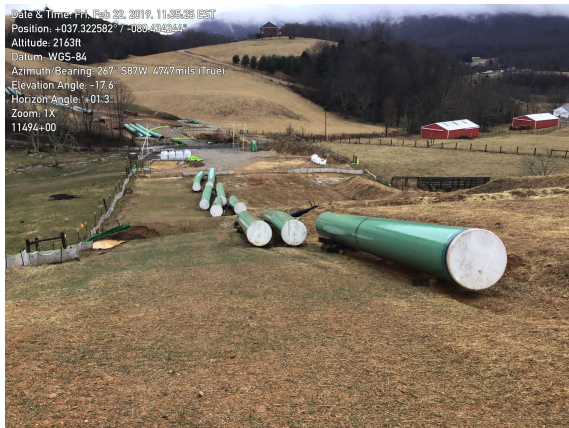
GPS Location	37.1360187745068, -80.3939645458761	GPS Location	37.1360187745068, -80.3939645458761		
Description	See photo for gps coordinates. Stabilized ROW atv11494+00	Description	See photo for gps coordinates. Stream s-rr3 during rain event		
<p>Date &amp; Time: Fri, Feb 22, 2019, 11:01:59 EST Position: +037 296322 / -080 336018 Altitude: 2030ft Datum: WGS-84 Azimuth/Bearing: 341° N19W 5343mils (True) Elevation Angle: -00.0 Horizon Angle: +01.0 Zoom: 1X 0.6 mt tabor</p>

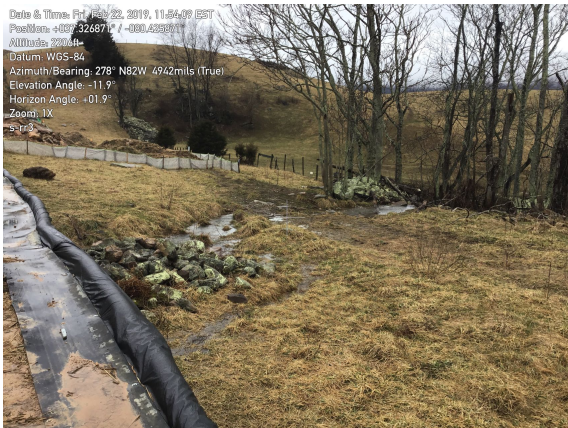
<p>Date &amp; Time: Fri, Feb 22, 2019, 11:04:00 EST Position: +037 322871 / -080 438000 Altitude: 2200ft Datum: WGS-84 Azimuth/Bearing: 278° N82W 4942mils (True) Elevation Angle: -11.9 Horizon Angle: +01.9 Zoom: 1X s-rr3</p>

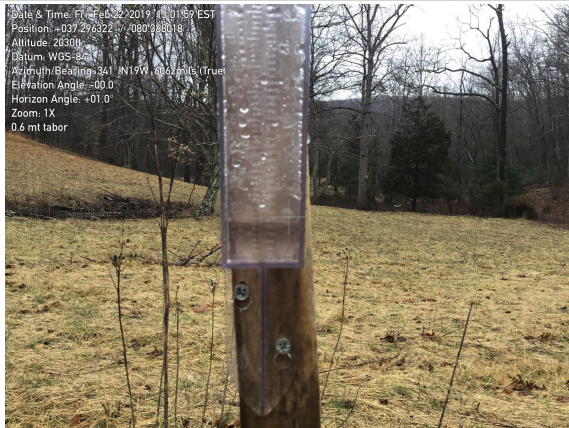
GPS Location	37.1360187745068, -80.3939645458761	GPS Location	37.1360187745068, -80.3939645458761		
Description	0.6 mt tabor rain gauge	Description	0.6 Catawba rain gauge

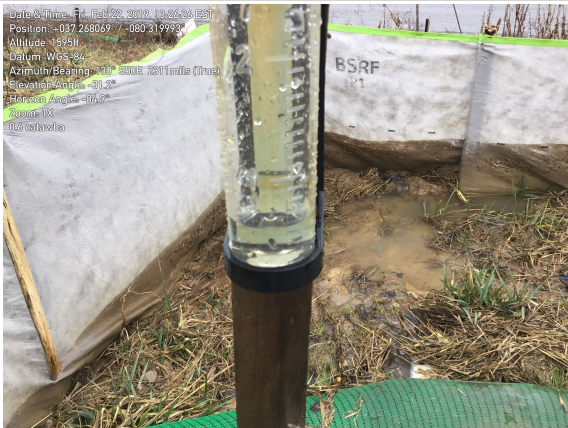
<p>Date &amp; Time: Fri, Feb 22, 2019, 10:52:34 EST Position: +037 288069 / -080 319970 Altitude: 1935ft Datum: WGS-84 Azimuth/Bearing: 341° N19W 5343mils (True) Elevation Angle: -01.2 Horizon Angle: -00.6 Zoom: 1X 0.6 Catawba</p>
