Visual Site Inspection Report

Project Name	H-600 Pipeline Spread G	AFE	124300137	Spread	H-600 Pipeline Spread G
Contractor	Precision			Report #	14528
Inspector	Trey Ingram			Date/Time	3/2/2019 11:47 AM
Permit #	TBD	Inspection Type	Daily	Station Begin	10300+00
State	VA	Inspection Area	Full	Station End	11300+00
County	Montgomery	Ground	Muddy	Temperature (°F)	45.00
Municipality	N/A	Weather	Cloudy	Rain Gauge (in)	0.50
GPS Location	37.3338476515141, -80.7502208090308			Rain Accumulation Time (days)	1.00

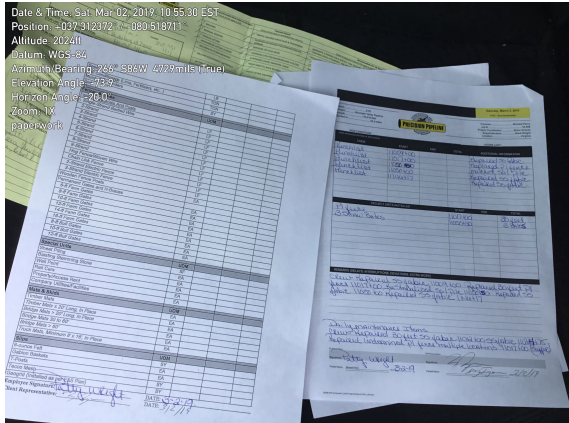
GPS Location	37.3338624939511, -80.7501798021893		GPS Location	37.3329892242675, -80.7503910642869	
Description	Paperwork		Description	Crew repairing Super silt fence 11156+00	
<p>Date & Time: Sat, Mar 02, 2019, 07:50:26 EST Position: -037.414700 / -88.741191 Altitude: 1828ft Datum: WGS-84 Azimuth/Bearing: 044° N44E 0782mils (True) Elevation Angle: -04.1° Horizon Angle: -00.3° Zoom: 1X yc37</p>

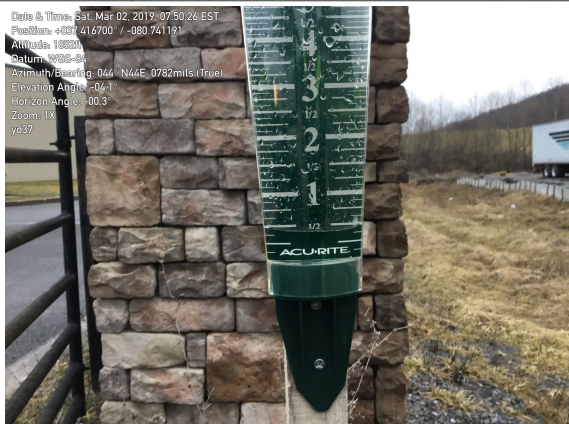
GPS Location	37.3328849114825, -80.7504298724986		GPS Location	37.3329385975723, -80.7503600512452	
Description	Rain gauge yd 37 .5"		Description	Rain gauge Pocahontas rd .5"	
<p>Date & Time: Sat, Mar 02, 2019, 08:54:39 EST Position: -037.352226 / -88.522541 Altitude: 1828ft Datum: WGS-84 Azimuth/Bearing: 071° N71E 1262mils (True) Elevation Angle: -05.2° Horizon Angle: -01.1° Zoom: 1X buffalo anklets 5</p>

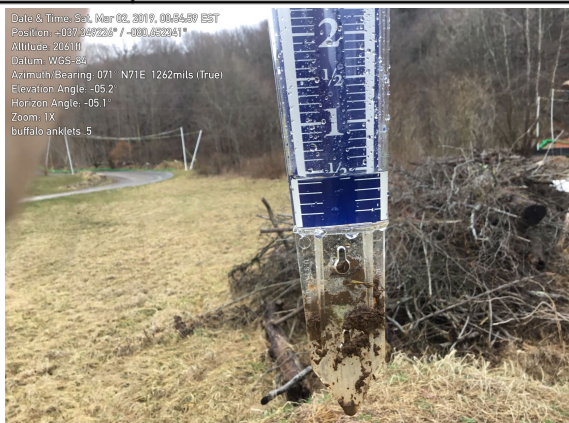
<p>Date & Time: Sat, Mar 02, 2019, 08:41:20 EST Position: -037.372428 / -88.679839 Altitude: 1828ft Datum: WGS-84 Azimuth/Bearing: 104° S26E 1849mils (True) Elevation Angle: -01.3° Horizon Angle: -01.6° Zoom: 1X 244</p>  			
GPS Location	37.3329652520244, -80.7504237537093		GPS Location	37.3328819778164, -80.7504390925921	
Description	Rain gauge buffalo anklets .5"		Description	Rain gauge ar234 .6"

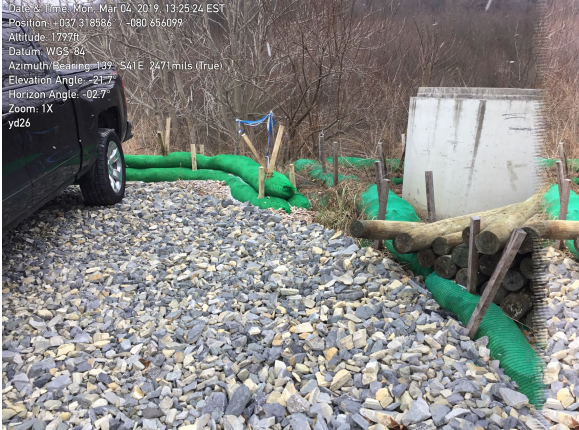
<p>Date & Time: Mon, Mar 04, 2019, 13:25:30 EST Position: +037.318586 / -080.656099 Altitude: 1797ft Datum: WGS-84 Azimuth/Bearing: 192° S41E 2471mils (True) Elevation Angle: -21.7° Horizon Angle: -02.7° Zoom: 1X yd26</p>		
GPS Location	37.31	Field Station#	+26	GPS Location	37.31
Description	CFS in good condition		Description	Generator in containment

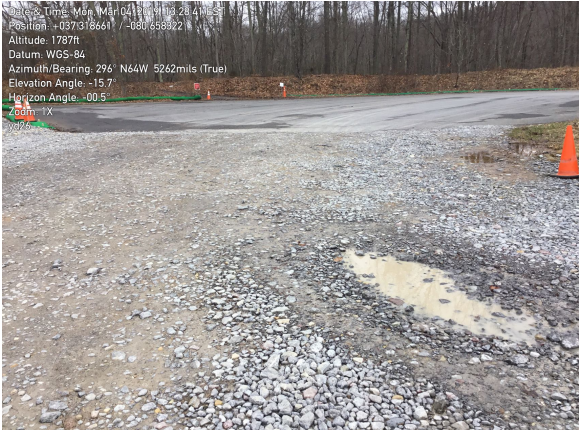
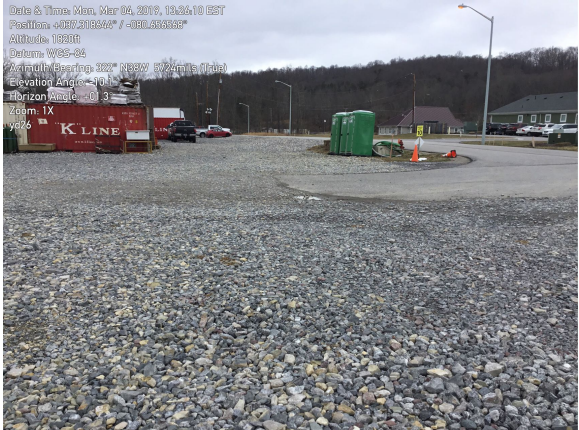
GPS Location	37.31	Field Station#	+26	GPS Location	37.31
Description	RCE yd 26		Description	RCE yd 26	
<p>Insert image here</p>

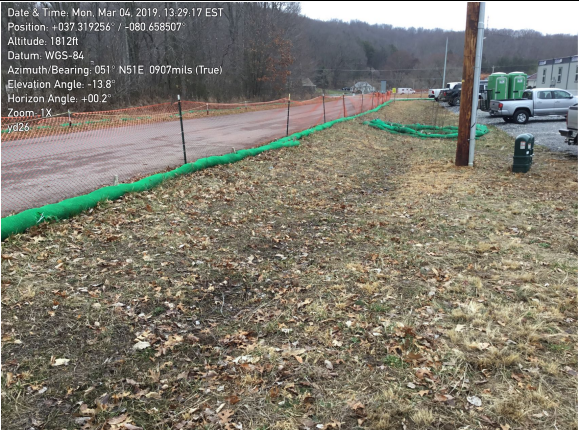
<p>Date & Time: Mon, Mar 04, 2019, 13:29:17 EST Position: +037.319256 / -080.658507 Altitude: 1812ft Datum: WGS-84 Azimuth/Bearing: 051° N51E 0907mils (True) Elevation Angle: -13.8° Horizon Angle: +00.2° Zoom: 1X yd26</p>		
GPS Location		Field Station#		GPS Location	37.31
Description			Description	RCE yd 26

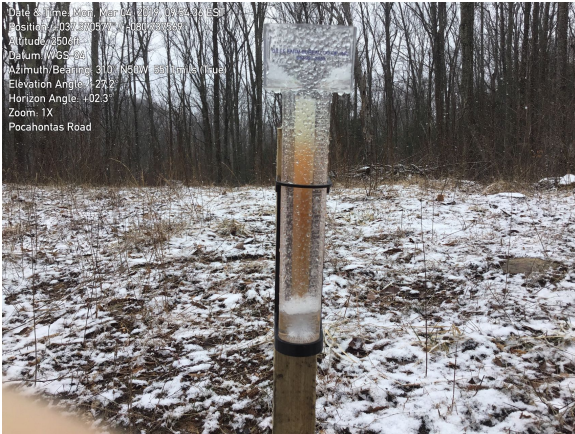
<p>Date & Time: Mon, Mar 04, 2019, 10:55:07 EST Position: +037.334060° / -080.88037° Altitude: 1573ft Datum: WGS-84 Azimuth/Bearing: 279° N01W 4700mils (True) Elevation Angle: +25.6° Horizon Angle: +00.6° Zoom: 1X Laydown yard 26</p>				
GPS Location	37.20	Field Station#	1+50	GPS Location	37.20	Field Station#	0+00
Description	Rain gauge at Pocahontas Road.			Description	18" compost filter sock at lay down yard 26.

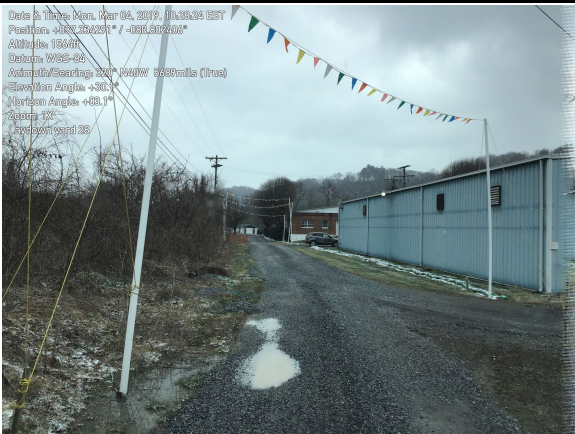
GPS Location	37.20	Field Station#	0+00	GPS Location	37.20	Field Station#	11768+00
Description	RCE in place at lay down yard 26.			Description	Rain gauge at Mount Tabor Road.

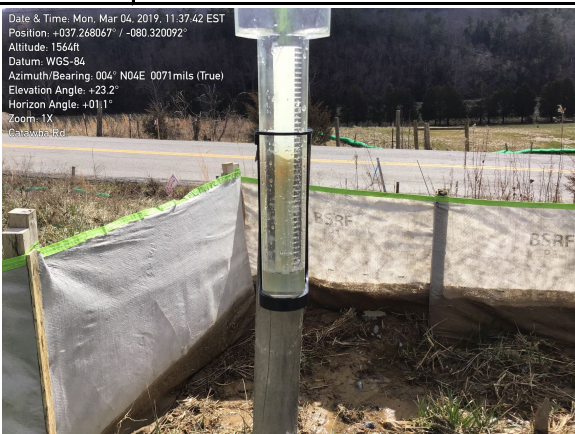
<p>Date & Time: Mon, Mar 04, 2019, 11:38:25 EST Position: +037.268067° / -080.320092° Altitude: 1564ft Datum: WGS-84 Azimuth/Bearing: 004° N04E 0071mils (True) Elevation Angle: +23.2° Horizon Angle: +01.1° Zoom: 1X Laydown yard 26</p>				
GPS Location	37.20	Field Station#	11990+00	GPS Location	37.20	Field Station#	0+00
Description	Rain gauge at Catawba Road.			Description	18" compost filter sock at lay down yard 26.

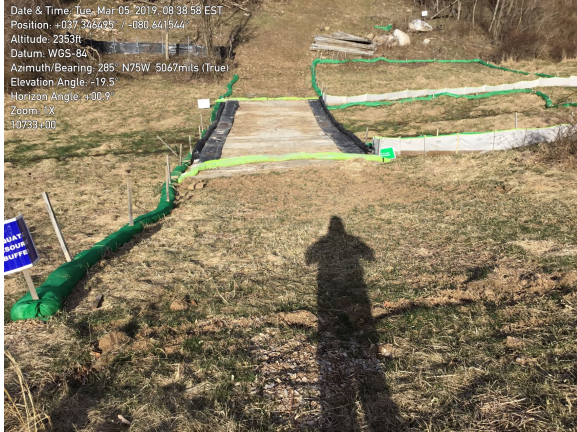
</div>				
GPS Location	37.31	Field Station#	10733+00		GPS Location	37.31	Field Station#	10713+00
Description	Wet land mat bridge			Description	Stream crossing			
<div><div>Date & Time: Tue, Mar 05, 2019, 09:06:32 EST Position: +037.349198° / -080.653032° Altitude: 1867ft Datum: WGS-84 Azimuth/Bearing: 173° S07E 3076mils (True) Elevation Angle: -18.2° Horizon Angle: -01.9° Zoom: 1X 10696+00</div>

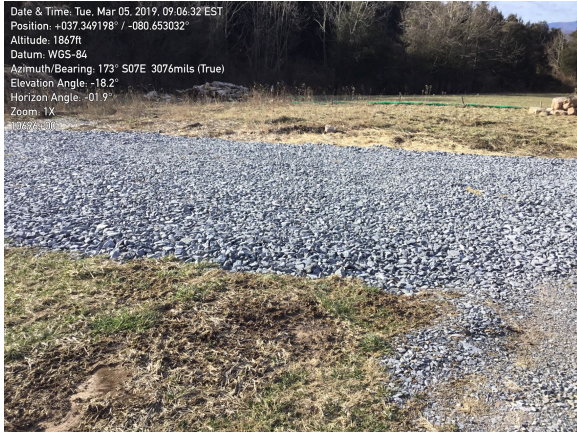
GPS Location	37.31	Field Station#	10696+00		GPS Location	37.31	Field Station#	10696+00
Description	RCE			Description	Drainage feature crossing			
Insert image here				<div><div>Date & Time: Tue, Mar 05, 2019, 09:20:39 EST Position: +037.350241° / -080.638172° Altitude: 2058ft Datum: WGS-84 Azimuth/Bearing: 065° N65E 1156mils (True) Elevation Angle: -21.6° Horizon Angle: +00.5° Zoom: 1X 10679+00</div>

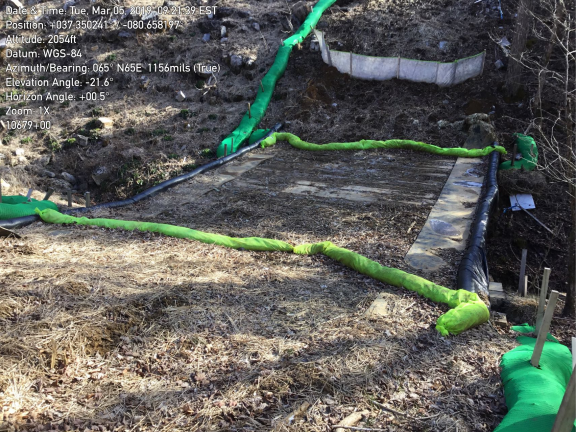
</div>				
GPS Location		Field Station#			GPS Location	37.31	Field Station#	10679+00
Description				Description	Stream crossing with mat bridge

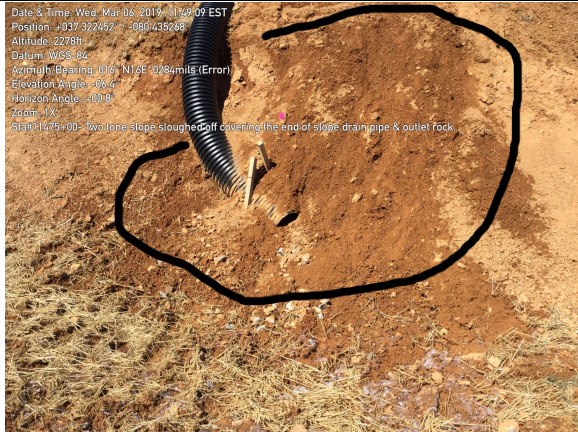
</div></div>			<div><div><div>Date & Time: Wed, Mar 06, 2019, 11:49:09 EST Position: +037.322452° / -080.439268° Altitude: 2278ft Datum: WGS-84 Azimuth/Bearing: 016° N16E 0284mils (Error) Elevation Angle: -36.4 Horizon Angle: -00.8 Zoom: 1X Sta#11475+00- Two tone slope sloughed off covering the end of slope drain pipe & outlet rock</div>

GPS Location	37.31	Field Station#	11172+70	GPS Location	37.31	Field Station#	11475+00
Description	Two CFS checks are under cut along with end treatment, below slope drain.			Description	Two tone slope has sloughed off covering the outlet end of slope pipe & outlet rock.		
<div><div><div>Date & Time: Wed, Mar 06, 2019, 11:42:10 EST Position: +037.322054° / -080.434910° Altitude: 2210ft Datum: WGS-84 Azimuth/Bearing: 031° N31E 0455mils (True) Elevation Angle: -35.4 Horizon Angle: -01.2 Zoom: 1X Sta#11476+00- Contractor repaired end treatment</div>

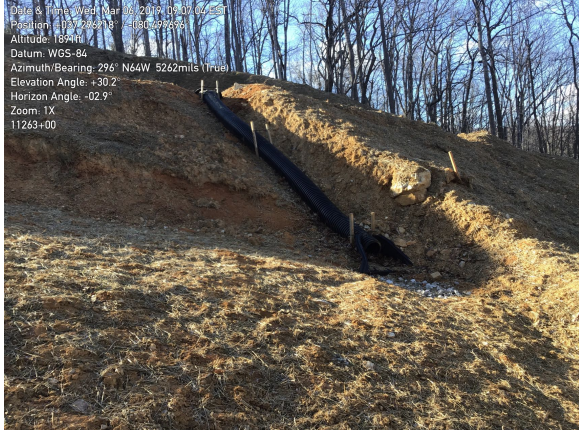
</div>				
GPS Location	37.20	Field Station#	11263+00	GPS Location	37.20	Field Station#	11269+00
Description	See photo for GPS location. Slope drain with rock outlet on place over two-tone.			Description	See photo for GPS location. Plunge pool in place.		
<div><p>Date & Time: Wed, Mar 06, 2019, 02:35:59 EST Position: +037.29843, +080.48795 Altitude: 2307ft Datum: WGS-84 Azimuth/Bearing: 338° N22W 6003mils (True) Elevation Angle: +18.2° Horizon Angle: -02.4° Zoom: 1X 11288+00</p>

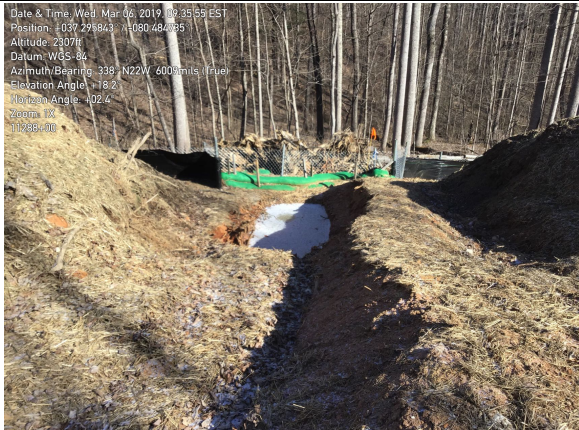
GPS Location	37.20	Field Station#	11288+00	GPS Location	37.20	Field Station#	11327+85
Description	See photo for GPS location. Water bar, end treatment, and sump pit in place.			Description	See photo for GPS location. Sensitive resource buffer in place at stream S-NN12.		
<div><p>Date & Time: Wed, Mar 06, 2019, 10:01:16 EST Position: +037.300914, +080.471138 Altitude: 2180ft Datum: WGS-84 Azimuth/Bearing: 070° N70E 1244mils (True) Elevation Angle: +27.5° Horizon Angle: +02.6° Zoom: 1X 11332+00</p>

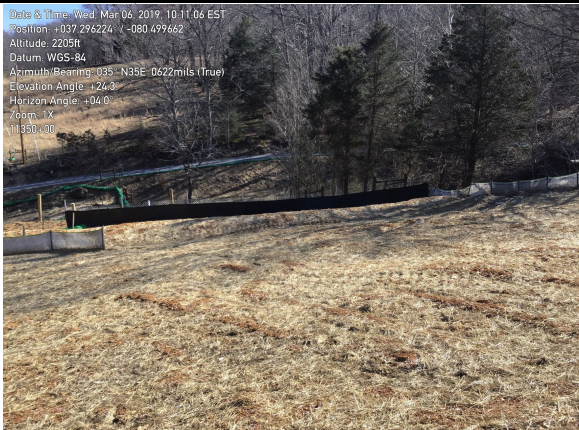
</div>			<div><p>Date & Time: Wed, Mar 06, 2019, 10:11:06 EST Position: +037.296224, +080.499662 Altitude: 2205ft Datum: WGS-84 Azimuth/Bearing: 035° N35E 0622mils (True) Elevation Angle: +24.3° Horizon Angle: +04.0° Zoom: 1X 11350+00</p>

</div>				
GPS Location	37.20	Field Station#	11323+00	GPS Location	37.20	Field Station#	11350+00
Description	See photo for GPS location. Compost filter checks in place in water bar throat.			Description	See photo for GPS location. Reinforced silt fence in place at stream buffer.

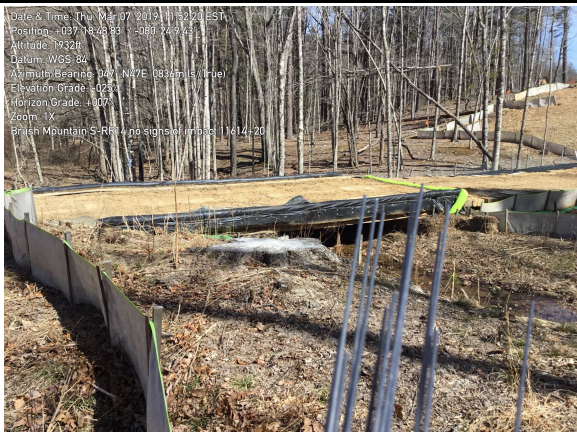
<div><div><div>Date & Time: Thu, Mar 07, 2019, 11:52:20 EST Position: +037.182833 / -080.244143 Altitude: 1932ft Datum: WGS-84 Azimuth/Bearing: 341.141W 6368mils (True) Elevation Grade: -022% Horizon Grade: +007% Zoom: 1X Brush Mountain S-RR14 no sign of impact 11614+20</div>

</div></div>				
GPS Location	37.13	Field Station#	11614+20		GPS Location	37.13	Field Station#	11608+00
Description	Correct coordinates on photo. S-RR14 crossing stable with no impact.			Description	Correct coordinates on photo. S-006 crossing stable with no impact to stream discovered.

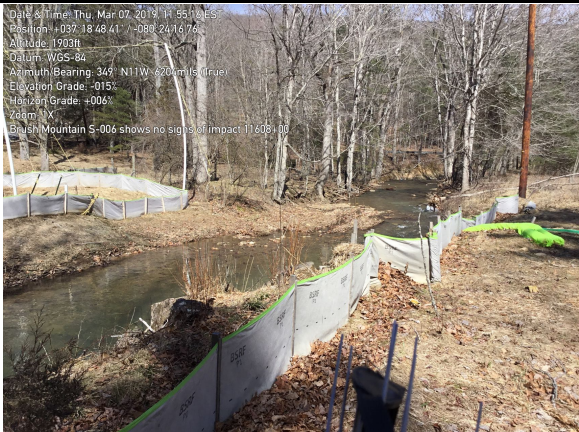
</div></div>				<div><div><div>Date & Time: Thu, Mar 07, 2019, 11:55:10 EST Position: +037.184841 / -080.241674 Altitude: 1990ft Datum: WGS-84 Azimuth/Bearing: 349.111W 6200mils (True) Elevation Grade: -015% Horizon Grade: +006% Zoom: 1X Brush Mountain S-006 shows no sign of impact 11608+00</div>

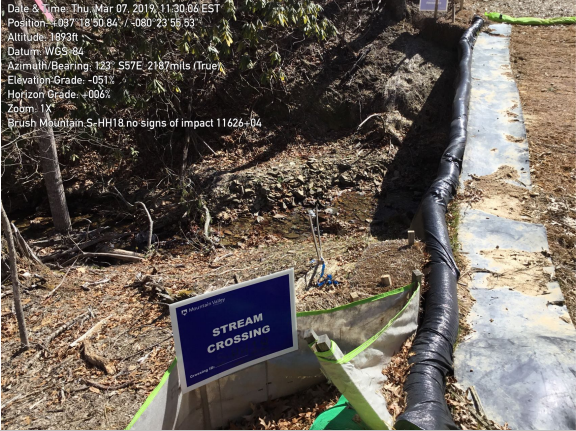
<p>Date & Time: Thu, Mar 07, 2019, 11:30:58 EST Position: -4037.18 50.84 / -580.23 55.53 Altitude: 1593ft Datum: WGS-84 Azimuth/Bearing: 123.557E, 2187mils (True) Elevation Grade: -051% Horizon Grade: +006% Zoom: 1X Brush Mountain S-HH18, no signs of impact 11626+04</p>

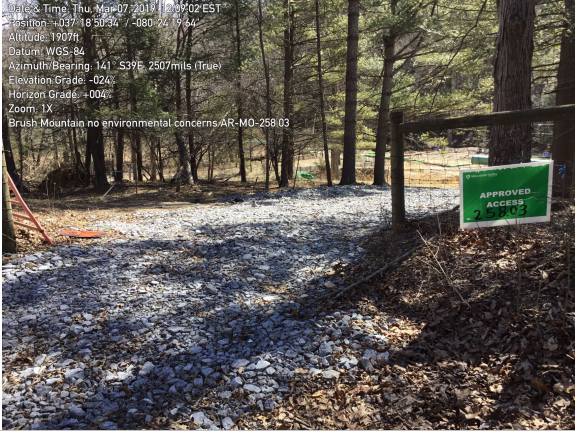
<p>Date & Time: Thu, Mar 07, 2019, 1:39:02 EST Position: -4037.18 50.84 / -580.23 55.53 Altitude: 1507ft Datum: WGS-84 Azimuth/Bearing: 141.539E, 2507mils (True) Elevation Grade: -024% Horizon Grade: +004% Zoom: 1X Brush Mountain no environmental concerns AR-MO-258.03</p>		
GPS Location 37.13		Field Station# 11626+04		GPS Location 37.13	
Description		Correct coordinates on photo. No impact noted at the S-HH18 crossing.		Description	
GPS Location		Field Station#		GPS Location	
Description				Description	
GPS Location		Field Station#		GPS Location

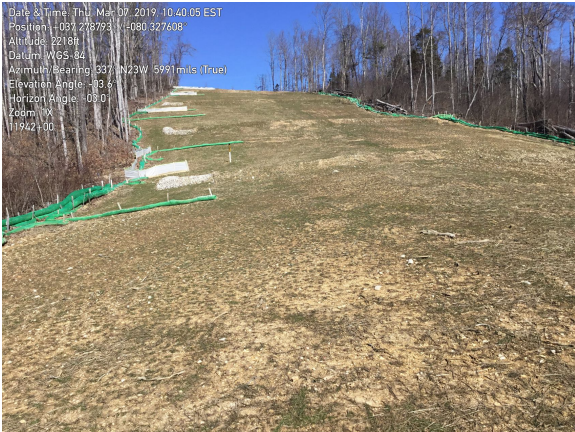
A/E	124300137	Date/Time	3/7/2019 2:20 PM	Report #	14669		
Pictures							
<div><div>Date & Time: Thu, Mar 07, 2019, 10:40:05 EST Position: +037.278937 / -080.327608 Altitude: 2218ft Datum: WGS-84 Azimuth/Bearing: 037° N23W 5991mils (True) Elevation Angle: -18.6° Horizon Angle: -03.0° Zoom: 1X 11942+00</div>

</div>				
GPS Location	37.31	Field Station#	11942+00	GPS Location	37.31	Field Station#	11942+00
Description	Row stabilized			Description	ECDs protecting karst feature		
<div><div>Date & Time: Thu, Mar 07, 2019, 11:03:46 EST Position: +037.278937 / -080.327650 Altitude: 2220ft Datum: WGS-84 Azimuth/Bearing: 155° S25E 2756mils (True) Elevation Angle: -17.9° Horizon Angle: -02.2° Zoom: 1X 11942+00</div>

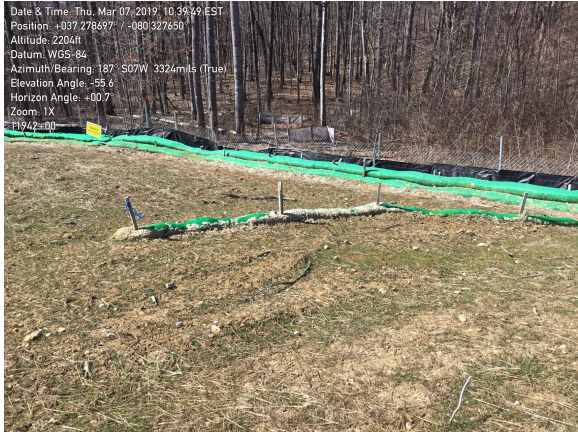
</div>			<div><div>Date & Time: Thu, Mar 07, 2019, 10:39:29 EST Position: +037.278937 / -080.327650 Altitude: 2204ft Datum: WGS-84 Azimuth/Bearing: 187° S07W 3324mils (True) Elevation Angle: -56.6° Horizon Angle: -00.7° Zoom: 1X 11942+00</div>

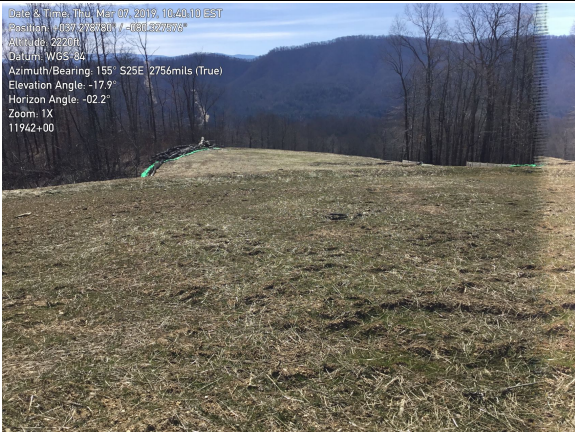
GPS Location	37.31	Field Station#	11942+00	GPS Location	37.31	Field Station#	11944+00
Description	Row stabilized			Description	ECDs protecting karst feature		
<div><div>Date & Time: Thu, Mar 07, 2019, 11:05:40 EST Position: +037.268939 / -080.322863 Altitude: 1696ft Datum: WGS-84 Azimuth/Bearing: 072° N77E 1369mils (True) Elevation Angle: -20.2° Horizon Angle: -01.3° Zoom: 1X 11979+00</div>

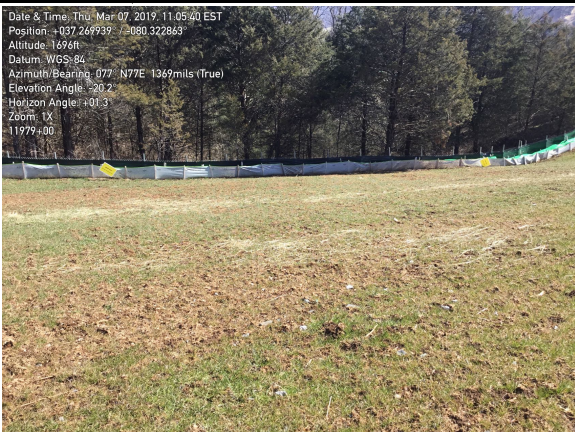
</div>				
GPS Location	37.31	Field Station#	11979+00	GPS Location	37.31	Field Station#	11975+00
Description	ECDs protecting karst feature			Description	ECDs protecting karst feature

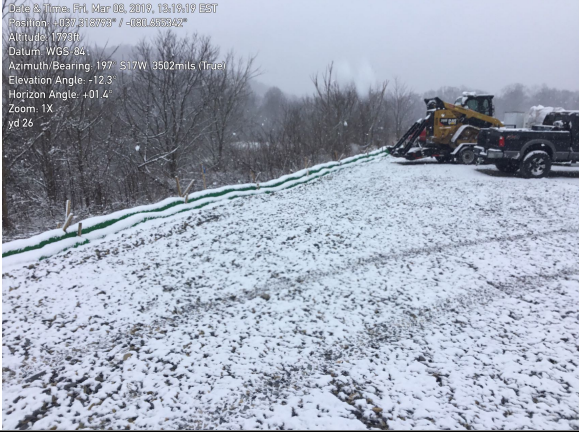
<p><small>Date & Time: Fri, Mar 08, 2019, 12:16:29 EST Position: +037.218272° / -081.532322° Altitude: 1799ft Datum: WGS-84 Azimuth/Bearing: 225° NW 4489mils (True) Elevation Angle: -12.1 Horizon Angle: +00.0 Zoom: 1X yd 26</small></p>				
GPS Location	37.31	Field Station#	+26	GPS Location	37.31	Field Station#	+26
Description	Sock at yd 26			Description	Yard 26 parking area

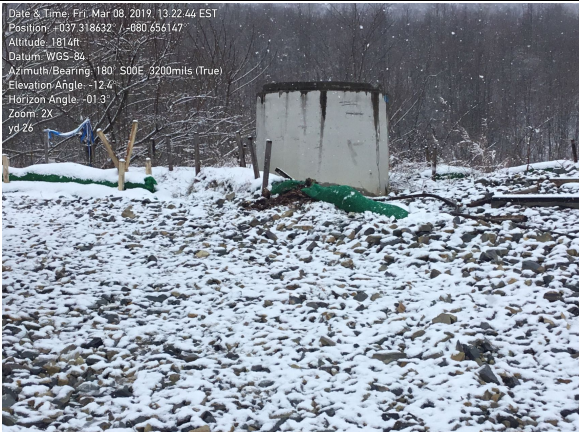
GPS Location	37.23	Field Station#	+26	GPS Location	37.23	Field Station#	+26
Description	Yard 26 ECD maintenance needed.			Description	Yard26		
Insert image here				Insert image here			
GPS Location		Field Station#		GPS Location		Field Station#	
Description				Description
