Visual Site Inspection Report

Project Name	H-600 Pipeline Spread G	AFE	124300137	Spread	H-600 Pipeline Spread G
Contractor	Precision			Report #	14740
Inspector	Len Kruizenga			Date/Time	3/11/2019 7:12 AM
Permit #	TBD	Inspection Type	VA SWPP	Station Begin	11022+00
State	VA	Inspection Area	Partial	Station End	10930+00
County	Giles	Ground	Muddy	Temperature (°F)	51.00
Municipality	N/A	Weather	Cloudy	Rain Gauge (in)	0.60
				Rain Accumulation Time (days)	0.60

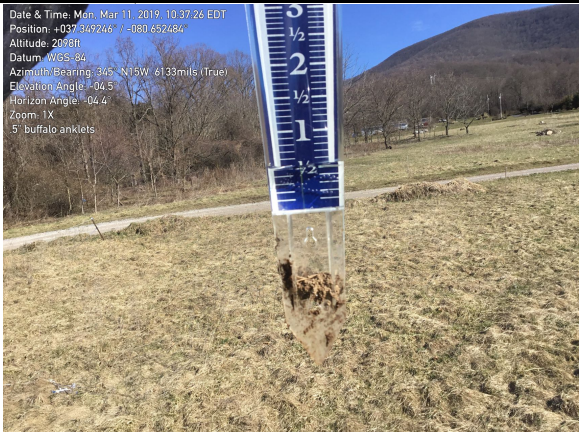
GPS Location		37.31	Field Station#		10688+00		
Description		Sediment build up on sock					
GPS Location		37.31	Field Station#		+1		
Description		.5" rainfall

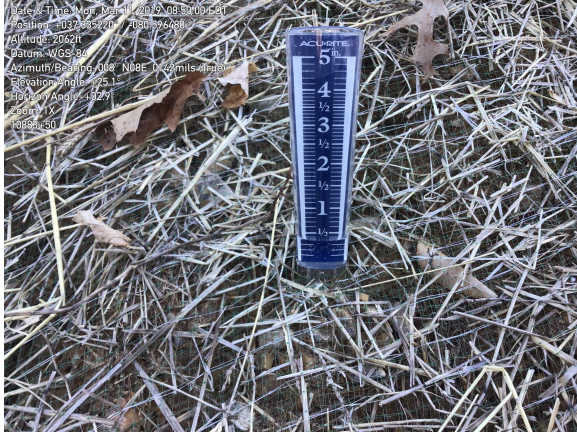
<p>Date & Time: Mon, Mar 11, 2019, 08:31:00 EDT Position: +037.265202° / -080.403183° Altitude: 1927ft Datum: WGS-84 Azimuth/Bearing: 340° N16W 604mils (True) Elevation Angle: +28.1° Horizon Angle: +02.0° Zoom: 1X 10883+50</p>

<p>Date & Time: Mon, Mar 11, 2019, 09:35:21 EDT Position: +037.314578° / -080.403183° Altitude: 1927ft Datum: WGS-84 Azimuth/Bearing: 340° N16W 604mils (True) Elevation Angle: +28.2° Horizon Angle: +02.0° Zoom: 1X Craig Creek</p>				
GPS Location	37.20	Field Station#	10883+50	GPS Location	37.20	Field Station#	11613+00
Description	See photo for GPS location. 0.5 inches rain fall at Kow Camp Road.			Description	See photo for GPS location. 0.6 inches of rain fall at Craig Creek Road

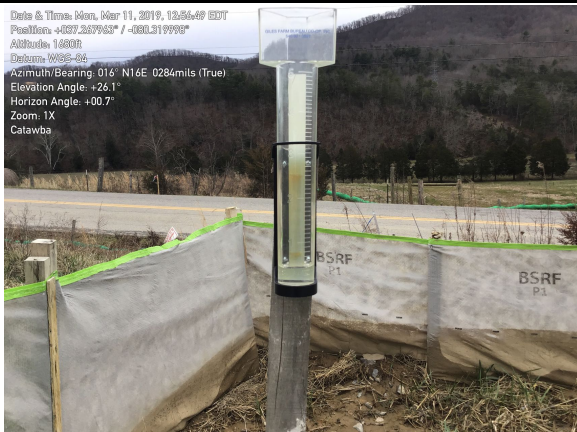
<p>Date & Time: Mon, Mar 11, 2019, 12:55:49 EDT Position: +037.267652° / -080.319998° Altitude: 1680ft Datum: WGS-84 Azimuth/Bearing: 016° N16E 0284mils (True) Elevation Angle: +26.1° Horizon Angle: +00.7° Zoom: 1X Catawba</p>

GPS Location	37.20	Field Station#	11990+00	GPS Location	37.20	Field Station#	11767+00
Description	See photo for GPS location. 0.5 inches of rain fall at Catawba Road.			Description	See photo for GPS location. 0.4 inches of rain fall at Mount Tabor Road.

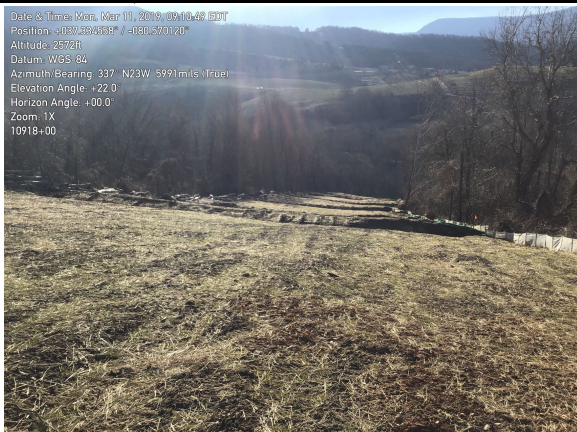
<p>Date & Time: Mon, Mar 11, 2019, 09:10:49 EDT Position: +037.284638° / -080.570170° Altitude: 2572ft Datum: WGS-84 Azimuth/Bearing: 337° N23W 5991mils (True) Elevation Angle: +22.0° Horizon Angle: +00.0° Zoom: 1X 10918+00</p>

<p>Date & Time: Mon, Mar 11, 2019, 09:17:35 EDT Position: +037.331549° / -080.583130° Altitude: 2148ft Datum: WGS-84 Azimuth/Bearing: 308° N52W 5476mils (True) Elevation Angle: +29.1° Horizon Angle: +02.7° Zoom: 1X 10929+00</p>				
GPS Location	37.20	Field Station#	10918+00	GPS Location	37.20	Field Station#	11929+00
Description	See photo for GPS location. ROW stabilized with seed and mulch. Water breakers in place.			Description	See photo for GPS location. RCE in place at Doe Creek Road.

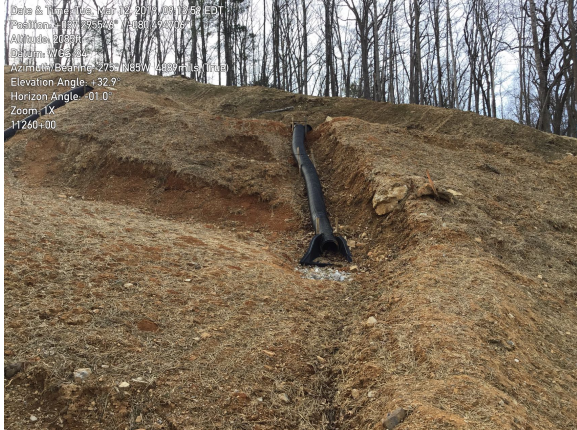
<p>Date & Time: Tue, Mar 12, 2019, 10:52:11 EDT Position: +037.26920° / -080.50103° Altitude: 3657ft Datum: WGS-84 Azimuth/Bearing: 327° N23W 9160mils (True) Elevation Angle: +32.9° Horizon Angle: +01.0° Zoom: 1X 11260+00</p>

<p>Date & Time: Tue, Mar 12, 2019, 09:20:03 EDT Position: +037.26920° / -080.50103° Altitude: 3657ft Datum: WGS-84 Azimuth/Bearing: 009° N09E 9160mils (True) Elevation Angle: +21.9° Horizon Angle: +01.7° Zoom: 1X 11270+00</p>				
GPS Location	37.20	Field Station#	11260+00	GPS Location	37.20	Field Station#	11270+00
Description	See photo for GPS location. Slope drain pipe over two tone with rock outlet.			Description	See photo for GPS location. Plunge pool in place.

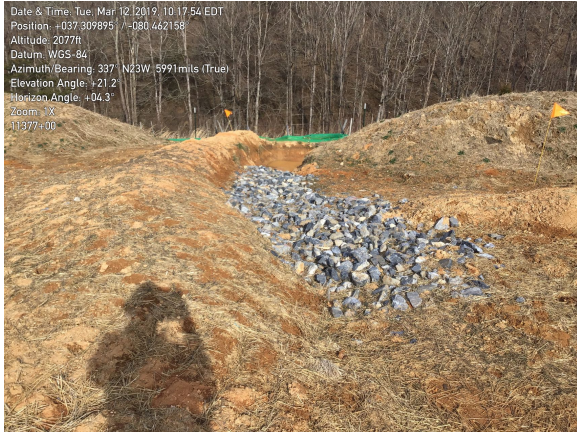
<p>Date & Time: Tue, Mar 12, 2019, 10:17:54 EDT Position: +037.309895° / -080.462158° Altitude: 2077ft Datum: WGS-84 Azimuth/Bearing: 337° N23W 5991mils (True) Elevation Angle: +21.2° Horizon Angle: +04.3° Zoom: 1X 11377+00</p>

GPS Location	37.20	Field Station#	11377+00	GPS Location	37.20	Field Station#	11354+00
Description	See photo for GPS location. Rock lined channel in place.			Description	See photo for GPS location. RCE in place at Old Furnace.

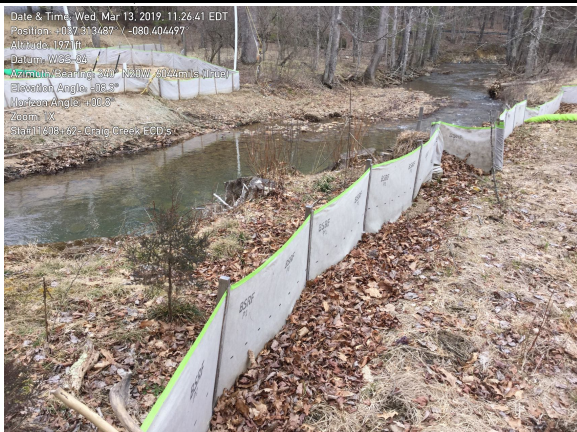
<p>Date & Time: Wed, Mar 13, 2019, 11:30:05 EDT Position: +037.313725° / -080.403760° Altitude: 1745ft Datum: WGS-84 Azimuth/Bearing: 345° N15W 6133mils (True) Elevation Angle: -08.1° Horizon Angle: +01.1° Zoom: 1X Sta# 11610+00 - CWD plunge pool, rock is clean, free of sediment.</p>

GPS Location	37.32	Field Station#	11608+62	GPS Location	37.32	Field Station#	11610+00
Description	Craig Creek ECD's			Description	CWD plunge pool, rock is clean.

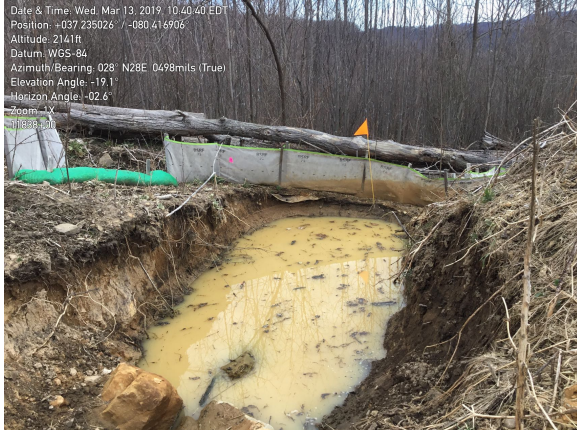
</div>				
GPS Location	37.31	Field Station#	11838+00	GPS Location	37.31	Field Station#	11838+00
Description	Sump			Description	Row		
<div><div>Date & Time: Wed, Mar 13, 2019, 11:45:31 EDT Position: +037 269705° / -080 322865° Altitude: 1751ft Datum: WGS-84 Azimuth/Bearing: 017° N17E 0302mils (True) Elevation Angle: -17.3° Horizon Angle: -04.8° Zoom: 1X 11979+00</div>

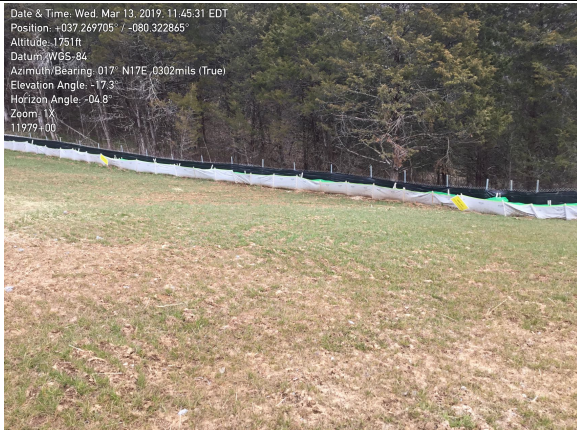
GPS Location	37.31	Field Station#	11979+00	GPS Location	37.31	Field Station#	11942+00
Description	ECDs protecting karst			Description	ECDs protecting karst		
<div><div>Date & Time: Wed, Mar 13, 2019, 11:32:20 EDT Position: +037 276834° / -080 326396° Altitude: 2086ft Datum: WGS-84 Azimuth/Bearing: 122° S58E 2169mils (True) Elevation Angle: -19.9° Horizon Angle: -09.6° Zoom: 1X 11950+00</div>

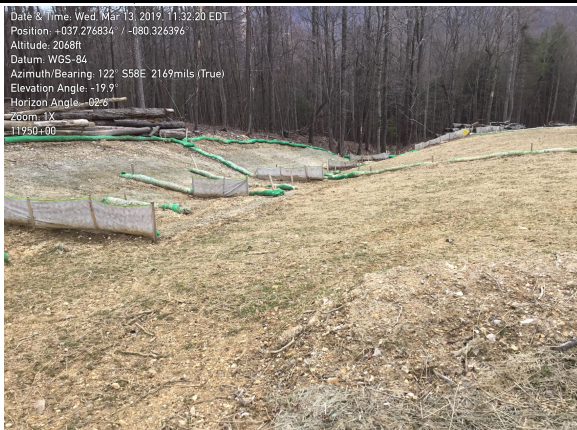
</div>				
GPS Location	37.31	Field Station#	11950+00	GPS Location	37.31	Field Station#	11944+00
Description	ECDs protecting karst			Description	ECDs protecting karst

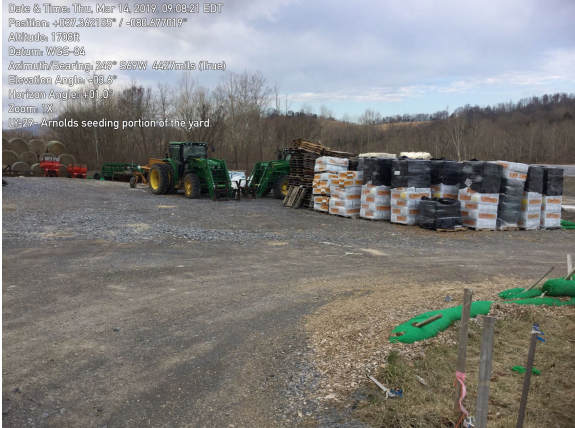
AFE	124300137	Date/Time	3/14/2019 8:47 AM	Report #	14842
Pictures					
<div><p><small>Date & Time: Thu, Mar 14, 2019, 09:08:21 EDT Position: +037.262183° / -080.670019° Altitude: 1760ft Datum: WGS-84 Azimuth/Bearing: 247° S47W 442mils (True) Elevation Angle: -06.4° Horizon Angle: +03.0° Zoom: 1X LY-29- Arnold's seeding portion of the yard</small></p>

</div>		
GPS Location	37.36	Field Station#	+0	GPS Location	37.36
Field Station#	+0		Description	LY-29- Arnold's seeding equipment and materials storage.	
Description			Description	LY- 29- culvert, swale & ECD's.	
<div><p><small>Date & Time: Thu, Mar 14, 2019, 09:16:49 EDT Position: +037.262390° / -080.676587° Altitude: 1762ft Datum: WGS-84 Azimuth/Bearing: 051° N61E 556mils (True) Elevation Angle: -02.8° Horizon Angle: +03.0° Zoom: 1X LY-29- Triple stack perimeter controls are in good condition.</small></p>

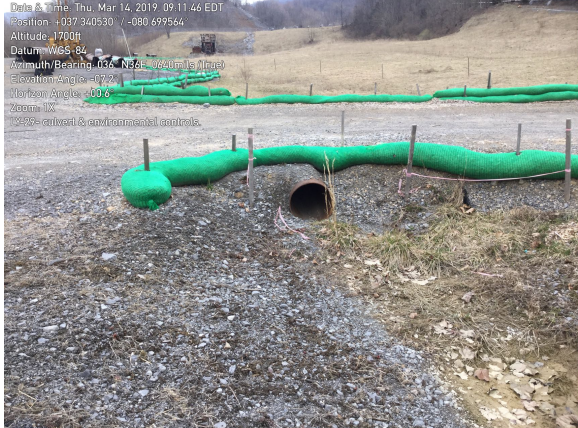
</div>			<div><p><small>Date & Time: Thu, Mar 14, 2019, 09:11:46 EDT Position: +037.340530° / -080.699564° Altitude: 1760ft Datum: WGS-84 Azimuth/Bearing: 152° N28E 622mils (True) Elevation Angle: -07.2° Horizon Angle: +00.6° Zoom: 1X LY-29- culvert & environmental controls</small></p>

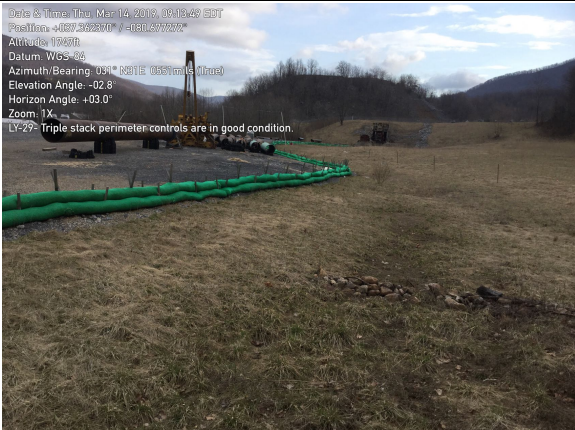
GPS Location	37.36	Field Station#	+0	GPS Location	37.36
Field Station#	+0		Description	LY-29- Triple stack perimeter controls are in good condition.	
Description			Description	LY-29- Precision Materials storage.	
<div><p><small>Date & Time: Thu, Mar 14, 2019, 09:21:21 EDT Position: +037.363299° / -080.676587° Altitude: 1712ft Datum: WGS-84 Azimuth/Bearing: 263° S83W 467mils (True) Elevation Angle: -06.4° Horizon Angle: +00.9° Zoom: 1X LY-29- Rock surface is graded & maintained, perimeter controls are in good condition.</small></p>

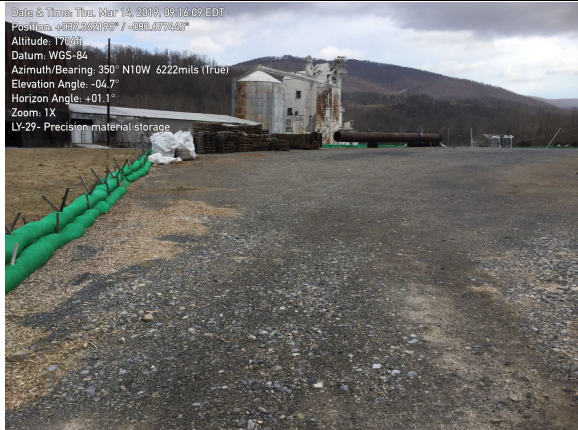
</div>			<div><p><small>Date & Time: Thu, Mar 14, 2019, 09:16:49 EDT Position: +037.262390° / -080.676587° Altitude: 1762ft Datum: WGS-84 Azimuth/Bearing: 350° N10W 622mils (True) Elevation Angle: -04.7° Horizon Angle: +01.1° Zoom: 1X LY-29- Precision material storage.</small></p>

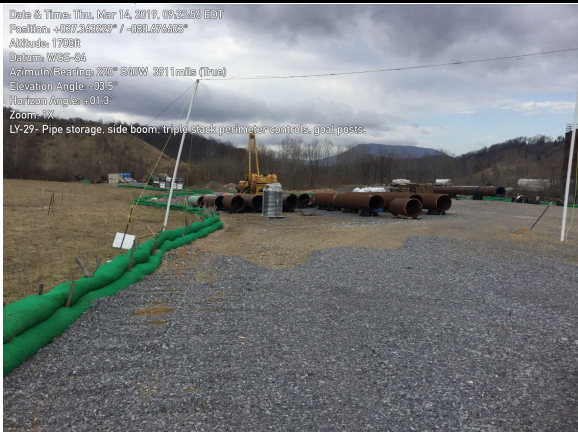
</div>			<div><p><small>Date & Time: Thu, Mar 14, 2019, 09:22:46 EDT Position: +037.363299° / -080.676587° Altitude: 1760ft Datum: WGS-84 Azimuth/Bearing: 320° S40W 391mils (True) Elevation Angle: -03.5° Horizon Angle: +01.3° Zoom: 1X LY-29- Pipe storage, side boom, triple stack perimeter controls, goal posts.</small></p>

Field Station#	+0		Description	LY-29- Pipe storage, side boom, triple triple stack perimeter controls, goal posts.	
Description	Rock surface is maintained and graded.		Description

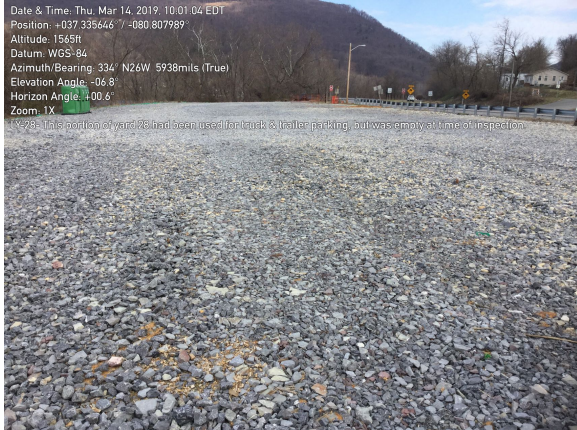
AFE	124300137	Date/Time	3/14/2019 9:55 AM	Report #	14848		
Pictures							
<div><div>Date & Time: Thu, Mar 14, 2019, 10:01:04 EDT Position: +037.335646° / -080.807989° Altitude: 1565ft Datum: WGS-84 Azimuth/Bearing: 334° N26W 5938mils (True) Elevation Angle: -06.8° Horizon Angle: +00.6° Zoom: 1X LY-28- This portion of yard 28 had been used for truck & trailer parking, but was empty at time of inspection.</div>

</div>				
GPS Location	37.33	Field Station#	+0	GPS Location	37.33	Field Station#	+0
Description	LY-28 - Truck & trailer parking portion of yard is empty at time of inspection.			Description	LY- 28- 12" CFS perimeter control

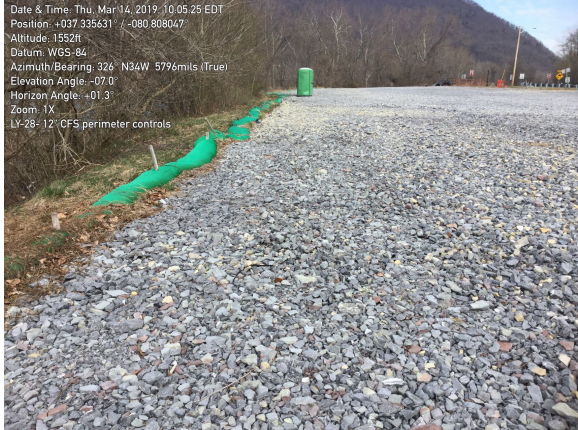
</div>			<div><div>Date & Time: Thu, Mar 14, 2019, 10:05:25 EDT Position: +037.335631° / -080.808047° Altitude: 1552ft Datum: WGS-84 Azimuth/Bearing: 326° N34W 5796mils (True) Elevation Angle: -07.0° Horizon Angle: +01.3° Zoom: 1X LY-28- 12" CFS perimeter controls</div>

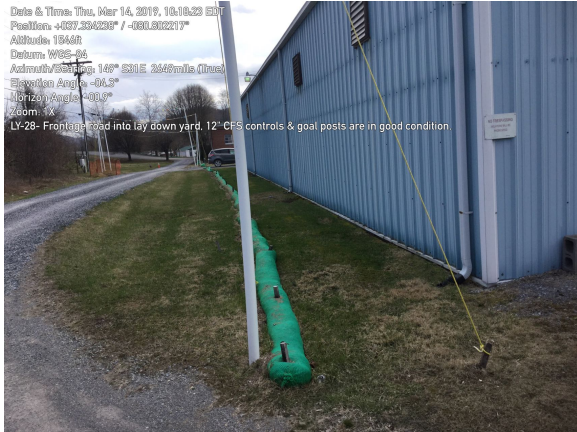
<div><div>Date & Time: Thu, Mar 14, 2019, 10:16:33 EDT Position: +037.334230° / -080.802217° Altitude: 1564ft Datum: WGS-84 Azimuth/Bearing: 149° S31E 2445mils (True) Elevation Angle: -04.5° Horizon Angle: +00.9° Zoom: 1X LY-28- Frontage road into lay down yard, 12" CFS controls, & goal posts are in good condition.</div>

</div>				
GPS Location	37.33	Field Station#	+0	GPS Location	37.33	Field Station#	+0
Description	LY28- Frontage road into yard 28, 12" CFS controls and goal posts are in acceptable condition.			Description	LY-28- Trucks are parked in this portion of yard.		
<div><div>Date & Time: Thu, Mar 14, 2019, 10:33:15 EDT Position: +037.334330° / -080.803021° Altitude: 1567ft Datum: WGS-84 Azimuth/Bearing: 229° N42W 5290mils (True) Elevation Angle: -05.2° Horizon Angle: +01.1° Zoom: 1X LY-28- 18" perimeter controls surrounding yard are in acceptable condition.</div>

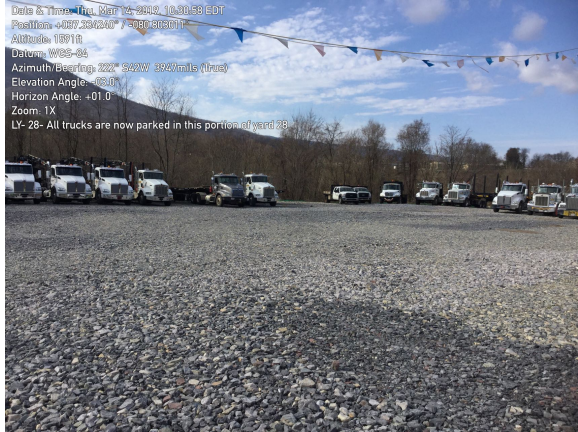
</div>			<div><div>Date & Time: Thu, Mar 14, 2019, 10:31:19 EDT Position: +037.334401° / -080.803046° Altitude: 1551ft Datum: WGS-84 Azimuth/Bearing: 222° S42W 3924mils (True) Elevation Angle: -05.0° Horizon Angle: +01.0° Zoom: 1X LY-28- All trucks are now parked in this portion of yard 28.</div>

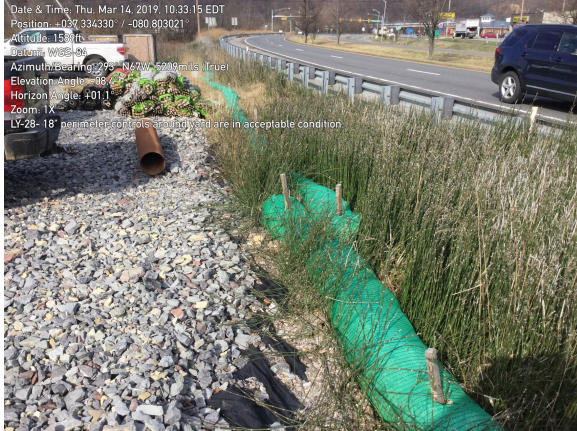
GPS Location	37.33	Field Station#	+0	GPS Location	37.33	Field Station#	+0
Description	LY- 28- 18" perimeter controls			Description	LY-28- 20 yard trash container, house keeping is acceptable.

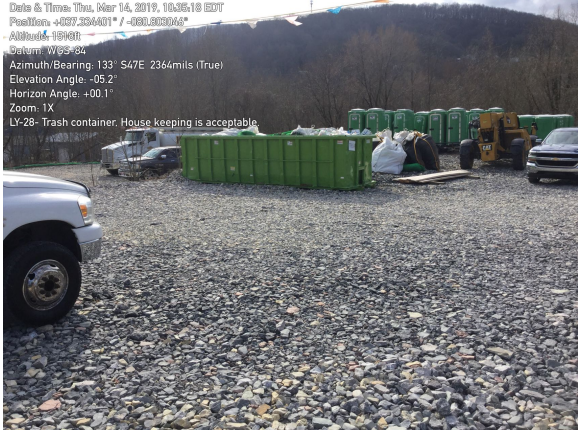
</div>			<div><div>Date & Time: Thu, Mar 14, 2019, 10:46:18 EDT Position: +037.334401° / -080.803046° Altitude: 1550ft Datum: WGS-84 Azimuth/Bearing: 133° S47E 2364mils (True) Elevation Angle: -05.2° Horizon Angle: +00.1° Zoom: 1X LY-28- Trash container. House keeping is acceptable.</div>

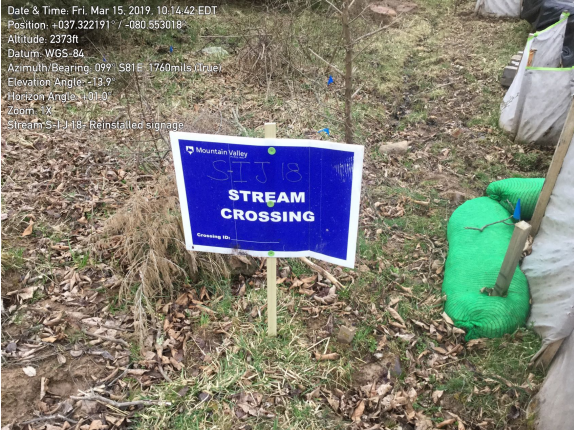
A/E	124300137	Date/Time	3/15/2019 8:47 AM	Report #	14885		
Pictures							
<div><div><div>Date & Time: Fri, Mar 15, 2019, 10:14:42 EDT Position: +037.322191° / -080.553018° Altitude: 2379ft Datum: WGS-84 Azimuth/Bearing: 092.581E 11749mils (True) Elevation Angle: -01.9° Horizon Angle: -01.0° Zoom: 1X Stream S- RR 5- Reinstalled signage</div><div>

</div></div></div>				
GPS Location	37.32	Field Station#	11022+00	GPS Location	37.32	Field Station#	11015+00
Description	Reinstalled Stream crossing signs at stream S - IJ18			Description	Reinstalled buffer, stream crossing, & no refueling signs at Stream S- RR 5

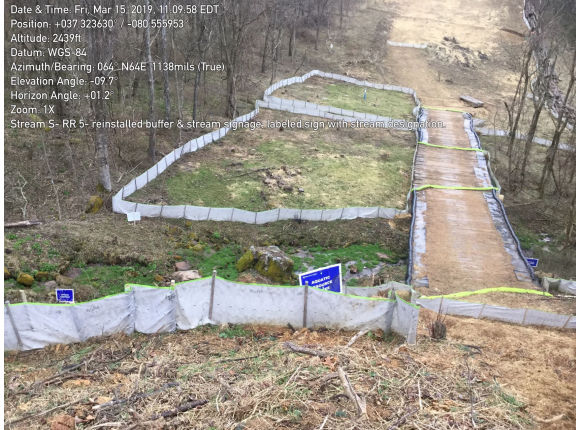
</div></div></div>			<div><div><div>Date & Time: Fri, Mar 15, 2019, 11:09:58 EDT Position: +037.323630° / -080.555953° Altitude: 2439ft Datum: WGS-84 Azimuth/Bearing: 064.664E 1138mils (True) Elevation Angle: -07.7° Horizon Angle: -01.2° Zoom: 1X Stream S- RR 5- reinstalled buffer & stream signage, labeled sign with stream designation</div><div>

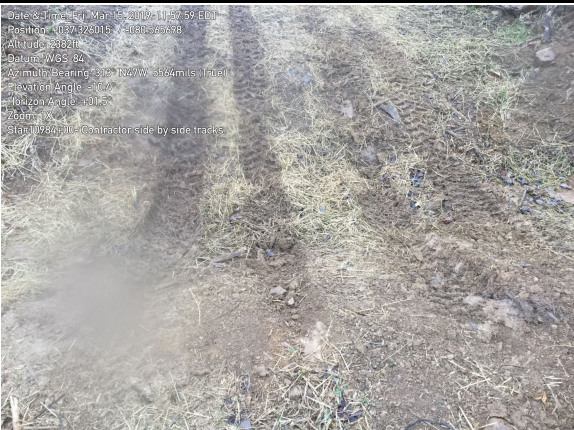
<div><div><div>Date & Time: Fri, Mar 15, 2019, 11:27:59 EDT Position: +037.322015° / -080.553038° Altitude: 2382ft Datum: WGS-84 Azimuth/Bearing: 092.102W 11364mils (True) Elevation Angle: -00.7° Horizon Angle: -01.5° Zoom: 1X Station 11022+00 Contractor side by side tracks</div><div>

</div></div></div>				
GPS Location	37.32	Field Station#	10984+00	GPS Location	37.32	Field Station#	10965+00
Description	Tracks left by contractor side by side.			Description	Karst ECD's are in acceptable condition.		
<div><div><div>Date & Time: Fri, Mar 15, 2019, 12:14:04 EDT Position: +037.276314° / -080.526557° Altitude: 2120ft Datum: WGS-84 Azimuth/Bearing: 011.162W 5120mils (True) Elevation Angle: -08.3° Horizon Angle: -01.0° Zoom: 1X Doe Creek Farms- Straw bales have been replaced at mat bridge at drain feature, too survey station 10956</div><div>

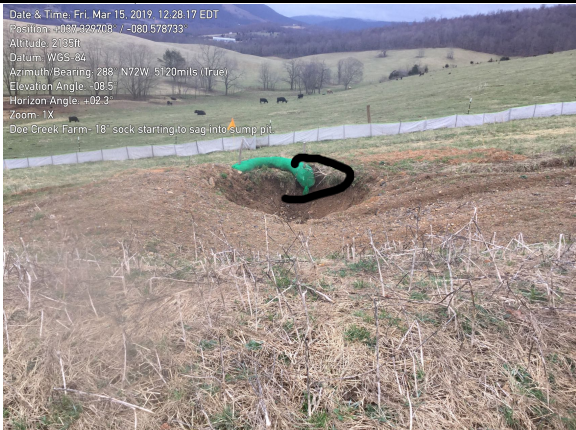
</div></div></div>			<div><div><div>Date & Time: Fri, Mar 15, 2019, 12:28:17 EDT Position: +037.276208° / -080.578733° Altitude: 203ft Datum: WGS-84 Azimuth/Bearing: 288.162W 5120mils (True) Elevation Angle: -08.5° Horizon Angle: -02.3° Zoom: 1X Doe Creek Farm - 18- sock starting to sag into sump pit, I informed environmental crew foreman</div><div>

GPS Location	37.32	Field Station#	10956+00	GPS Location	37.32	Field Station#	10946+00
Description	Doe Creek Farms- Contractor replaced straw bales at all four corners of mat bridge over drainage feature.			Description	Sock starting to sag into sump pit, I informed environmental crew foreman

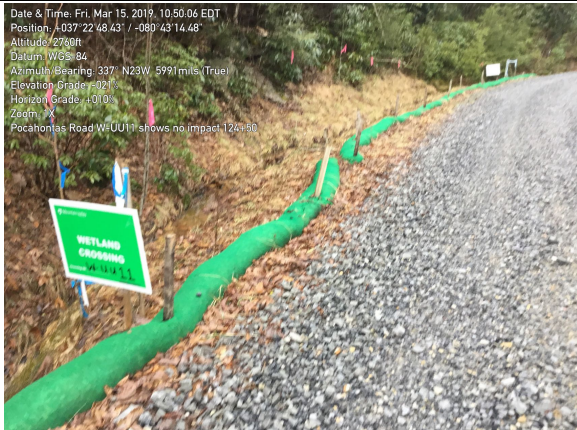
</div>			
GPS Location	37.36	Field Station#	152+70	GPS Location	37.36	
Description	Failed culvert at S-PP19 crossing on Pocahontas Road.			Description	Failed culvert at S-PP14 crossing on Pocahontas Road.	
<div><div>Date & Time: Fri, Mar 15, 2019, 10:50:06 EDT Position: +037 22 48.43 / -080 43 14.48 Altitude: 2740ft Datum: WGS-84 Azimuth/Bearing: 337° N23W 5991mils (True) Elevation Grade: -0.2% Horizon Grade: +010% Zoom: 1X Pocahontas Road W-UU11 shows no impact 124+50</div>

GPS Location	37.31	Field Station#	124+50	GPS Location	37.31	
Description	Adjacent wetland to road not impacted.			Description	Wetland adjacent to road shows no impact.	
<div><div>Date & Time: Fri, Mar 15, 2019, 10:45:57 EDT Position: +037 22 49.71 / -080 43 2.58 Altitude: 2578ft Datum: WGS-84 Azimuth/Bearing: 075° N75E 1333mils (True) Elevation Grade: -0.08% Horizon Grade: +006% Zoom: 1X Pocahontas Road end treatment functional 139+50</div>

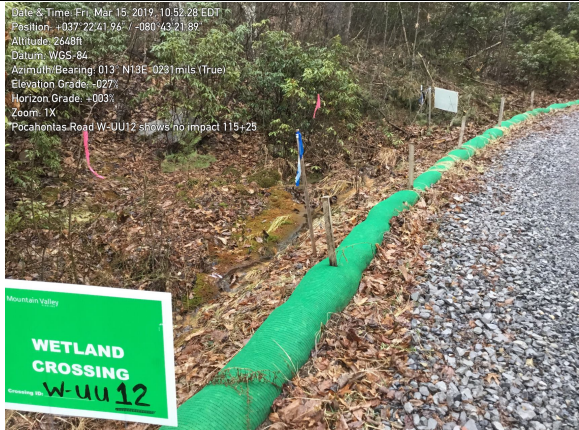
</div>			<div><div>Date & Time: Fri, Mar 15, 2019, 10:57:26 EDT Position: +037 22 41.94 / -080 43 21.89 Altitude: 2648ft Datum: WGS-84 Azimuth/Bearing: 013° N13E 0231mils (True) Elevation Grade: -0.2% Horizon Grade: +003% Zoom: 1X Pocahontas Road W-UU12 shows no impact 115+25</div>

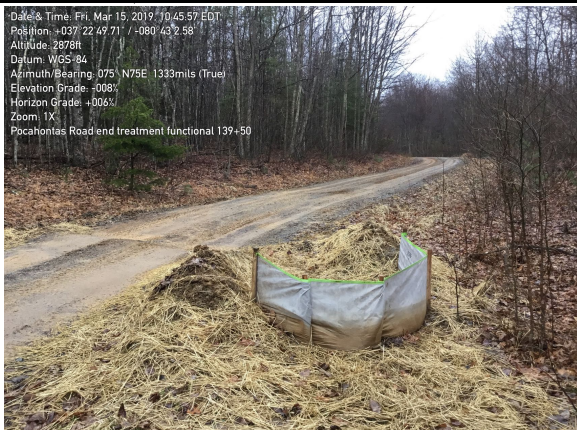
</div>			
GPS Location	37.31	Field Station#	139+50	GPS Location	37.31	
Description	ECDs are in place and effective. Maintenance to be conducted upon receipt of approval from the FS.			Description	Logging damage to MVP ECDs along Pocahontas Road.

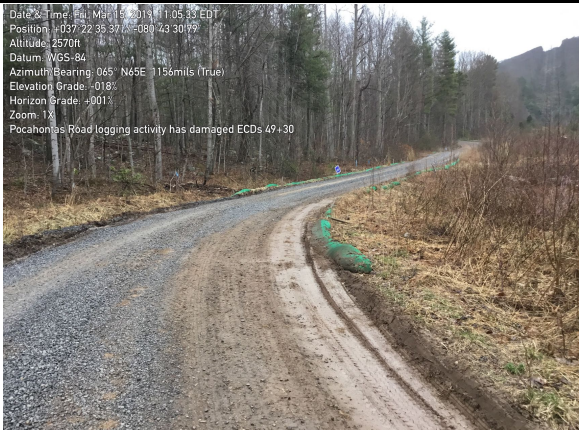
</div>			<div><div>Date & Time: Fri, Mar 15, 2019, 11:05:33 EDT Position: +037 22 35.37 / -080 43 30.49 Altitude: 2570ft Datum: WGS-84 Azimuth/Bearing: 065° N65E 1156mils (True) Elevation Grade: -0.018% Horizon Grade: +001% Zoom: 1X Pocahontas Road logging activity has damaged ECDs 49+30</div>

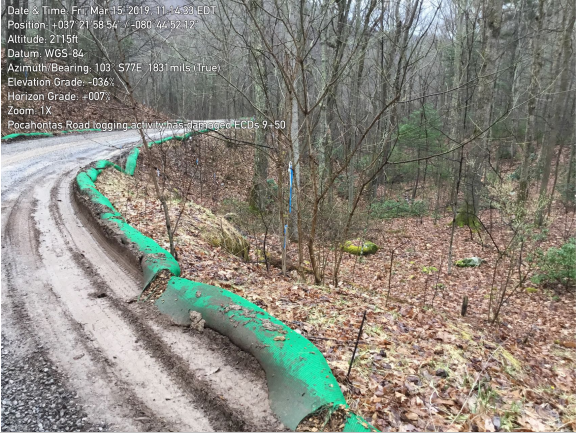
AFE	124300137		Date/Time	3/15/2019 11:24 AM		Report #	14894	
Pictures								
<small> Date & Time: Fri Mar 15/2019 11:24:52 EDT Position: 4037.2158 N / -100.4492 W Altitude: 2115ft Datum: WGS-84 Azimuth/Bearing: 103.577E 183.1mils True Elevation Grade: -036% Horizon Grade: +007% Zoom: 1X Pocahontas Road logging activity has damaged ECDs 9+50 </small>

<div style="text-align: center;">Insert image here</div>		
GPS Location		37.31	Field Station#		9+50	GPS Location		
Description		Logging damages to ECDs along Pocahontas Road.				Description		
<div style="text-align: center;">Insert image here</div>			<div style="text-align: center;">Insert image here</div>					
GPS Location			Field Station#			GPS Location		
Description						Description		
<div style="text-align: center;">Insert image here</div>			<div style="text-align: center;">Insert image here</div>					
GPS Location			Field Station#			GPS Location

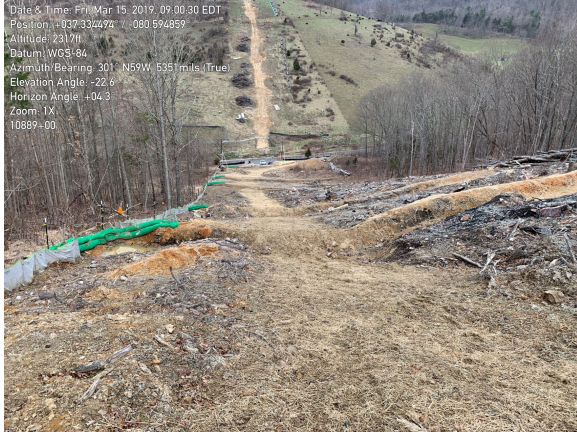
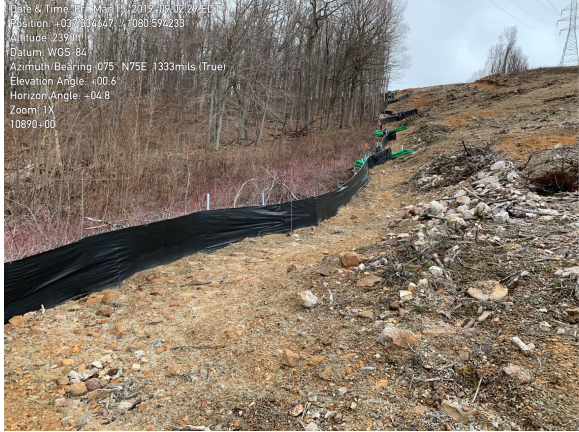
GPS Location	37.31	Field Station#	10889+00	GPS Location	37.31	Field Station#	10890+00
Description	See photo for GPS location. ROW stabilized with seed, mulch, and earth guard pellets.			Description	See photo for GPS location. Reinforced super silt fence in place.

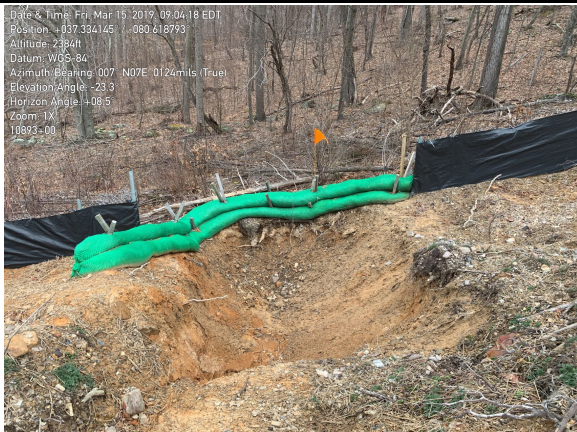
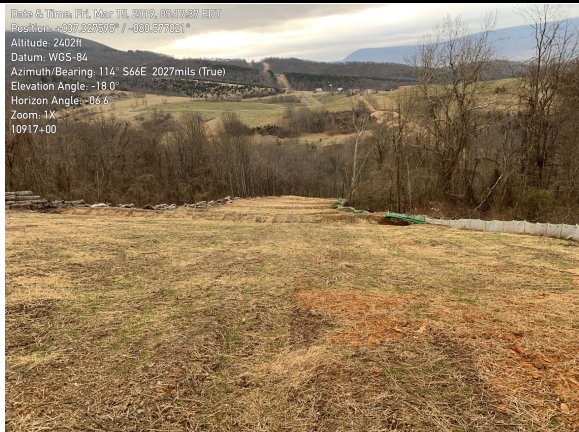
GPS Location	37.31	Field Station#	10893+00	GPS Location	37.31	Field Station#	10917+00
Description	See photo for GPS location. Water bar end treatment in place.			Description	See photo for GPS location. ROW stabilized with seed, mulch and minor vegetation growth.

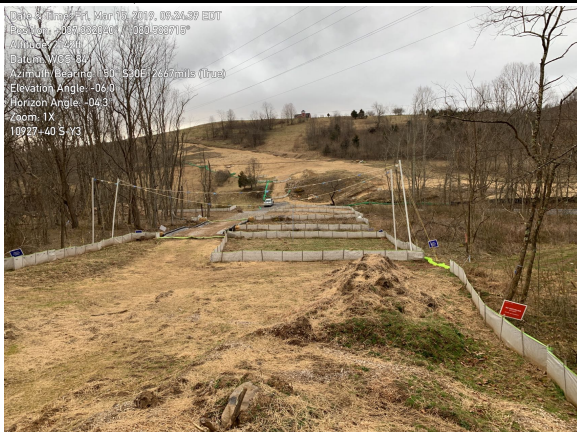
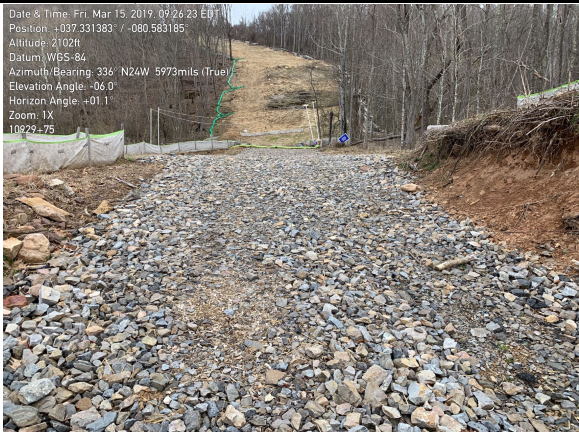
GPS Location	37.31	Field Station#	10927+40	GPS Location	37.31	Field Station#	10929+75
Description	See photo for GPS location. Sensitive resource buffer in place at stream S-Y3.			Description	See photo for GPS location. RCE in place at doe creek road.
