Visual Site Inspection Report

Project Name	H-600 Pipeline Spread G	AFE	124300137	Spread	H-600 Pipeline Spread G
Contractor	Precision			Report #	14761
Inspector	Garrett Barclay			Date/Time	3/18/2019 2:19 PM
Permit #	TBD	Inspection Type	VA SWPP	Station Begin	11020+00
State	VA	Inspection Area	Partial	Station End	11150+00
County	Craig	Ground	Dry	Temperature (°F)	42.00
Municipality	N/A	Weather	Sunny	Rain Gauge (in)	0.00
				Rain Accumulation Time (days)	1.00

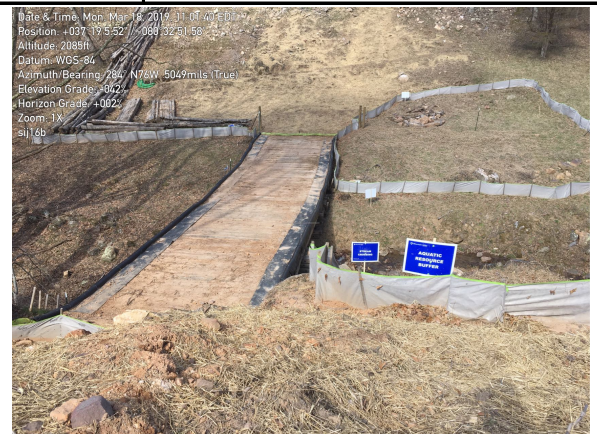
GPS Location	37.31	Field Station#	11025+54	GPS Location	37.32	Field Station#	11050+10
Description	Replaced signage for stream buffer s-ij18			Description	ECD's and ROW conditions		
<p>Date & Time: Mon, Mar 18, 2019, 11:07:07 EDT Position: +037° 19' 5.52" / -080° 32' 51.58" Altitude: 2088ft Datum: WGS-84 Azimuth/Bearing: 784° N76W 5049mils (True) Elevation Grade: +022% Horizon Grade: +002% Zoom: 1X sij166</p>

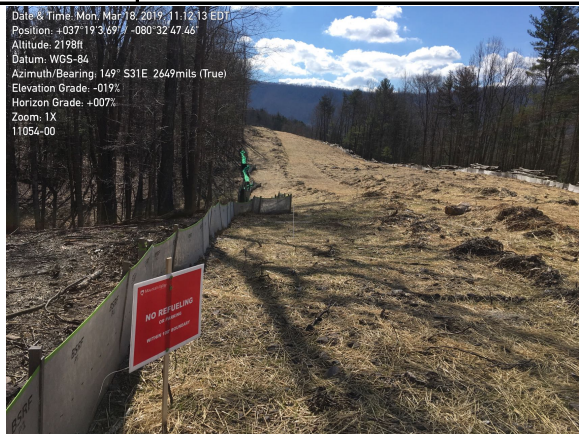
<p>Date & Time: Mon, Mar 18, 2019, 11:12:13 EDT Position: +037° 19' 3.69" / -080° 32' 47.46" Altitude: 2198ft Datum: WGS-84 Azimuth/Bearing: 149° S31E 2649mils (True) Elevation Grade: -019% Horizon Grade: +007% Zoom: 1X 11054-00</p>

GPS Location	37.32	Field Station#	111050+10	GPS Location	37.32	Field Station#	11120+00
Description	Replaced signage for stream buffer @ sij16			Description	ECD and ROW conditions		
<p>Date & Time: Mon, Mar 18, 2019, 14:24:28 EDT Position: +037° 19' 21.63" / -080° 33' 8.20" Altitude: 2451ft Datum: WGS-84 Azimuth/Bearing: 158° S22E 2809mils (True) Elevation Grade: +011% Horizon Grade: -006% Zoom: 1X j</p>

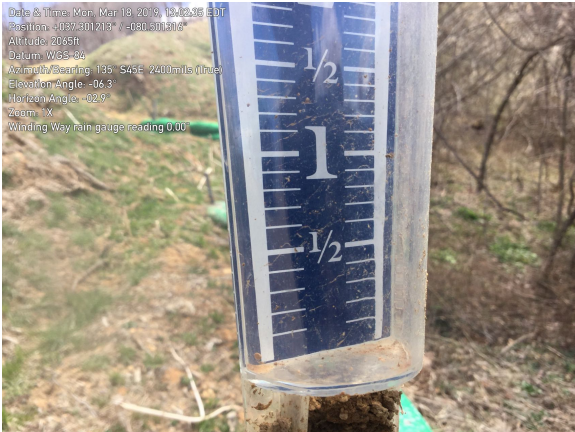
A/E	124300137	Date/Time	3/18/2019 1:33 PM	Report #	14958		
Pictures							
<div><div><div>Date & Time: Mon, Mar 18, 2019, 13:42:16 EDT Position: +037.301213° / -080.501306° Altitude: 2026ft Datum: WGS-84 Azimuth/Bearing: 135° S45E 240mils (True) Elevation Angle: -06.3° Horizon Angle: -02.9° Zoom: 1X Winding Way rain gauge reading 0.00</div><div>

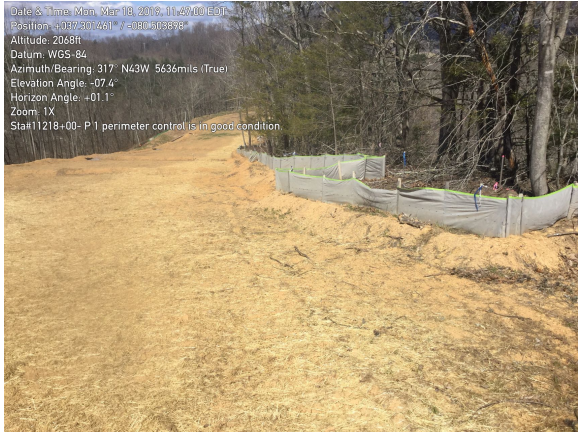
</div></div></div>			<div><div><div>Date & Time: Mon, Mar 18, 2019, 11:27:00 EDT Position: +037.301213° / -080.501306° Altitude: 2026ft Datum: WGS-84 Azimuth/Bearing: 317° N63W 563mils (True) Elevation Angle: -07.4° Horizon Angle: +01.1° Zoom: 1X Sta#11218+00: P1 perimeter control is in good condition</div><div>

</div></div></div>				
GPS Location	37.32	Field Station#	11227+00	GPS Location	37.32	Field Station#	11218+00
Description	Winding Way rain gauge reading- 0.0"			Description	P1 silt fence perimeter controls are in acceptable condition.		
<div><div><div>Date & Time: Mon, Mar 18, 2019, 11:51:13 EDT Position: +037.301959° / -080.509386° Altitude: 2028ft Datum: WGS-84 Azimuth/Bearing: 276° N84W 490mils (True) Elevation Angle: -12.9° Horizon Angle: +00.8° Zoom: 1X Sta#11214+00: Slope drain & controls in good condition</div><div>

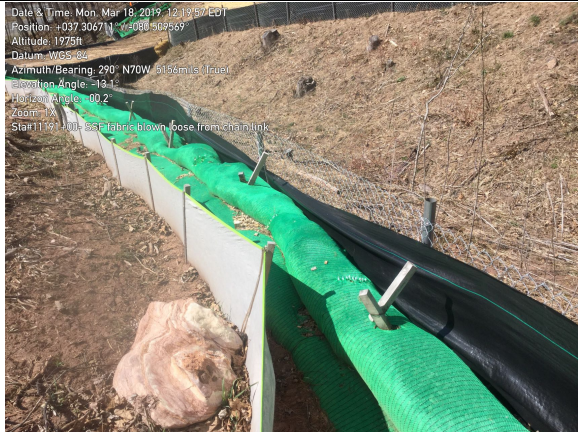
</div></div></div>			<div><div><div>Date & Time: Mon, Mar 18, 2019, 12:12:50 EDT Position: +037.306711° / -080.507569° Altitude: 1975ft Datum: WGS-84 Azimuth/Bearing: 290° N70W 616mils (True) Elevation Angle: -13.1° Horizon Angle: +00.2° Zoom: 1X Sta#11191+00: SSF fabric blown loose from chain link</div><div>

GPS Location	37.32	Field Station#	11214+00	GPS Location	37.32	Field Station#	11191+00
Description	Slope drain & controls are in acceptable condition.			Description	SSF fabric blown loose, environmental crew addressed the issue.		
<div><div><div>Date & Time: Mon, Mar 18, 2019, 12:28:01 EDT Position: +037.305230° / -080.515111° Altitude: 1929ft Datum: WGS-84 Azimuth/Bearing: 327° N33W 481mils (True) Elevation Angle: -16.1° Horizon Angle: +00.9° Zoom: 1X Sta#11184+00: CWD inlet</div><div>

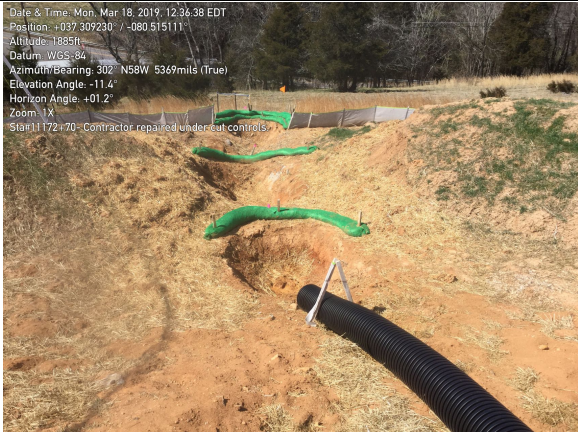
</div></div></div>			<div><div><div>Date & Time: Mon, Mar 18, 2019, 12:36:38 EDT Position: +037.305230° / -080.515111° Altitude: 1885ft Datum: WGS-84 Azimuth/Bearing: 302° N58W 536mils (True) Elevation Angle: -11.4° Horizon Angle: +01.2° Zoom: 1X Sta#11172+70: Contractor repaired under cut controls</div><div>

Description	CWD pipe inlet			Description	Contractor has addressed under cut controls.

7. Identify all remedial measures that have been taken since the previous inspection was conducted. Sta#11172+70- Under cut controls have been repaired.					
Comments (Reference above questions as appropriate.) SWPPP inspection: Sta#11254+88 to 11161+00. MP- 213 to 211 There have been no rain events so the row is dry and in stable condition, no sediment movement. Water bars are stable and in good condition. End treatments are in acceptable condition. P1 silt fence perimeter controls are in acceptable condition. CFS perimeter controls are acceptable condition. Slope drains are in good condition. CWD pipe and plunge pool are in good condition. SSF is in good condition, fabric was loose at sta#11191+00, Environmental crew addressed it. Rain gauge readings- 0.0"					
Note: It is a condition of National Pollutant Discharge Elimination System and Erosion and Sediment permits that a maintenance program be conducted to provide for the operation and maintenance of all BMPs to be inspected on a weekly basis and after each stormwater event. Please list in the space provided comments to note if repairs or replacement are needed or have been made for BMPs as a result of the inspection. Failure to conduct the required inspection may result in permit suspension or the imposition of civil penalties. If supplemental monitoring is required as part of a permit condition this form may be used to meet those monitoring requirements.

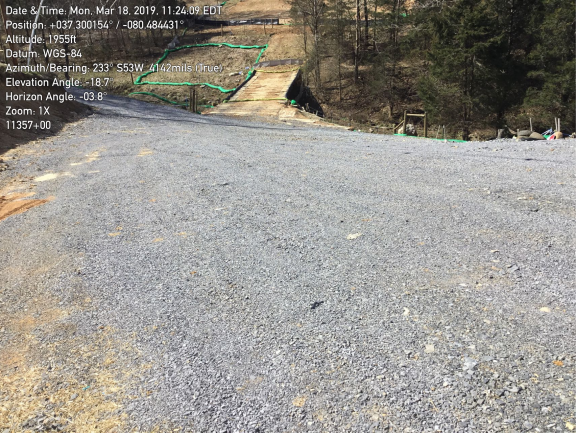
GPS Location		Field Station#		GPS Location	37.31	Field Station#	11357+00
Description				Description	RCE in good condition

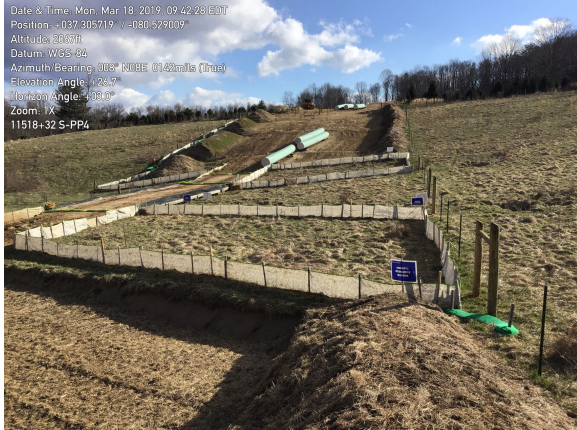
A/E	124300137	Date/Time	3/18/2019 3:16 PM	Report #	14964		
Pictures							
<div><div>Date & Time: Mon, Mar 18, 2019, 09:42:28 EDT Position: +037.305719, -080.429009 Altitude: 2207ft Datum: WGS-84 Azimuth/Bearing: 000° N00E 01.5mils (True) Elevation Angle: +22.9° Horizon Angle: +03.0° Zoom: 1X 11518+32 S-PP4</div>

</div>					
GPS Location	37.20	Field Station#	11518+32	GPS Location	37.20	Field Station#	11506+00
Description	See photo GPS location. Sensitive resource buffer in place at stream S-PP4.			Description	See photo GPS location. Plunge pool in place.		
<div><div>Date & Time: Mon, Mar 18, 2019, 10:28:31 EDT Position: +037.322815, -080.427768 Altitude: 2231ft Datum: WGS-84 Azimuth/Bearing: 329° N01W 58.0mils (True) Elevation Angle: +22.7° Horizon Angle: +03.0° Zoom: 1X 11477+00</div>

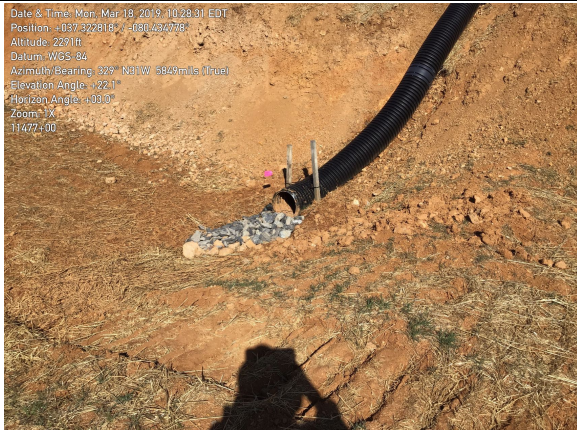
GPS Location	37.20	Field Station#	11477+00	GPS Location	37.20	Field Station#	11311+00
Description	See photo GPS location. Slope drain with rock outlet in place over two-tone.			Description	See photo GPS location. Water bar, end treatment, and sump pit in place.		
<div><div>Date & Time: Mon, Mar 18, 2019, 10:59:15 EDT Position: +037.297137, -080.491918 Altitude: 2209ft Datum: WGS-84 Azimuth/Bearing: 315° N45W 54.0mils (True) Elevation Angle: +21.8° Horizon Angle: +03.2° Zoom: 1X 11332+00</div>

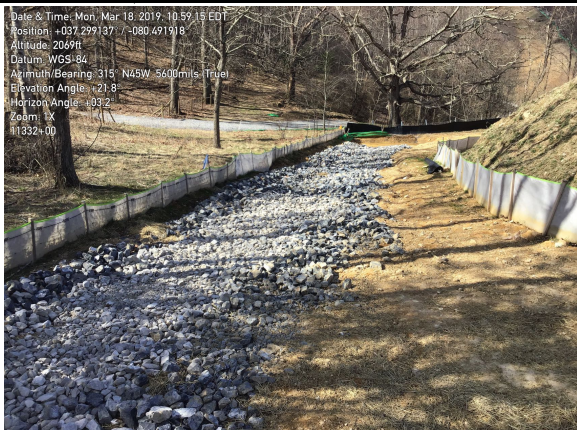
</div>					
GPS Location	37.20	Field Station#	11332+00	GPS Location	37.20	Field Station#	11329+00
Description	See photo GPS location. Rock lined channel in place.			Description	See photo GPS location. RCE in place at access road 256.02.

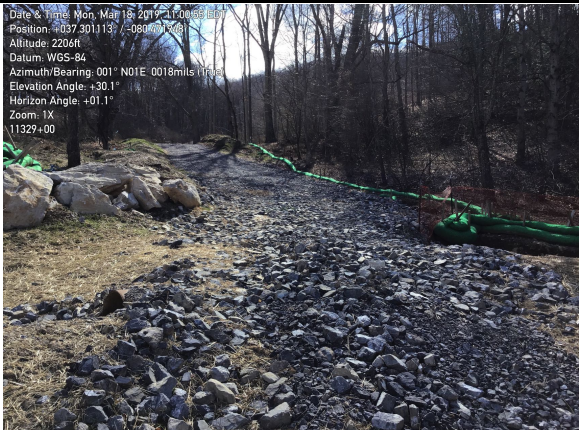
</div>		<div><div>Date & Time: Mon, Mar 18, 2019, 11:00:08 EDT Position: +037.301113, -080.491528 Altitude: 2206ft Datum: WGS-84 Azimuth/Bearing: 001° N01E 00.1mils (True) Elevation Angle: +30.1° Horizon Angle: +01.1° Zoom: 1X 11329+00</div>

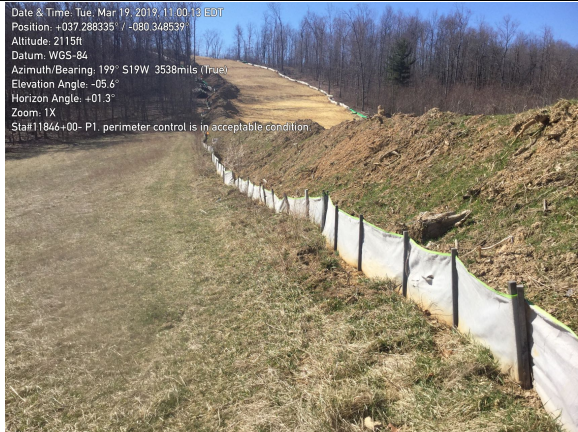
<p>Date & Time: Tue, Mar 19, 2019, 11:00:15 EDT Position: +037 288335 / -080 348539 Altitude: 2115ft Datum: WGS-84 Azimuth/Bearing: 199° S19W 3538mils (True) Elevation Angle: -05.6° Horizon Angle: +01.3° Zoom: 1X Sta#11846+00- P1 perimeter control is in acceptable condition</p>

GPS Location	37.28	Field Station#	11848+30	GPS Location	37.28	Field Station#	11846+88
Description	P1 silt fence has a hole at ground level.			Description	P1 silt fence perimeter controls.		
<p>Date & Time: Tue, Mar 19, 2019, 11:19:08 EDT Position: +037 285622 / -080 366670 Altitude: 2139ft Datum: WGS-84 Azimuth/Bearing: 045° N45E 0800mils (True) Elevation Angle: -06.6° Horizon Angle: +00.7° Zoom: 1X Sta#11869+00- Row dry & stable, water bars & level spreaders in good condition</p>

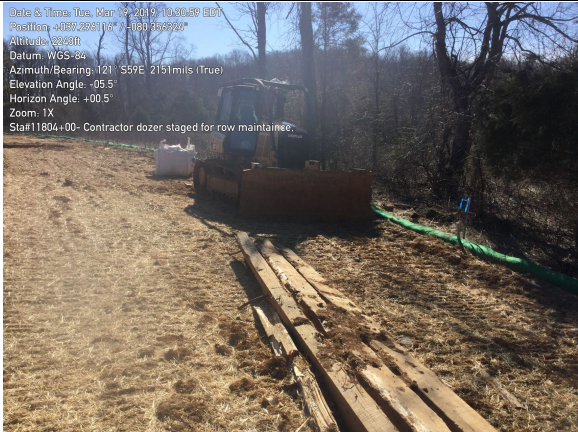
<p>Date & Time: Tue, Mar 19, 2019, 10:30:59 EDT Position: +037 286116 / -080 362923 Altitude: 2090ft Datum: WGS-84 Azimuth/Bearing: 121° S59E 2151mils (True) Elevation Angle: -05.5° Horizon Angle: +00.5° Zoom: 1X Sta#11804+00- Contractor dozer staged for row maintenance</p>

GPS Location	37.28	Field Station#	11869+00	GPS Location	37.28	Field Station#	11804+00
Description	Row is dry and in stable condition, controls in restored areas look good.			Description	Dozer staged for row maintenance.

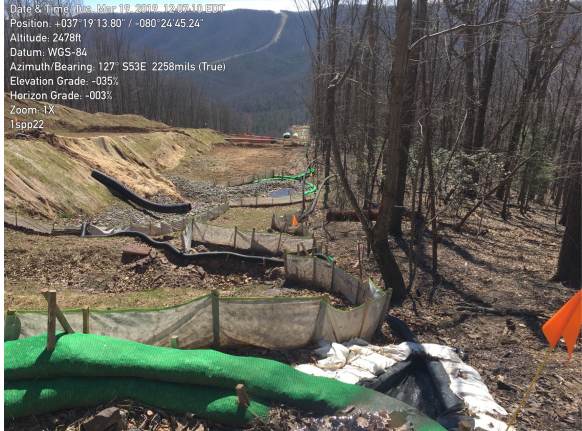
</div>			<div> </div>				
GPS Location	37.28	Field Station#	11568+00	GPS Location	37.28	Field Station#	11023+80
Description	ECD's and ROW conditions			Description	Crews loading up fencing material

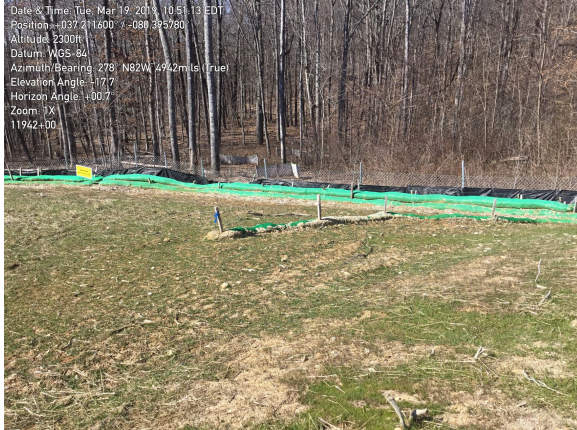
</div></div>				
GPS Location	37.31	Field Station#	11942+00	GPS Location	37.31	Field Station#	11950+00
Description	ECDs protecting karst feature			Description	ECDs protecting karst feature		
<div><div>Date & Time: Tue, Mar 19, 2019, 10:57:04 EDT Position: +037 276632° / -080 326459° Altitude: 2061ft Datum: WGS-84 Azimuth/Bearing: 177° S03E 3147mils (True) Elevation Angle: -18.2° Horizon Angle: -01.4° Zoom: 1X 11950+00</div><div>

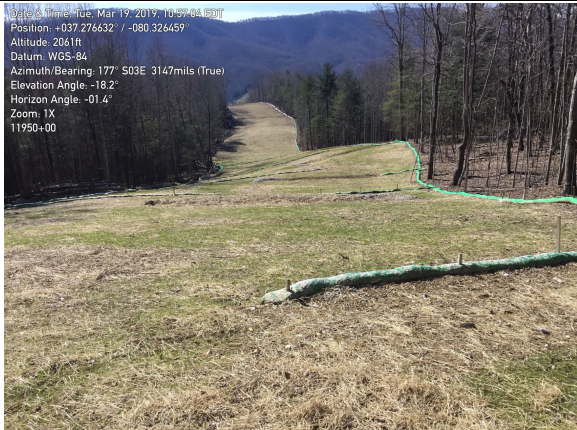
GPS Location	37.31	Field Station#	11950+00	GPS Location	37.31	Field Station#	11979+00
Description	Row			Description	ECDs protecting karst feature		
<div><div>Date & Time: Tue, Mar 19, 2019, 11:11:59 EDT Position: +037 268998° / -080 321438° Altitude: 1485ft Datum: WGS-84 Azimuth/Bearing: 128° S52E 2276mils (True) Elevation Angle: -14.8° Horizon Angle: -04.2° Zoom: 1X 11985+00</div><div>

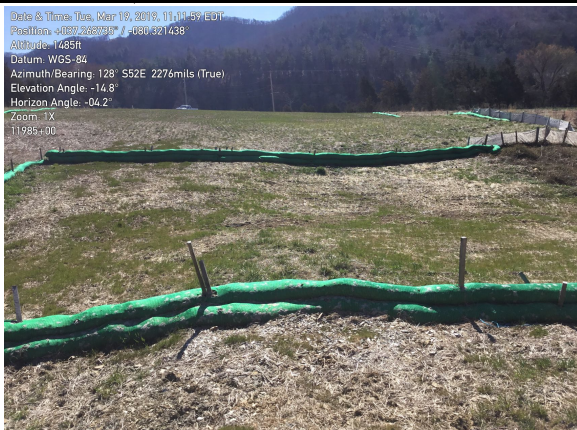
</div></div>				
GPS Location	37.31	Field Station#	11985+00	GPS Location	37.31	Field Station#	11985+00
Description	ECDs protecting drainage feature			Description	Row

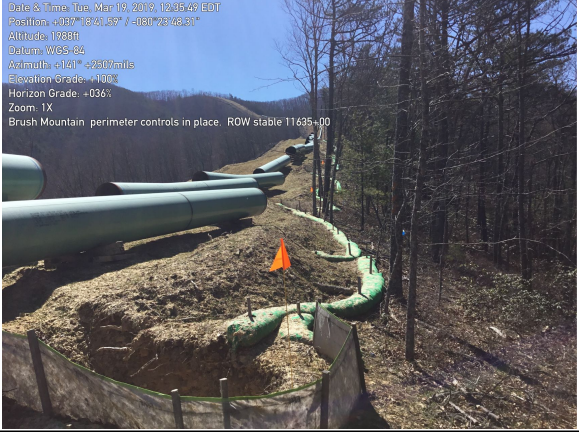
<p> Date & Time: Tue, Mar 19, 2019, 12:45:49 EDT Position: +037° 18' 21.57" / -080° 23' 45.31" Altitude: 1938ft Datum: WGS-84 Azimuth: 261° -581W 4440mils (True) Elevation Grade: +036% Horizon Grade: +006% Zoom: 1X Brush Mountain perimeter controls in place. ROW stable 11635+00 </p>

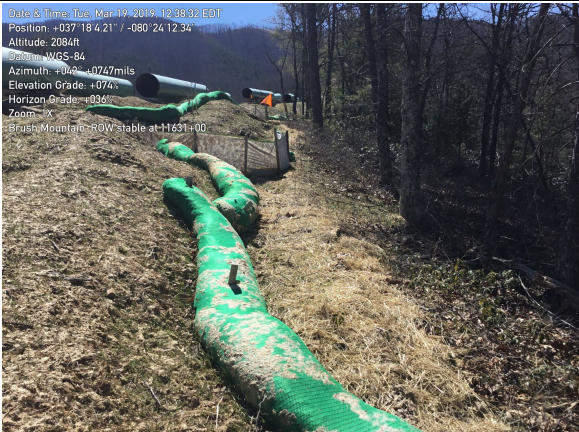
<p> GPS Location 37.13 Field Station# 11664+00 </p> <p> Description Correct coordinates on photo. End treatment conditions were checked. </p>	
<p> Date & Time: Tue, Mar 19, 2019, 12:36:32 EDT Position: +037° 18' 4.21" / -080° 24' 12.34" Altitude: 2084ft Datum: WGS-84 Azimuth: +029° -0516mils Elevation Grade: +074% Horizon Grade: +036% Zoom: 1X Brush Mountain ROW stable at 11631+00 </p>

<p> Date & Time: Tue, Mar 19, 2019, 12:40:20 EDT Position: +037° 18' 48.58" / -080° 23' 50.61" Altitude: 1960ft Datum: WGS-84 Azimuth: -029° -0516mils Elevation Grade: +045% Horizon Grade: +037% Zoom: 1X Brush Mountain ROW stable with controls in place and 11630+00 </p>

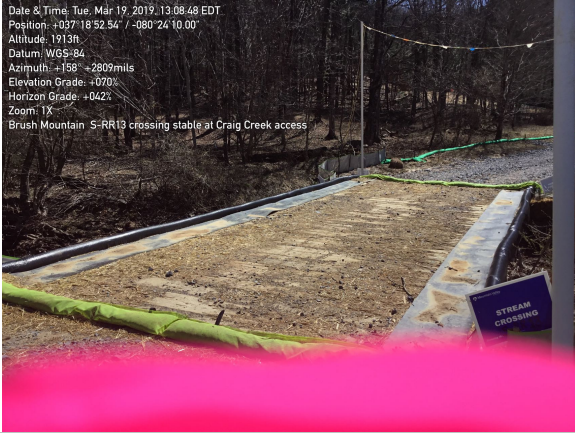
<small> Date & Time: Tue Mar 19 2019 13:08:48 EDT Position: +037°18'52.54" / -080°24'10.00" Altitude: 1913ft Datum: WGS-84 Azimuth: +158° -2809mils Elevation Grade: +070% Horizon Grade: +042% Zoom: 1X Brush Mountain S-RR13 crossing stable at Craig Creek access </small>

GPS Location 37.13		Field Station# 11608+17		GPS Location 37.13	
Description		Correct coordinates on photo. Resource crossings are stable.		Description	
GPS Location		Field Station#		GPS Location	
Description				Description	
GPS Location		Field Station#		GPS Location	
Description				Description

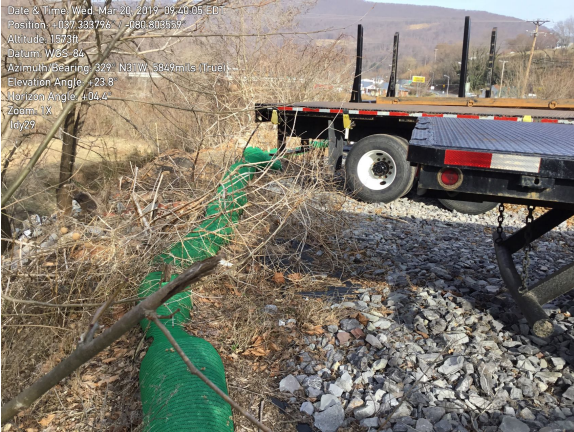
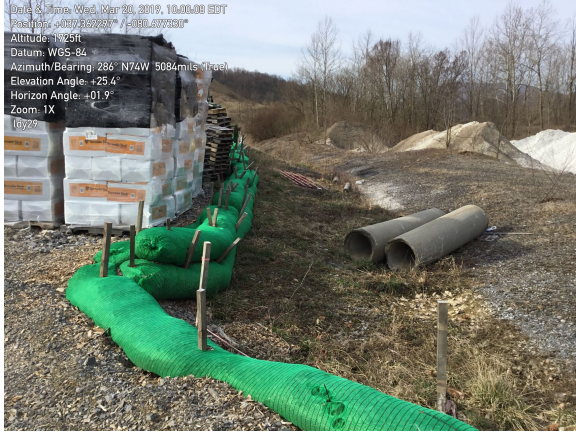
GPS Location	37.33	Field Station#	1+11	GPS Location	37.33
Description			Description		
ECD's and ROW conditions @ LDY 28			ECD's and ROW conditions @ LDY 29

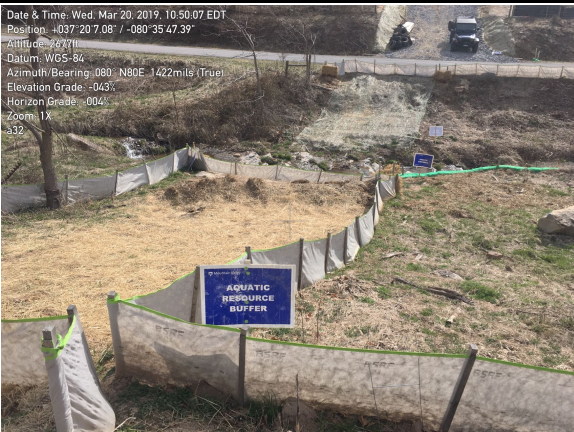
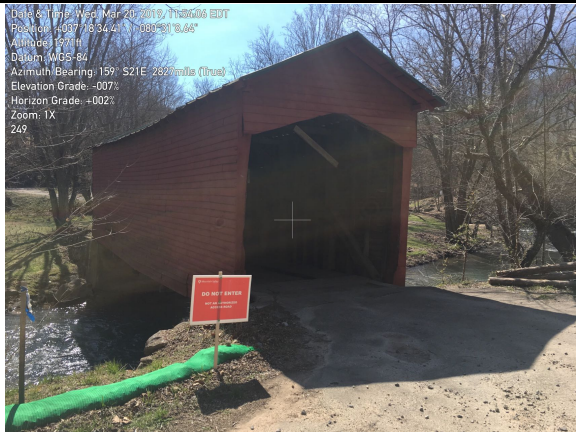
GPS Location	37.33	Field Station#	10882+91	GPS Location	37.33
Description			Description		
Installed new signage @ S-A32			Installed new signage @ AR 249

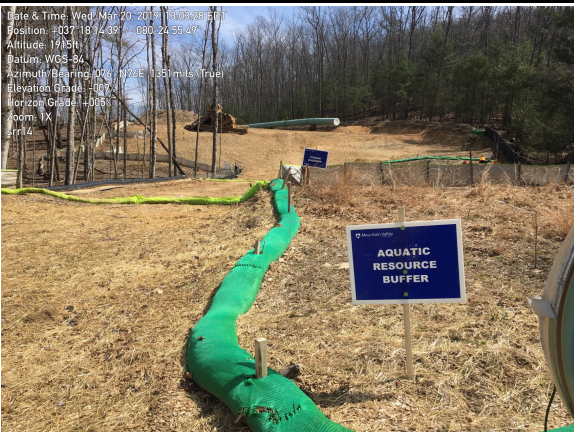
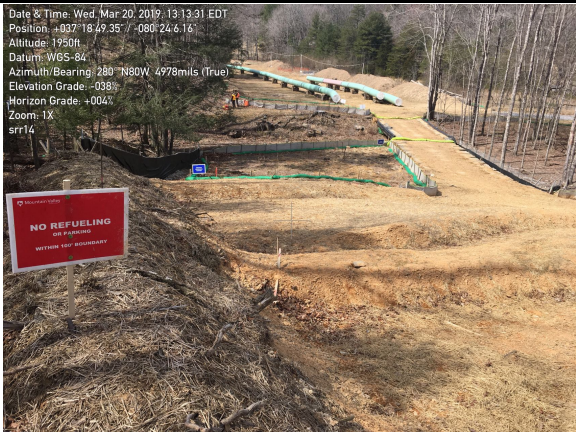
GPS Location	37.33	Field Station#	11614+20	GPS Location	37.33
Description			Description		
Installed new signage @ S-RR14			Installed new signage @ S-RR14

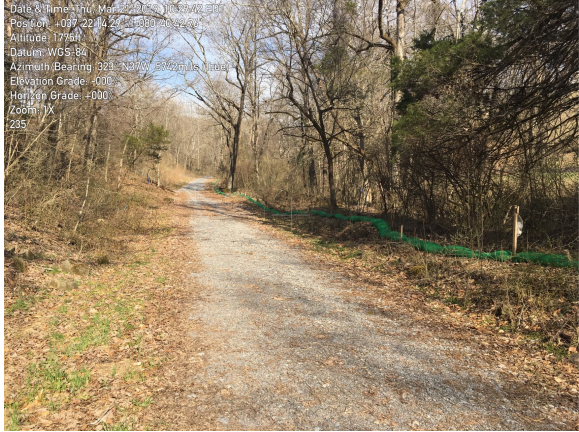
GPS Location	37.28	Field Station#	10510+78	GPS Location	37.28	Field Station#	10526+62
Description	ECD's and ROW comdtns for AR 234			Description	ECD's and ROW comdtns for AR 235		
<p>Date & Time: Thu, Mar 21, 2019, 11:10:24 EDT Position: +037.20 14.48 / +080.36 18.56 Altitude: 2237ft Datum: WGS-84 Azimuth/Bearing: 003° N03E 0053mils (True) Elevation Grade: -043% Horizon Grade: +013% Zoom: 1X 235</p>  			<p>Date & Time: Thu, Mar 21, 2019, 12:06:41 EDT Position: +037.14 08.71 / +080.20 08.19 Altitude: 1907ft Datum: WGS-84 Azimuth/Bearing: 002° N34W 544mils (True) Elevation Grade: -011% Horizon Grade: +006% Zoom: 1X 5006</p>

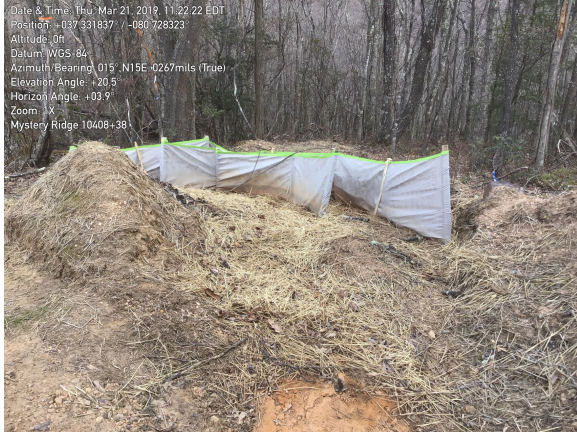
GPS Location	37.21	Field Station#	10408+38	GPS Location	37.21	Field Station#	10446+00
Description	See photo for GPS location. End treatment in place.			Description	See photo for GPS location. Mystery Ridge Road in skull cap area.		
<p>Date & Time: Thu, Mar 21, 2019, 11:53:36 EDT Position: +037 370952 / -080 236187 Altitude: 2279ft Datum: WGS-84 Azimuth/Bearing: 352° N08W 5258mils (True) Elevation Angle: +30.7 Horizon Angle: +03.5 Zoom: 2X Pocahontas Road</p>

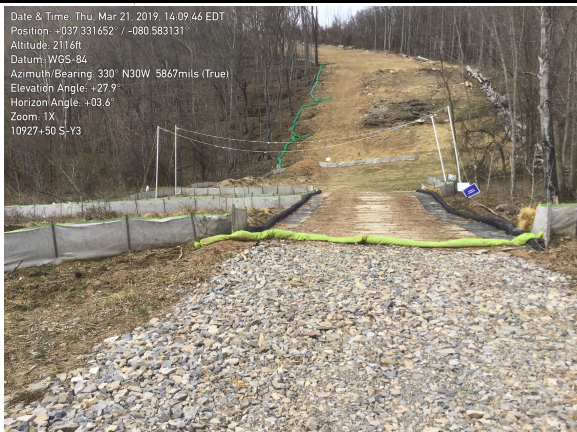
GPS Location	37.20	Field Station#	10927+50	GPS Location	37.20	Field Station#	10925+00
Description	See photo for GPS location. Sensitive resource buffer in place at stream S-Y3.			Description	See photo for GPS location. End treatment, sump pit, and water bar in place.

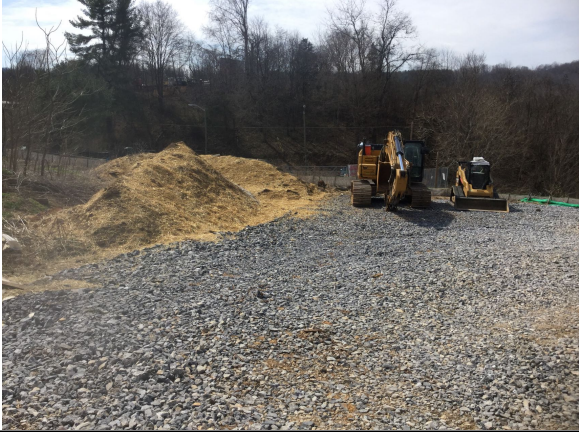
GPS Location 37.31		Field Station# 11227+00		GPS Location 37.31	
Description		Topsoil mulched at AR- 25, equipment staged for row maintenance		Description	
				Rock lined swale

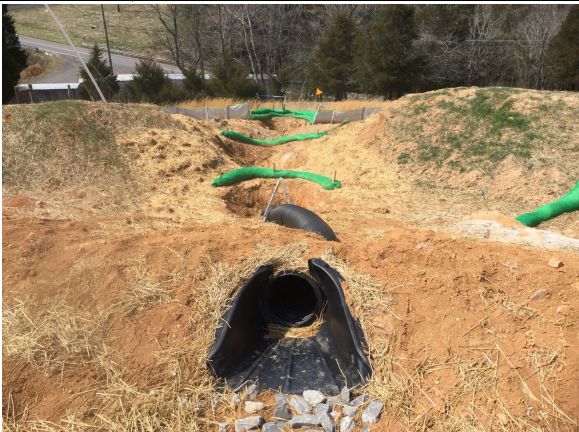
Insert image here		
GPS Location 37.31		Field Station# 11172+70		GPS Location	
Description		Slope drain, checks, end treatment		Description

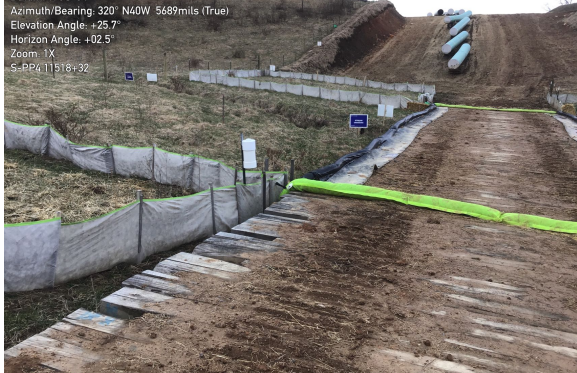
GPS Location	37.20	Field Station#	11518+32	GPS Location	37.20	Field Station#	11504+00
Description	See photo for GPS location. Sensitive resource buffer in place at stream S-PP4.			Description	See photo for GPS location. Plunge pool in place.		
<p>Date & Time: Fri, Mar 22, 2019, 09:27:42 EDT Position: +037.324922° / -080.426906° Altitude: 2240ft Datum: WGS-84 Azimuth/Bearing: 300° N40W 5333mils (True) Elevation Angle: +27.2° Horizon Angle: +03.2° Zoom: 1X 11502+00</p>

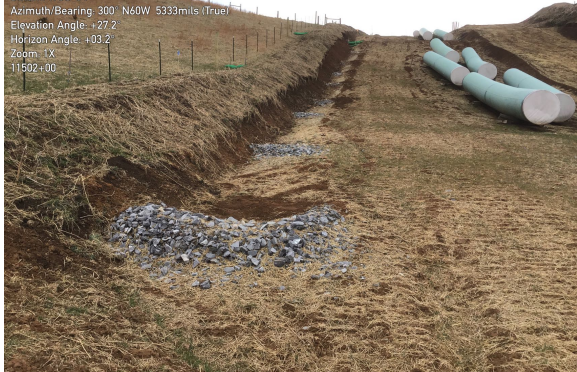
GPS Location	37.20	Field Station#	11502+00	GPS Location	37.20	Field Station#	11473+50
Description	See photo for GPS location. Rock checks in place in channel.			Description	See photo for GPS location. Slope drain in place over two-tone with rock outlet.		
<p>Date & Time: Fri, Mar 22, 2019, 13:36:40 EDT Position: +037.300165° / -080.470152° Altitude: 2169ft Datum: WGS-84 Azimuth/Bearing: 013° N13E 5631mils (True) Elevation Angle: +27.4° Horizon Angle: +01.4° Zoom: 1X 11332+00</p>

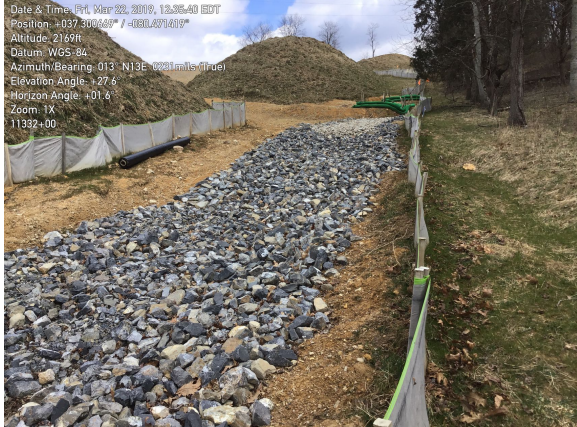
GPS Location	37.20	Field Station#	11332+00	GPS Location	37.20	Field Station#	11330+00
Description	See photo for GPS location. Rock lined channel in place.			Description	See photo for GPS location. Broad base dip in place on access road 256.02.

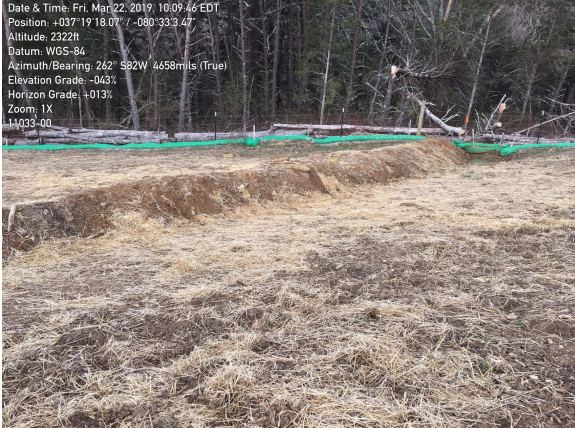
GPS Location	37.24	Field Station#	11033+00	GPS Location	37.24	Field Station#	11043+00
Description	Water bar and end treatment			Description	ECD's and ROW conditions		
<p>Date & Time: Fri, Mar 22, 2019, 11:14:27 EDT Position: +037° 19' 6.07" / -080° 32' 52.94" Altitude: 2166ft Datum: WGS-84 Azimuth/Bearing: 110° S70E 1956mils (True) Elevation Grade: -018% Horizon Grade: -000% Zoom: 1X 11166-00</p>

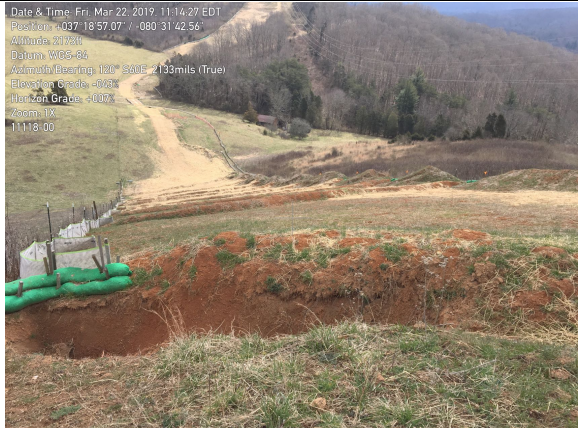
<p>Date & Time: Fri, Mar 22, 2019, 11:14:27 EDT Position: +037° 18' 57.07" / -080° 31' 42.54" Altitude: 2174ft Datum: WGS-84 Azimuth/Bearing: 120° S60E 2133mils (True) Elevation Grade: -024% Horizon Grade: -007% Zoom: 1X 11118-00</p>

GPS Location	37.24	Field Station#	11050+14	GPS Location	37.24	Field Station#	11118+00
Description	ECD's and ROW conditions			Description	ECD's and ROW conditions		
<p>Date & Time: Fri, Mar 22, 2019, 10:00:22 EDT Position: +037° 19' 4.57" / -080° 33' 41.44" Altitude: 2170ft Datum: WGS-84 Azimuth/Bearing: 288° N72W 5120mils (True) Elevation Grade: -008% Horizon Grade: -001% Zoom: 1X 11051-00</p>

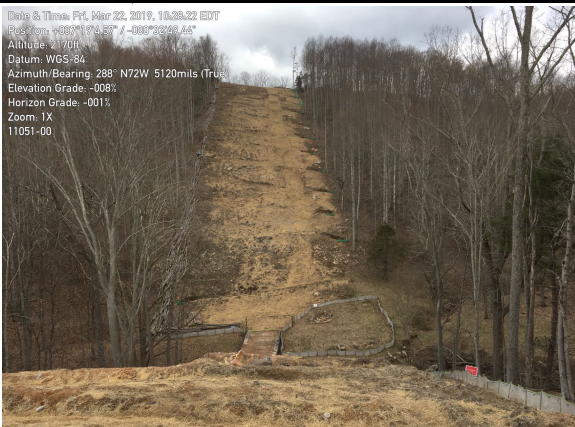
GPS Location	37.24	Field Station#	11051+00	GPS Location	37.24	Field Station#	10838+40
Description	ECD's and ROW conditions			Description	Verified path cleared
