Visual Site Inspection Report

Project Name	H-600 Pipeline Spread G	AFE	124300137	Spread	H-600 Pipeline Spread G
Contractor	Precision			Report #	15140
Inspector	Garrett Barclay			Date/Time	3/25/2019 12:10 PM
Permit #	TBD	Inspection Type	VA SWPP	Station Begin	11530+00
State	VA	Inspection Area	Partial	Station End	11560+00
County	Giles	Ground	Dry	Temperature (°F)	55.00
Municipality	N/A	Weather	Cloudy	Rain Gauge (in)	0.00
				Rain Accumulation Time (days)	1.00

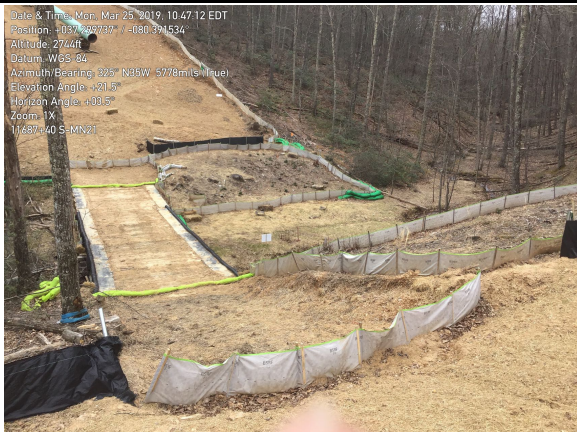
<p>Date & Time: Mon, Mar 25, 2019, 10:47:12 EDT Position: +037 294347 / -080 378651° Altitude: 2244ft Datum: WGS-84 Azimuth/Bearing: 025° N35W 5778mils (True) Elevation Angle: +20.5° Horizon Angle: +03.5° Zoom: 1X 11687+00 S-MN21</p>

GPS Location	37.20	Field Station#	11687+40	GPS Location	37.20	Field Station#	11730+00
Description	See photo for GPS location. Sensitive resource buffer in place at stream S-MN21.			Description	See photo for GPS location. Priority one silt fence fabric separating from stake.

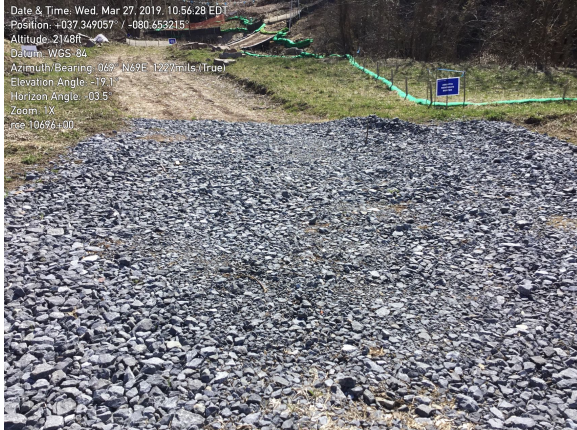
</div>			
GPS Location		37.31	Field Station#		10696+00		
Description		RCE buffalo anklets					
<div><div>Date & Time: Wed, Mar 27, 2019, 11:12:39 EDT Position: +037.337289° / -080.425830° Altitude: 2297ft Datum: WGS-84 Azimuth/Bearing: 122° 558E 2169mils (True) Elevation Angle: -14.2° Horizon Angle: -00.8° Zoom: 1X rce 10712+00</div>

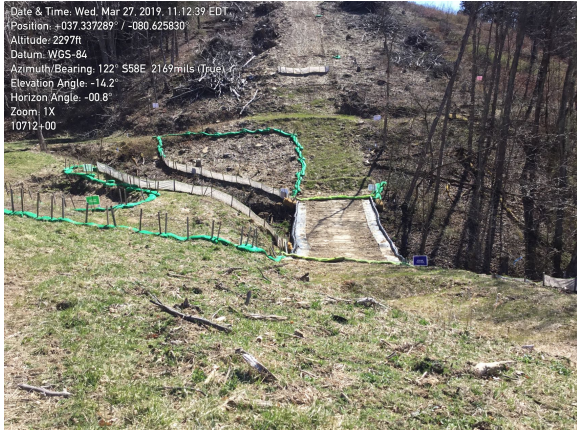
GPS Location		37.31	Field Station#		10712+00		
Description		Timber mat crossing, ECDs in good condition					
GPS Location		37.31	Field Station#		10695+00		
Description		RCE off buffalo anklets					
Insert image here				<div><div>Date & Time: Wed, Mar 27, 2019, 11:13:17 EDT Position: +037.348593° / -080.447804° Altitude: 2280ft Datum: WGS-84 Azimuth/Bearing: 182° S02W 3236mils (True) Elevation Angle: -26.6° Horizon Angle: +02.4° Zoom: 1X rce 10712+00</div>

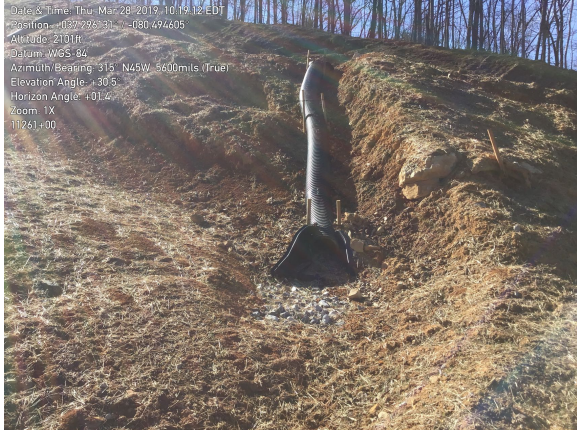
GPS Location	37.20	Field Station#	11262+00	GPS Location	37.20	Field Station#	11271+00
Description	See photo for GPS location. Slope drain pipe in place with rock filter outlet.			Description	See photo for GPS location. Plunge pool in place.		
<p>Date & Time: Thu, Mar 28, 2019, 10:39:14 EDT Position: +037.293821, +080.559721 Altitude: 2060ft Datum: WGS-84 Azimuth/Bearing: 011° N11E 0196mils (True) Elevation Angle: +24.4° Horizon Angle: +00.1° Zoom: 1X 11275+00</p>

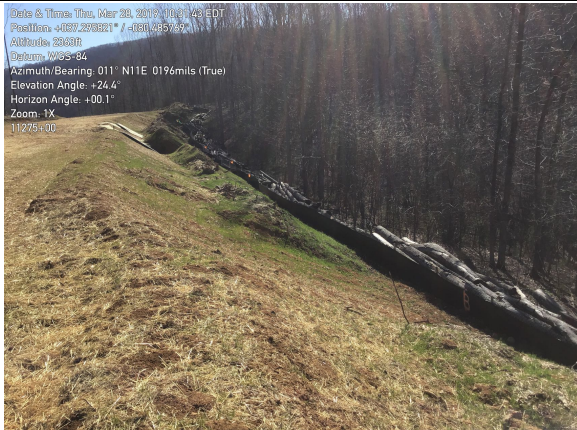
GPS Location	37.20	Field Station#	11275+00	GPS Location	37.20	Field Station#	11280+00
Description	See photo for GPS location. Reinforced super silt fence in place.			Description	See photo for GPS location. Water bars in place. ROW stabilized with seed and mulch.		
<p>Date & Time: Thu, Mar 28, 2019, 11:01:21 EDT Position: +037.310054, +080.471588 Altitude: 2270ft Datum: WGS-84 Azimuth/Bearing: 014° N14E 0249mils (True) Elevation Angle: +26.8° Horizon Angle: +01.4° Zoom: 1X 11332+00</p>

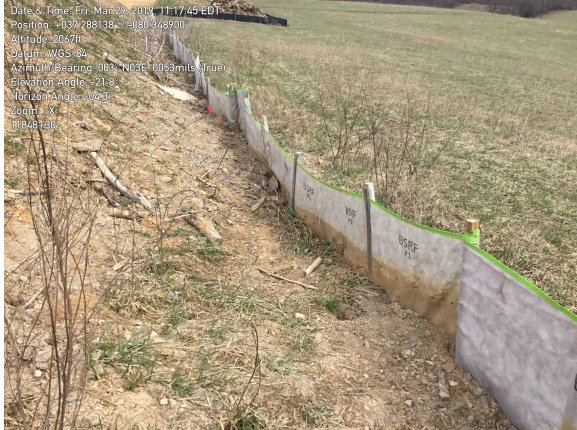
<p>Date & Time: Fri, Mar 29, 2019, 11:16:27 EDT Position: +037 288222° / -080 332222° Altitude: 2170ft Datum: WGS-84 Azimuth/Bearing: 010° N10E 0178mils (True) Elevation Angle: -13.7° Horizon Angle: -01.7° Zoom: 1X 11850+00</p>				
GPS Location	37.31	Field Station#	11848+00	GPS Location	37.31	Field Station#	11850+00
Description	ECDs in good condition			Description	Row with temporary stabilization

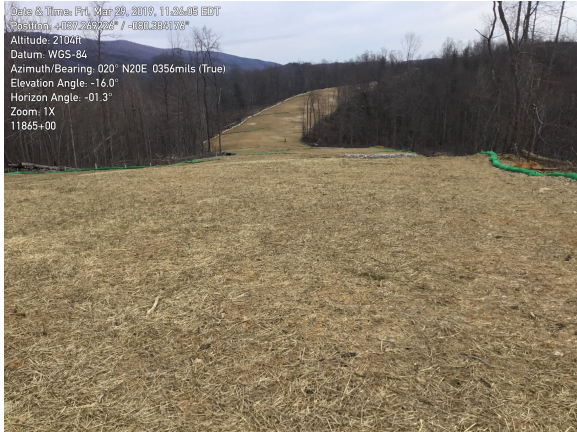
<p>Date & Time: Fri, Mar 29, 2019, 11:06:06 EDT Position: +037 269428° / -080 354202° Altitude: 2104ft Datum: WGS-84 Azimuth/Bearing: 020° N20E 0356mils (True) Elevation Angle: -16.0° Horizon Angle: -01.3° Zoom: 1X 11865+00</p>

GPS Location	37.31	Field Station#	11865+00	GPS Location	37.31	Field Station#	11877+00
Description	Restoration row			Description	Perimeter controls

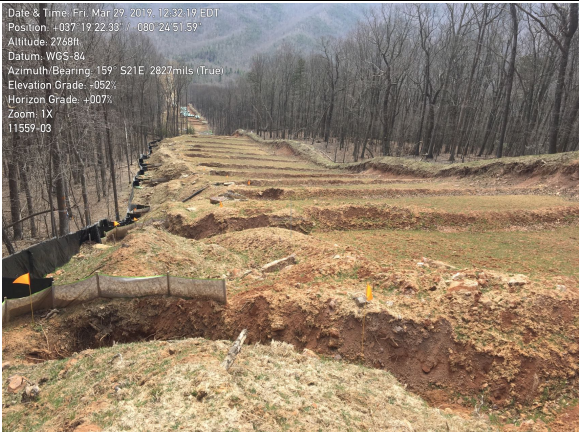
<p>GPS Location 37.24 Field Station# 11559+03</p> <p>Description ECD's and ROW conditions</p>

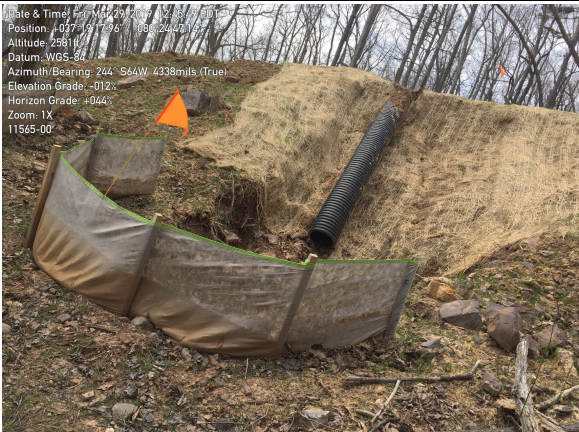
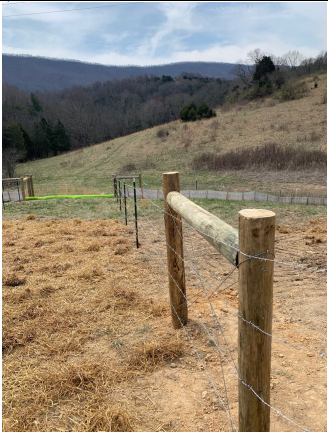
<p>GPS Location 37.24 Field Station# 11565+00</p> <p>Description Slope drain ECB and end treatment</p>	
<p>GPS Location 37.24 Field Station# 11550+00</p> <p>Description ECD's and ROW conditions</p>		<p>GPS Location 37.24 Field Station# 11565+00</p> <p>Description ECD's and ROW conditions</p>		<p>GPS Location 37.24 Field Station# 11124+00</p> <p>Description Fence gap installed</p>

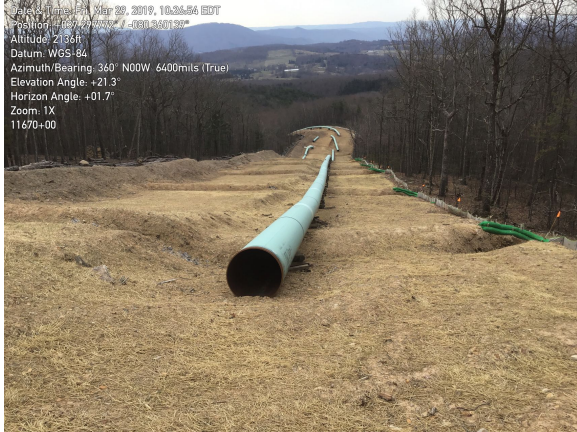
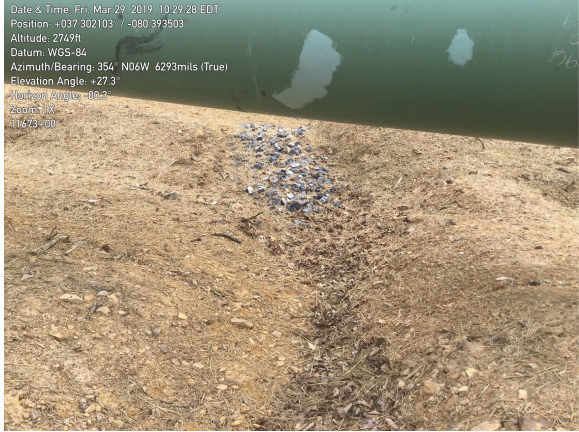
<p>Date & Time: Fri, Mar 29, 2019, 10:29:28 EDT Position: +037 302103 / -080 393503 Altitude: 2749ft Datum: WGS-84 Azimuth/Bearing: 354° N06W 6293mils (True) Elevation Angle: +27.3° Horizon Angle: +08.3° Zoom: 1X 11673+00</p>				
GPS Location	37.20	Field Station#	11670+00	GPS Location	37.20	Field Station#	11673+00
Description	See photo for GPS location. ROW stabilized with seed and mulch. Water bars in place.			Description	See photo for GPS location. Rock lined channel over two-tone to prevent erosion.

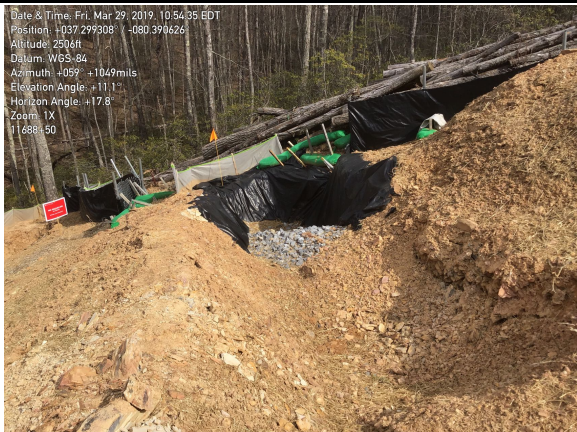
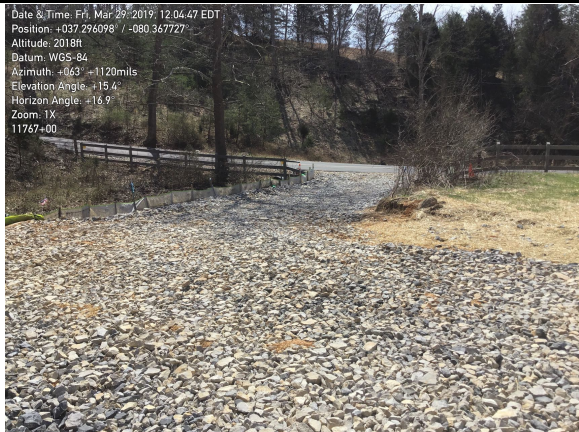
GPS Location	37.20	Field Station#	11688+50	GPS Location	37.20	Field Station#	11767+00
Description	See photo for GPS location. Geotextile fabric lined sump with rock lining. Water bar and end treatment in place.			Description	See photo for GPS location. RCE in place at main line valve 26.		
  <p>Date & Time: Fri, Mar 29, 2019, 10:51:34 EDT Position: +037 300247 / -080 392282 Altitude: 1927ft Datum: WGS-84 Azimuth: +042° +0871mils Elevation Angle: +12.7° Horizon Angle: +12.1° Zoom: 1X 11687+40 S-MN21</p>

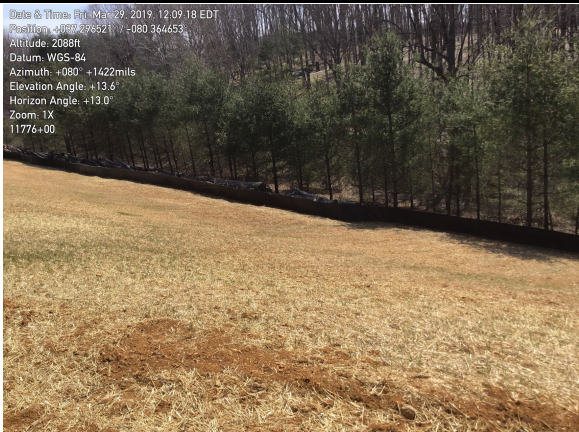
<p>Date & Time: Fri, Mar 29, 2019, 12:09:18 EDT Position: +037 296521 / -080 366553 Altitude: 2088ft Datum: WGS-84 Azimuth: +080° +1422mils Elevation Angle: +13.6° Horizon Angle: +13.0° Zoom: 1X 11776+00</p>				
GPS Location	37.20	Field Station#	11687+40	GPS Location	37.20	Field Station#	11776+00
Description	See photo for GPS location. Sensitive resource buffer in place at stream S-MN21.			Description	See photo for GPS location. Minor vegetation growth where ROW is returned to original grade. Reinforced super silt fence in place.
