# Visual Site Inspection Report

<b>Project Name</b>	H-600 Pipeline Spread H	<b>AFE</b>	124300138	<b>Spread</b>	H-600 Pipeline Spread H
<b>Contractor</b>	Precision			<b>Report #</b>	12818
<b>Inspector</b>	Dawn McCullough			<b>Date/Time</b>	1/9/2019 6:54 PM
<b>Permit #</b>	TBD	<b>Inspection Type</b>	VA SWPP	<b>Station Begin</b>	13262+58
<b>State</b>	VA	<b>Inspection Area</b>	Partial	<b>Station End</b>	13315+70
<b>County</b>	Franklin	<b>Ground</b>	Damp	<b>Temperature (°F)</b>	35.00
<b>Municipality</b>	N/A	<b>Weather</b>	Sunny	<b>Rain Gauge (in)</b>	0.00
<b>GPS Location</b>	37.3255903271319, -80.0287939060433			<b>Rain Accumulation Time (days)</b>	1.00

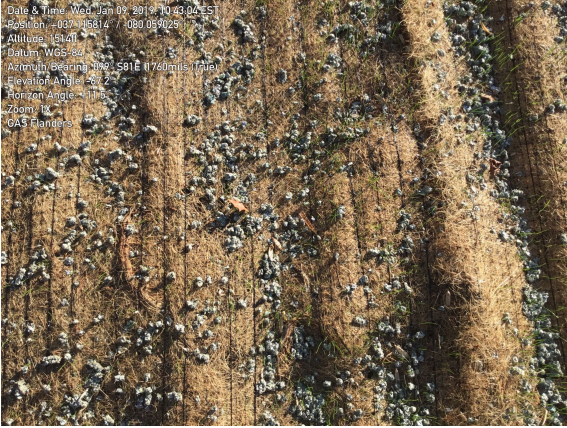
<p>Date &amp; Time: Wed Jan 09, 2019, 10:43:04 EST Position: +037.115814 / -080.057029 Altitude: 1512ft Datum: WGS-84 Azimuth/Bearing: 259.577W 4569mils (True) Elevation Angle: -06.2 Horizon Angle: +00.9 Zoom: 1X GAS Flanders</p>

<p>Date &amp; Time: Wed Jan 09, 2019, 10:43:13 EST Position: +037.115804 / -080.057043 Altitude: 1518ft Datum: WGS-84 Azimuth/Bearing: 259.577W 4569mils (True) Elevation Angle: -06.2 Horizon Angle: +00.9 Zoom: 1X GAS Flanders</p>		<b>GPS Location</b> 37.3256837251012, -80.028649102971	
<b>Description</b>		<b>Description</b>		Please see photo for coordinates. ~Sta. No. 13265+00, germination noted in areas that have been hand seeded.

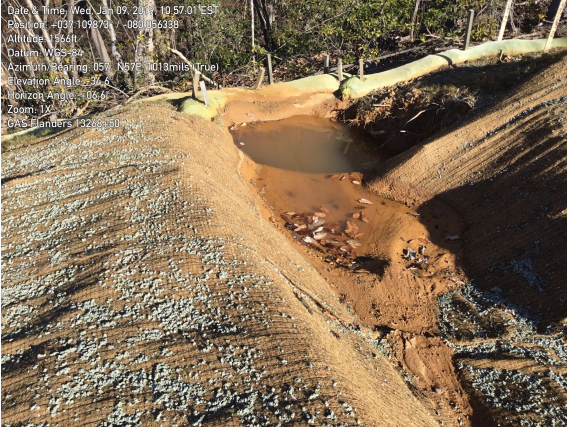
<p>Date &amp; Time: Wed Jan 09, 2019, 10:57:01 EST Position: +037.109765 / -080.056288 Altitude: 1560ft Datum: WGS-84 Azimuth/Bearing: 057.827E 1011mils (True) Elevation Angle: -06.6 Horizon Angle: +00.6 Zoom: 1X GAS Flanders 13265+00</p>

<b>Description</b>		<b>Description</b>		Please see photo for coordinates. ~Sta. No. 13268+50, sump needed cleaned, added as punch list item.

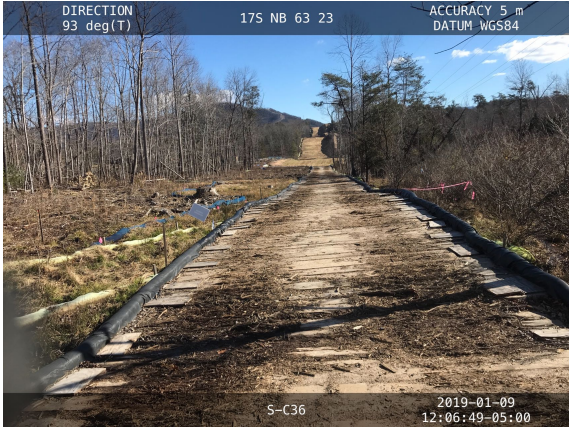
<p>DIRECTION 93 deg(T) 17S NB 63 23 ACCURACY 5 m DATUM WGS84 S-C36 2019-01-09 12:06:49-05:00</p>

<p>DIRECTION 277 deg(T) 17S NB 62 23 ACCURACY 5 m DATUM WGS84 12086+56 S-MM14 2019-01-09 11:36:39-05:00</p>		<b>GPS Location</b>	37.2562557924886, -80.2760454174879
<b>Description</b>		Photo shows the general ROW condition and bridge over S-C36.		<b>Description</b>	Photo shows the general ROW condition and bridge over S-MM14.

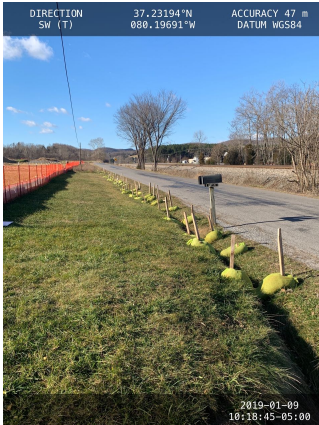
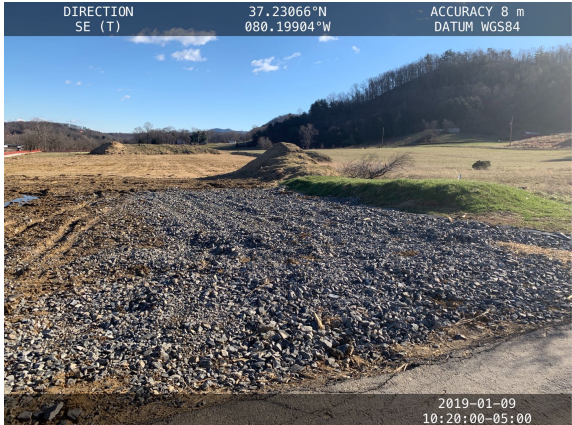
<b>GPS Location</b>	37.2306571094099, -80.1990823940924		<b>GPS Location</b>	37.2306571094099, -80.1990823940924	
<b>Description</b>	12451+00_010919 Checks in ditch for filtration. Looking SW. See picture for GPS data.		<b>Description</b>	12452+00_010919 RCE. Looking SE. See picture for GPS data.

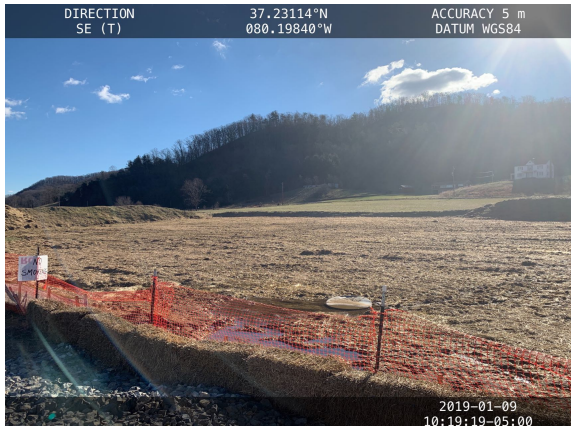
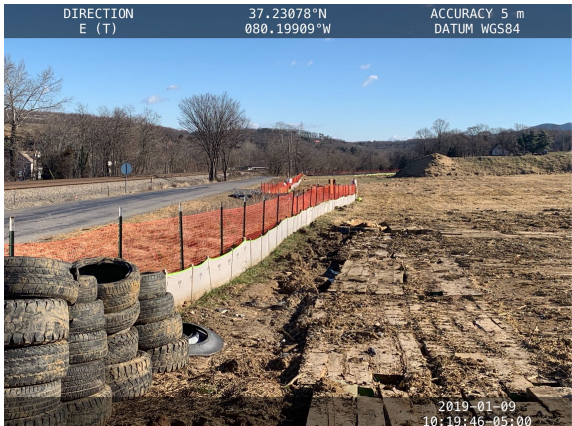
<b>GPS Location</b>	37.2306770922318, -80.1990515958777		<b>GPS Location</b>	37.2306427539572, -80.1990420261526	
<b>Description</b>	12451+00_010919 Stabilized ROW. Looking SE. See picture for GPS data.		<b>Description</b>	12452+00_010919 Silt fence perimeter controls. Looking E. See picture for GPS data.

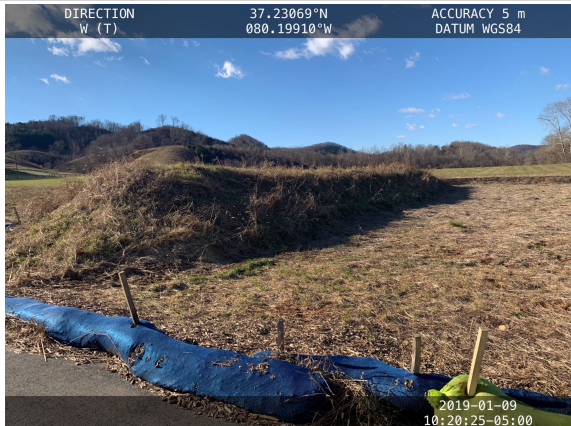
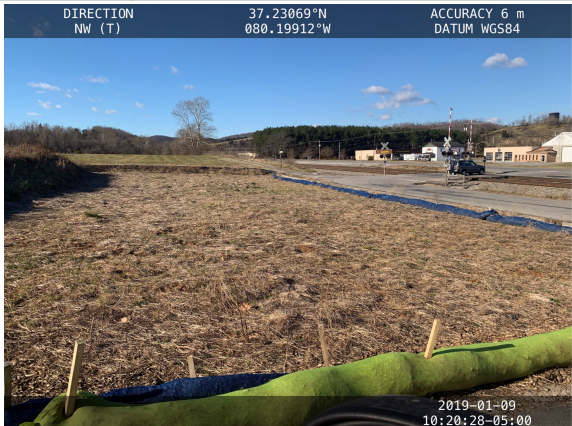
<b>GPS Location</b>	37.2306260678013, -80.1990504923173		<b>GPS Location</b>	37.2305936165836, -80.1990450562645	
<b>Description</b>	12453+00_010919 Stabilized top soil pile on the disturbed variance. Looking W. See picture for GPS data.		<b>Description</b>	12453+00_010919 Stabilized ROW. Looking NW. See picture for GPS data.

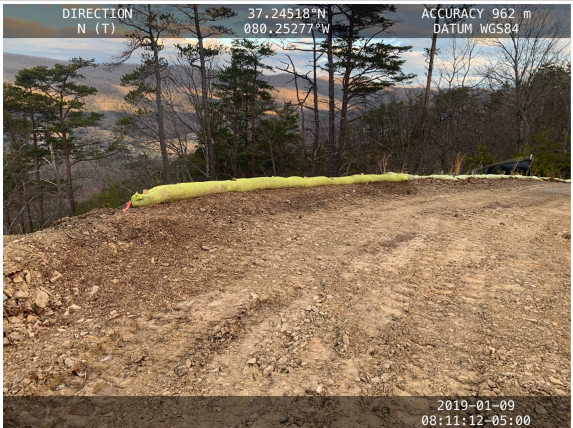
<b>GPS Location</b>	37.2602081282376, -80.1690043063918	<b>GPS Location</b>	37.2602081282376, -80.1690043063918		
<b>Description</b>	12234+77_010919 Crew adding rock to the RCE. Looking NE. See picture for GPS data.	<b>Description</b>	12234+00_090119 CFS along access road. Looking N. See picture for GPS data.

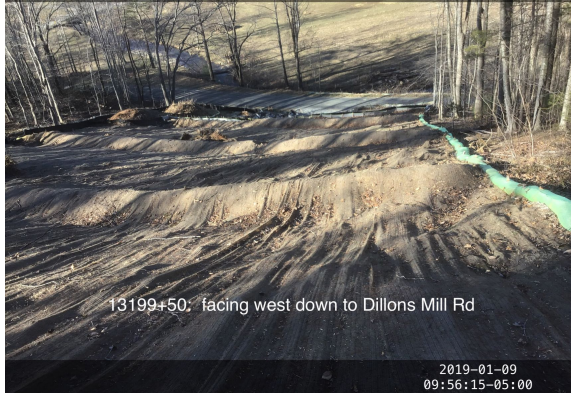
<div>13199+50: facing west down to Dillons Mill Rd</div> <div>2019-01-09 09:56:15-05:00</div>			<div>DIRECTION E (T)</div> <div>37.12254°N 080.07006°W</div> <div>ACCURACY 10 m DATUM WGS84</div>

<div>13210+50: ECB ends, strictly Earthguard from here</div> <div>2019-01-09 10:18:45-05:00</div>		
GPS Location	37.2355367755864, -80.2295069956037		GPS Location	37.2355216881607, -80.2296186425539	
Description	Station 13199+50, facing west down to Dillons Mill.		Description	Station 13210+50, facing east.	
<div>DIRECTION S (T)</div> <div>37.12218°N 080.06672°W</div> <div>ACCURACY 5.00 km DATUM WGS84</div>

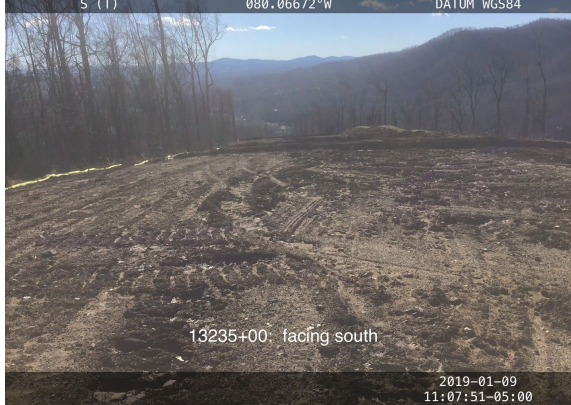
<div>13235+00: facing south</div> <div>2019-01-09 11:07:51-05:00</div>			<div>DIRECTION E (T)</div> <div>37.11592°N 080.06427°W</div> <div>ACCURACY 30 m DATUM WGS84</div>

GPS Location	37.235662420315, -80.2295794990661		GPS Location	37.2356811538685, -80.2297016233953	
Description	Station 13235+00, facing south.		Description	Station 13250+00, facing east down towards Flanders Road.	
<div>DIRECTION SE (T)</div> <div>37.11580°N 080.06334°W</div> <div>ACCURACY 10 m DATUM WGS84</div>

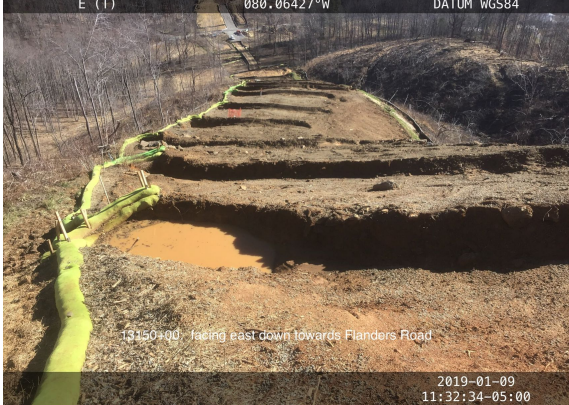
<div>13150+00: facing east down towards Flanders Road</div> <div>2019-01-09 11:32:34-05:00</div>

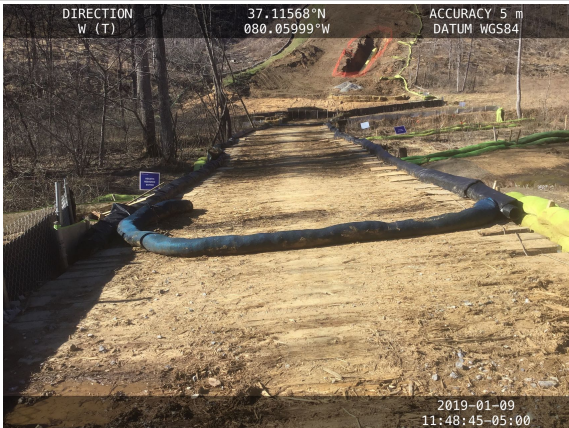
<div>13251+00: facing west. Bridge and ECDs functioning properly and in satisfactory condition. See photo for location.</div> <div>2019-01-09 11:48:45-05:00</div>		
GPS Location	37.2355893720288, -80.2296475601198		GPS Location	37.2355893720288, -80.2296475601198	
Description	SSF at the bottom of this steep side slope @ station 13251+00 on the coming in side of Flanders Road is full. See photo for location.		Description	Stream S-II4, facing west. Bridge and ECDs functioning properly and in satisfactory condition. See photo for location.
