Visual Site Inspection Report

Project Name	H-600 Pipeline Spread H	AFE	124300138	Spread	H-600 Pipeline Spread H
Contractor	Precision			Report #	12960
Inspector	Dustin Lyons			Date/Time	1/14/2019 10:02 AM
Permit #	TBD	Inspection Type	VA SWPP	Station Begin	12005+00
State	VA	Inspection Area	Partial	Station End	12072+00
County	Montgomery	Ground	Frozen	Temperature (°F)	31.00
Municipality	N/A	Weather	Cloudy	Rain Gauge (in)	0.60
GPS Location	37.2706981888388, -80.3142796364429			Rain Accumulation Time (days)	2.00

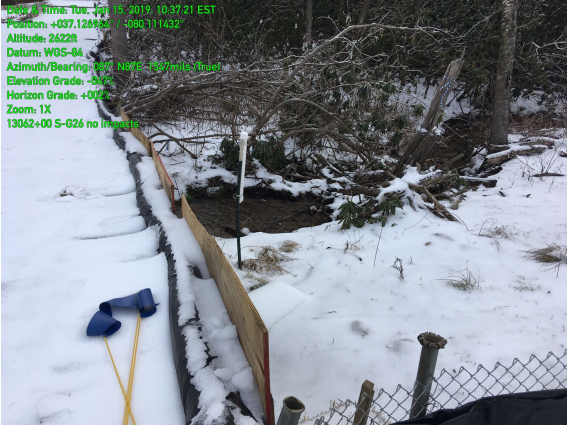
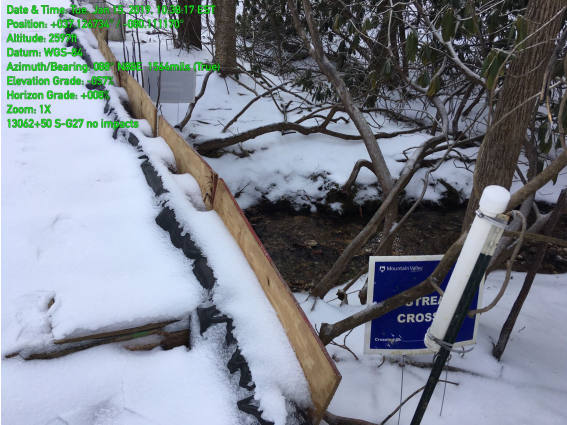
GPS Location	37.2938489671153, -80.0226855287543	GPS Location	37.2938614525248, -80.0227615703643		
Description	No visible issues or impacts in the area	Description	No visible issues or impacts in the area

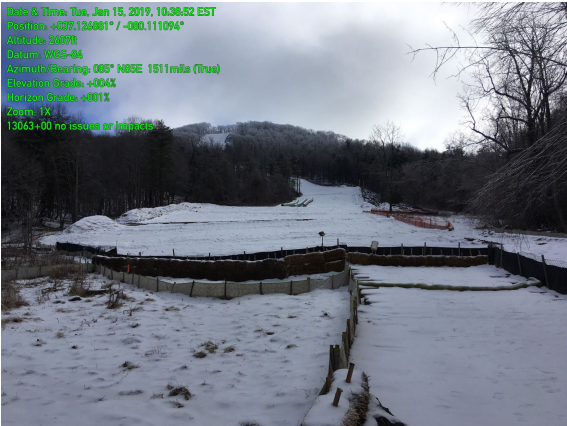
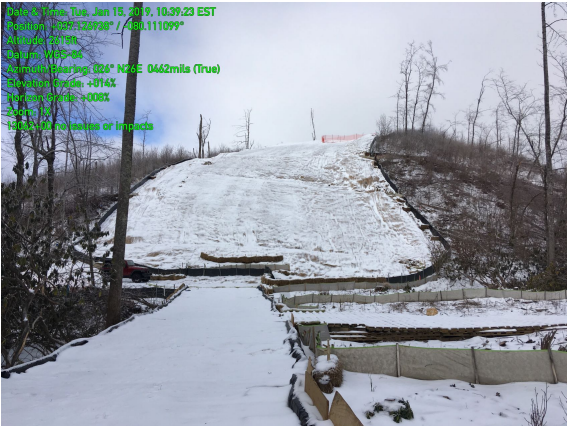
GPS Location	37.2937207203706, -80.0225391146541	GPS Location	37.293700603803, -80.0228062459082		
Description	No issues or impacts found	Description	No issues or impacts found

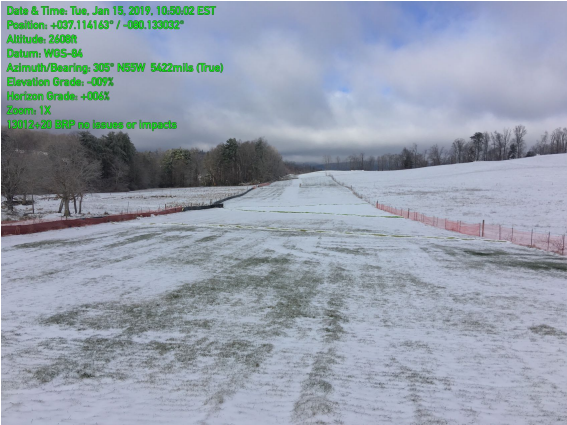
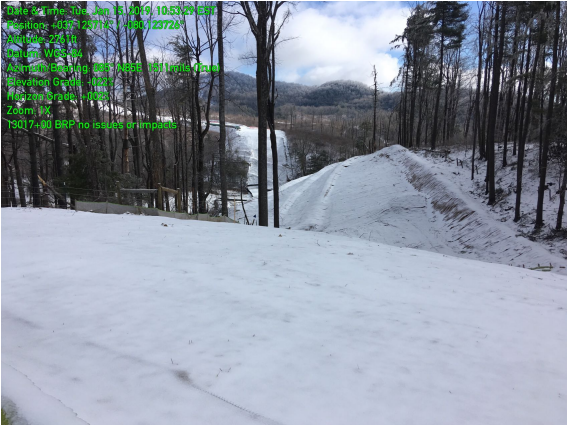
GPS Location	37.2937088180681, -80.0228448864818	GPS Location	37.293756092002, -80.0228867959976		
Description	No issues or impacts found	Description	No issues or impacts found

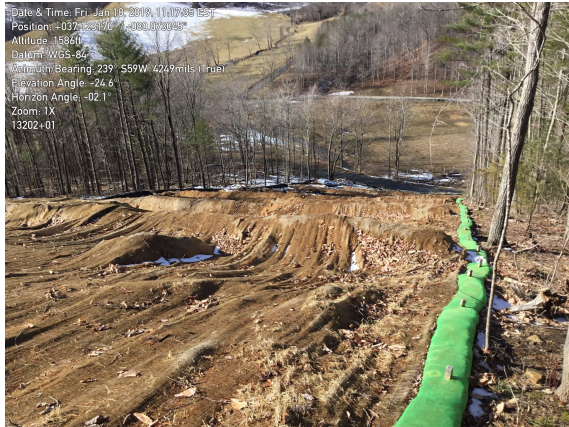
A/E	124300138	Date/Time	1/18/2019 6:39 AM	Report #	13183
Pictures					
<p>Date & Time: Fri, Jan 18, 2019, 11:10:55 EST Position: +037.32562885 / -080.02876006 Altitude: 1586ft Datum: WGS-84 Azimuth/Bearing: 239° 55'W 4249mils (True) Elevation Angle: -24.6° Horizon Angle: -02.1° Zoom: 1X 13202+01</p>

GPS Location	37.3256288545957, -80.0287600682926		GPS Location	37.3256337210623, -80.0287522819462	
Description	Please see photo for coordinates. ~Sta. No. 13202+01, ROW stabilized, no environmental issues observed.		Description	Please see photo for coordinates. ~Sta. No. 13203+00, ROW stabilized, no environmental concerns observed.	
<p>Date & Time: Fri, Jan 18, 2019, 11:19:55 EST Position: +037.3256360997 / -080.02874847 Altitude: 1896ft Datum: WGS-84 Azimuth/Bearing: 071° 17'E 1262mils (True) Elevation Angle: -04.1° Horizon Angle: -01.9° Zoom: 1X 13210+00</p>

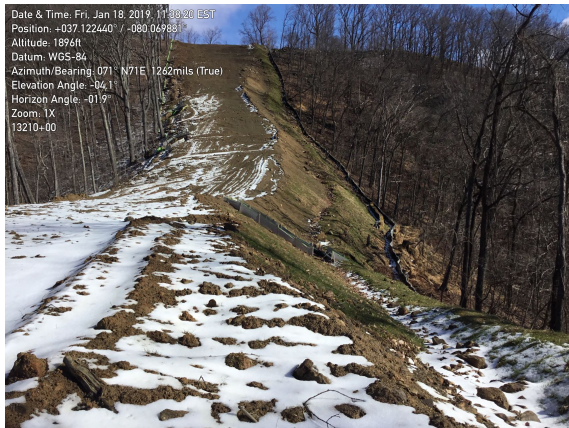
GPS Location	37.3256360997607, -80.028748476029		GPS Location	37.3256367592657, -80.0287474208209	
Description	Please see photo for coordinates. ~Sta. No. 13210+00, soil piles stabilized.		Description	Please see photo for coordinates. ~Sta. No. 13255+00, waterbars and soil piles stable.	
<p>Date & Time: Fri, Jan 18, 2019, 14:32:24 EST Position: +037.3256368439 / -080.0287472853 Altitude: 1358ft Datum: WGS-84 Azimuth/Bearing: 341° 11'W 6062mils (True) Elevation Angle: -43.7° Horizon Angle: -00.9° Zoom: 1X S-GH7upstream</p>

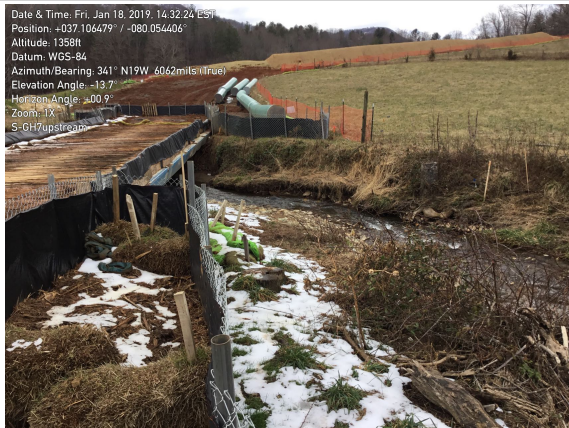
GPS Location	37.3256368439082, -80.0287472853929		GPS Location	37.3256368439082, -80.0287472853929	
Description	Please see photo for coordinates. S-GH7, upstream side of stream crossing, ECDs functioning acceptably.		Description	Please see photo for coordinates. ~Sta. No. 13311+00, waterbar and sump functioning acceptably.

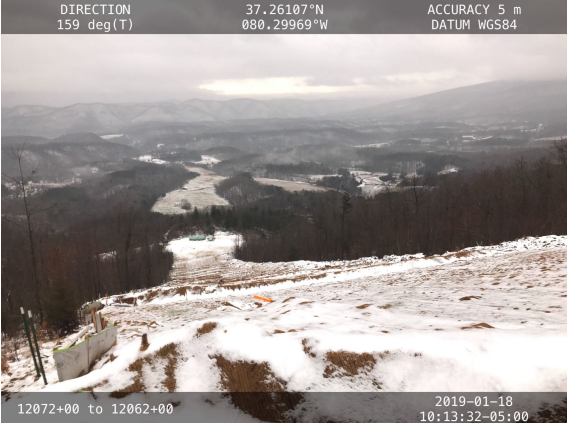
12072+00 to 12062+00 2019-01-18 10:13:32-05:00		DIRECTION 309 deg(T) 37.26182°N 080.30237°W ACCURACY 5 m DATUM WGS84

12036+00 to 12054+00 2019-01-18 10:26:45-05:00			
GPS Location	37.2618964780469, -80.302024874911		GPS Location	37.2618803009738, -80.3020320833477	
Description	Photo shows the general condition of the ROW from about 12062+00 to 12072+00. GPS data is included on Photo.		Description	Photo shows the general condition of the ROW from about 12054+00 to 12036+00. GPS data is included on Photo.	
DIRECTION 46 deg(T) 37.26441°N 080.30667°W ACCURACY 5 m DATUM WGS84

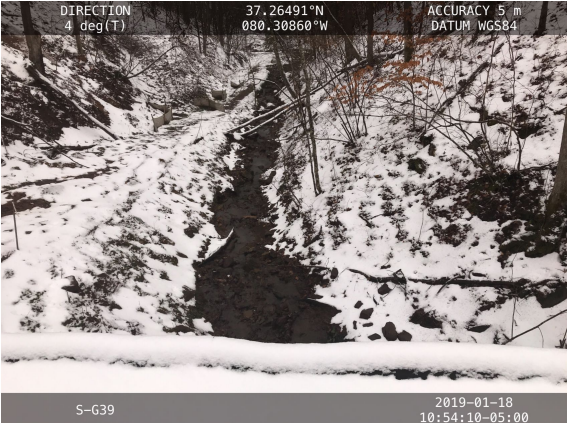
S-G39 2019-01-18 10:54:10-05:00		DIRECTION 308 deg(T) 37.27062°N 080.31427°W ACCURACY 5 m DATUM WGS84

ATWS-MN-268.0 Rock construction entrance 2019-01-18 11:09:25-05:00			
GPS Location	37.2618803009738, -80.3020320833477		GPS Location	37.2618803009738, -80.3020320833477	
Description	Photo shows the general condition of stream S-G39. GPS data is included on Photo.		Description	Photo shows the condition of the rock construction entrance at MVP-MN-268.0. GPS data is included on Photo.

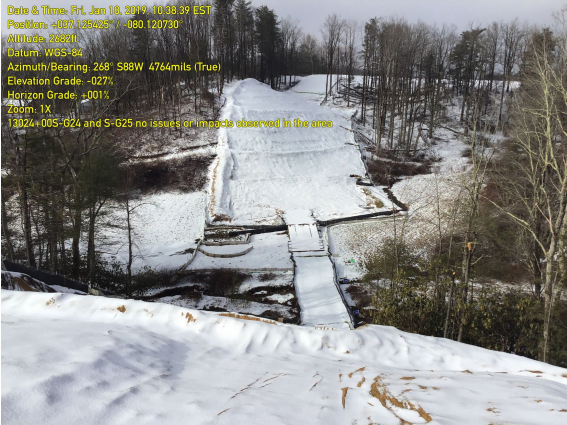
A/E	124300138	Date/Time	1/18/2019 10:03 AM	Report #	13120
Pictures					
<p>Date & Time: Fri, Jan 18, 2019, 10:06:39 EST Position: +037.1261907° / -88.1185894° Altitude: 2552ft Datum: WGS-84 Azimuth/Bearing: 268° S88W 4764mils (True) Elevation Grade: -027% Horizon Grade: +001% Zoom: 1X 13024+00 S-G24 and S-G25 no issues or impacts observed in the area</p>

GPS Location	37.1261907834905, -80.1185894385726	GPS Location	37.1278245002377, -80.1175784972311		
Description	S-G24 and S-G25 no visible issues or impacts in the area.	Description	S-H1 no issues or impacts found throughout the area.		
<p>Date & Time: Fri, Jan 18, 2019, 10:46:30 EST Position: +037.1306250° / -80.1113501° Altitude: 2632ft Datum: WGS-84 Azimuth/Bearing: 296° N64W 5267mils (True) Elevation Grade: -004% Horizon Grade: +003% Zoom: 1X 13062+00 S-G26 no issues found</p>

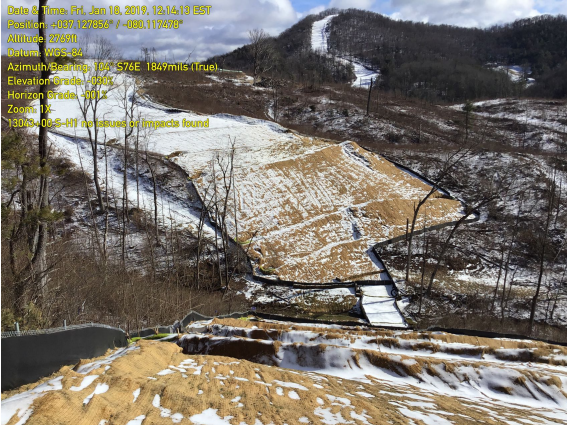
<p>Date & Time: Fri, Jan 18, 2019, 10:14:13 EST Position: +037.1278245° / -88.1175784° Altitude: 2550ft Datum: WGS-84 Azimuth/Bearing: 108° S72E 1849mils (True) Elevation Grade: -005% Horizon Grade: +012% Zoom: 1X 13024+00 S-H1 no issues or impacts found</p>

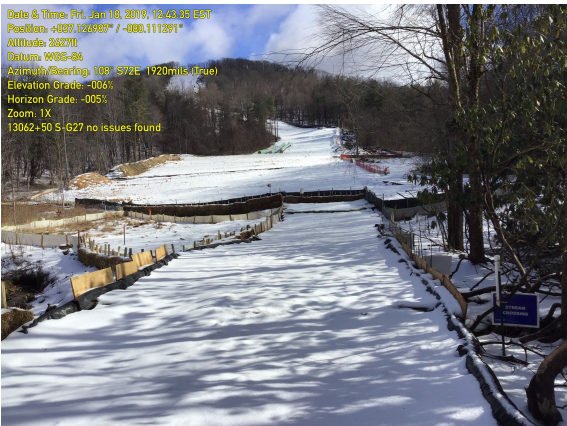
<p>Date & Time: Fri, Jan 18, 2019, 10:46:30 EST Position: +037.1306250° / -80.1113501° Altitude: 2632ft Datum: WGS-84 Azimuth/Bearing: 108° S72E 1920mils (True) Elevation Grade: -005% Horizon Grade: +005% Zoom: 1X 13062+50 S-G27 no issues found</p>

GPS Location	37.1270078514117, -80.1113504078985	GPS Location	37.1270078514117, -80.1113504078985		
Description	S-G26 no issues or impacts observed in the area.	Description	S-G27 no issues or impacts observed in the area		
<p>Date & Time: Fri, Jan 18, 2019, 13:50:43 EST Position: +037.1285225° / -80.1302436° Altitude: 2654ft Datum: WGS-84 Azimuth/Bearing: 158° S22E 2809mils (True) Elevation Grade: +000% Horizon Grade: +000% Zoom: 1X 12973+00 GMS of US-221 before BRP</p>

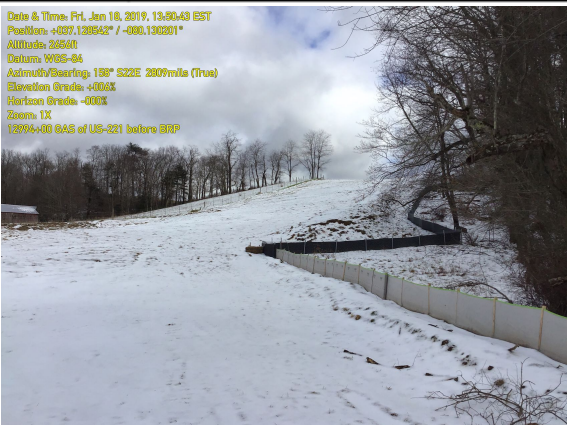
GPS Location	37.1285225451338, -80.1302436367424	GPS Location	37.1325403266001, -80.1317694783957		
Description	No ECD deficiencies observed in the area.	Description	No impacts or other issues along the access road or the ROW.

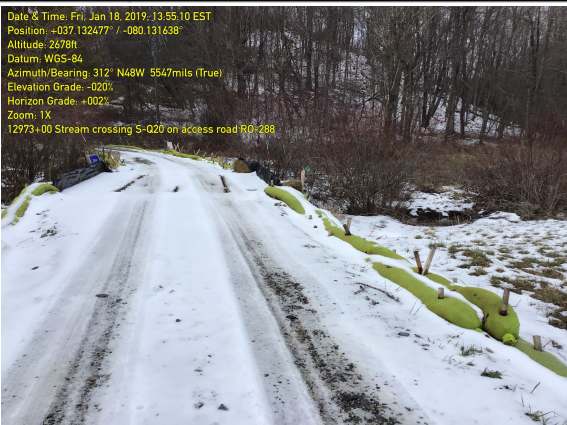
<p>Date & Time: Fri, Jan 18, 2019, 13:55:10 EST Position: +037.1325403° / -80.1317694° Altitude: 2678ft Datum: WGS-84 Azimuth/Bearing: 312° N48W 5547mils (True) Elevation Grade: -020% Horizon Grade: +002% Zoom: 1X 12973+00 Stream crossing S-Q20 on access road RD-288</p>

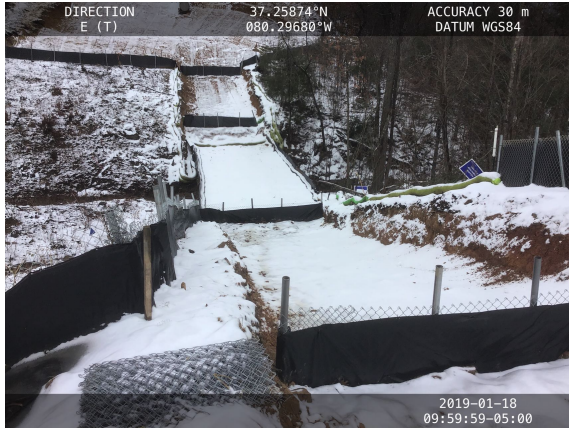
GPS Location		37.2585451417018, -80.2965983469787		GPS Location 37.2586516756911, -80.2928270772847	
Description		Stream S-MM15, station 12076+95, facing east.		Description Stream S-MM14, station 12086+56, facing northwest.
