# Visual Site Inspection Report

<b>Project Name</b>	H-600 Pipeline Spread H	<b>AFE</b>	124300138	<b>Spread</b>	H-600 Pipeline Spread H
<b>Contractor</b>	Precision			<b>Report #</b>	14129
<b>Inspector</b>	Dustin Lyons			<b>Date/Time</b>	2/18/2019 2:46 PM
<b>Permit #</b>	TBD	<b>Inspection Type</b>	VA SWPP	<b>Station Begin</b>	12005+00
<b>State</b>	VA	<b>Inspection Area</b>	Partial	<b>Station End</b>	12072+00
<b>County</b>	Montgomery	<b>Ground</b>	Wet	<b>Temperature (°F)</b>	46.00
<b>Municipality</b>	N/A	<b>Weather</b>	Cloudy	<b>Rain Gauge (in)</b>	1.10
<b>GPS Location</b>	37.2700953204532, -80.3138301149759			<b>Rain Accumulation Time (days)</b>	3.00

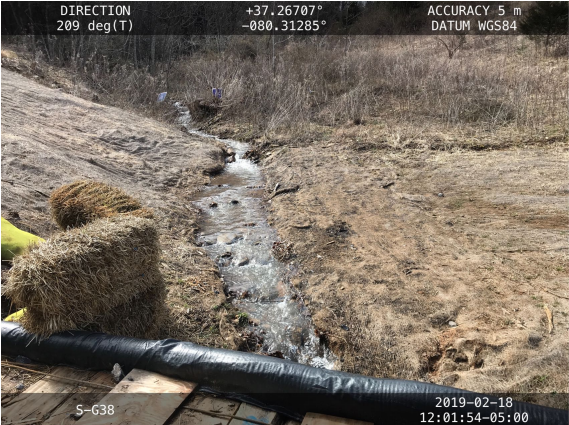
<p>DIRECTION 209 deg(T) +37.26707° -080.31285° ACCURACY 5 m DATUM WGS84</p> <p>S-G38 2019-02-18 12:01:54-05:00</p>

<p>DIRECTION 334 deg(T) +37.26852° -080.31314° ACCURACY 5 m DATUM WGS84</p> <p>S-G36 Downstream side of bridge 2019-02-18 12:06:52-05:00</p>		<b>GPS Location</b> 37.270120005158, -80.3137504868957	
<b>Description</b> See photo for gps data. Photo shows the condition of stream S-G38.		<b>Description</b> See photo for gps data. Photo shows the condition of S-G36 and the downstream side of the bridge on MVP-MN-268.01.

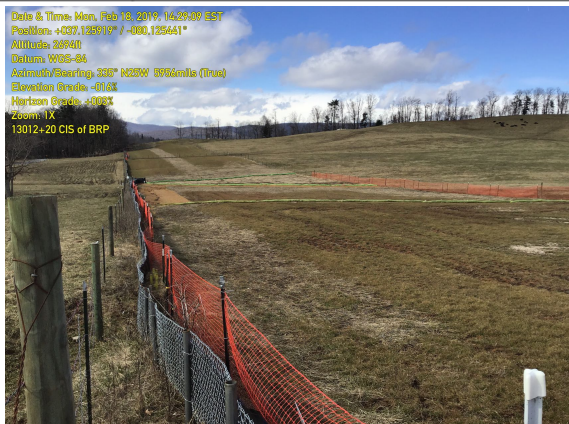
<p>Date &amp; Time: Mon, Feb 18, 2019, 14:30:13 EST Position: +037.125964° / -000.125228° Altitude: 2094ft Datum: WGS-84 Azimuth/Bearing: 104° 575E 1824mils (True) Elevation Grade: -001% Horizon Grade: -004% Zoom: 1X 13012+70 GAS of BRP</p>

GPS Location	37.1259695850658, -80.1253087074311		GPS Location	37.1259141806859, -80.1253208611907	
Description	Stabilized ROW and ECD's remain in good condition.		Description	Stabilized ROW and ECD's remain in good condition.	
<p>Date &amp; Time: Mon, Feb 18, 2019, 14:45:11 EST Position: +037.155312° / -000.128836° Altitude: 2625ft Datum: WGS-84 Azimuth/Bearing: 178° 5245' 311mils (True) Elevation Grade: -018% Horizon Grade: -002% Zoom: 1X 12865+20 GAS of Bottom Creek Road</p>  		<p>Date &amp; Time: Mon, Feb 18, 2019, 15:08:30 EST Position: +037.191930° / -000.15755° Altitude: 3736ft Datum: WGS-84 Azimuth/Bearing: 178° 505E 3111mils (True) Elevation Grade: -002% Horizon Grade: -002% Zoom: 1X 12865+00 CIS of Honeysuckle Road</p>  			
GPS Location	37.1553121973175, -80.1288396679611		GPS Location	37.1919308044363, -80.1575501170756	
Description	No issues or impacts found on either side of the Bottom Creek Road crossing.		Description	No issues or impacts found on either side of the Honeysuckle Road crossing.

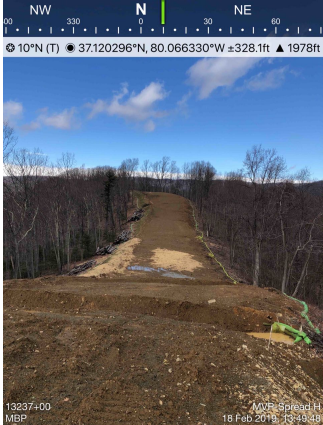
<b>GPS Location</b>	37.3254764151861, -80.0286842011652	<b>GPS Location</b>	37.3255609286891, -80.028723314179		
<b>Description</b>	Please see photo for coordinates. ~Sta. No. 13237+00, ROW stabilized, ECDs functioning acceptably.	<b>Description</b>	Please see photo for coordinates. ~Sta. No. 13256+00, waterbar and sump functioning acceptably.

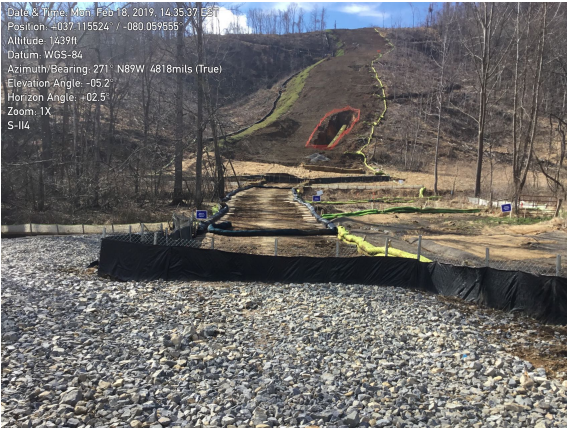
<b>GPS Location</b>	37.3255736216534, -80.028734358722	<b>GPS Location</b>	37.3255504819323, -80.0287278211111		
<b>Description</b>	Please see photo for coordinates. ~Sta. No. 13260+60, S-II4, ECDs functioning acceptably along bridge and stream banks.	<b>Description</b>	Please see photo for coordinates. ~Sta. No. 13273+46, minor rill erosion noted in travel lane, waterbars functioning acceptably.

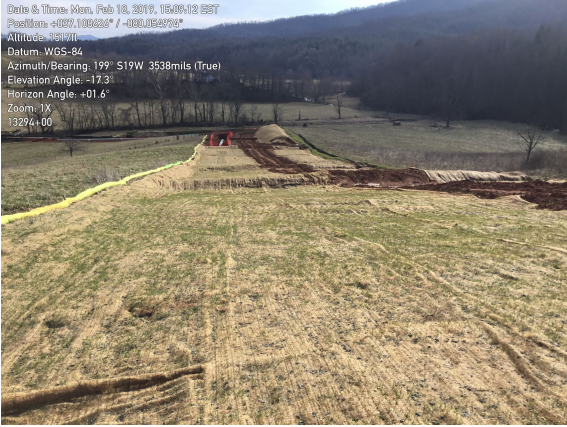
<b>Description</b>	Please see photo for coordinates. ~Sta. No. 13294+00, ROW stabilized, with sparse germination noted.	<b>Description</b>	Please see photo for coordinates. ~Sta. No. 13309+09, S-GH7, downstream of bridge, no stream impacts noted.

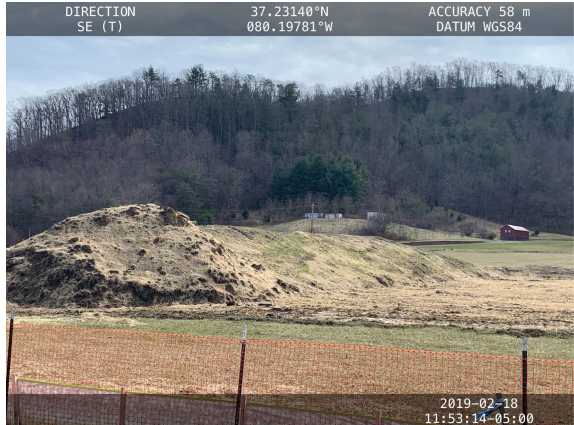
GPS Location	37.3313681048599, -79.9582236829963		GPS Location	37.331335729345, -79.9581151664005	
Description	YellowFinchRoad_021819 Rain gauge total (1.0") Looking NW. See picture for GPS data.		Description	12451+20_021819 Stabilized topsoil pile. Looking SE. See picture for GPS data.

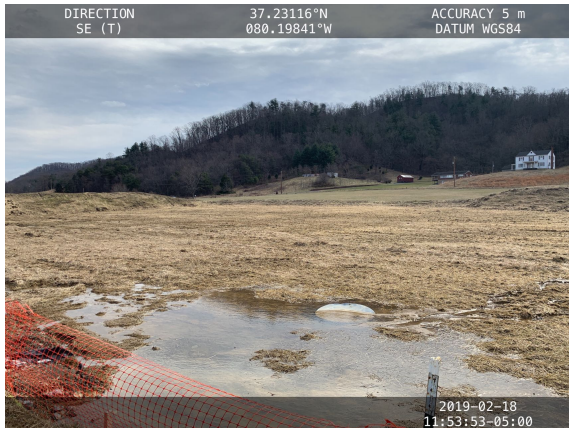
GPS Location	37.3312295617973, -79.9580587120926		GPS Location	37.3311872622668, -79.9581122758371	
Description	12451+00_021819 Stabilized ROW. LOOKING SE. See picture for GPS data.		Description	12452+50_021819 P1 Silt fence perimeter controls. Looking W. See picture for GPS data.

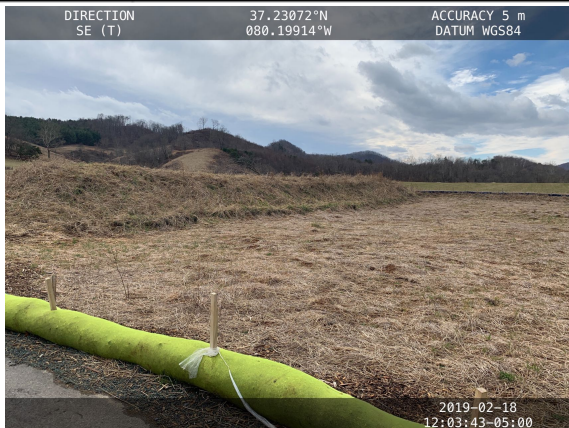
GPS Location	37.3311878039441, -79.9580667108057		GPS Location	37.3313556395133, -79.9580819187863	
Description	12453+00_021819 stabilized topsoil pile on variance. Looking SE. See picture for GPS data.		Description	12453+00_021819 Stabilized disturbed variance. Looking S. See picture for GPS data.

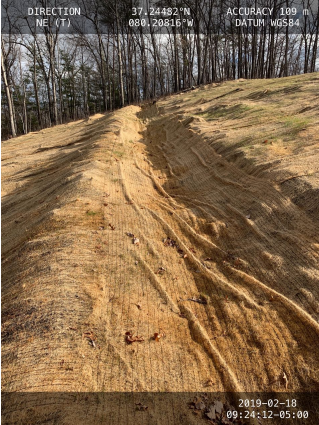
<b>GPS Location</b>	37.3248490746055, -79.9535895951782	<b>GPS Location</b>	37.3248622441599, -79.953741150886		
<b>Description</b>	12378+00_021819 Water bar. Looking NE. See picture for GPS data.	<b>Description</b>	12380+04_021819 Bridge crossing S-NN19. Looking E. See picture for GPS data.

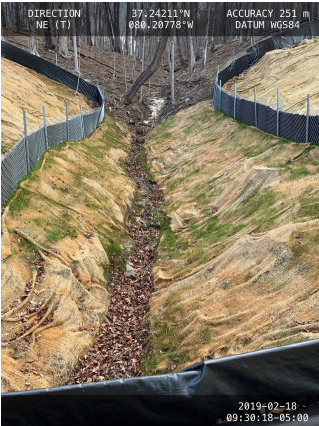
<b>GPS Location</b>	37.3247692382988, -79.9537422478394	<b>GPS Location</b>	37.3248215784017, -79.9537394549091		
<b>Description</b>	12380+00_021819 Stream S-NN19. Looking NE. See picture for GPS data.	<b>Description</b>	12409+03_021819 Stabilized extra work space. Looking NE. See picture for GPS data.

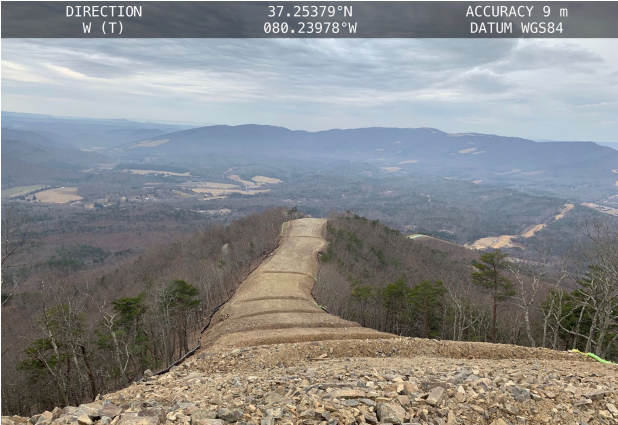
<b>GPS Location</b>	37.324786643868, -79.9536823755921	<b>GPS Location</b>	37.324805204365, -79.9536989261927		
<b>Description</b>	12268+70_021819 Stabilized ROW. Looking W. See picture for GPS data.	<b>Description</b>	12234+77_021819 RCE. Looking E. See picture for GPS data.

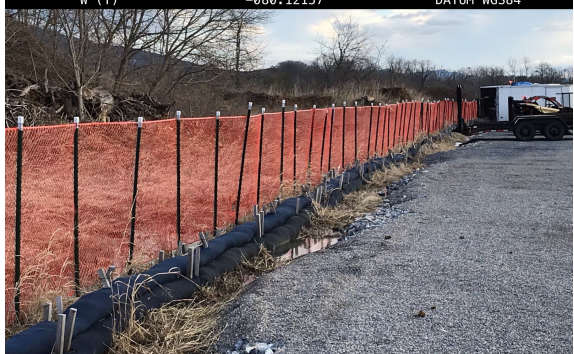
GPS Location	37.2714789631192, -80.1204487961532		GPS Location	37.2714789631192, -80.1204487961532	
Description	MVP-LY-049_021819 condition of compost filter sock and safety fence along north boundary. Looking W. See photo for gps data.		Description	MVP-LY-049_021819 dumpster area free of loose trash. Looking SW. See photo for gps data.	
<div>DIRECTION E (T)</div> <div>+37.26944° -080.12410°</div> <div>ACCURACY 16 ft DATUM WGS84</div>   <div>2019-02-18 09:44:05-05:00</div>			<div>DIRECTION SE (T)</div> <div>+37.27076° -080.11998°</div> <div>ACCURACY 16 ft DATUM WGS84</div>   <div>2019-02-18 09:39:16-05:00</div>		
GPS Location	37.2714789631192, -80.1204487961532		GPS Location	37.2714789631192, -80.1204487961532	
Description	MVP-LY-049_021819 condition of compost filter sock and safety fence along west boundary. Looking E. See photo for gps data.		Description	MVP-LY-049_021819 condition of compost filter sock and safety fence along south boundary. Looking SE. See photo for gps.

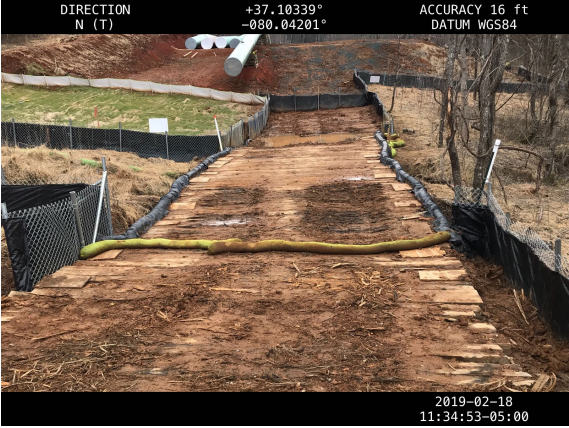
<b>GPS Location</b>	37.1037972299728, -80.0434901845456	<b>GPS Location</b>	37.1037972299728, -80.0434901845456		
<b>Description</b>	13348+46_021819 S-RR08 mat bridge clean and closed. Looking N. See photo for gps data.	<b>Description</b>	13358+64_021819 S-RR11 mat bridge clean and closed. Looking NE. See photo for gps data.

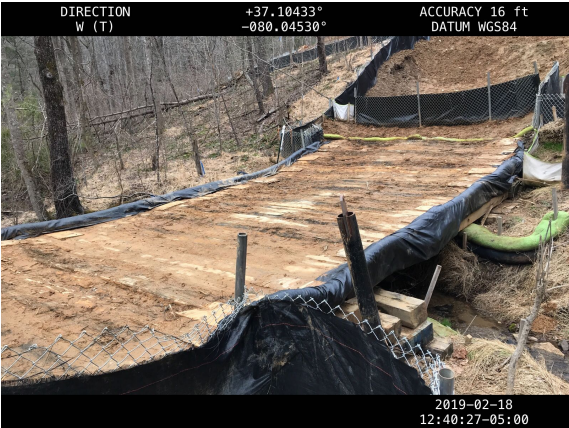
<b>GPS Location</b>	37.1038620220843, -80.043520527035	<b>GPS Location</b>	37.1038620220843, -80.043520527035		
<b>Description</b>	133374+13_021819 S-GH9 mat bridge clean and closed. Looking W. See photo for gps data.	<b>Description</b>	13334+17_021819 S-GH11 geotech repaired. Looking NE. See photo for gps data.

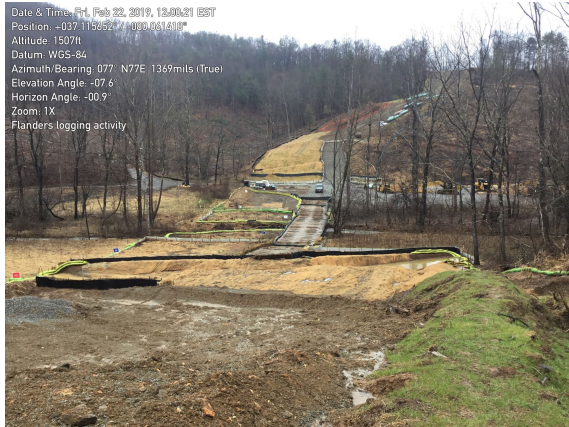
GPS Location	37.1221020911235, -80.0759553071857	GPS Location	37.1221020911235, -80.0759553071857		
Description	Please see photo for coordinates. S-II4, Flanders Road crossing, ECDs functioning acceptably, no off ROW impacts noted.	Description	Please see photo for coordinates. MVP-ATWS-1055, sediment entering extra workspace from off ROW logging activities.

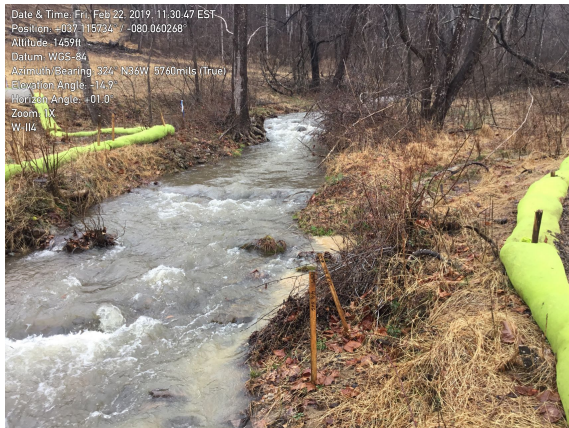
GPS Location	37.1219779551375, -80.0759898406268	GPS Location	37.1221086290079, -80.0760112144799		
Description	Please see photo for coordinates. S-II4, looking upstream, turbid water flowing into stream from off ROW tributary.	Description	Please see photo for coordinates. ~Sta. No. 13270+00, rill erosion previously noted.		
<p>Date &amp; Time: Fri, Feb 22, 2019, 13:00:54 EST Position: +037.1150112, -80.059988* Altitude: 1500ft Datum: WGS-84 Azimuth/Bearing: 201. S20W 5760mils (True) Elevation Angle: -12.1 Horizon Angle: -01.0 Zoom: 1X 13276+00</p>

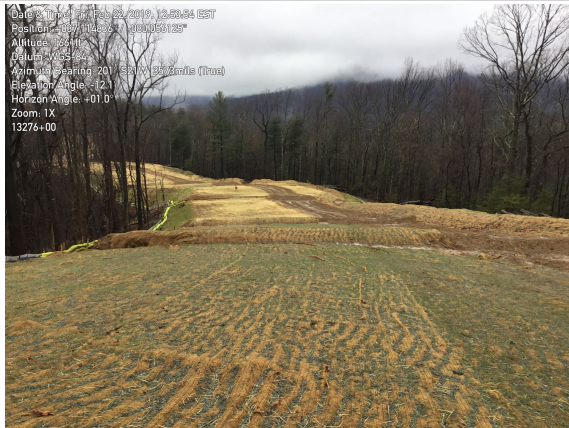
GPS Location	37.1221086290079, -80.0760112144799	GPS Location	37.1221086290079, -80.0760112144799		
Description	Please see photo for coordinates. ~Sta. No. 13276+00, ROW stabilized with no off ROW impacts noted.	Description	Please see photo for coordinates. S-GH7, upstream side of bridge crossing, ECDs functioning acceptably.

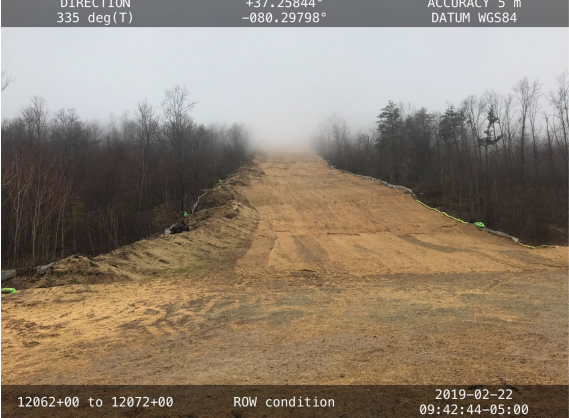
12062+00 to 12072+00    ROW condition    2019-02-22 09:42:44-05:00		DIRECTION 144 deg(T)    +37.26278°    ACCURACY 5 m -080.30335°    DATUM WGS84

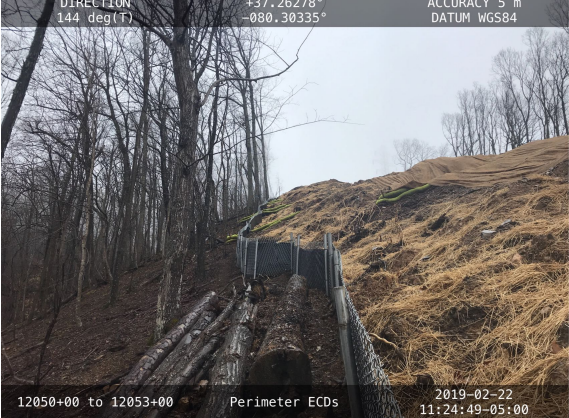
12050+00 to 12053+00    Perimeter ECDs    2019-02-22 11:24:49-05:00		<b>GPS Location</b> 37.1922450419862, -80.3665465024117	
<b>Description</b> See photo for gps data. Photo shows the ROW condition from about 12062+00 to 12072+00.		<b>Description</b> See photo for gps data. Photo shows the perimeter ECDs from about 12050+00 to 12053+00.		<b>GPS Location</b> 37.1922450419862, -80.3665465024117	
DIRECTION 149 deg(T)    +37.26509°    ACCURACY 5 m -080.30866°    DATUM WGS84

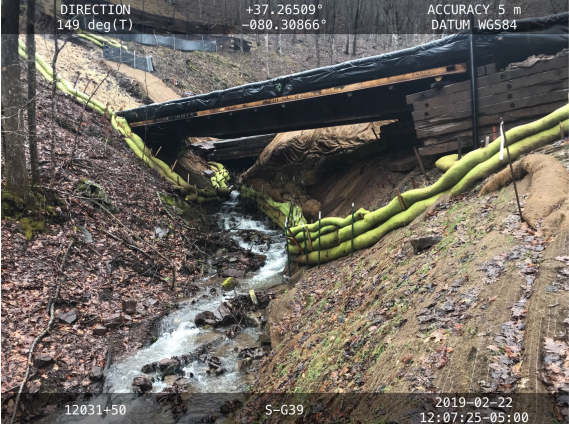
12031+50    S-G39    2019-02-22 12:07:25-05:00		DIRECTION 83 deg(T)    +37.26496°    ACCURACY 10 m -080.30883°    DATUM WGS84

<b>Description</b> See photo for gps data. Photo shows stream S-G39.		<b>Description</b> See photo for gps data. Photo shows the tension crack at 12031+25.		<b>GPS Location</b> 37.1922450419862, -80.3665465024117	
DIRECTION 18 deg(T)    +37.26709°    ACCURACY 5 m -080.31283°    DATUM WGS84

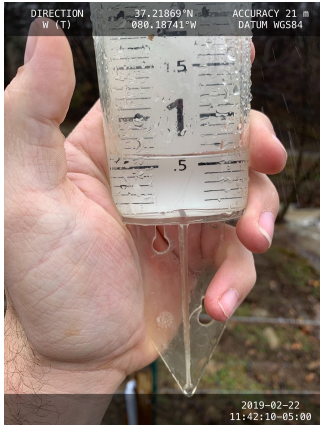
GPS Location	37.3312476208942, -79.9581902072891		GPS Location	37.3313310991642, -79.9582921128402	
Description	YellowFinchRoad_022219 Rain gauge total. Looking W. See picture for GPS data.		Description	12451+00_022219 Stabilized area where water was crossing the ROW. Looking NW. See picture for GPS data.

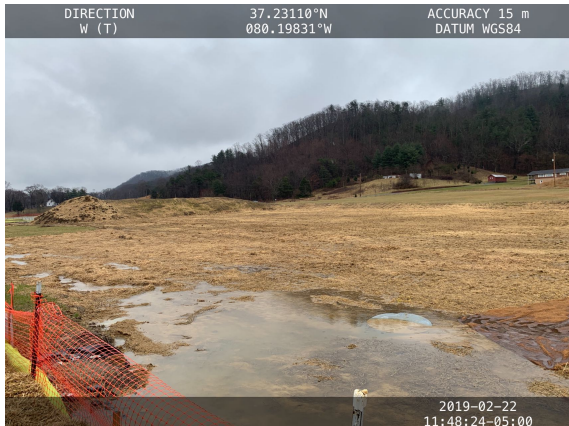
GPS Location	37.3313500642267, -79.9582866635602		GPS Location	37.3312795402513, -79.9582301060075	
Description	12451+00_022219 Stabilized ROW. Looking w. See picture for GPS data.		Description	12452+80_022219 RCE. LOOKING E. See picture for GPS data.

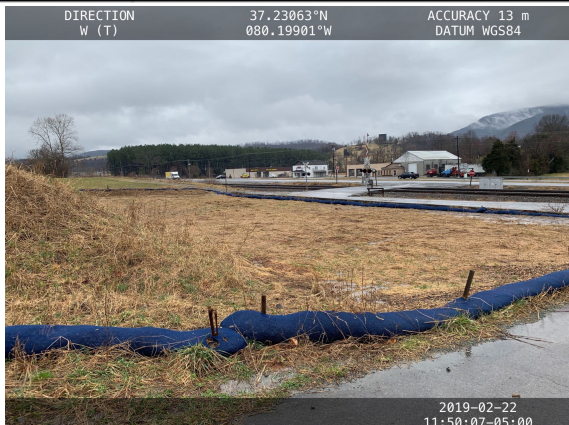
GPS Location	37.3312642498074, -79.9582242079959		GPS Location	37.3312087640668, -79.9582270136337	
Description	12453+00_022219 Stabilized disturbed variance. Looking W. See picture for GPS data.		Description	12453+00_022219 Stabilized topsoil pile. Looking W. See picture for GPS data.

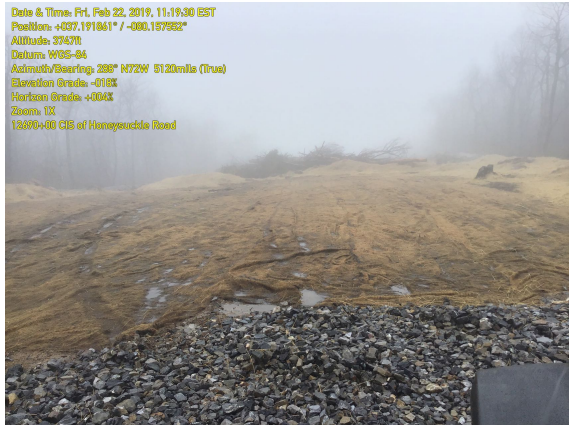
GPS Location	37.1918582171548, -80.157553721294	GPS Location	37.1918582171548, -80.157553721294		
Description	No issues or impacts observed in the area.	Description	No issues or impacts found throughout the work area on both sides of the Bottom Creek Road crossing.		
<p>Date &amp; Time: Fri, Feb 22, 2019, 11:59:08 EST Position: +037.130872° / -080.136458° Altitude: 2770ft Datum: WGS-84 Azimuth/Bearing: 230° S59W 424ftmils (True) Elevation Grade: -021% Horizon Grade: +002% Zoom: 1X 12973+00 RD-288 entrance to ROW</p>

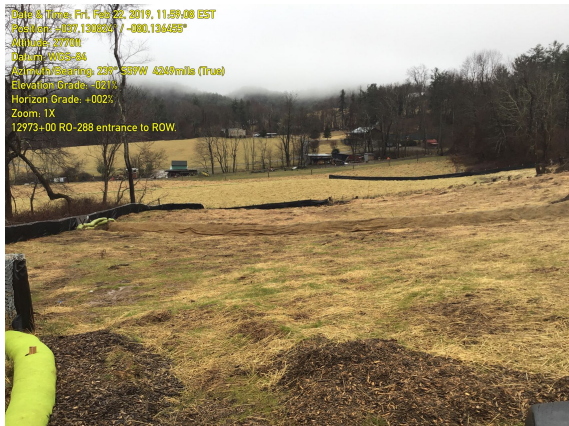
GPS Location	37.1308726631451, -80.1363142301144	GPS Location	37.1284374688166, -80.1302197483183		
Description	ROW and access road remain in good condition. No issues or impacts.	Description	No issues or impacts found throughout.		
<p>Date &amp; Time: Fri, Feb 22, 2019, 13:27:38 EST Position: +037.127065° / -080.117270° Altitude: 2724ft Datum: WGS-84 Azimuth/Bearing: 300° N40W 533mils (True) Elevation Grade: -047% Horizon Grade: -002% Zoom: 1X 13063+00 S-401 from the GIS</p>

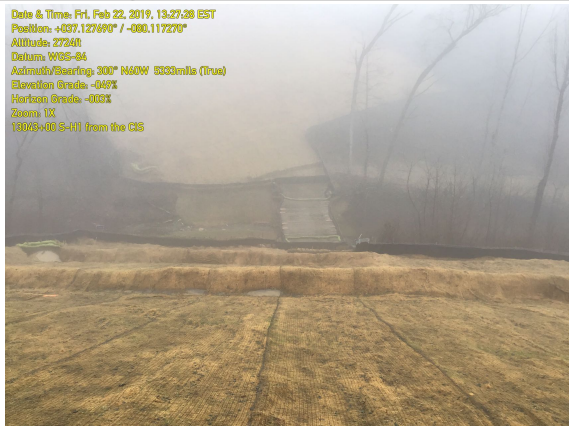
GPS Location	37.1277188882577, -80.1172443945707	GPS Location	37.1261765342552, -80.1185867563636		
Description	No issues or impacts observed near S-H1	Description	No issues or impacts were found near the stream crossings.

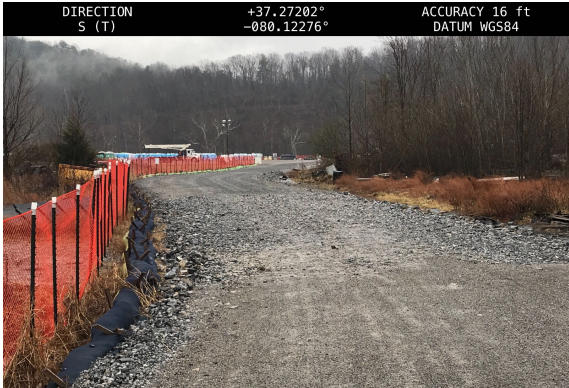
<div>2019-02-22 09:17:12-05:00</div>		
GPS Location	37.2712740255867, -80.1203627978266		GPS Location	37.2712740255867, -80.1203627978266	
Description	MVP-LY-049_022219 condition of rock approach. Looking S. See photo for gps data.		Description	MVP-LY-049_022219 condition of safety fence and compost filter sock along drive. Looking S. See photo for gps data.	
<div>DIRECTION E (T)</div> <div>+37.27100° -080.12205°</div> <div>ACCURACY 16 ft DATUM WGS84</div>

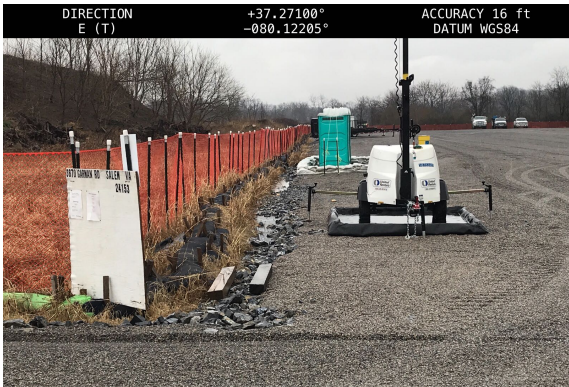
GPS Location	37.2712736903106, -80.1203588583322		GPS Location	37.2712736903106, -80.1203588583322	
Description	MVP-LY-049_022219 condition of containment, compost filter sock and safety fence along north boundary. Looking E. See photo fo gps.		Description	MVP-LY-049_022219 dumpster area free of loose trash. Looking NE. See photo for gps data.	
<div>DIRECTION NW (T)</div> <div>+37.26998° -080.12360°</div> <div>ACCURACY 16 ft DATUM WGS84</div>

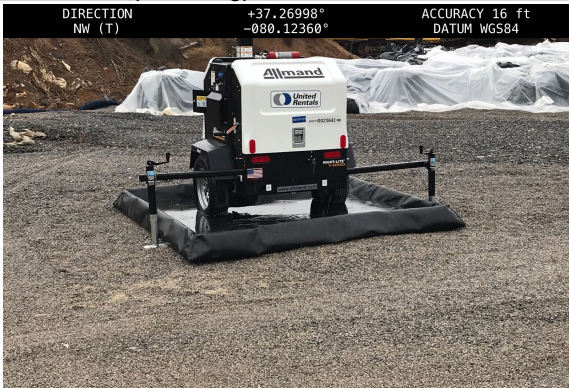
<div>2019-02-22 09:23:35-05:00</div>		
GPS Location	37.2712736903106, -80.1203588583322		GPS Location	37.2712736903106, -80.1203588583322	
Description	MVP-LY-049_022219 condition of containment under light plant. Looking W. See photo for gps data.		Description	MVP-LY-049_022219 condition of containment under porta toilets. Looking N. See phot for gps data.

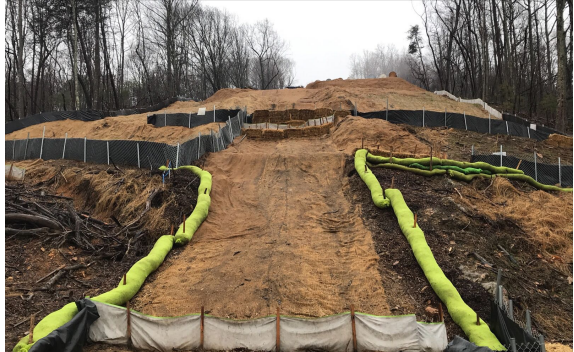
<div>2019-02-22 11:56:06-05:00</div>		
GPS Location	37.1037953859541, -80.0436123926938		GPS Location	37.1037953859541, -80.0436123926938	
Description	13412+75_022219 slope and travel lane stabilized. Looking W. See photo for gps data.		Description	13348+46_022219 S-RR08 mat bridge clean and closed. Looking SE. See photo for gps data.	
<div>DIRECTION N (T)</div> <div>+37.10249° -080.04116°</div> <div>ACCURACY 16 ft DATUM WGS84</div>

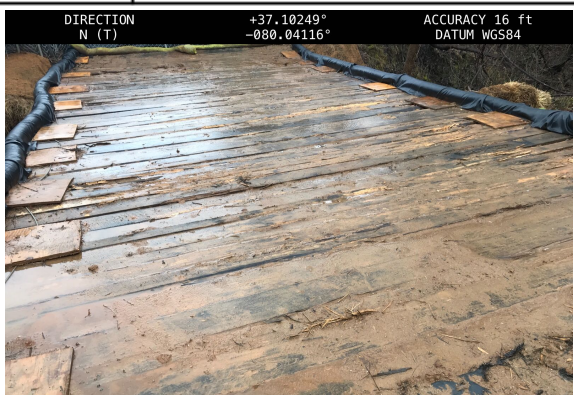
GPS Location	37.1038560290235, -80.043623540625		GPS Location	37.1038560290235, -80.043623540625	
Description	13352+23_022219 S-RR09 mat bridge clean and closed. Looking NE. See photo for gps data.		Description	13358+64_022219 S-RR11 mat bridge clean and closed. Looking SE. See photo for gps data.	
<div>DIRECTION N (T)</div> <div>+37.09602° -080.03218°</div> <div>ACCURACY 16 ft DATUM WGS84</div>

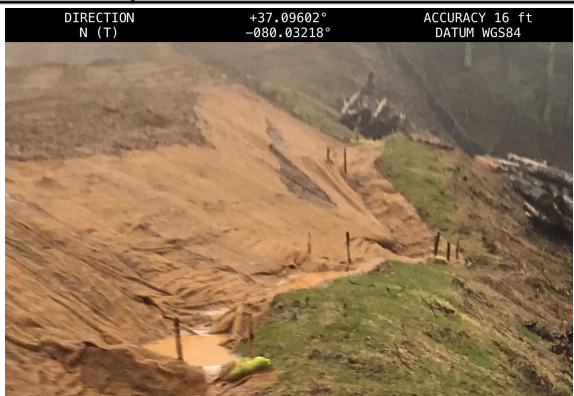
<div>2019-02-22 14:27:10-05:00</div>		
GPS Location	37.1038560290235, -80.043623540625		GPS Location	37.1038116468462, -80.0435739197582	
Description	13396+00_022219 slope and erosion control blanket starting to slide. No off ROW impact. Looking S. See photo for gps data.		Description	13323+43_022219 cows on spoil piles. Looking N. See photo for gps data.
