# Visual Site Inspection Report

<b>Project Name</b>	H-600 Pipeline Spread H	<b>AFE</b>	124300138	<b>Spread</b>	H-600 Pipeline Spread H	
<b>Contractor</b>	Precision			<b>Report #</b>	14619	
<b>Inspector</b>	Pat Davis			<b>Date/Time</b>	3/6/2019 5:42 PM	
<b>Permit #</b>	TBD	<b>Inspection Type</b>	VA SWPP	<b>Station Begin</b>	+0	
<b>State</b>	VA	<b>Inspection Area</b>	Partial	<b>Station End</b>	+0	
<b>County</b>	Montgomery	<b>Ground</b>	Muddy	<b>Temperature (°F)</b>	21.00	
<b>Municipality</b>	N/A	<b>Weather</b>	Sunny	<b>Rain Gauge (in)</b>	0.00	
				<b>Rain Accumulation Time (days)</b>	0.00

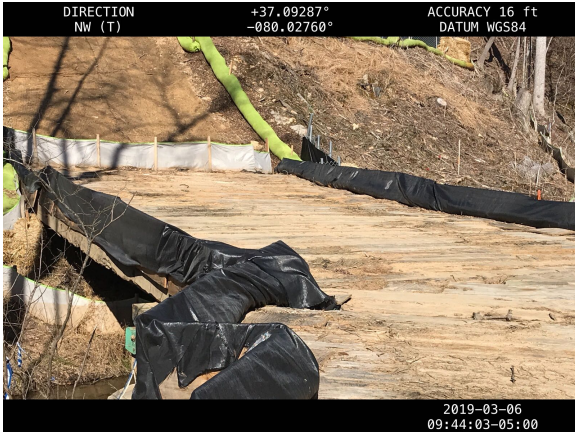
<div>2019-03-06 09:54:07-05:00</div>									
GPS Location		37.09		Field Station#		13413+05		GPS Location		37.09		Field Station#		13408+00	
Description		13413+05_030619 S-IJ1 mat bridge clean and closed. Looking NW. See photo for gps data.						Description		13408+00_030619 slope in slide area stabilized. Looking NW. See photo for gps data.					
<div>DIRECTION N (T) +37.10142° -080.03572° ACCURACY 16 ft DATUM WGS84</div>

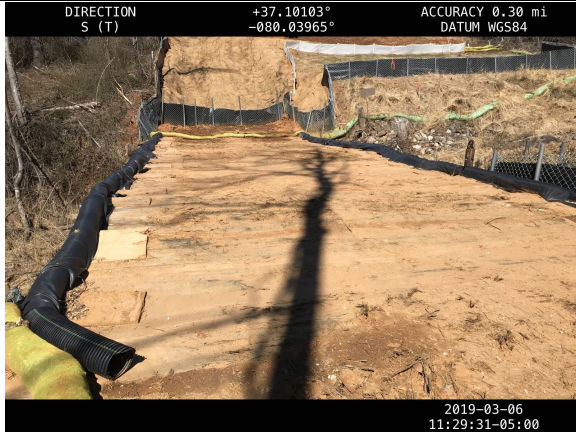
Description		13371+50_030619 condition of erosion control blanket on steep slope. Looking N. See photo for gps data.						Description		13358+64_030619 S-RR11 mat bridge clean and closed. Looking S. See photo for gps data.					
<div>DIRECTION NW (T) +37.10247° -080.04094° ACCURACY 16 ft DATUM WGS84</div>

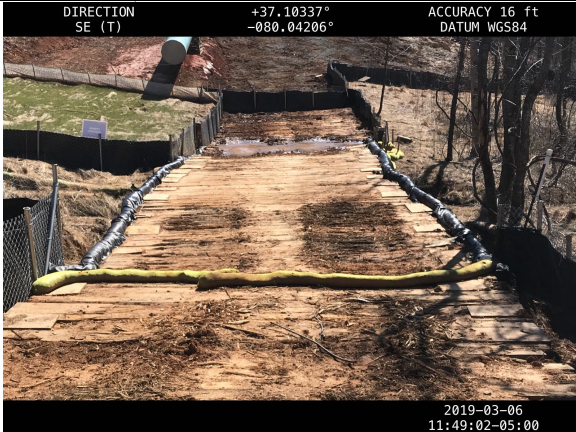
<div>2019-03-06 11:49:02-05:00</div>									
GPS Location		37.09		Field Station#		13352+23		GPS Location		37.09		Field Station#		13348+46	
Description		13352+23_030619 S-RR09 mat bridge clean and closed. Looking NW. See photo for gps data.						Description		13348+46_030619 S-RR08 mat bridge clean and closed. Looking SE. See photo for gps data.

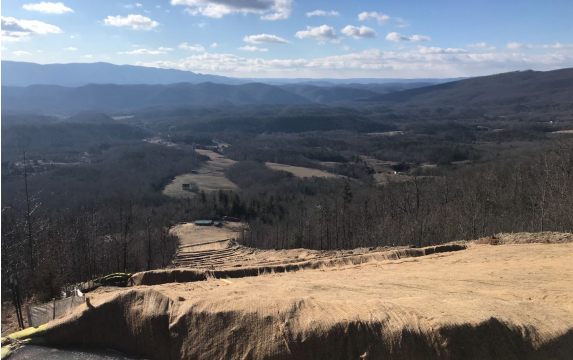
<div>12062+00 to 12072+00</div> <div>2019-03-06 08:48:26-05:00</div>			<div>DIRECTION 91 deg(T)</div> <div>+37.26159° -080.30178°</div> <div>ACCURACY 5 m DATUM WGS84</div>

<div>12056+00 to 12059+00</div> <div>Perimeter ECDs</div> <div>2019-03-06 09:06:04-05:00</div>				
GPS Location	37.26	Field Station#	12062+00	GPS Location	37.26	Field Station#	12056+00
Description	See photo for gps data. Photo shows the stabilized ROW from 12062+00 to 12072+00.			Description	See photo for gps data. Photo shows the perimeter ECDs from station 12056+00 to 12059+00.		
<div>DIRECTION 152 deg(T)</div> <div>+37.25862° -080.29640°</div> <div>ACCURACY 5 m DATUM WGS84</div>

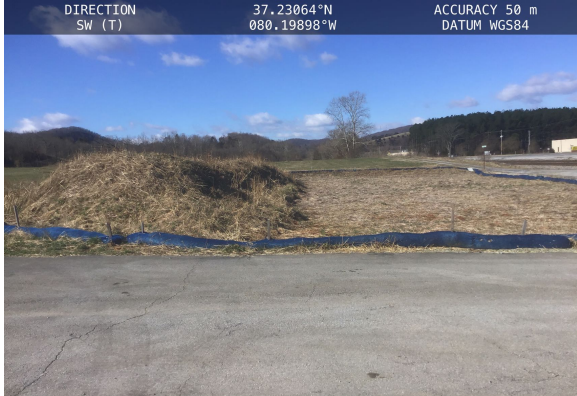
<div>2019-03-06 09:28:48-05:00</div>											
GPS Location		37.23		Field Station#		12452+00		GPS Location		37.23		Field Station#		12451+50	
Description		Topsoil pile and CFS in satisfactory condition.						Description		ECDs parallel to Cove Hollow Road are all in acceptable condition.					
<div>DIRECTION SE (T)</div> <div>37.23145°N 080.19738°W</div> <div>ACCURACY 5 m DATUM WGS84</div>
