Visual Site Inspection Report

Project Name	H-600 Pipeline Spread H	AFE	124300138	Spread	H-600 Pipeline Spread H	
Contractor	Precision			Report #	14933	
Inspector	Pat Davis			Date/Time	3/18/2019 6:45 PM	
Permit #	TBD	Inspection Type	VA SWPP	Station Begin	+0	
State	VA	Inspection Area	Partial	Station End	+0	
County	Roanoke	Ground	Dry	Temperature (°F)	50.00	
Municipality	N/A	Weather	Sunny	Rain Gauge (in)	0.00	
				Rain Accumulation Time (days)	0.00

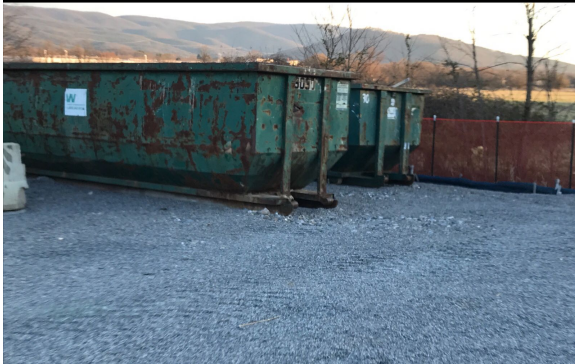
<div>2019-03-18 08:03:30-04:00</div>											
GPS Location		37.27		Field Station#		+0		GPS Location		37.27		Field Station#		+0	
Description		MVP-LY-049_031819 dumpster area free of loose trash. Looking NE. See photo for gps data.						Description		MVP-LY-049_031819 condition of CFS and safety fence along north drive. Looking NW. See photo for gps data.					
<div>DIRECTION E (T)</div> <div>+37.27168° -080.12309°</div> <div>ACCURACY 16 ft DATUM WGS84</div>

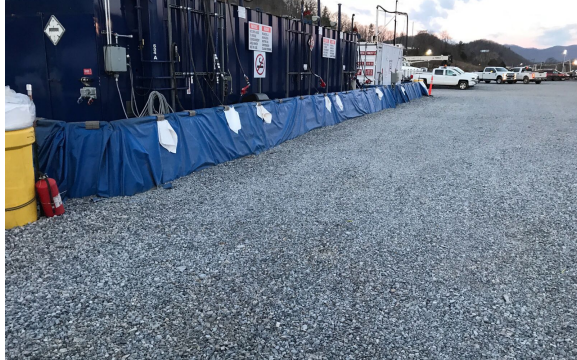
<div>2019-03-18 08:25:24-04:00</div>				
GPS Location	37.23	Field Station#	+0	GPS Location	37.23	Field Station#	+0
Description	MVP-PY-006_031819 no fluid deposits on the north side of the bulk fuel tanks. Looking NE. See photo for gps data.			Description	MVP-PY-006_031819 no fluid deposits on the south side of the bulk fuel tanks. Looking NE. See photo for gps data.		
<div>DIRECTION W (T)</div> <div>+37.23610° -080.22759°</div> <div>ACCURACY 16 ft DATUM WGS84</div>

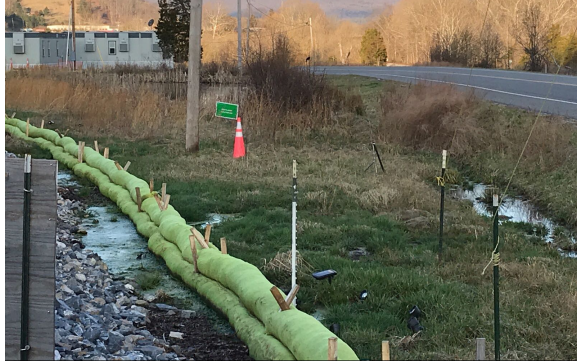
GPS Location	37.23	Field Station#	+0	GPS Location	37.23	Field Station#	+0
Description	MVP-PY-006_031819 feature signage. Looking W. See photo for gps data.			Description	MVP-PY-006_031819 condition of containment under light plant. Looking N. See photo for gps data.		
<div>DIRECTION S (T)</div> <div>+37.23511° -080.22870°</div> <div>ACCURACY 16 ft DATUM WGS84</div>

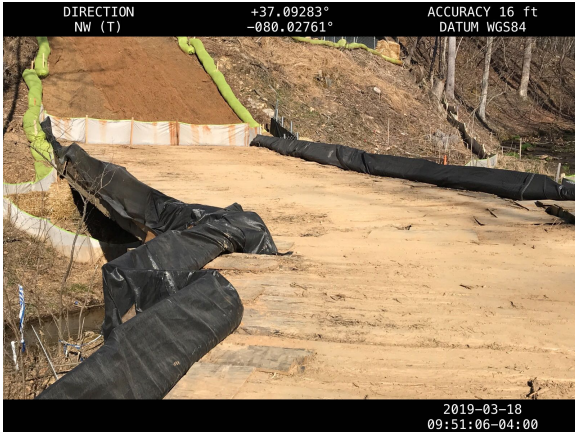
Description		13352+23_031819 S-RR09 mat bridge clean and closed. Looking NW. See photo for gps data.						Description		13321+47_031819 S-GH15 mat bridge clean and closed. Looking N. See photo for gps data.					
<div>DIRECTION W (T) +37.10397° -080.04433° ACCURACY 16 ft DATUM WGS84</div>

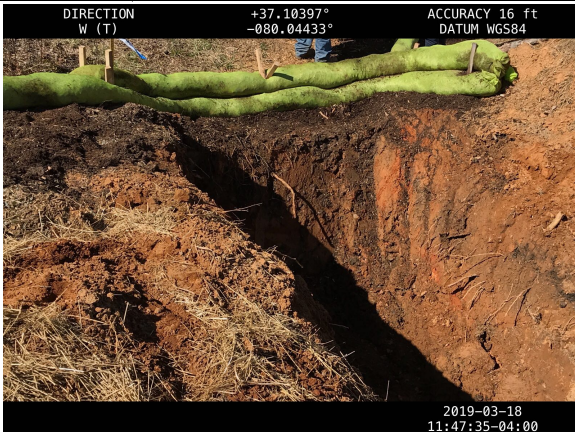
<div>2019-03-18 13:48:43-04:00</div>											
GPS Location		37.10		Field Station#		13340+50		GPS Location		37.10		Field Station#		13337+13	
Description		13340+50_031819 sump cleaned out and end treatment replaced. Looking W. See photo for gps data.						Description		13337+13_031819 CFS replaced. Looking N. See photo for gps data.

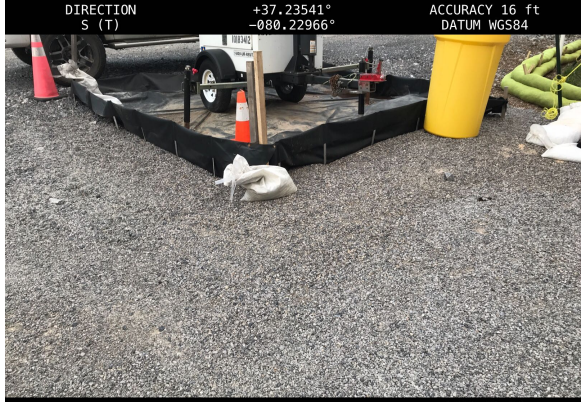
GPS Location	37.23	Field Station#	+0	GPS Location	37.23	Field Station#	+0
Description	MVP-PY-006_032219 condition of containment under light plant. Looking S. See photo for gps data.			Description	MVP-PY-006_032219 condition of CFS along boundary. Looking E. See photo for gps data.

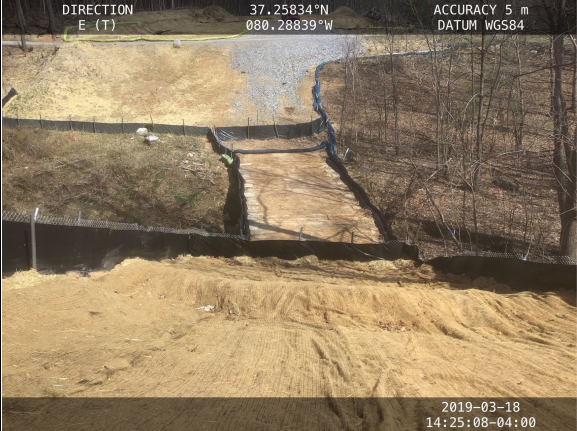
Insert image here			
GPS Location		37.25		Field Station#		12101+57		GPS Location			
Description		Stream S-MM11, facing east. Bridge and ECDs in satisfactory condition.						Description			
Insert image here				Insert image here							
GPS Location				Field Station#				GPS Location			
Description								Description			
Insert image here				Insert image here							
GPS Location				Field Station#				GPS Location			
Description								Description			
Insert image here				Insert image here							
GPS Location				Field Station#				GPS Location			
Description								Description

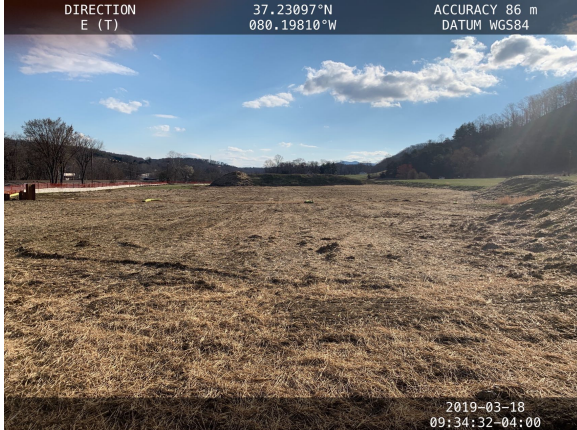
<div>2019-03-18 09:35:58-04:00</div>				
GPS Location	37.23	Field Station#	12445+00	GPS Location	37.23	Field Station#	12446+26
Description	Stabilized ROW. Looking E. See picture for GPS data.			Description	Clean water diversion berm. Looking E. See picture for GPS data.		
<div>DIRECTION N (T)</div> <div>37.23084°N 080.19742°W</div> <div>ACCURACY 5 m DATUM WGS84</div>

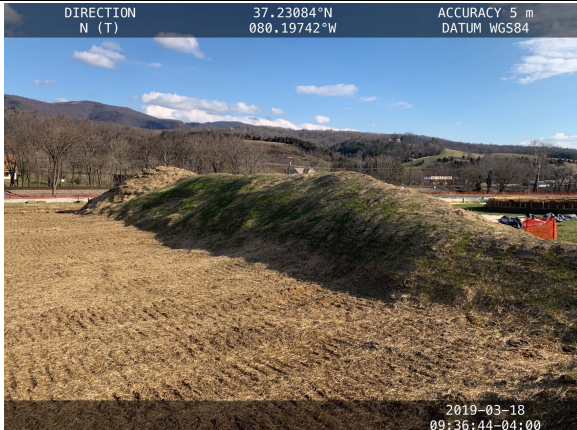
Description	Stabilized topsoil pile. Looking N. See picture for GPS data.			Description	Dewatering structure. Looking NE. See picture for GPS data.		
<div>DIRECTION S (T)</div> <div>37.23101°N 080.19788°W</div> <div>ACCURACY 61 m DATUM WGS84</div>

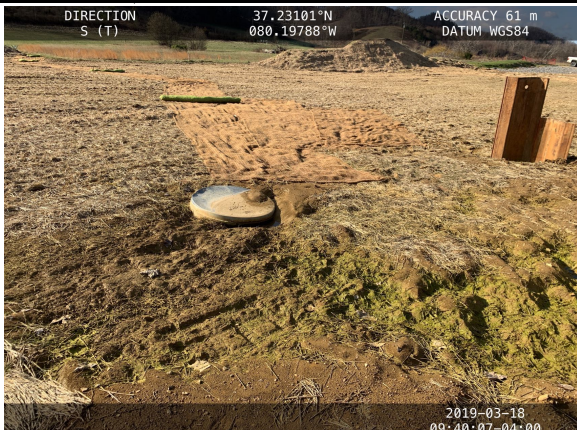
<div>2019-03-18 09:42:06-04:00</div>				
GPS Location	37.23	Field Station#	12445+43	GPS Location	37.23	Field Station#	12449+38
Description	Night cap covering up well point pumping system. Looking S. See picture for GPS data.			Description	Stabilized disturbed variance. Looking W. See picture for GPS data.

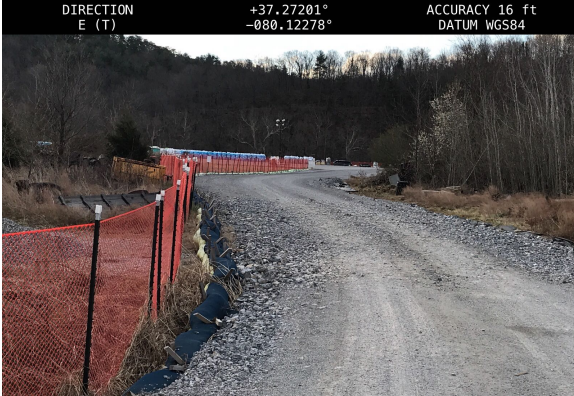
<div>2019-03-22 08:19:57-04:00</div>		
GPS Location	37.27	Field Station#	+0		
Description	MVP-LY-049_032219 condition on rock entrance. Looking E. See photo for gps data.				
<div>DIRECTION NW (T)</div> <div>+37.27097° -080.12190°</div> <div>ACCURACY 16 ft DATUM WGS84</div>

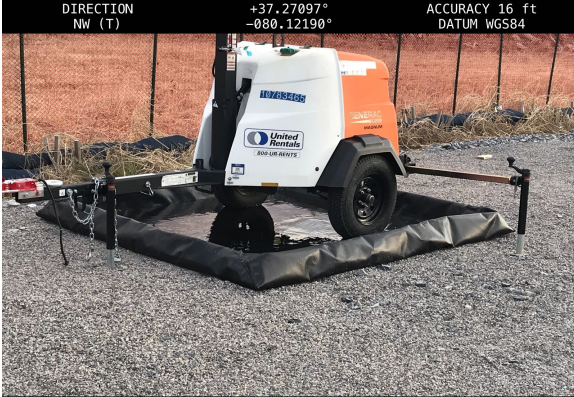
<div>2019-03-22 08:21:08-04:00</div>		
GPS Location	37.27	Field Station#	+0		
Description	MVP-LY-049_032219 condition of containment under light plant. Looking NW. See photo for data.

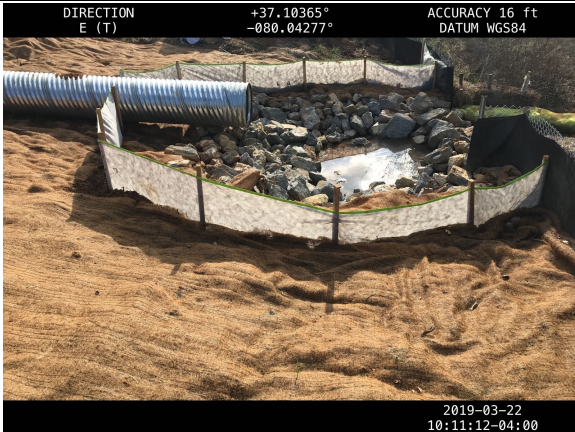
Description	13345+00_032219 clear Water Cross Over plunge pool. Looking E. See photo for gps data.			Description	13352+23_032219 S-RR09 mat bridge clean and closed. Looking SE. See photo for gps data.		
<div>DIRECTION SW (T) <div>+37.10621° -080.04929° ACCURACY 33 ft DATUM WGS84</div></div>

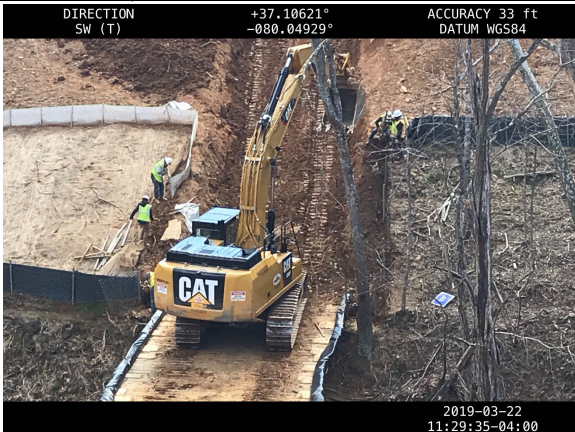
<div>2019-03-22 13:42:28-04:00</div>				
GPS Location	37.27	Field Station#	13325+30	GPS Location	37.27	Field Station#	13404+00
Description	13325+30_032219 S-GH14 crew preforming maintenance on ECD's at bridge. Looking SW. See photo for gps data.			Description	13404+00_032219 repaired CFS In J Hook on sump. Looking SE. See photo for gps data.

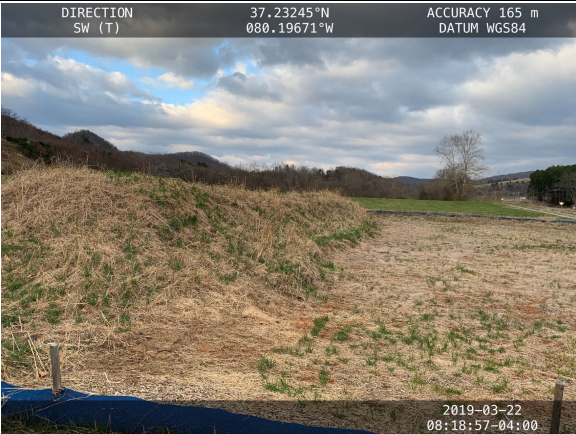
GPS Location	37.33	Field Station#	12448+50	GPS Location	37.33	Field Station#	12245+27
Description	Stabilized topsoil pile. Looking SW. See picture for GPS data.			Description	CFS checks for filtration purposes. Looking W. See picture for GPS data.

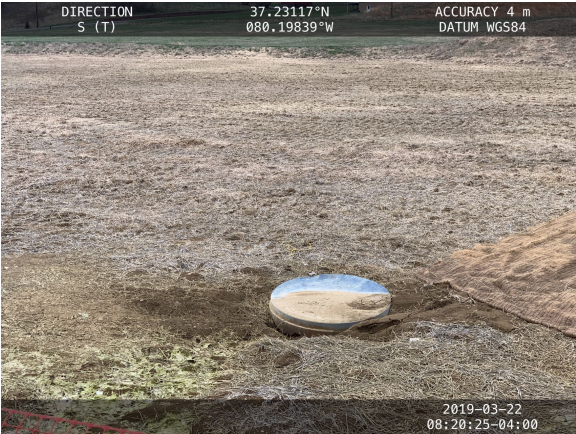
GPS Location	37.33	Field Station#	12245+60	GPS Location	37.33	Field Station#	12246+00
Description	End cap covering up the well point system. Looking S. See picture for GPS data.			Description	Erosion control blanket lined drainage with checks along the way. Looking S. See picture for GPS data.
