# Visual Site Inspection Report

<b>Project Name</b>	H-600 Pipeline Spread G	<b>AFE</b>	124300137	<b>Spread</b>	H-600 Pipeline Spread G
<b>Contractor</b>	Precision			<b>Report #</b>	17729
<b>Inspector</b>	Len Kruizenga			<b>Date/Time</b>	5/28/2019 7:46 AM
<b>Permit #</b>	TBD	<b>Inspection Type</b>	VA SWPP	<b>Station Begin</b>	12005+00
<b>State</b>	VA	<b>Inspection Area</b>	Full	<b>Station End</b>	12005+00
<b>County</b>	Giles	<b>Ground</b>	Wet	<b>Temperature (°F)</b>	90.00
<b>Municipality</b>	N/A	<b>Weather</b>	Sunny	<b>Rain Gauge (in)</b>	1.50
				<b>Rain Accumulation Time (days)</b>	2.00

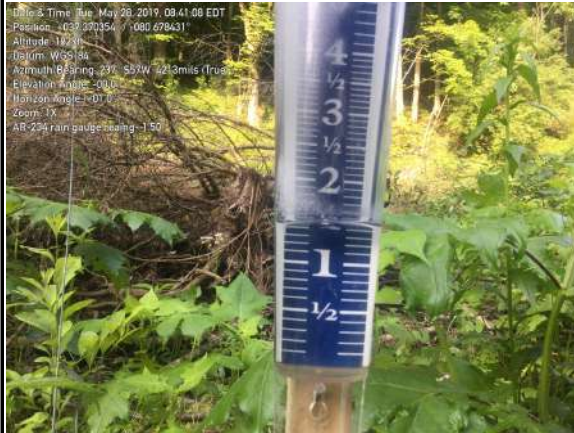
</div></div></div>			<div><div><div><div><div><div><span>Date &amp; Time: Tue, May 28, 2019 09:41:00 EDT</span></div><div><span>Position: +002.542137° / +000.678431°</span></div><div><span>Altitude: 1625ft</span></div><div><span>Datum: WGS84</span></div><div><span>Azimuth Bearing: 231° 55'W 523mils (True)</span></div><div><span>Elevation Angle: -00.0°</span></div><div><span>Horizon Angle: -00.0°</span></div><div><span>Zoom: 1X</span></div><div>AR-234 rain gauge reading: -1.50"</div></div></div></div><div>

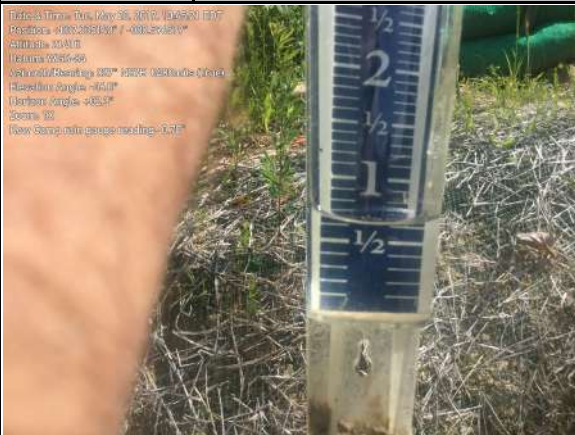
GPS Location	37.33	Field Station#	11677+00	GPS Location	37.33
Description	Buffalo Anklets rain gauge reading-0.80"		Description	AR-234 rain gauge reading- 1.50"	
<div><div><div><div><div><div><span>Date &amp; Time: Tue, May 28, 2019 10:55:00 EDT</span></div><div><span>Position: +002.568137° / +000.550135°</span></div><div><span>Altitude: 2868ft</span></div><div><span>Datum: WGS84</span></div><div><span>Azimuth Bearing: 329° 35'W 2293mils (True)</span></div><div><span>Elevation Angle: -05.7°</span></div><div><span>Horizon Angle: -00.0°</span></div><div><span>Zoom: 1X</span></div><div>Kow Camp rain gauge reading: -0.70"</div></div></div></div><div>

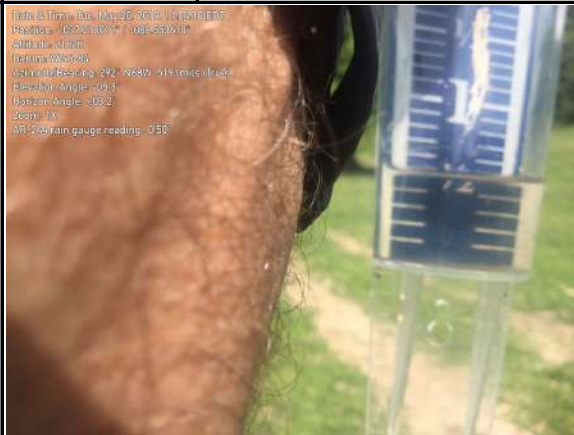
</div></div></div>			<div><div><div><div><div><div><span>Date &amp; Time: Tue, May 28, 2019 11:24:54 EDT</span></div><div><span>Position: +002.501337° / +000.501353°</span></div><div><span>Altitude: 2868ft</span></div><div><span>Datum: WGS84</span></div><div><span>Azimuth Bearing: 242° 46'W 214mils (True)</span></div><div><span>Elevation Angle: -05.1°</span></div><div><span>Horizon Angle: -00.0°</span></div><div><span>Zoom: 1X</span></div><div>AR-244 rain gauge reading: -0.50"</div></div></div></div><div>

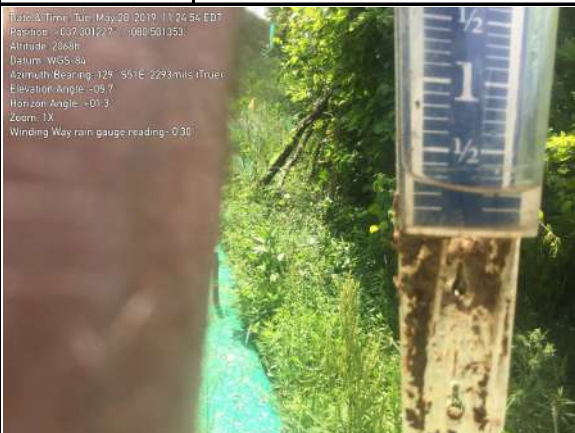
GPS Location	37.33	Field Station#	10888+00	GPS Location	37.33
Description	Kow Camp rain gauge reading-0.70"		Description	AR-244- rain gauge reading- 0.50"	
<div><div><div><div><div><div><span>Date &amp; Time: Tue, May 28, 2019 11:24:54 EDT</span></div><div><span>Position: +002.501337° / +000.501353°</span></div><div><span>Altitude: 2868ft</span></div><div><span>Datum: WGS84</span></div><div><span>Azimuth Bearing: 329° 35'W 2293mils (True)</span></div><div><span>Elevation Angle: -05.7°</span></div><div><span>Horizon Angle: -00.0°</span></div><div><span>Zoom: 1X</span></div><div>Winding Way rain gauge reading: -0.30"</div></div></div></div><div>

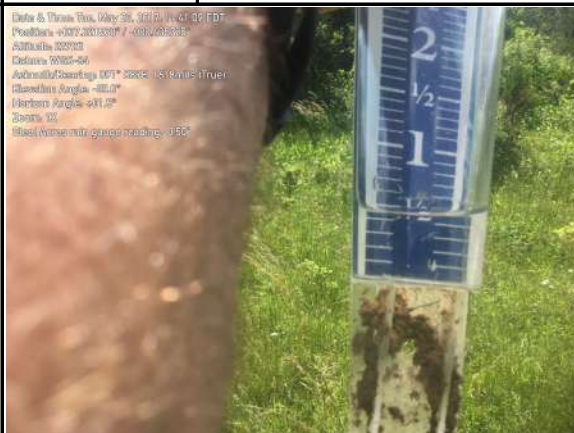
</div></div></div>			<div><div><div><div><div><div><span>Date &amp; Time: Tue, May 28, 2019 11:43:22 EDT</span></div><div><span>Position: +002.501337° / +000.501353°</span></div><div><span>Altitude: 2868ft</span></div><div><span>Datum: WGS84</span></div><div><span>Azimuth Bearing: 329° 35'W 2293mils (True)</span></div><div><span>Elevation Angle: -05.7°</span></div><div><span>Horizon Angle: -00.0°</span></div><div><span>Zoom: 1X</span></div><div>Steel Acres rain gauge reading: -0.50"</div></div></div></div><div>

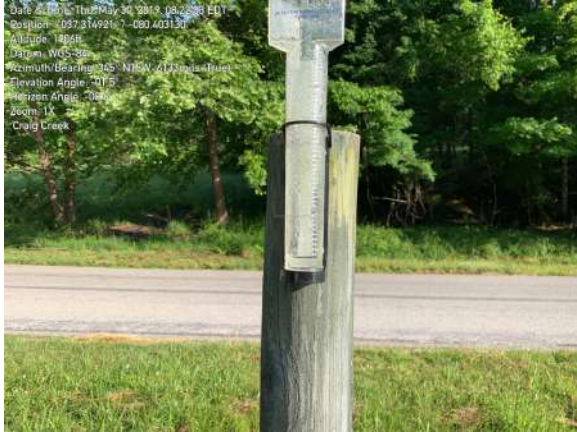
GPS Location	37.18	Field Station#	11613+00	GPS Location	37.18	Field Station#	11469+00
Description	See photo for GPS location. Rain gauge at Craig Creek Road. Reading is 0.4 inches.			Description	See photo for GPS location. Sump pit with silt fence end treatment in place.

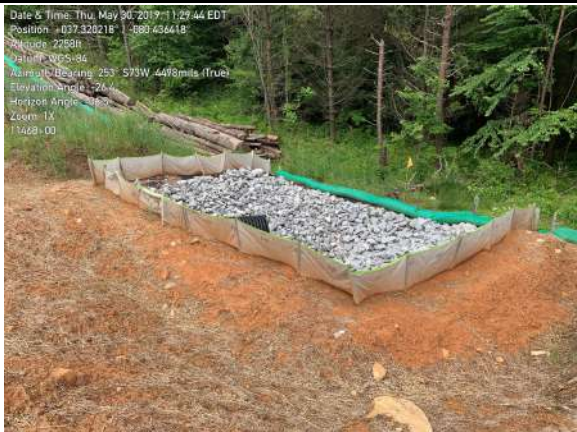
GPS Location	37.18	Field Station#	11468+00	GPS Location	37.18	Field Station#	11403+00
Description	See photo for GPS location. Plunge pool in place.			Description	See photo for GPS location. Rock lined channel in place over fill slope.

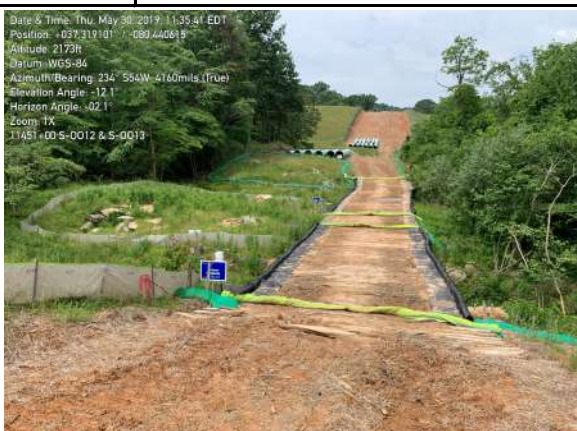
GPS Location	37.18	Field Station#	11451+00	GPS Location	37.18	Field Station#	11381+00
Description	See photo for GPS location. Sensitive resource buffer in place at streams S-0012 and S-0013.			Description	See photo for GPS location. Reinforced silt fence, triple stack CFS, and priority one silt fence in place due to karst feature off ROW.

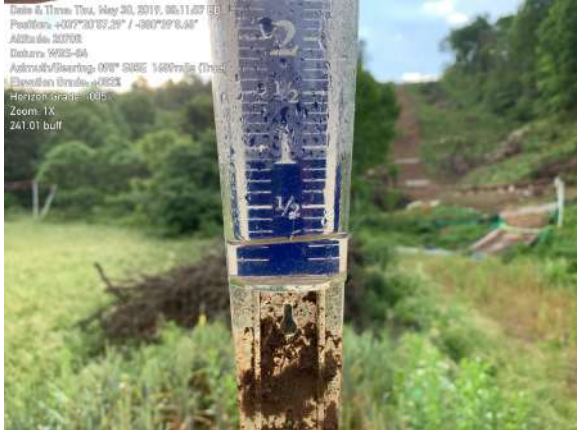
<p>Date &amp; Time: Thu, May 30, 2019, 08:22:19 EDT Position: +037° 22' 13.04" / -080° 40' 42.23" Altitude: 1763ft Datum: WGS-84 Azimuth/Bearing: 267° 54' 57" 439ftmils (True) Elevation Grade: +005% Horizon Grade: +001% Zoom: 1X 234</p>				
GPS Location	37.24	Field Station#	2+41	GPS Location	37.24	Field Station#	2+34
Description	.2" of rain collected @ AR 241.01			Description	.2" of rain collected @ AR 234

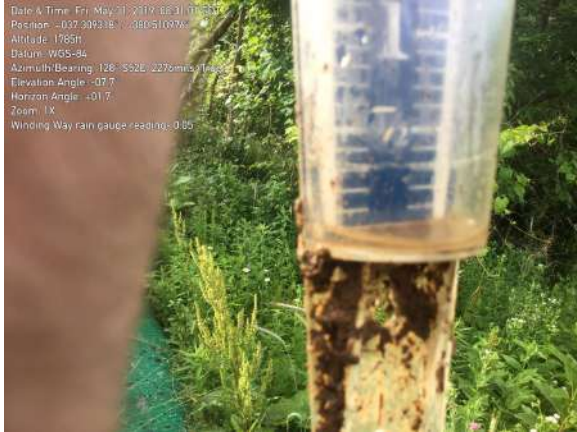
A/E	124300137	Date/Time	5/31/2019 7:22 AM	Report #	17908
Pictures					
<p>Date &amp; Time: Fri, May 31, 2019 08:31:01 EDT Position: -037.304318° / -050.510970° Altitude: 1785ft Datum: WGS-84 Azimuth/Bearing: 126.5526, 2276mils (True) Elevation Angle: -07.7° Horizon Angle: -01.7° Zoom: 1X Winding Way rain gauge reading: 0.05"</p>

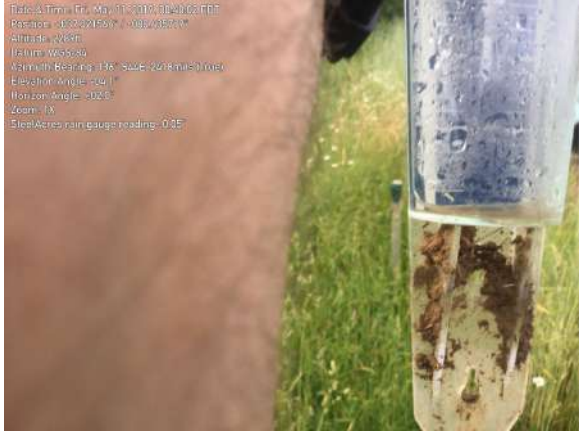
<p>Date &amp; Time: Fri, May 31, 2019 08:20:02 EDT Position: -037.291577° / -00.739270° Altitude: 200ft Datum: WGS-84 Azimuth/Bearing: 136.5456, 2218mils (True) Elevation Angle: -04.1° Horizon Angle: -02.5° Zoom: 1X Steel Acres rain gauge reading: 0.05"</p>

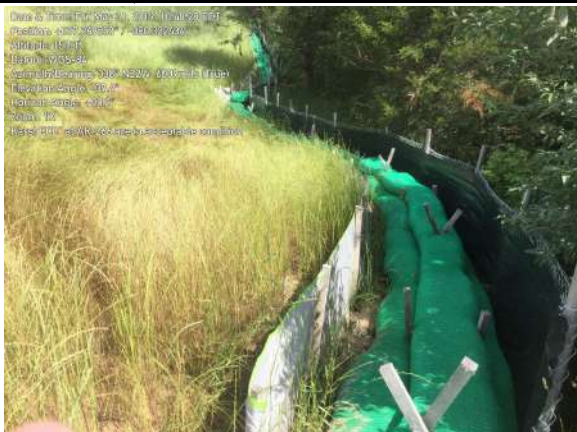
GPS Location	37.26	Field Station#	11988+00	GPS Location	37.27
Description	Catawba rain gauge reading- 0.10"		Description	Contractor replaced down P1 at Karst.	
<p>Date &amp; Time: Fri, May 31, 2019 11:24:52 EDT Position: -037.263527° / -080.327721° Altitude: 1919ft Datum: WGS-84 Azimuth/Bearing: 010.5226, 1687mils (True) Elevation Angle: -06.1° Horizon Angle: -01.0° Zoom: 1X Karst ECD's are in good condition.</p>

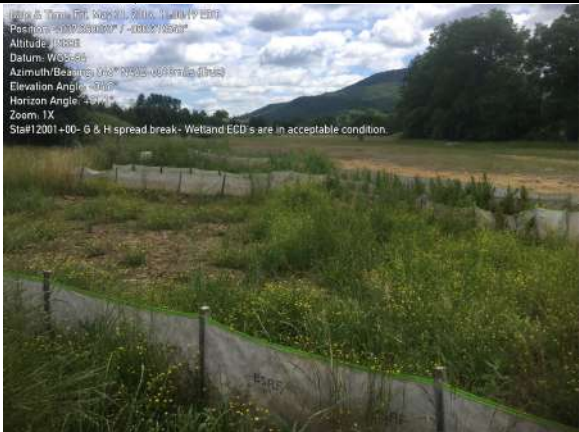
<p>Date &amp; Time: Fri, May 31, 2019 11:40:19 EDT Position: -037.263527° / -080.327721° Altitude: 1919ft Datum: WGS-84 Azimuth/Bearing: 010.5226, 1687mils (True) Elevation Angle: -06.1° Horizon Angle: -01.0° Zoom: 1X Staff 12001+00- G &amp; H spread break- Wetland ECD's are in acceptable condition.</p>

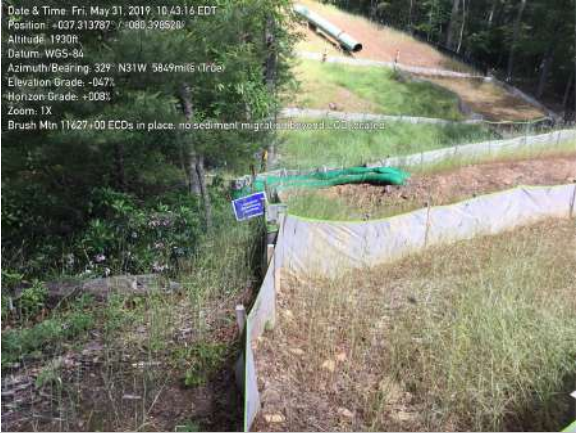
<b>AFE</b>	124300137	<b>Date/Time</b>	5/31/2019 11:47 AM	<b>Report #</b>	17919		
<b>Pictures</b>							
<p>Date &amp; Time: Fri, May 31, 2019, 10:43:16 EDT  Position: +037.313787° / -080.376588°  Altitude: 1920ft  Datum: WGS-84  Azimuth/Bearing: 329° N31W 58.69mils (True)  Elevation Grade: -047%  Horizon Grade: +008%  Zoom: 1X  Brush Min 11627+00 ECDs in place, no sediment migration observed. ECDs in place.</p>

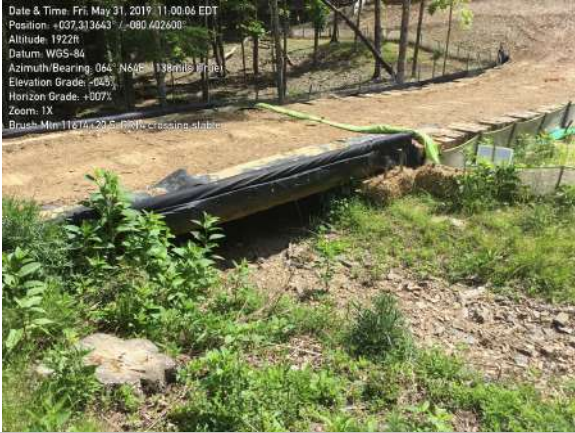
<p>Date &amp; Time: Fri, May 31, 2019, 11:00:08 EDT  Position: +037.313643° / -080.402600°  Altitude: 1922ft  Datum: WGS-84  Azimuth/Bearing: 064° N64E 138.6mils (True)  Elevation Grade: -043%  Horizon Grade: +007%  Zoom: 1X  Brush Min 11614+20 S-RR14 crossing stable.</p>

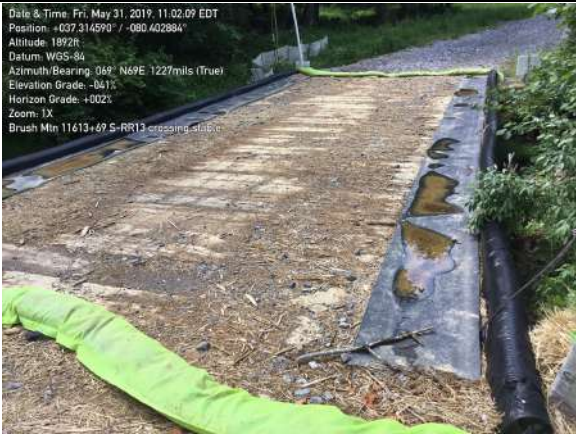
<p>Date &amp; Time: Fri, May 31, 2019, 11:02:09 EDT  Position: +037.314590° / -080.402884°  Altitude: 1892ft  Datum: WGS-84  Azimuth/Bearing: 089° N69E 1227mils (True)  Elevation Grade: -041%  Horizon Grade: +002%  Zoom: 1X  Brush Min 11613+69 S-RR13 crossing stable.</p>

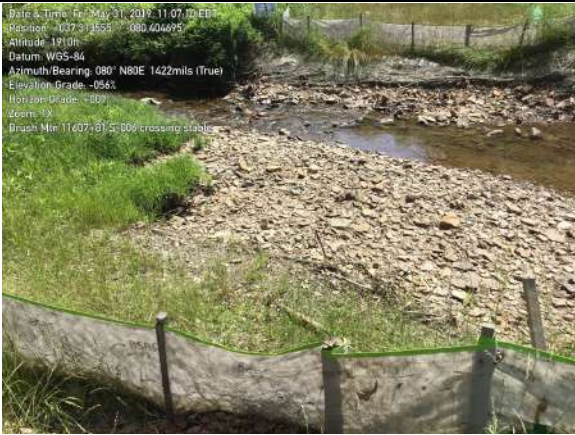
<p>Date &amp; Time: Fri, May 31, 2019, 11:07:10 EDT  Position: +037.313553° / -080.404695°  Altitude: 1910ft  Datum: WGS-84  Azimuth/Bearing: 080° N80E 1422mils (True)  Elevation Grade: -054%  Horizon Grade: -039%  Zoom: 1X  Brush Min 11607+81 S-RR13 crossing stable.</p>

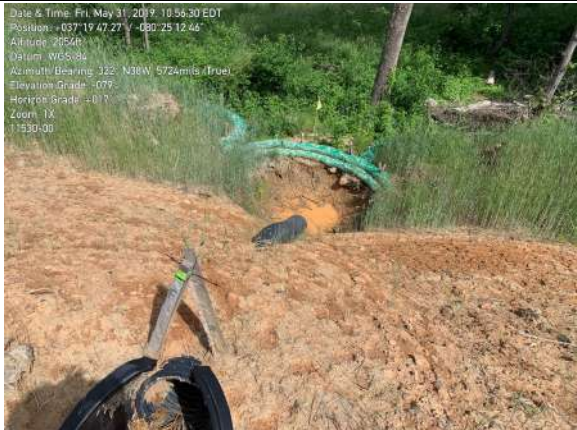
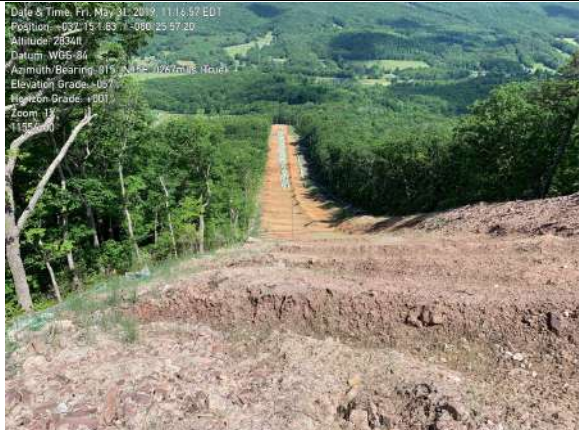
GPS Location	37.24	Field Station#	11530+00	GPS Location	37.24	Field Station#	11556+00
Description	ECD's and ROW conditions			Description	ECD's and ROW conditions

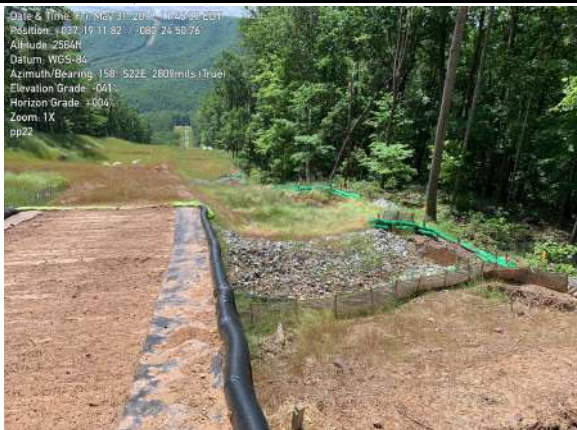
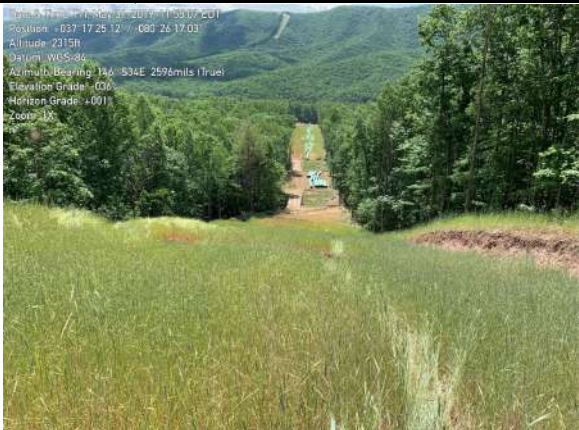
GPS Location	37.24	Field Station#	11570+00	GPS Location	37.24	Field Station#	11590+00
Description	ECD's and ROW conditions			Description	ECD's and ROW conditions

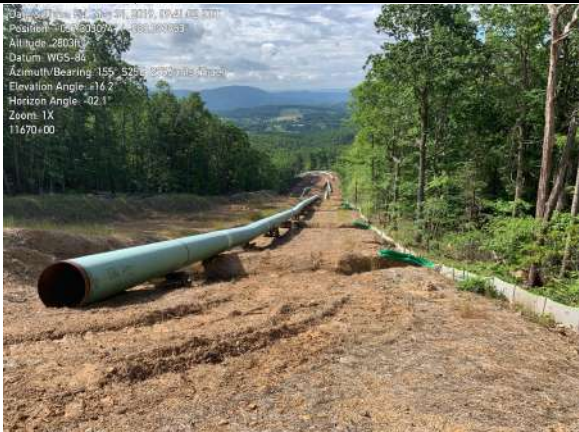
GPS Location	37.18	Field Station#	11767+00	GPS Location	37.18	Field Station#	11670+00
Description	See photo for GPS location. Rain gauge at Mount Tabor Road.			Description	See photo for GPS location. Waterbars, sump pits, and end treatments in place.

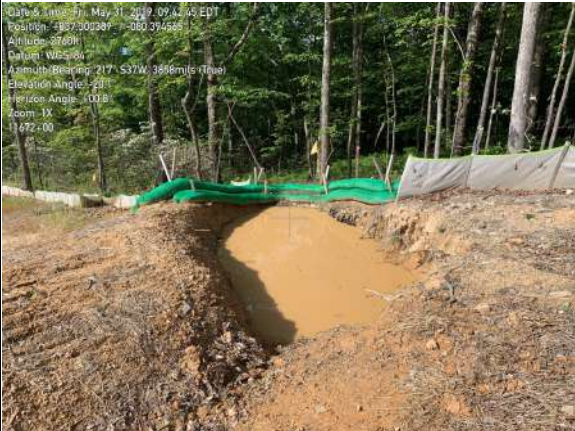
<b>GPS Location</b>	37.18	<b>Field Station#</b>	11672+00	<b>GPS Location</b>	37.18	<b>Field Station#</b>	11674+00
<b>Description</b>	See photo for GPS location. Sump pit and end treatment in place.			<b>Description</b>	See photo for GPS location. Rock lined channel in place over two tone.

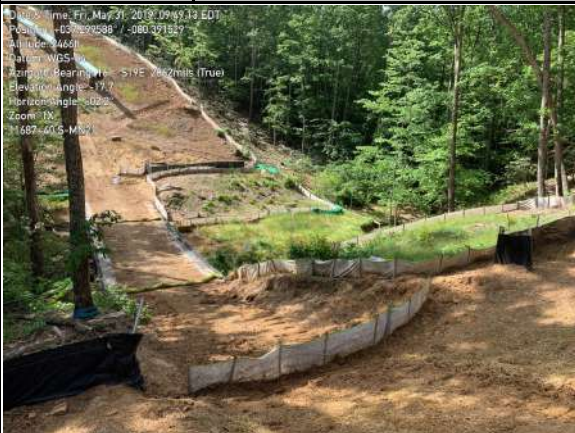
<b>GPS Location</b>	37.18	<b>Field Station#</b>	11676+40	<b>GPS Location</b>	37.18	<b>Field Station#</b>	11731+00
<b>Description</b>	See photo for GPS location. Sensitive resource buffer in place at stream S-MN21.			<b>Description</b>	See photo for GPS location. Waterbar, priority one silt fence end treatment in place.
